Blackbeck Gunpowder Works,
Cumbria:
an archaeological
and architectural survey

SURVEY REPORT

Archaeological Investigation Report Series AI/32/2004

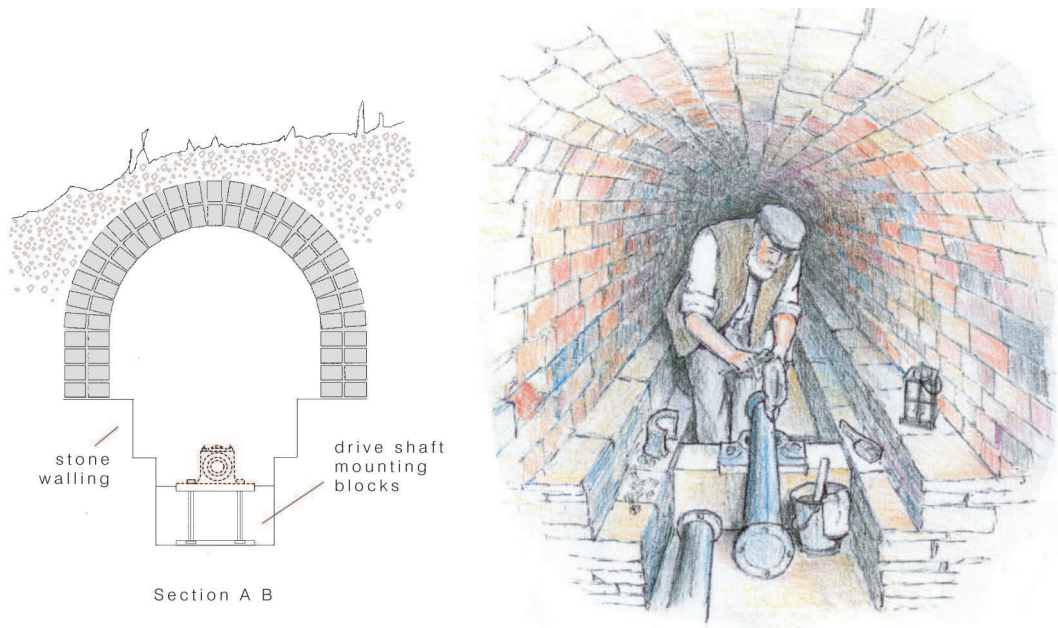
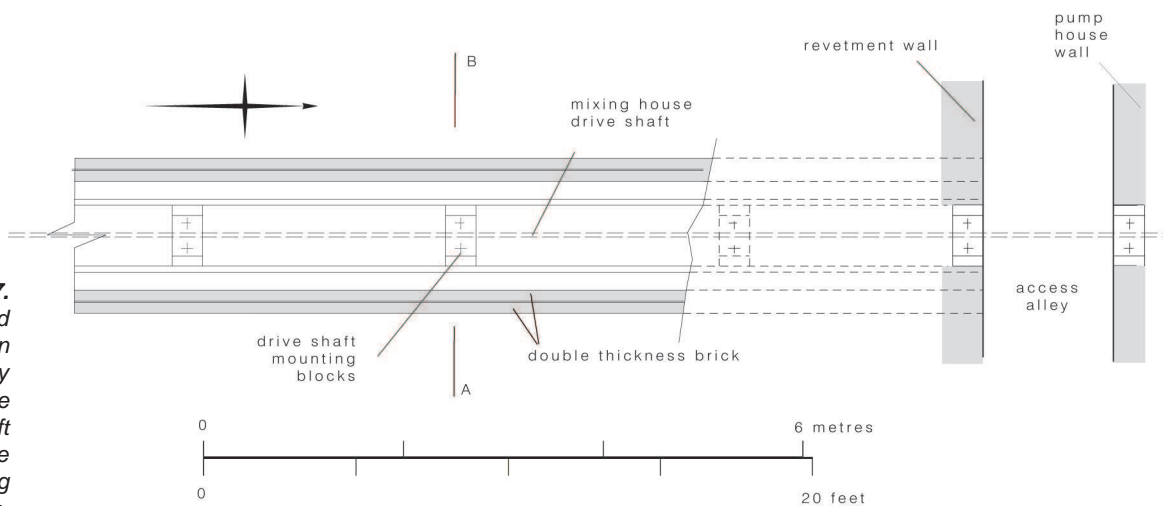
Figure 47. Section, plan and reconstruction drawing by English Heritage of the drive shaft tunnel to the second mixing house.

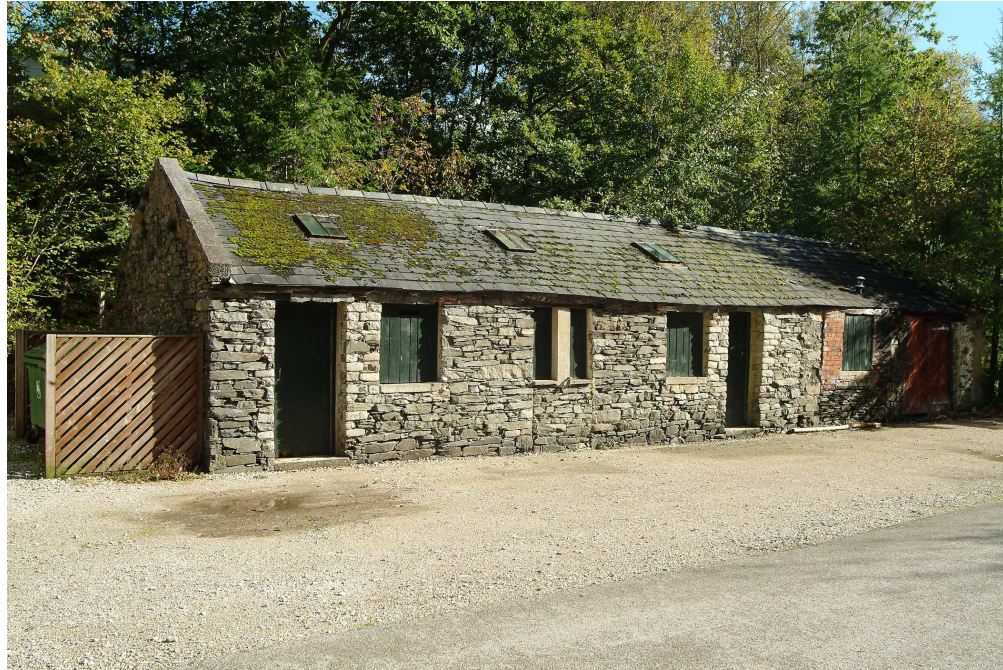
Figure 48.
*Building range east of
 the incorporating mills,
 from the north west.*
 (NMR: DP004099)

The northern end of the range, equivalent to compartments 34-36 of the 1928 site plan, still survives (Fig 48) and consists of a single-storey stone rubble structure under a slate roof, gabled north to south; overall this surviving part measures 17m by 6m. The northern end seems to have been built as a single long room with a central doorway between two windows, its roof supported on two identical trusses with king post trusses. The king posts are bolted to the tie beams, and both they and the principal rafters have decorative run-out chamfers. When this room was subdivided, its original doorway was blocked and new doorways were inserted into the two rooms north and south of the subdividing wall, one the laboratory in 1928, the other the wash house - it still contains sinks. The lintel of the original doorway is a reused length of cast-iron tram rail whereas all the other lintels are of timber with external slate sheathing. The two inserted doorways, and the adjacent edges of the two windows, are built with distinctive stones which incorporate quartzite, confirming both their association and contemporaneity. The cross wall which runs back from the blocked original doorway is built of breeze blocks, with glazed lights contrived either side of it above the blocked base. The southern end of the surviving range, a case making shed in 1928, appears to abut the north end just described, on the evidence of a straight joint, and originally to have had two tall wide openings in its front wall. The southern one still functions, but the northern one has been blocked in two stages - the base is full width stone with a narrower window set between red brick blocking. The doorway and window both have timber lintels. Two windows

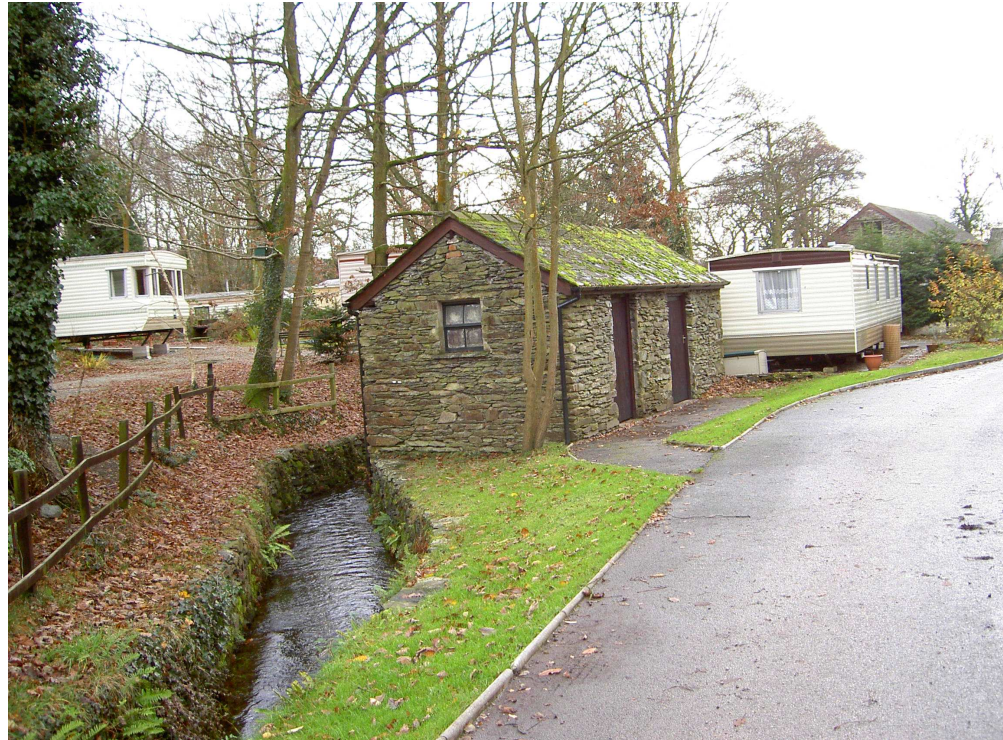
Figure 49.
Oil store from the north west. The store and stable (right) is visible in the background.
(Christopher Dunn, November 2003)

This small building (Fig 49), situated on the western side of the beck a short distance north west of the charcoal house, is shown but not annotated on both the 1881 site plan and the first edition of the OS 25" map (Ordnance Survey 1890b). It is annotated 'Store' on the site plan of 1898 and 'Oil Store' on the 1928 plan, on which it is numbered 37. It is a single-storey rectangular building, gabled north to south, and measures 8.7m by 3.4m. It has walls of coursed rubble and a slated roof. Its west front wall has two doorways, one wider than the other, and both with modern concrete lintels. There is a small window with a slate lintel in the north gable wall. The building, at the time of survey, was used by the caravan park for storage.

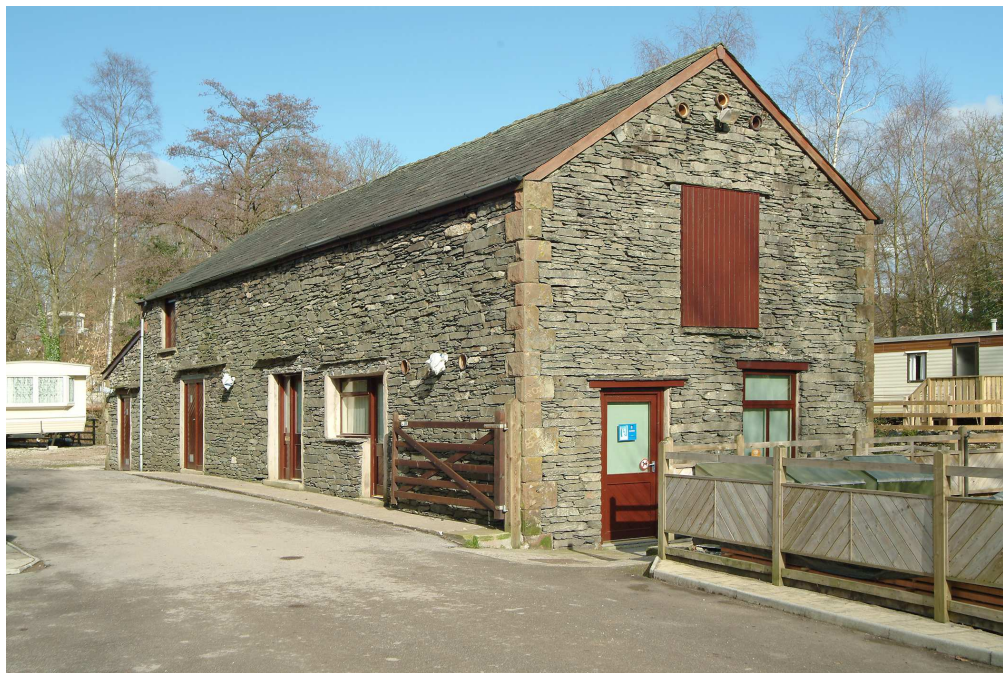
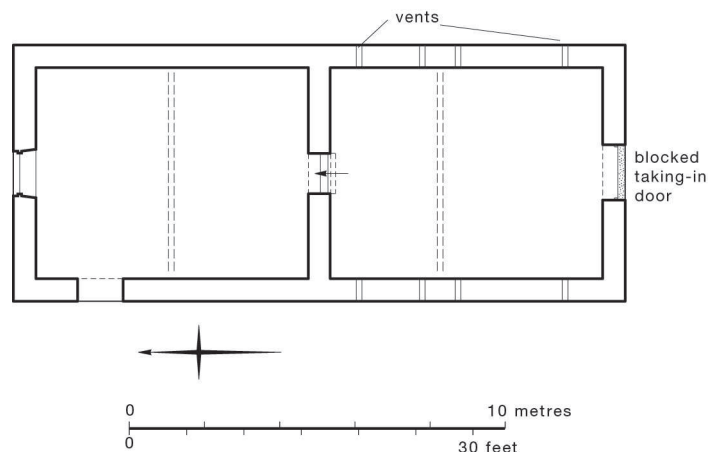
Figure 50.
Store and stable
looking north east
(NMR: DP003425)
and plan of first floor
by English Heritage.

This building (Fig 50), aligned north-south, is situated against the west side of the beck and is now separated from the saltpetre house by the main caravan park road - the latter follows the line of the principal factory road and tramway which served the gunpowder works. It had been erected by the time the 1898 site plan was prepared and replaced a much smaller rectangular building shown here on both the 1881 site plan and the first edition of the OS 25" map (surveyed 1888). It is suggested above (section 6.1.2) that this earlier structure may have been the sulphur store. On the 1898 site plan the later building is subdivided internally into two unequal parts with the much longer northern compartment labelled 'Store' while the one to the south is annotated 'Stable'. On the 1913 edition of the OS 25" map (revised 1911) it measures 20m by 5m overall and is linked by a probable wall extending north to the old office and carpenters store, and east to the cylinder house; the wall was probably installed to restrict access to the principal processing area of the works. On the 1928 site plan the building is labelled 'Store' (although the writing suggests that this may have been added later); it still survives and at the time of survey contained toilets and a shop for the caravan park.

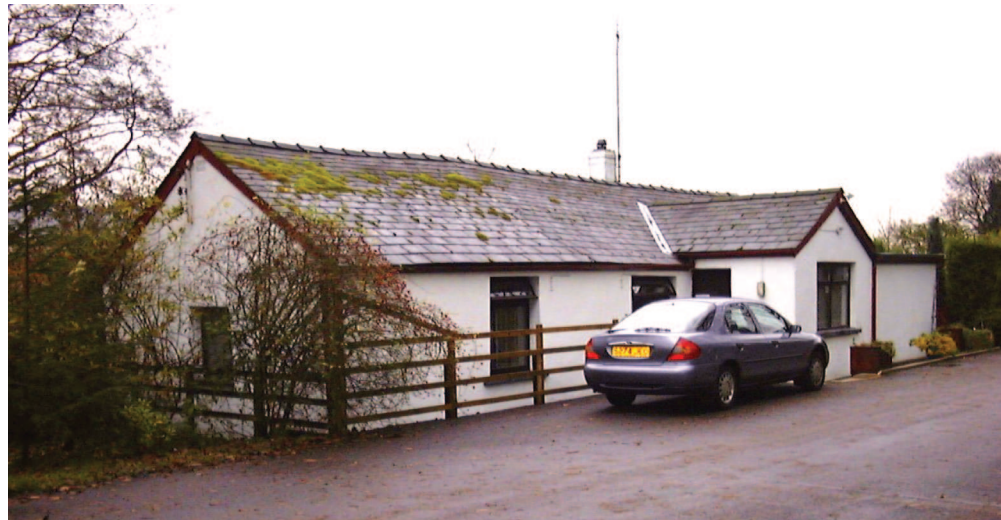
Figure 52.
Caravan park
manager's new house
from the north west.
Single storey part to
left incorporates north
end of weigh office
and store.
(NMR: DP003426)

When EH made a preliminary visit to Blackbeck at the end of 2000 the building was still a dwelling for the caravan park's site manager and consisted of a single-storeyed bungalow, rendered on the outside, under a slated roof (Fig 51). However when the EH investigators returned in late 2003 they found that the southern part of this building had been demolished and replaced with a much taller house for the site manager, built on a different alignment but still with a projection on its north side (Fig 52). Apparently this projection, although re-roofed and newly rendered, still contains the northern end of the gunpowder building in its fabric and during construction of the new house the remains of a weighbridge were also observed (Mike Thwaites, *pers comm*).

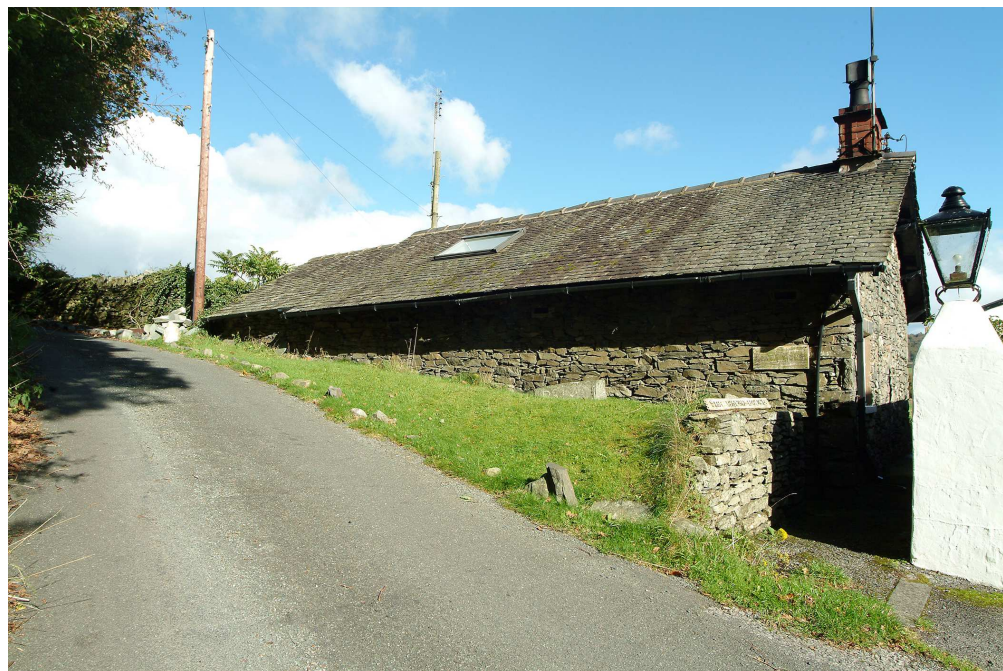
Figure 53.
*Women's changing
house from the
south west.*
(NMR: DP004104)

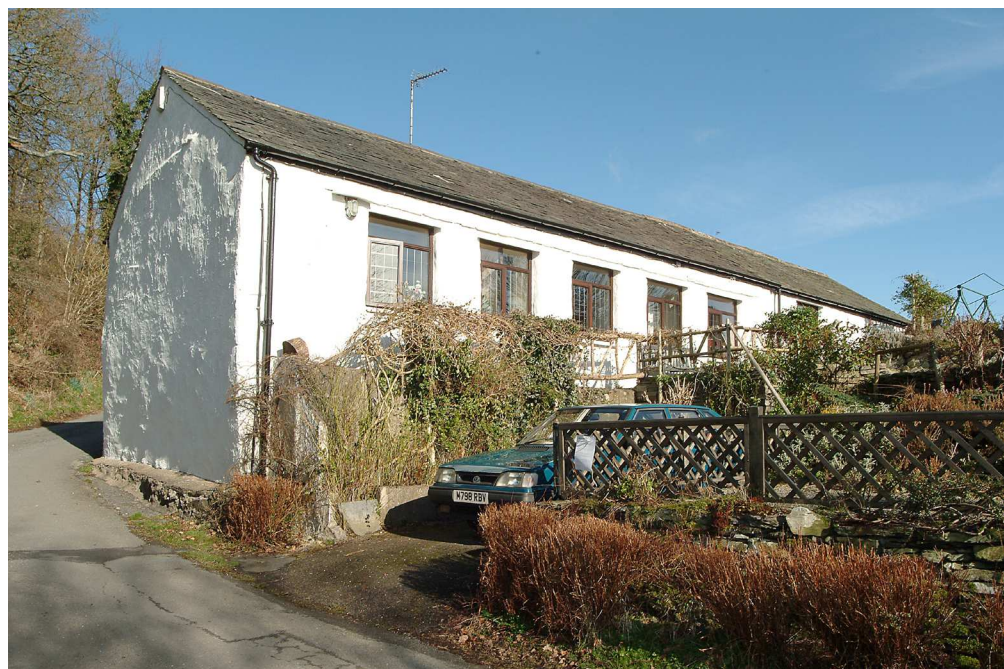
This building (Fig 54), located at the north end of a prominent rock outcrop, is situated a short distance south of the women's changing house, from which it was originally separated by a small yard or turning area off from the public road on its west side (Ordnance Survey 1913b). It is now a dwelling called The Cooperage, but it clearly has much earlier origins as

Figure 54.
Cooperage at the southern extremity of the works (near Pool Bridge), from the south. (NMR: DP003379)

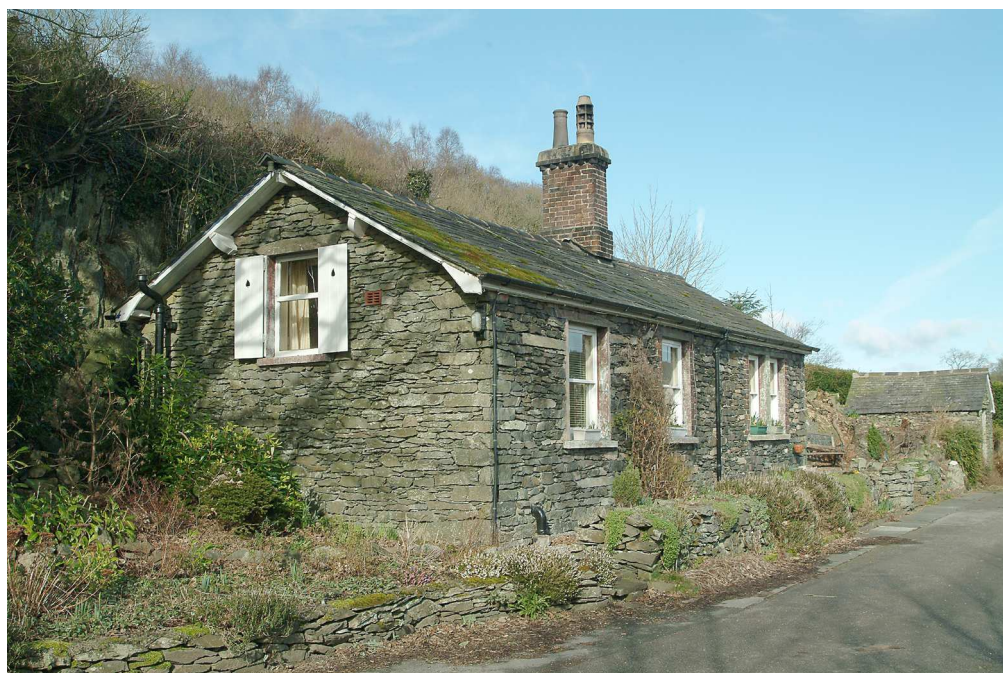
This small building, orientated almost north to south, is shown on the OS 25" maps surveyed in 1888 and revised in 1911 (Ordnance Survey 1890b; 1913b). It still survives (Fig 55) and is now a dwelling, called The Lodge, situated at Pool Bridge just inside the main entrance to the caravan park and on the west side of the access road. It originally flanked the principal road and rail link to the gunpowder works - a location which indicates that it must have been the office from which the movement of materials and products in and out of the works was controlled - apparently the office was staffed by a single clerk (note in caravan park files). The OS 1888 map shows a small projection at the south-west corner of the building but this

Figure 55.
Small office at the southern entrance of the works (near Pool Bridge), from the south.
(NMR: DP003377)

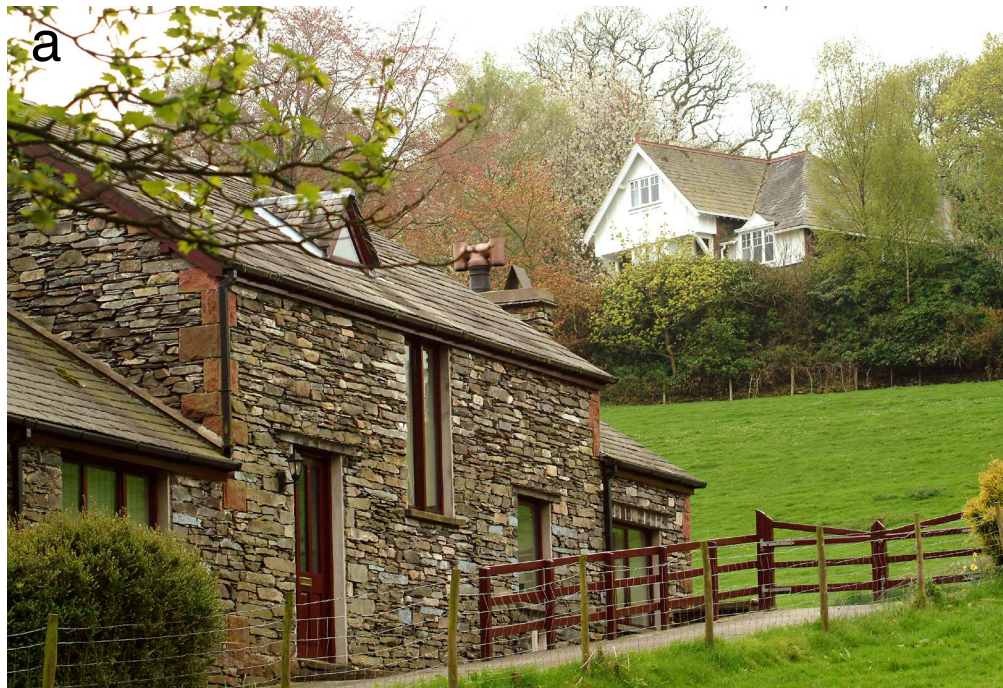
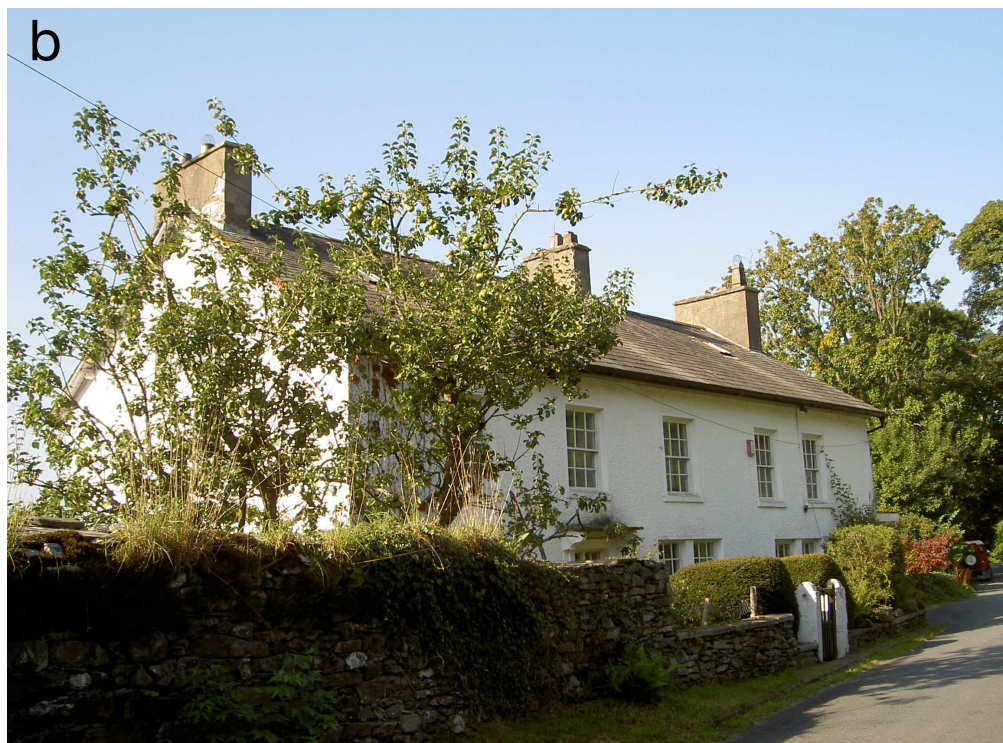
Figure 56.
Houses associated with the gunpowder works: (a) Lindeth on hillside with watch house (now Meadow Bank Cottage) in left foreground, looking south west; (b) Abbots Reading, looking north east. ((a) NMR: DP003535, (b) Christopher Dunn, October 2004)

Lindeth, now a private residence, is situated on the hillside to the west of the works (Fig 56a). It was erected for the works manager between 1888 and 1911 on the edge of what had previously been a small wood and agricultural land (Ordnance Survey 1890b; 1913b). Direct access between the house and the works was provided by a footpath, shown on both the 1913 edition of the OS 25" map and 1928 site plan, which went past the watch house. The house lay just outside the survey area and has not been investigated by EH.

This house is situated on the east side of the Rusland Pool valley, 1km from the gunpowder works on the side of a minor road linking the villages of Bouth and Rusland (Fig 56b). It has not been investigated by EH because it lay well beyond the limits of the survey area.
