THE HERMITAGE,
17 UPPER SUTTON LANE,
LB HOUNSLOW

A LATE-MEDIEVAL TIMBER-FRAMED
HALL HOUSE AT HESTON

Richard Bond & Mike Dunn

Reports and Papers B/024/2003
2003

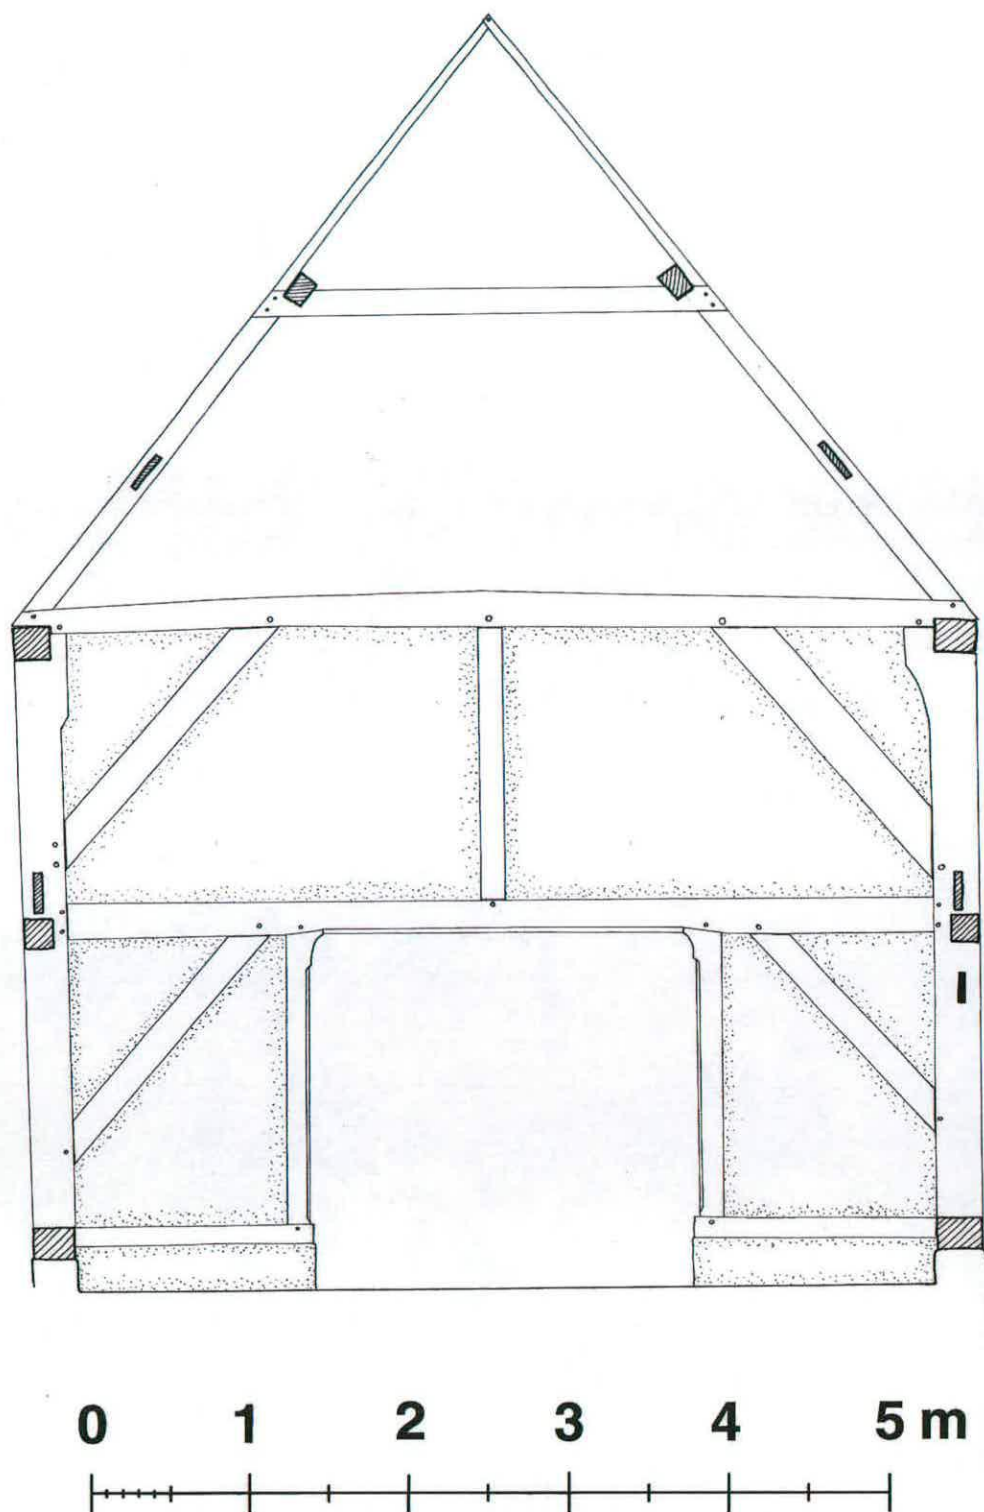
Figure 5 West elevation of east intermediate cross frame
as constructed

As constructed, the east cross frame between the hall and the cross passage resembled the spere truss of an aisled or base-cruck hall house.³ At ground floor it comprised a large central opening flanked by two short, closed, sections (*fig 5*). The closed end sections, which encompassed straight braces set between the north and south posts and the cross rail, screened the front and rear doorways and helped shield the hall from draughts and cold air blowing in from outside. The wall posts forming the jambs of the central opening were chamfered and had a stepped, curved jowl that gave the corners of the opening a rounded profile. The curvature of the jowls matched that of the carved brackets that supported the first floor mid-rails of the west cross frame and west gable frame (see below).

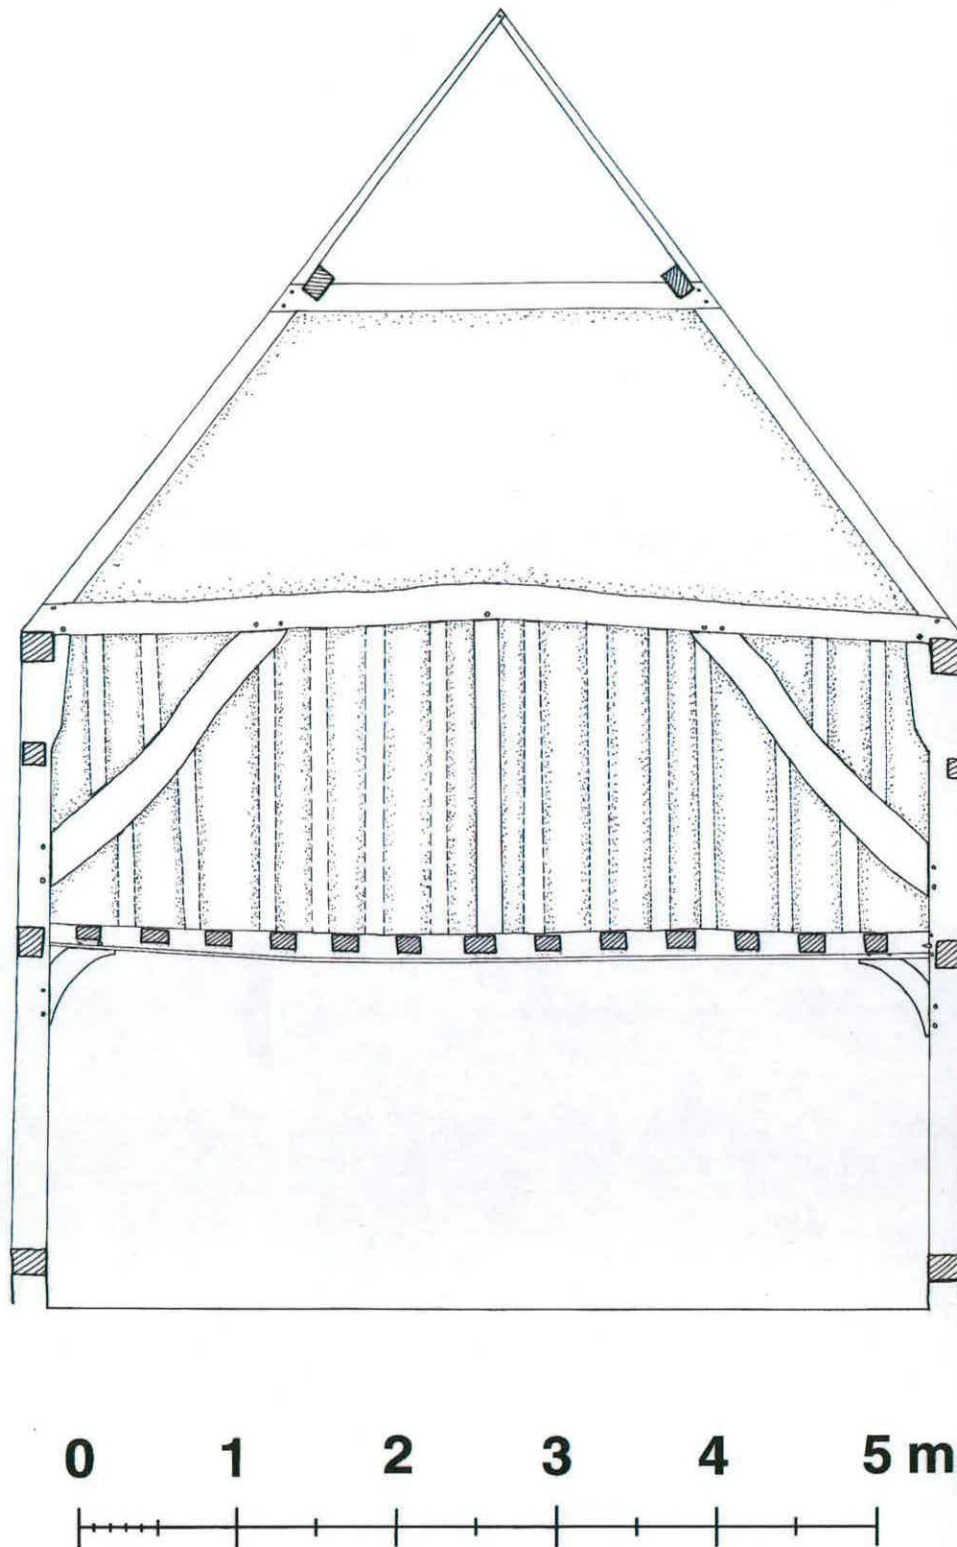
**Figure 7 West elevation of west intermediate cross frame
as constructed**

Between the hall and the solar (west) end stood a second internal cross frame. As has been mentioned, the lower part of the cross frame was left open to give a two-bay hall arrangement on the ground floor (*fig 7*). At first floor a partition wall on the line of the cross frame divided the solar chamber from the upper part of the central (open) bay. The cross frame was closed up to collar level, and between the collar and the saddle of the open gablet a short sloping section of infilling provided a ceiling for the solar chamber and kept it free of the smoke rising into the roof space from the open hall. The first floor chamber would have been accessible via a staircase set along the south wall of the west part of the hall. A mortice hole in the mid-rail of the south wall indicates the position of a trimmer joist for the staircase.

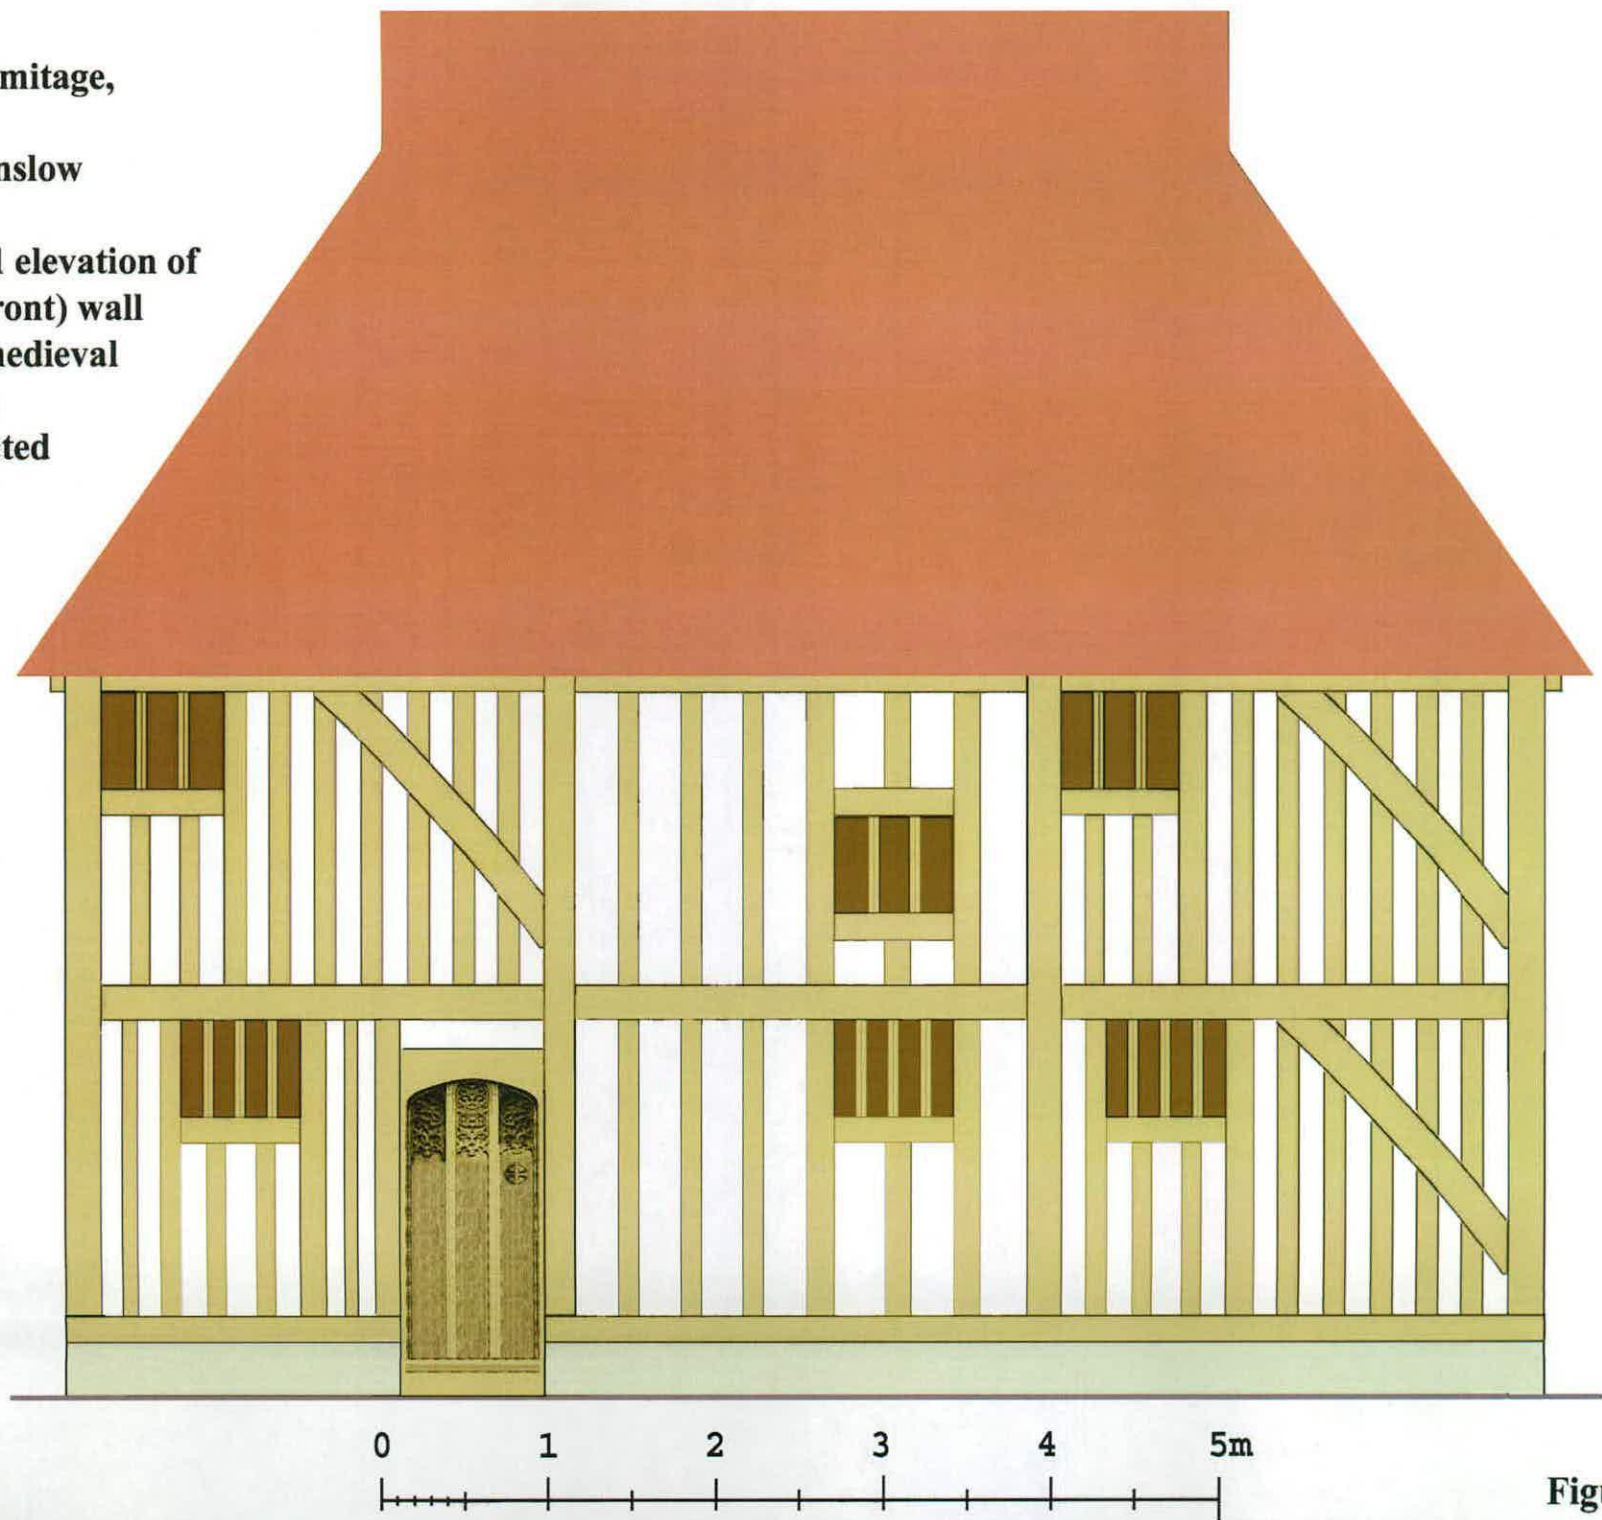
Figure 8

In the external walls all of the framing members – the wall posts, braces, central intermediate posts and intermediate studs – had their outer faces set flush with the exterior wall face. The spaces between the timbers were infilled, leaving the timber frame itself exposed to view on the outside of the building. The only exception to this was the wall on the north side of the house in the central bay. Here, the braces and posts were set back from the exterior wall face, and in front of them was a row of closely-spaced secondary studs with narrow lath and plaster panels infilling the spaces between them. The idea was clearly to create a close-studded effect and make the central hall bay stand out from the rest of the building (*figs 8 & 12*).

**External elevation of
north (front) wall
of late-medieval
house as
constructed**

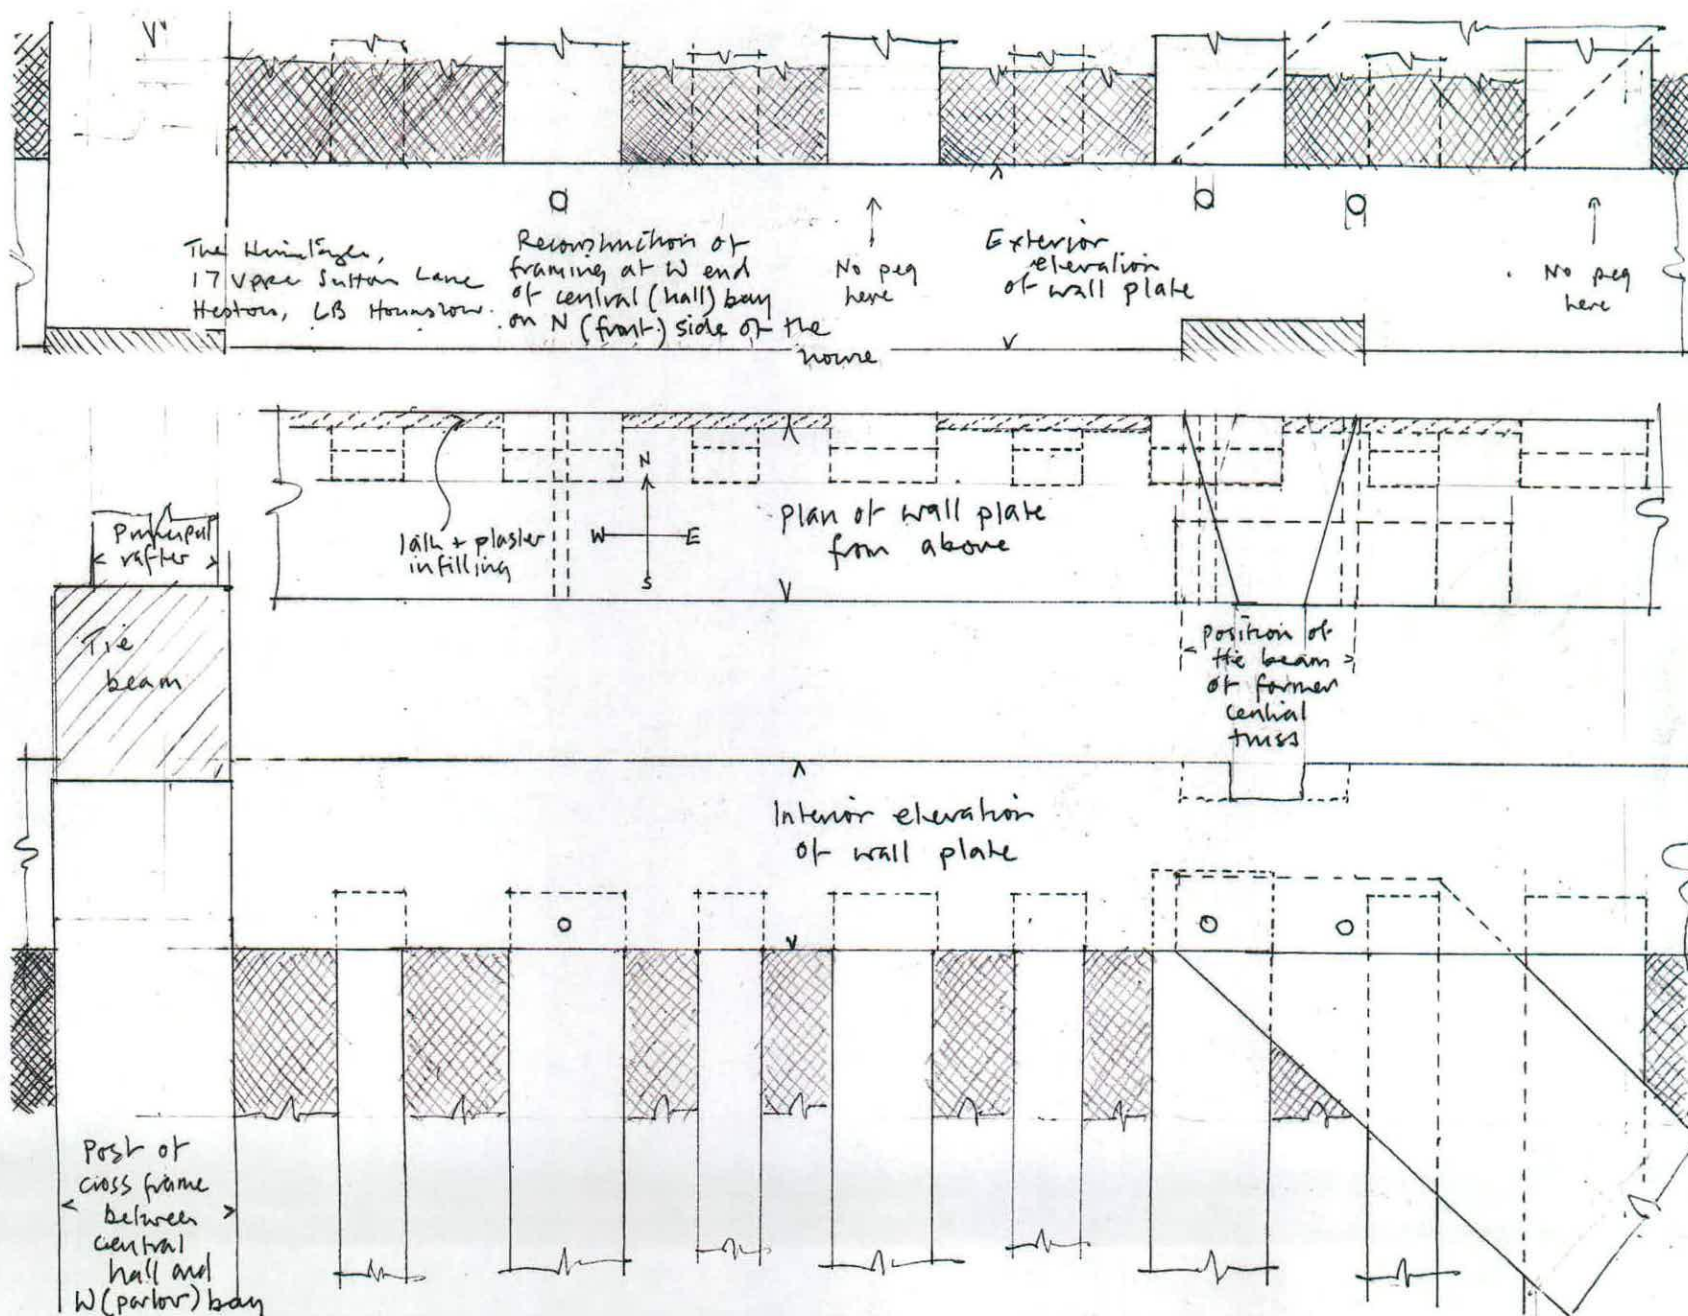
Figure 12 Sketch showing method of wall construction on front (N) wall of central hall bay
