St PAUL'S CHURCH DEPTFORD LEWISHAM

Glazing and window ferramenta

Reports and Papers 72

2002

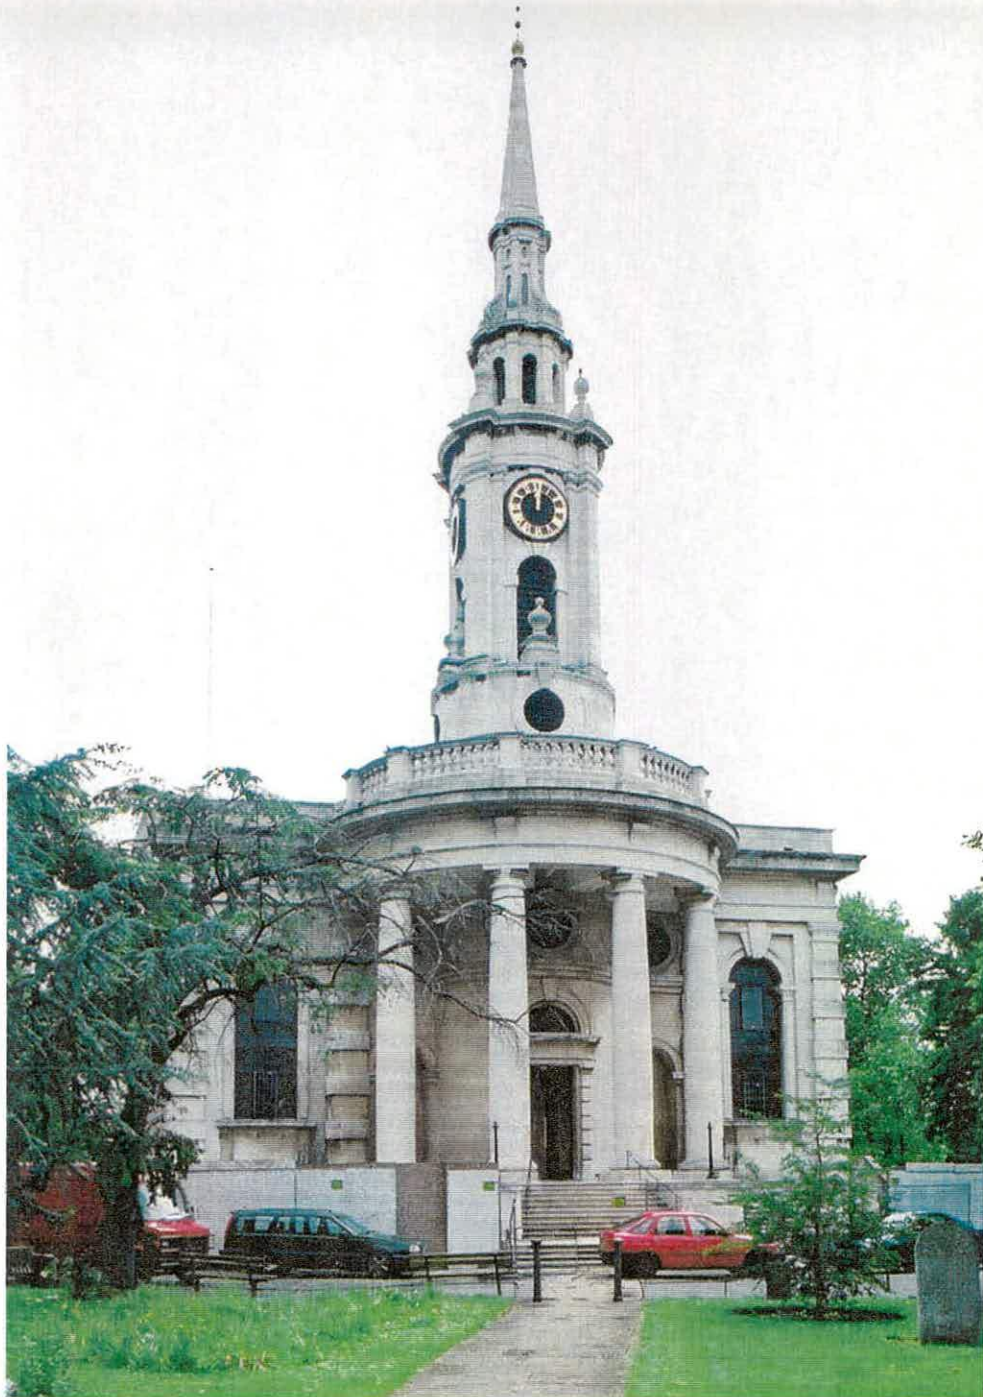
Fig. 8, St Paul, Deptford, the west front viewed from the west, June 2002.

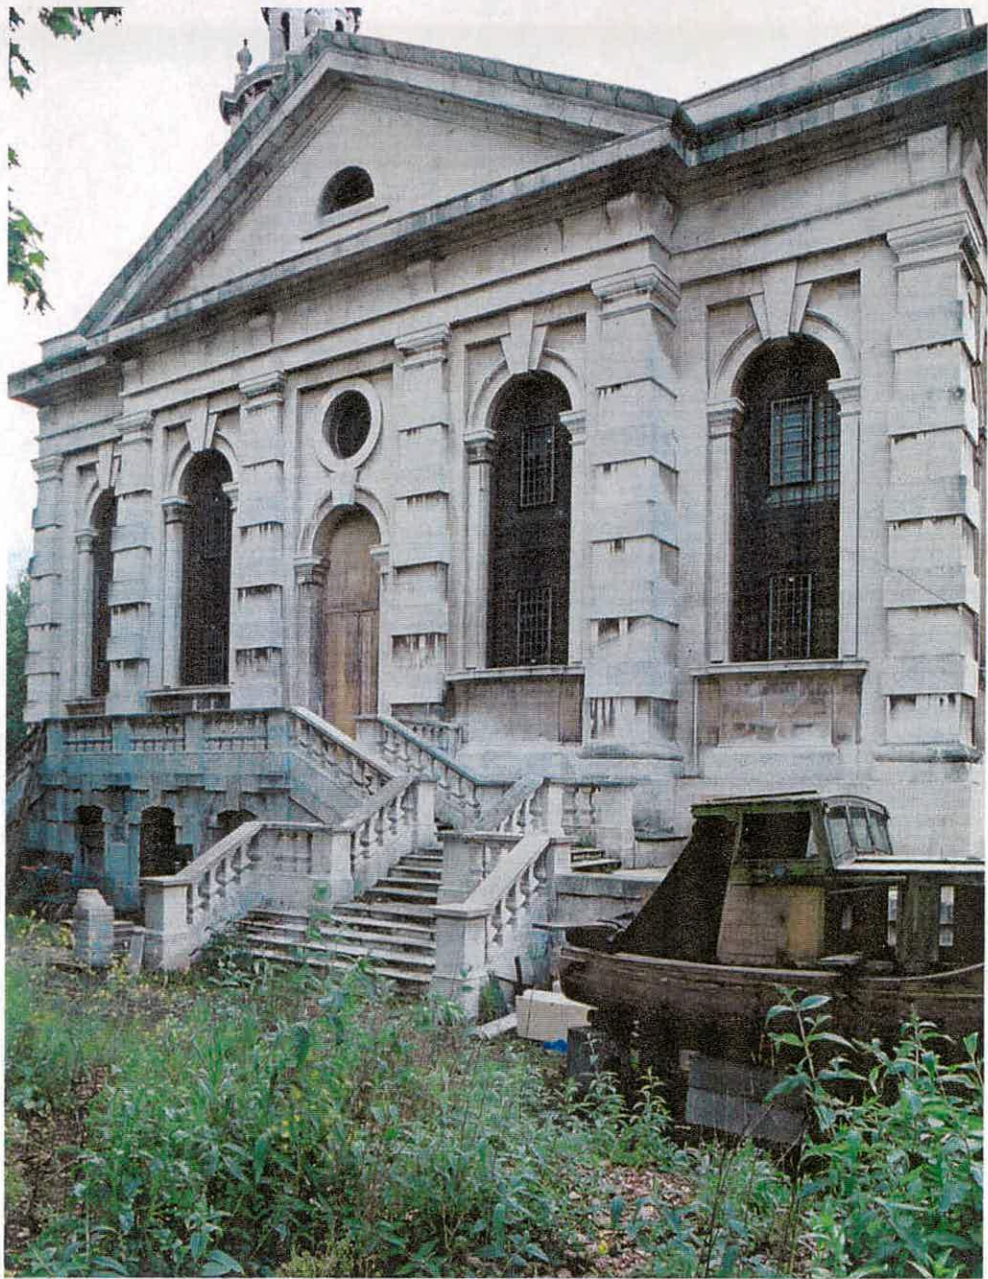
Fig. 9, St Paul, Deptford, the south front viewed from the south-east, June 2002.

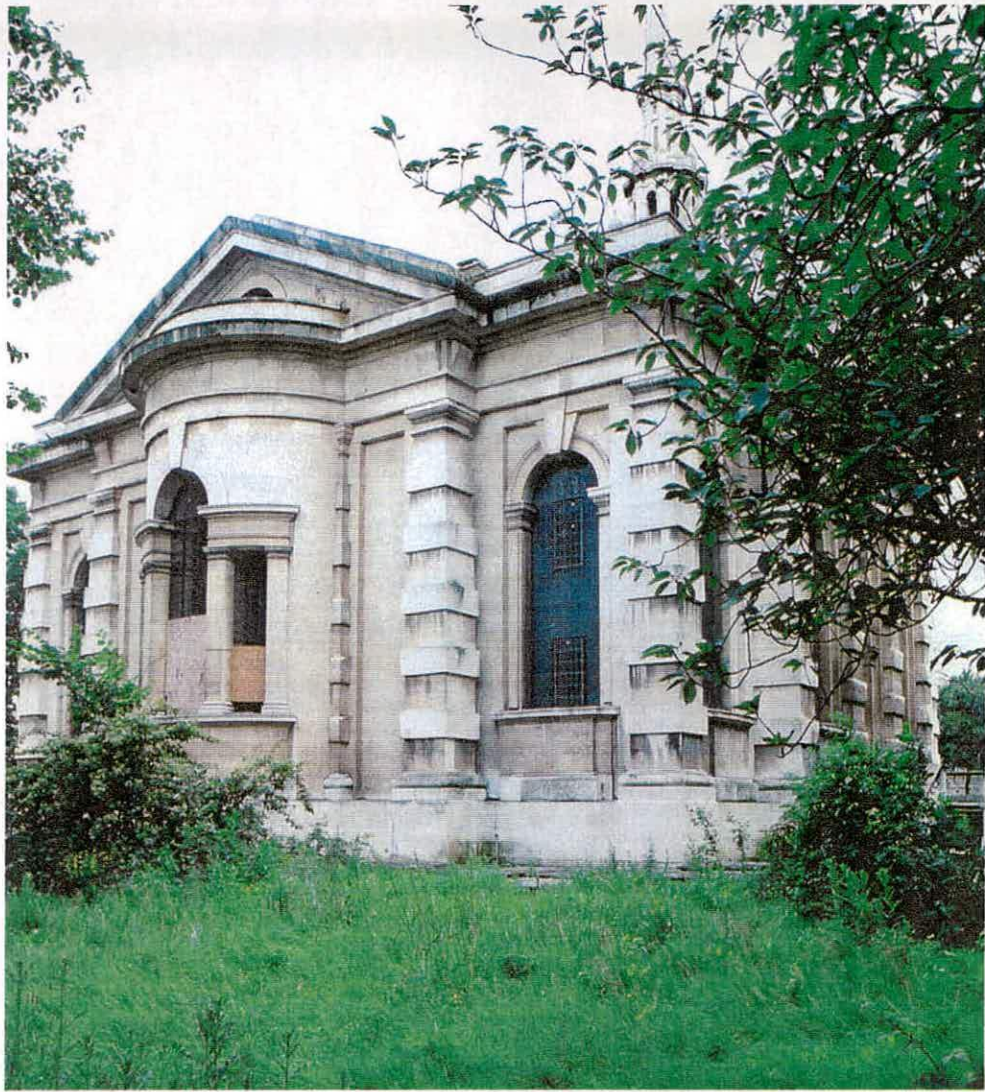
Fig. 10, St Paul, Deptford, the east front viewed from the north-east, June 2002.

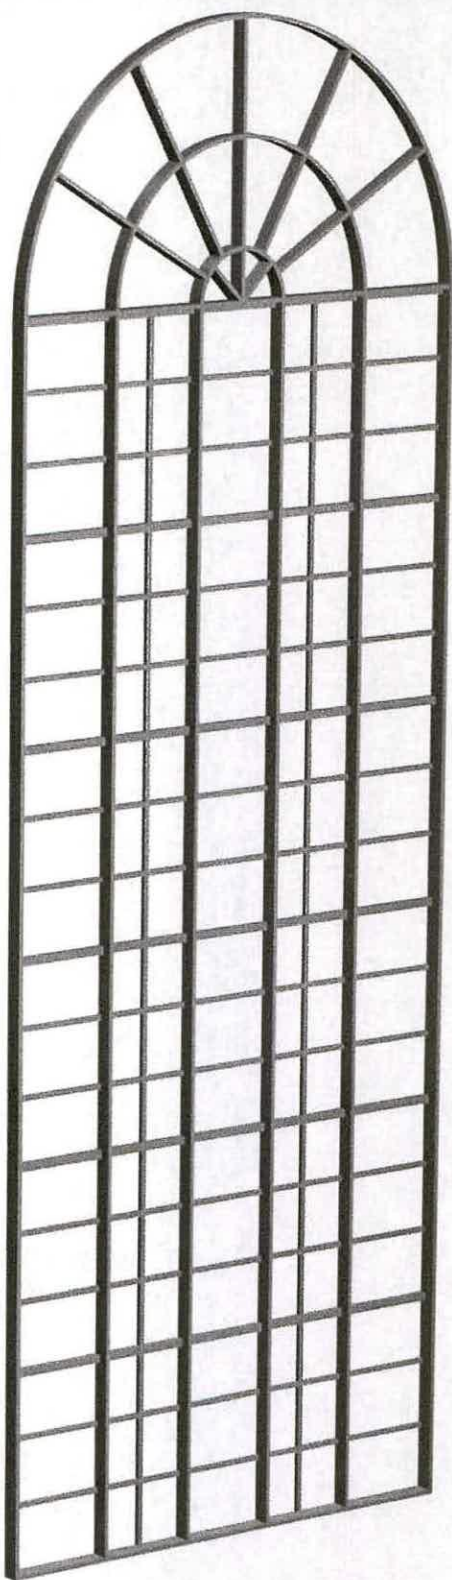
The total surface area presented by the ferramenta of each standard window based on present observations, in square metres. Refer to Fig. 16 for the composition of each frame.

Fig. 16, a perspective reconstruction drawing, showing the framework of the standard window ferramenta, as it would appear stripped of glazing, casements, security bars and modern grilles.

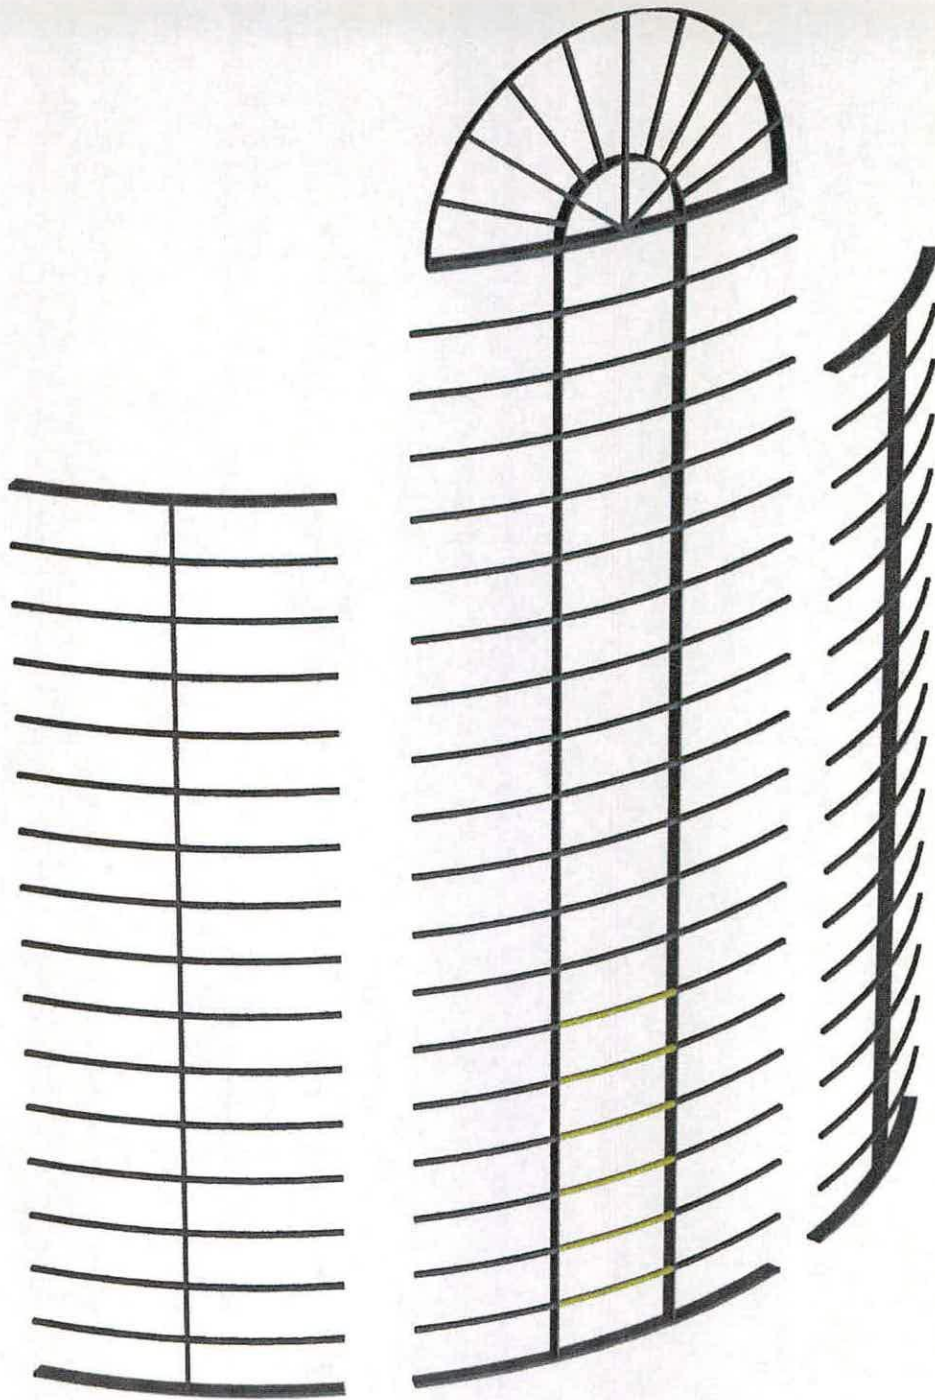
Fig. 17, a perspective reconstruction drawing of the original ferramenta in the east window. The yellow bars are reconstructed, the rest survives *in-situ*.

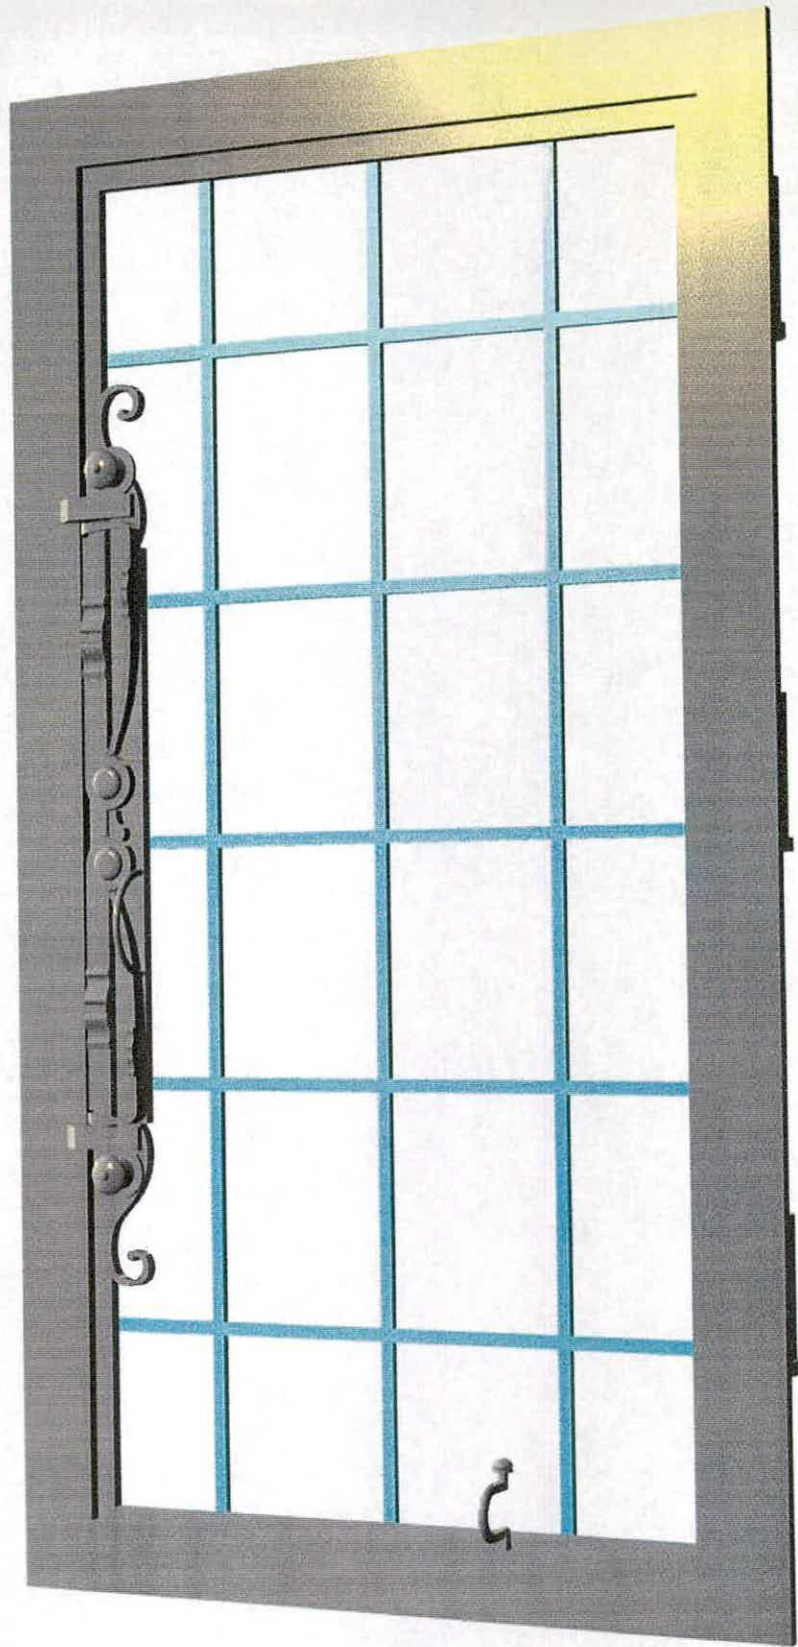
The total surface area presented by each casement in a standard window based on present observations, in square metres. Refer to Fig. 19 for the composition of this frame.

Fig. 19, a drawing illustrating the interior detailing of the casements for the standard windows.

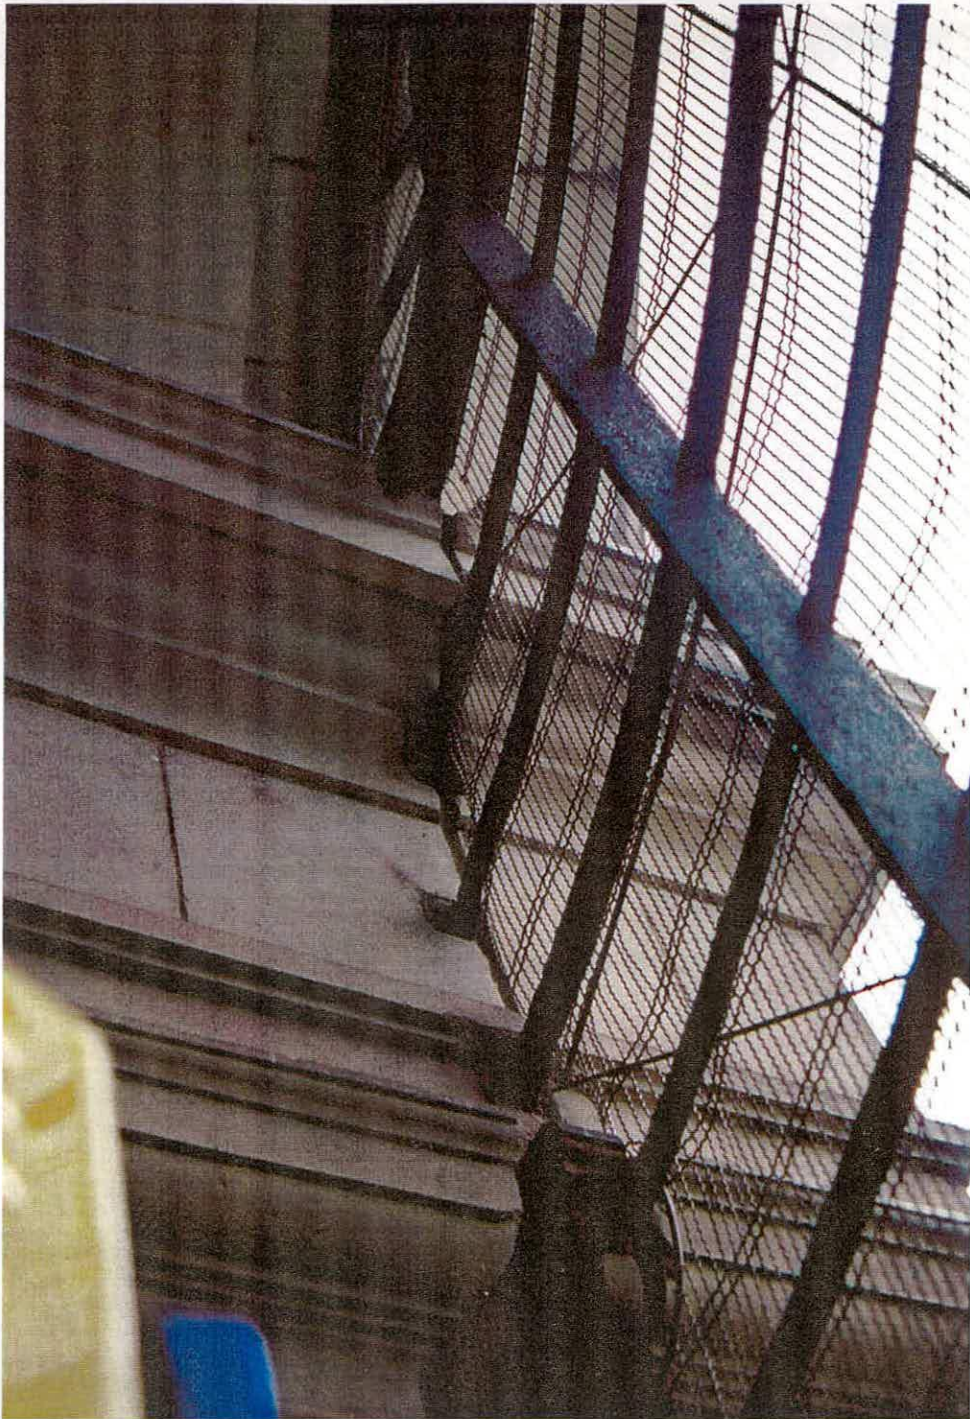
Fig. 21, a detail of the east window showing the mouldings of the cornice and capitals cut by a narrow rebate for the original glazing.

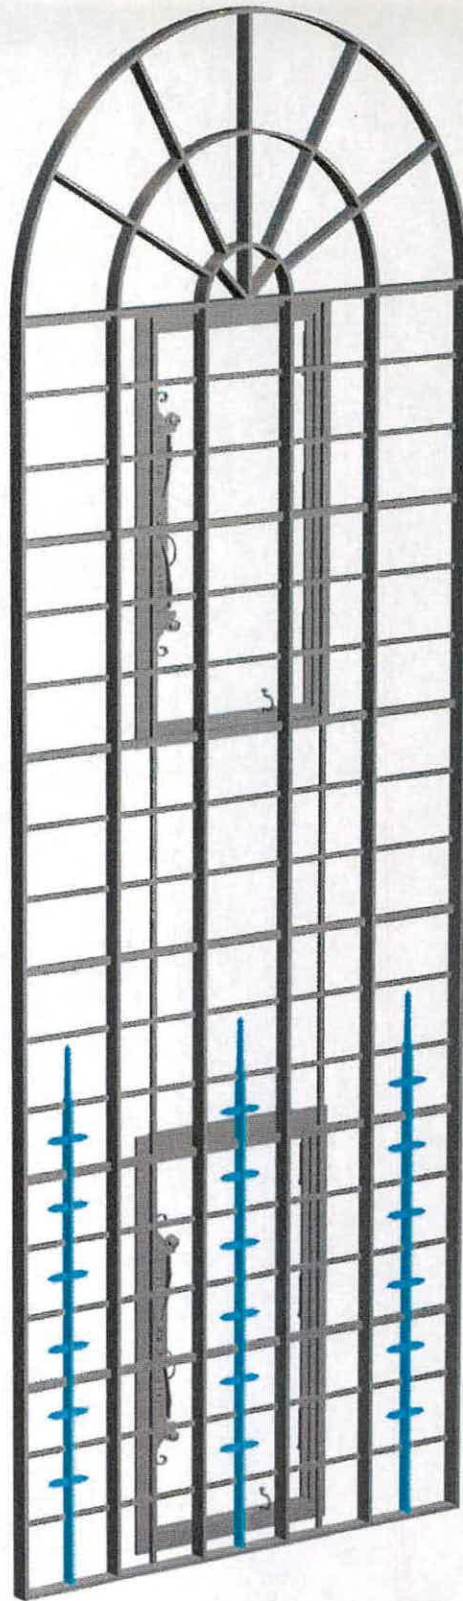
Fig. 23, a reconstruction illustrating the ferramenta, casements and the security bars (highlighted in this diagram in blue) that appear to be a later addition, although the joints with the bottom rail are now generally concealed by render.
