Church House Farm, Wellington, Herefordshire : Historic Building Assessment

Research Report Series 050-2019

**CHURCH HOUSE FARM
WELLINGTON
HEREFORDSHIRE**

HISTORIC BUILDING ASSESSMENT

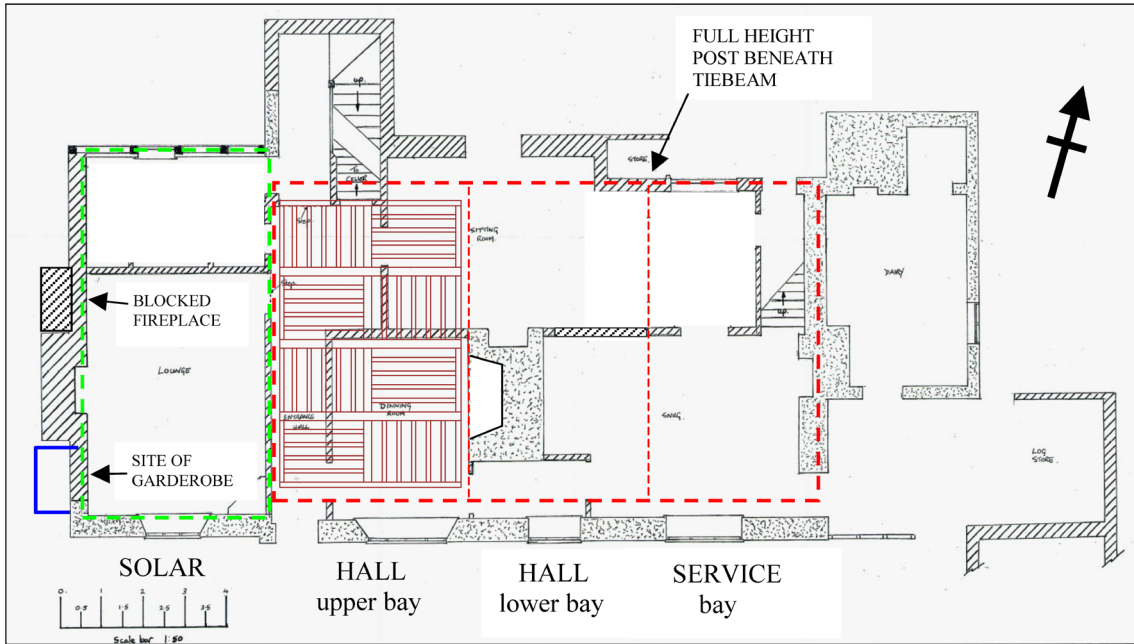
Figure 2 Ground plan of Church House Farm (prior to recent work) with early building sections outlined in green, red and blue. From James 2019 (see Appendix 1)

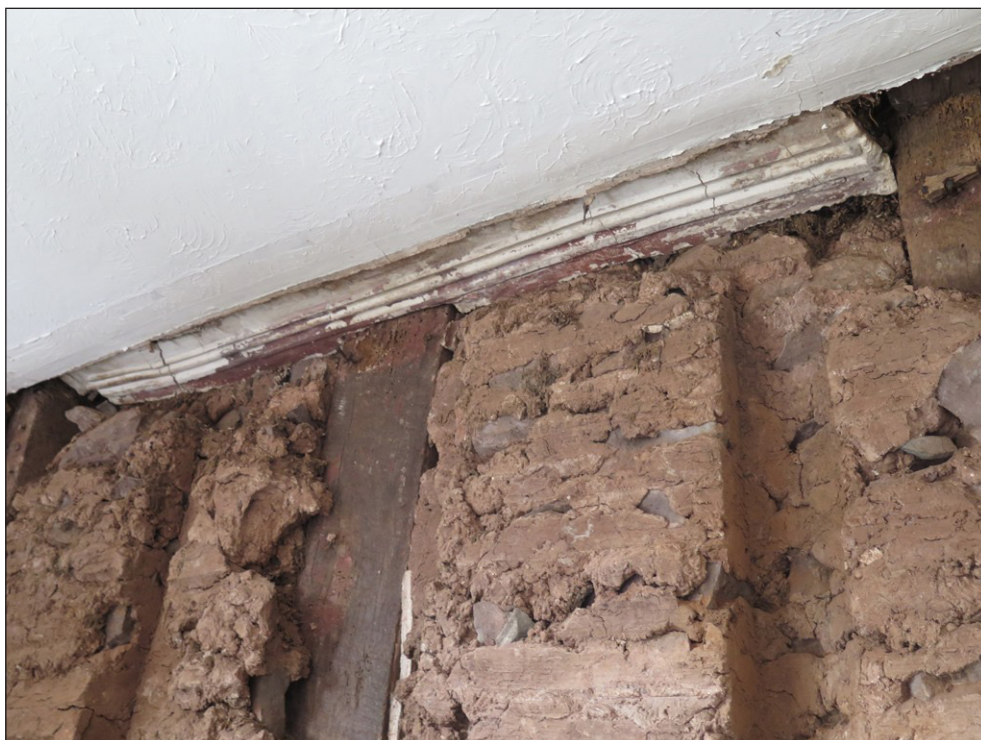
Figure 19 Counter change ceiling inserted into the original hall, and retained in subsequent rebuildings of the range (DP221699)

Another major phase of modification to the building was the construction of the counter-change ceiling which now sits to the east of the cross wing (Figure 19). It is presumed that this was inserted into the earlier open hall, and retained when that hall was demolished at a later stage (James 2019; see Appendix One). The ceiling abuts the cross wing, but does not appear to be contemporary, because, as James has noted, it is not in any way structurally attached to the cross wing. Counter-change ceilings are known from the late 16th and early 17th century, and given this it seems likely that the insertion of the floor was part of the significant upgrading of the building in the late 16th century.

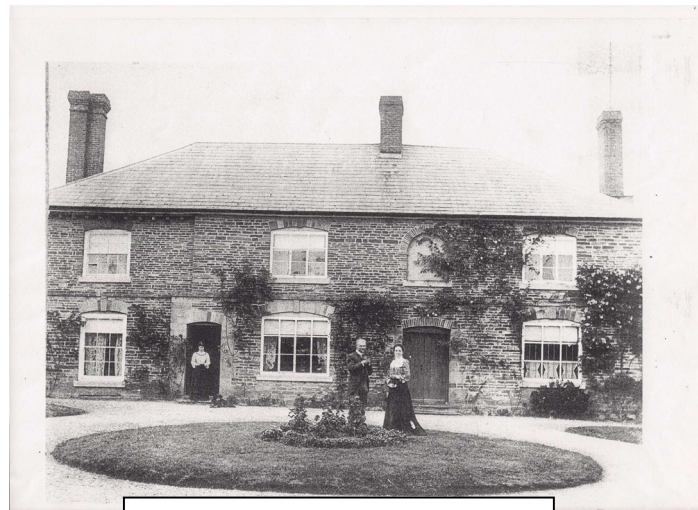
Fig 4 Church House Farm, c.1900.

An earlier photograph of the front (Figure 4) shows this doorway in place, possibly as a 'back door', and a plain, double-leaf main door still present but not obviously in use. The windows on the front of the building are casements but the earlier photo shows sash windows on the front of the wing.
