Abbey Farm Barn Snape Suffolk

Record Drawings
Schedule of Repairs and
Repair Details

for English Heritage
Mr & Mrs H. S. Raynor

March 2001

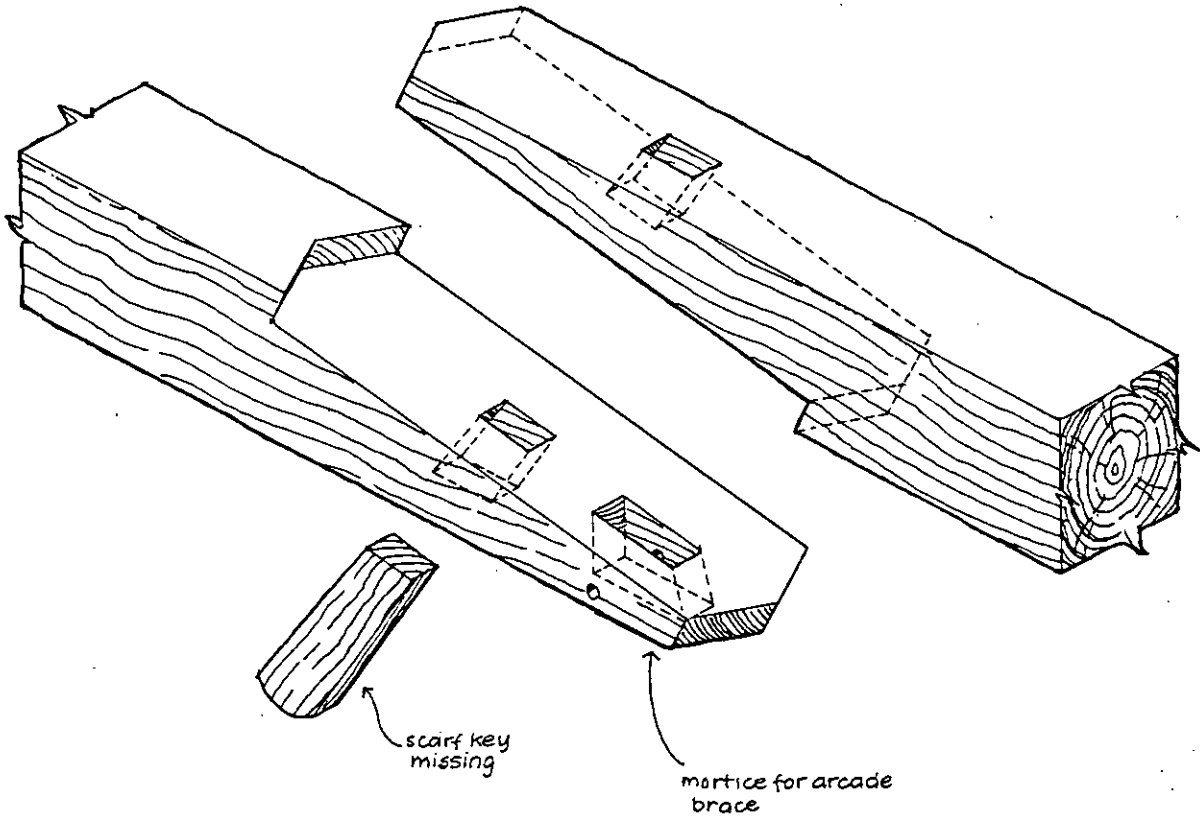
Figure 13 Scarf joint. Bay 3 North

SCARF JOINT, Arcade Plate, Bay 3 north
 stop splayed, with under-squinted sallied
 abutments & scarf key.
