PALACE HOUSE MANSION

PALACE STREET, NEWMARKET, SUFFOLK

*Report Outlining the Analysis and Interpretation of a
Late Seventeenth-Century, Solid-Frame,
Counterbalanced, Sash Window*

Reports and Papers 15

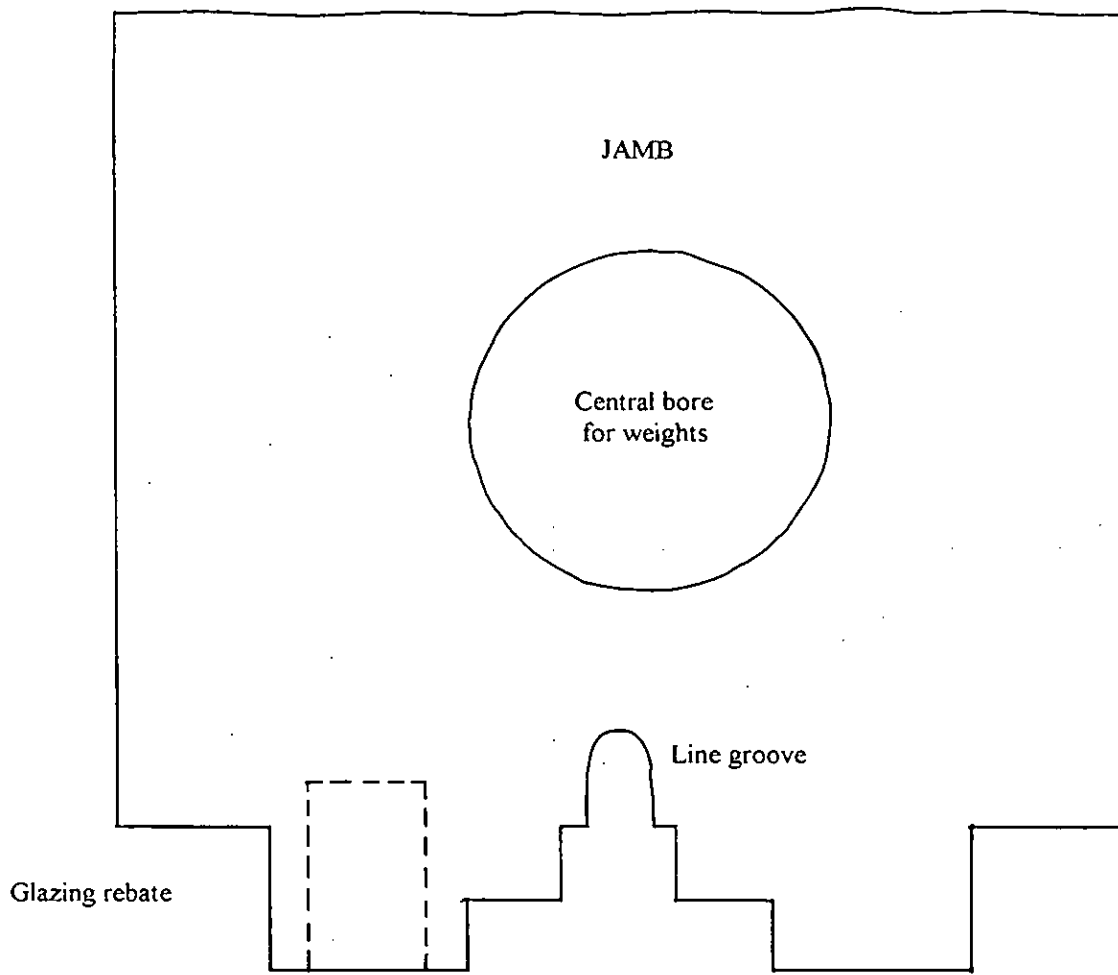
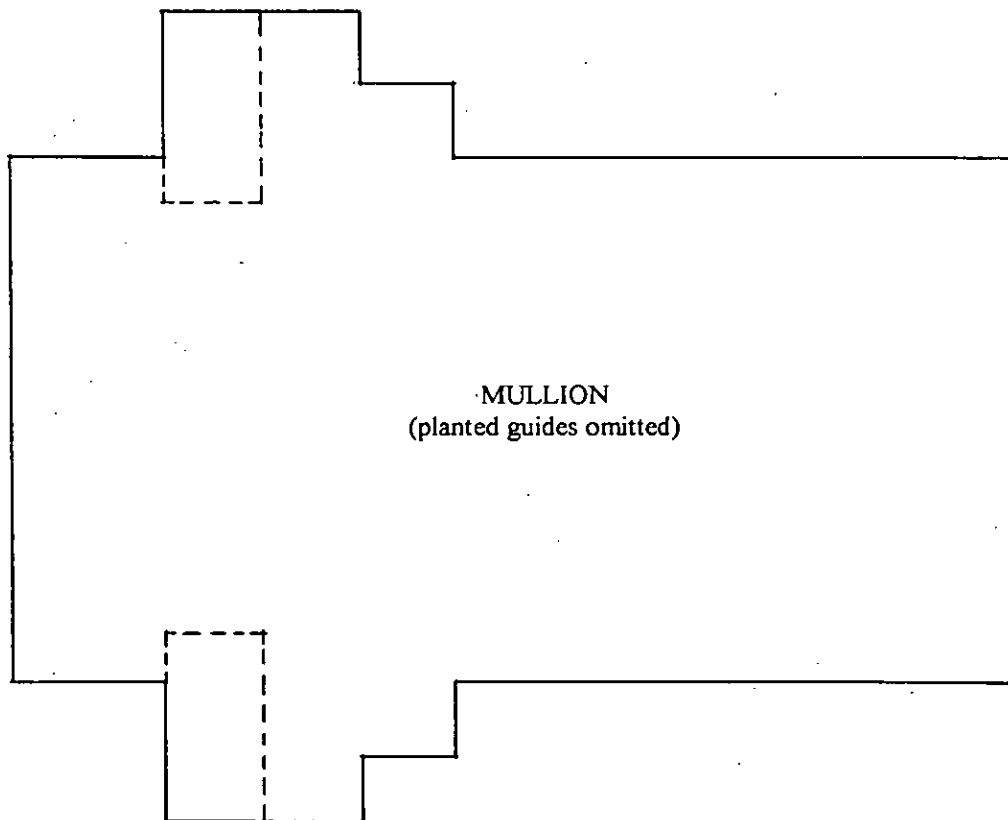
Fig. 1
Full-size frame sections

The frame head, 127 x 87mm (5"x 3.5"), also has the central, staggered 'U' shaped guide run from the solid (*Fig. 1*). The exposed cill, 127 x 83mm (5"x 3.25"), was prepared with a slight bevel which gave a weathered upper surface and an upstand, married to the jamb guides, to retain the lower rail of the sash and offer protection from wind-blown rain. The transoms, 63 x 57mm (2.5"x 2.25"), have a simple rebate, 19 x 19mm (0.75"x 0.75"), cut in their upper external face to receive the glazed lights.

A thin cover architrave survives, nailed to the internal face of the head of the frame, although the upper part has been hewn away. Formerly 76mm (3") in width, it would appear to be contemporary and have the same painted application as survives on the framing. A band, 76mm (3") wide, bereft of paint and set 19mm (0.75") from the sash-guide face, suggest that it covered the internal face of the frame jambs and concealed the weight and pulley wheel access pockets. It also appears to have been placed to cover the internal face of the cill. The surviving moulding, merely 6mm (0.25") in thickness, has a rather plain and somewhat unusual form with an ovolo and fillet at its termination (*Fig. 1*).

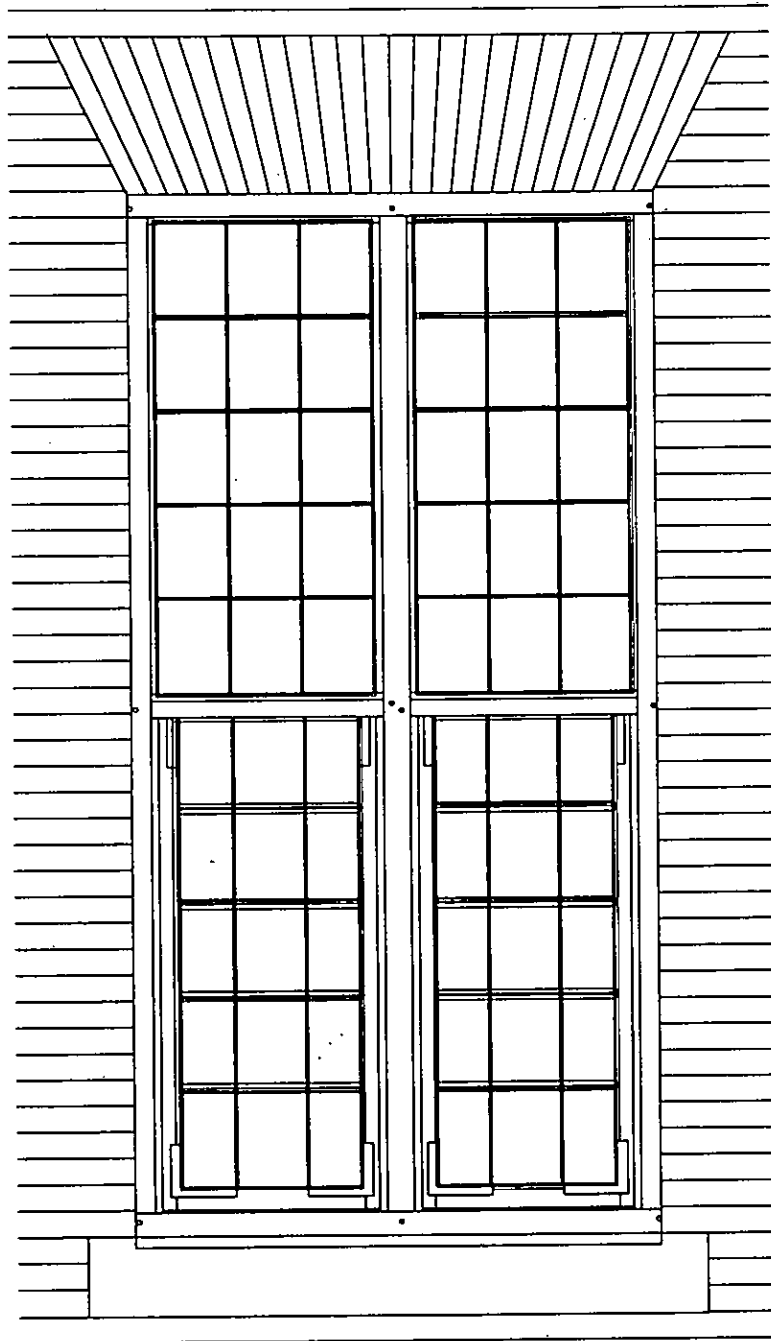
Fig.6

Original form and external appearance of window -
based on detailed analysis of frame and extant opening.

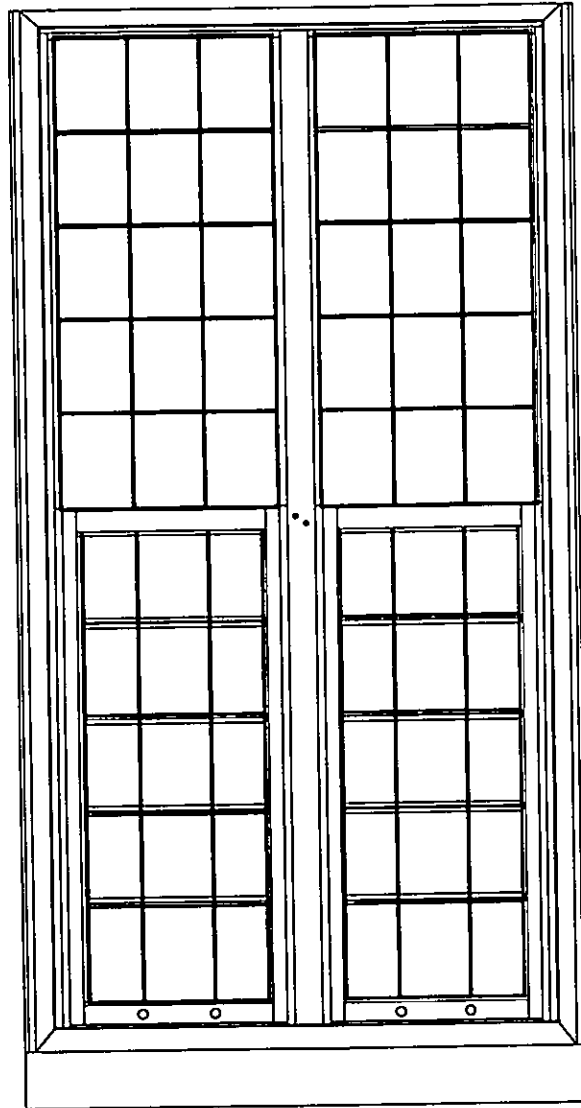
Fig.7

Original form and internal appearance of window -
based on detailed analysis of frame and extant opening (Scale 1:20).

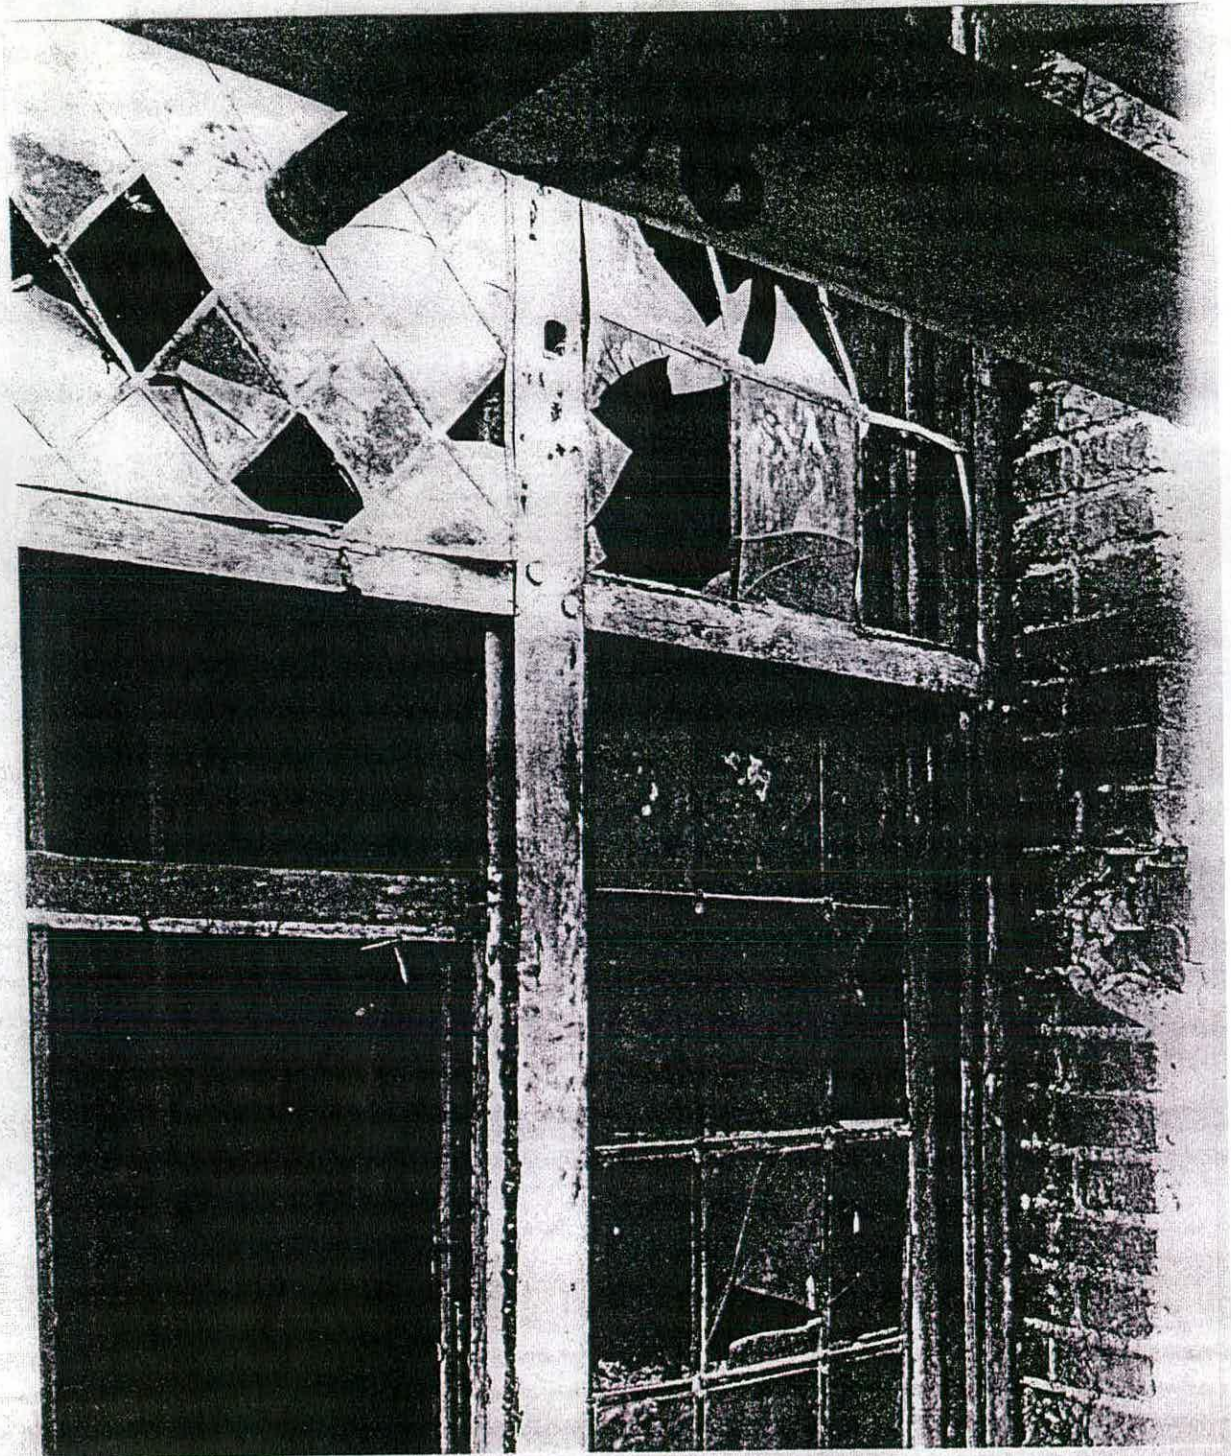
Fig.10

The frame shortly after its discovery
showing damage to glazing and relationship to external brick reveal
(RCHME).

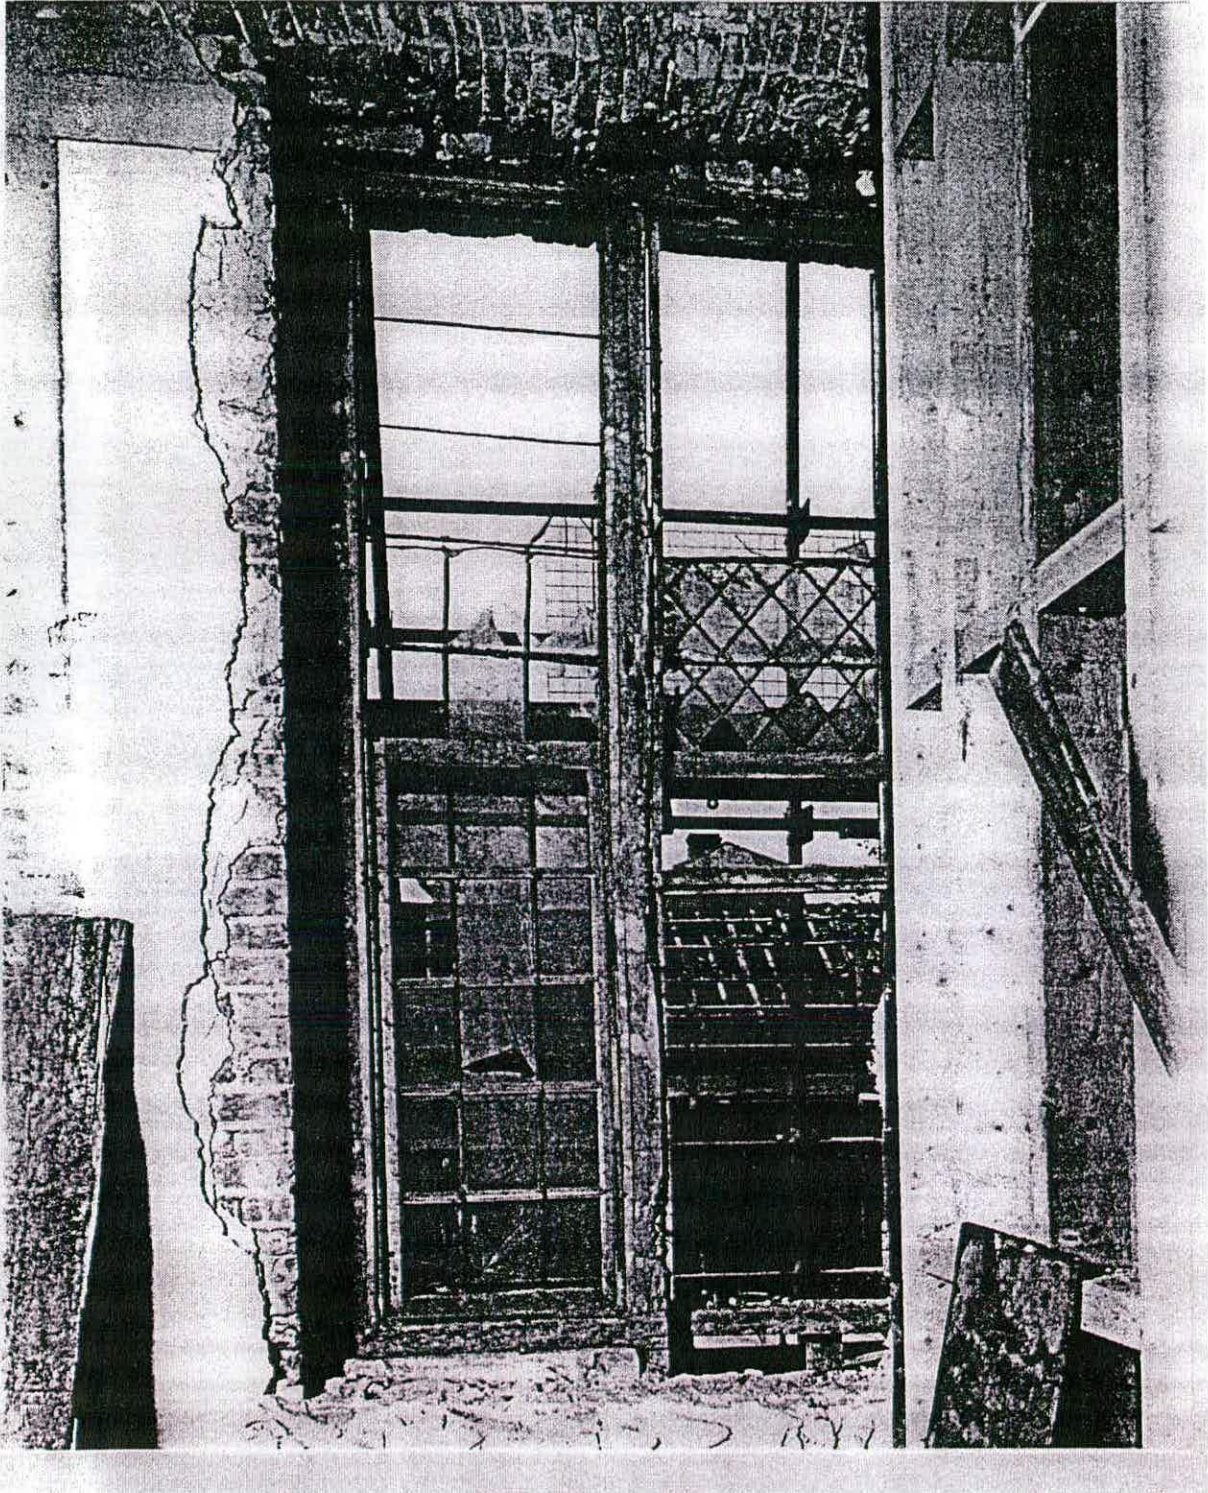
Fig.11

The frame shortly after its discovery
showing glazing and relationship to internal brick reveals
(RCHME).

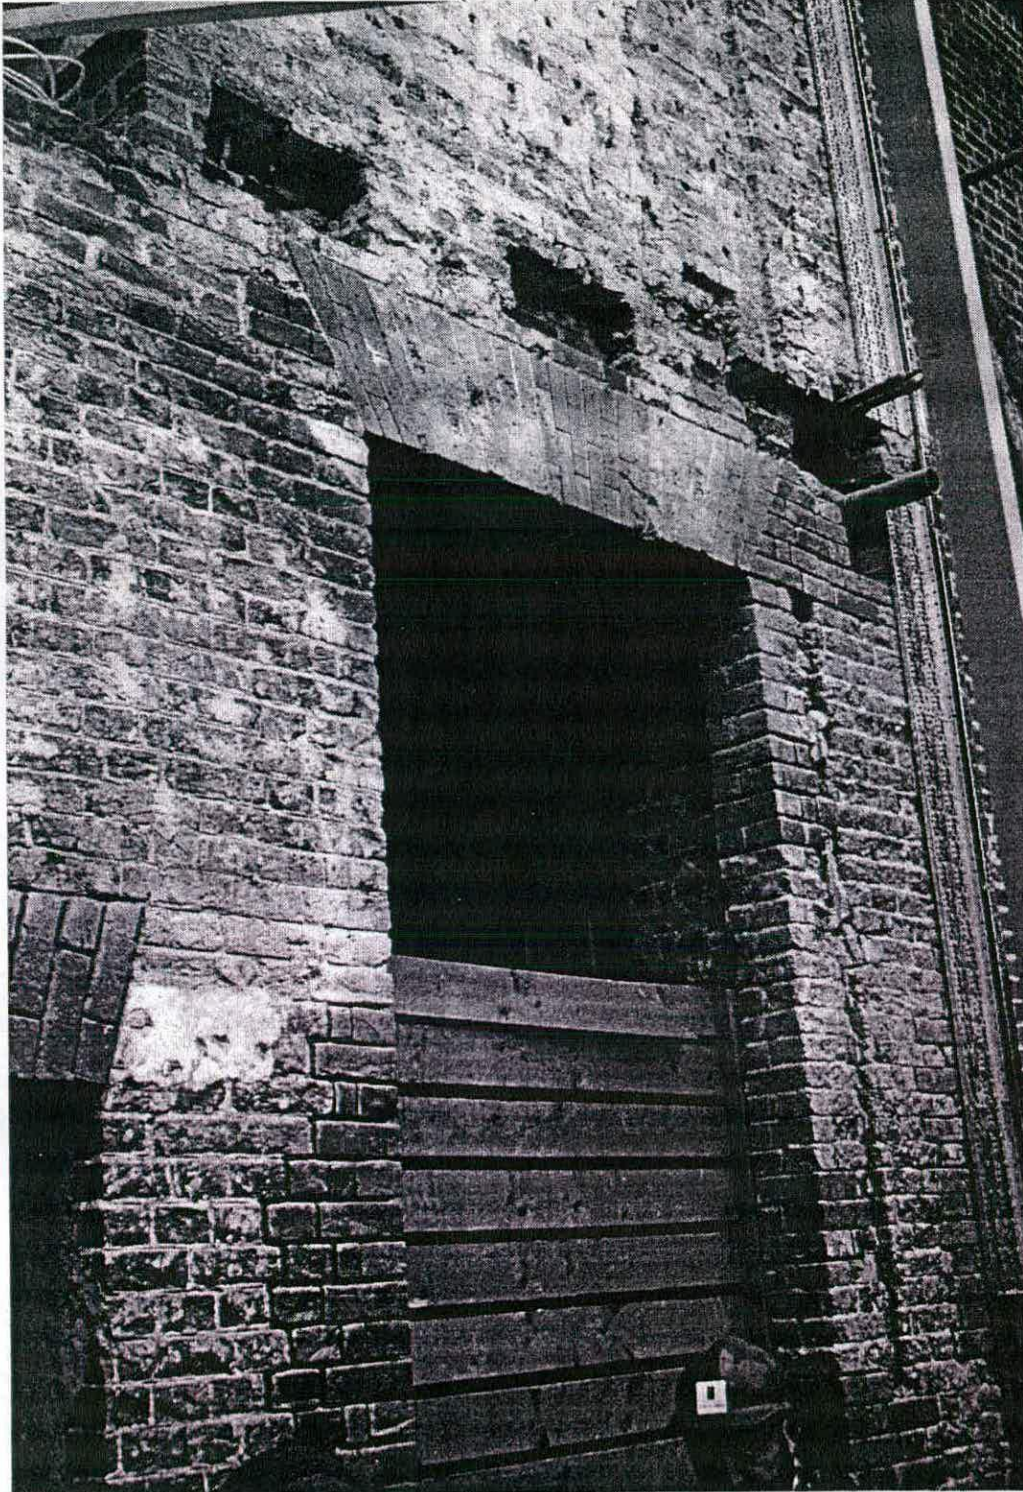
Fig.12

The brickwork of Samwell's original pavilion facade exposed during the restoration programme, showing the window opening together with the scars of subsequent development. (1997).

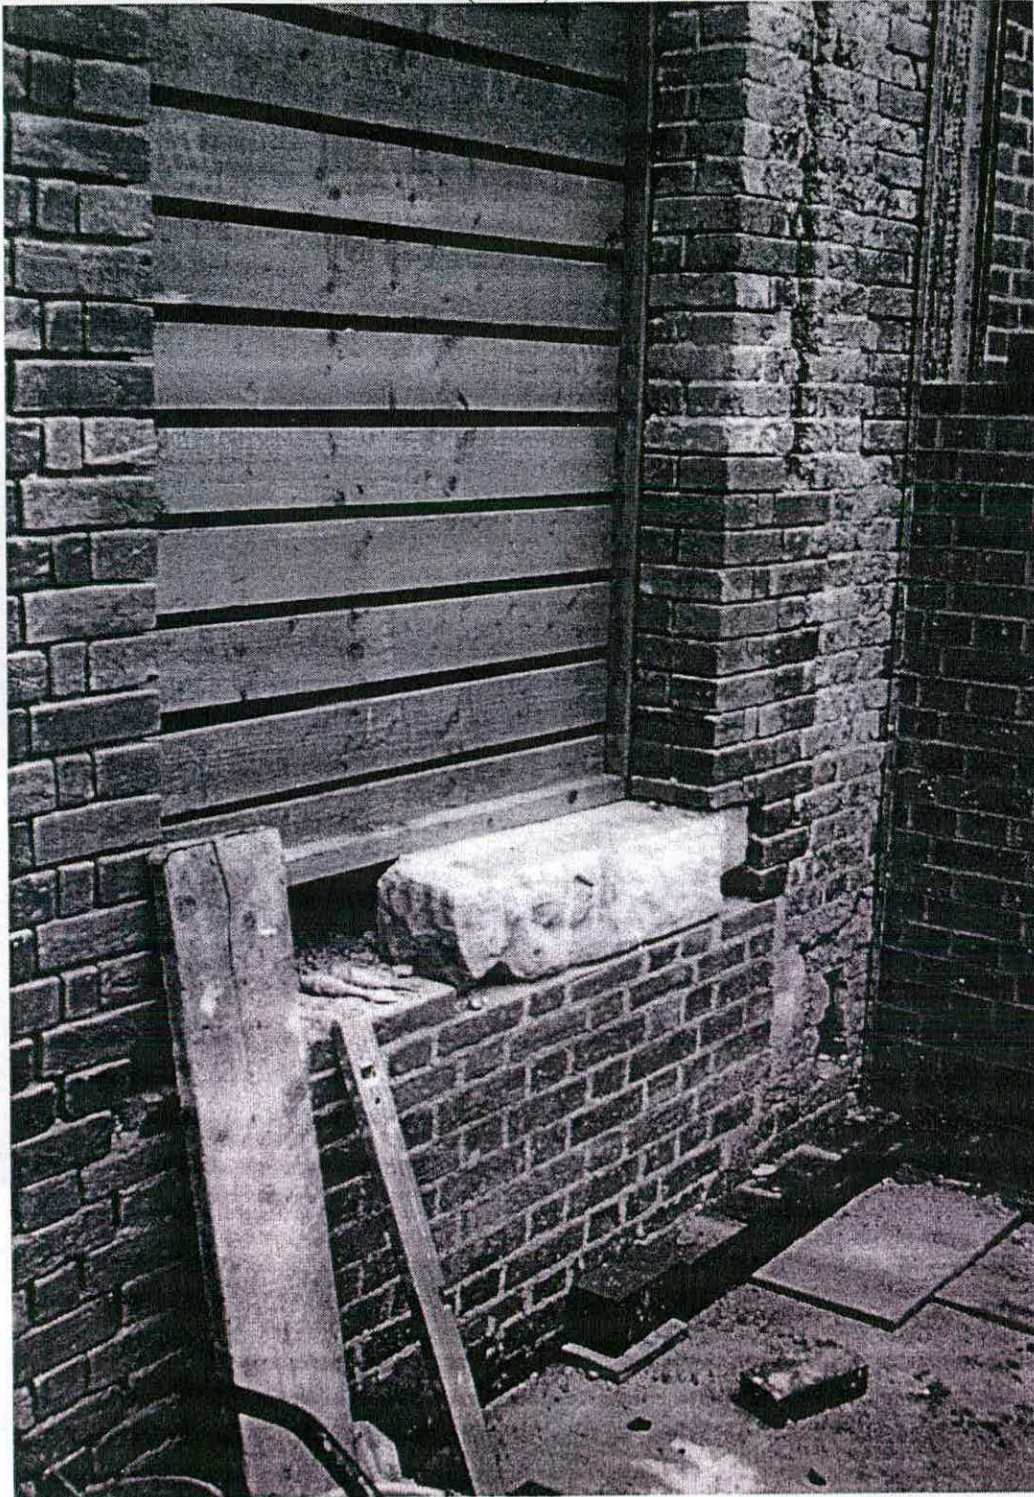
Fig.13

The brickwork of Samwell's original pavilion facade (much repaired) exposed during the restoration programme, showing the window opening together with the surviving section of the original stone cill. (1997).

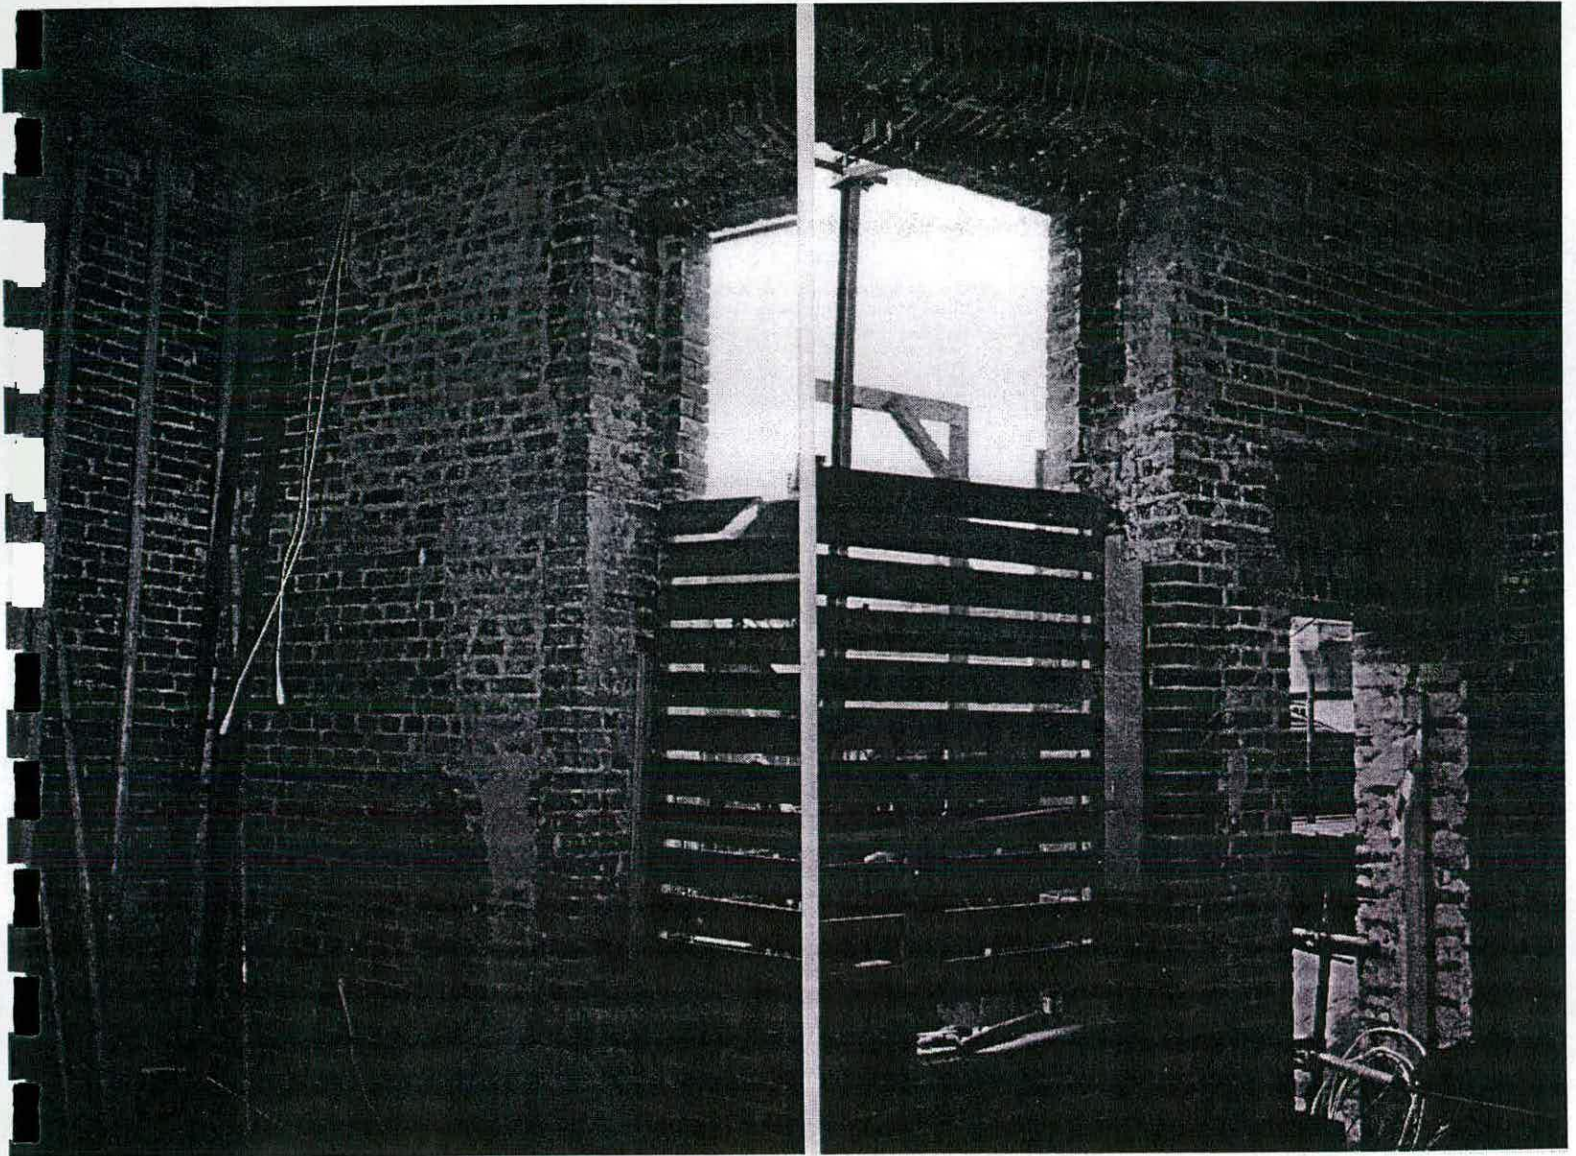
Fig.14

Two views of internal arrangement of window opening
indicating multi-phasing of brickwork
and later door opening to staircase.
