# NOS 38 and 39 GREAT JAMES STREET, CAMDEN

*An Assessment of the Historic Fabric*

Roger Bowdler and Richard Lea

Historical Analysis & Research Team  
*Reports and Papers (First Series, 3)*  
1996

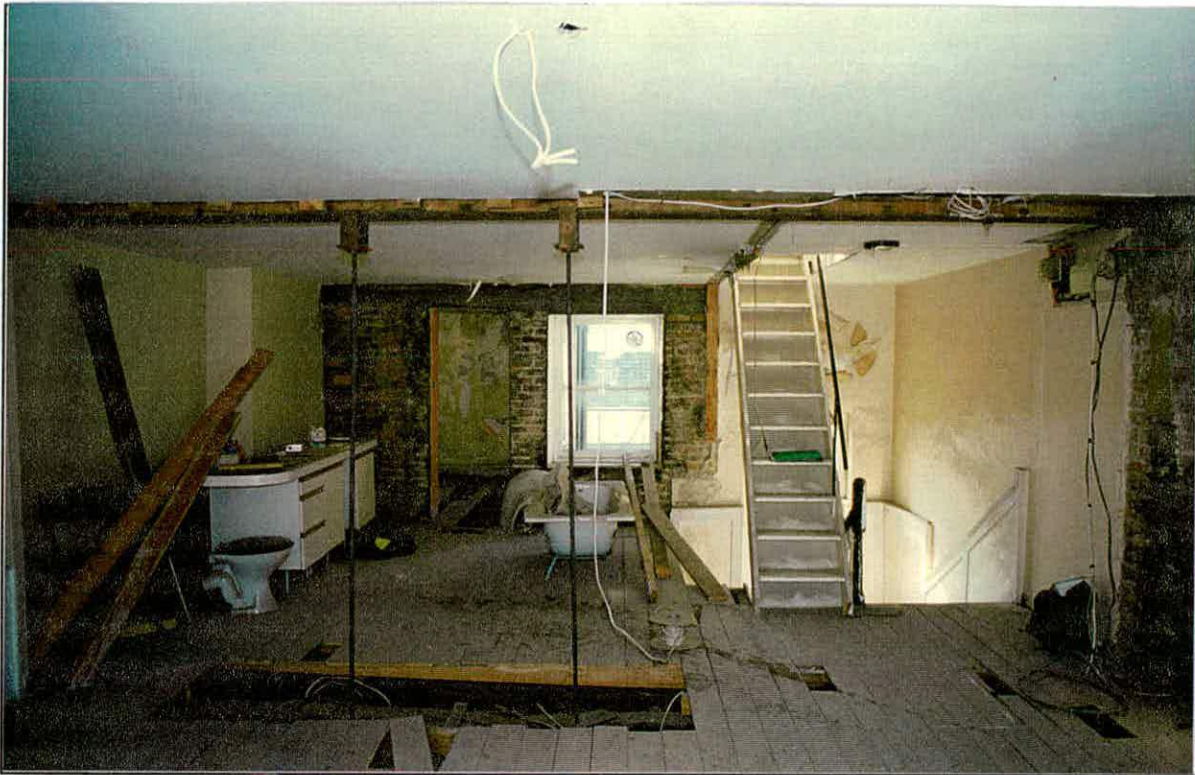
**Figure 65** No 39, third floor front and back rooms looking west

**7.2.2 The third floor back room** There are new repairs to the brickwork of the west wall. *Ceiling*: plasterboard ceiling probably from the 1960s. *Cornice*: removed (see panelling notes). *Panelling*: like the front room, this room has been stripped of its original plain panelling. *Dado*: none in-situ (see panelling notes). *Skirting*: 1960s, see panelling notes. *Doors*: none in-situ. *Windows*: modern sashes with horns and no glazing bars. *Fireplace*: the diagonal corner stack has been removed, the rectangular chimney breast is plastered, probably in the 1960s. *Floor*: modern floorboards, as in the front room, the floor has been levelled with firrings.

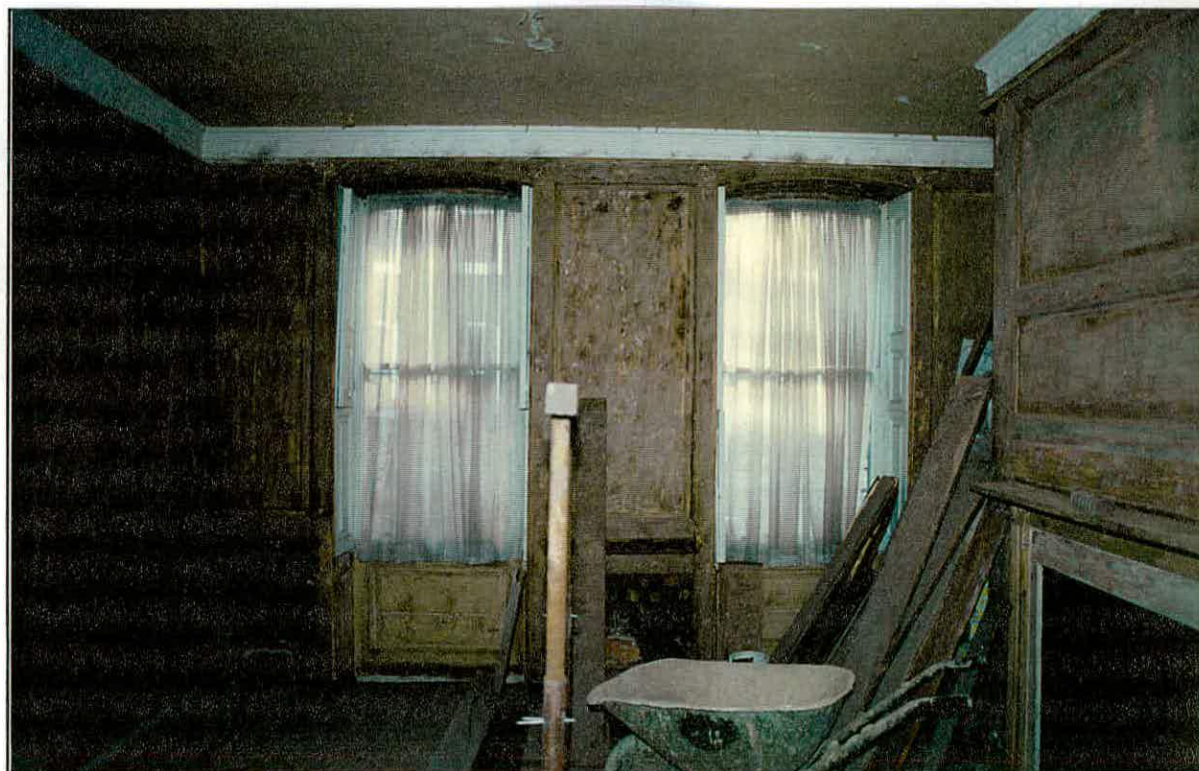
Figure 92 No 39, ground floor front room looking east

**7.5.1 The ground floor front room** A large square section post with chamfered corners has been inserted between the main ground and first floor beams. This is probably contemporary with the insertion of the post in the middle of the double door on the first floor in the 1960s. *Ceiling*: original plaster on lath. *Cornice*: original timber box cornice replaced by Adamesque frieze consisting of composition on timber. *Panelling*: original ovolo moulded raised and fielded panelling, stripped of paint on the east and north walls, only partly stripped in the south wall. The west wall has been altered by the insertion of an elliptical arched recess with a door to the back room. The composition decoration applied to the pilasters either side of the recess suggest that this alteration is contemporary with the addition of the frieze, probably in the 1920s. A cupboard with glazed doors was installed in the recess west of the chimney breast probably in the 1920s. *Dado*: large moulded dado survives on south side of room only. *Skirting*: original bead moulded board survives on south side of room only. *Doors*: to hall, not in-situ but ovolo moulded raised and fielded six panel doors, stripped of paint are stored in the room. Door to back room ovolo moulded raised and fielded four panel probably dates from 1920s. *Windows*: original shutters survive, apparently original linings do not have box seats. *Fireplace*: timber reeded surround with paterae, c 1810. *Floor*: original floor frame and floorboards under cork floor tiles.
