RAF Perranporth, St Agnes, Cornwall: an archaeological survey

SURVEY REPORT

Archaeological Investigation Report Series
AI/44/2002

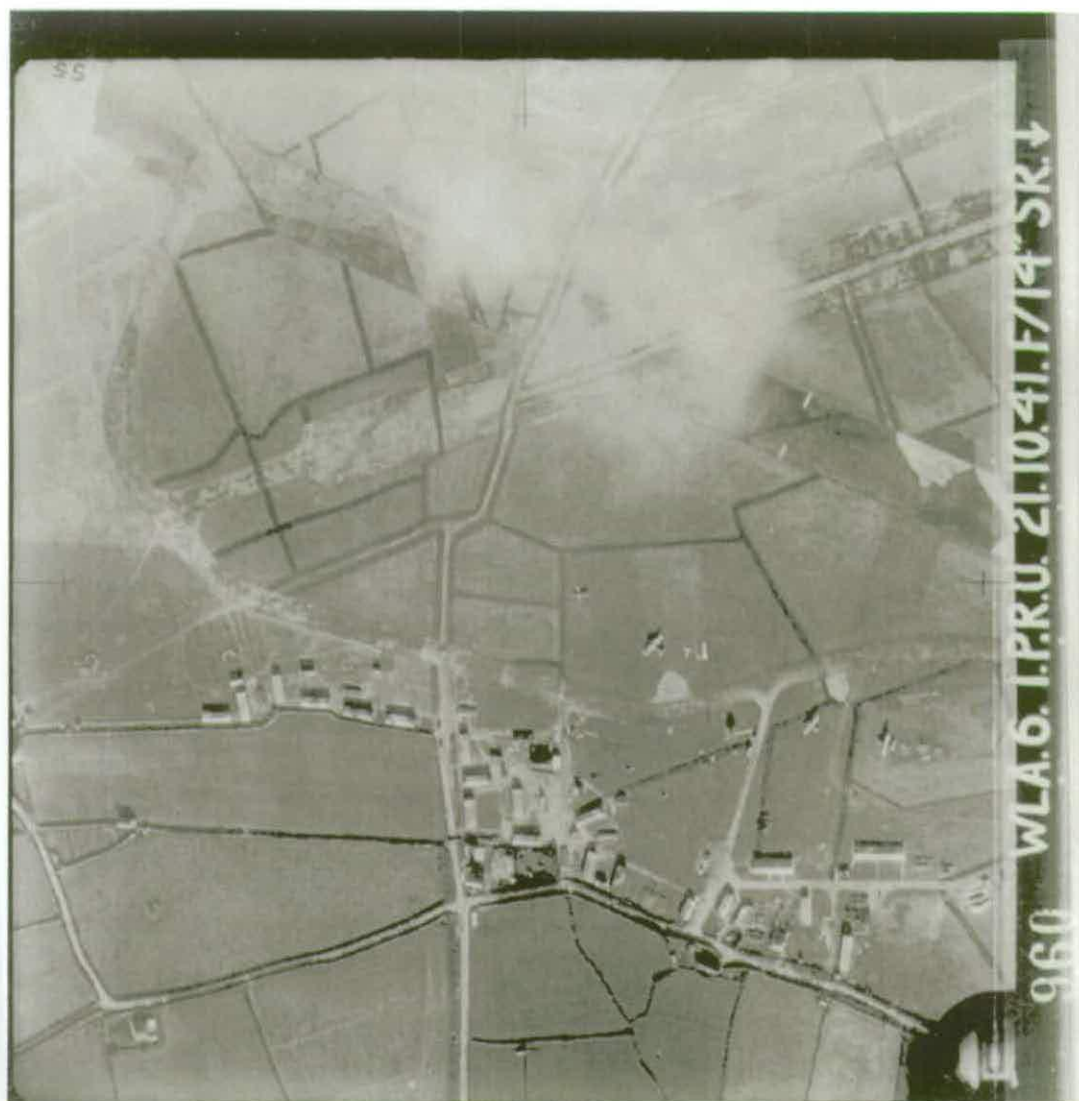
*Plate 2. RAF
Perranporth
1941. English
Heritage
(NMR) RAF air
photo: WLA6
960 21.10.41.*

During the construction of the airfield a fairly dense pattern of small field plots was effaced, also a number of buildings, including a Methodist chapel, were demolished. An RAF air photograph, dated October 1941 (Pl. 2), was taken when the airfield was in the early stages of its development. The main runways (oriented NE - SW and NW - NE respectively) are camouflaged as country roads and field hedges. This camouflage appears to have been painted not only on the runways but also on the grass areas. The air photograph also shows the headquarters and administrative buildings as well as an interesting variety of aircraft. The SE flight complex and the perimeter track extension had yet to be constructed.

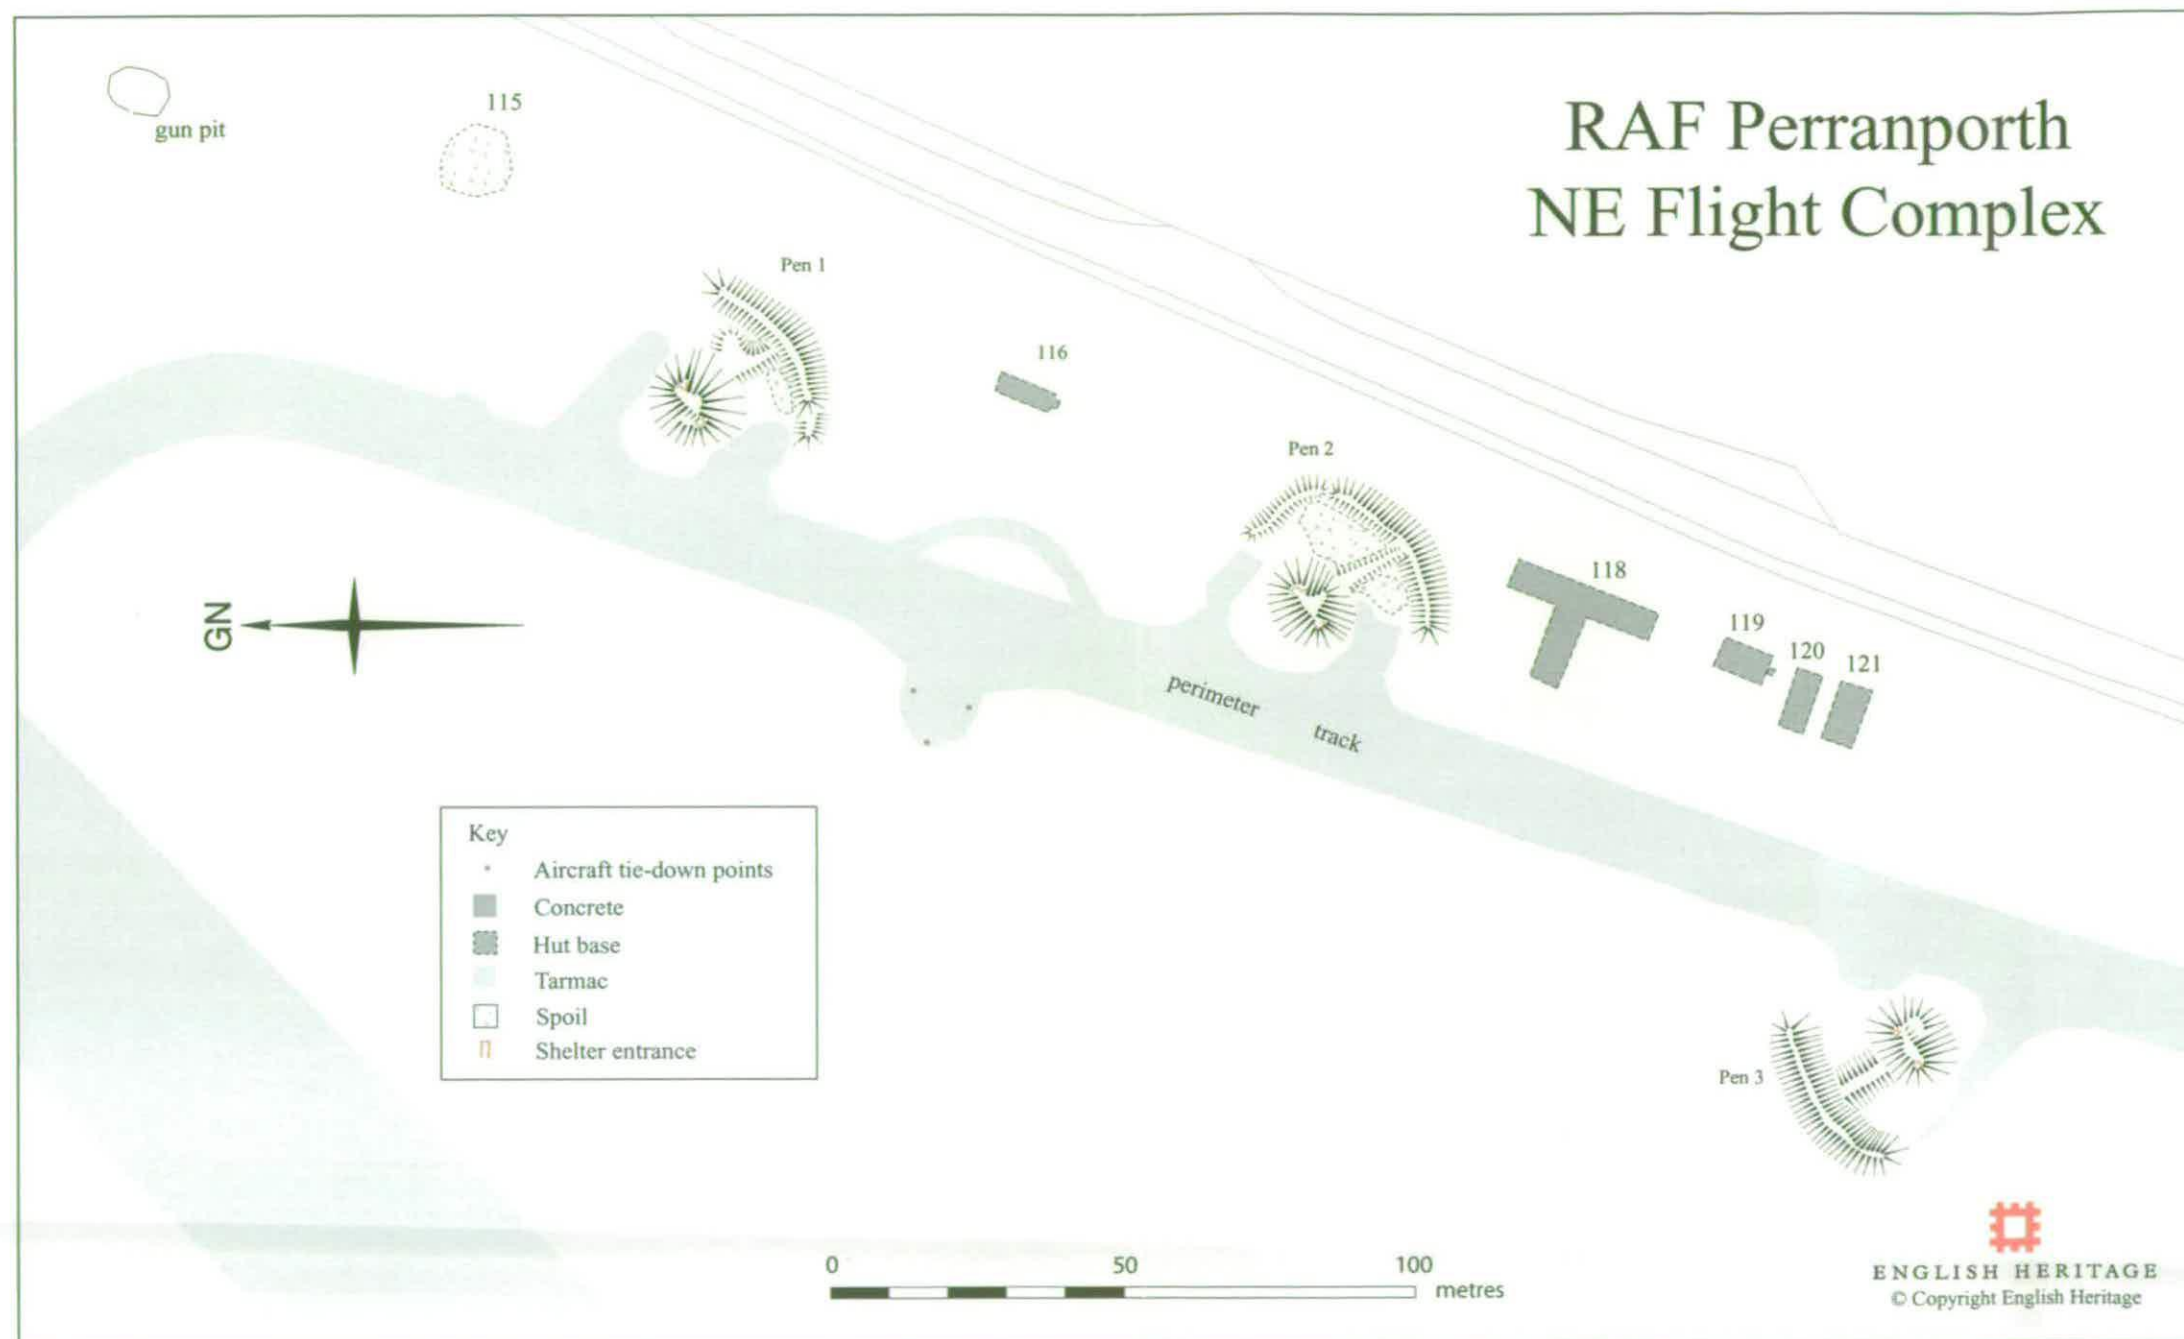
Fig. 3. The NE flight complex.

Two types of aircraft pens survive *in situ* on the airfield. The 'early' type, which were certainly in existence by November 1941, comprise a crescentic bank of soil or sand standing to 2m in height. The 'interior' is sub divided by a lower bank thus creating two protected aircraft hard standings. In the three western pens this lower bank is faced by blockwork walls up to 0.8m high however no such walls are evident in the eastern pens. Built onto the end of each sub dividing wall is a 2.5m high mound which covers a pre-fabricated concrete Stanton shelter with, at each end, a passage

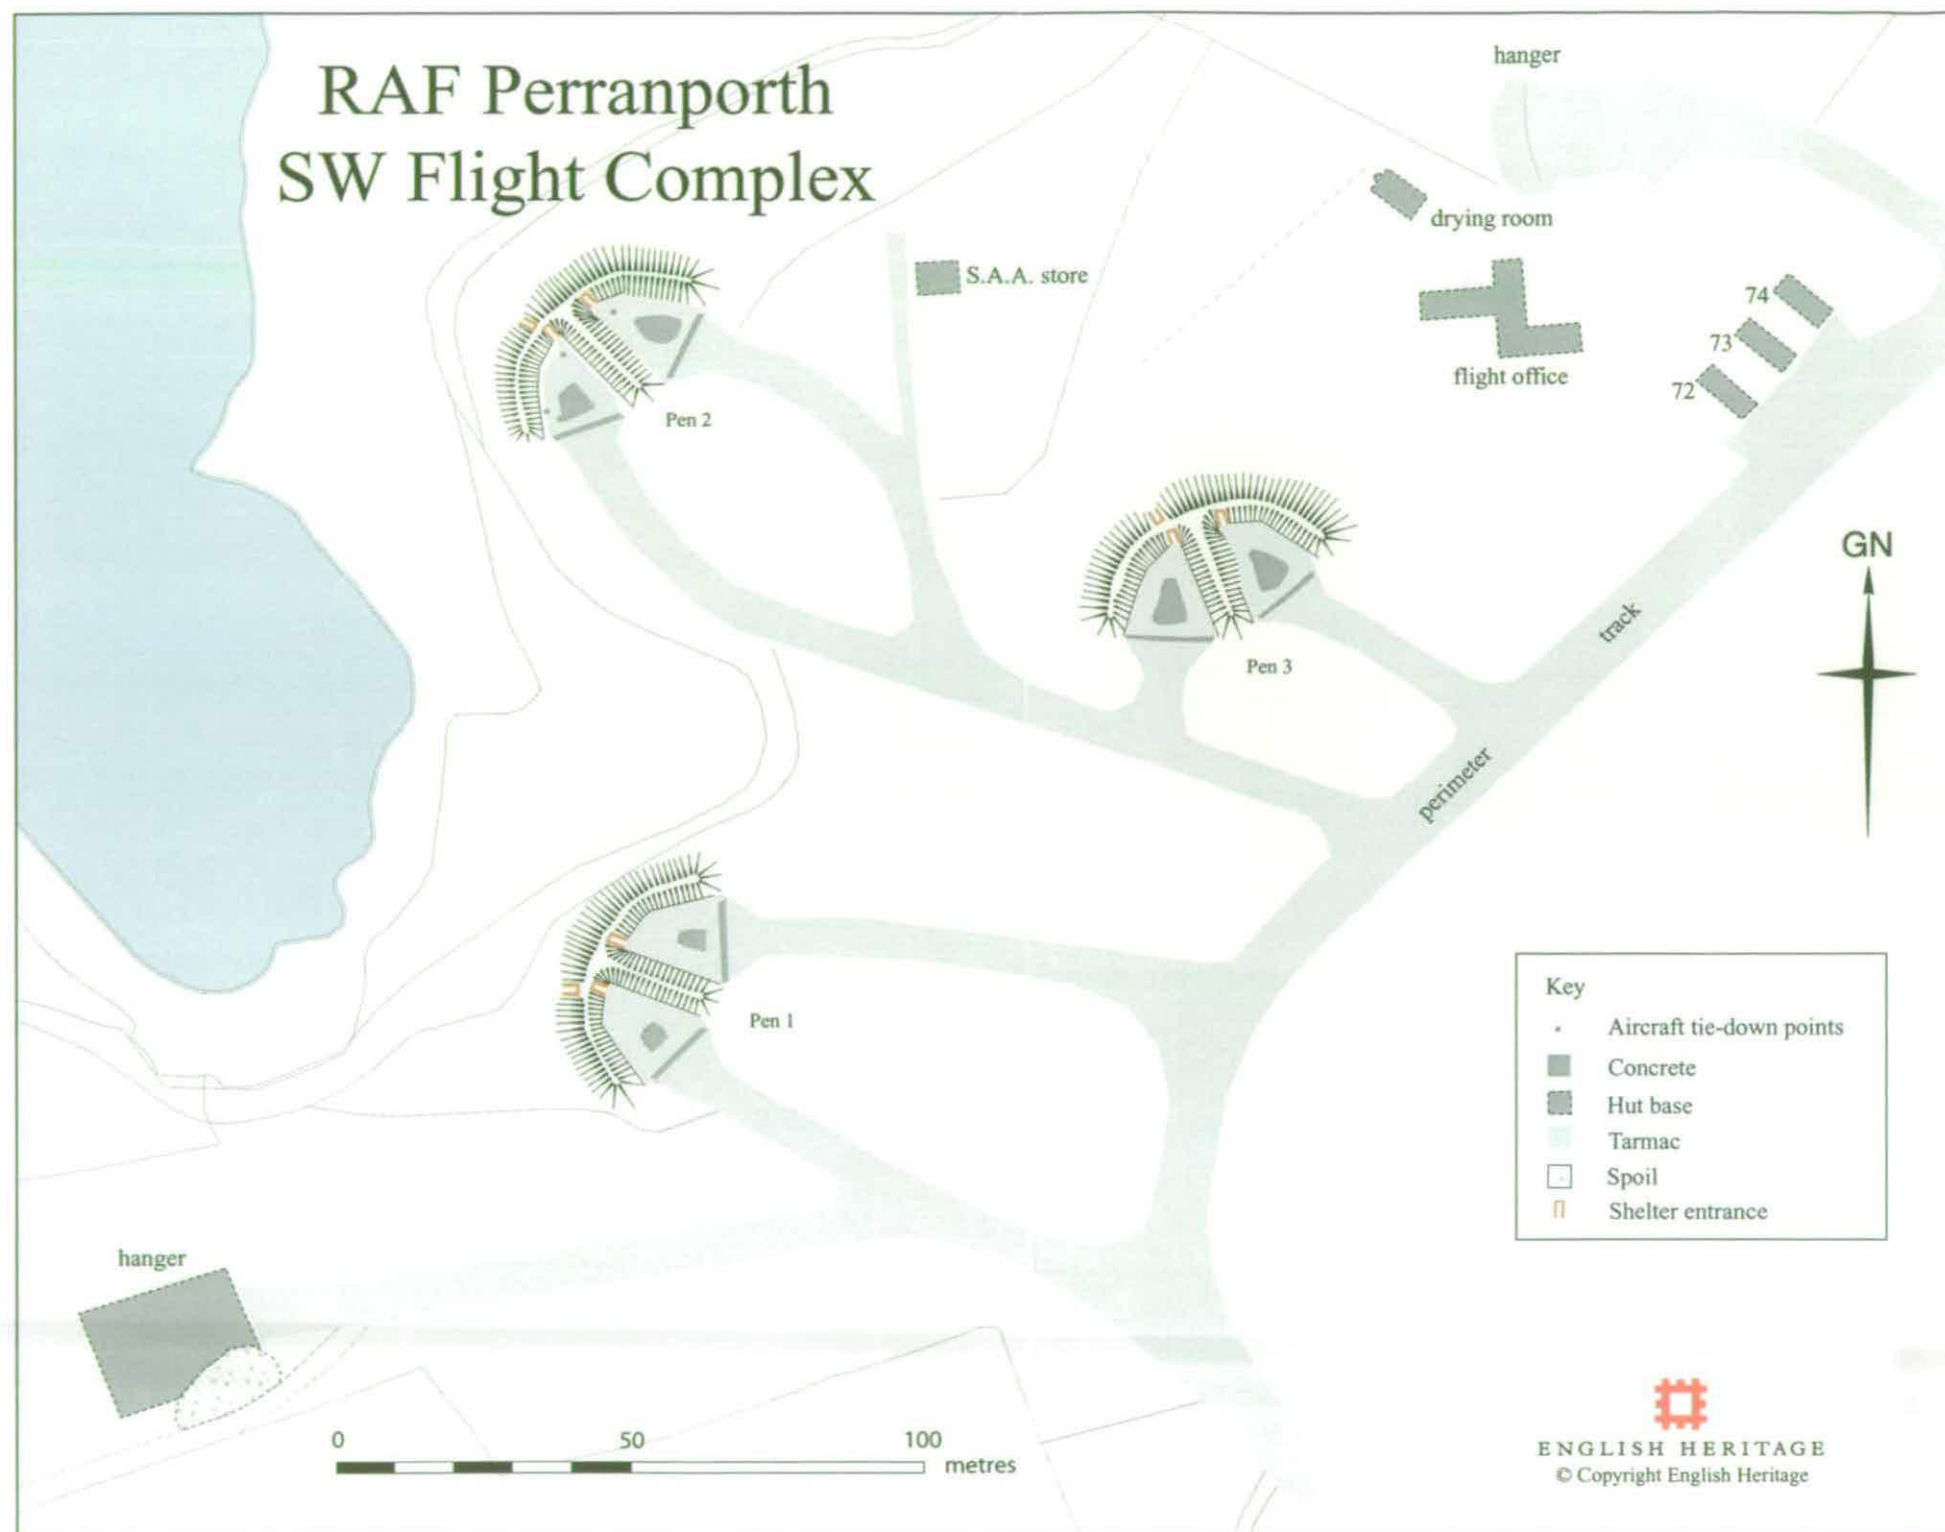
Fig. 6. The SW flight complex.

The 'later' type, built sometime after November 1941, comprise a crescentic earthen bank about 2.4m in height which incorporates a prefabricated concrete Stanton shelter. There is a passage at each end of the shelter with entranceways (three in total - two on the inside and one on the outside) constructed of concrete blocks with a flat reinforced concrete roof. The earthen bank is bisected by an up to 1.8m high earthen bank which is retained by a concrete block wall from 0.6m to 0.8m in height. The tarmac surface of each pen has up to two inserted concrete pads and a narrow concrete strip across its entrance with a maximum of three inset aircraft tie-down points.

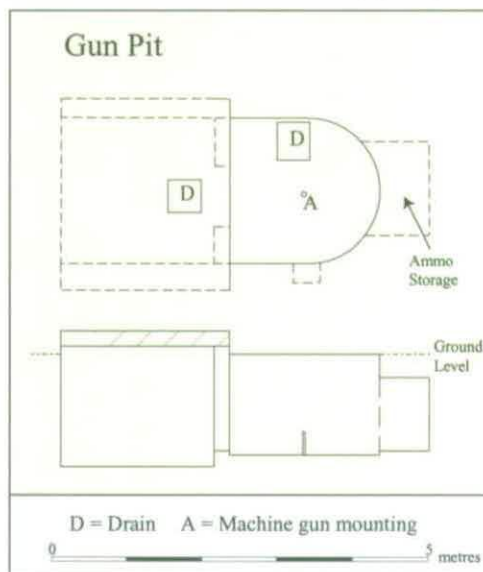
Fig. 9. Machine gun pit.

The two machine gun pits (GP) consist of below-ground 'U' shape pits faced with brick. In the centre of the floor is an iron spigot onto which a pedestal with a machine gun was mounted, probably a Lewis or Vickers model. At one end of the pit is a rectangular, concrete roofed shelter, covered by a low mound of earth and at the other is an ammunition locker (Fig. 9; Pl. 12).
