**MULTI-BEAM SURVEYS OF THE DESIGNATED WRECKS ON THE  
GOODWIN SANDS AND THE DOWNS**

**PROJECT REPORT  
2018**

**August 2018**

**Ref: 7770**

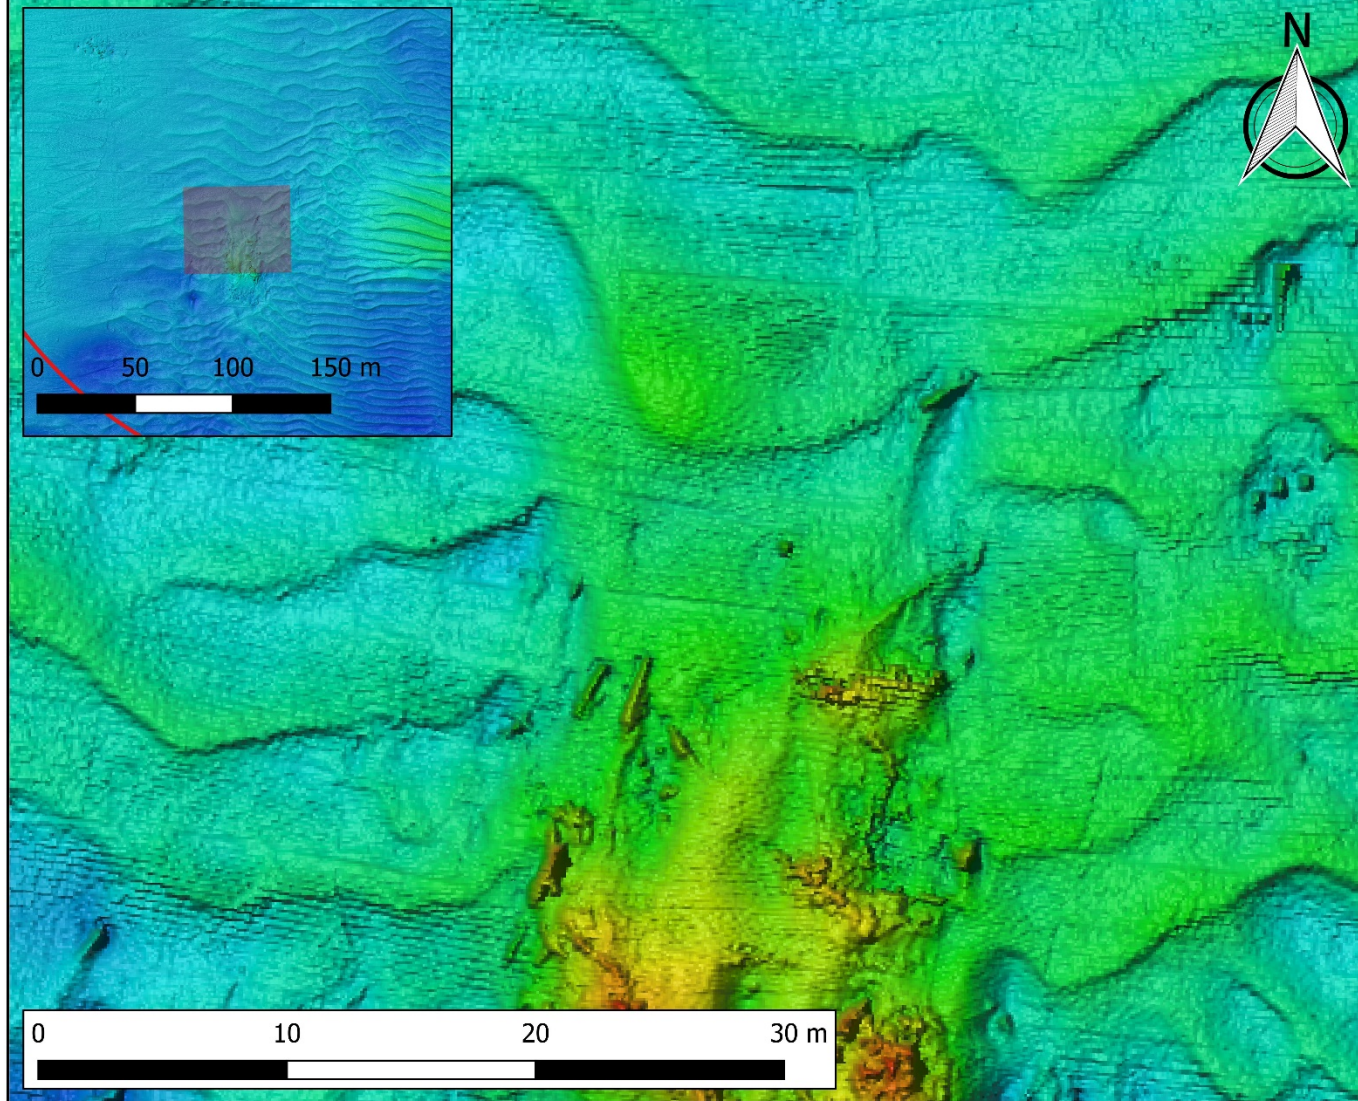
Figure 2: The main site with exposed features labelled.

- 4.3.2. There has been noteworthy bed level loss at the southern end of the site. This has revealed numerous rectangular anomalies covering an area of 12 x 6m. These anomalies are highly likely to be the stone cut blocks that have been recorded on the East site, as well as seen on other areas of the Main site (Figure 2).

- 4.3.3. Three metres southeast of these anomalies is an anchor, which is significantly more exposed than observed in the 2017 data. The length of the anchor from the crown to the end of the exposed shank is approximately 3.65m and the width across the flukes is approximately 2.7m (Figure 2).

- 4.3.4. Scour has occurred in the area east of the two anchors (one anchor on top of the other known from diving the site) at the southeast end of the wreck mound. This has revealed a 5 x 4m area of exposed features (Figure 2).

- 4.3.5. The area immediately northwest of the anchors is significantly exposed and from the excavation of this area (trench1) in 2017 it is known to contain boxes of cargo and cut stone blocks (Figure 2).

appears to be more pronounced suggesting it is more exposed than observed from the 2017 multi-beam bathymetry data (Figure 2).

- 4.3.7. Moving north from the strip iron is the location of the 2017 trench 2. The two crossed guns (guns 3 and 4) are visible, as are the two guns (guns 5 and 6) 4.5m further to the north. This area had almost completely filled in, covering those guns by the time of the last dive on the site in 2017. Their current exposure demonstrates the mobility of the seabed (Figure 2).

- 4.3.8. There are three linear features outside the main wreck mound to the west. There is a high potential that these could represent partially exposed guns (Figure 2).

- 4.3.9. There is another anomaly approximately 24m southwest of the main wreck mound. It is roughly 2.4 x 1.4m with a distinct scour all around it. (Figure 2)

- 4.3.12. On the eastern edge of the main wreck mound is a section of structure that has been identified as a gunport structure (PA 2017). This was covered in a sheet of teram at the end of the 2017 excavation. However, this area is visible on the 2018 data suggesting it may have come off due to the reduction of surface sediments in this area of the site (Figure 2).
