# BINDON MILL AND MILL HOUSE, WOOL, DORSET

## HISTORIC BUILDINGS REPORT

ANALYSIS AND ASSESSMENT OF THE  
BUILDINGS AND MILL MACHINERY

Research Department Report Series No 23/2006

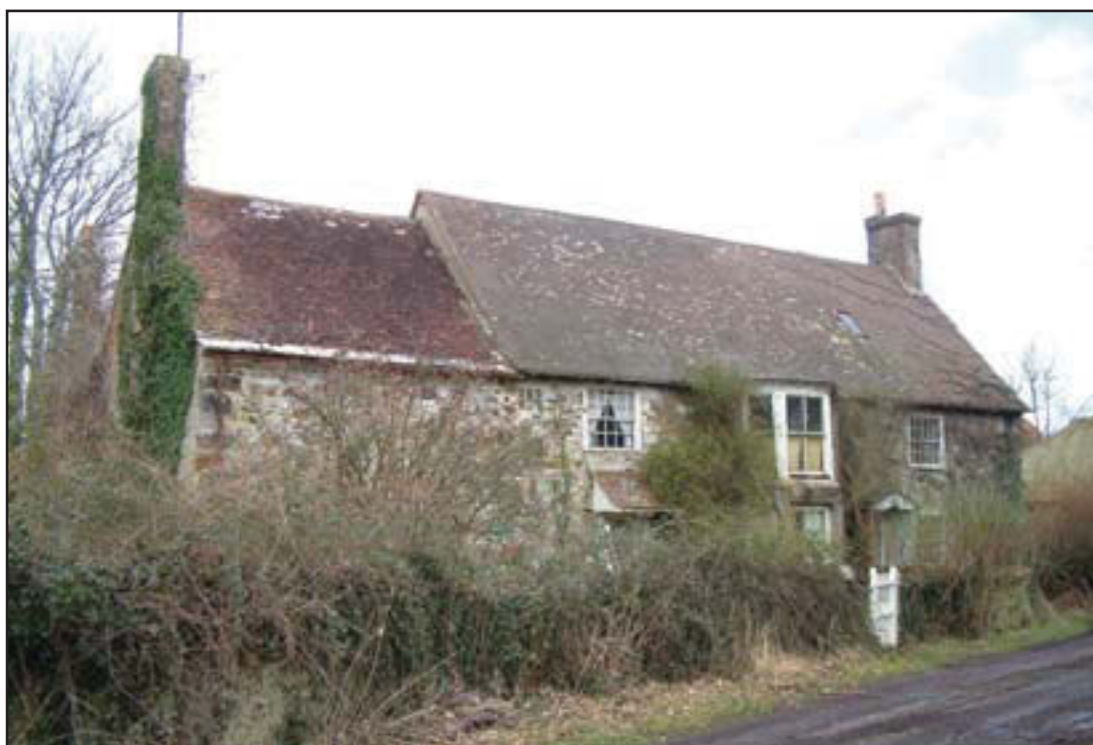
**Figure 9.**

*The mill house viewed from the south west. [DP021003]*

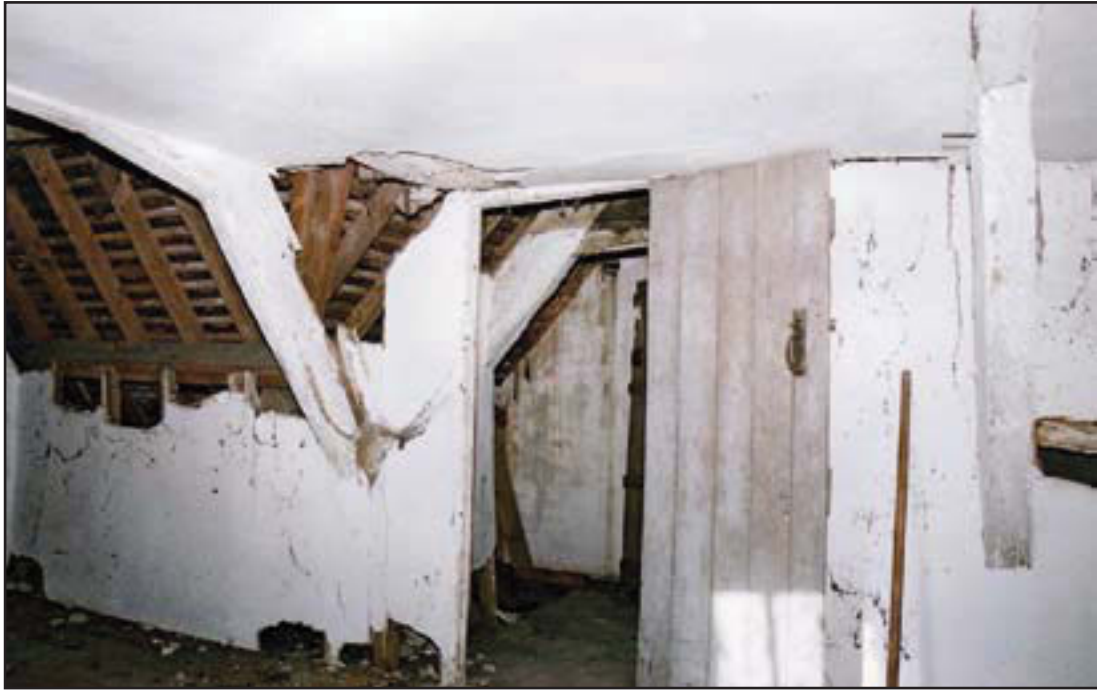
**Figure 10.**

*Interior, second floor of house, viewed from the south east, showing roof trusses at the intersection of the phase-1 roofs. [OP04330]*

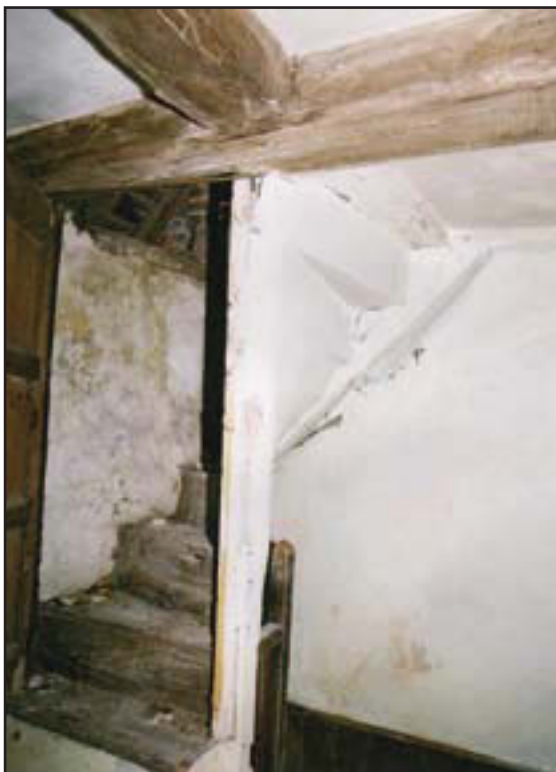
**Figure 11.**

*Interior, first floor of house, viewed from the south east, showing junction of tie-beams at intersection of the phase-1 ranges. [OP04331]*

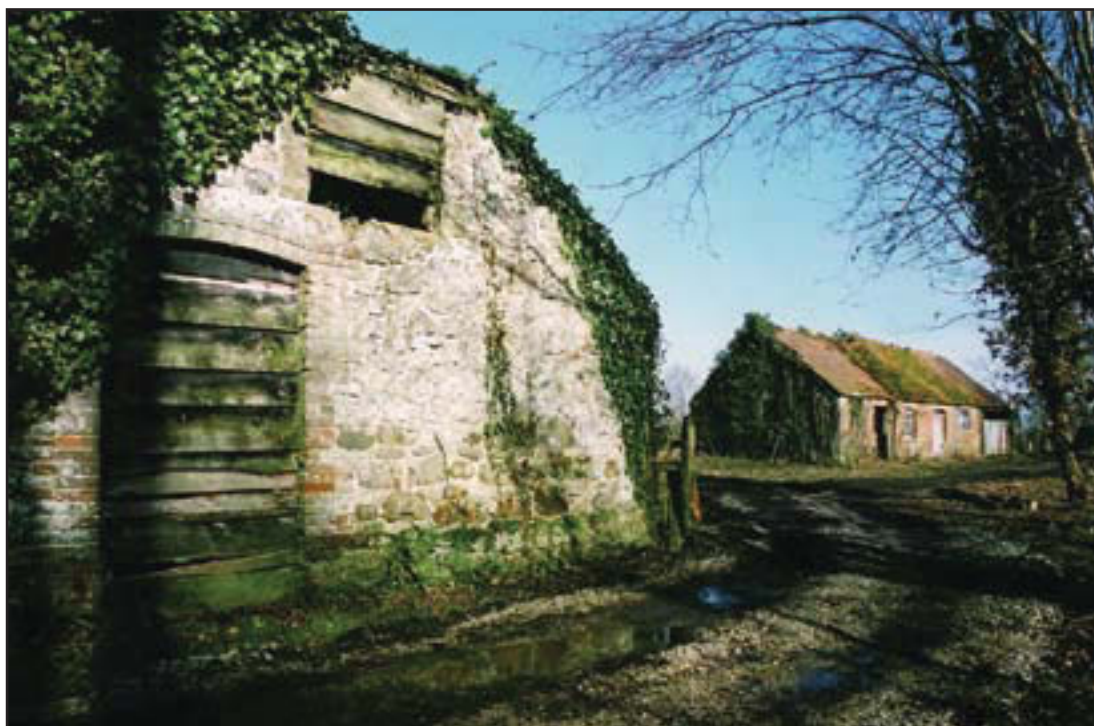
**Figure 16.**

The remainder of the range running south from the south-east corner of the extended mill appears to be of mid-to-late-19th-century date, although only the northern end of the range was accessible. It is single-storeyed, mostly of mixed rubble with brick details, and with a hipped slate roof. Much chalk rubble is visible on the few internal walls that were accessible, at the north end. A brick cross-wall, in header bond, is in

*Outbuildings from south west, showing southern end of range running south from south-east corner of the east range of the mill, and the cattle shed to the right. [OP04334]*

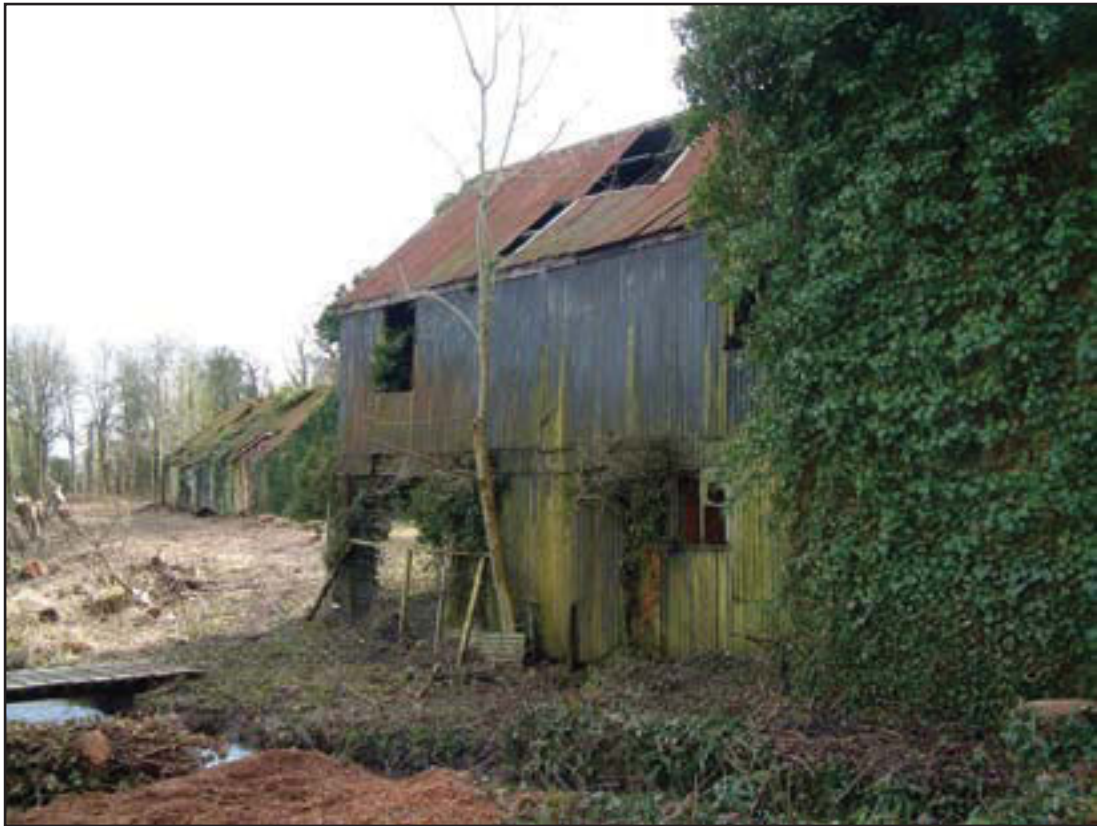
**Figure 17.**

*The corrugated-iron shed, with cattle shed beyond. Viewed from the north west. [DP021002]*

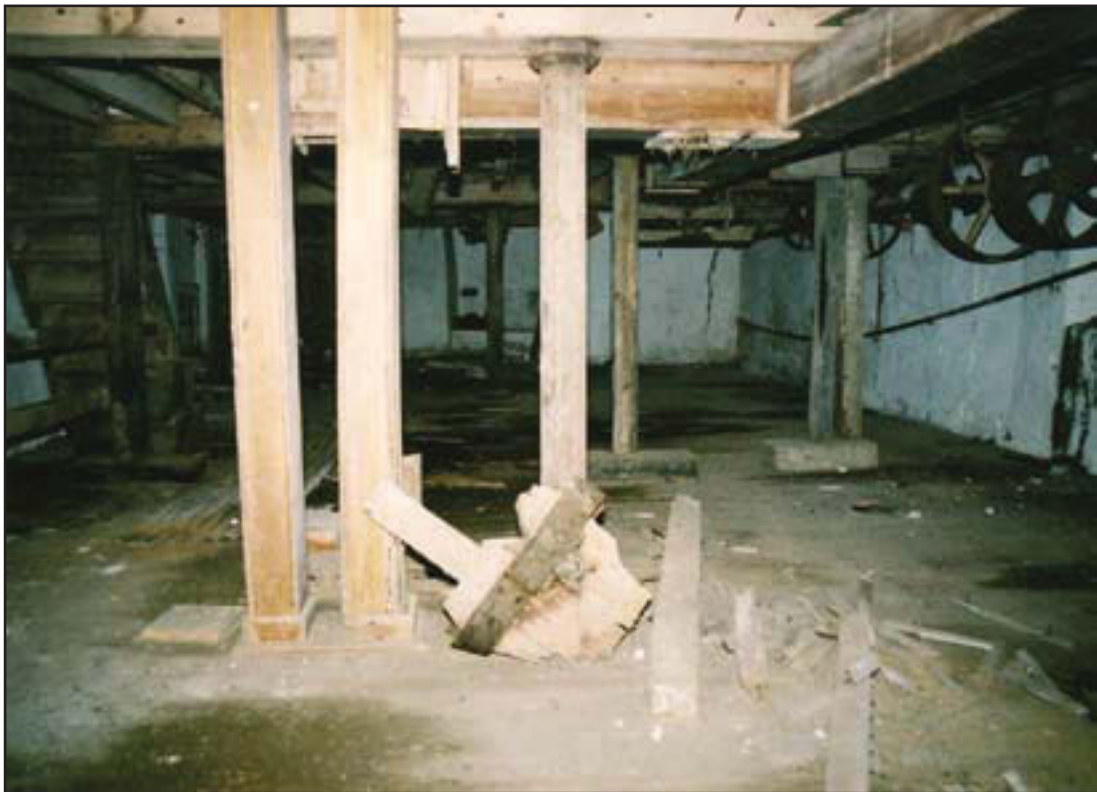
**Figure 19**

*Interior, first floor of mill, from north, showing elevator casing in the foreground and lay-shaft with belt wheels along the east wall (right). [OP04336]*

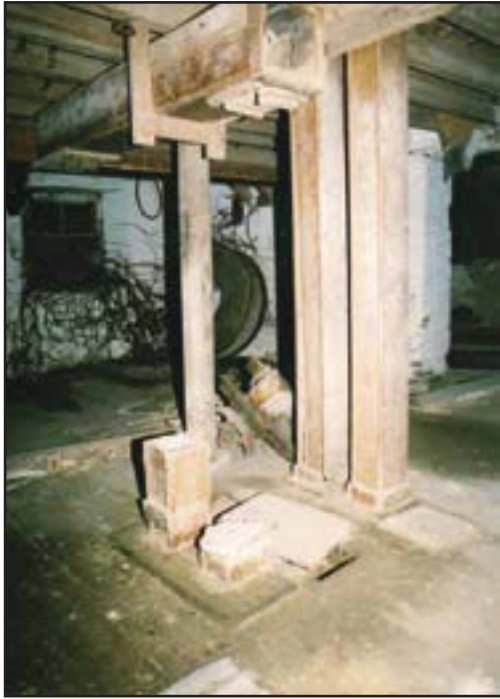
**Figure 20.**  
*Interior, first floor of mill, from south east, showing elevator casing, aspirator trunking above, and a millstone in the background. To right is the doorway into the north extension. [OP04337]*

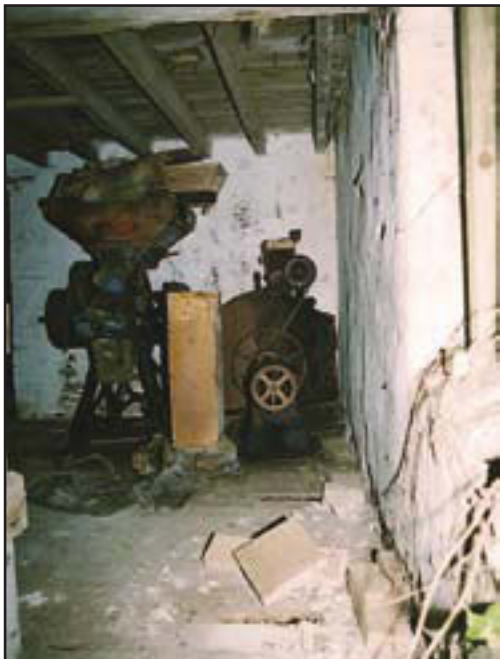
**Figure 22.**  
*Interior, first floor of mill, from south, showing machines in the north-east corner. The oats crusher is to the left. [OP04339]*

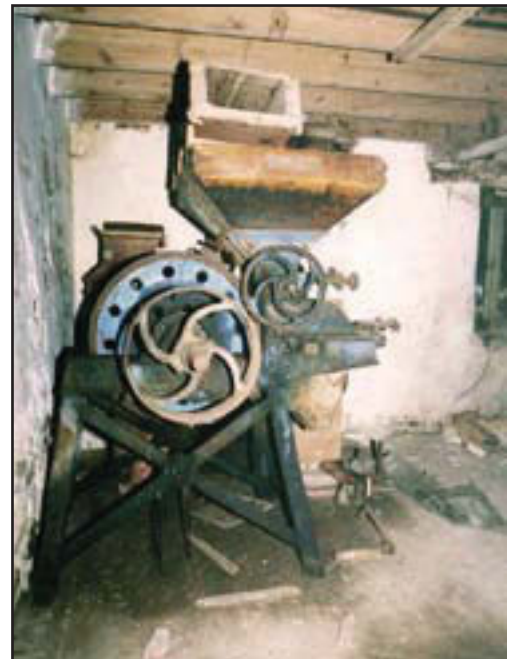
The first floor was once the stone floor, containing the millstones. During the 1890s remodelling, the millstones would have been replaced by roller-mills, which have been removed subsequently. The number and positions of the roller mills could not be determined. Some machines were presumably installed in the eastern extension, but their distribution and former functions could not be investigated due to access restrictions. At this level, there is a surviving, long, secondary, lay-shaft carrying a series of belt-wheels along the east side, driven off the primary lay-shaft belt-wheel on the ground floor, and a tertiary lay-shaft at the south end. There are the vertical wooden trunkings for a couple of elevators<sup>21</sup> towards the north end, with some wooden aspirator ducting<sup>22</sup> above, a spare composition runner millstone, with fragments of another in the north-west corner, and a couple of machines in the north-east corner [see Figure 22]. Inaccessibility precluded an examination of these, although the more westerly of the two machines appears to be an oats roller, for crushing, or bruising oats for animal feed.<sup>23</sup>

**Figure 23.**  
*Interior, first floor of mill, from east, showing the oats crusher in the north-east corner. [OP04340]*
