**Building Recording at  
Halesowen Abbey, 1989/90**

**Iain Ferris**

**Birmingham University Field Archaeology Unit 1990**

## Building Recording at Halesowen Abbey, 1989/1990

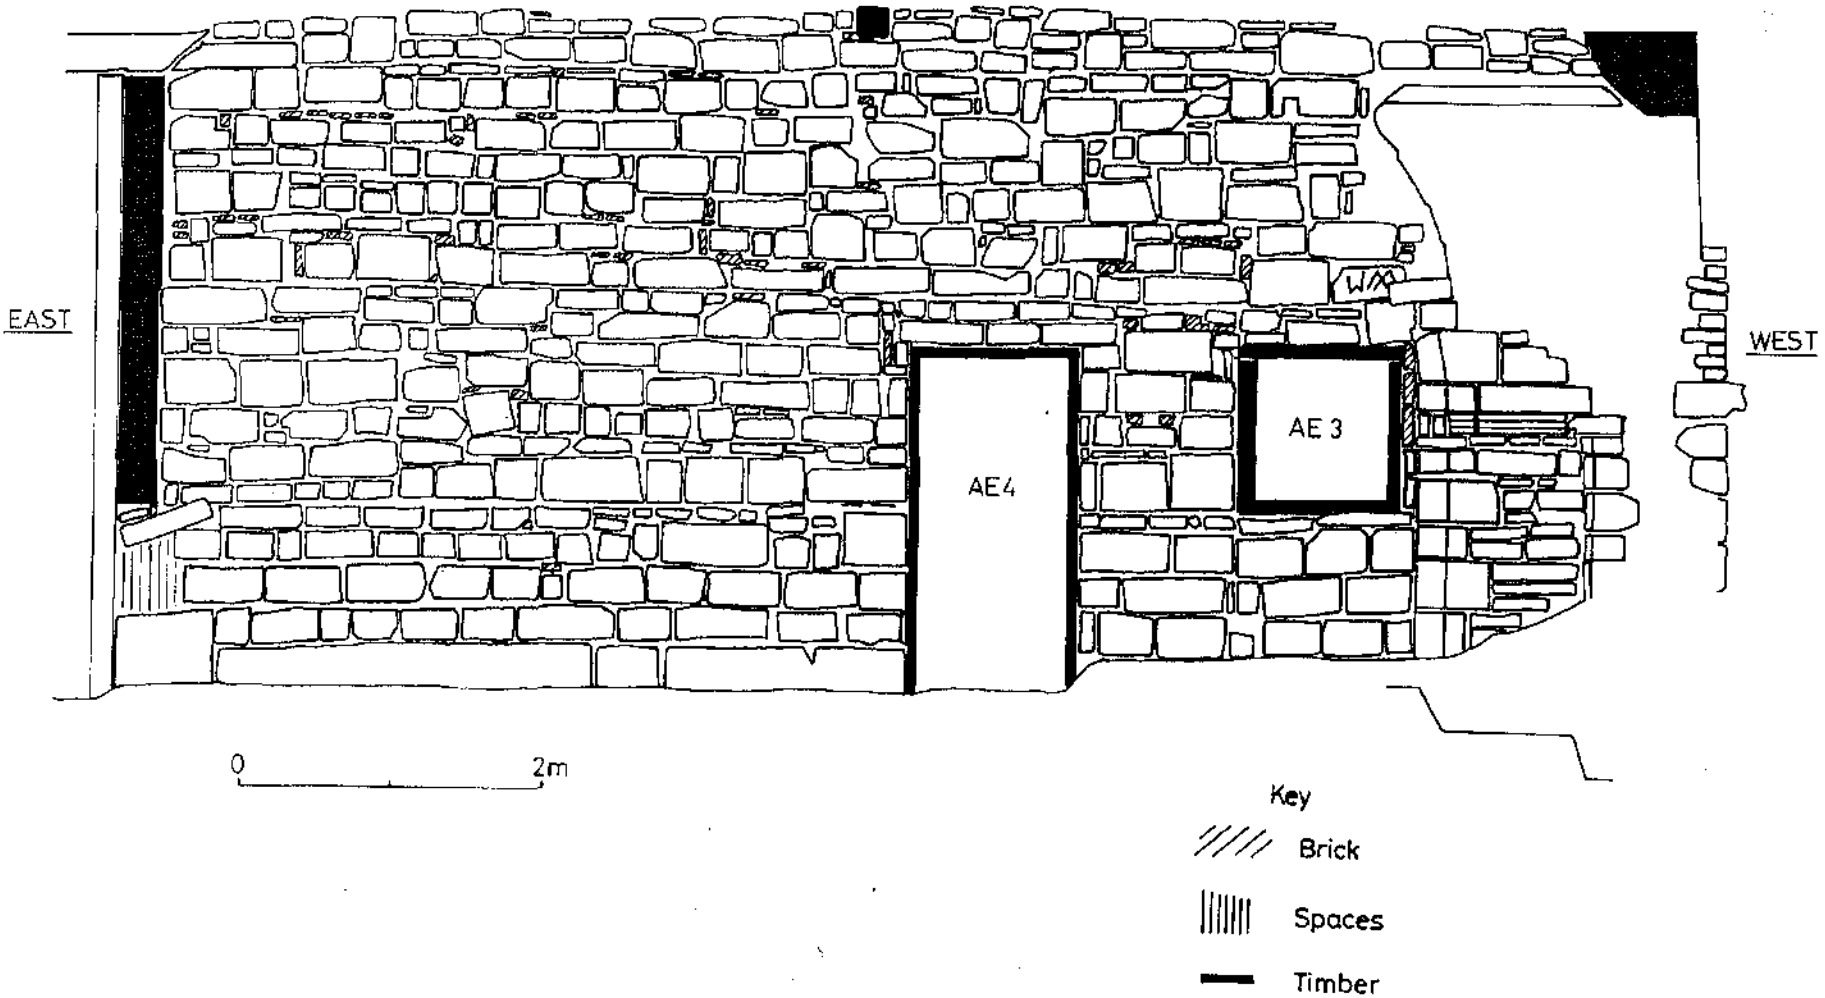
Figure 13 Structure 4. Detail of Stonework at West End of North Wall. (Sternberg)

The barn is built of a mixture of materials - timber, sandstone blocks, sandstone rubble and brick - which very much reflects the types of build, and reuse of materials, already seen in Structure 3. Again, like Structure 3, it is possible to identify some medieval masonry incorporated within the building, as well as medieval stonework reused in the later builds. As has already been noted, the eastern gable end of the barn butts up against the west wall of the south transept of the monastic church, while parts of the south wall of the nave of that church are certainly incorporated within the north wall of the barn, as at the west end external face of this wall (Figure 13). Again, by examining the interior faces of the wall, around doorways AE4 and AE8 (Figure 14), it can be seen that wide, arched doorways of medieval build (AE17, AE18) still exist in situ here, that to the west end of the wall probably being the entrance into the church reserved for layfolk and that to the east being in the position of the processional door into, and out of, the cloister to the south. Other portions of church wall may be incorporated within the barn's north-wall fabric - indeed the rubble build used in much of this wall, to the east of the cart door, may simply be the consolidated exposed core of the medieval wall, while the lower portions of the sandstone wall to the west of the door may be medieval. The inner face of the west wall of the barn, at least at its lowest level (the unusual thickness of this

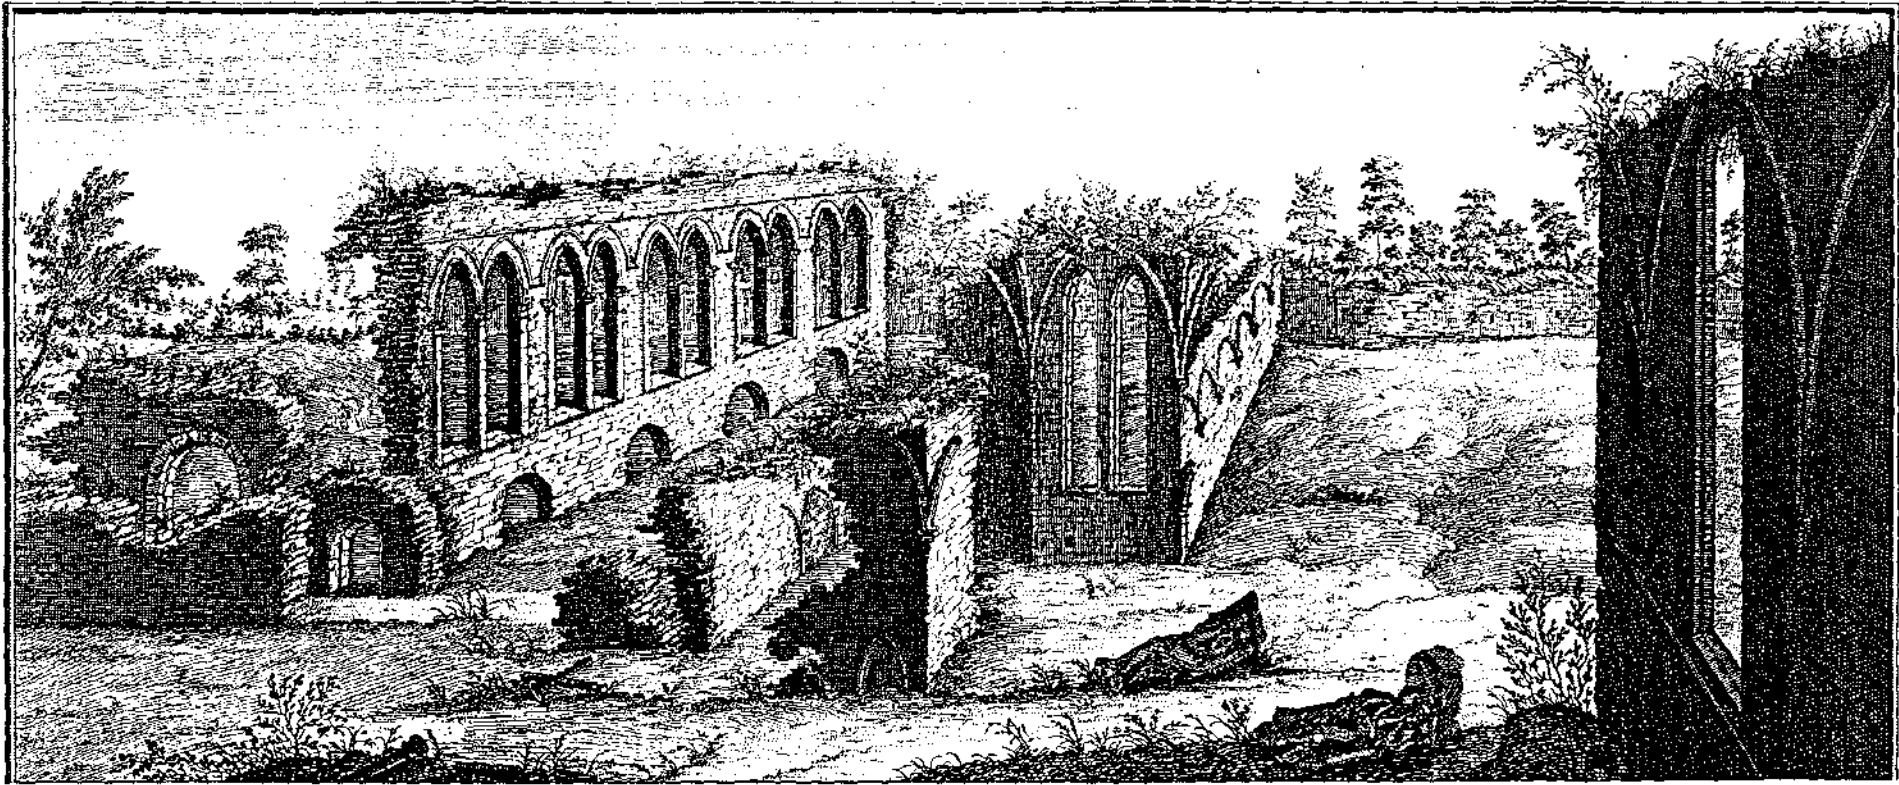
Figure 16 S. and N. Buck. (1731)

An examination of the various illustrations/drawings of the abbey complex do not help to date closely either the shed, Structure 3, or the barn, Structure 4. The Buck drawing of 1731 (Figure 16) shows no agricultural buildings on the site, though the veracity of this illustration has already been questioned above. The Hooper engraving of 1774 (Figure 17) shows, from a distance, a farm building roughly in the position of Structure 3 but detail is lacking. An engraving of 1799 by J. Caldwell (Figure 18), and confirmed by drawings of 1801 and 1808 by D. Parkes (Figures 19 and 20) shows a large barn-like structure, partially hidden behind the walling of the south transept, while an engraving by W. Angus, based on another drawing by Parkes (Figure 22), and published in 1813 (though it is likely to be somewhat earlier as Parkes had been recorded as drawing at Halesowen as early as 1789) shows the east end of a barn butted up against the south transept wall. The details of this walling are completely unlike anything visible today, suggesting that much of this face was destroyed when the brick building forming the east side of the farmyard was built up against the long barn. There is a noticeable building break visible on the Angus/Parkes illustration which tends to support the theory of the barn having been extended eastwards at some stage and not originally to have incorporated the fragments of medieval transept walling.
