**Archaeological Recording at  
Eastcote Manor Moat Bridge,  
Solihull, West Midlands**

Birmingham University Field Archaeology Unit  
**Project No. 446**  
January 1997

by  
Mark Hewson

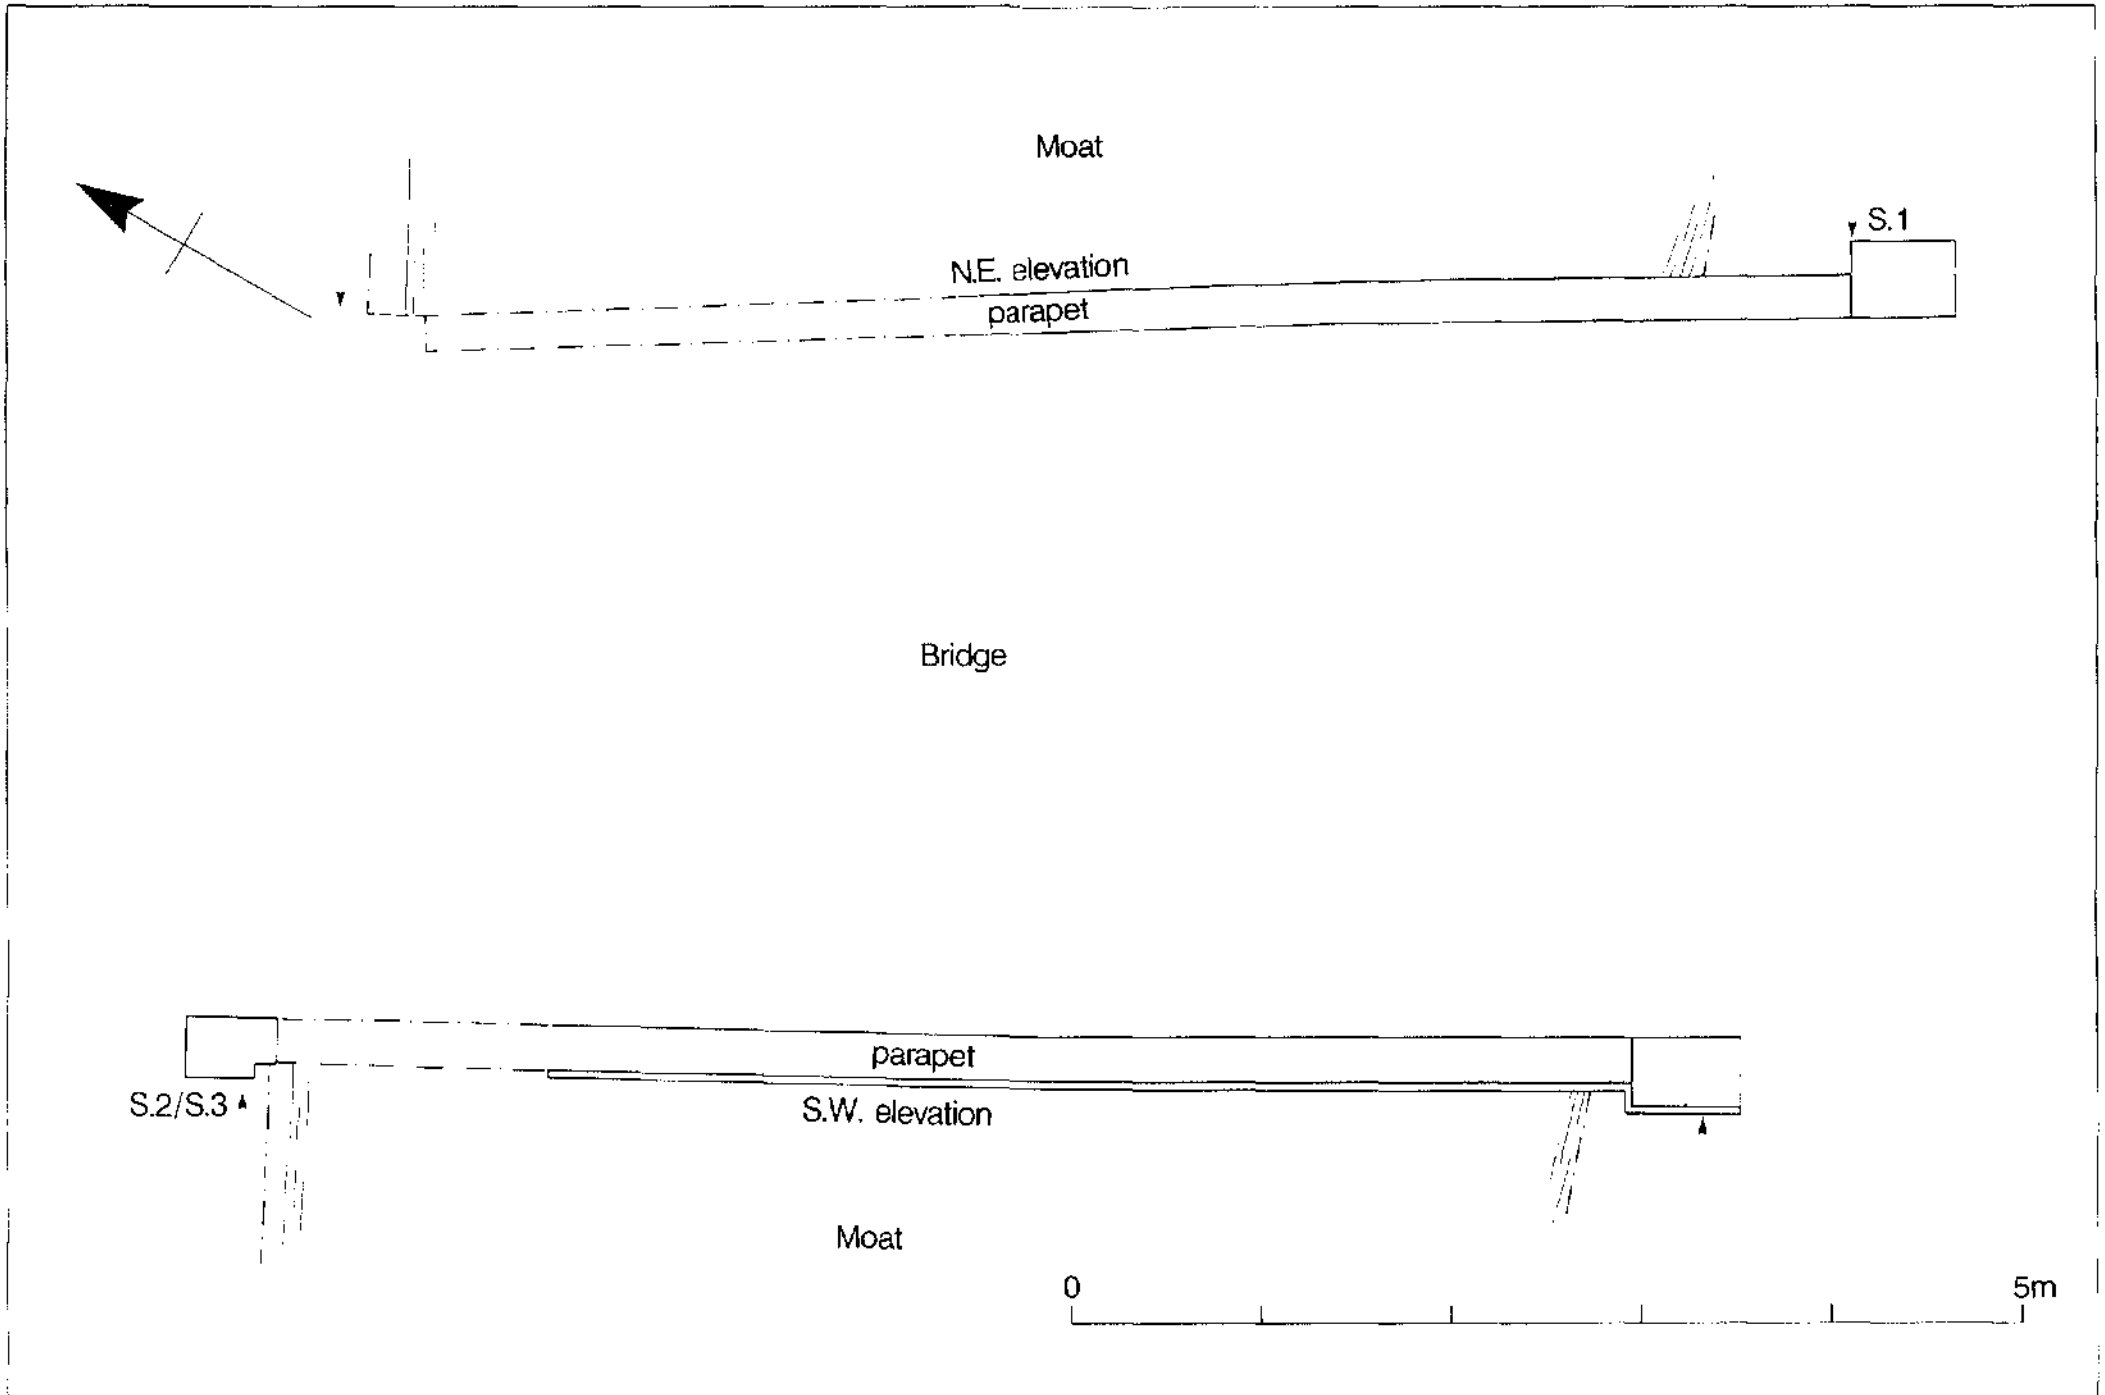
Fig.5

Both of these elevations were in poor condition having been subject to root action and pressure from above. The lowest courses, whilst predominantly of green sandstone blocks similar to those of the bridge sides, have modern tile and brick fragments as infilling incorporated among them in the joints between courses. These courses did not appear to be mortared - whether the mortar has been eroded over time or was never used is unknown. Additionally, brick and mortar rubble was evident in these lower courses. Three courses of modern brickwork were bonded to the lower sandstone courses, above which was a layer of cement and the brick span of the arch itself.
