**Himley Quarry, Stallings Lane,  
Kingswinford, West Midlands**

**Archaeological Field Survey**

Birmingham University Field Archaeology Unit  
**Project No. 680.1**  
March 2000

by  
CHRIS HEWITSON

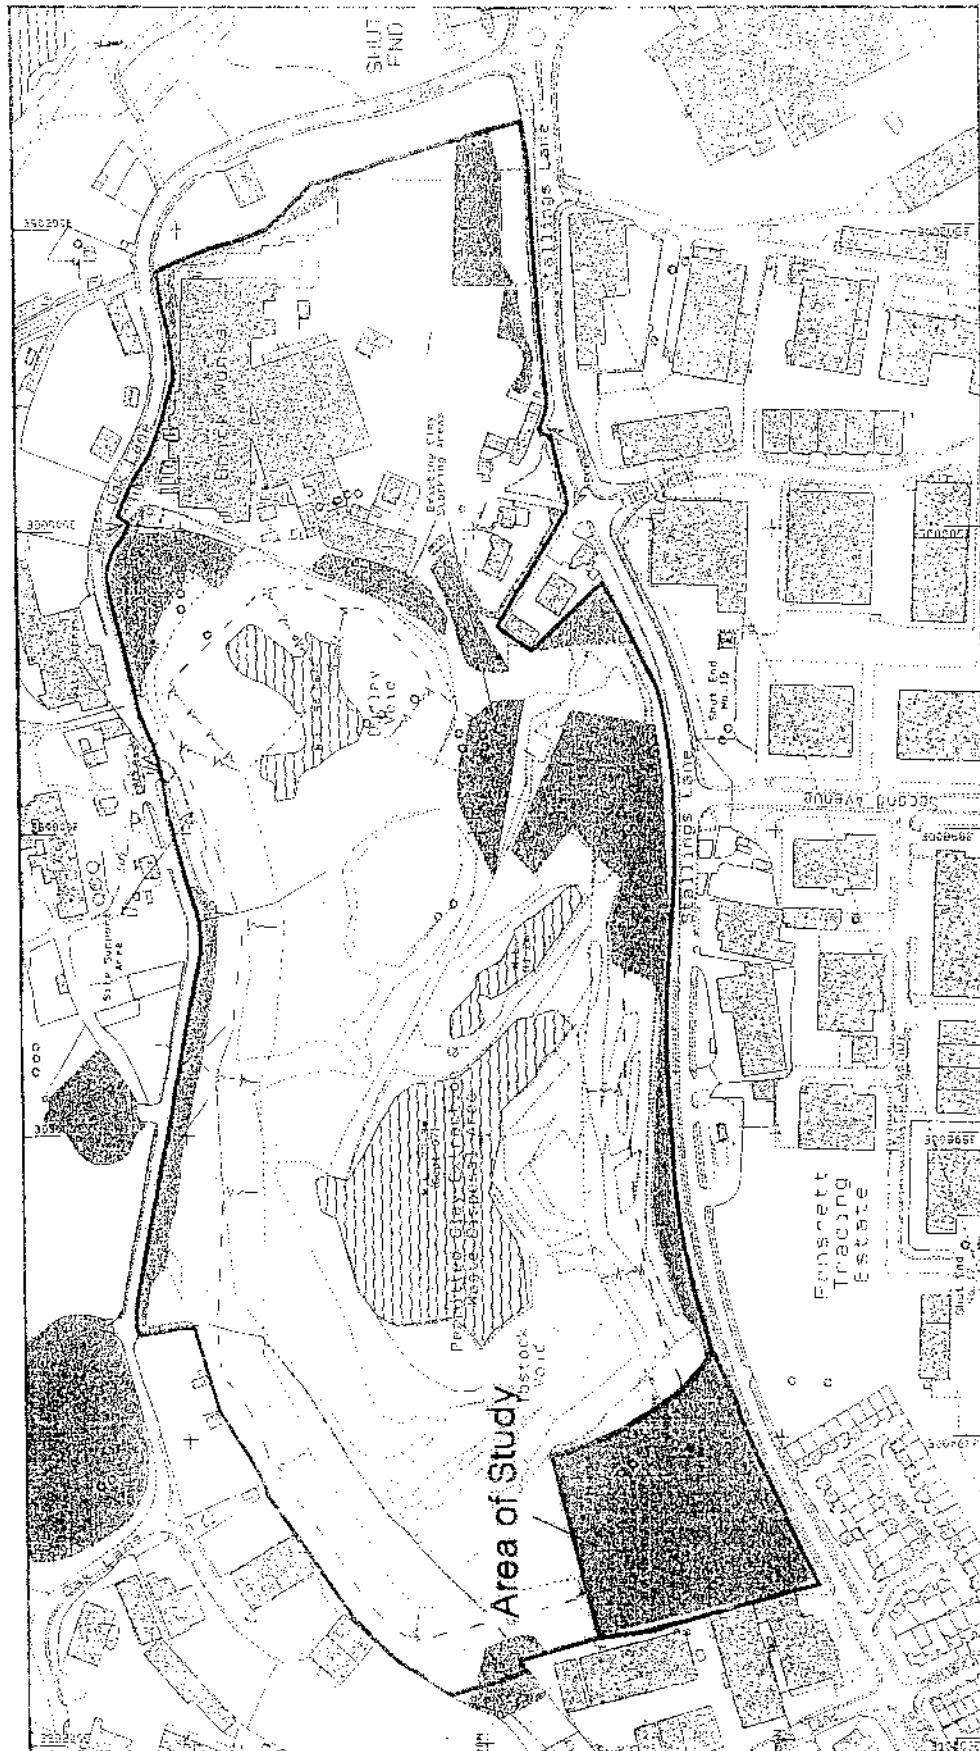
Fig.2

The remains of the **Stables** mentioned in the SMR reference have entirely been demolished. They are located directly adjacent to the quarry edge (Fig. 3), which appears to be located further east than denoted on the quarry map (Fig. 2). All that remains is a moss-covered rubble spread, c.20m in length north - south and c.10m wide east - west. It survives to a height of c.0.5m in the north-west corner. Clearly the stables had been levelled some time ago. The size of the spread suggests it may be a combination of the demolition of the two buildings (the **Stables** and **Structure B**, Fig. 3) visible in this locale on the 1919 Ordnance Survey Map.
