**An archaeological
assessment of the Old
Farmhouse and Dairy,
Merridale,
Wolverhampton,
Black Country**

Birmingham University Field Archaeology Unit
Project No. 777
March 2001

by
Stephen Litherland and Sarah Watt

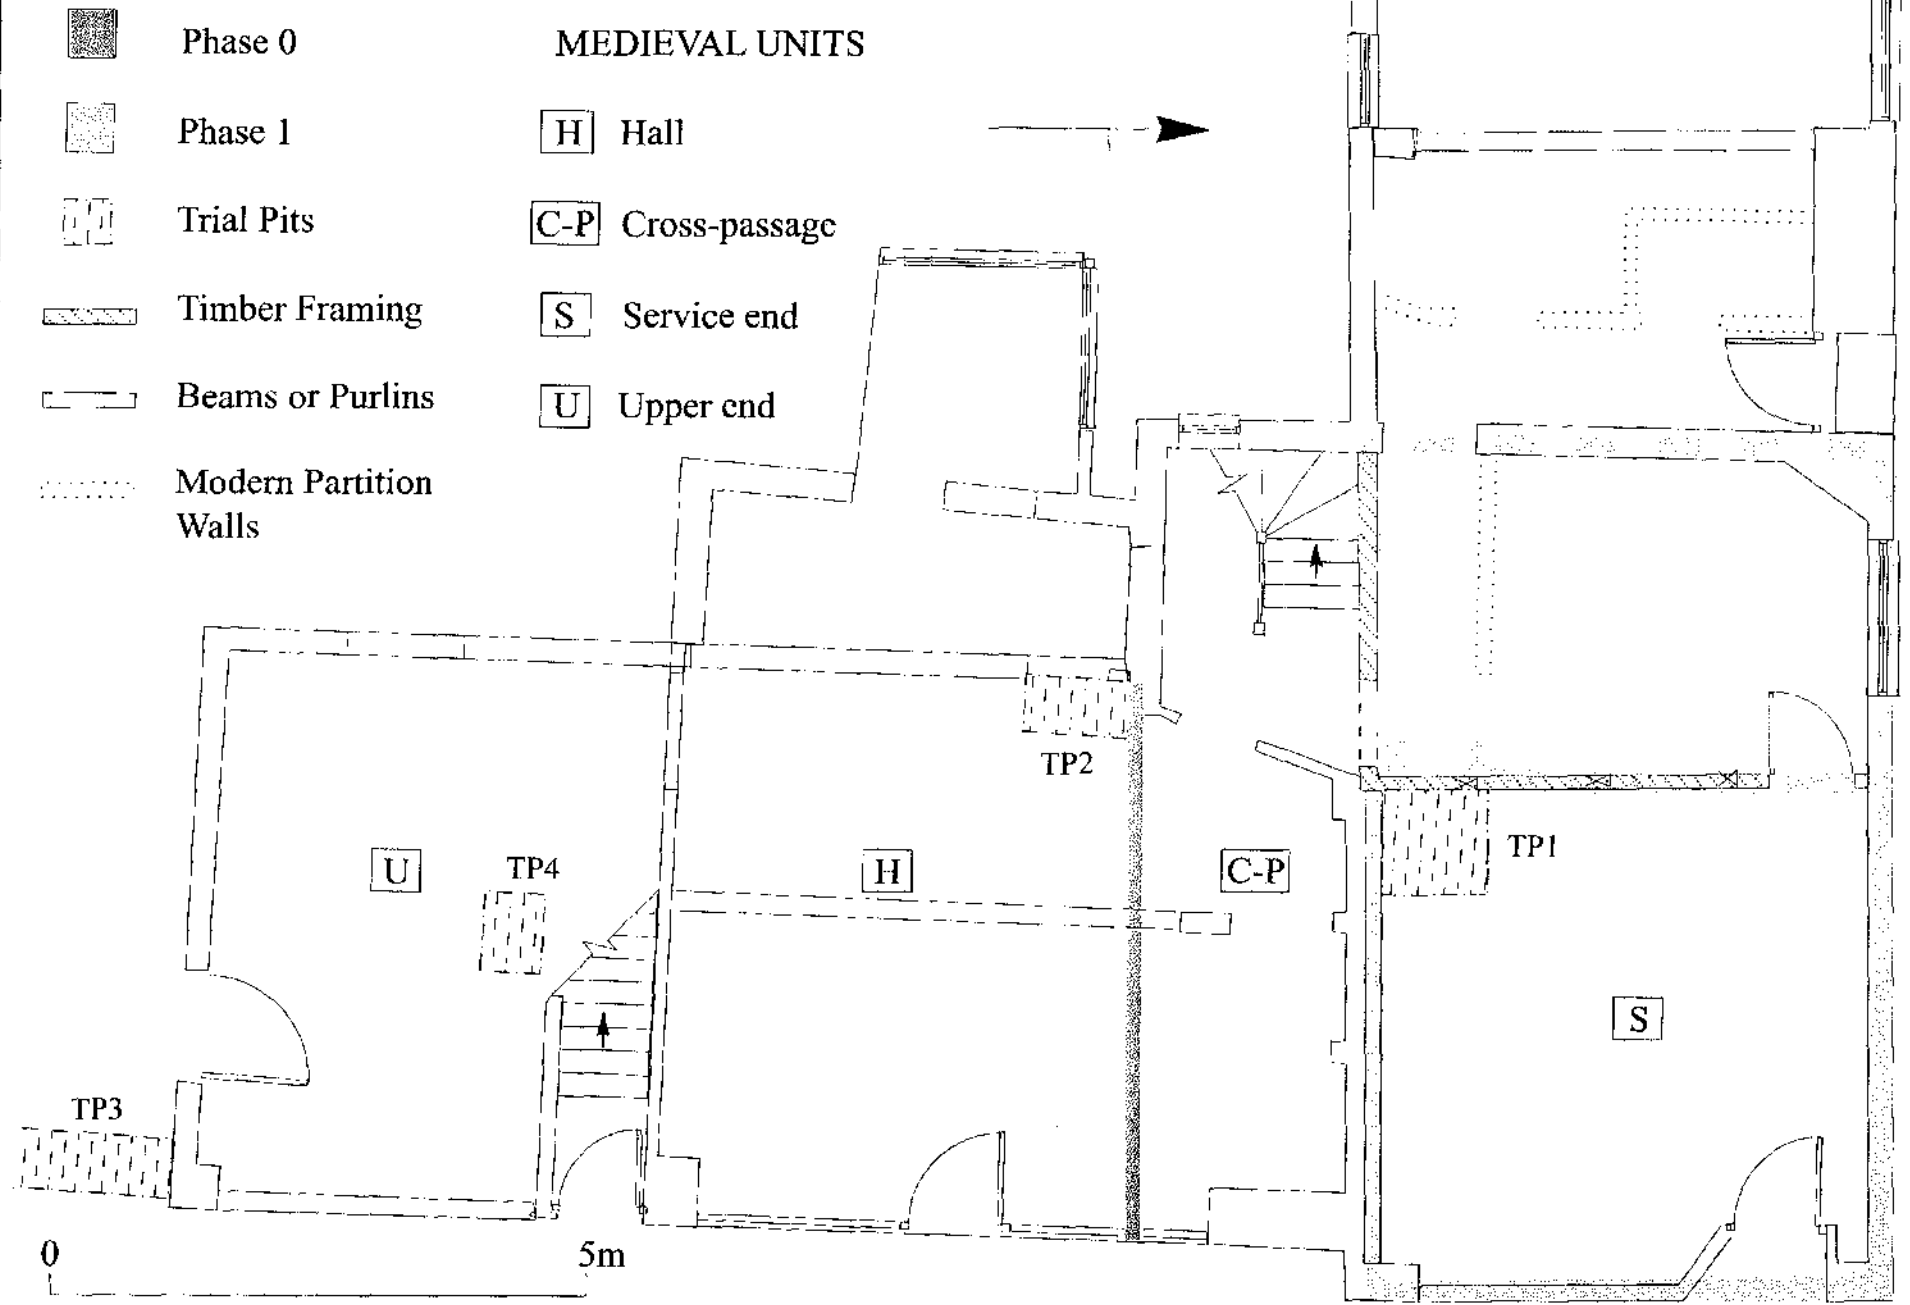
Fig.10

Trial pits (Fig. 10)

The preliminary phase, Phase 0 (Fig. 10), is only represented by the survival of buried archaeological remains, although it is also indirectly attested through a lingering effect on the form of the later development of the standing building. The roughly hewn sandstone foundation seen in TP2 represents the line of a spere truss located at the lower end of a medieval hall dividing this hall from the cross-passage entrance. The hall was located where the brick-built main range now stands and was probably very similar in size. The typical medieval hall was the main communal room of a house, with a centrally placed hearth and a trampled clay floor, like that seen in TP2. The hall was open to the roof to allow smoke from the fire to disperse. The classic medieval arrangement was for the

Phase 1 is represented by the timber-framed elements of the cross-wing and its sandstone undercroft or cellar (Figs. 7 & 10). The transverse partition wall, from the sill beam to the top of the second panel of framing on the first floor, and the frames of the ground-floor ceiling on either side are the main elements to survive, together with parts of the southern wall frame. The cross-wing was originally jettied on three sides. Dragon beams survive in both rooms of the wing and all the main timbers are chamfered and stopped against each other. In addition, the joists for the jetties are pegged into the dragon beams and the whole construction is of high quality. The ground floor panelling of the transverse partition wall consisted of four pairs of roughly 4 feet square panels, while the first floor consisted of five pairs of slightly smaller panels, together with straight downward braces. This pattern was repeated in the panelling of the north-facing jettied first floor (Fig. 5), and it is reasonable to assume that this was the overall style of the cross-wing. The cross-wing was located at the service end of the house. It was probably a rebuild of an earlier service wing, and this may explain its division into two rooms. However, it is also clear that the front room was the more important, given the quality of the carpentry. There would have been access to both rooms from the cross-passage.

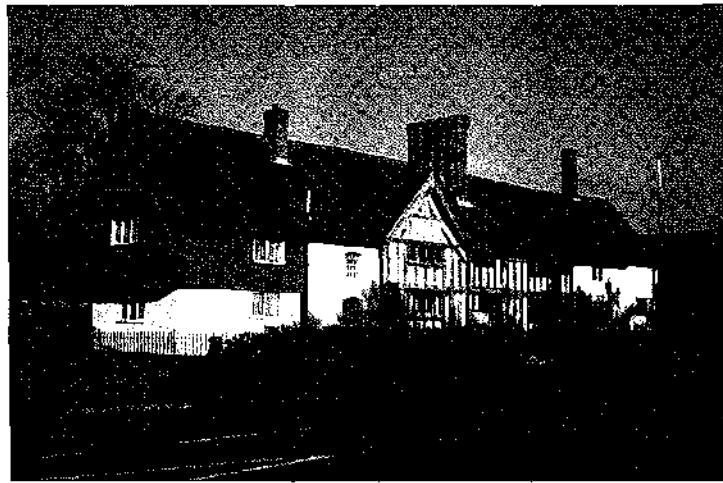
Plate 20

Perhaps, the closest local parallel to Merridale farmhouse is Northcote Farm in Bushbury (Plate 20). This farmstead was the residence of the Underhills, a family of middling importance in medieval Wolverhampton, like the Salford family. At Northcote Farm a basic medieval plan was progressively remodelled in the post-medieval period, whilst retaining a gabled, one room deep, farmhouse plan. Furthermore, the c.1500 service range was also of unusually high quality, with jetties on three sides. The final local parallel to draw attention to is Old Moseley Hall, also in Bushbury (Plate 21). Here, the remodelling of the house involved cladding the timber-framed manor house with a set of external brick walls. Like Merridale farmhouse, these brick walls incorporated a set of stringcourses to emphasise the floor levels inside the building, although the brickwork here is about 100 years later.
