**Archaeological Building
Recording in the East
Wing of Alton Towers,
Alton, Staffordshire**

Birmingham University Field Archaeology Unit
Project No. 1039
February 2003

by
Malcolm Hislop

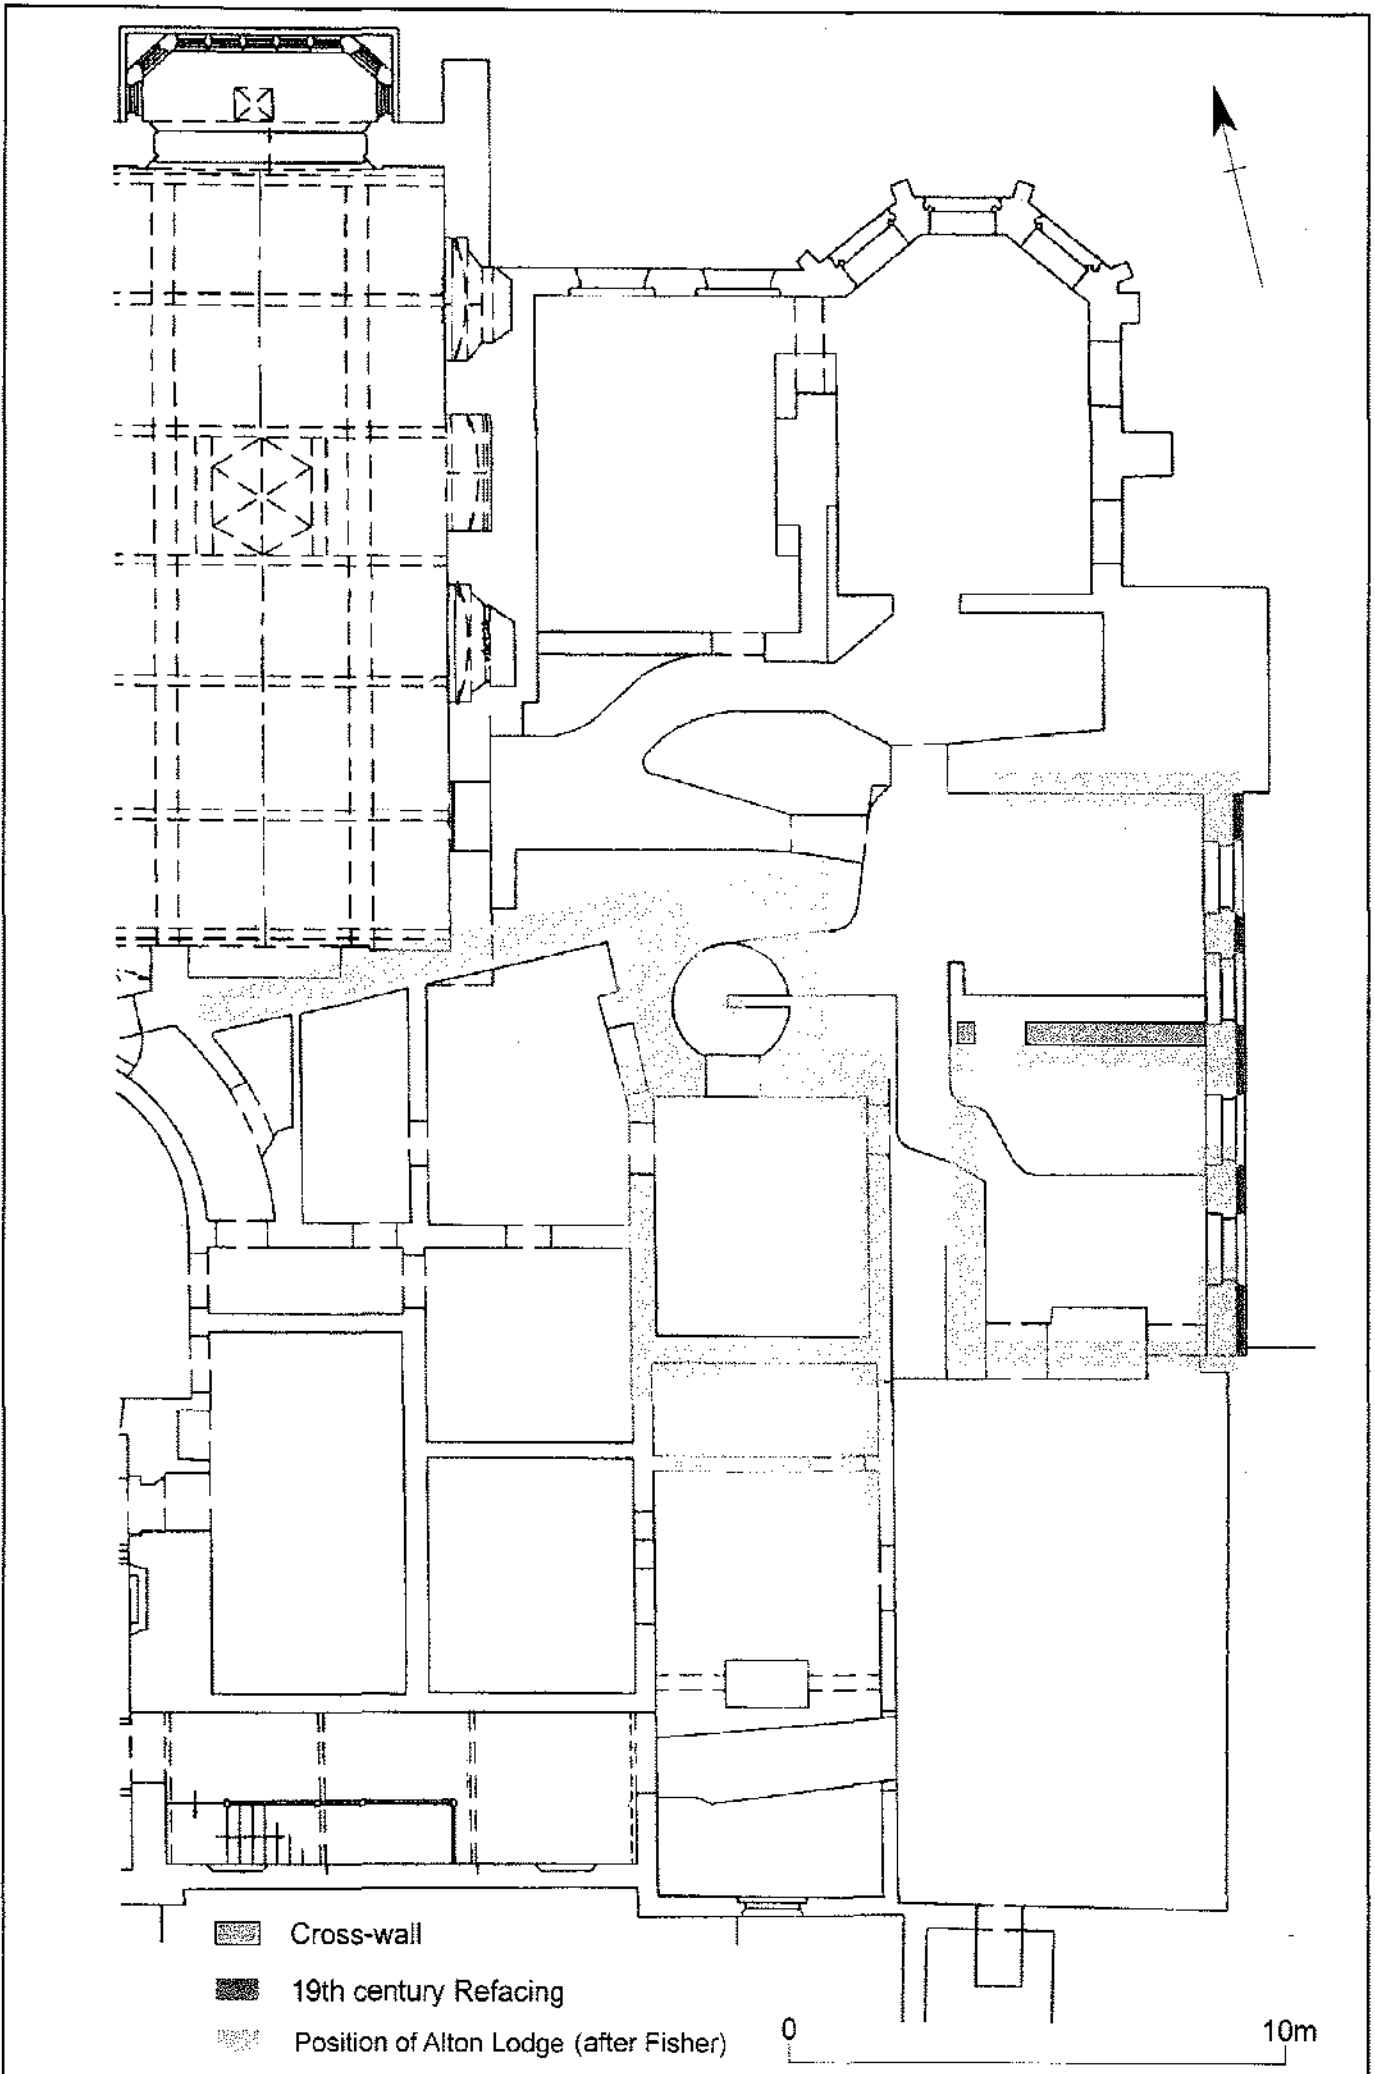
Fig.5 Position of Cross-wall

The cross-wall was situated between the two centre windows of the wing (Fig. 5). It was approximately 6m high, 4m wide and 0.52m thick. It was built of coursed sandstone rubble, incorporating some reused fragments of dressed stone and a number of dressed stone blocks, and laid with lime-based mortar. It rose from the 19th-century first floor level through two full stories and part of a further storey. Formerly, it extended right across the building, but most of the western half (Plate 1) had been demolished by the time of the survey, and the brief was confined to the eastern part.
