The Malthouse, Harvington
Hall, Kidderminster,
Worcestershire

Evaluation, Historic Building
Recording and Interpretation,
2004

P.N. 1249
January 2005

By Leonie Driver and Malcolm Hislop

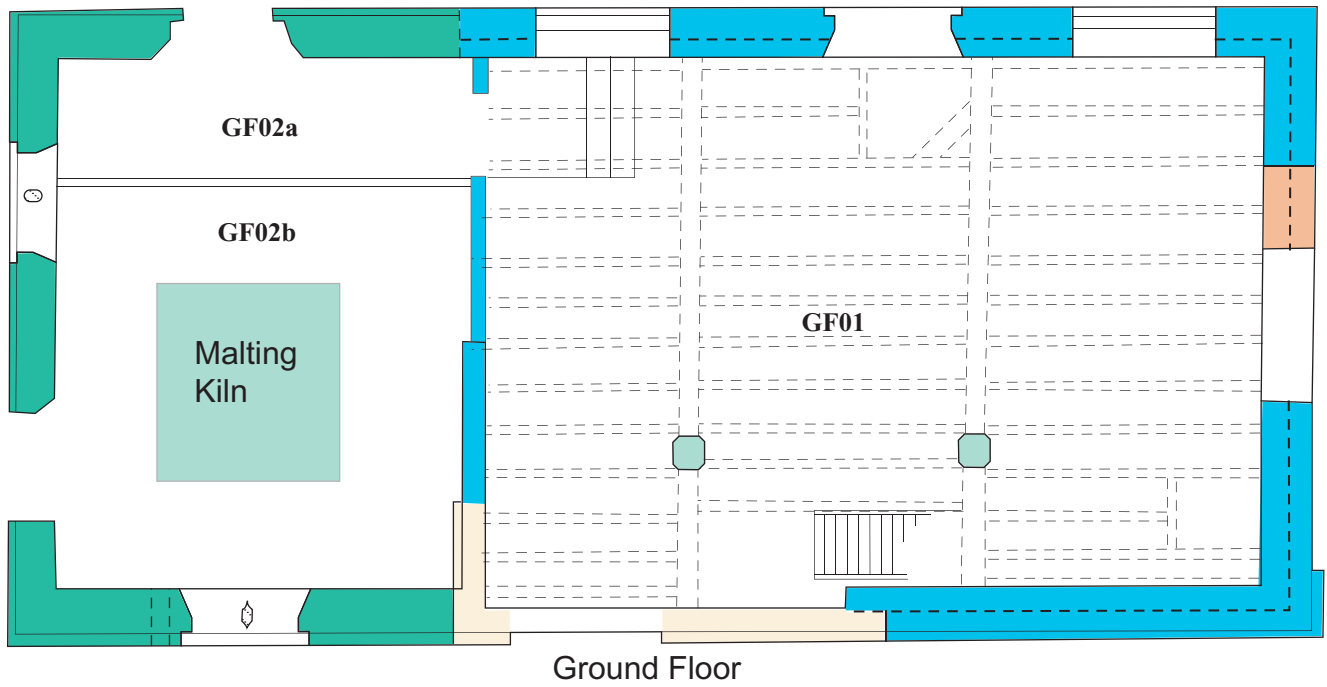
Fig.8

GF02b was entered from a doorway in the partition wall but also directly from the outside via a door in the northwest wall with splayed jambs. It contains the malting kiln, which is a square, red brick construction dating from c.1830, which occupies the centre of the room leaving a passageway around all four sides (Plate 17). The walls are carried up and over the passages as half vaults to create a funnel shaped kiln. The stoke hole is on the northwest side. It has a semi-circular arch and is directly in front of the hearth (Plate 18). Inside the kiln are the broken remains of the cast iron disperser plate that covered the hearth.

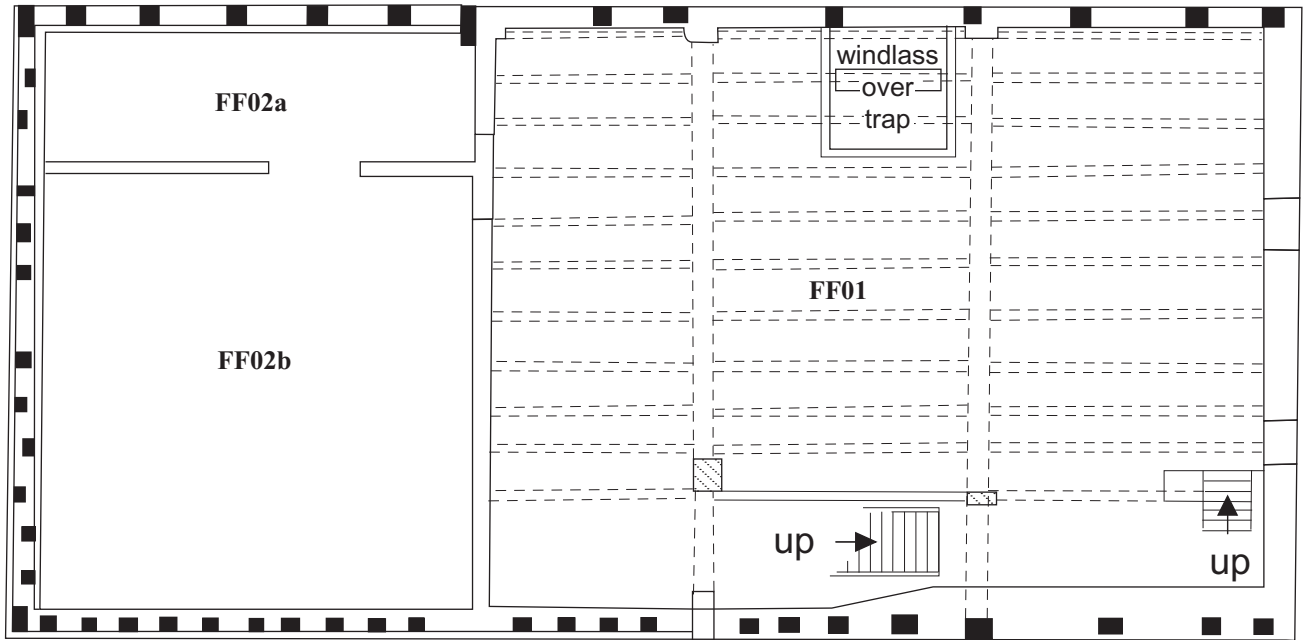
Fig.9

20th wooden steps ranged against the southwest wall leads up to the first floor. The staircase is divided from FF01 by a 19th/early 20th century stud and lath partition, plastered on the northeast side. Mid-20th-century floorboards, laid around the earlier hatch on the northeast side of the room. Above the hatch is a 19th-century wooden windlass, complete with iron handles, chain and hook (Plate 20). The second hatch in the south corner of the building is currently under the stairs to the second floor.

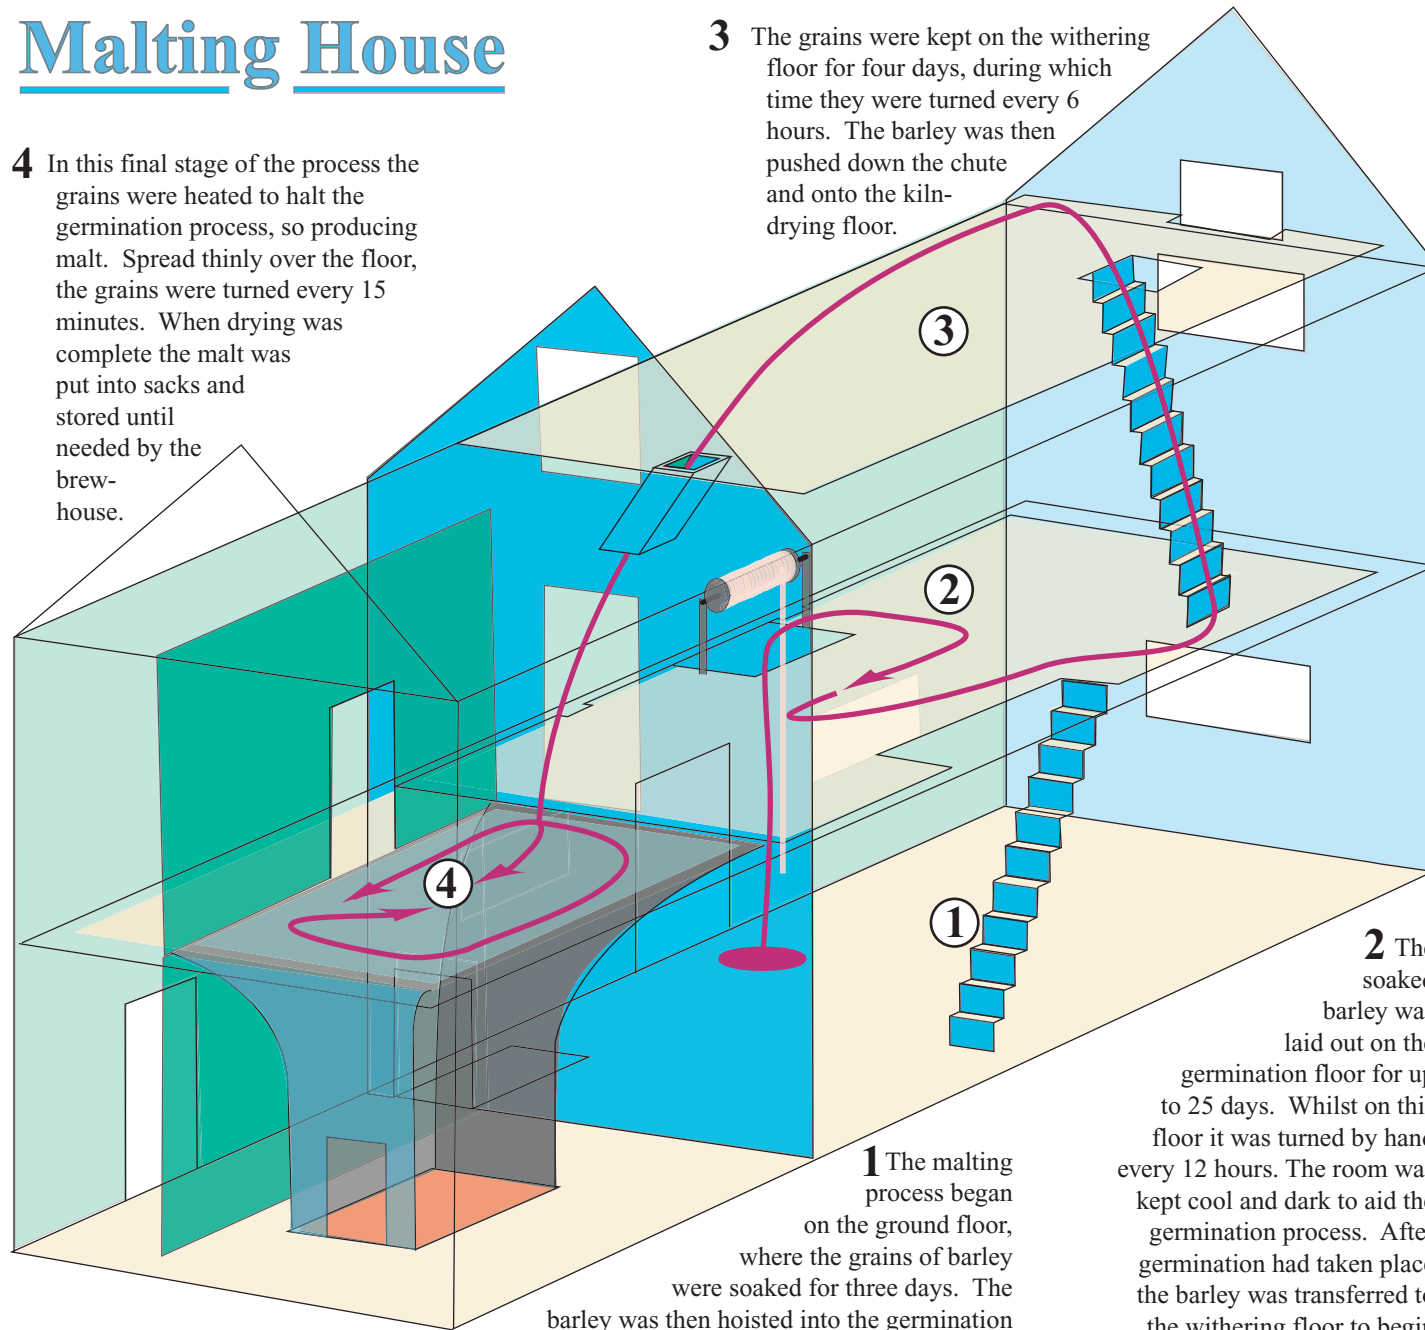
Fig.11

2 The soaked barley was laid out on the germination floor for up to 25 days. Whilst on this floor it was turned by hand every 12 hours. The room was kept cool and dark to aid the germination process. After germination had taken place the barley was transferred to the withering floor to begin

1 The malting process began on the ground floor, where the grains of barley were soaked for three days. The barley was then hoisted into the germination room.

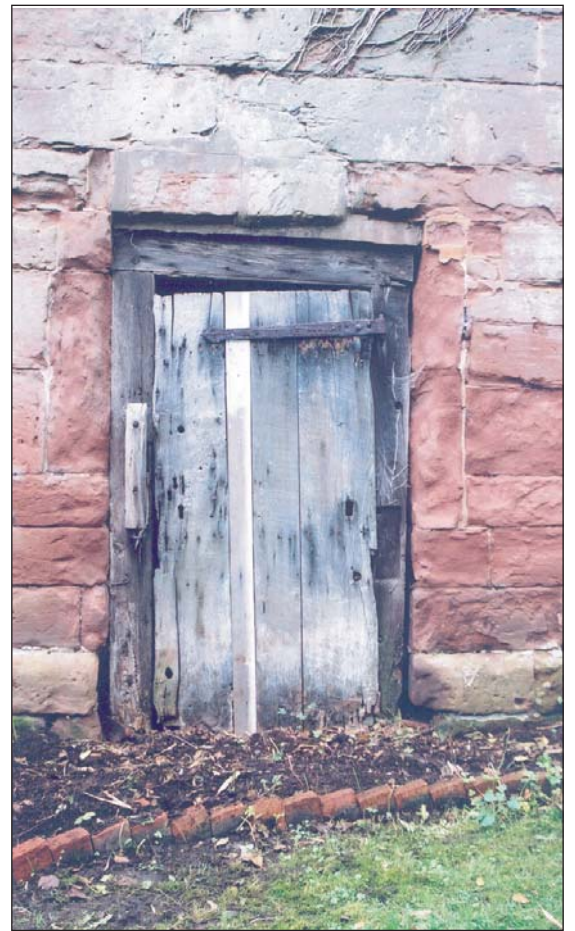
Plate 14

In contrast to the Southeast Block the Northwest Block has a plain projecting stone plinth, which is carried around the three sides of this part of the malthouse. Central old boarded door with leaf-head strap hinges, probably 17th century (Plate 14). It could not be ascertained whether this doorway was original or whether it had been inserted. The vertical jamb stones in the upper half of the frame look awkward, contrasting markedly with the horizontal jamb stones in the lower half of the frame. In common with the doorway to the Southeast Block, there was no stone lintel, only the wooden lintel of the doorframe. It is possible that this doorway represents an opened out window, the upper jambs of which survive, though not the head or sill. The timber framing above consists of a single tier of rectangular panels, though redundant peg holes in the sill beam show that the present configuration is a modification to the original pattern of closely-spaced studs. The panels are infilled with brick laid in stretcher bond, except for the centre panel, which contains a hatch.

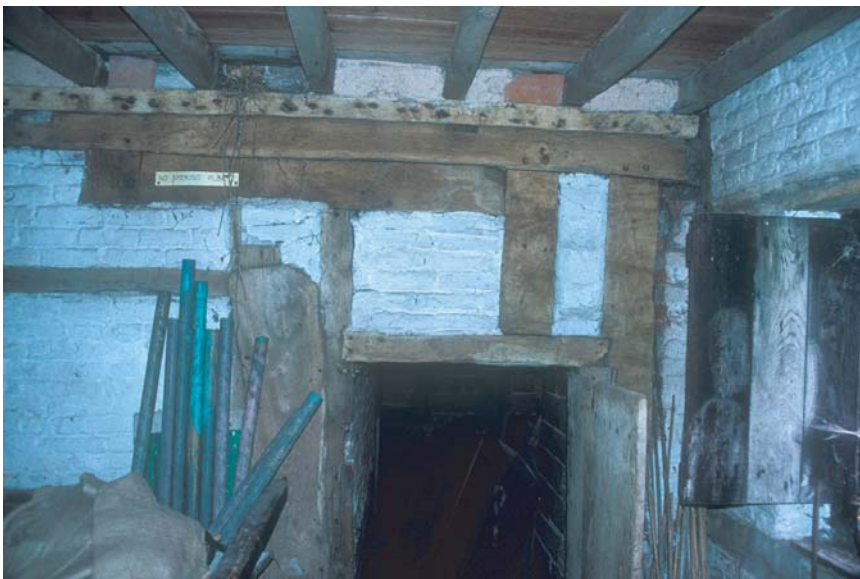
Plate 13

stretcher bond and the northeastern half of the wall is timber-framed, much modified, though a few surviving fragments together with peg holes in the main rail suggest that it was formerly made up of closely spaced studs (Fig. 8, Plate 13). A break in the sequence of peg holes suggests that there was an opening, either a door or window, at this end of the elevation. The framing of the upper storeys is also of closely spaced studs a pattern that is carried up into its tie beam and two-collar roof. At second-floor level, redundant mortices in the soffit of the upper collar show that there was originally a mullioned window in the gable.
