THE HALL

ARCHAEOLOGICAL
INVESTIGATIONS

NATIONAL TRUST
SEATON DELAVAL HALL
NORTHUMBERLAND

NAA 21/66
July 2021

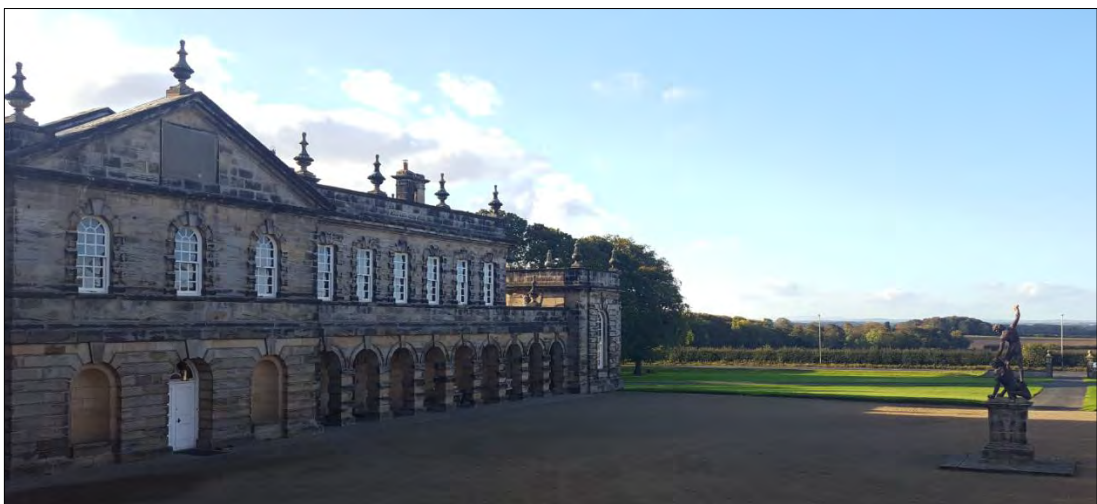
Plate 1: northern end of the front façade of the West Wing prior to restoration.

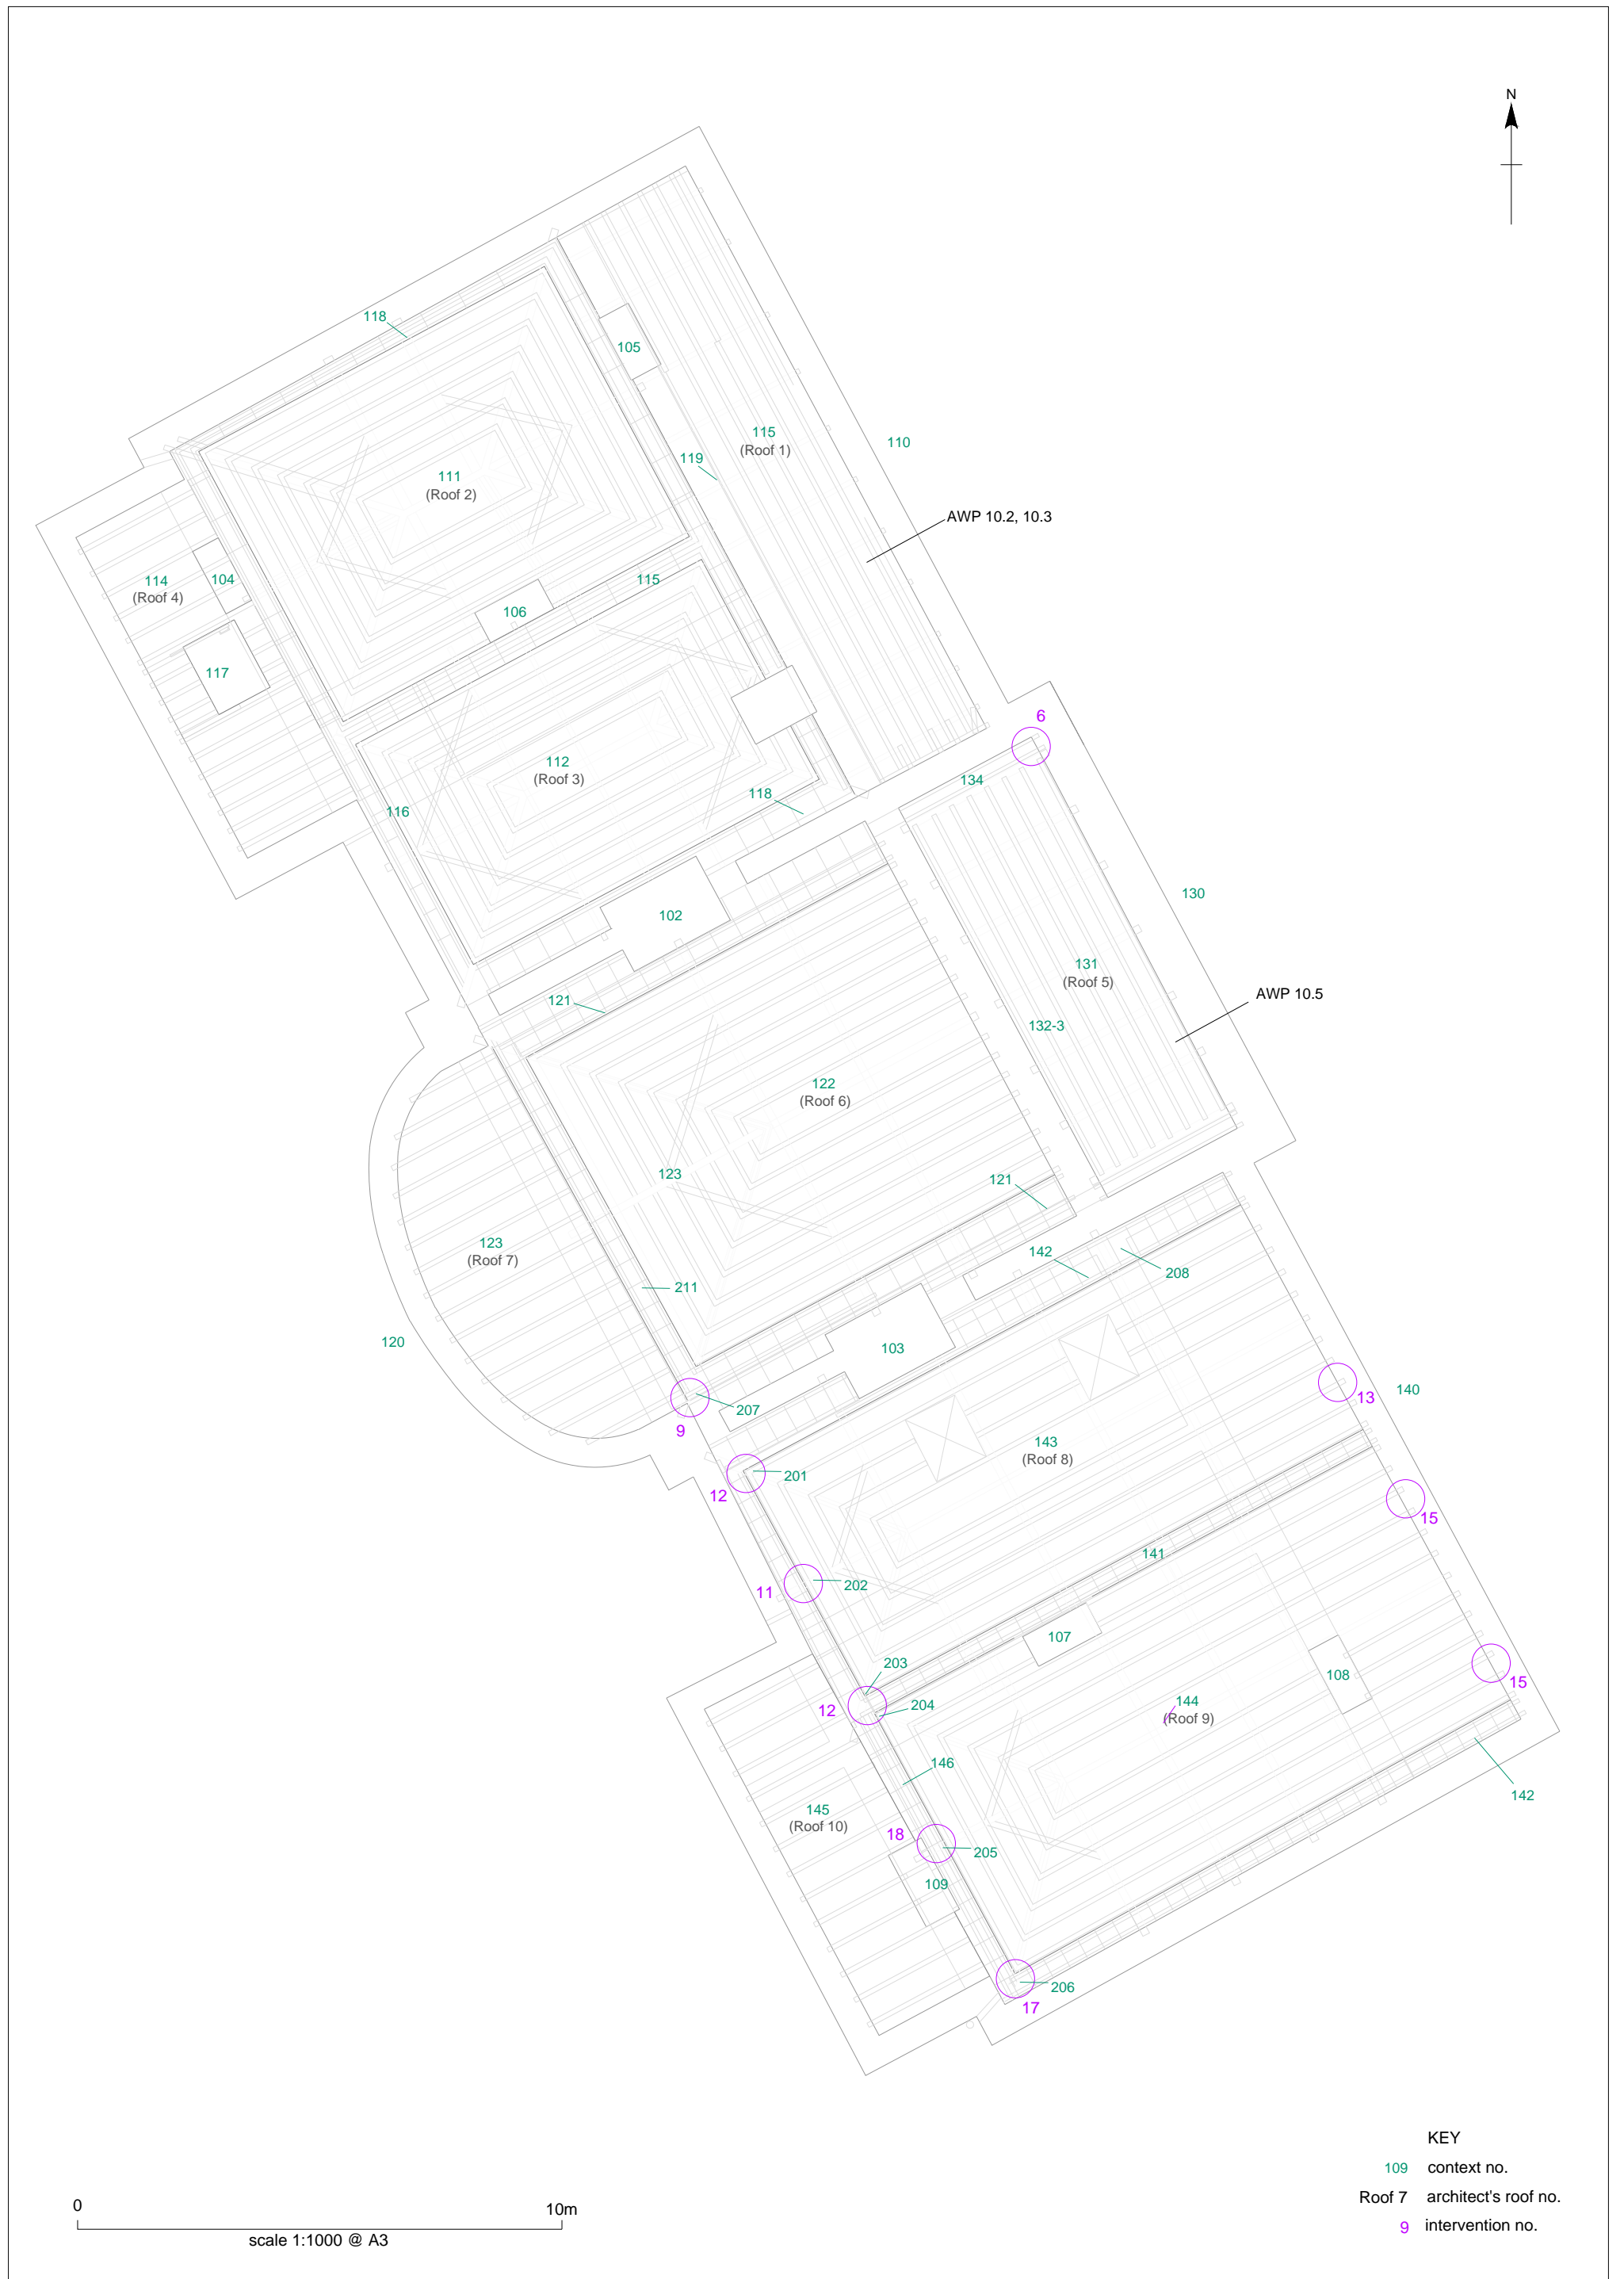
Figure 9

Seaton Delaval Hall: plan of West Wing roof showing context numbers and areas of monitoring

- 8.15 The roof was covered by five layers of a bituminous roof membrane (Kevin Dunn, HPR, *pers. comm.*). Fragments of lead sheeting remained visible along the gutters, associated with an earlier lead roof, replaced when the felt was laid in the 1960s. Traces of lead flashing were also preserved just below the parapet on the inner face of the outer wall (Plate 2). Each of the structural elements were given a separate context number (Appendix A, Table 1) and is illustrated on figure 9.

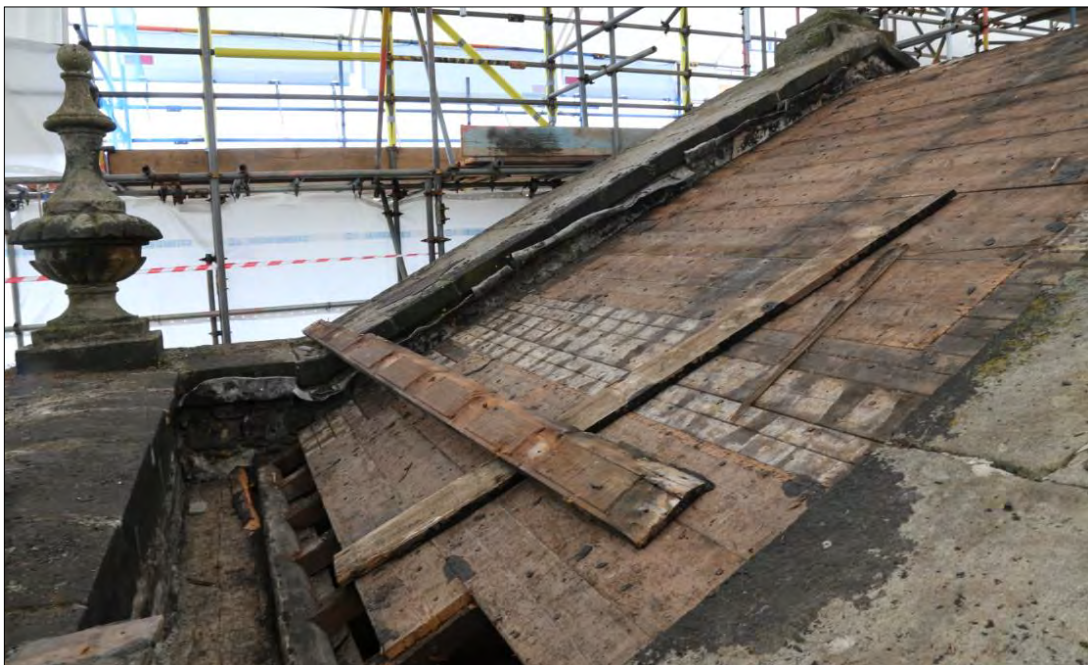
Plate 2: evidence of lead flashing surviving beneath the coping of the pediment chamber roof (130).

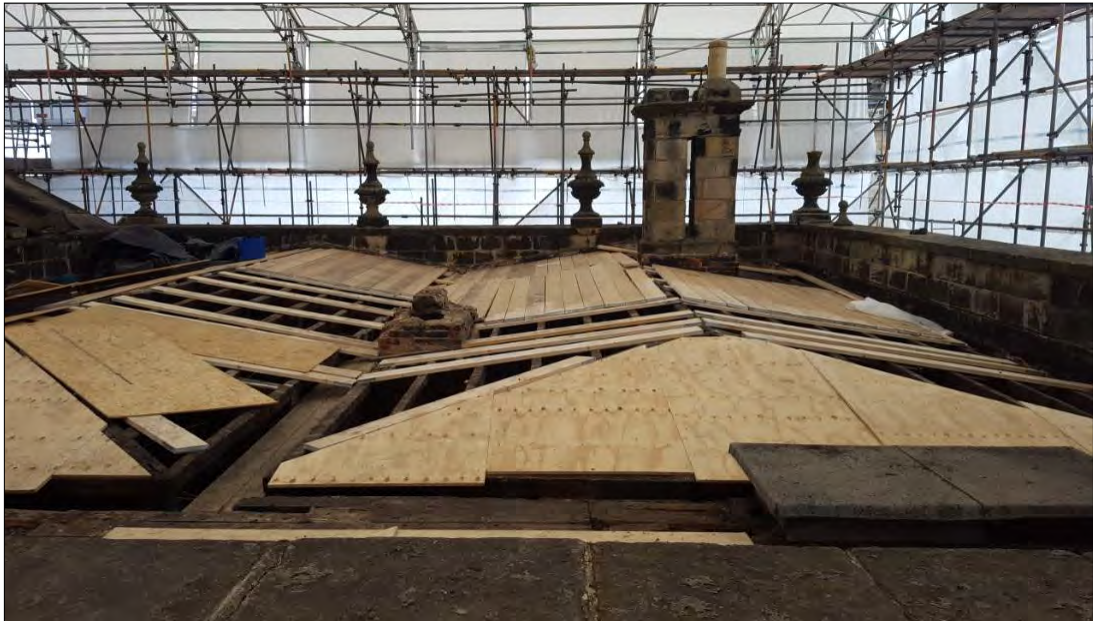
Plate 4: south range looking east towards the south-east stack (108). The remains of the of the central stack (107) are also visible in the valley between the two hipped sections.

8.22 Only one other chimney stack – the south-east stack (108) of the south range – remained extant at the time of recording. This was a double flue, similar in construction and design to the two main stacks (102, 103), comprising an ashlar superstructure on a brick base. The condition of the stonework suggested it may have been replaced in the latter half of the 19th century, when the southern main stack was also replaced (103). The four other stacks had been found to be structurally unstable and taken down prior to survey (104–6, 107). A watching brief was conducted during the dismantling of 107 (see below).

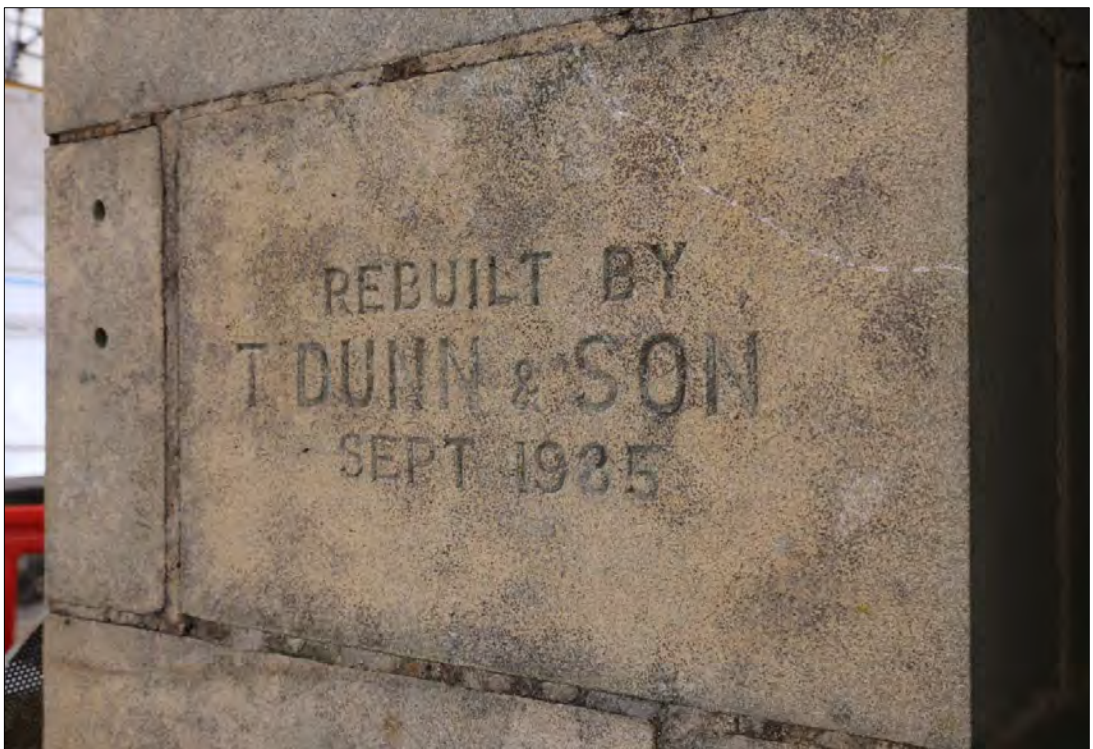
Plate 5: date stone referencing the restoration of the main south stack 103.

8.21 The two central stacks were of ashlar build and feature a cluster of six flues each. The southern stack (103) was a later replacement, the stone was much cleaner and crisper

than the north stack (102) which was blackened and abraded. A date plaque on the south-central stack dates the replacement to a phase of renovation in 1985 (Plate 5).

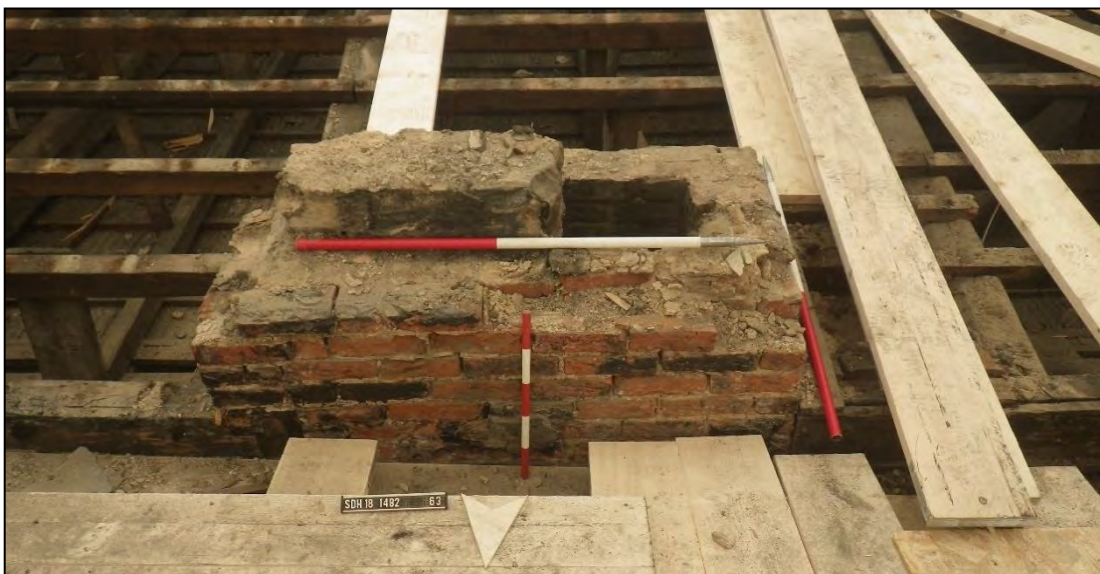
8.24 Chimney 107 (assigned 63 at the time of survey) had proved structurally unsound and was dismantled during the initial strip of the felt roof in May 2019. It was located between the north (143) and south (144) roofs of the south range (140). The chimney plinth was constructed of brick with ashlar copings above (Plate 6). The plinth measured 1.48m by 0.82m, with only one flue exposed on the west side. The internal measurements of the flue were 0.38m by 0.15m. Above the plinth was a section of sandstone coping which was later removed. The bricks were orange-red, each measuring 0.23m by 0.11m by 0.06m set in running bond and held in a hard creamy-white lime mortar.

Plate 6: chimney 107 during dismantling, looking south.

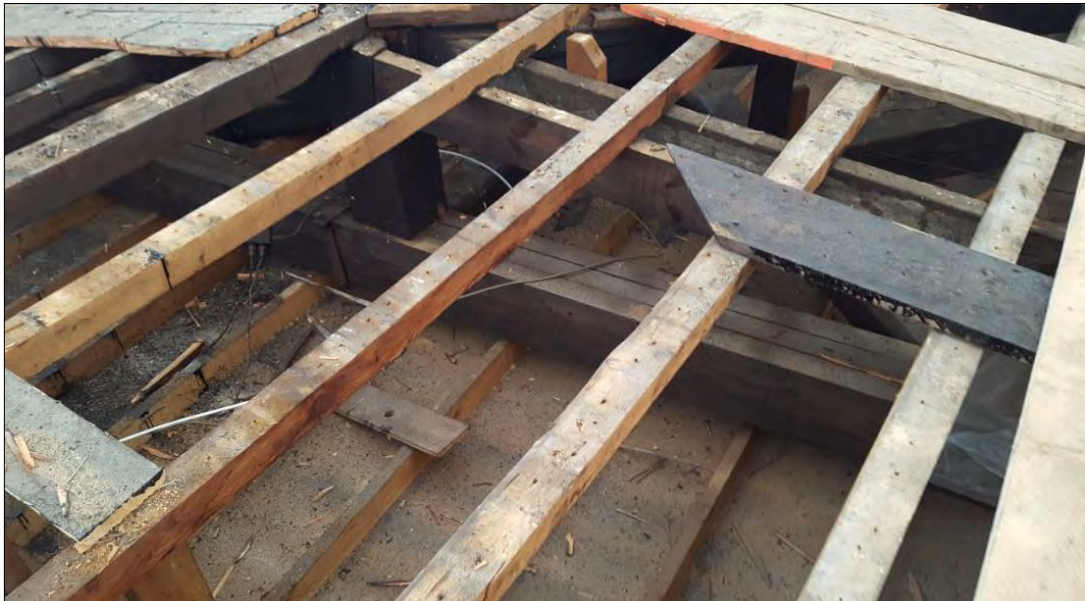
The lower structure – tie-beams, ceiling joists and struts – were earlier and included original elements. There was also evidence of later repairs and modification, like the replacement of some of the lath and plaster with modern plasterboard (Plate 12).

Plate 12: section of replacement roof structure in the north range – purlins truss and ceiling are all modern.

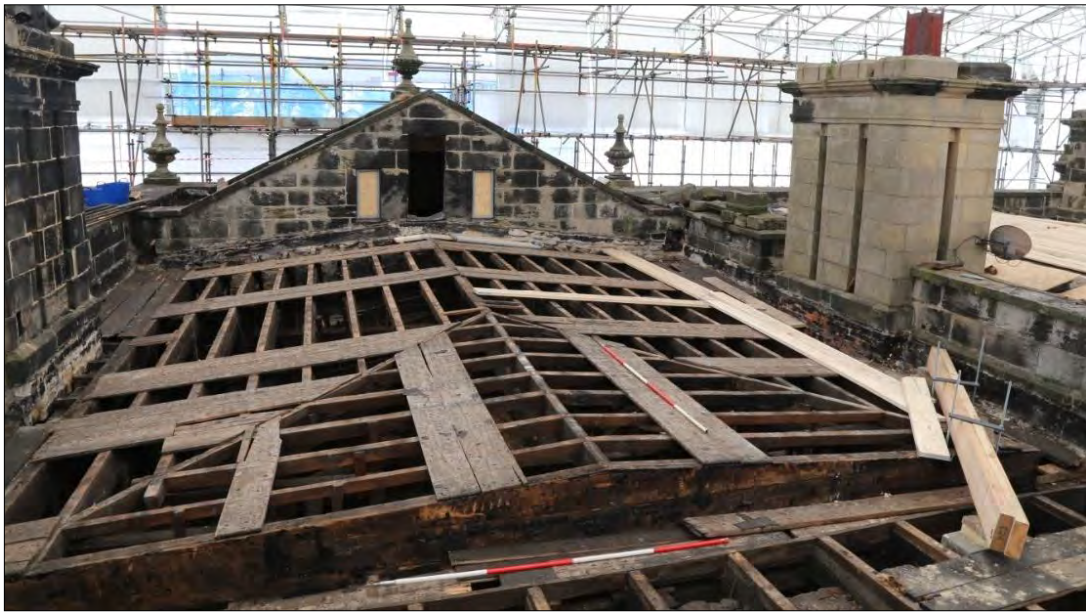
- 8.13 It is unclear why the roof was reconfigured in this way but may relate to drainage issues. Notably the rake on the apsidal bay had also been increased, so there may have been a problem with run-off from the hip flooding the main gutter and causing damp within the interior. Alternatively, there was evidence of fire damage in this area which may have weakened the structure, necessitating the modifications.
- 8.14 Considerable charring was identified on the south-west hip truss where it joined the wall plate. This related to the 1752 fire which started behind the kitchen flue, spreading south. Notably, evidence of charring was limited to the south-west section of the roof.

Plate 18: looking south-east across the central roof (122) showing the reconfiguration of the west end.

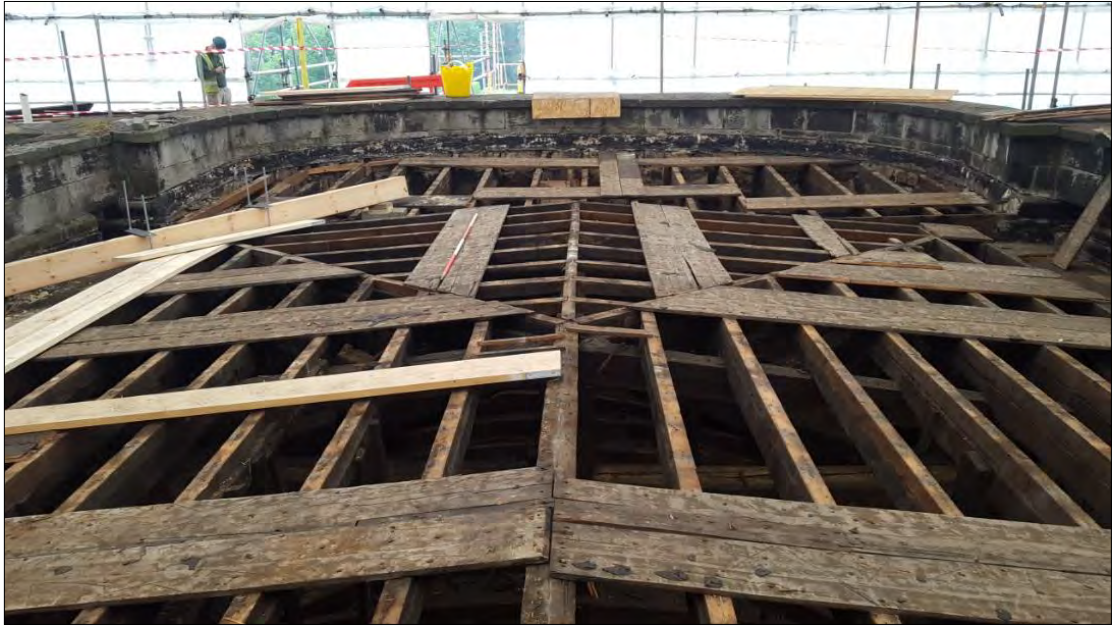
Plate 20: looking east across the west end of the central range towards the apsidal bay, showing the modifications to the earlier hipped section (124).

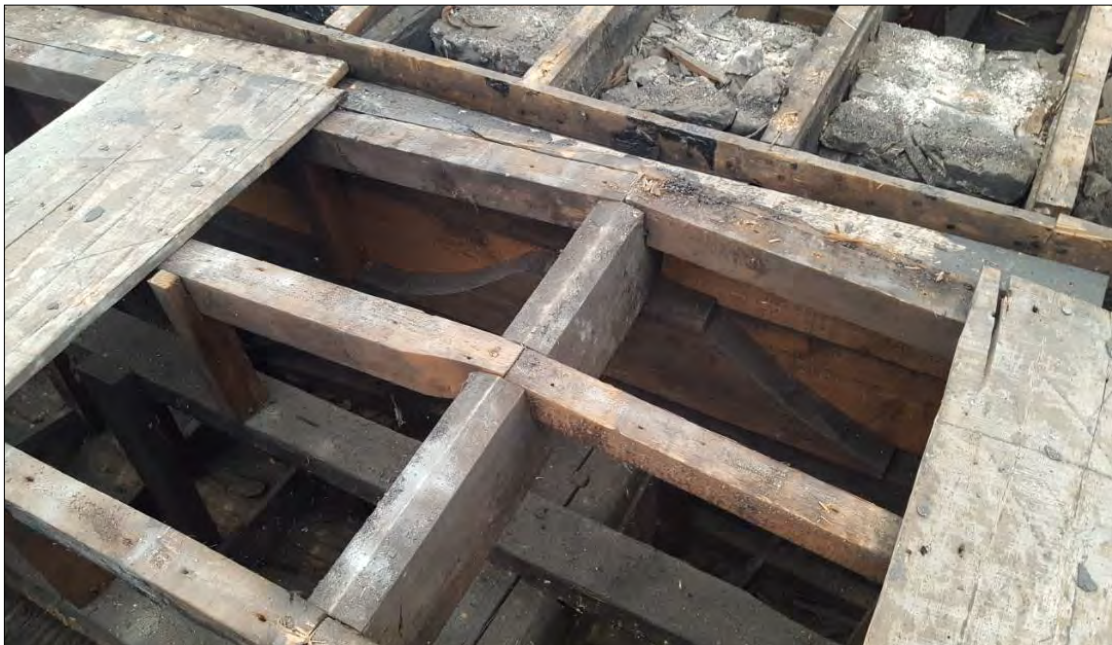
Plate 21: bracing associated with the inserted wooden gable. There are clearly three phases of development visible at this end of the roof.

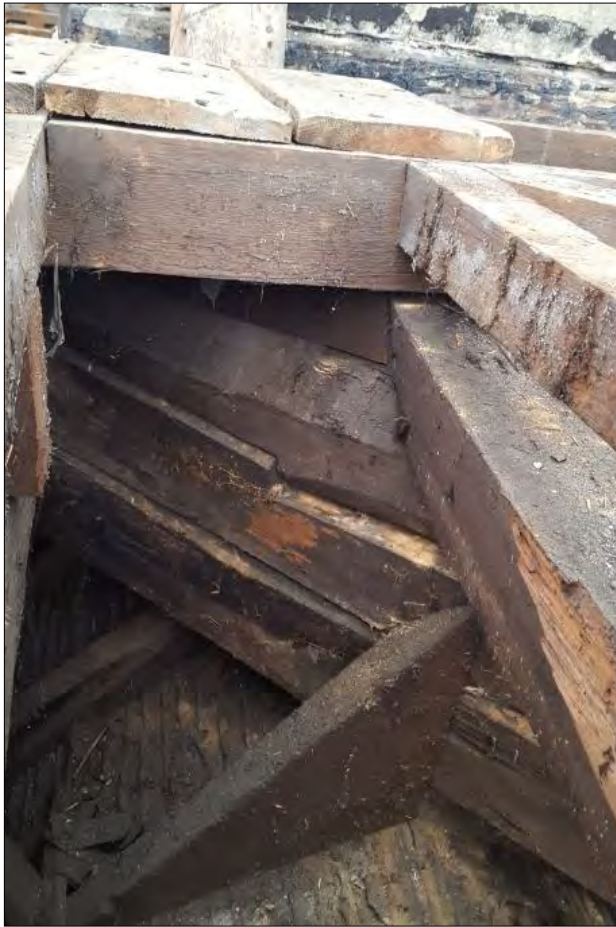
Plate 22: north-west hip truss. This is carried over the ceiling vaulting, visible beneath. It has subsequently been built up to support the gable roof and the insertion of a later tie beam.

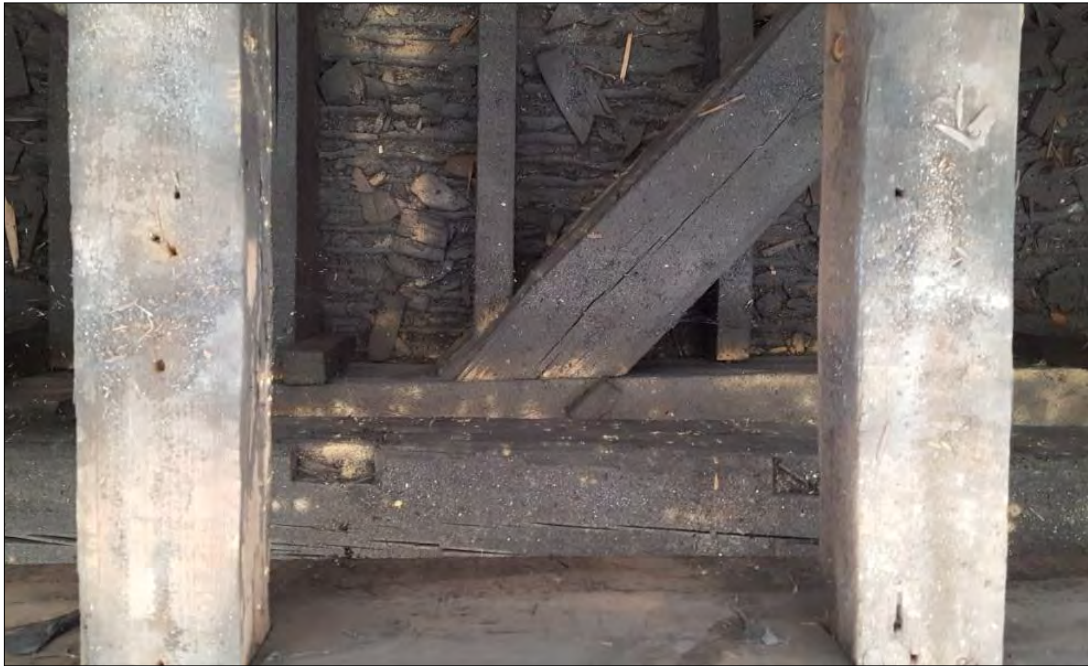
Plate 24: evidence of timber reuse or reconfiguration visible on the joist running below the central ridge of roof 122.

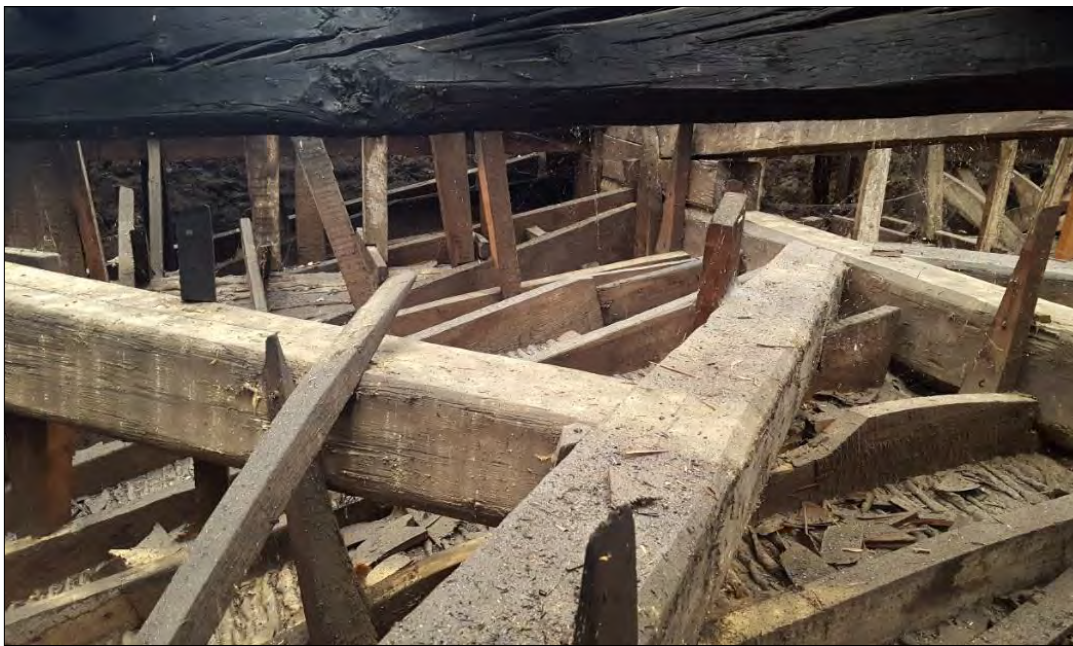
Plate 25: section of the south-west lower roof structure showing a principal truss, main joists, vaulting joists and ceiling struts. There is clear evidence of charring on the hip truss, just visible at the top of the picture

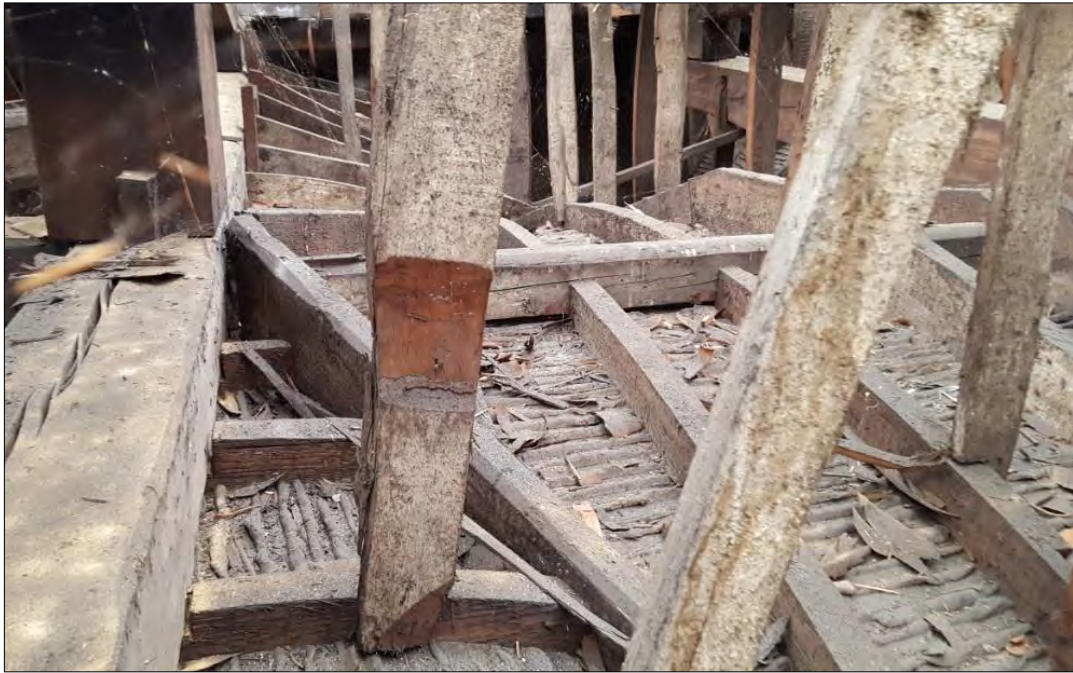
Plate 26: detail of lower roof and ceiling structure at the west end of the central range. The strut at the centre of the picture has been either reused or was intended to be in an alternative position. It has been shaped to accept a cross timber.

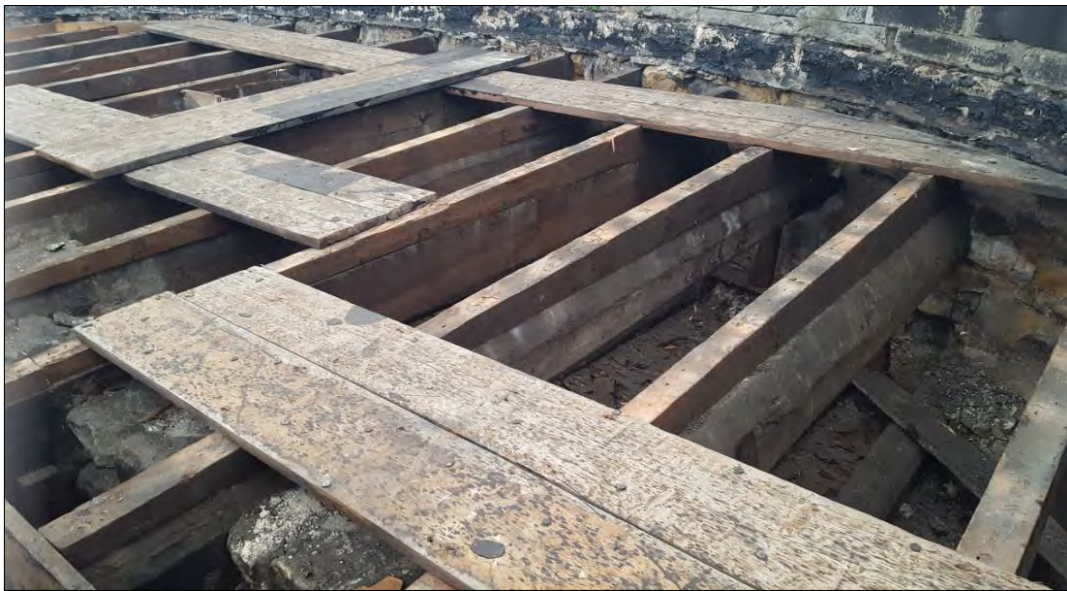
Plate 31: timber rafters associated with the apsidal bay (123). Later timbers have been added to the earlier rafters to increase the rake.

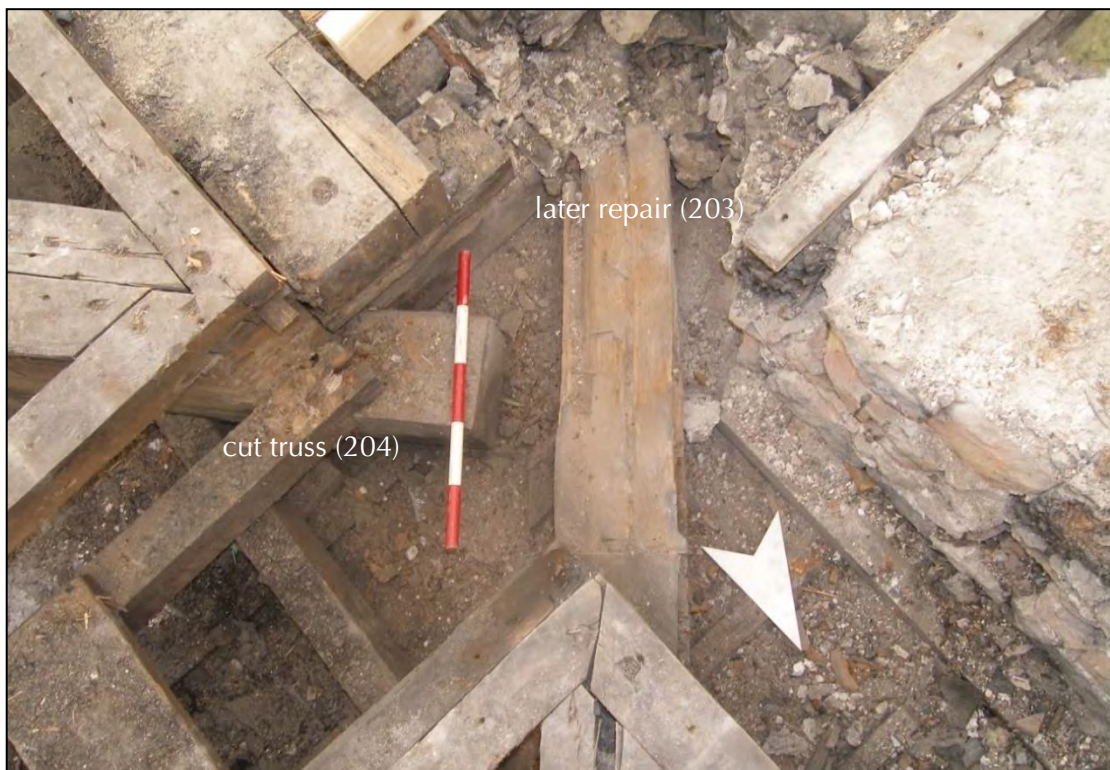
- 8.27 On the south range (140), recording took place during the repairs to hip trusses, purlins and guttering at either end of roof 143 and 144.
- 8.28 At the west end (Fig. 9, interventions 11, 12, 17, 18), adjacent to gutter 146, construction of the hip trusses were similar to those observed in in the south-west corner of the central range (repair 9; 207), the main difference being that the tie beam extended beyond the packer and principal rafters into the wall, thereby tying the structure into the wall plate (Plate 34). At the junction of roof 143 and 144 (repair 12) the tie beam (truss 204) was tied neither into the wall plate or truss 203 (Plate 34), making the structure very unstable.

Plate 34: intersection of truss 203 and 204. The latter tied neither into the wall or truss 203. Gutter 146 is visible in the upper-left corner.

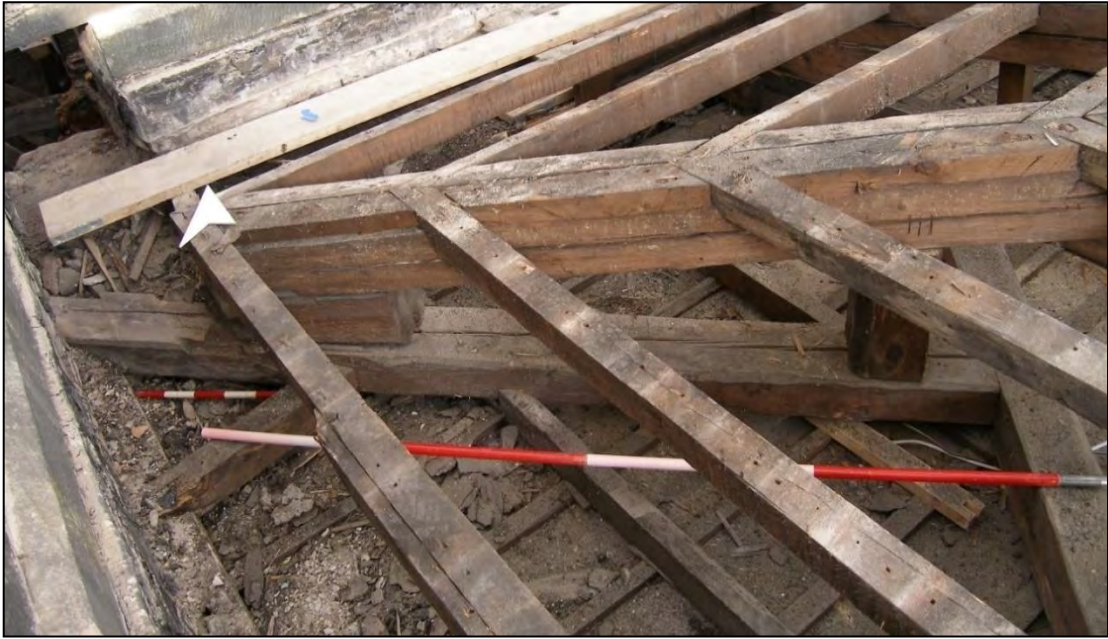
Plate 35: hip truss 201 in the north-west corner of roof 143. This originally spanned gutter 146 to tie into the wall but had been cut. The gutter passed under the stone wall at the top of the photo.

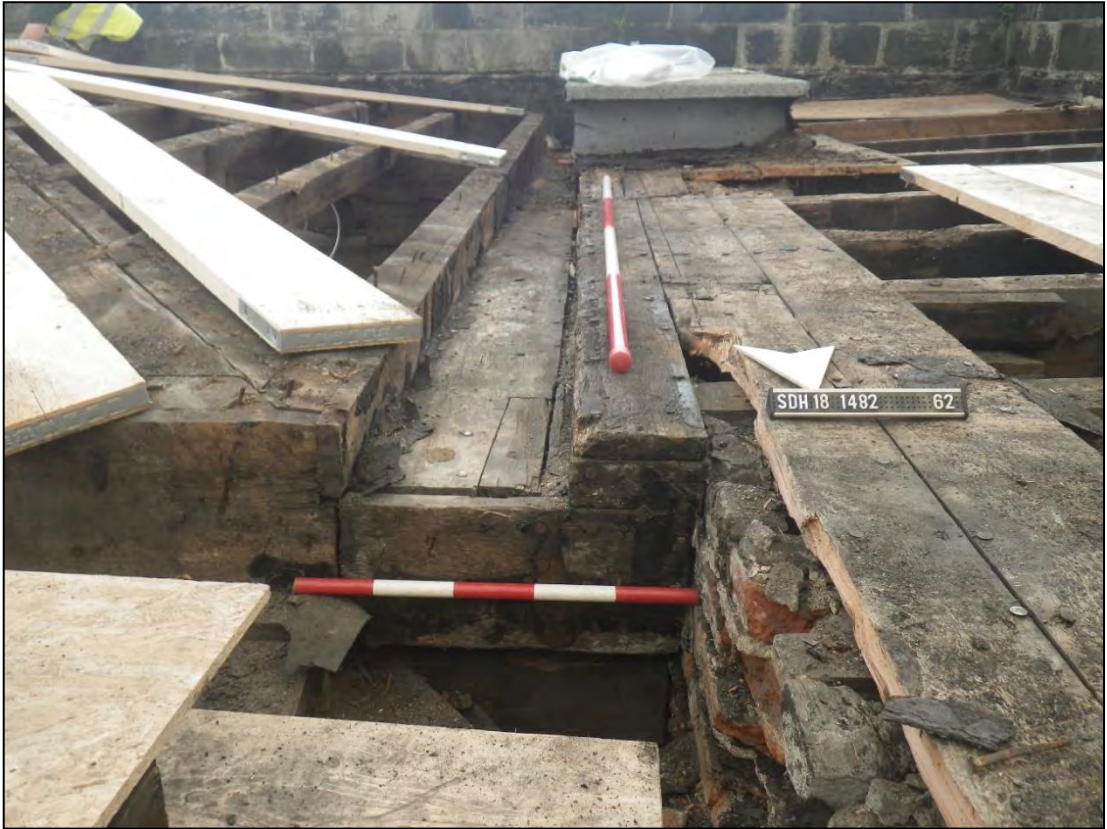
- 8.31 The southern end of gutter **146** (assigned **62** at the time of survey in May 2019) was recorded prior to removal. The gutter ran north-south and was 0.28m wide, 5.95m long and 0.1m deep on the north side, sloping to 0.28m deep on the south side. It ran flush with the end rafter of roof **144** (Plate 39). On the west side it was offset c.0.08m from the brick wall by a series of timbers laid flush with the sarking boards of roof **145**. This was to accommodate the width of chimney **109**. The main board was slightly narrower than the gutter at 0.25m and attached together using large flat nail heads each 0.01m in diameter. A separate piece of timber tucked into the north-west corner of the beam was evidence of repair. Traces of bitumen and roofing felt were visible, also indicative of later repair.

Plate 39: gutter 146 looking south. Chimney 109 can be seen at the end of the ranging rod.

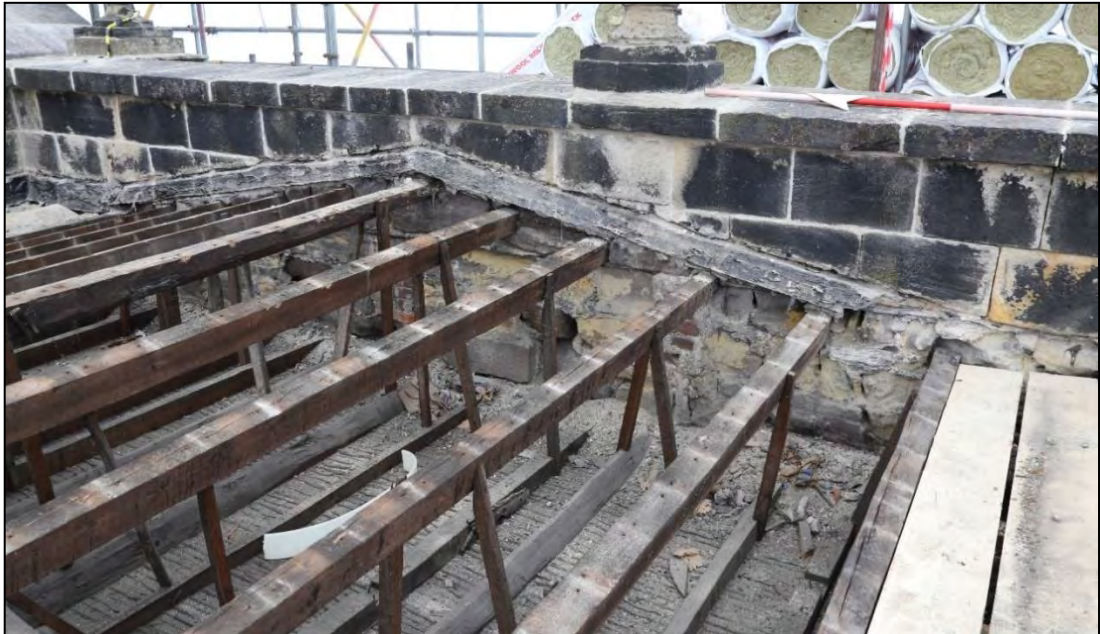
- 8.32 At the eastern end of roofs **143** and **144** the purlins ran directly into the east gable rather than being supported by a truss. Many of the ends were decayed and had fallen out of their sockets, supported only by struts suspended from the ceiling joists. Monitoring was conducted during replacement of the timbers (Fig. 9, repairs 13 and 15).

Plate 40: east end of the roof 143 looking east. The purlins can be seen tied directly into the east wall beneath the line of the inset gable (marked by a line of lead flashing).

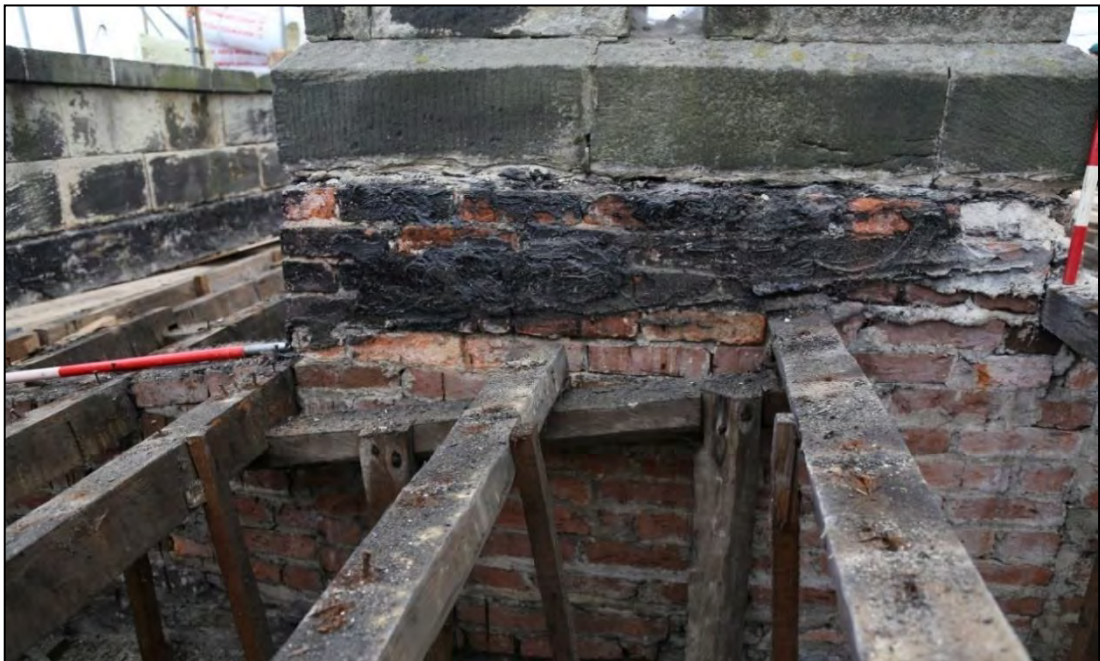
- 8.34 Just west of the façade, the existing purlins cut through the stone cross wall that ran the full length of the building. Where it ran across the south range the upper courses of the wall had been extended in as part of a later phase of modification, to support the purlins when the two east hip trusses had been removed. On roof 144, brick was clearly visible on each side of chimney 108 (Plate 41). On roof 143, truss 208 followed the line of the

Plate 41: chimney 108 and raised section of the cross wall which supported the shallow pitched roof, replacing the former hip truss.

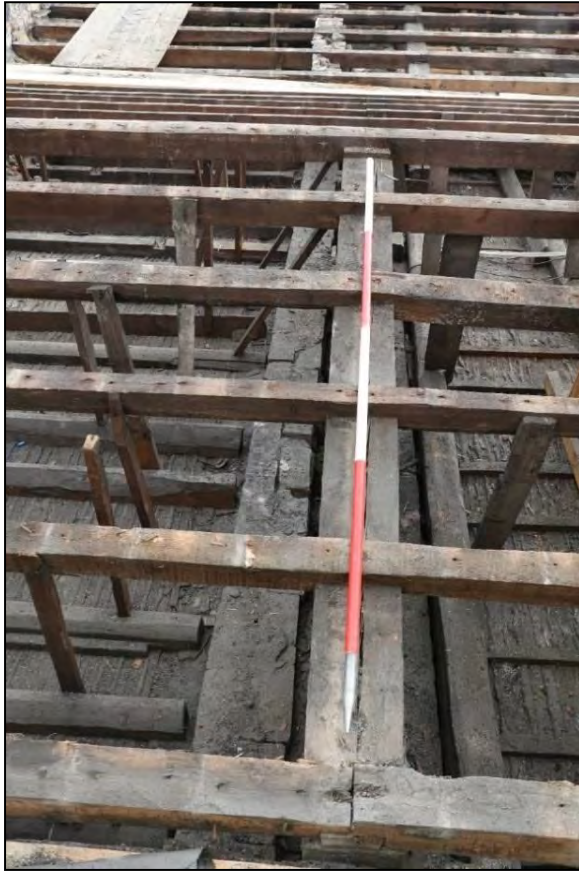
Plate 422: truss 208 on roof 143, looking south.

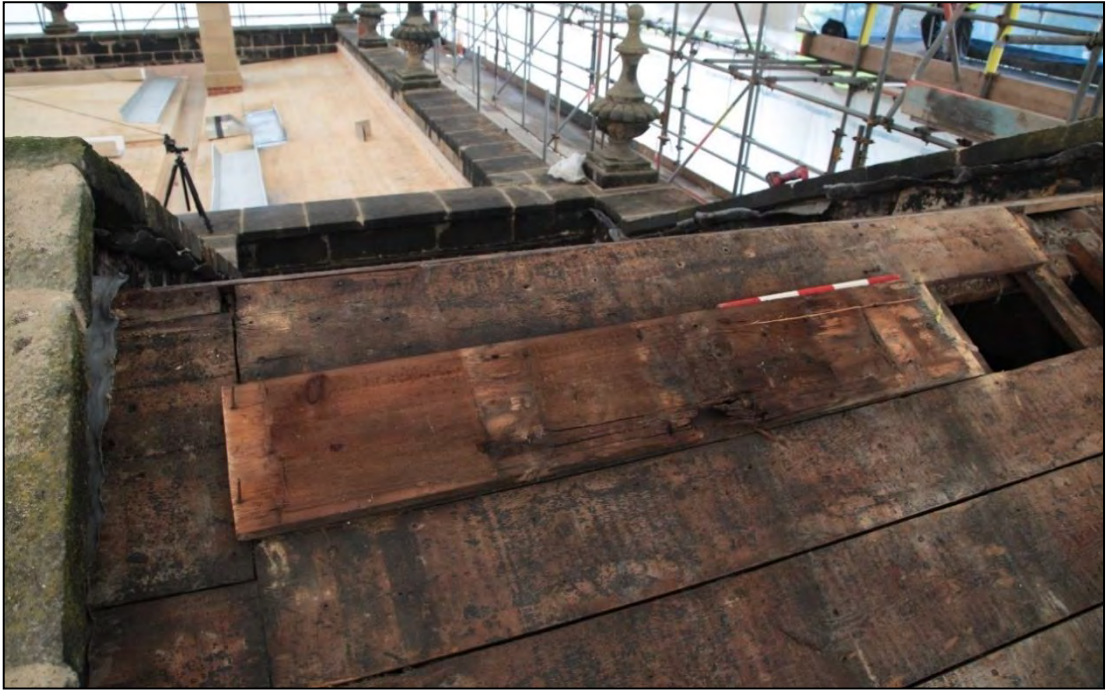
- 8.35 A small number of the sarking boards on the clock chamber gable were in poor condition and had to be removed or repaired. The ends of six boards were removed - five on the south gable and one on the north. On close inspection, the sarking boards had been shaped by adze *in situ* to fit the rafters (Plate 43). Each was adzed at 0.3m intervals to create a 0.12m-long groove to fit the 0.1m rafters.

Plate 43: underside of one of the sarking boards removed from the pediment chamber roof. The groove formed to hold the rafters can be seen evenly spaced along the board.

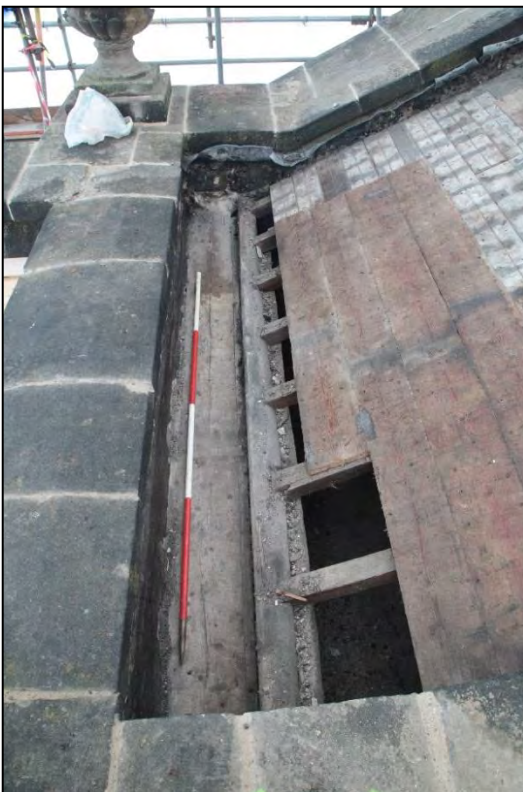
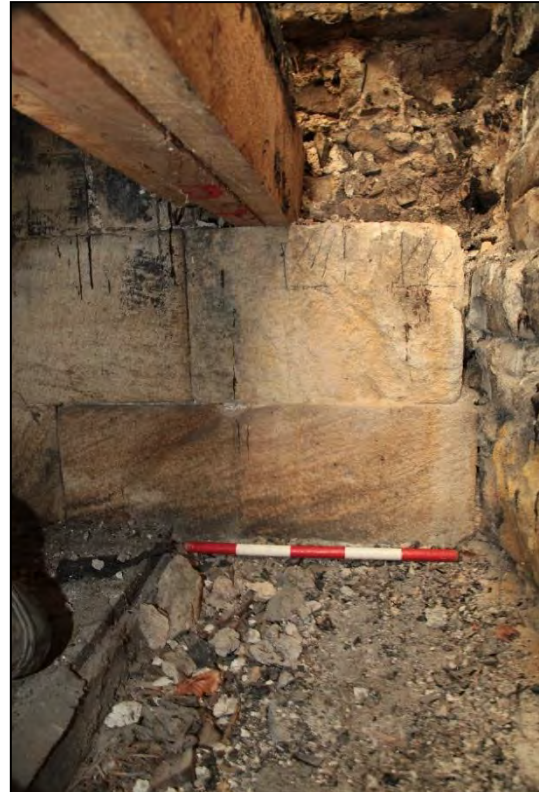
- 8.36 On the north side of the gable, the central support beam of gutter **134** was replaced (Fig 9, repair 6). The timber forming the guttering was c.0.3m wide and 3.8m long. It sloped slightly to the west, sitting 0.37m above the height of the clock room floor to the west and 0.5m to the east, and was flanked by the gable roof purlin. Evidence of bitumen and roofing felt was still in place (Plate 43).

- 8.37 As part of the pediment chamber repairs, a corner of masonry on the south side of the clock chamber gable was cut to accommodate new joists. The stone was photographed prior to alteration (Plate 44).

Plates 44, 45: (left) gutter 134 looking west; (right) masonry alterations to the stone at the south-west corner of the pediment roof.

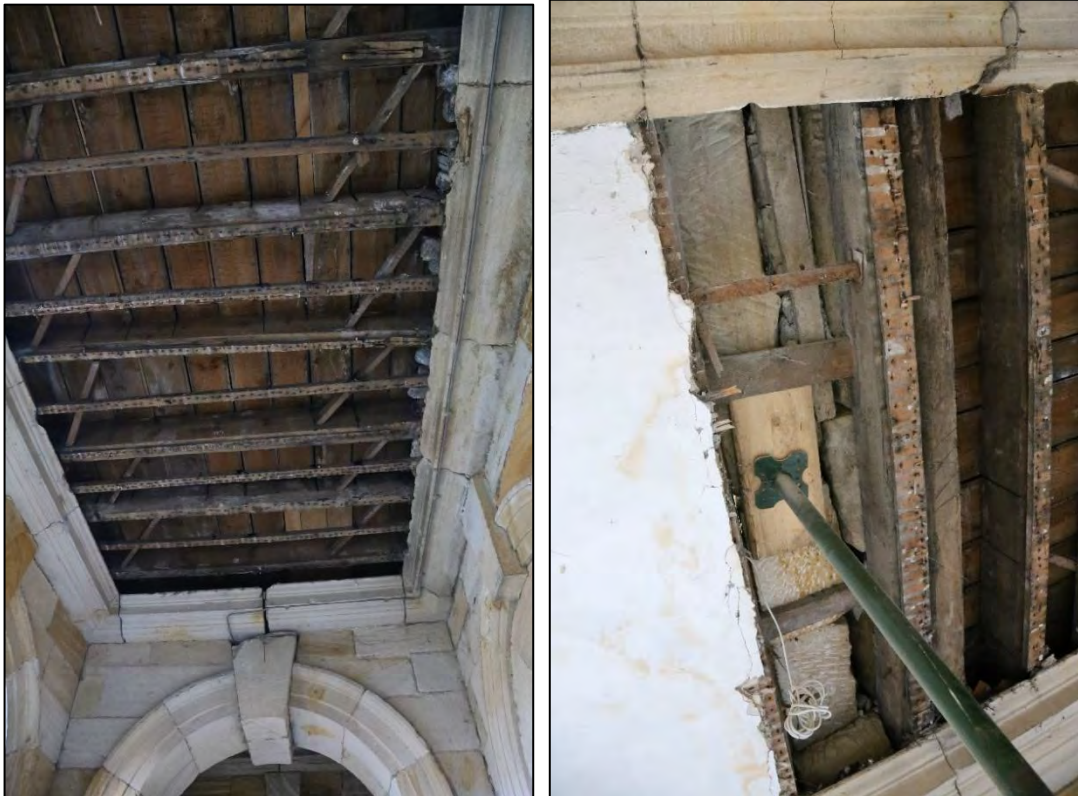
- 8.40 The construction of the ceiling was different on the north side of the central porch from that on the south. On the south side the principal joists were spaced c.0.35m apart with

timber c.0.1m thick (Plate 48). Between these were smaller, secondary joists, 0.07m wide and 0.03m thick, set with a diagonal brace at intervals to provide further support and rigidity. At the junction with the kitchen passage and the main body of the West Wing, the ceiling joists were set further apart at c.0.43m (Plates 49 and 50). On the north side of the porch the ceiling joists were also set 0.35m apart but there were no secondary joists between. This arrangement was repeated in the section running west to join the Central Hall west arcade (Plate 50).

Plates 48, 49: (left) ceiling configuration on the north side of the arcade with secondary timbers and braces, and (right) arrangement on the south side without secondary supports.
