THE HALL

ARCHAEOLOGICAL
INVESTIGATIONS

NATIONAL TRUST
SEATON DELAVAL HALL
NORTHUMBERLAND

NAA 21/66
July 2021

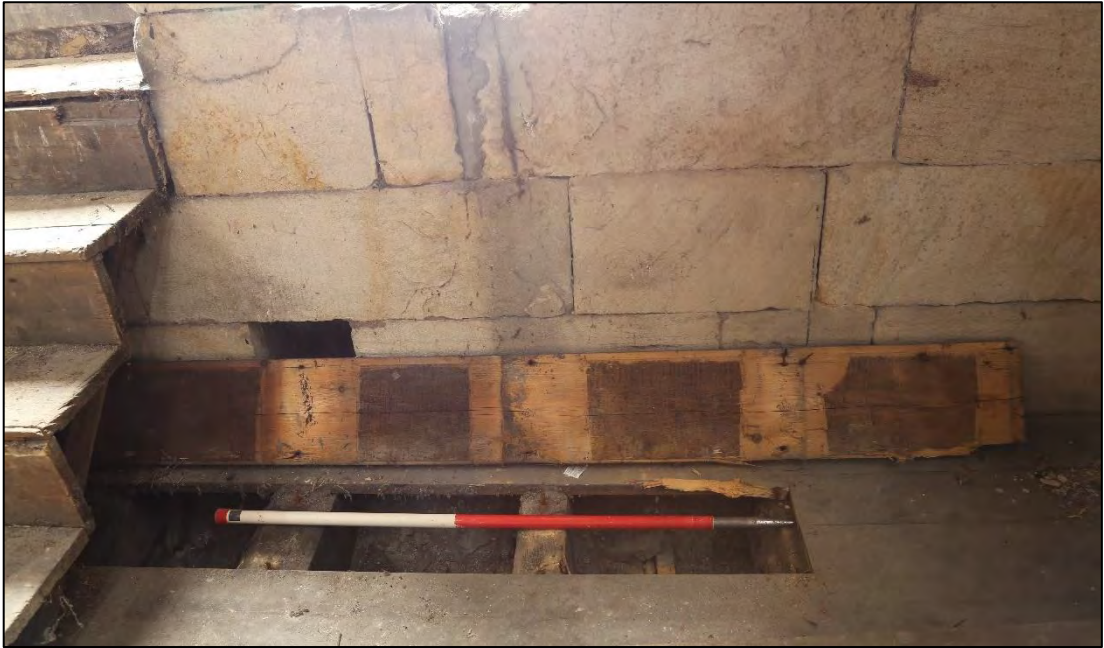
- 8.43 A watching brief was conducted during removal of floor timbers from the pediment chamber on 23rd May 2020. Only some of the floorboards were being replaced as part of the conservation works (Mosedale Gillatt Architects 2017a). Access to the chamber was from the central roof (130) via a small door (Fig. 9). Four wooden steps led down onto the floor of the chamber, which was set c.0.8m below the threshold of the door.
- 8.44 The floorboards, like the sarking boards previously discussed, had been adzed to fit snugly above the supporting floor joists (Plate 52). The nails holding the boards in place were handmade. The upper side of the lathe and plaster ceiling below was clearly visible through the floor joists.
- 8.45 Within the area exposed during the repair works, no finds were recovered from the below floor voids.

Plate 52: removed floorboard of the clocktower. The access steps are visible to the left (south).

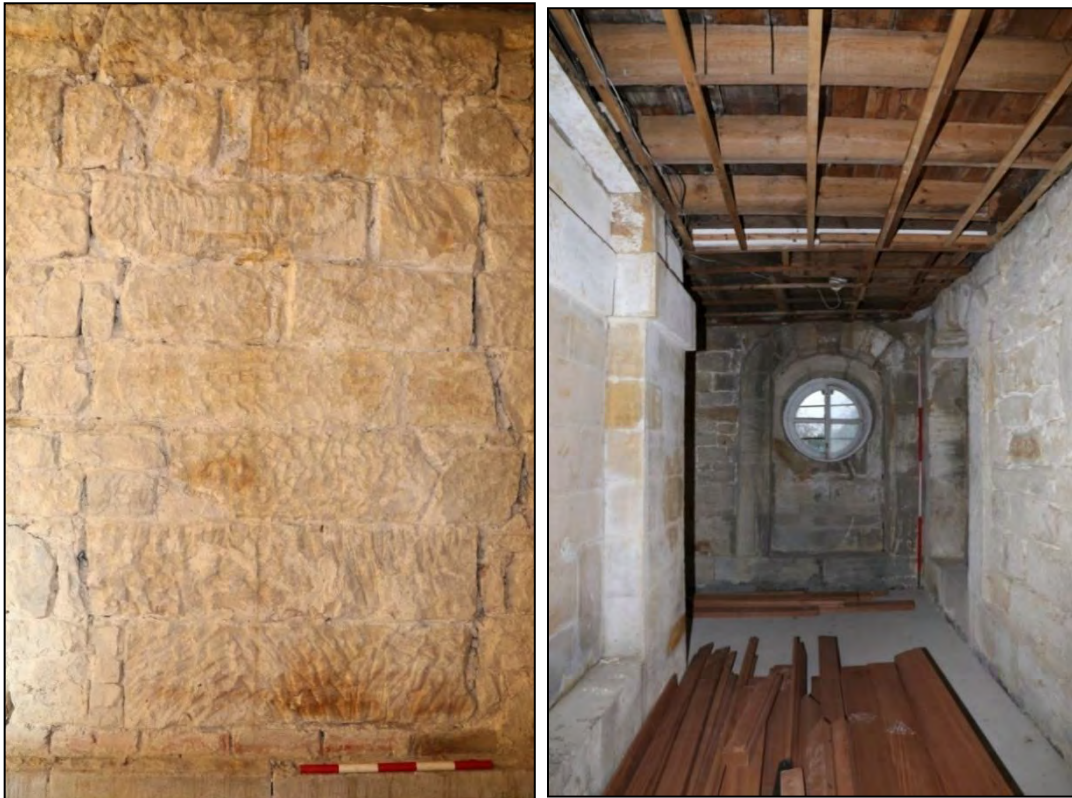
Plates 55, 56: (left) blocked opening on north wall in the west kitchen passage; (right) view down the kitchen passage looking south towards the oculus window.

- 8.52 The blocked opening on the east wall was approximately 1.5m wide and 0.3m deep. The stone visibly curved just below the ceiling joists, forming an archway that disappeared into the floor above. This formerly opened out to the arcade, providing access to the central courtyard and north portico. The extension of the arch into the ceiling indicates this has been lowered since construction.

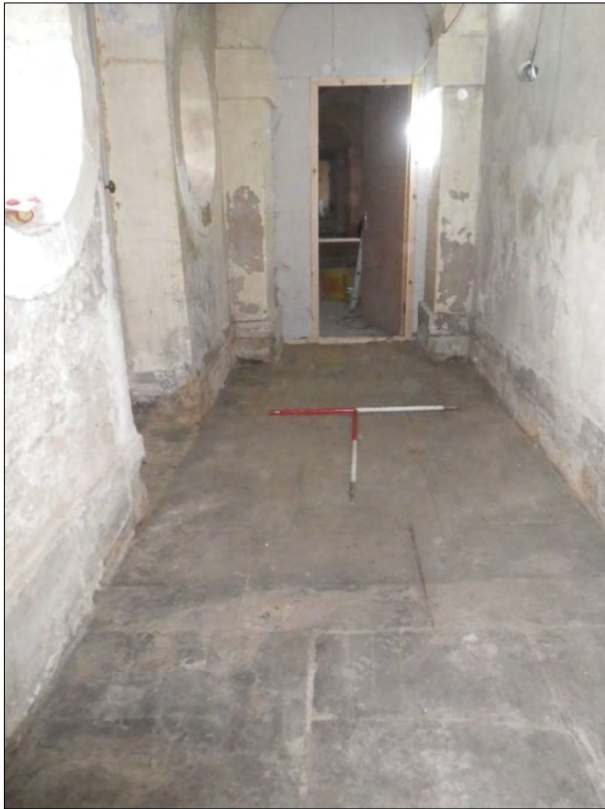
- 8.56 In June 2020, a section of the concrete floor was removed (Fig. 8). Previously it was believed that the original flagstone surface in this area had been lost, and laying new paving was scheduled as part of the conservation works. However, during the excavations for the service trench the original flagged floor (167) was discovered intact and well-preserved beneath the modern concrete surface.

- 8.57 An area c.5m long and running the full width of the corridor (1.75m) was exposed during monitoring (Plate 60; Fig. 8). The flagstone floor was exposed across this area. It was constructed of sandstone flags, measuring c.0.55m by 0.55 to 0.70m. Above the floor had been placed a protective membrane over which a c.0.08–0.1m concrete screed floor had been laid. During investigations the concrete was carefully removed with a small electrical chisel prior to hand clearance, to ensure no damage to the underlying historic fabric.

Plate 60: flagstone floor 167 in the west kitchen passage.

- 8.58 Plans to lay new paving were subsequently revised, and the original flagstone surface left *in situ*. There was no excavation beneath the flagstone floor.

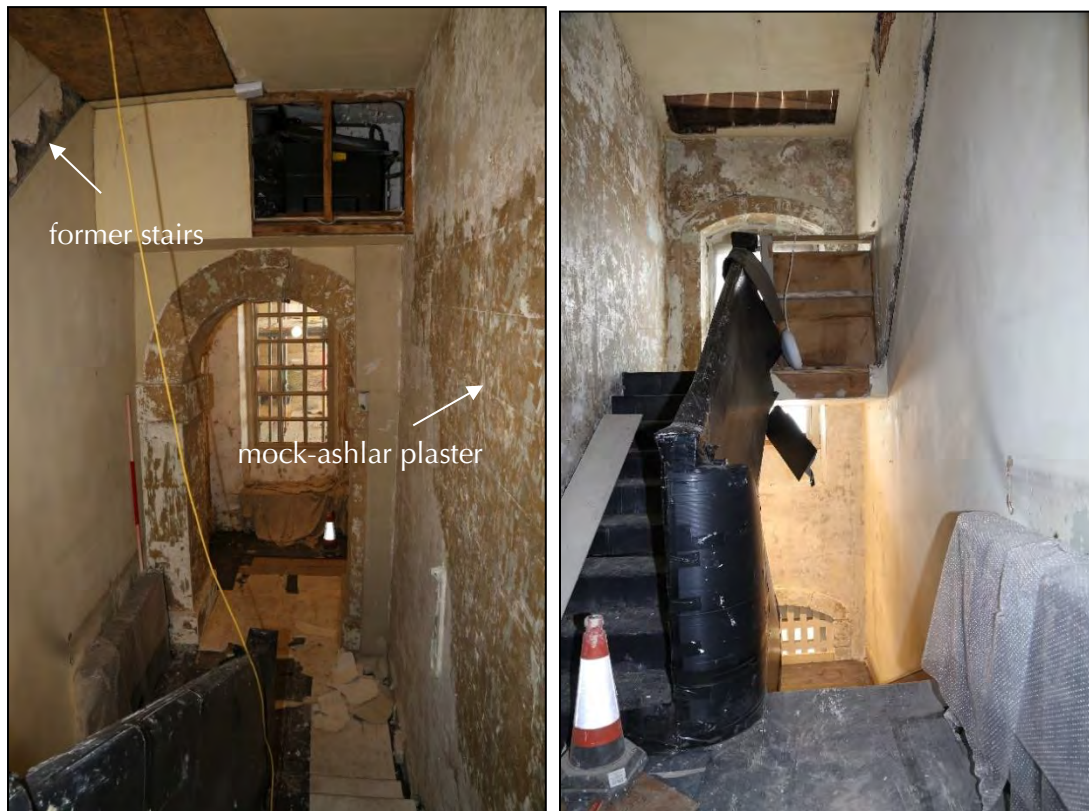
- 8.60 Prior to modification, the upper flight of stairs had ended at a landing below the original loft hatch (Plate 61). Evidence of an earlier set of stairs remained visible as a scar in the plasterwork. Above the line of the stair, a patch of plaster was missing, exposing a brick wall beneath. This ran the whole length of the building, forming part of the west wall of the wing.

- 8.61 The upper landing cut across an 18-light sashed window located within a segmented-arched window frame on the west wall, that disappeared below the height of the landing. Around the window, a brownish-yellow plaster covered the wall (Plate 61). This had been scored to represent ashlar. The same decorative scheme was observed on the ground floor and within both sections of the kitchen passage.

Plates 61, 62: (left) looking south down the stairs to the original roof-hatch opening. The scar in the plasterwork associated with the original flight of steps can just be seen on the left side of the picture and on the right the wall is covered in 'mock-ashlar' plaster; (right) view up the stairs to the new roof hatch. The modern sarking boards are visible above.

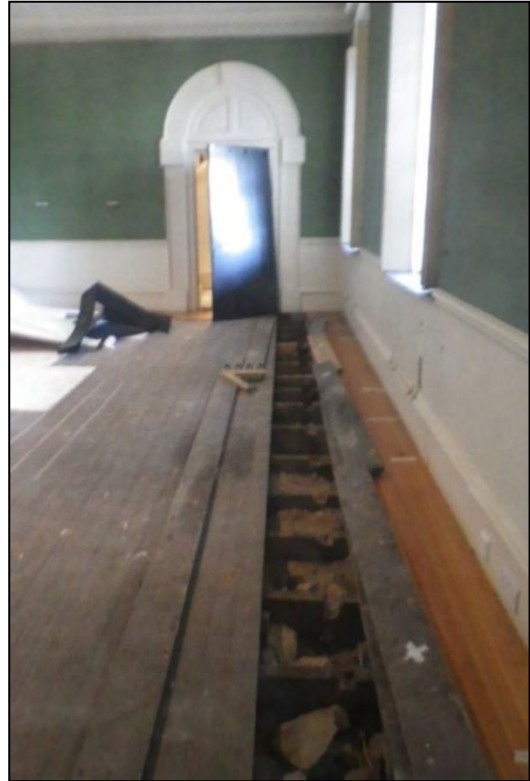
8.65 During the installation of radiator piping in the front office of the West Wing (Plate 63) rough stonework was observed in the centre of the room, c.0.02m below the floor joints. Such a small area was exposed during the works that it was difficult to determine the nature of the feature and it was potentially the top of a drain (as observed in the East Wing) or an outcropping of bedrock. To avoid damage to the feature, the floor joists were cut and reinforced rather than risk breaking through into the possible historic fabric.

Plate 63: removal of the floor in the front office for installation of new pipework for heating.

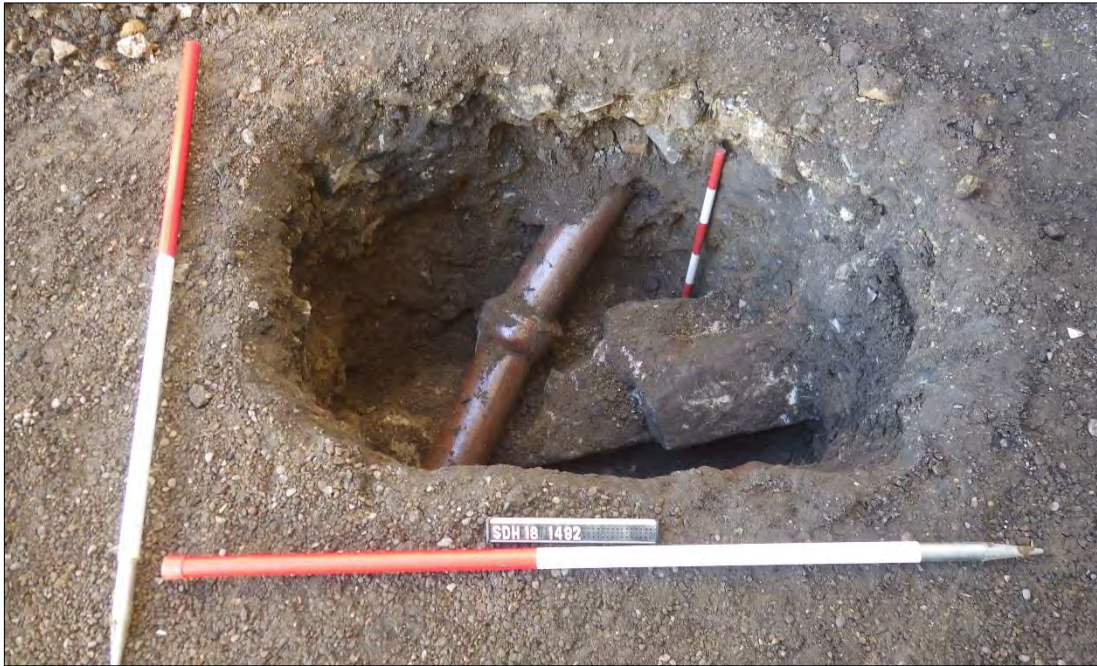
- 8.71 In December 2018 additional monitoring was carried out during investigative drainage works in the service courtyard to the rear (west) of the West Wing. This entailed a watching brief during the hand excavation of an exploratory pit, c.1.0m in diameter, in the south-east corner of the yard (Fig. 8). This encountered the upper portion of a drain (32) running north-west across the area.
- 8.72 The drain had an oval or elliptical profile, with heavily mortared walls between 0.15m and 0.2m thick, constructed of roughly squared, unworked sandstone blocks, with sides averaging 0.15–0.4m in length. The upper arch of the stonework was 0.4m below the current yard surface and had been disturbed by the installation of two modern salt-glazed ceramic pipes (Plate 65). The drain was badly damaged as a result, and partially infilled with rubble and silt.

Plate 65: drain 32 with salt-glazed drain insertion.

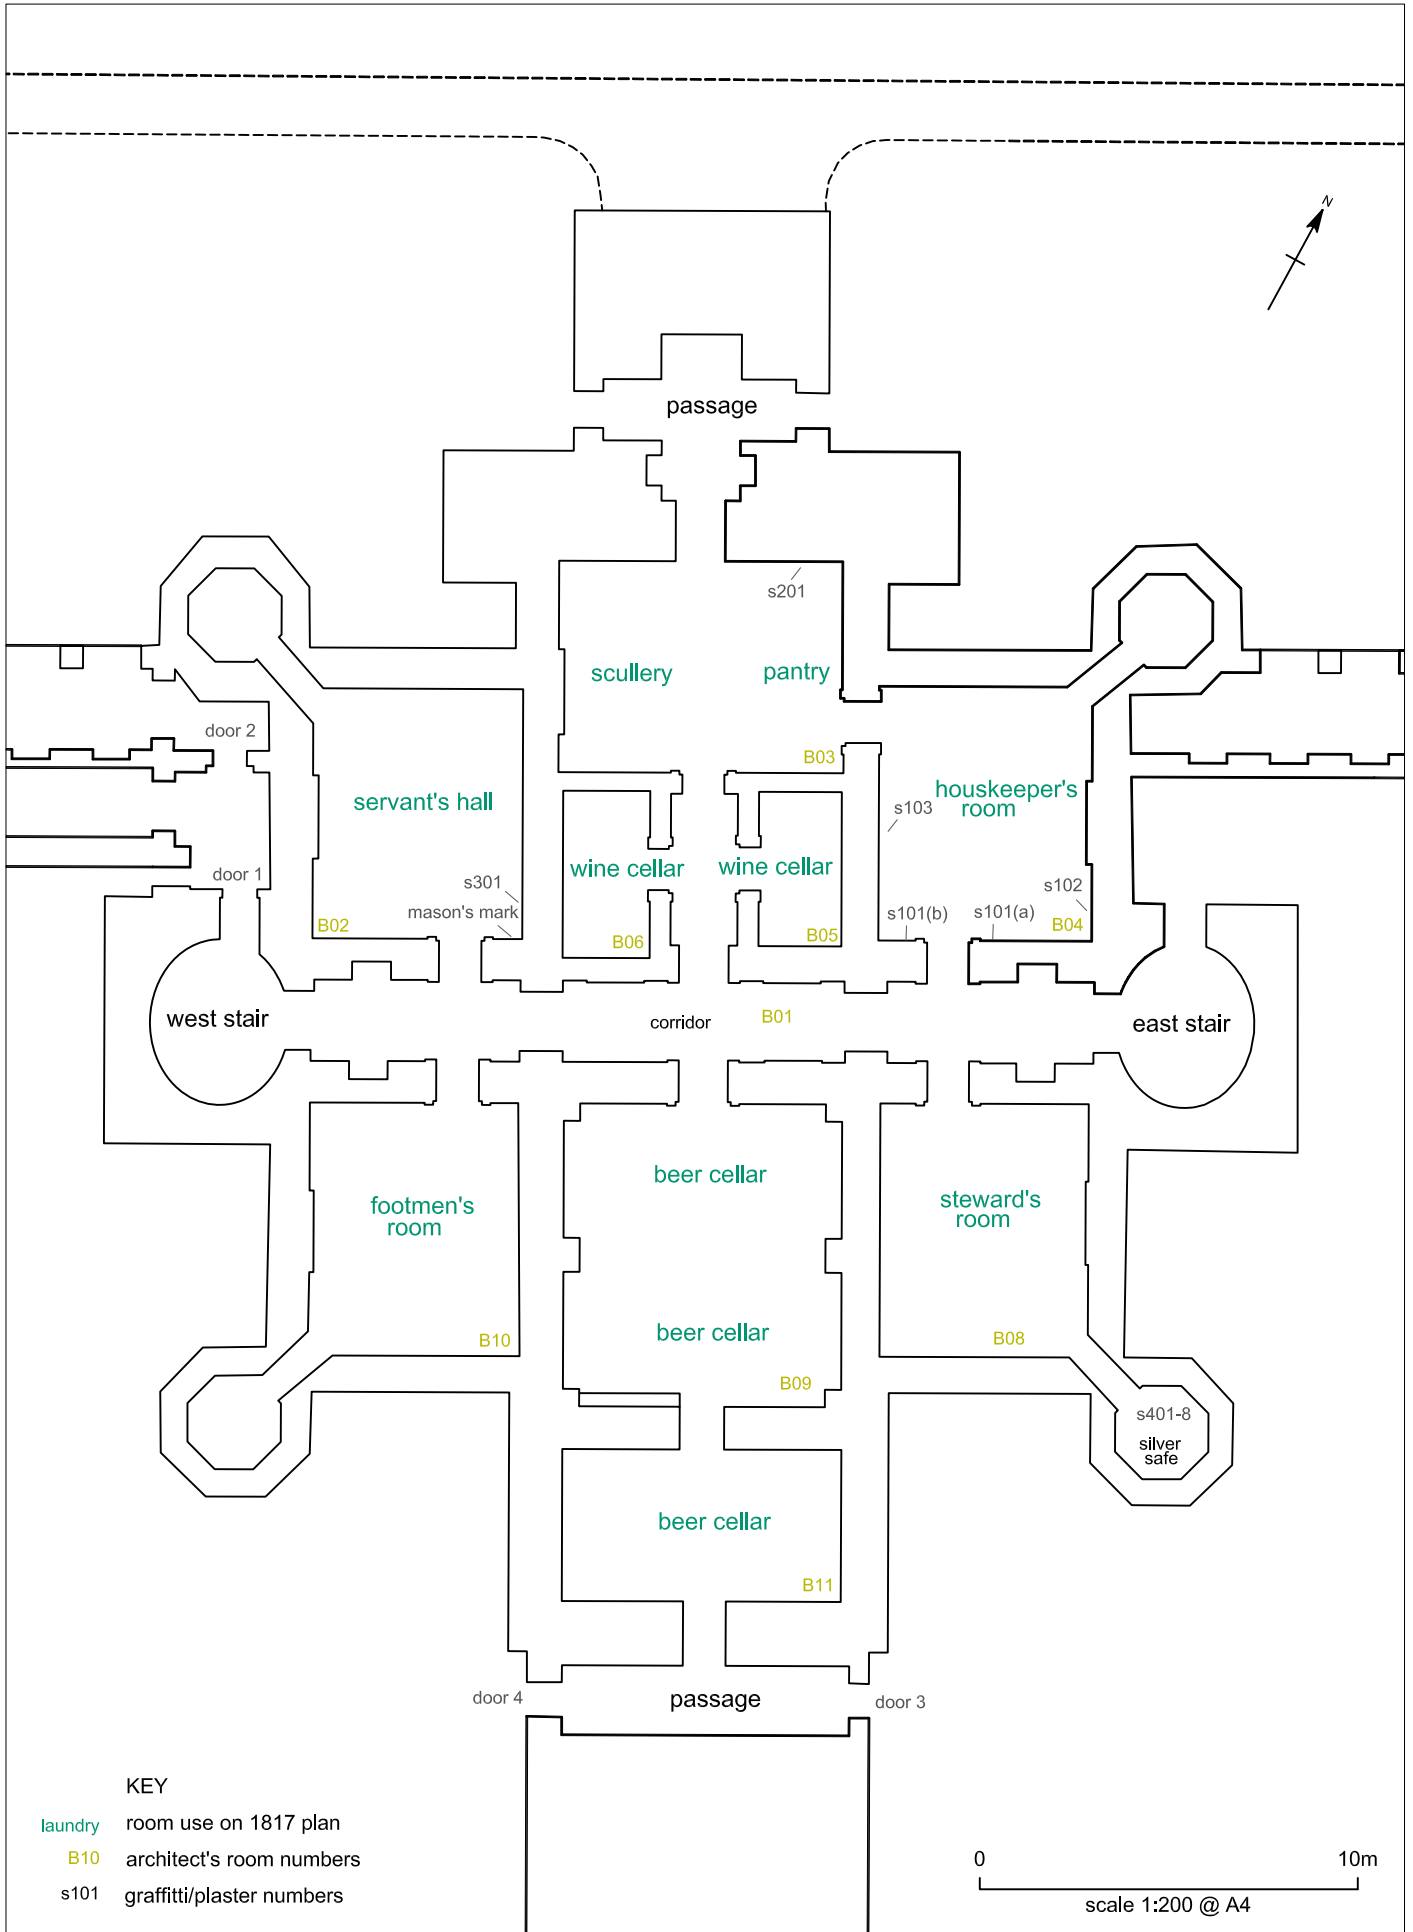
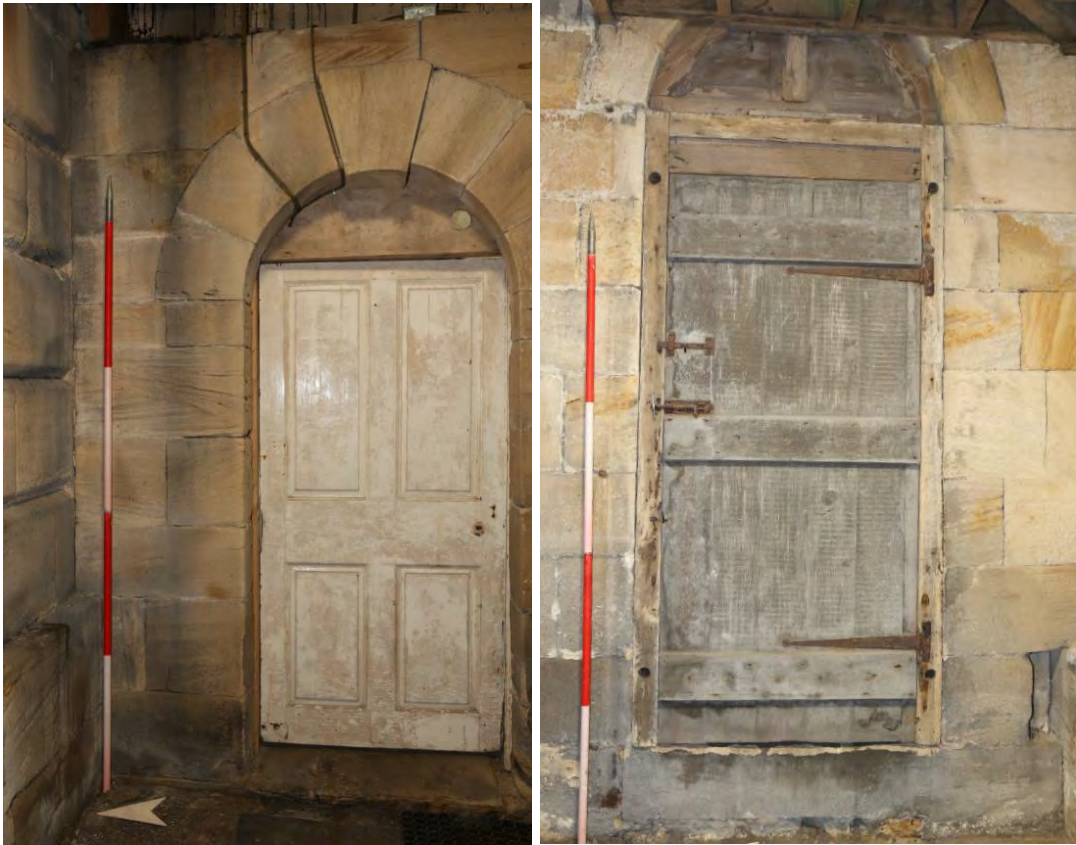
9.12 The door leading from the east kitchen passage (Fig. 10) into the basement of the Central Hall via the west stair tower (door 1) was a four-panelled door, with fielded panels which were longer at the top. This type and form of door suggests a late 19th-century replacement rather than original Georgian timberwork. The door opened to the right, to enable it to be opened with the left hand if the right hand was carrying goods from the kitchen. Both the handle and lock plate were missing. A wooden panel blocked the overlight (Plate 66).

Plates 66 and 67: (left) door into the Central Hall from the east kitchen passage; and (right) door from the arcade into the same.

- 9.14 The door leading from the arcade into the kitchen passage (door 2) was of a simple plank and batten construction with iron hinges, latch and lock. The door was fitted in a crude wooden architrave with wooden panel in the overlight space. The threshold was c.0.25m above ground level of the kitchen passage. This type of poor-quality door is usually consigned to areas away from public view; however, this would have been clearly visible from the front arcade. With the height of the threshold and the interrupted stonework, it is clear that this was a later modification in what would have been a blind arch along the rear wall of the arcade. It was likely inserted when the kitchen passage was blocked, probably in the late 19th century.

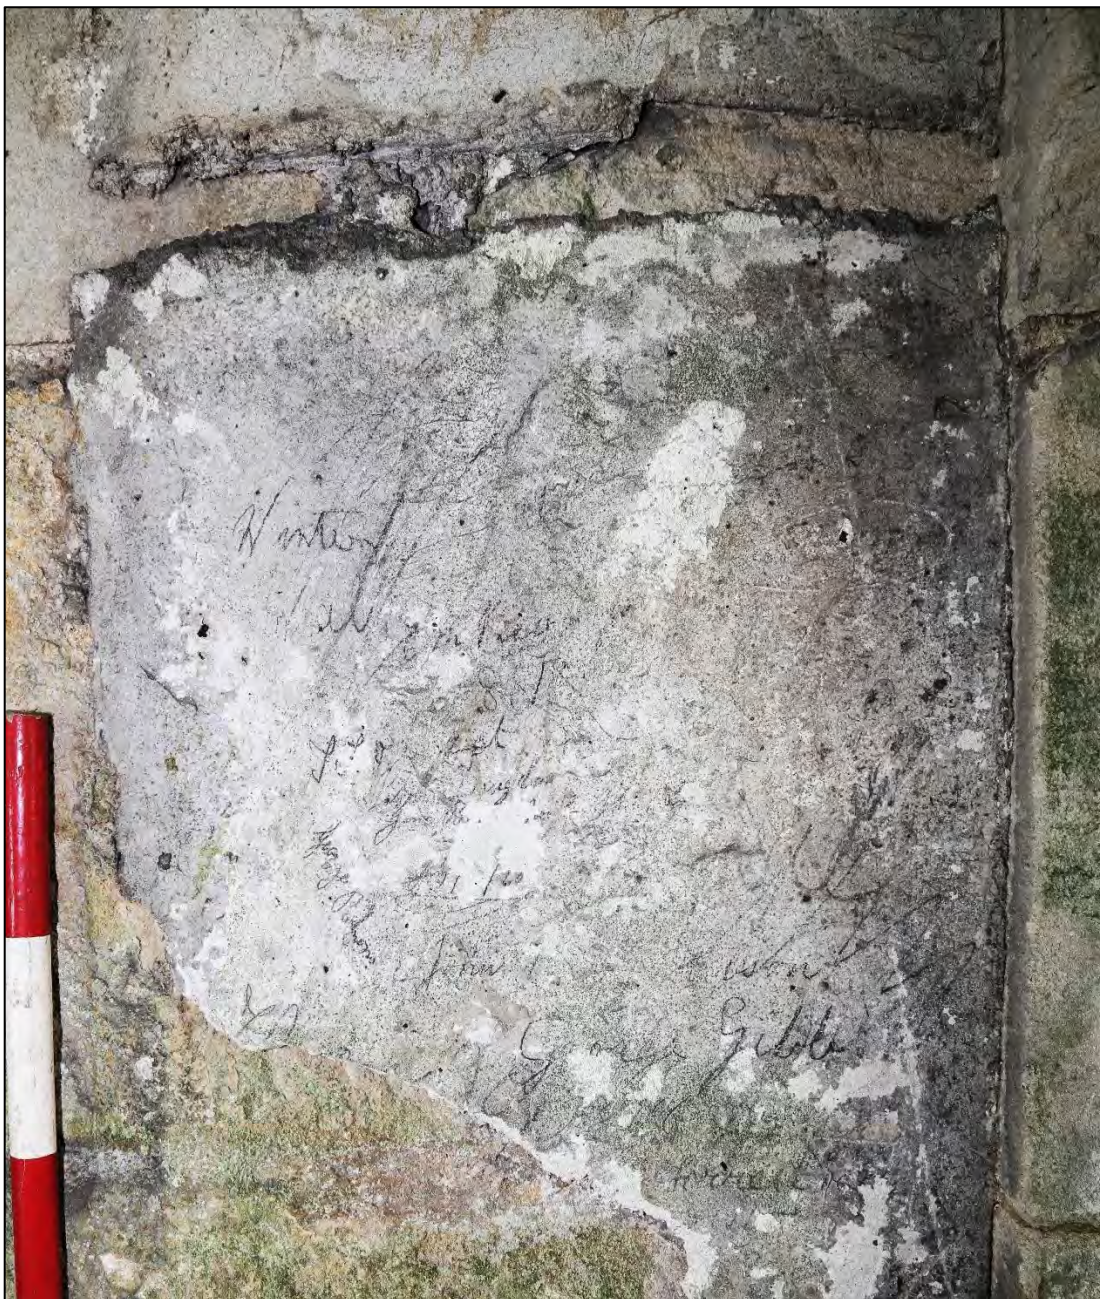
- 9.21 On the west wall of B04 was a small panel of plaster (**s103a**) surviving to the south of the door (Plate 69). Several names were written on the plaster in pencil, not all of which were legible. In the upper south (left) corner, below a faint inscription, was the word 'winter'(?). There were a number of other names below, most of which could not be deciphered except for the name 'George Gibb' written in large text, and 'George Parkers' written diagonally.

Plate 69: panel of plaster (s103a) beside the door on the west wall of room B04.

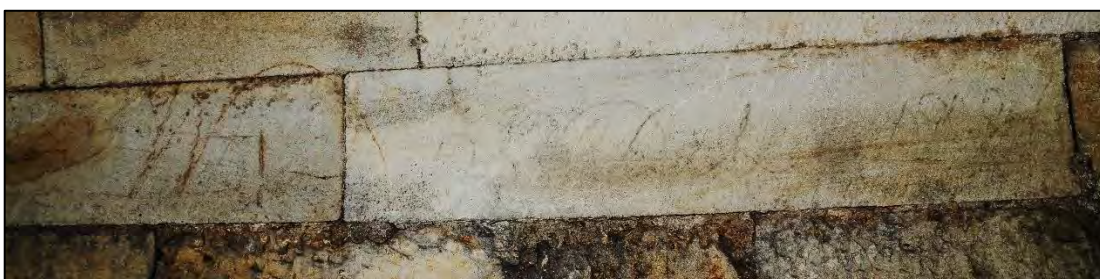
- 9.22 Most of the graffiti on the west wall (**s103b**) was on the plaster by the door apart from three inscriptions marked directly on the masonry in the centre of the wall (Plate 70). The first was very faint and read 'Delaval'. To the south (left) of this was a large 'W' in a different colour and probably of a later date. White lettering was written over the top of 'Delaval' but was so faint it was impossible to discern what it said.

Plate 70: graffiti on centre of west wall of room (s100).

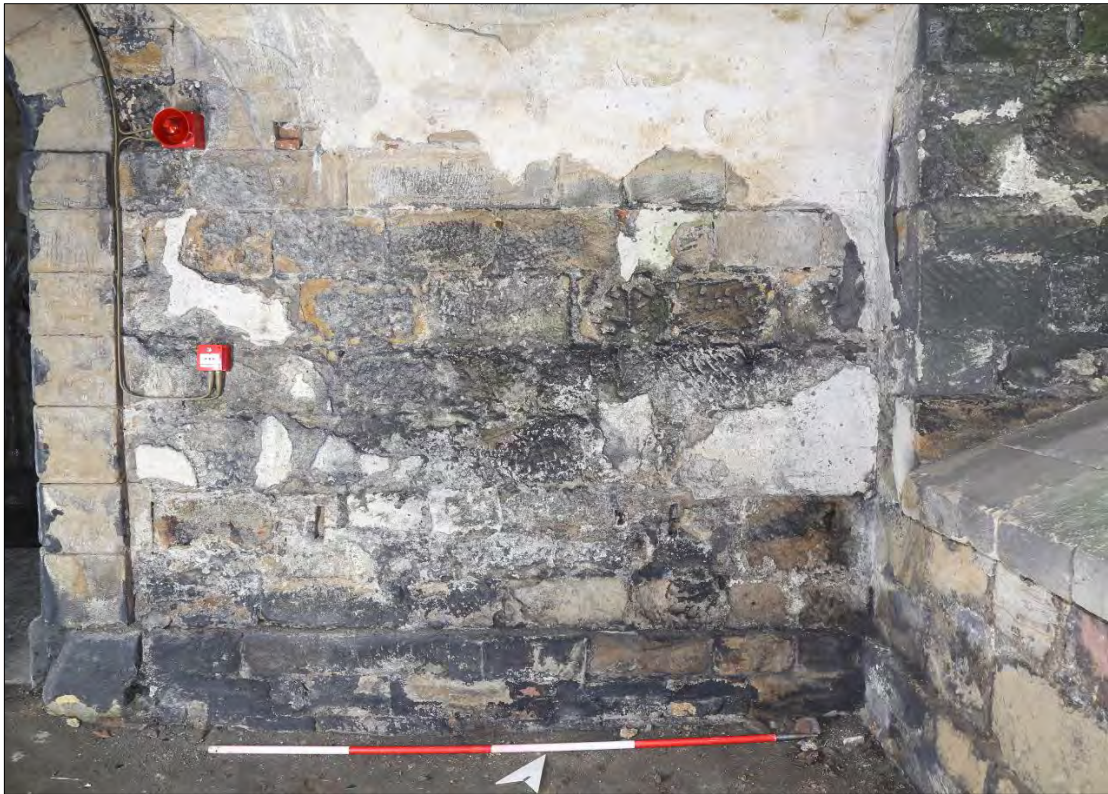
Plate 71: plaster (s201) preserved on the north wall of the pantry (B03).

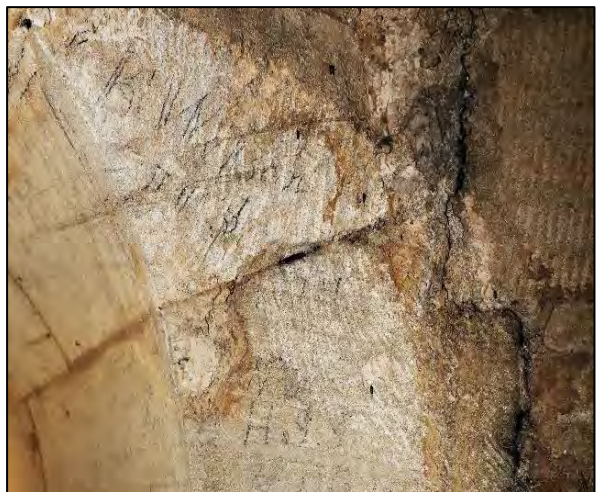
Plate 72: graffiti beside door to s400, looking north-west.

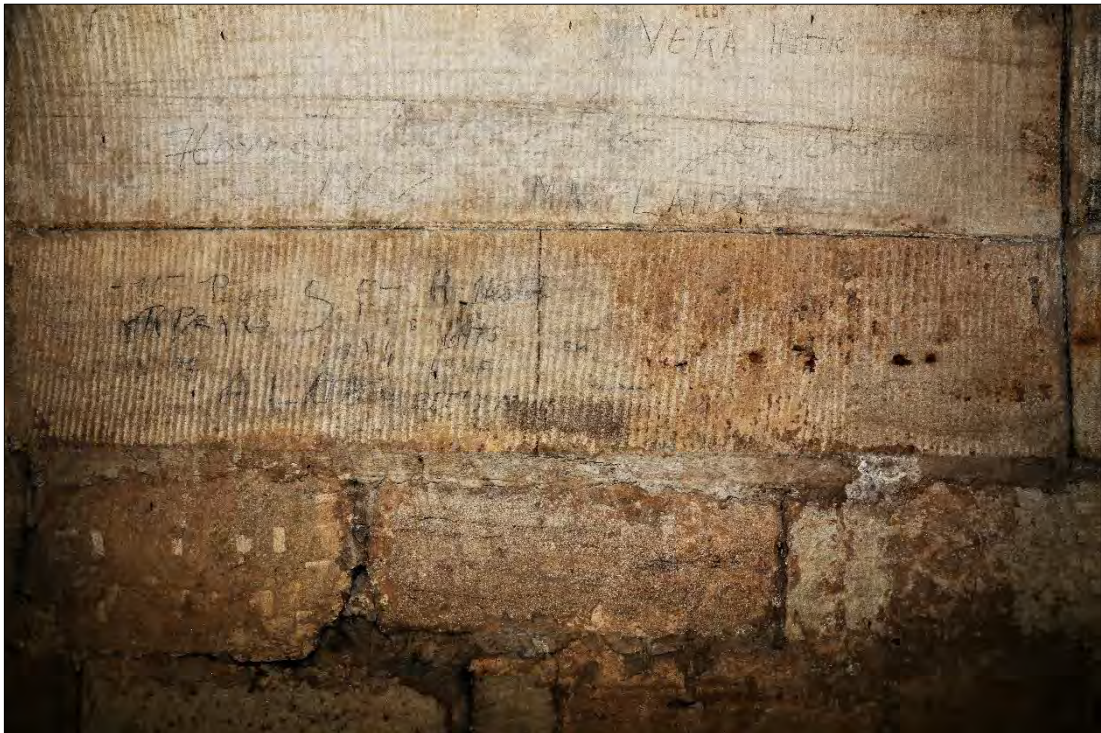
- 'Vera Hettic,' near the top of the wall (Plate 73);
- 'Jon ...' whose surname was indecipherable;
- 'May Laidler';
- 'Hoyt', dated 1907;
- 'W E Pears' and 'R Pears' (?) dated 1919;
- 'S F' dated 1919 (?);
- 'B Parker' dated 1991 (?); and
- 'H Heston' dated 1975.

Plate 73: graffiti on wall s402, looking north.

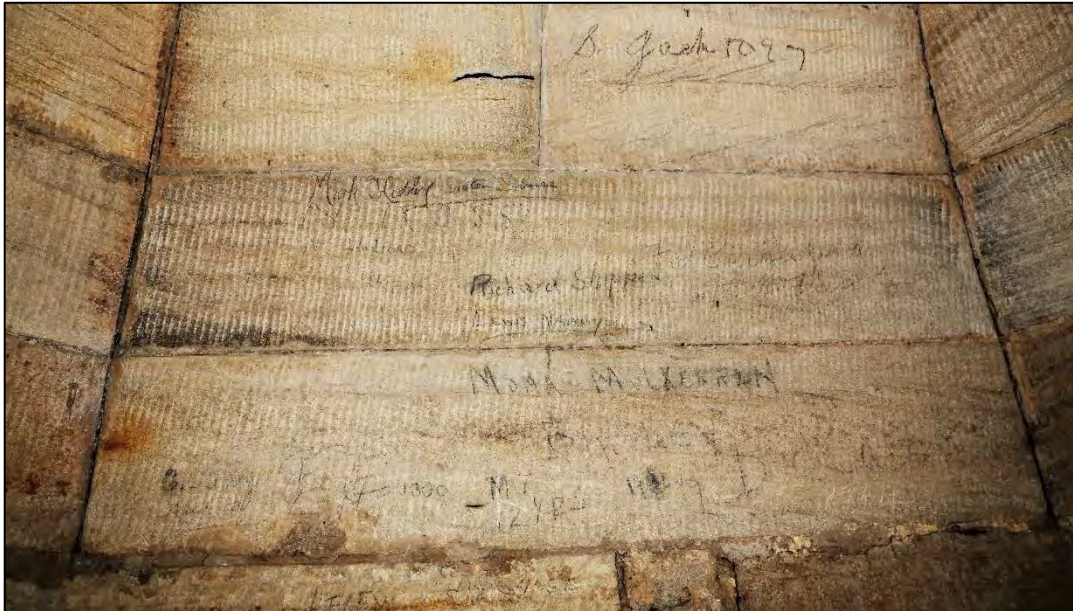
9.27 Names inscribed on the north-west wall (s403) (Plate 74) were:

Plate 34: graffiti on north-east wall (s403).

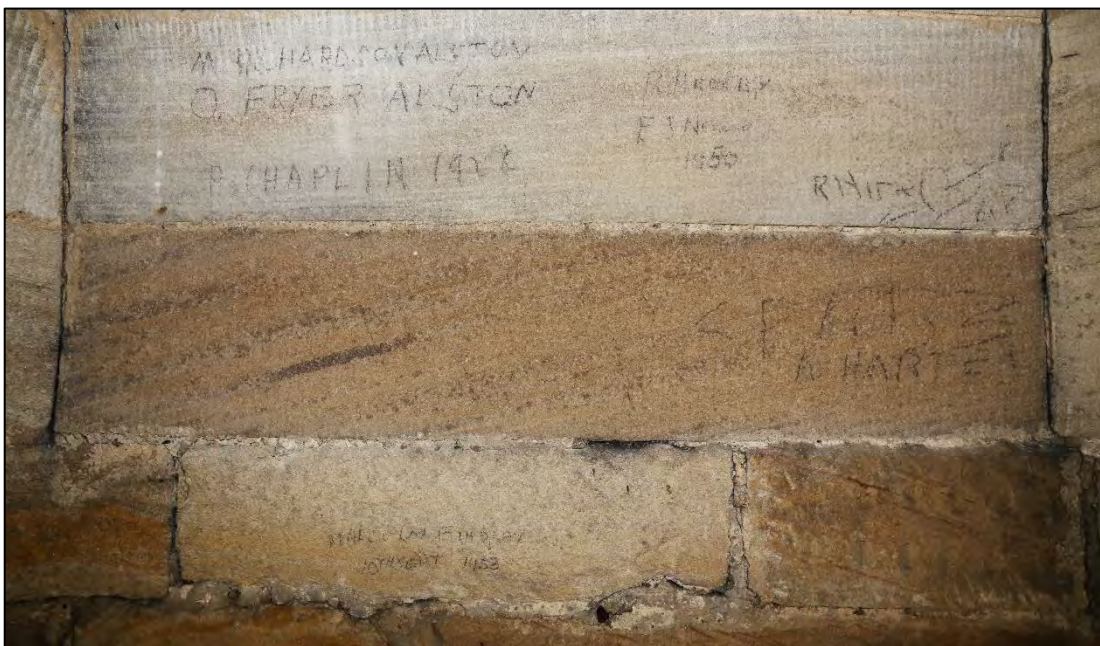
9.29 The east wall (s404) featured some distinctive graffiti (Plate 75) that read 'M Richardson Alston, O Fryer Alston, P Chaplin 1928'. Beside these names was the name 'R Hedley FJN... 1956' and '... Findlay' dated 10th September 1953.

Plate 75: graffiti on east wall (s404).

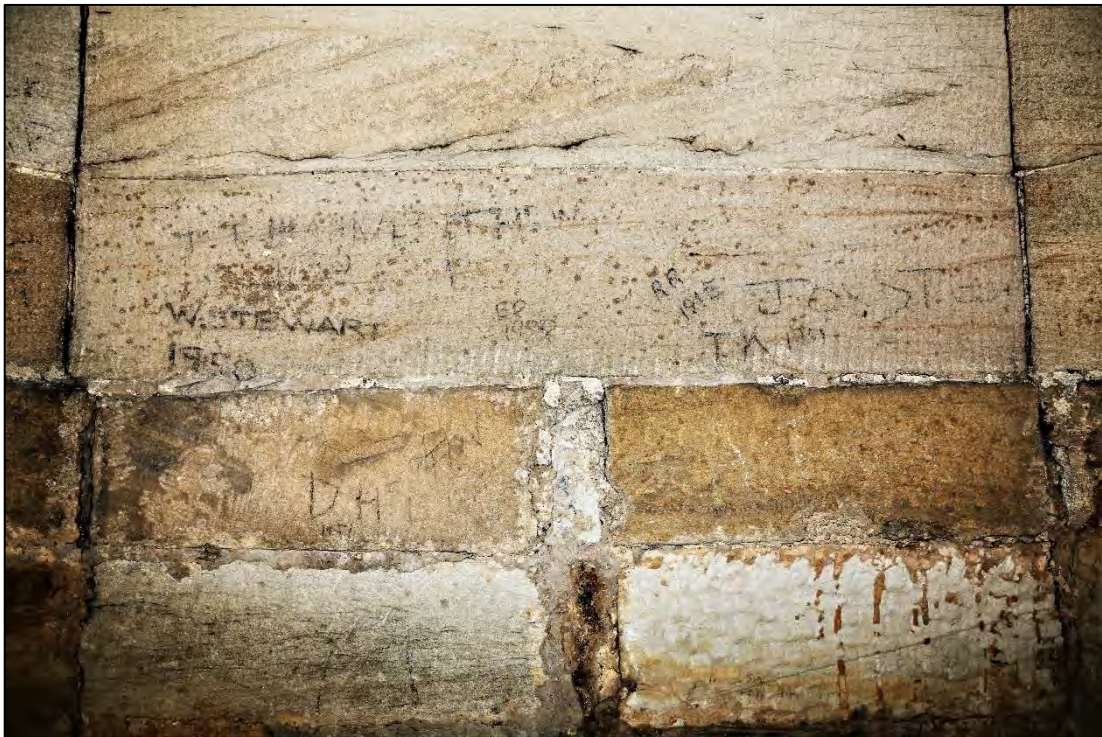
9.30 On the south-east wall (s405) (Plate 76) were the inscriptions:

- 'W. Stewart 1950';
- 'DH 1951';
- 'BP 1990';
- 'RR 1915';
- 'TK 1951'; and
- 'JO ST(?)'.

Plate 76: graffiti on south-west wall (s405).

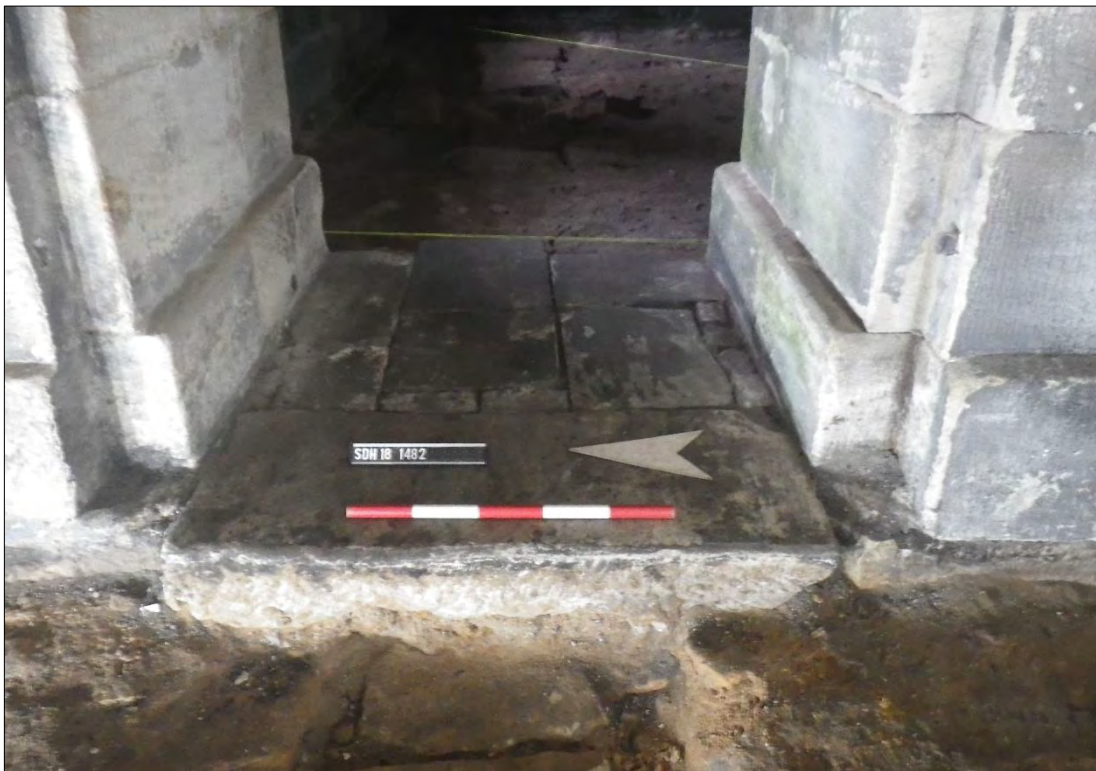
Plate 77: remains of flagged floor 132 in the doorway between the pantry and Housekeeper's Room.

9.36 Fragments of the previous flagstone floor remained (132) in a number of rooms, with well-preserved *in situ* surfaces between room B03 and B04 (Plate 77), between rooms

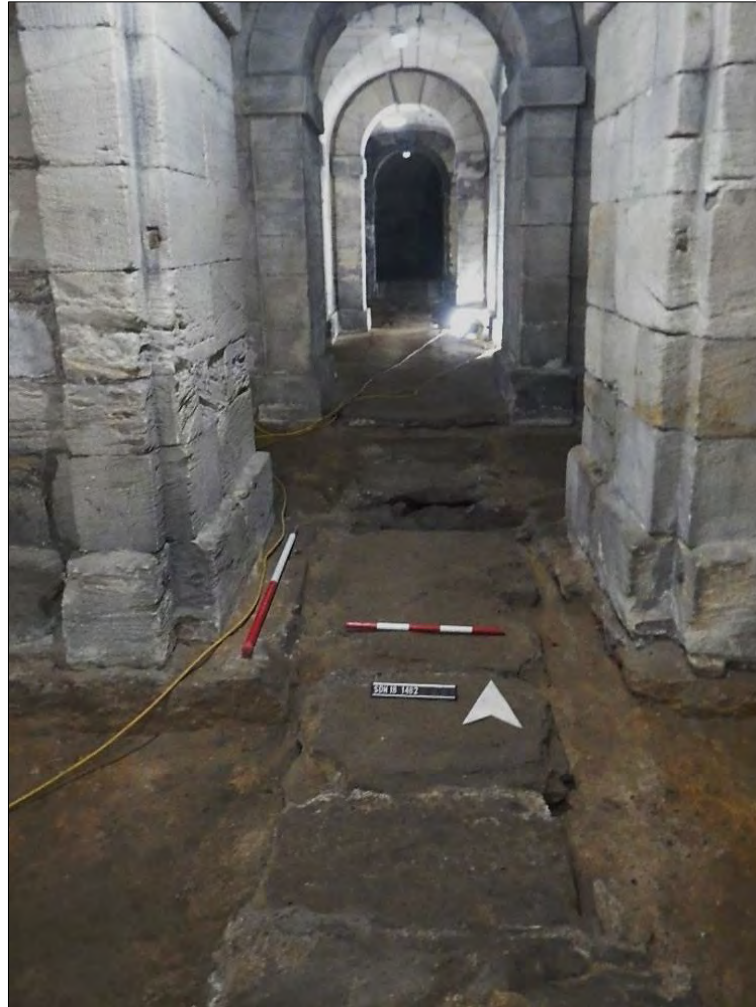
Plate 78: drain 118 running north through the centre of the basement.

- 9.37 Running along the north-south axis of the building was drain **118**. This was the largest of the basement drains and ran northwards from B11, beneath the south portico, through to B03 (Plate 78). The exposed element of the feature was 29m long and investigations were made at intervals along its course, where modern activity had already disturbed the historic fabric. The drain was square in section with internal dimensions of 0.5m in width and 0.4m in depth. The side walls of the feature stood 0.3m high and were 0.15–0.2m thick, constructed of two courses of roughly squared sandstone blocks with a dressed surface on the inner face. Sandstone slabs were laid along the base of the drain, the full dimensions of which were obscured. The feature was capped with large flat

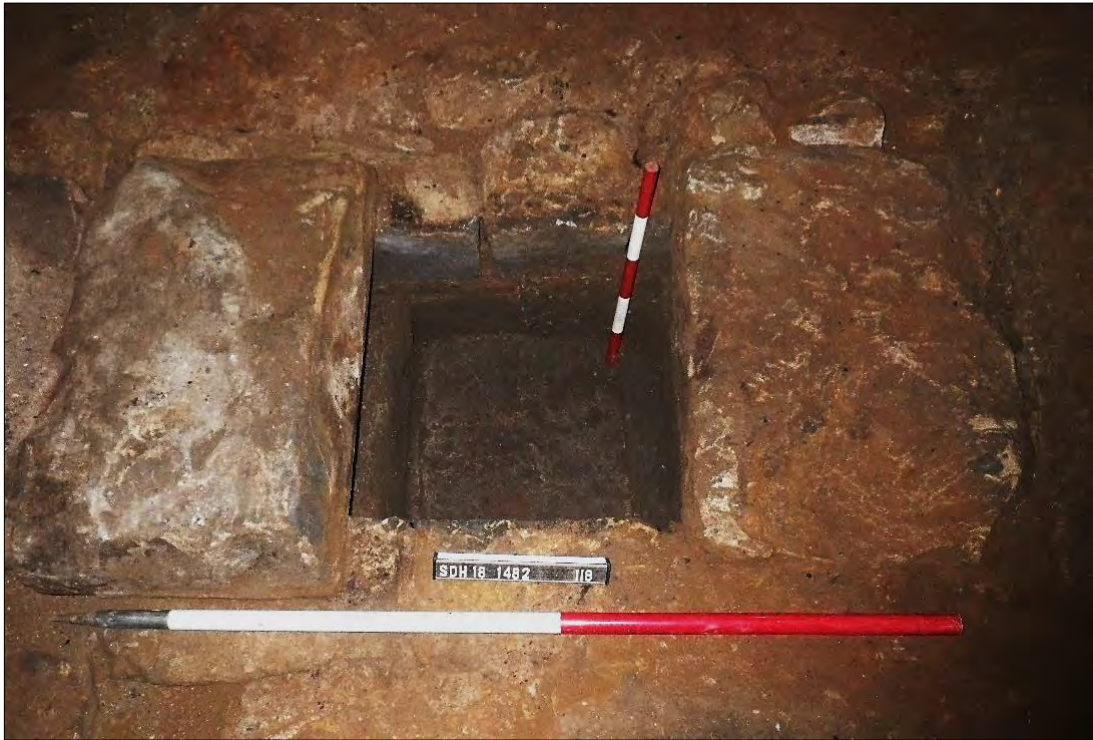
sandstone slabs, measuring an average of 0.4m by 0.65m and c.0.15m thick. These lay directly beneath the flagstone floor (132) (Plate 79).

Plate 79: drain 118 in B03, with capping stone removed to expose the interior construction.

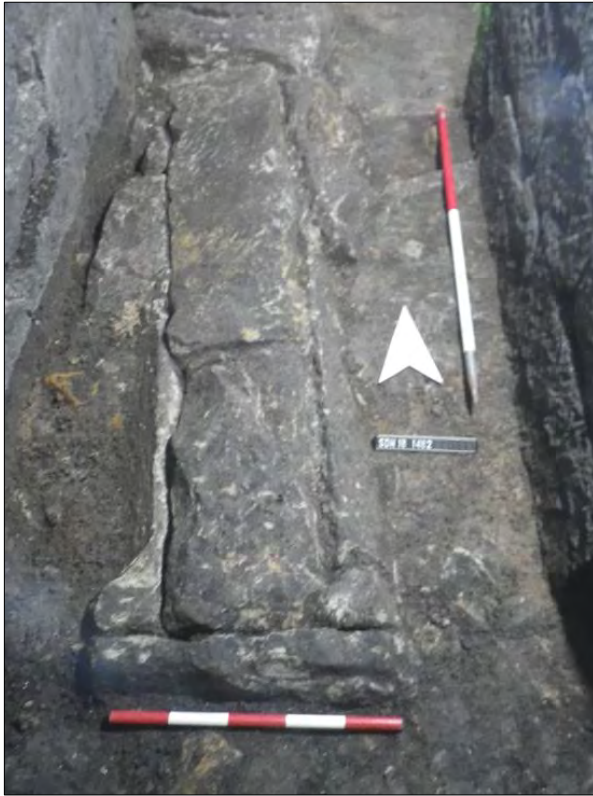
9.38 The southern end of drain 118 began at the door opening between B11 and B12. This was the highest point of the feature (the feature draining northwards) and had suffered considerable damage as a result, probably during the removal of the flagstone floor. There was evidence that the stone capping had been badly repaired by the addition of copious amounts of creamy white mortar (202). There was no trace of any form of inlet (Plate 80).

Plate 80: southern extent of drain 118 with capped end.

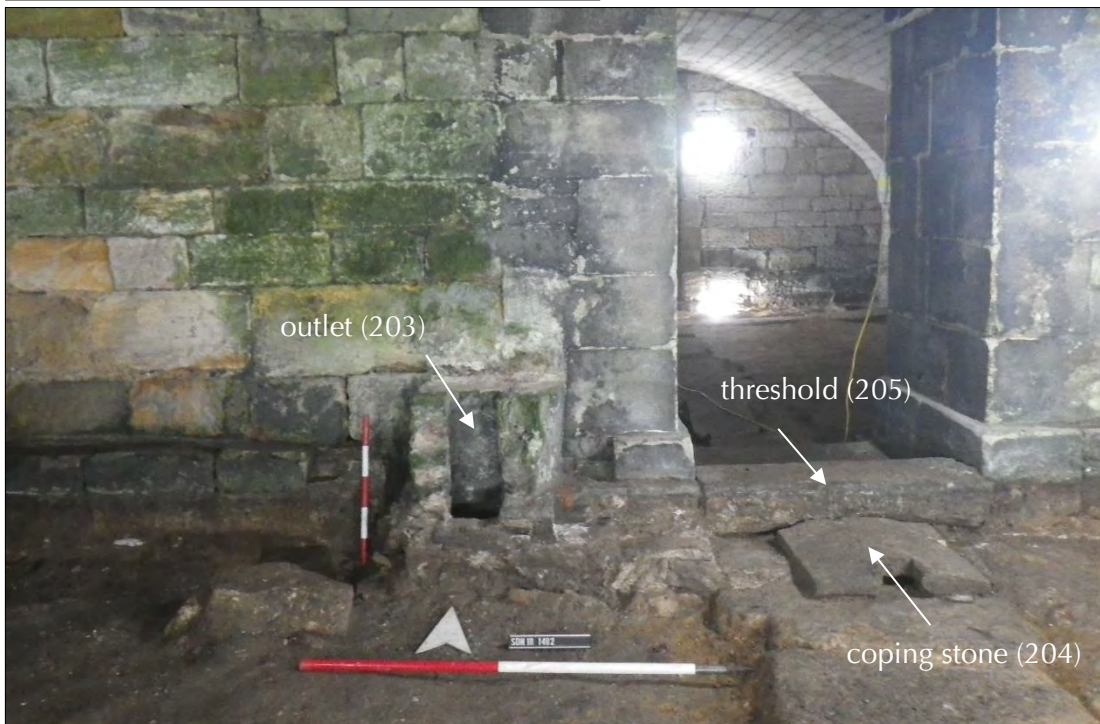
setting for the sink (203) was a square, mortared-brick plinth with a curved stone upper surface matching the dimensions of 137. This stood 0.45m above the original floor level. At the junction of drain 202 and 118. The capping stones had been replaced by finely tooled coping stone measuring 0.52m by 0.45m (204). It is uncertain whether this formed part of later repairs or functioned as access for maintenance.

Plate 81: outlet 203 with coping stone 204 over drain 118 and step 205 on the right.

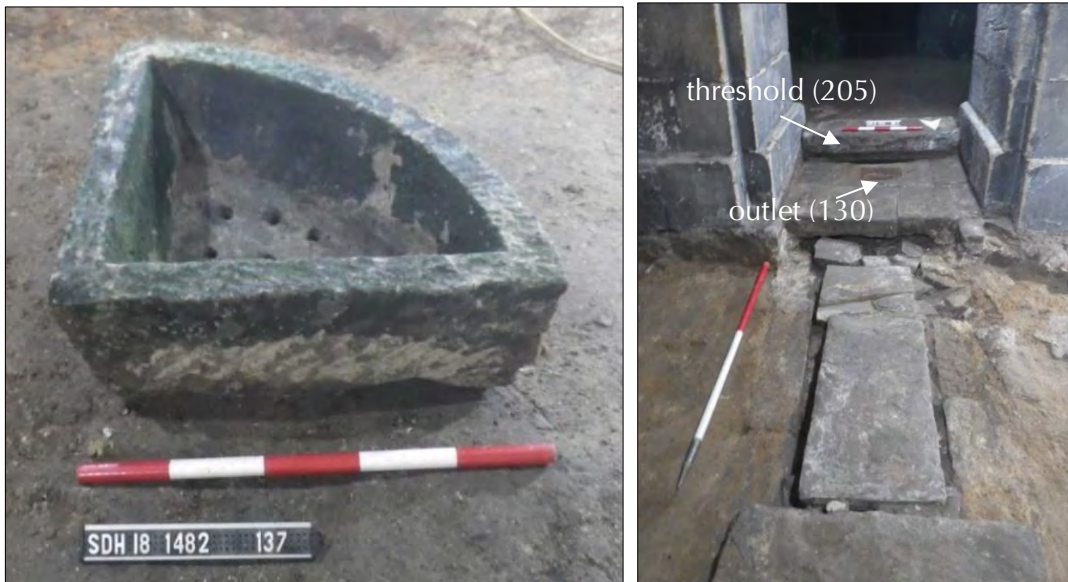
Plates 82, 83: (left) carved stone sink 137 with rough tooling and perforated base; and (right) drainage inlet 130 with threshold stone 205 in doorway and damage to drain 118 visible (room B09).

- 9.40 The threshold between B06/09 and B11 was set with a 0.25m² metal grille inlaid into a 0.65m² chamfered paving slab (130). The grille facilitated drainage from the flagstone surface. A threshold step, 0.2m high (205), had been inserted above the remains of this, partially covering the metal grill (Plate 83). This was therefore clearly a later addition.

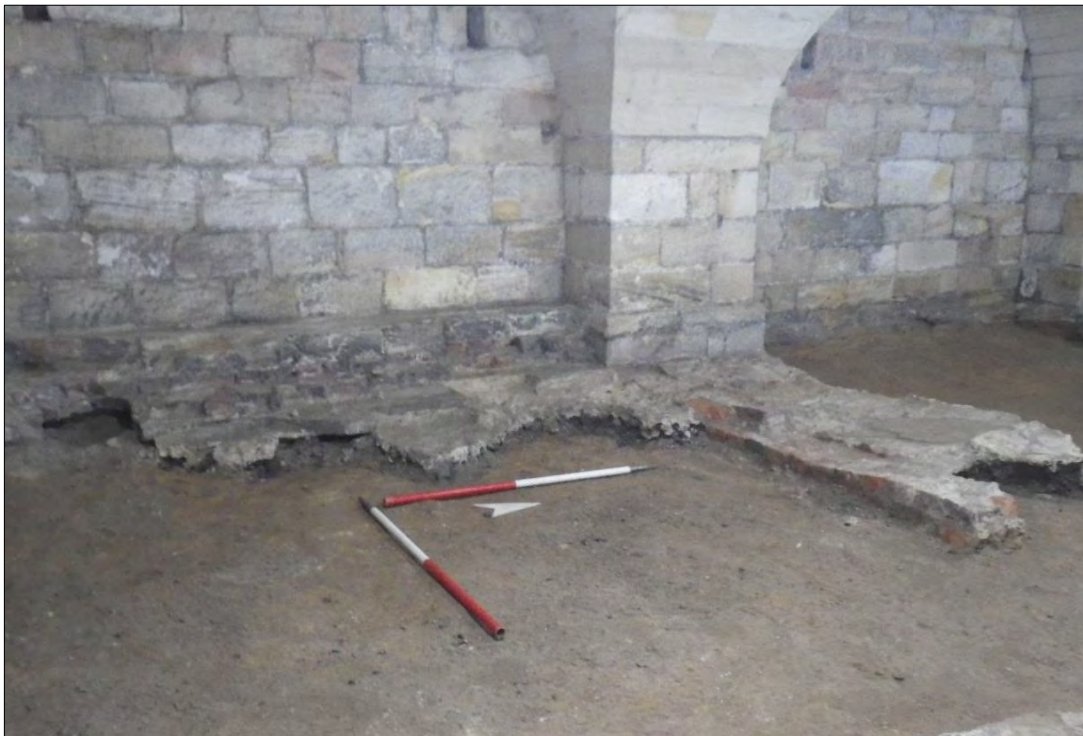
- 9.42 Excavations within B06/07/09 exposed the remains of a brick wall (127) and a series of surfaces (128 and 129). Three courses of wall 127 survived, built of red-orange handmade brick, measuring 0.08m by 0.11m by 0.24m and set in grey mortar flecked with white. This was bedded directly onto the natural sandstone. The wall ran east from the south side of the central pier and was 2m long, creating a bay within the south-west corner of the room (Plate 84).

Plate 84: wall 127 with mortared floor surface 128 to the south, overlain by raised area 129 against the west wall.
