THE HALL

ARCHAEOLOGICAL
INVESTIGATIONS

NATIONAL TRUST
SEATON DELAVAL HALL
NORTHUMBERLAND

NAA 21/66
July 2021

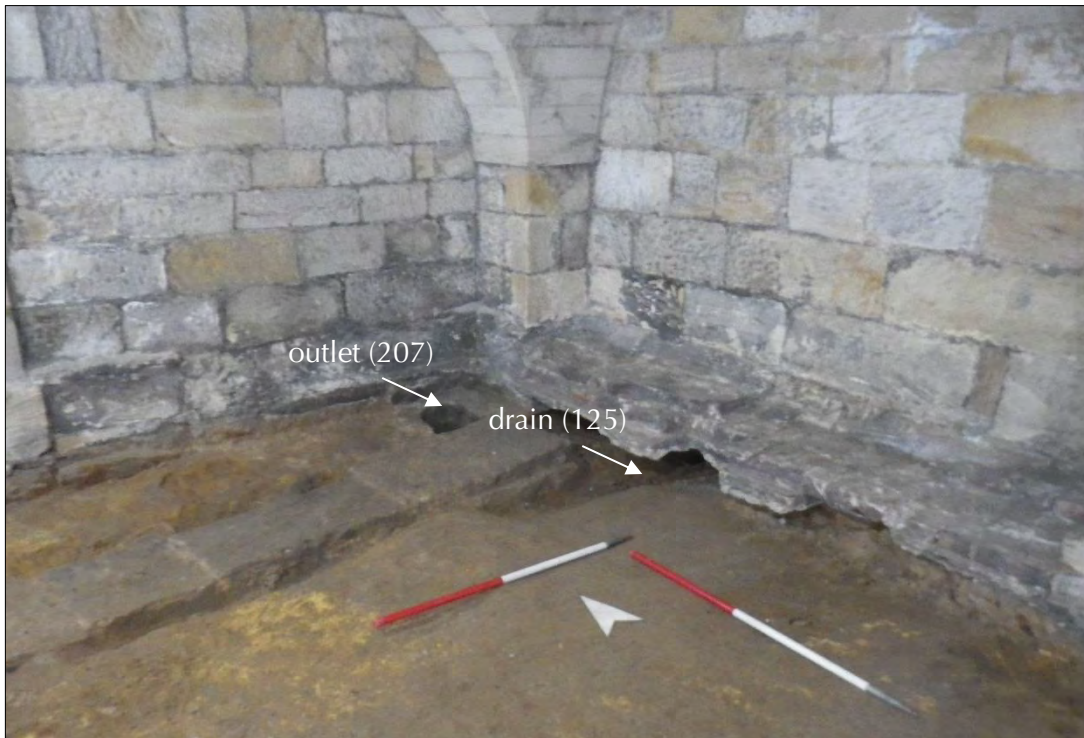
- 9.45 Another drainage outlet (207) (similar to 203 in B11) was situated in the north-east corner of the room B09. This was connected to 118 by a stone-capped drain (131) which ran on a slight south-west alignment. The area along the east wall, to the south of 207 and deposit 128, was heavily disturbed and a channel had been excavated beneath the main wall to connect with a small drain (125) in B08 (Plate 85). However, this apparently did not adjoin drain 126 that runs south to north across the room. This is an anomaly.

Plate 85: drain 131 and inlet 207 in the north-east corner, with disturbed area beneath floors 128 and 129.

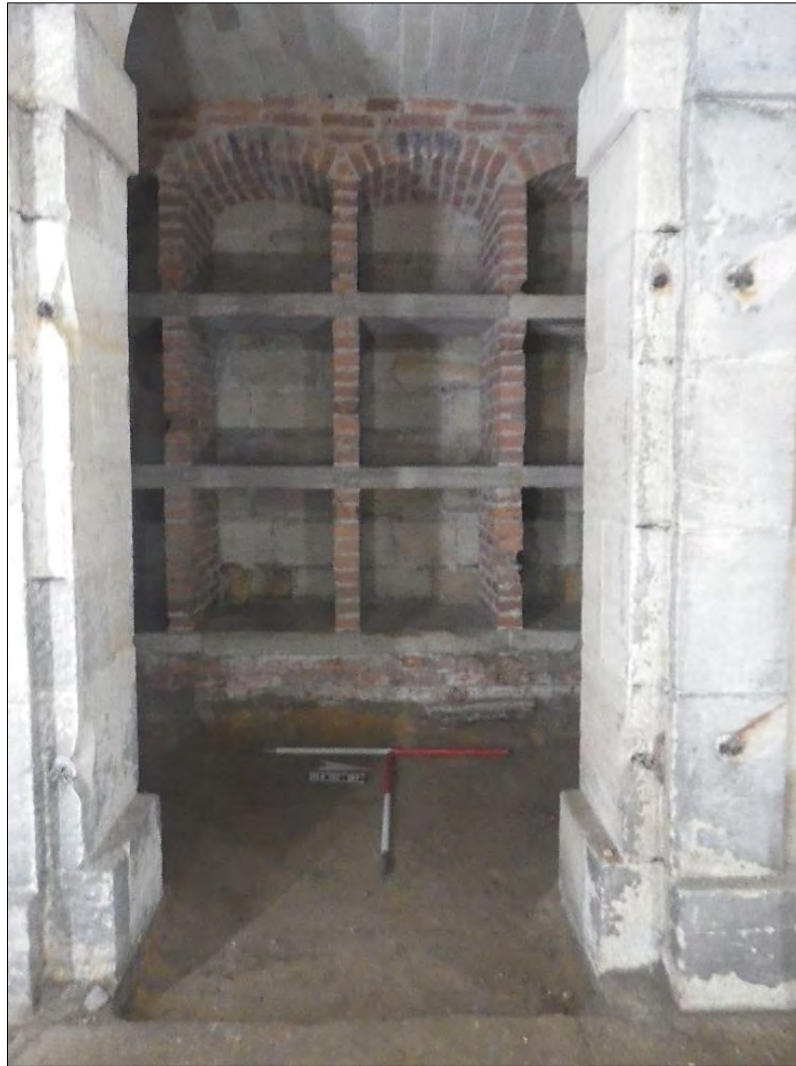
Plate 86: brick storage wine bins in B06, facing east.

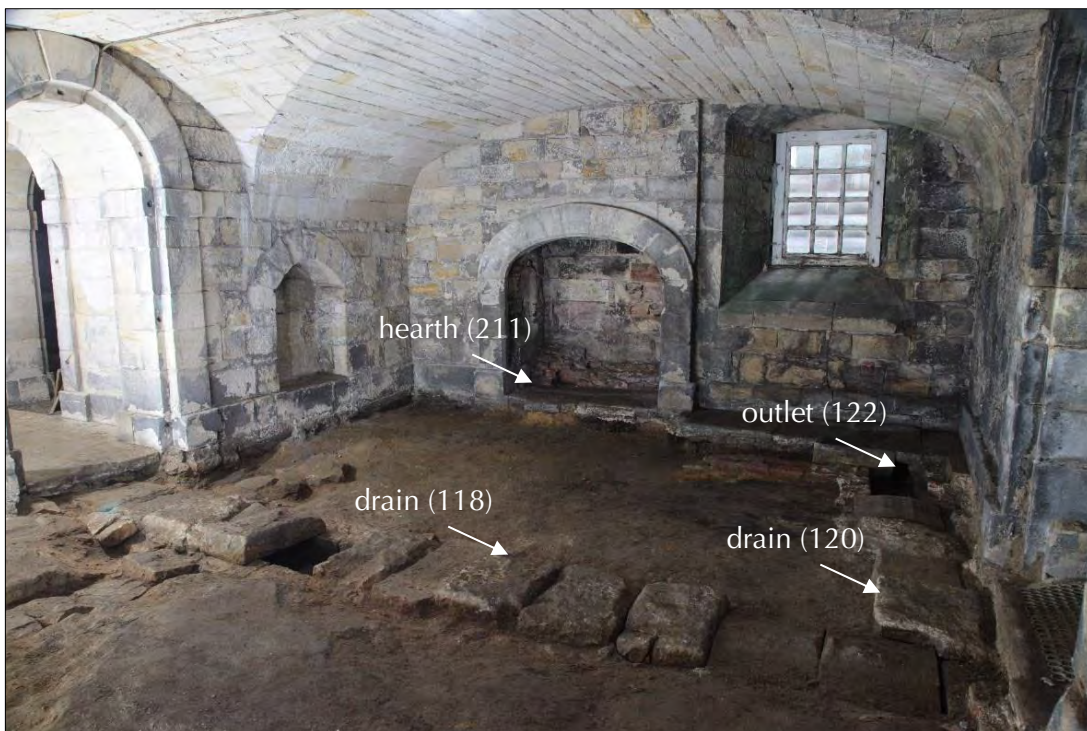
- 9.49 In the north-west corner of the room, drain 120 was overlain by a flagged area (122) that extended south for 2.3m along the west wall. South of this was a fireplace and range (211) used for heating water for the scullery, among other things. Two large stone slabs were positioned between the hearth and drain. These measured 0.65m by 0.8m and were 0.15m thick. A finely tooled raised lip had been cut around the outer edge of the stones to form a shallow dished area to channel waste water into 120 via a 0.2m-thick carved stone slab. This covered a 0.6m² area and was fitted with a 0.25m² metal grille, similar in design to 130 in B11.

Plate 87: drain 118 and hearth 211, with drainage area 122 and drain 120 in the corner, facing south-west.

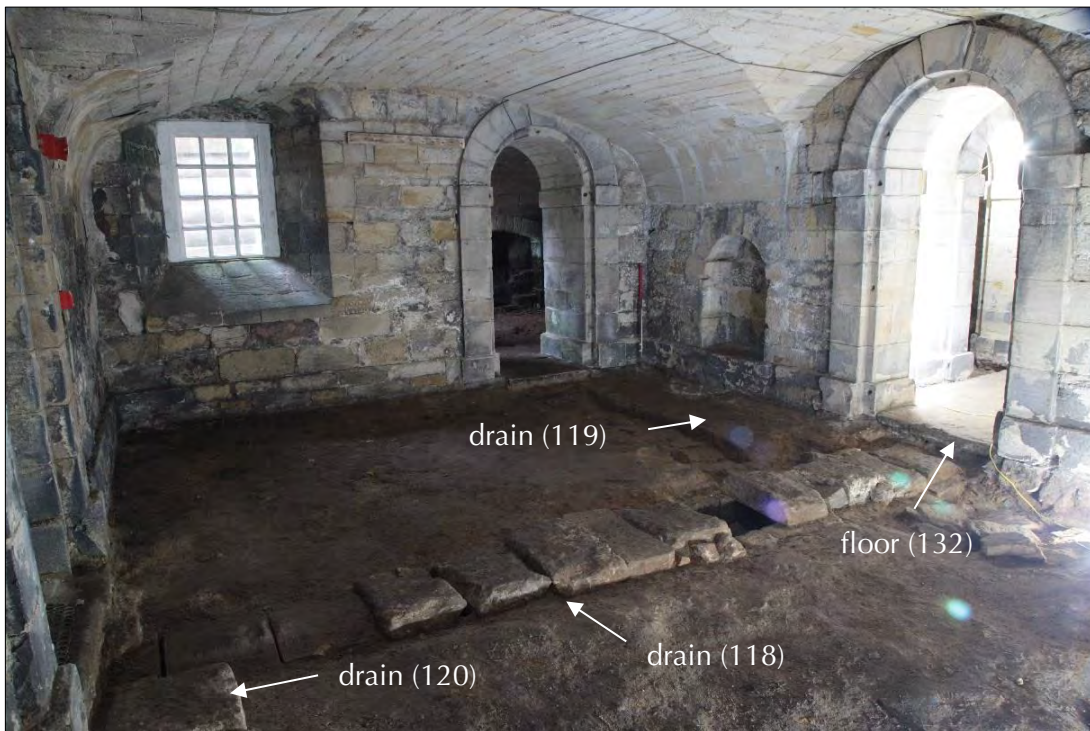
- 9.52 In the south-east corner of B03, a stone drain (**119**) ran east through the doorway leading into B04 to connect **118** with drain **117** (Plates 89 and 90). Drain **119** was square in section, 0.5m wide and 0.35m deep, and was cut into the natural sandstone. The edges of the drain were lined with unworked sandstone blocks, laid on edge to support square capping stones. These were generally 0.4–0.45m in width and 0.1m thick.

Plate 89: B03 looking south-east with drain 118 running south beneath the preserved area of flagstone floor between B05 and B06. Drain 119 also visible running east into B04.

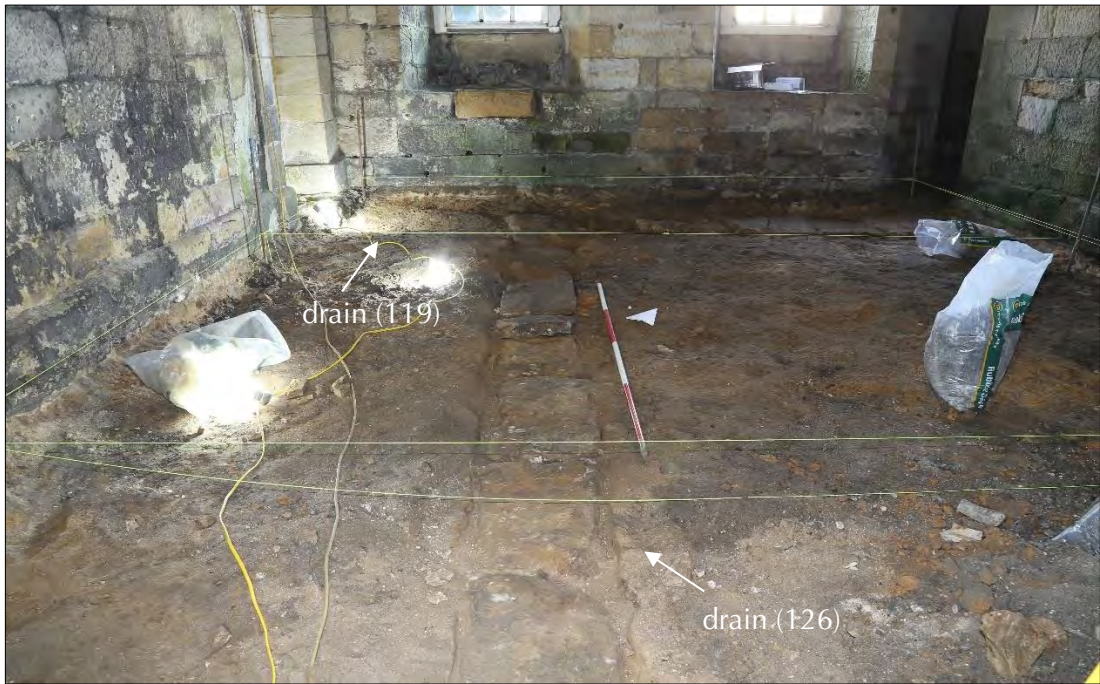
Plate 90: B04 during ground reduction, with drain 126 running north-west and drain 119 on the north side of the room.

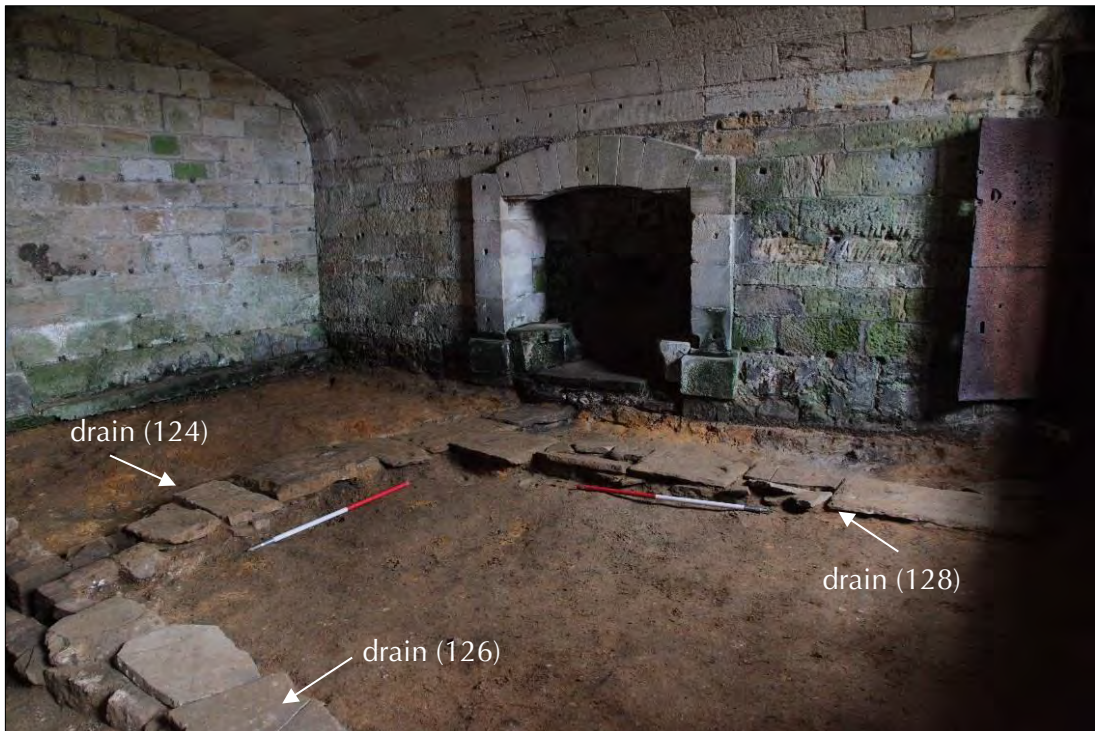
The construction of the drain changed in B08 (Plate 91), with a move from stone construction to a mixture of reclaimed bricks and masonry held in mortar. The reason for this is uncertain. It may indicate the drains on this side of the property were installed at a different time from those on the north. Alternatively, it may reflect a change in the readily available building material, or possibly it is associated with the changing nature of the underlying geology south of corridor B01, because the permeable nature of the

Plate 91: B08 with drain network 123/124/126 and fireplace 212, facing north-east.

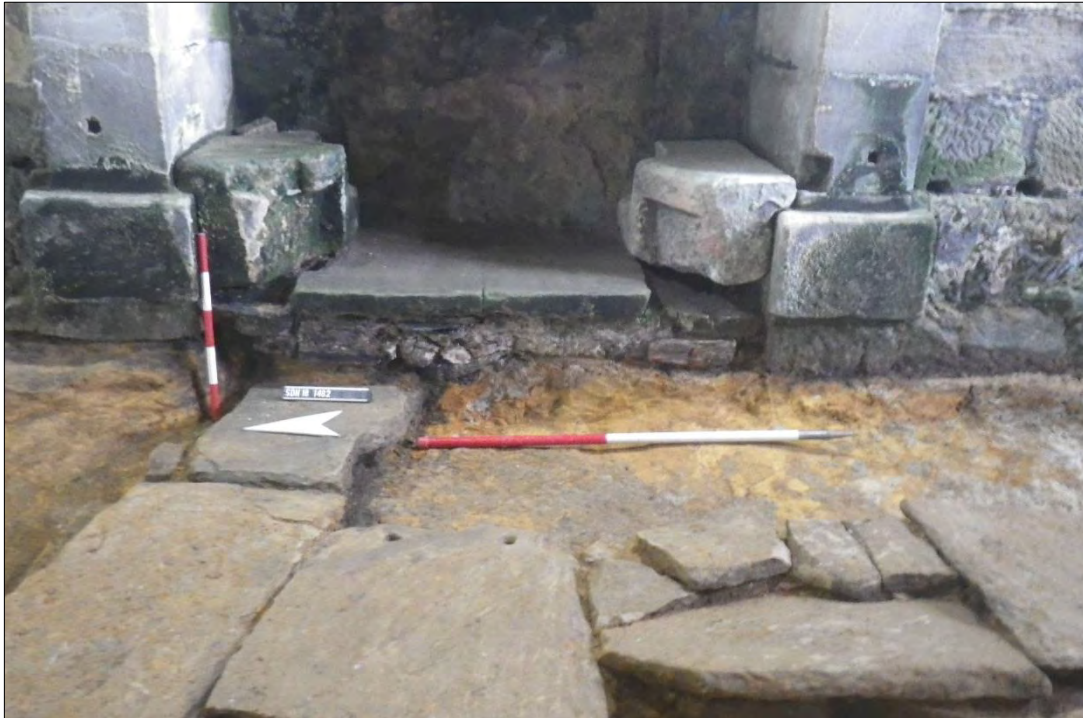
- 9.55 Three further drains were identified in B08, forming an interconnecting network beneath the floor surface. Drain **124** was of the same build as **126** and ran east, exiting the building beneath fireplace **212** in the east wall. Drain **123** intersected **124** and ran south, parallel to **126**, into the silver safe in the south-east tower (Plate 92) from where it probably vented out of the building.

Plate 92: hearth 212 overlying drain 124, with capping to drain 123 in the foreground.

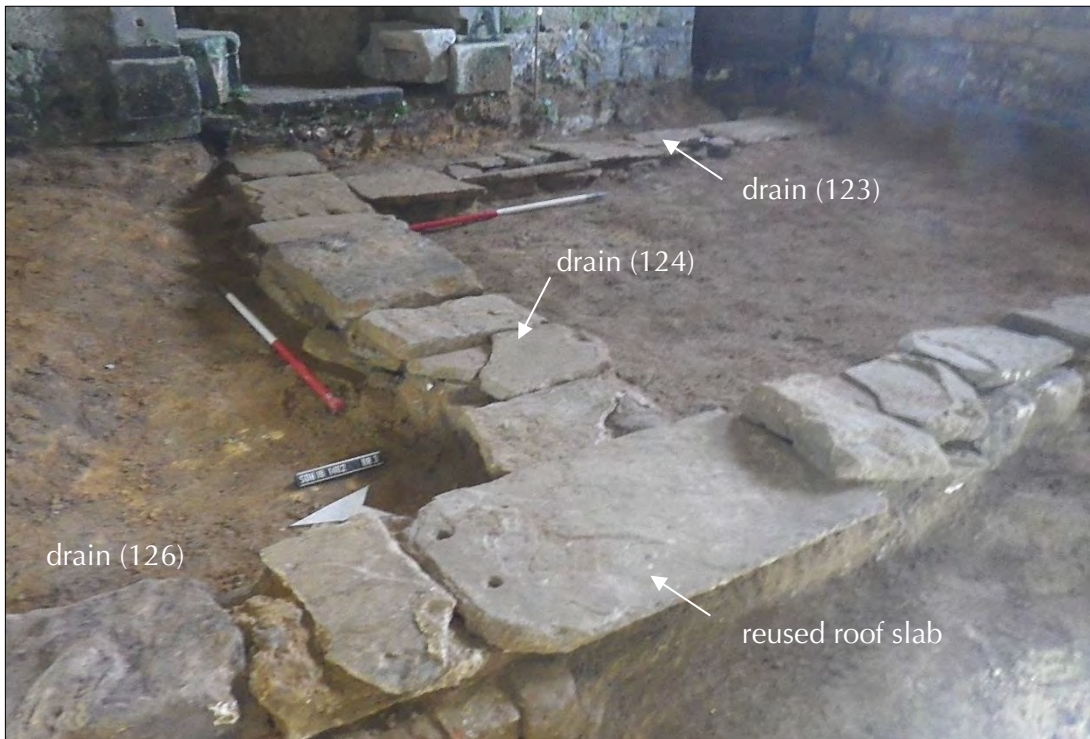
- 9.56 The stones capping the drains in this room were reused stone roof-slates; the carved peg-holes are clearly visible. These, and the supporting handmade bricks used in the construction of the drains, were probably reclaimed from the demolition of the earlier Tudor/Stuart mansion house (Plate 93). Many of the roofing slabs showed signs of damage prior to reuse. One complete example was recorded at the junction of drains **126** and **124**. This substantial roofing stone measured 1m by 0.55m, with a thickness of just over 0.05m (Plate 94) and was carefully removed and retained for future display.

Plate 93: drainage network 123, 124 and 126 in room B08, looking south-west.

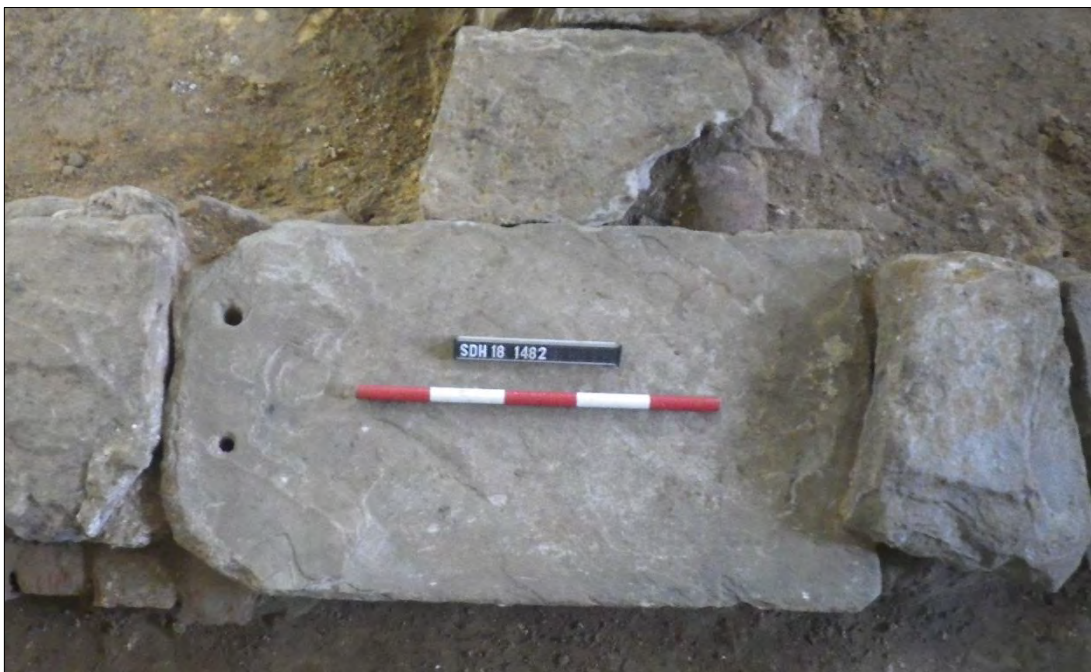
Plate 94: reused roofing slab overlying junction of drains 126 and 124.

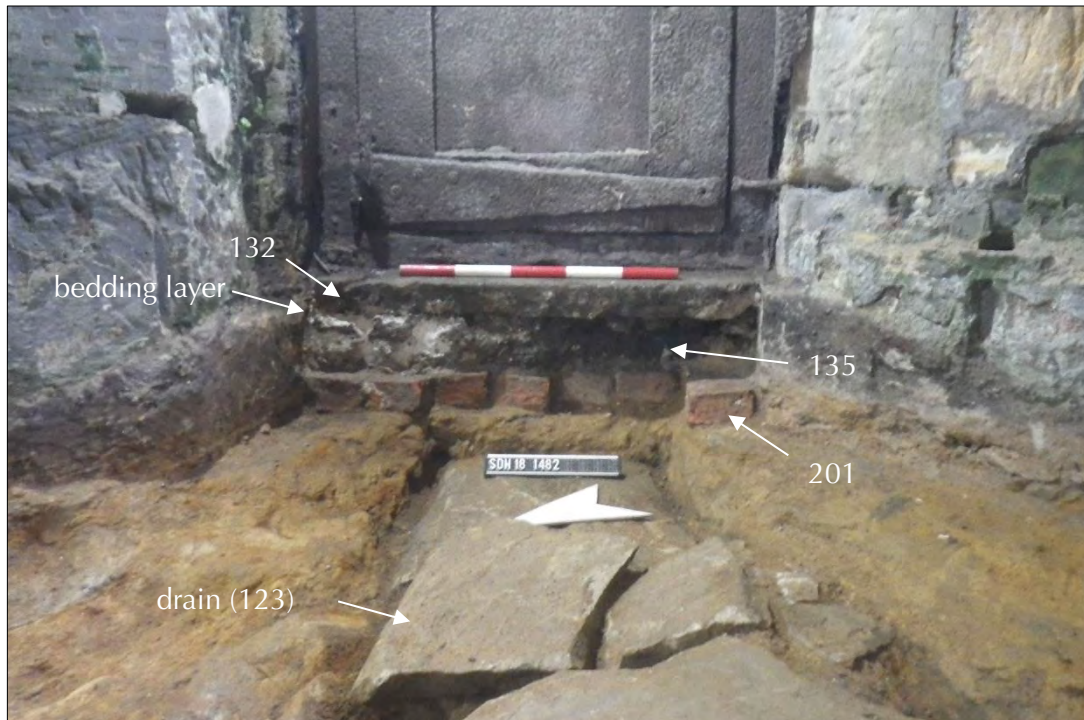
- 9.58 In the south-east corner of B08, drain 123 ran beneath the doorway to the silver safe. The iron door into this area was locked and corroded shut until recently which probably accounts for the preservation of the flagstone floor in this area. A section cut beneath the threshold to the door provided a good indication of the sequence of deposits in the room (Plate 95).

Plate 95: section showing sequence of basement deposits as preserved beneath the door to the silver safe. Drain 123 in the foreground.

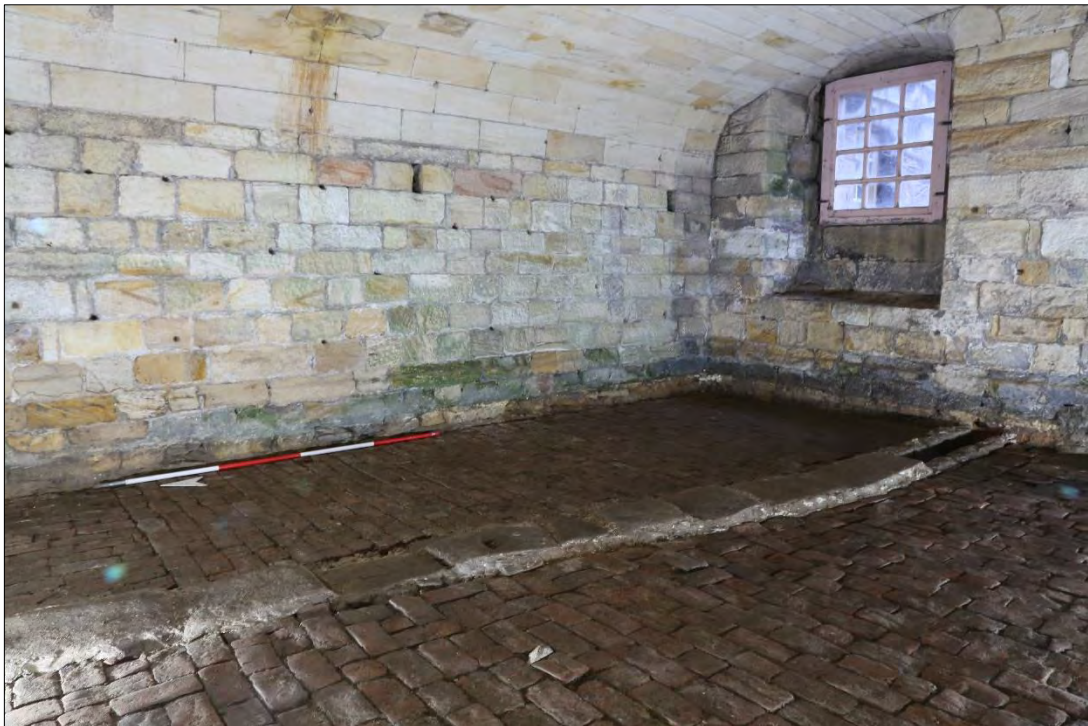
Plate 97: southern extent of drain 134, showing stone walls and brick surface 133.

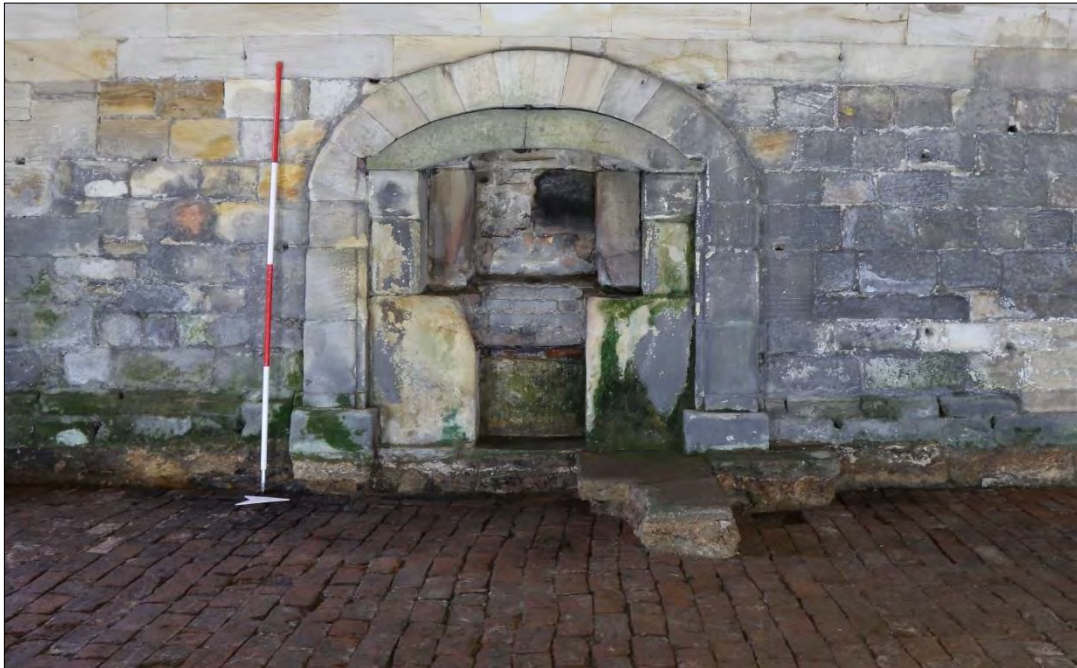
Plate 98: brick surface 133 at foundation level, with the remains of infill 135 visible under flagstone floor 132 and fireplace 213; facing south-west.

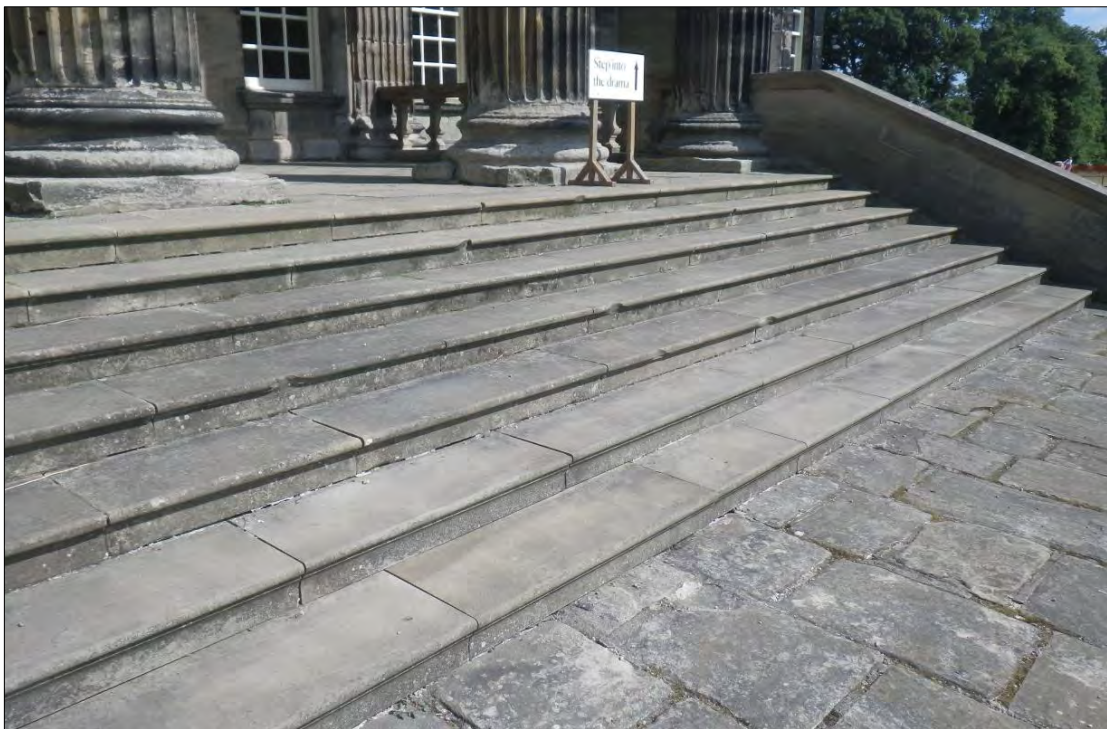
- 9.68 Both sets of stairs had been extensively repaired probably by Lord Hastings in the 1950s/60s, during which the original sandstone flags had predominantly been replaced by cast-concrete pavers.

Plate 103: pre-intervention survey of the portico steps showing cast-concrete pavers of the upper flight and flagstones of the intermediate half landing.

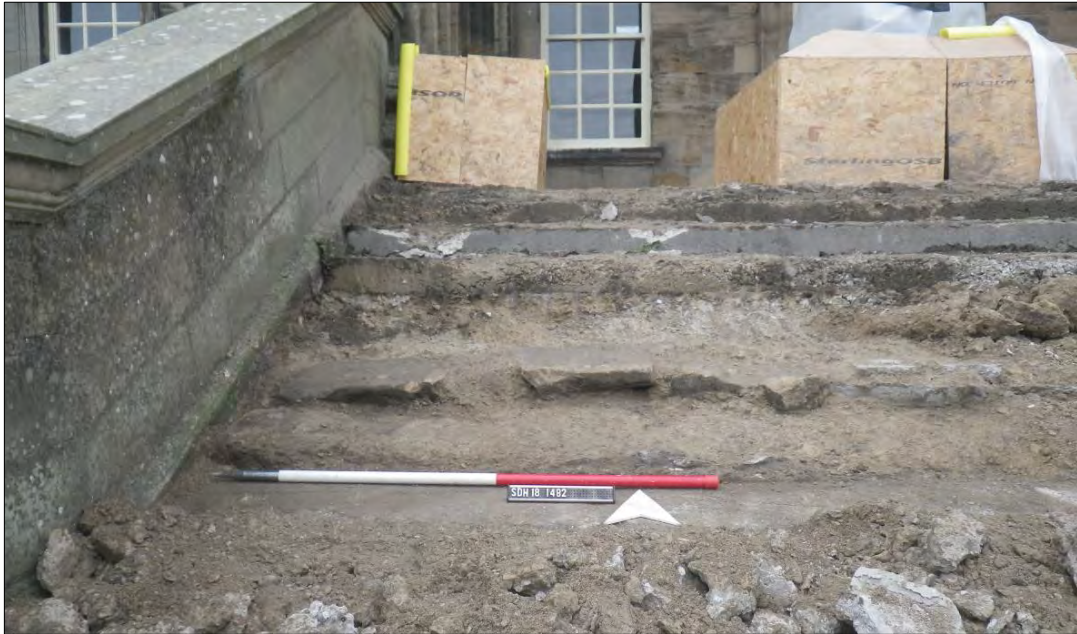
- 9.70 Several monitoring visits were made during the dismantling of the south portico steps in July and August 2019. Initially the concrete pavers were removed from the principal flight and the upper landing, revealing the concrete risers beneath. These were removed to reveal fragments of the original sandstone risers preserved beneath, although badly damaged.
- 9.71 The flagstones on the landings were also set in concrete, beneath which was a layer of cement mortar above a yellow-sand bedding layer (Plate 104). Below this was a mixed-rubble sandstone infill that formed the superstructure of the feature. Fragments of dressed

Plate 104: principal flight of the south portico steps during excavation with the remains of the original sandstone risers exposed.

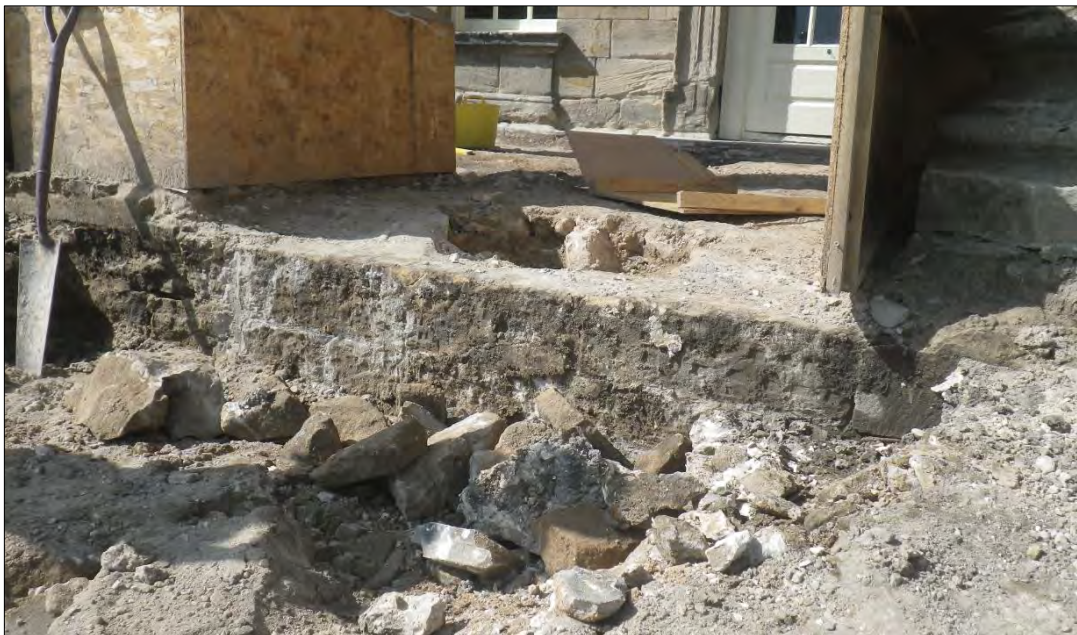
sandstone were evident in the fill, some of which from their dimensions were part of the original steps, while others were possibly demolition debris from an earlier structure. No diagnostic pieces of moulded stone or tracery were recovered. The original masonry sandstone risers of the upper landing were exposed during the works. These were set in finely jointed even courses, and measured c.0.6m by 0.35m (Plate 105).

Plate 105: south face of the original upper landing riser exposed during excavation with rubble from the infill visible in the foreground.

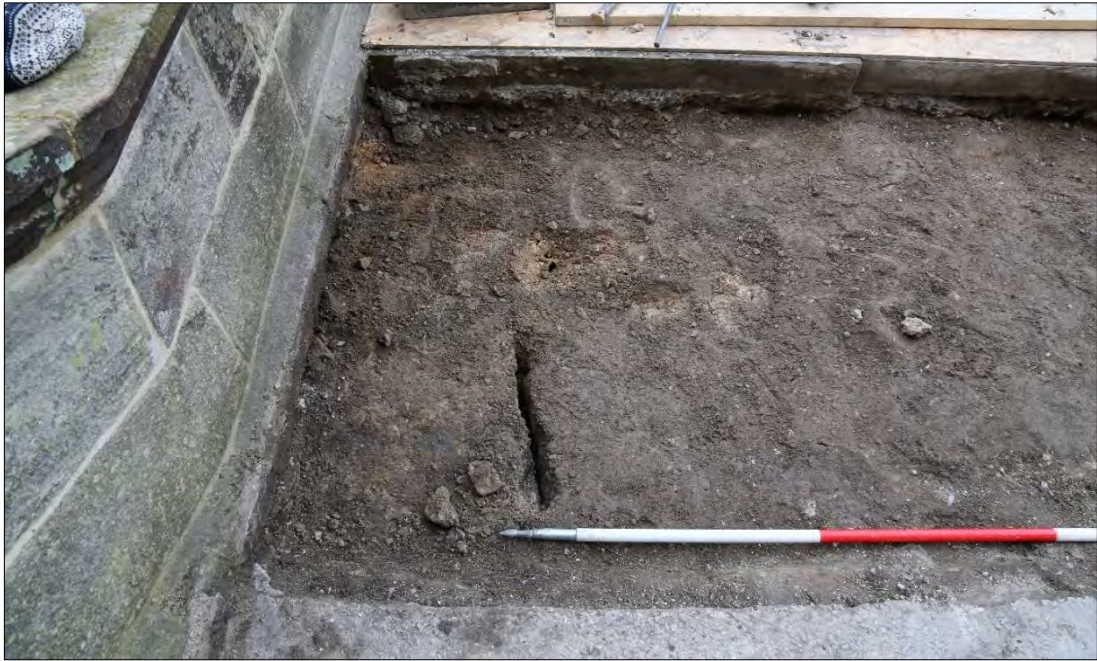
Plate 106: sand-covered masonry, with one of the joints of the masonry visible.

- 9.73 The steps were similar in construction to those of the south portico. A sandy bedding layer was visible extending across the half landing, below which was a sandy layer overlying the rubble infill (Plate 106). Only the surface of the infill was exposed at the time of the visit. Above the sandy bedding layer was a layer of cement mortar into which the concrete pavers had been set.
- 9.74 The risers were constructed of shuttered concrete, overlain on a sandy bedding layer (Plate 106).
- 9.75 No finds were identified during the monitoring.

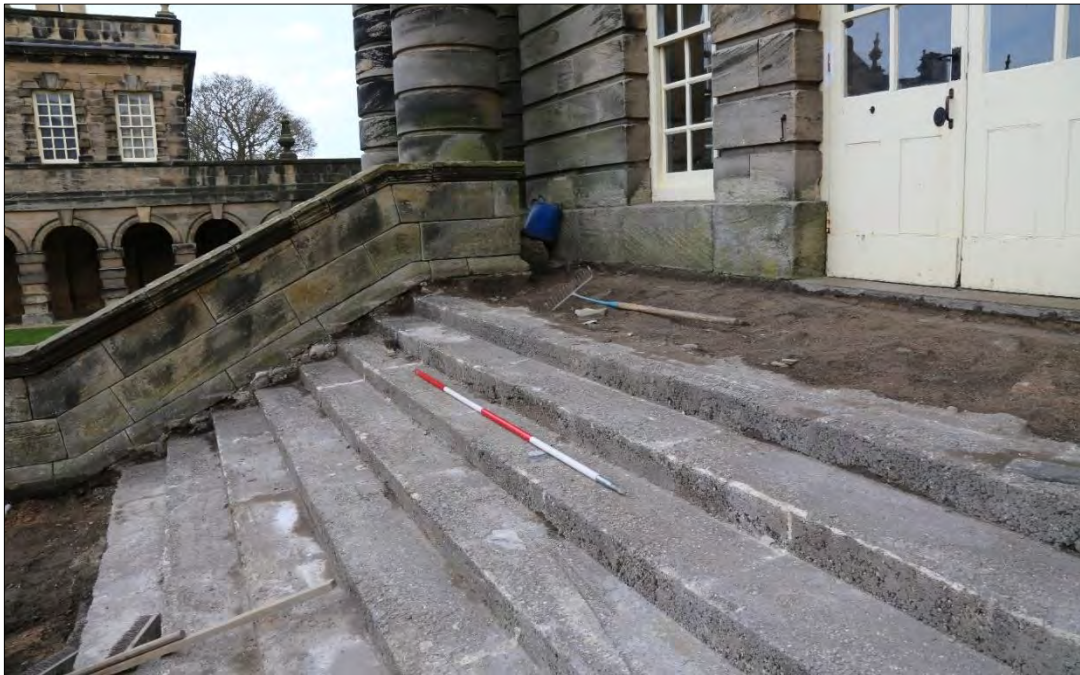
Plate 107: concrete risers of the upper landing.

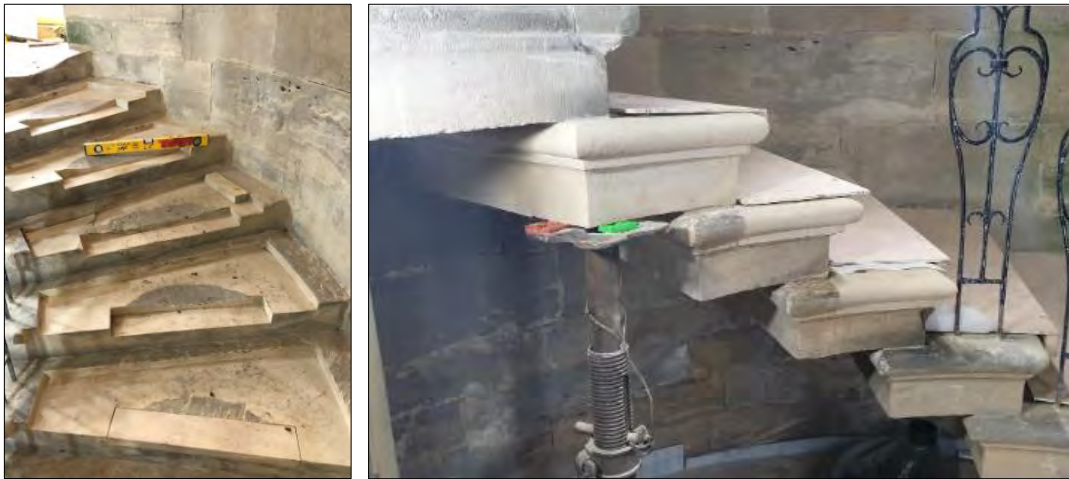
Plate 108: primary and secondary indents in west stairs. Image provided by HPR.

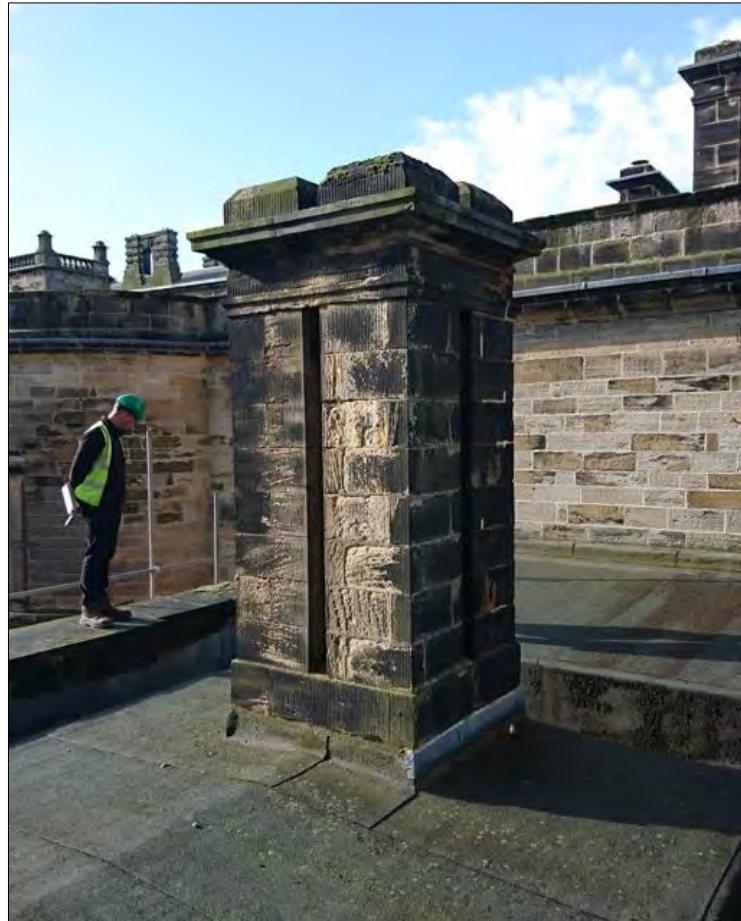
- 10.13 The Carriage House roof was covered with felt of unknown date that had reached the end of its serviceable life and urgently needed replacement (Mosedale Gillatts Architects 2017c). It was divided into two sections of unequal size by a brick cross-wall, set with a single chimney (Plate 111; Fig.15). The eastern section was the larger and comprised a shallow-pitched, felt-covered roof, with a broad drainage channel running along the two long sides (Plates 112 and 113). These vented into a flat 'sump' area west of the chimney to be discharged via an internal drainpipe. The gable, and pitch of the roof was concealed by the parapet, creating the impression of a flat roof when viewed from the ground, in-keeping with the classical style of the architecture.
- 10.14 The western section comprised a smaller flat roof with an east-sloping rake.

Plate 111: Carriage House chimney, looking west. Image reproduced by kind permission of Mosedale Gillatt Architects.

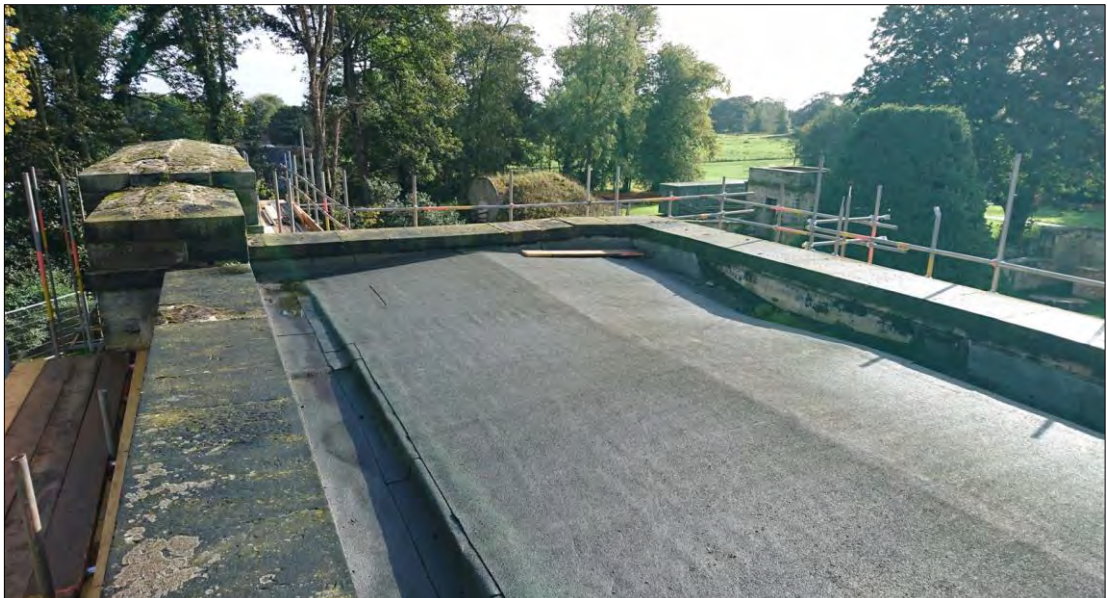
Plate 112: east roof of the Carriage House looking east, showing the shallow-pitched gable hidden by the parapet, and two flanking drainage channels. Image reproduced by kind permission of Mosedale Gillatt Architects.

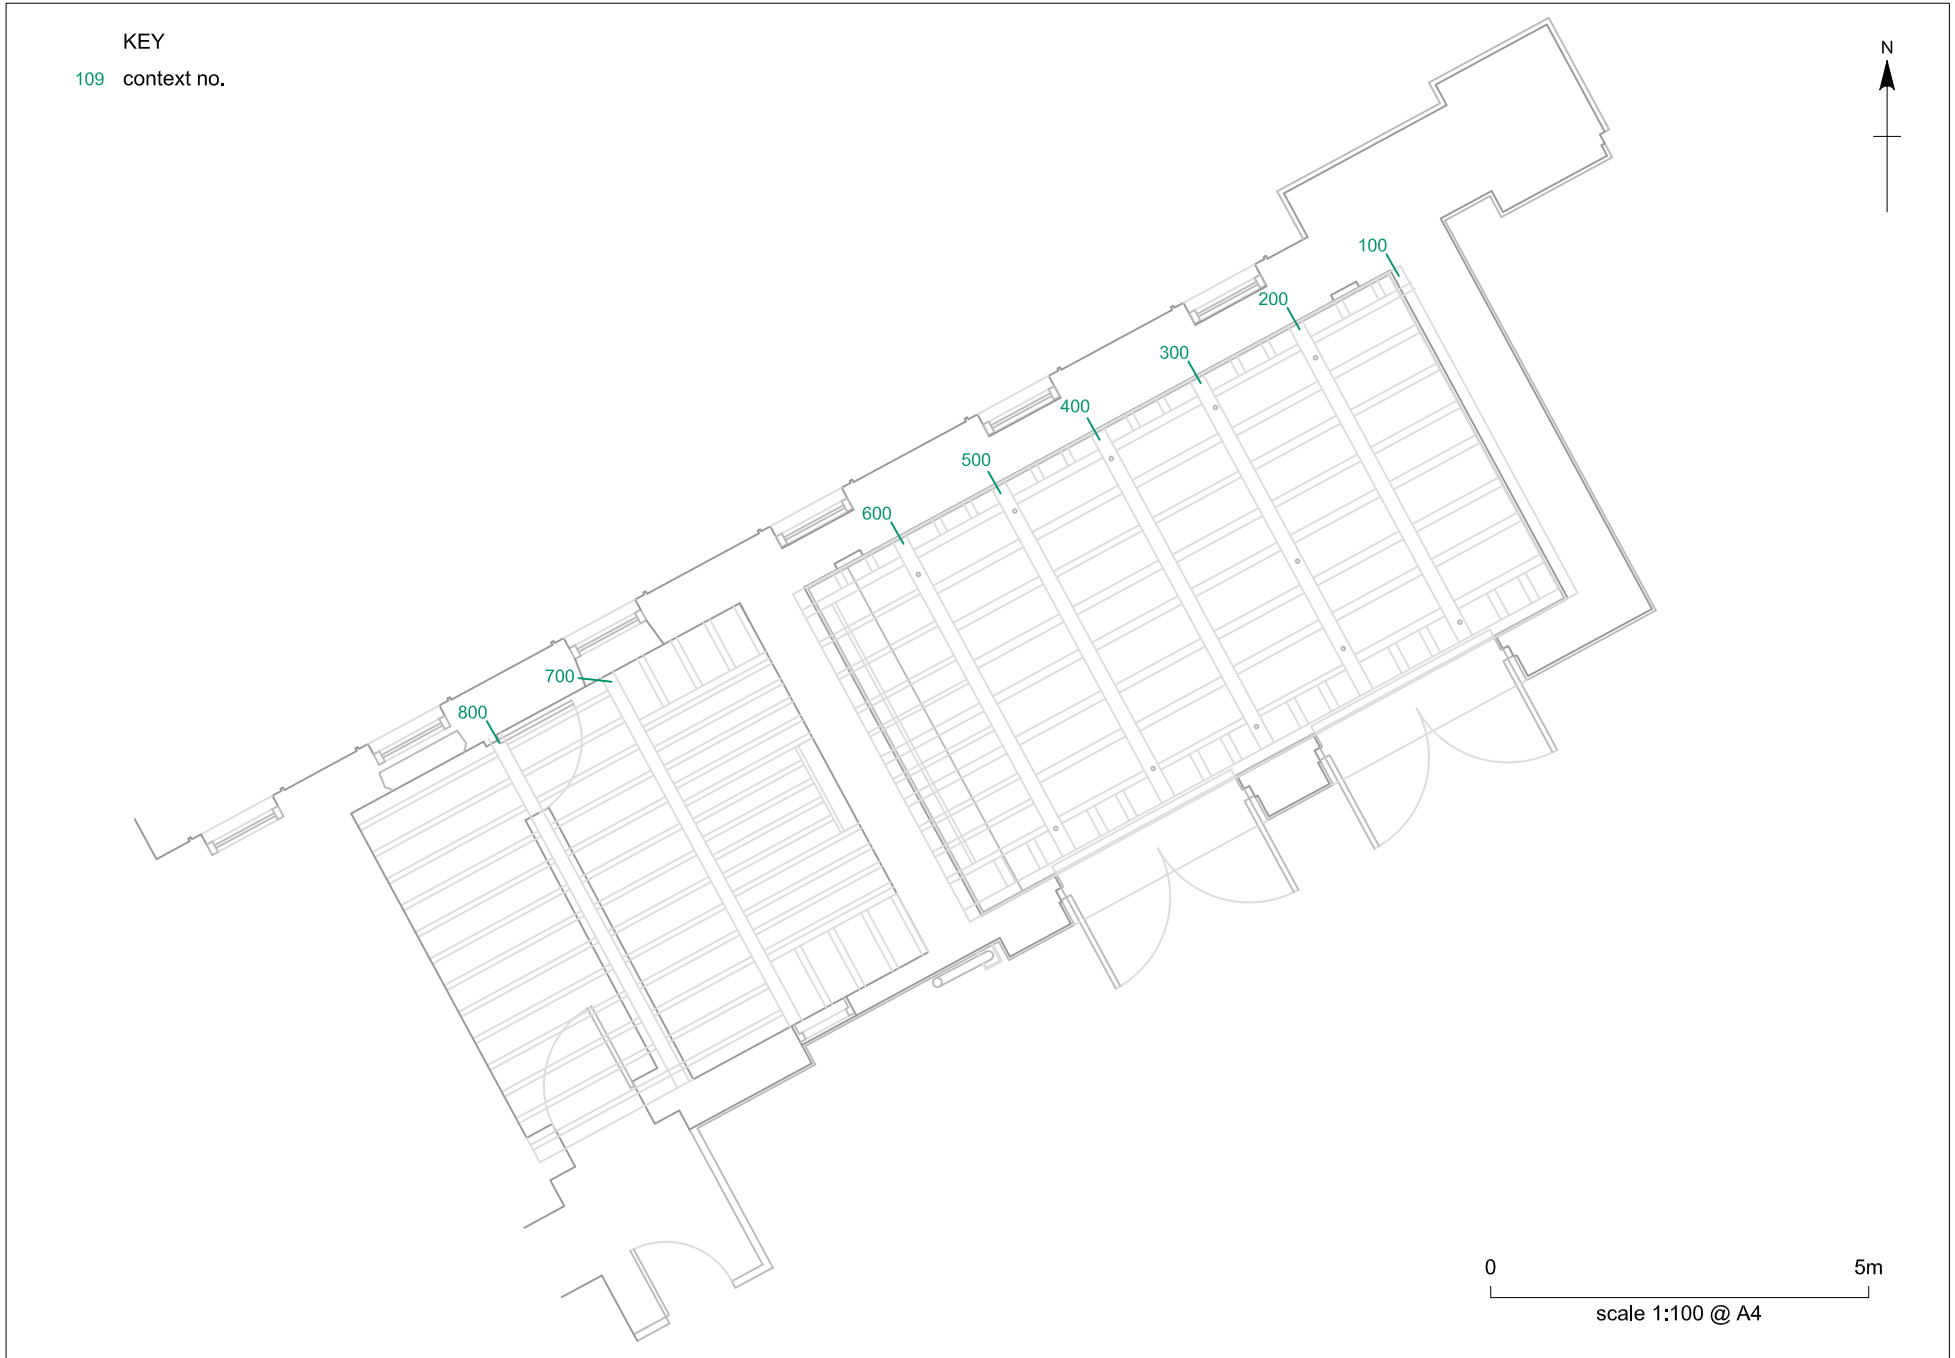
Figure 15

- 10.15 Access to the east roof was provided in January 2020. The east roof structure comprised six shallow principal rafter trusses (100–600) (Fig. 15). Trusses 200 to 600 comprised two horizontal tie beams (each 0.09m wide) clamped together at the centre by a metal bracket and set into the wall plate. The two principal rafters were joined together by two iron braces, set into the centre of the tie beams to form an apex. This was held in place by a large iron bolt. This tension of the ironwork supported the truss. Six short timber hangers were between the tie and rafters to maintain stability.

- 10.17 Eight purlins notched into the rafters ran from truss 100-600. The west bay of the roof (west of truss 600) featured eleven purlins connected with a truss on the opposite side of the chimney, forming part of the west roof. Each truss was spaced at roughly 1.3m intervals with purlins spanning across. These were c.0.09–0.15m in width and spaced between 0.4m and 0.5m apart (Fig. 15).

Seaton Delaval Hall: plan of Carriage House roof showing truss numbers

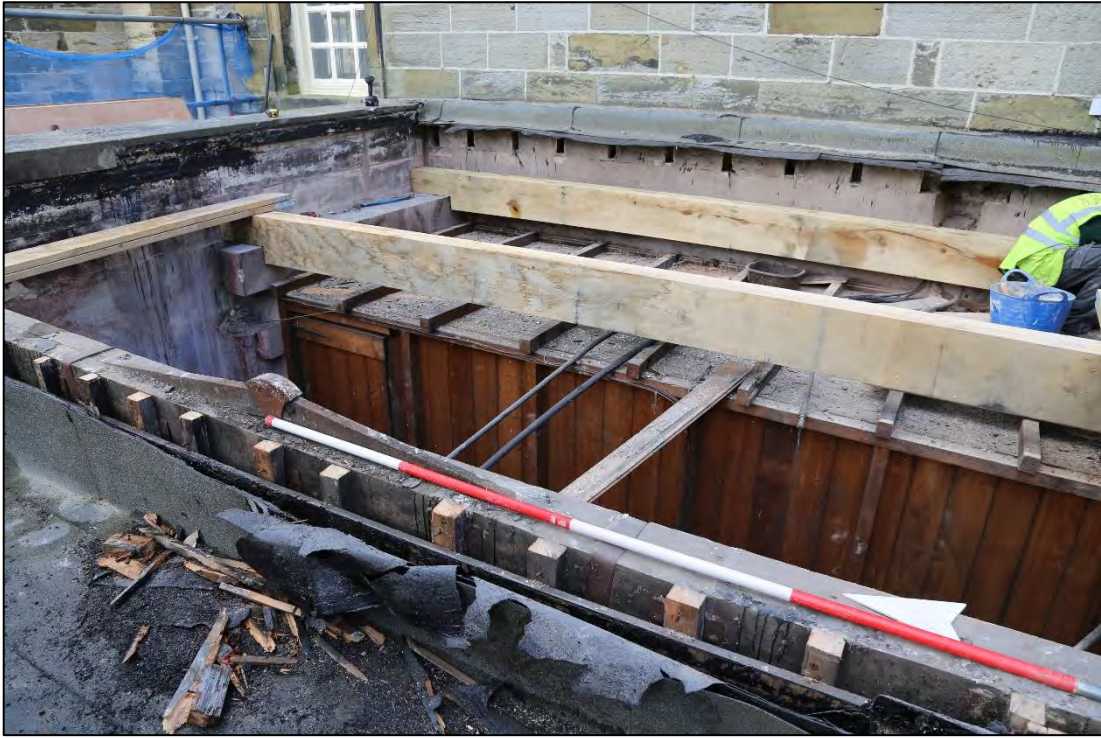
- 10.20 The east truss (700) was also set with 13 purlins, although these were spaced closer together than on the west side. Rather than resting on the top of the truss, as was the case elsewhere, these were held by ties attached to the east side of the truss (Plate 115). This modification in design was to accommodate the chimney. On the east roof, the chimney was straddled by nine purlins, five on the south side, four on the north. These were evenly spaced along the length of the roof, set between the wall plate on the south side and the masonry on the north side (Fig. 15).

Plate 115: east side of truss 700 with the purlin holes visible in the masonry to the rear.

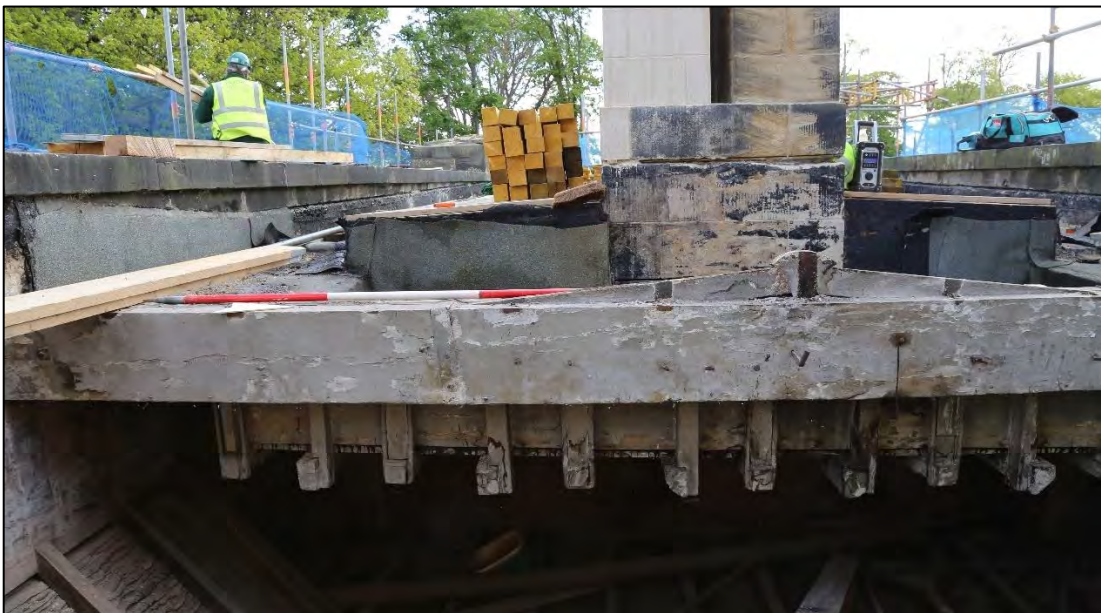
Plate 116: truss 700; looking east with the purlins visibly supported from the truss above.

10.21 The purlins and sarking boards were examined after their removal. Some of the sarking boards had been adzed to sit more snugly on the purlins, which in turn had been shaped to fit the trusses. The profile of the cut (Plate 116) reflected the shape of the truss, comprising a cut of about 0.09m for the first tie beam next to a shorter deeper cut for the iron clamp (Plate 117).

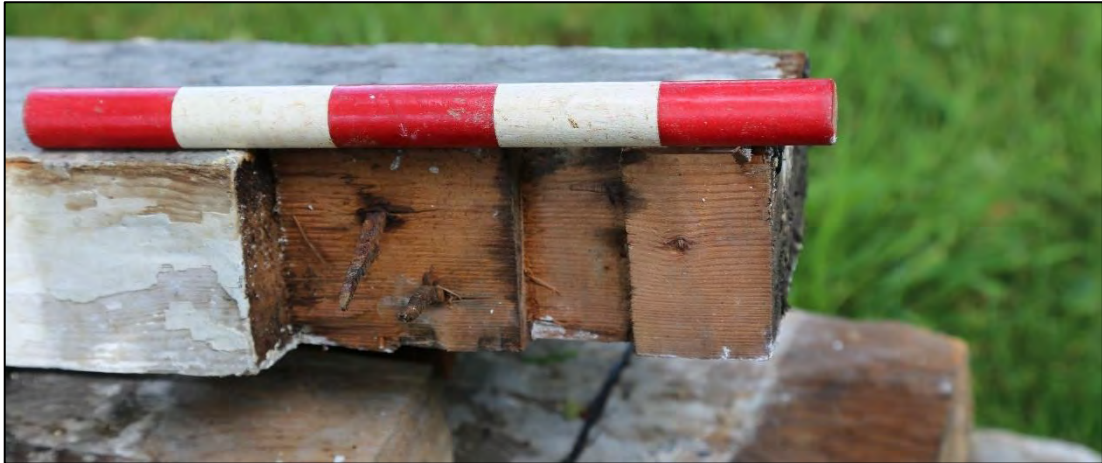
Plate 117: purlin cut to accommodate trusses with a deeper cut for the internal iron clamp.
