THE HALL

ARCHAEOLOGICAL
INVESTIGATIONS

NATIONAL TRUST
SEATON DELAVAL HALL
NORTHUMBERLAND

NAA 21/66
July 2021

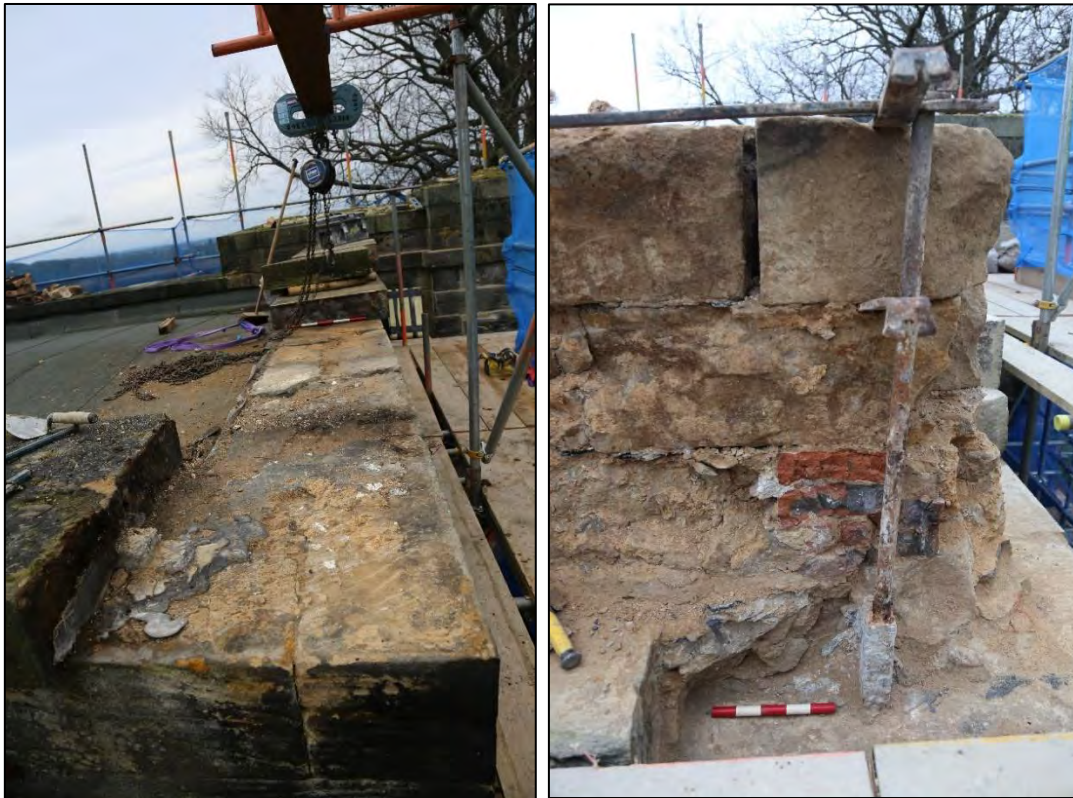
Plates 118, 119: (left) looking north, the removal of the coping stones along the eastern side of the building; (right) iron beam, pin, and brackets revealed behind masonry.

- 10.24 The masonry on the south-west corner was also removed over the course of consolidation works, beginning with the parapet. This comprised a course of large coping stones that projected 0.06m out from the face of the wall below. The coping stones were 0.17m thick and 0.73m wide on the east wall, and 0.79m wide on the south wall. Below the coping stones the main fabric of the wall was exposed, comprising an inner and outer leaf of stone set with lime mortar, with no inner core material between (Plate 118).

- 10.25 Below the coping stones on the south wall was an RSJ which ran the whole length of the building. It was joined with a tie that ran down into the masonry and was attached at each level of stonework to a large metal clamp inserted into the stone (Plate 119). The support structure terminated at the sixth course of stone in a large clamp (Plate 120), which held in place another RSJ that also ran the length of the building, extending across the top of the three stone-arched doorways (Plate 121). The concealed steel framework was probably the product of early 20th-century repair work which, ironically, had itself resulted in structural instability.

- 10.23 Several monitoring visits were made between January and May 2020 during high-level repairs to the stonework of the Carriage House. The repairs principally involved replacing damaged masonry on the south-east corner of the structure which had moved significantly out of alignment projecting the south wall forward. Large horizontal cracks had formed in the stonework revealing concealed ironwork, the erosion of which was exacerbating the problem, placing the roof structure at risk from rot (Mosedale Gillatt Architects 2017c). To remediate the situation the outer ashlar facing stones and inner brick leaf on the south-east corner were dismantled, the iron clamps removed and the structure rebuilt. Prior to dismantling, the masonry was recorded and numbered by layer (1–12) in the order of their removal so they could be correctly reinstated.

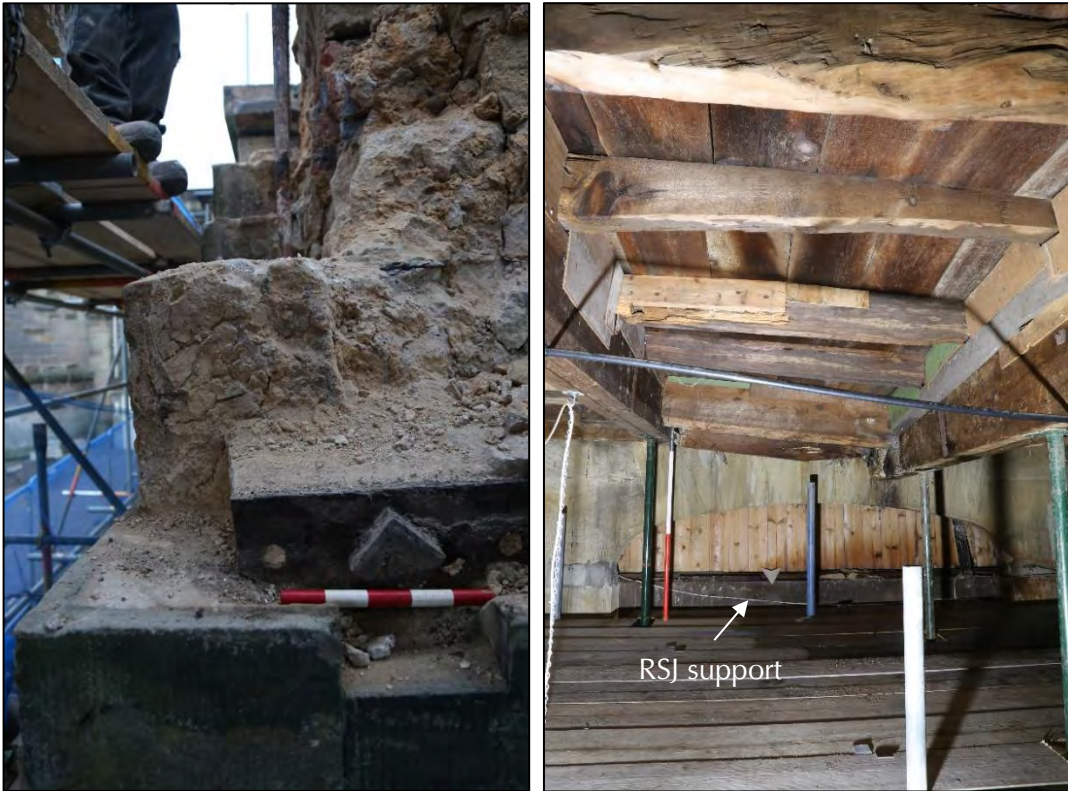
Plates 120, 121: (left) iron bracket tied in the masonry; (right) view of the inside of the carriage house looking south.

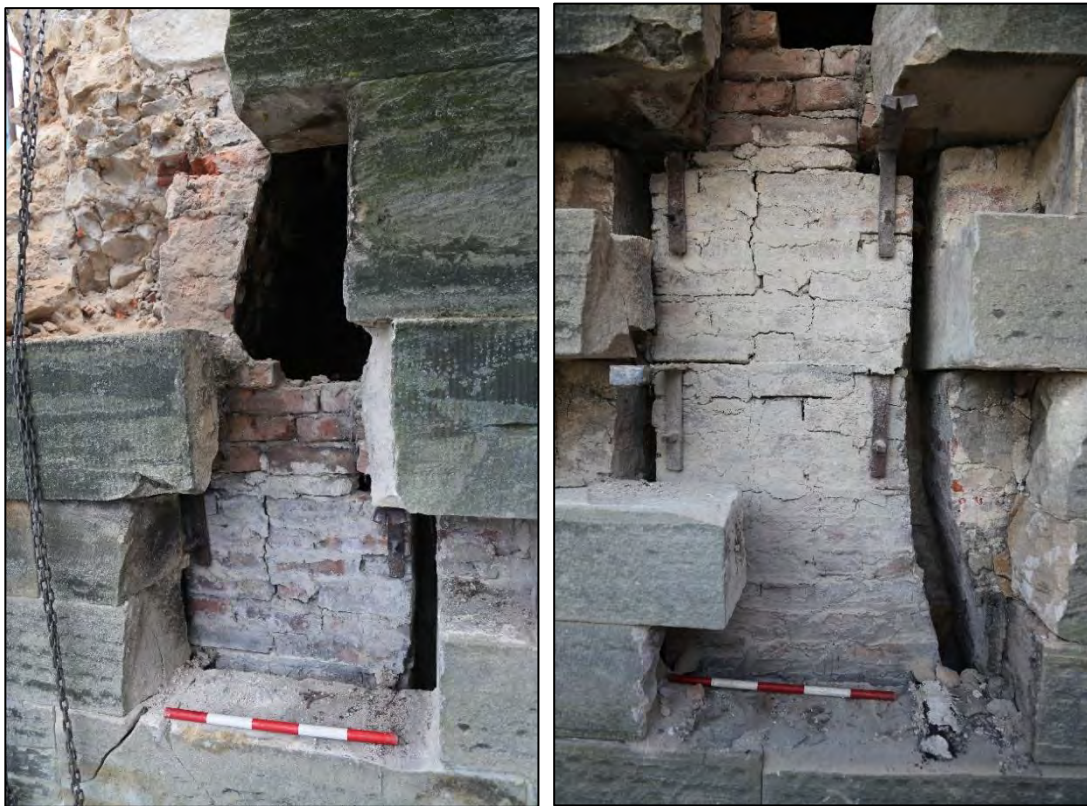
Plates 122, 123: (left) cavity visible at the top of the chimney; (right) the chimney tapers out near the base of the wall and was tied to the masonry through iron brackets.

10.26 Further north along the east wall, a large cavity was uncovered associated with a brick flue (Plate 122). This was tied into the masonry by large iron clamps. The flue was constructed of red handmade brick and was c.0.5m at its widest point, tapering out near the base of the wall (Plate 123). At the time of survey the Carriage House was being used for storage and there was no access to the interior to look for evidence of a hearth; however, the architect's drawings show no such feature surviving *in situ*. The feature therefore likely dates to the early 19th century construction but was later blocked.

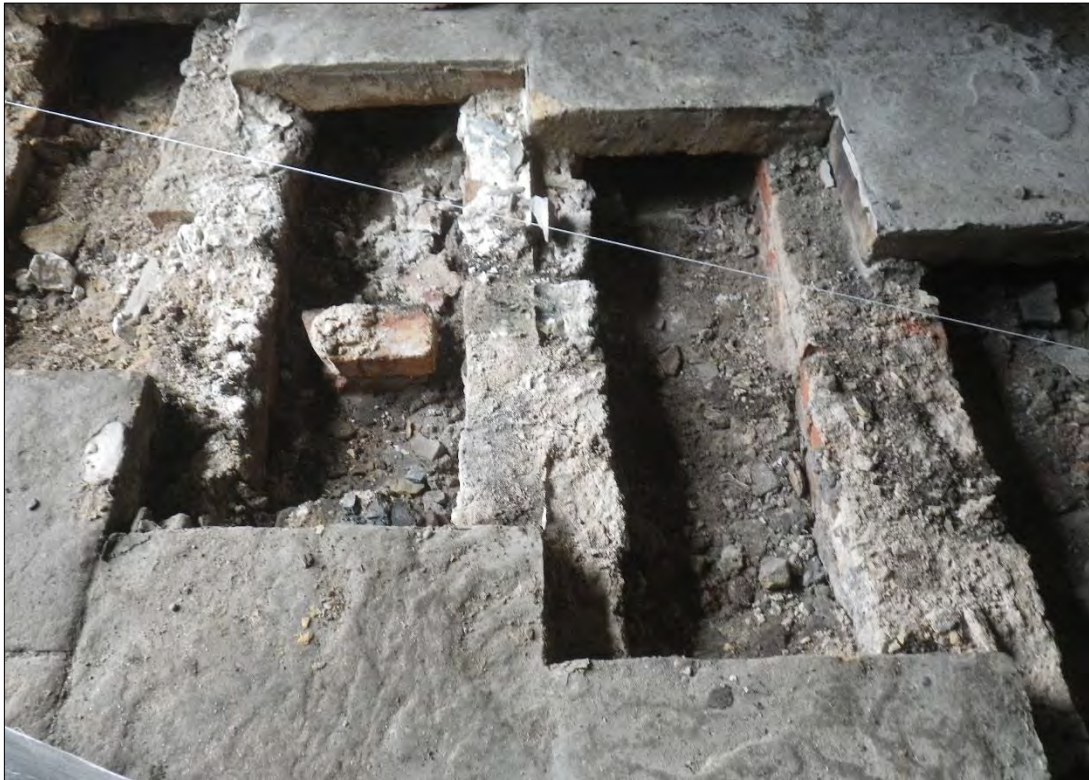
10.29 Removal of the flags along the length of the proposed trench revealed a series of brick plinths (170) measuring 0.24m wide and 0.14m deep, which were set 0.32m apart acting as supports to the stone floor above. The bricks were red-orange and unstamped, the dimensions were 0.22m by 0.11m by 0.06m and bonded with a creamy-white mortar (Plates 124 to 126).

Plate 124: brick support structure 170 after lifting of flagstone floor 169.

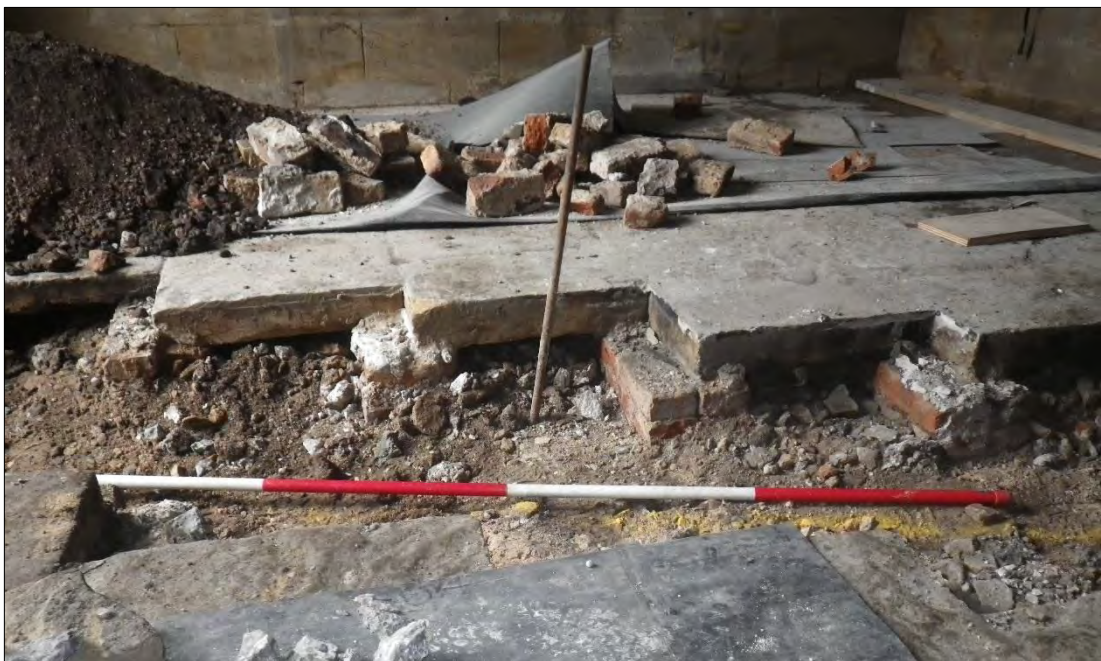
Plate 125: Carriage House floor structure; looking north-west.

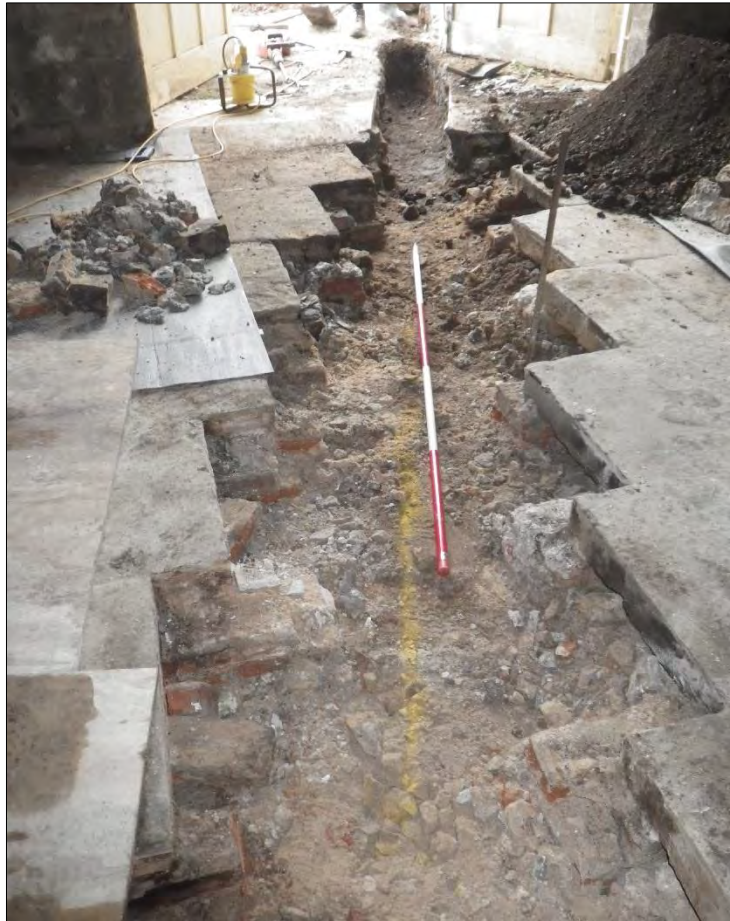
10.30 Portions of the brick supports along the length of the ducting were removed and the modern concrete door-sill was cut through with minimum excavation of the underlying ground surface (168). This consisted of compacted ash and black silty sand typical of the ground make-up of both the kitchen and stable yards.

Plate 126: interior of the Carriage House after removal of flagstone floor 169 and brick supports 170, with the service trench cutting courtyard soil 168 in the doorway.

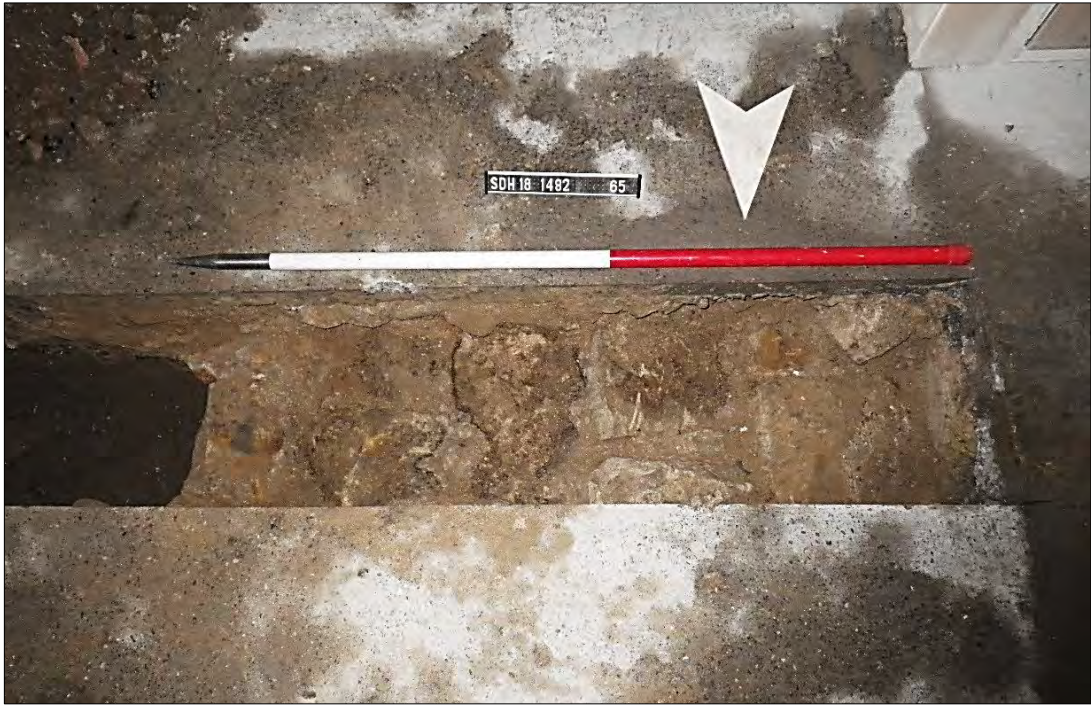
- 10.33 The modern concrete surface of the passageway was cut, exposing a mortared sandstone feature (65) immediately beneath. This was situated c.7.5m west of the external east wall, running north-west to south across the passage on the same alignment as the doors between the central stables and south block. The feature was hand cleaned and a section excavated on the east side to a depth of 0.45m. It was found to be a substantial stone culvert with arched roof and was presumably the same as that identified in the 2017 excavations, running through the centre of the East Wing (Plate 127).

Plate 127: upper surface of culvert 65 directly beneath the concrete floor surface in the passage between the central stables and south block.

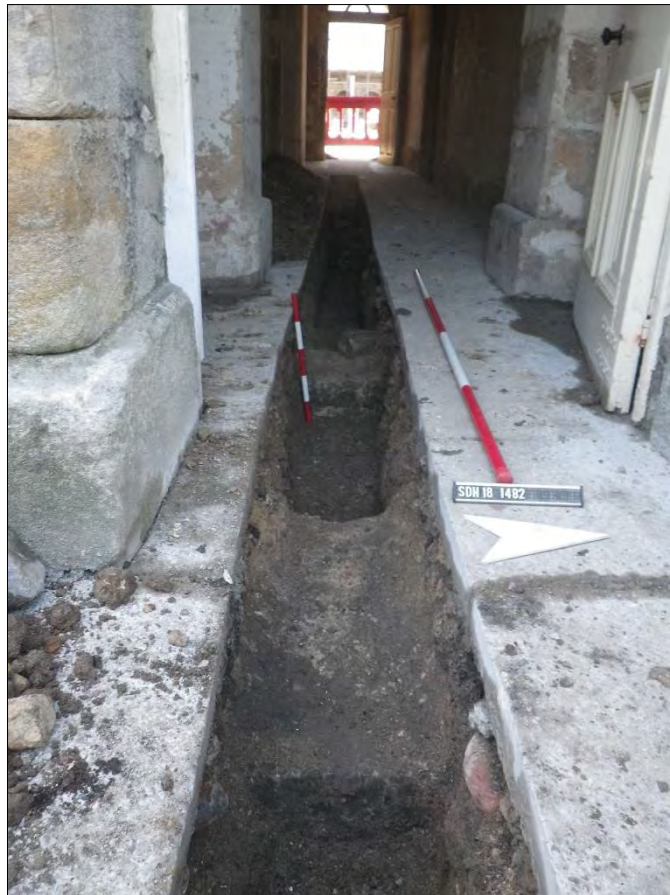
Plate 128: wall foundations 66 beneath the passage between the central stables and south block.

10.34 At the eastern end of the trench the wall footings of the East Wing (66) were exposed spanning the two easternmost openings. These were each c.1m wide and comprised two outer faces of dressed stone infilled with a heavily compacted crushed sandstone core with small clay lenses (196). The upper surfaces of the footings lay 0.25m below the concrete floor. The bottom of the foundations continued at a depth greater than 0.45m, which was the required depth of the service trench, and were therefore not exposed (Plate 128). The continuation of the foundations between the two openings is odd but there was no evidence that the passageway was a later modification. It might suggest a change of design after construction began, or simply it was considered more prudent to run the foundations along the full length of the building without variations to accommodate openings.

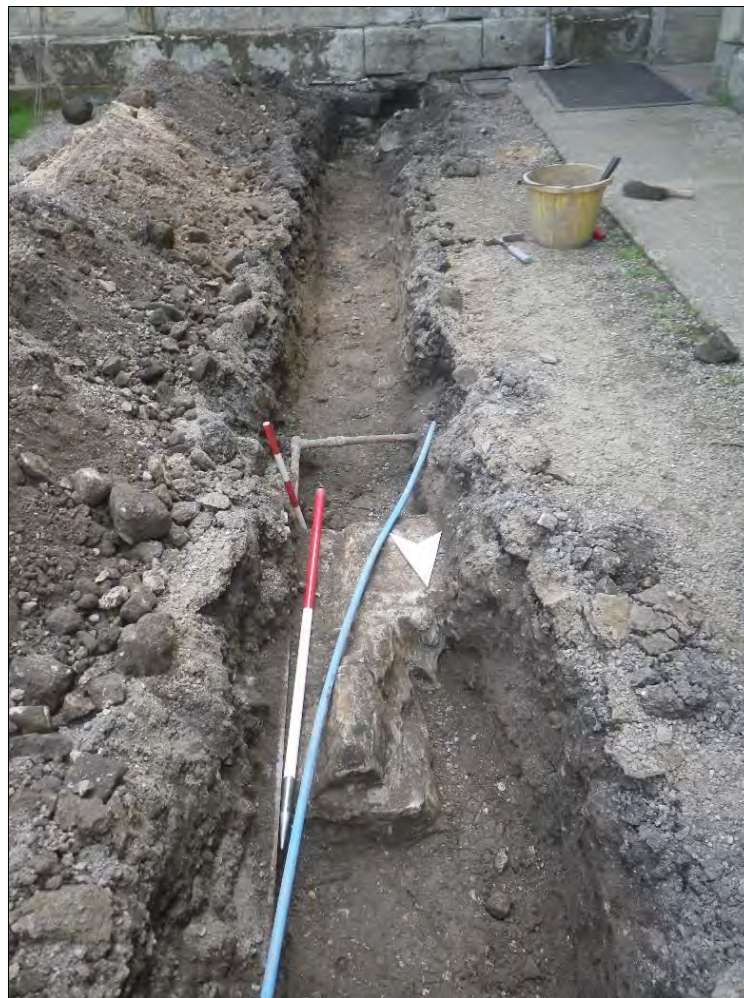
Plate 129: wall foundation 64 in the electrical ducting trench with the south wall of yard in the background.

existing ground surface. This ran parallel to the south wall of the stable yard (Plate 129) (197), located c.5.4m to the north. The wall was similar in construction to the two foundation walls (66) previously described and constructed of heavily mortared sandstone blocks, surviving two courses high, forming a foundation 1m wide with a relatively level upper surface. The wall had been damaged by the insertion of later cast-iron waterpipes. No trace of ashlar masonry was evident above the foundation course although corresponding markings on the East Wing's elevation confirmed the existence of a range extending east (Plates 130 and 131). There is documentary evidence to suggest that this might have been a greenhouse/conservatory or stables (Newman 2017a; Simpson and Brown Architects 2017) (Figs 4 and 14).

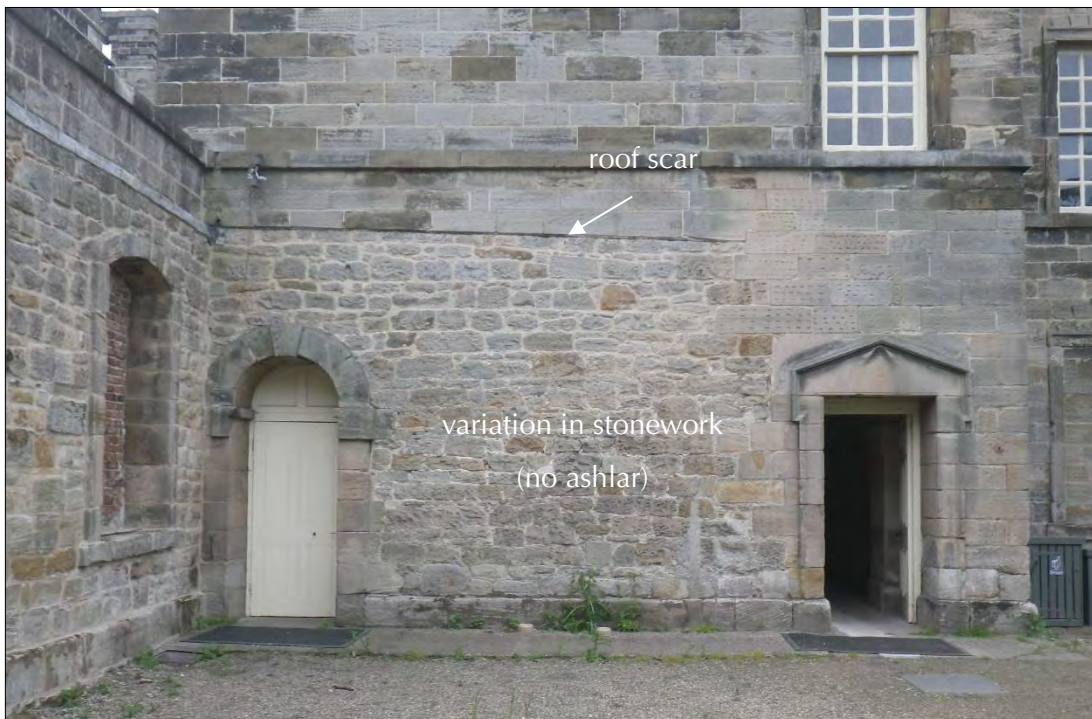
Plate 130: east-facing wall profile with traces of the former south range.

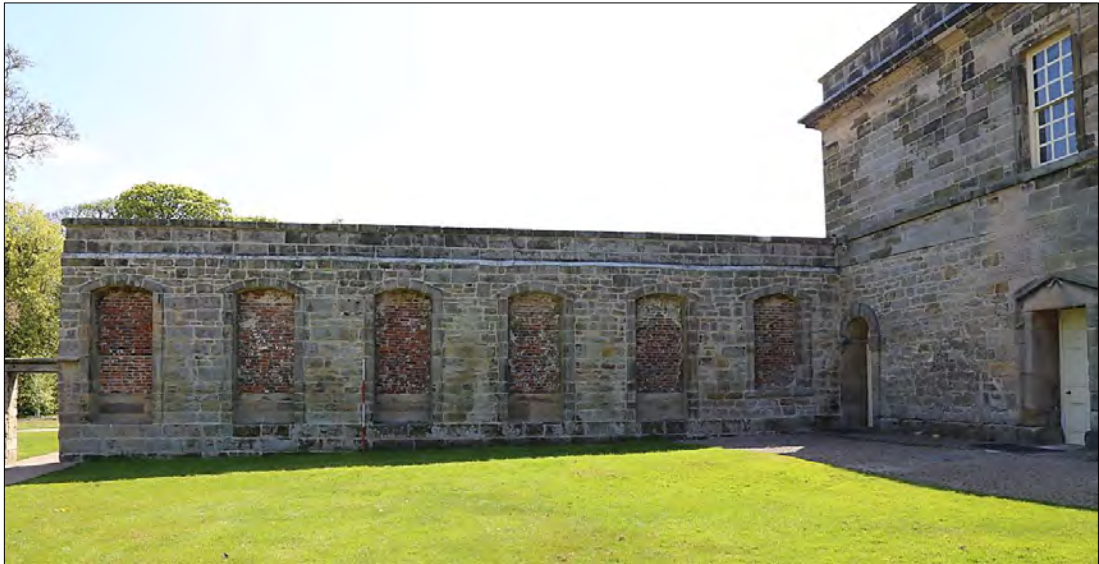
Plate 131: north- and east-facing internal elevations of the missing range on the south side of the stable yard.

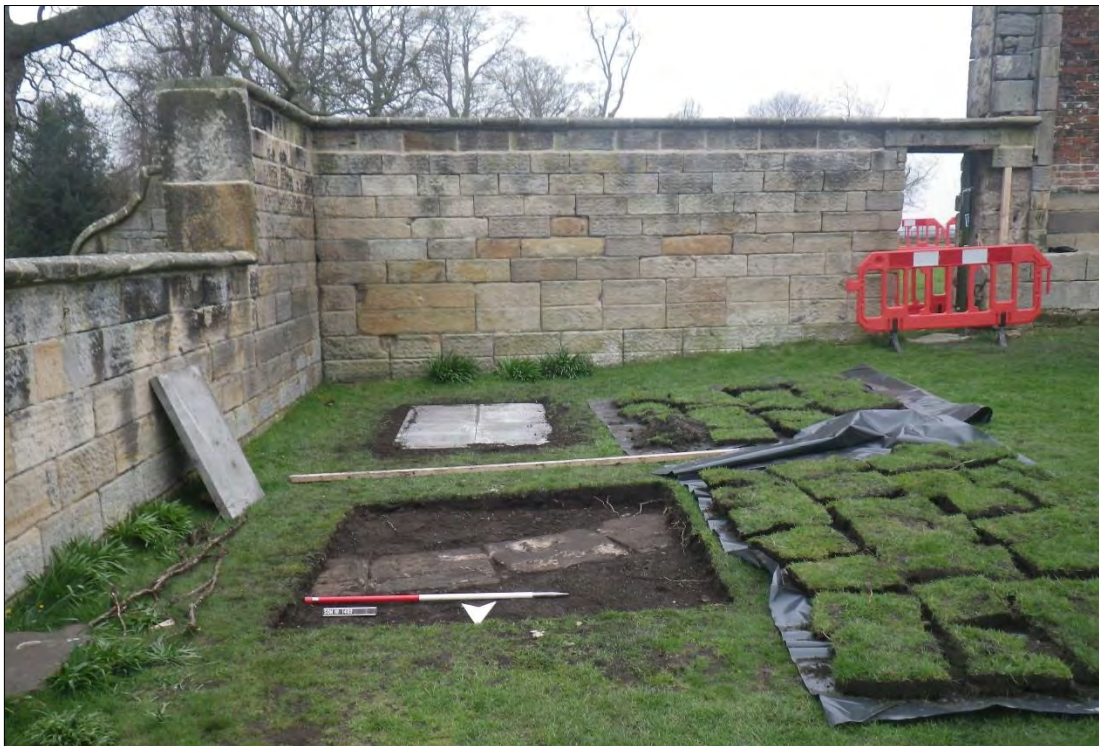
Plate 132: low kerb or boundary 56 directly below the turf in the south-east corner of the yard, facing south.

immediately under the thin covering of turf. The slabs were up to 0.15m thick, 0.55m wide and 0.6–0.7m long and formed a low curb with an outer radius of 5.4m, demarcating the corner of the yard (Plate 132). It bore no resemblance to any other of the flagged areas typical of the Hall and there were no traces of mortar bonding or any other structural remains evident above the slabs. As such, **56** was interpreted as the boundary of a flower bed or parterre rather than a free-standing structure. This feature appears in LC19 EC20 OS coverage.

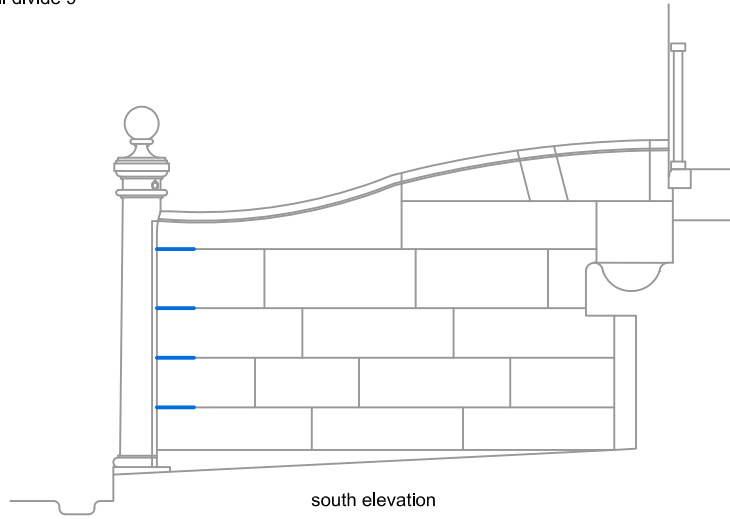
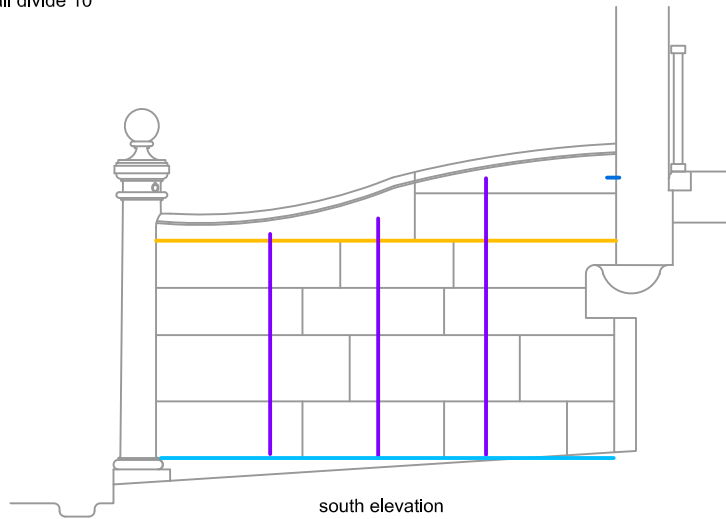
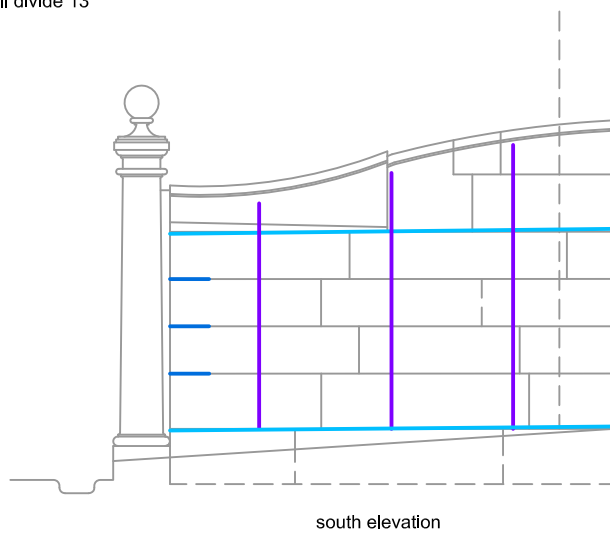
- 10.41 All stall dividers were of very similar construction, with slight variations in internal support (Fig. 18). Each was 2.37m long, 0.14m wide and 1.59m tall at the wall. They were built of seven courses of ashlar sandstone, with a curved and moulded top course. An outer timber shutter on each side of the stall wall provided additional warmth and protected a horse from damaging itself on the stonework. The timberwork encased the stone superstructure which was carefully dismantled block by block and laid flat on the ground adjacent to its former position so it could be accurately rebuilt once repairs had taken place.

- 10.40 Six of the dividers (**S01**, **S04**, **S08**, **S09**, **S10** and **S13**) had been identified as unstable and required dismantling and repair as part of the conservation works (Mosedale Gillatt Architects 2017c). Divider **S01** had already been dismantled and recorded as part of the Phase I works (Solstice 2017b). Three of the other dividers (**S13**, **S10**, and **S09**) were recorded during visits in January and May 2020 (Fig. 17). All of the dividers were of similar construction and, after the final monitoring visit in May 2020, discussions were entered into between the architects and contractors regarding the need to fully dismantle the remaining two dividers (**S04** and **S08**). No further monitoring was requested after this date. A full record had, however, been collected during earlier visits suitable to inform a record of the construction and development of these historic features.

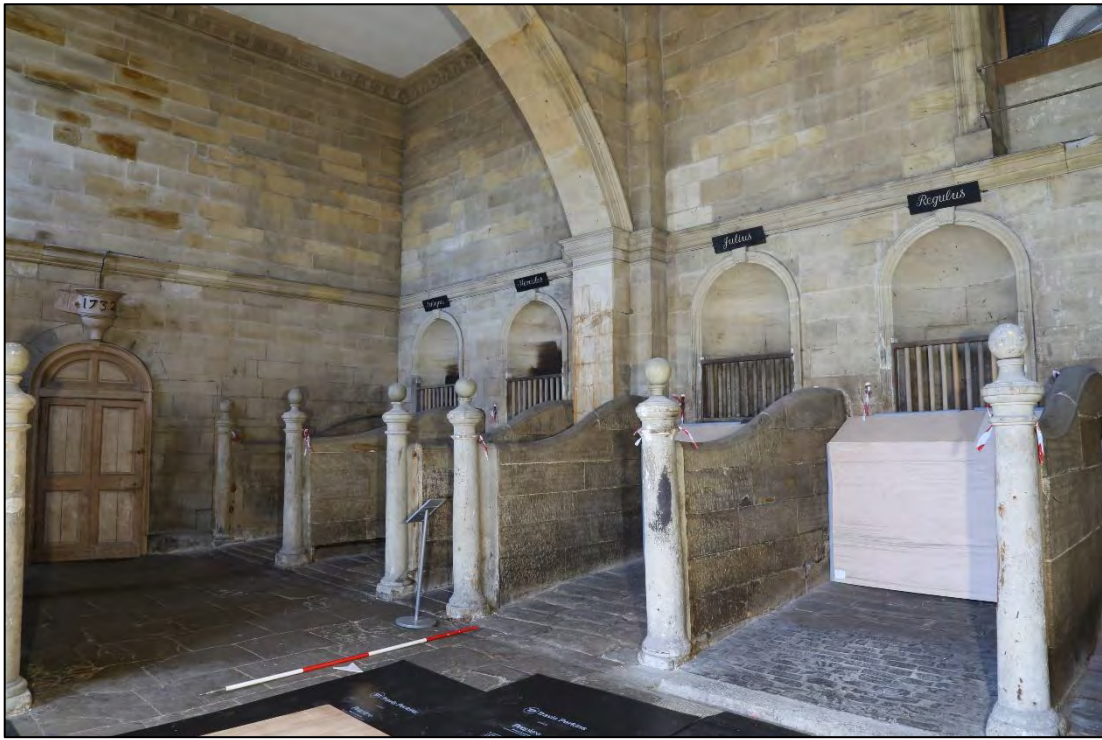
- 10.38 There were 12 stalls in total in the central stables, eight along the west wall and four along the east. Between these were four narrow storage bays (two on each side), each measuring c.2m by 0.85m, used for feed and bedding (Plate 133; Fig. 17). On the rear of each stall was a stone feeding trough built into the wall above which was a hay rack. This comprised a stone arched recess, with central keystone, set with an iron grille at the base.

- 10.39 The 14 surviving stall dividers were built of ashlar which were keyed into timber end posts painted to give the appearance of stone (Plate 133). These were set directly into the ground beneath, through the level of the flagstone floor which remained *in situ* across the south and central areas of the stable. Previous archaeological investigation had established this surface had been extensively re-laid in the 20th century (Solstice 2017b). On the north side of the stables the flags had been replaced by a cast-concrete floor. In the two north-east stalls, the cast concrete featured a chevron design. This is, typically found on stables and is designed to improve drainage into a channel behind the stall.

*Plate 133: stall dividers **S08**, **S07**, **S06**, **S05** and **S04** along the west wall of the stable. The bars of the hay racks in the arched recesses can just be seen.*

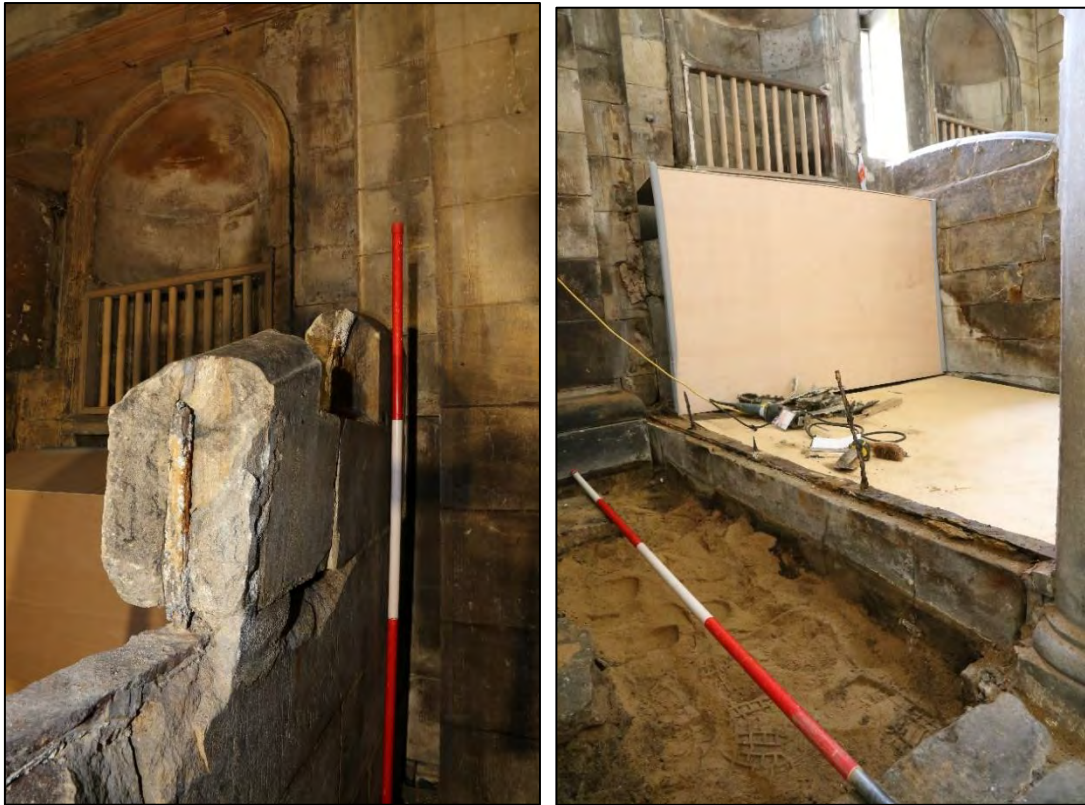
- 10.42 Just below the first course of ashlars in **S013** was a horizontal iron tie bar set in a shallow channel in the masonry. This ran along the full length of the stall (Plate 134; Fig. 18). Evenly spaced along this were three iron pins which fasten the upper bar to a lower bar, set just above the bottom course of ashlars (Plate 135). Holes had been drilled through the masonry to accommodate the iron pins. At the west end, iron clamps on each course pinned the stone structure to the wooden end post.

- 10.43 Stall divider **S10** was very similar in construction but the upper tie had been replaced by a wooden batten and there were no end clamps. However, **S09** had no iron support structure apart from the end clamps (Plate 136).

Plates 44, 135: (left) iron strap found across the upper part of the divider S13 with two of the three vertical iron dowels emerging upwards from the tie; (right) the lower strap near the base of divider S10.

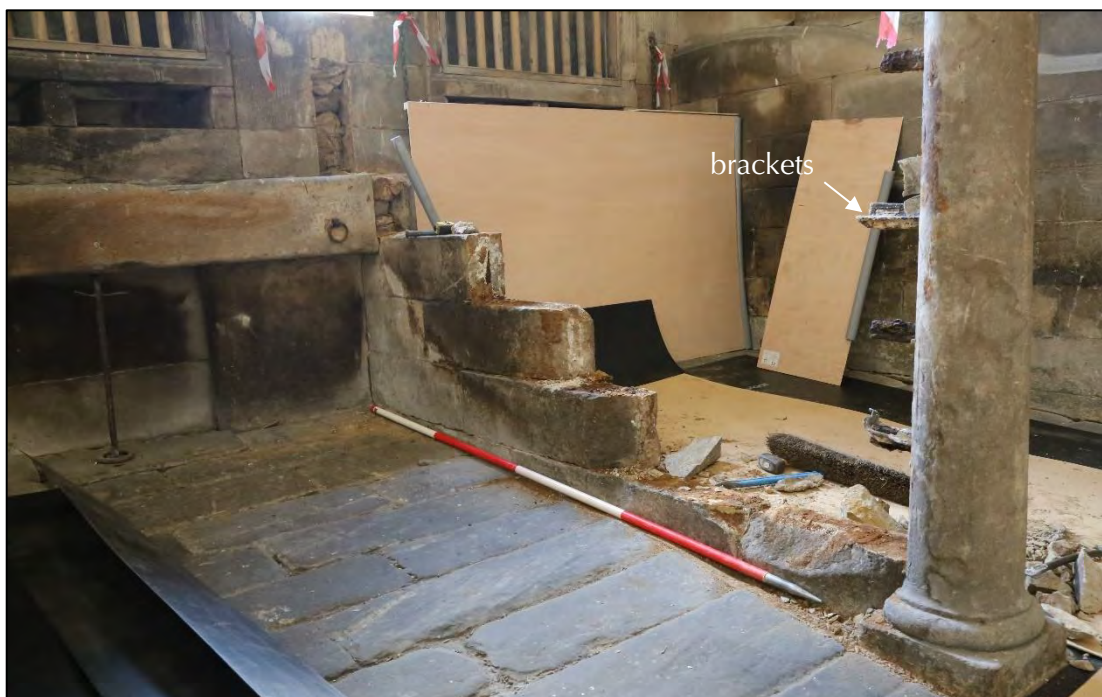
Plate 136: dismantled divider S09; view is south-east toward the trough, with iron brackets visible along the post. The remainder of the divider could not be removed because it supported the trough.

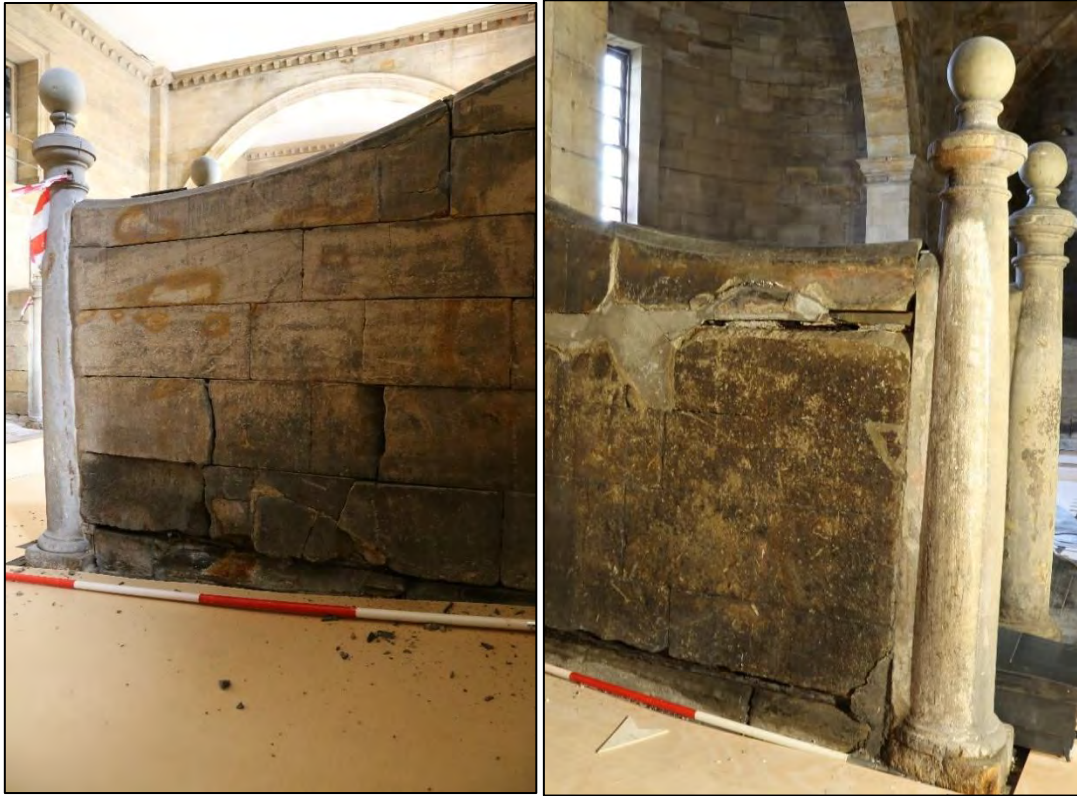
*Plates 537, 138: (left) the masonry of **S10** was cut flush with the stone divider; and (right) timber batten in **S13** filling the gap between the post and masonry.*

- 10.44 The treatment of the end posts varied. At the west end of **S09** the post was designed to sit flat against the straight ends of the masonry (Plate 137), whereas the masonry of **S10** had been cut in a curve to sit flush with the timber end post. Different again, a vertical baton of wood, 0.14m wide, had been inserted between the stonework and the post in **S13** (Plate 138). Some of the timber end posts retained iron rings for tethering the horses.

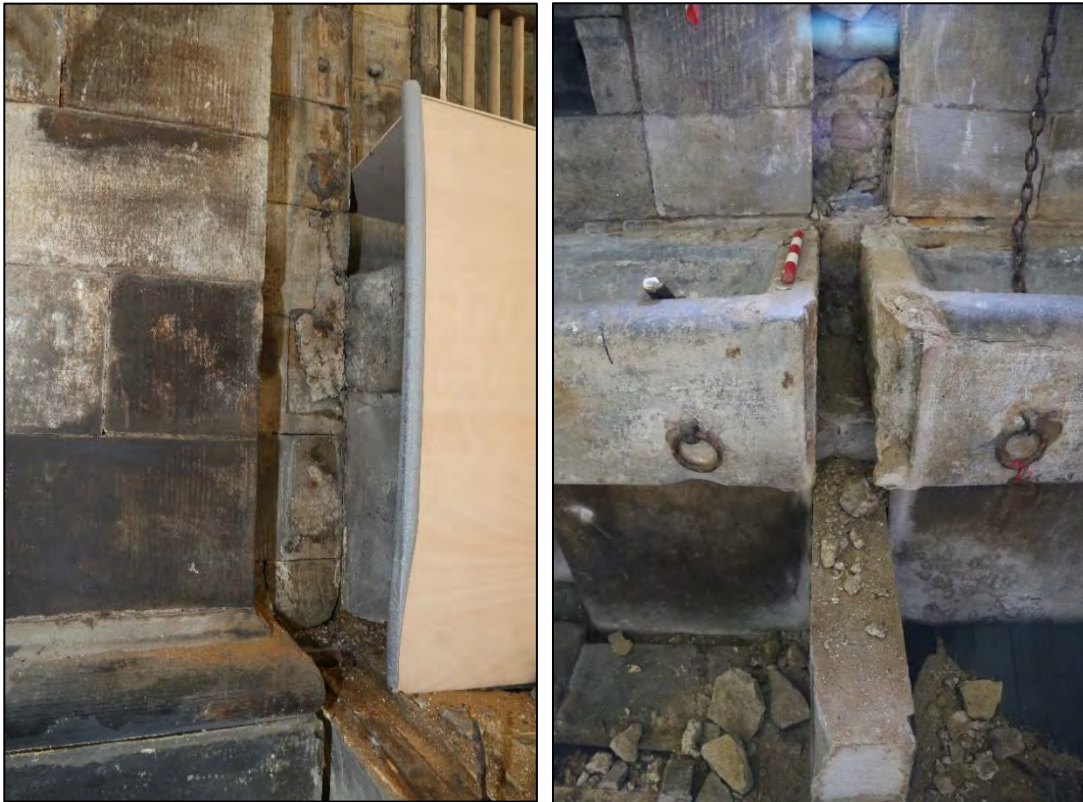
- 10.45 The dividers were set directly into a c.0.15m-deep sandy deposit which also provided a level bedding layer for the flagstone floor (Plate 139). Previous excavation had identified this as being unusually deep, measuring up to 0.25m in places (Solstice 2017b).

- 10.46 Dividers **S13** and **S10** were attached directly into the stone wall through a series of notched joints poured with lead at the time of construction (Plate 136). There were no notches in **S09**, which was set directly into the east wall between the two stone mangers (Plate 140) which would have provided additional stability and may account for the absence of the lead jointing. The inner core of the East Wing walls was visible in the gap left after the removal of the stall dividers, indicating that these were a later modification cut into the earlier fabric.

Plates 139, 140: (left) lead-filled notched in wall of divider S10; (right) troughs on either side of divider S09.

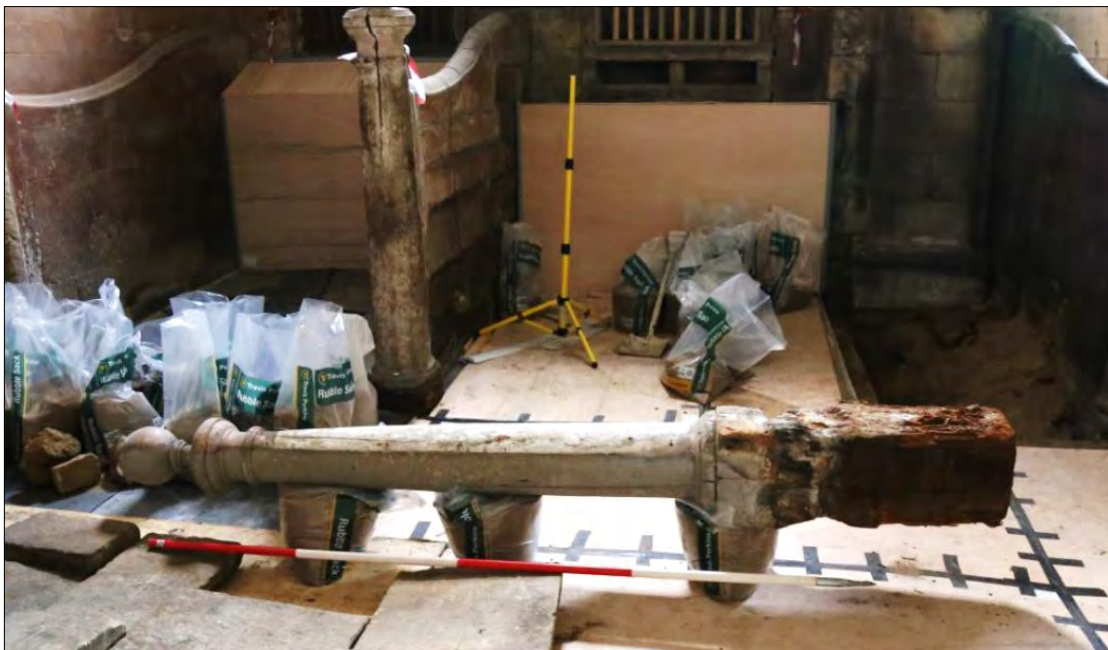
Plates 141: timber tethering post of S13 after removal.

10.47 Monitoring of the resetting of the tethering post of S13 was conducted as part of Item 7 (Plates 141). The post was removed as part of the dismantling of the stall and found to

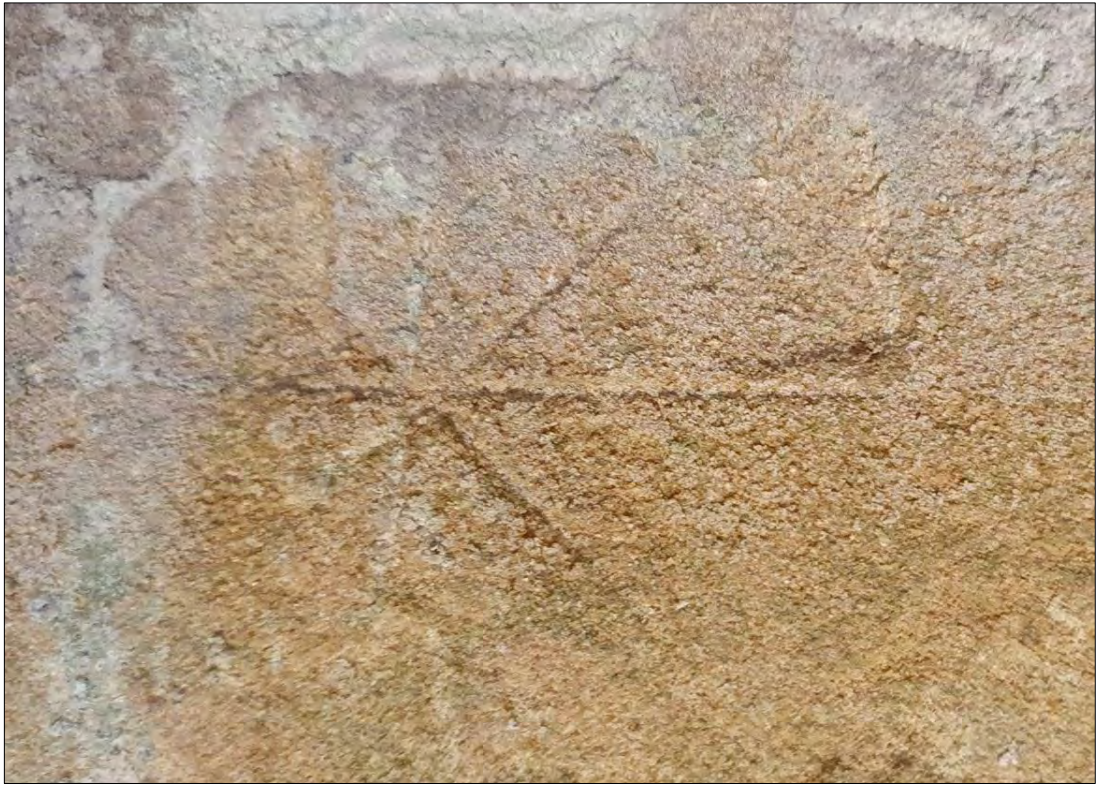
12.2 No *in-situ* evidence pre-dating the construction of the 18th-century Hall was identified, although there was considerable amount of reused building material associated with earlier structures on the site. Perhaps the earliest of these was a masonry block with a medieval mason's mark, found built into the wall in the south-east corner of B02 (the Servant's Hall) (Plate 142; Fig. 10). This may have come from the medieval tower that previously stood on the site. The carving was very faint and was only identified during a recent visit to the Hall after the main recording work was completed. New lighting in the basement has facilitated the identification of such marks and more may be identified in the future.

Plate 142: medieval mason's mark identified in the south-east corner of B02.
