ARCHAEOLOGICAL BUILDING ASSESSMENT AND SURVEY

ALL SAINTS' CHURCH
ALL SAINTS' ROAD
SHILDON
CO. DURHAM

Project No.: 1403

QUALITY ASSURANCE				
Project Number	1403			
Report Number	17–125			
Manager	Matthew Town			
Draft	Matthew Town			
Graphics	Dawn Knowles			
Edit	Dr Hannah Russ			
Authorised	Dr Freddie Foulds			
Issue 1		13-11-2017		
Issue 2		21-11-2017

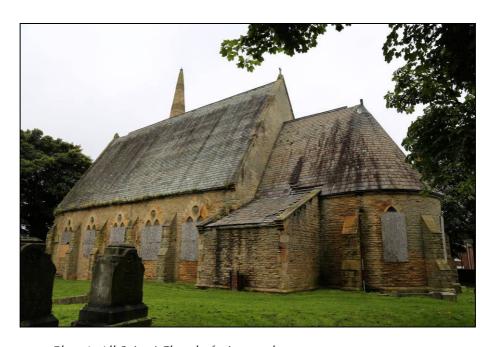
Plate 1: All Saints' Church, facing north-west

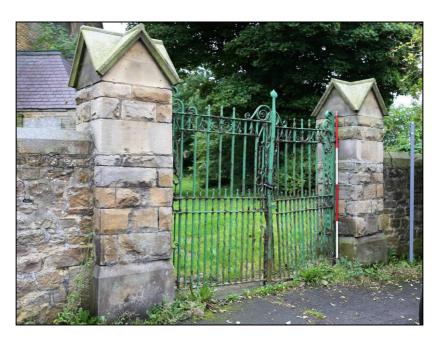
Plate 2: the pedestrian gate to the church from All Saints' Road, facing south

- 3.2 There are two access points to the church; an ornate iron gate, with stone pillars, leads into the churchyard from All Saints' Road, and formed the pedestrian access leading to the original church door at the western end of the church (Plate 2). A drive from Kilburn Street, to the north-east of the church, was originally accessed through an iron gate (only the iron posts of which now survive) leading to the north side of the church, with a drive heading southwards to the vicarage, built in 1870 ('Souvenir' September 1923; Plate 3).

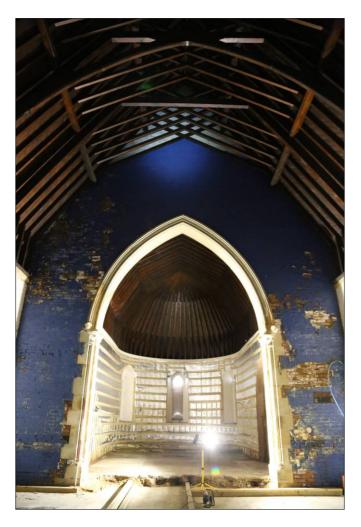
Plate 12: the chancel arch, facing east

- Access to the chancel is by means of a large pointed arch, which extends to the ceiling, with alternating ashlar sandstone quoins on each side of the arch (Plate 12). The arch comprises roll-moulded hoodmould with headstops, set above crocketed capitals on rounded columns. The chancel walls are mostly obscured by later thermal insulation and battens, but the areas exposed seem to indicate similar brickwork to the nave, and the wall plate is the same. The floor in the chancel survives, and comprises small square quarry tiles (mostly obscured under later cement and debris). At the eastern end, there are two steps (in ashlar sandstone) leading up to the altar, and the tiling here has an ornate *fleurs-de-lys* and rose pattern in red, cream and blue (Plate 13). The roof of the chancel comprises a tight network of close-set trusses supported by struts projecting from the wall-plate, with cross-braces across the top. The roof is a very distinctive feature (Plate 11).

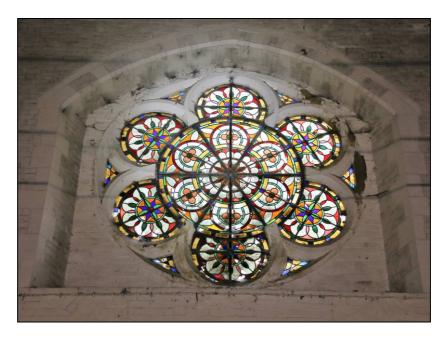
Plate 16: Catherine Window in western wall, from the interior

5.15 The western wall of the nave has a large Catherine window, comprising a sexfoil rose, with bar tracery around the petals holding the metal armature of the main design (Plate 16). The window is beautifully glazed with a floral design, and is set within a large recess with flattened two-centred arch, with alternating ashlar quoins; externally, the window has a chamfered band around the edges

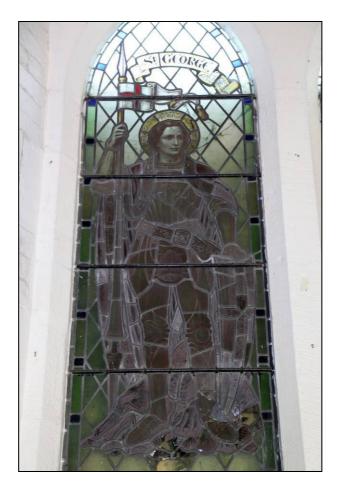
Plate 17: St George and Dragon

St George, depicted in his armour with spear and shield standing over the defeated dragon (Plate 17), and St Mary, depicted with flowers (lilies and roses) which were traditionally used to show her virtue and purity. On the southern side, the first and second windows included stained glass elements, but these were too damaged to be able to identify their depictions. The tower lobby also has similarly styled opposing lancet windows with green and yellow diamond panes, but without the quatrefoil windows above.

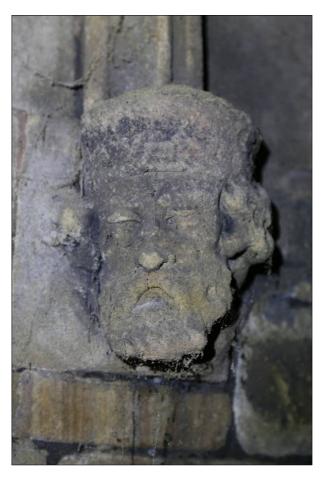
Plate 18: headstop, possibly of Joseph – main door.

5.20 The main doorway into the church has a pointed arch hoodmould with headstops (possibly Mary and Joseph – Plate 18), the arch above the hoodmould comprising alternating sandstone detailing, with two recessed chamfered arches forming the frame. The interior side has a flattened brick arch over a broad recess, with alternating sandstone quoins on each side. The original doorway appears to have used alternating types of wood to give an aesthetic striped effect; most of this door was sawn through at the base of the arch, with an iron bar fixing the door remains together – this was for the installation of more modern doors in the space. The doorway is accessed by two broad stone steps, leading up into the nave.
