BUILDING RECORDING

THIRLEY COATES FARM  
HARWOOD DALE  
NORTH YORKSHIRE

Report No: **NAA 19/07**

# THIRLEY COTES FARM, HARWOOD DALE, NORTH YORKSHIRE

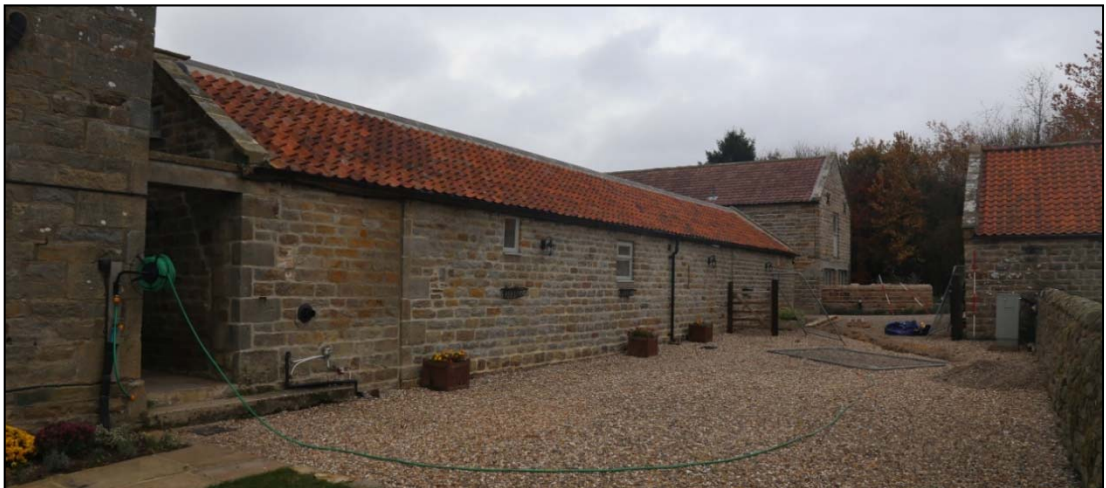
west where there are seven doors leading out onto the foldyard (Plate 6). The east side of the building features two small windows at the south end (Plate 7) and three ventilation slits at the north end (Plate 8). A building scar on the southern end of the east elevation is evidence of an extension added in the late 19th century (Fig. 4).

*Plate 7: east elevation of the east range seen connecting to the farmhouse on the left. The southern extension of the building is visible as a wall scar and variation in build at the south end of the range (nearest the farmhouse). On the right of the picture the west end of the cart shed is just visible.*

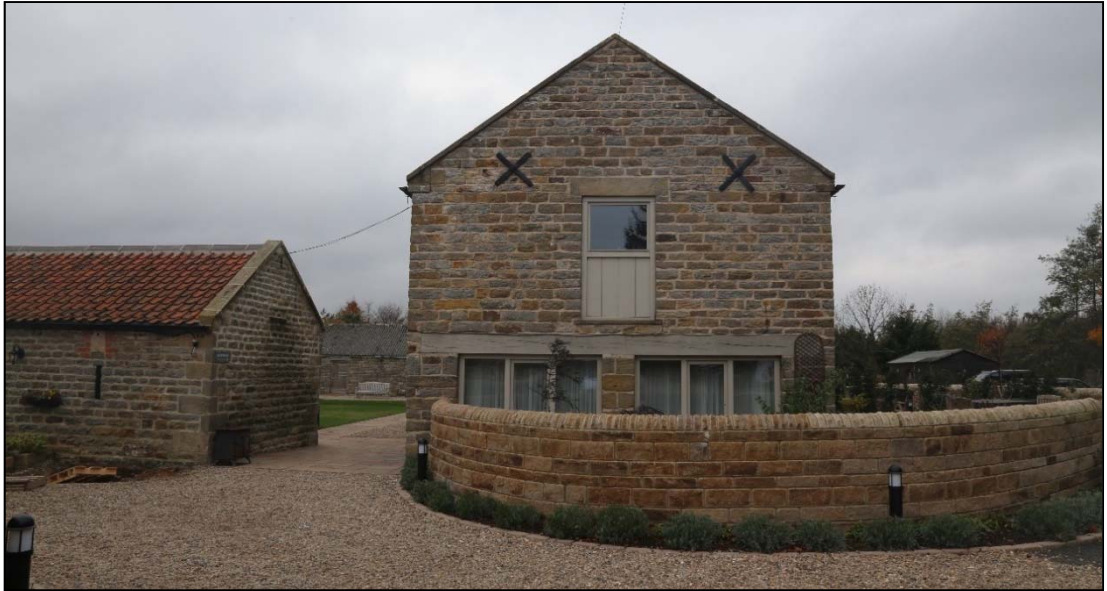
- 5.11 The east gable features a central door at first floor level (Plate 11). This would have led directly into the hay loft, facilitating the loading and unloading of material directly onto a waiting cart below. At ground level, a large wooden lintel spans the width of the gable end, supported in the centre on a stone pier. This suggests the building may have

originally incorporated a cart shed at this end prior to the construction of the separate shed in the early 20th century.

*Plate 11: east elevation of the main barn showing the remains of the first cart shed.*

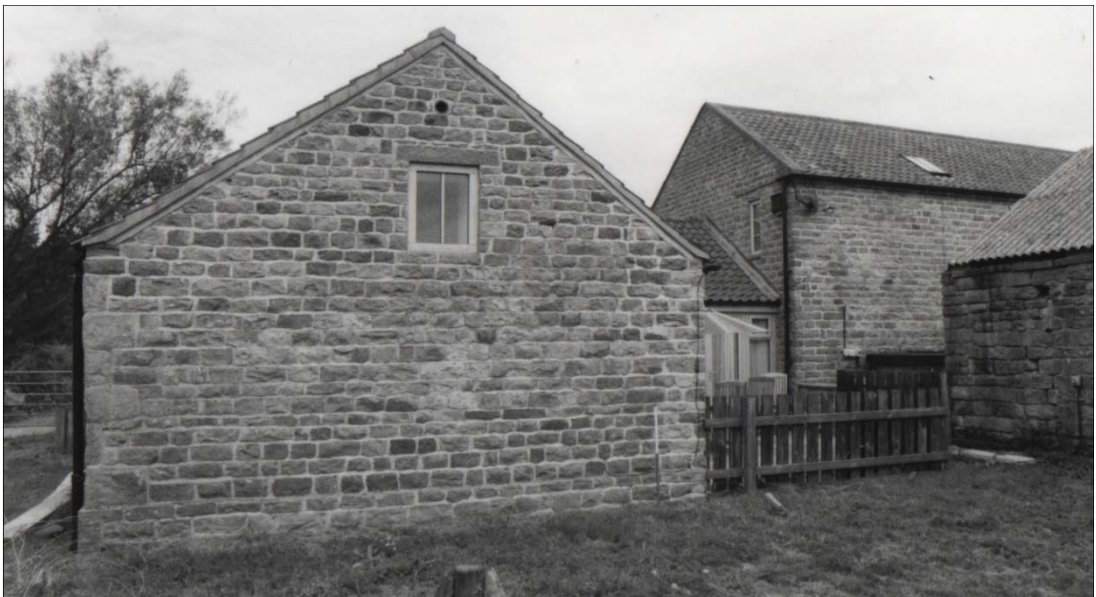
*Plate 14: south facing elevation of the north-west range. (Photo by CS Archaeology 2018).*

- 5.14 There are no other openings of note except for a small square window located close to the roof apex on the south facing gable (Plate 14). This window is clearly modern but may have replaced an earlier vent or owl hole.

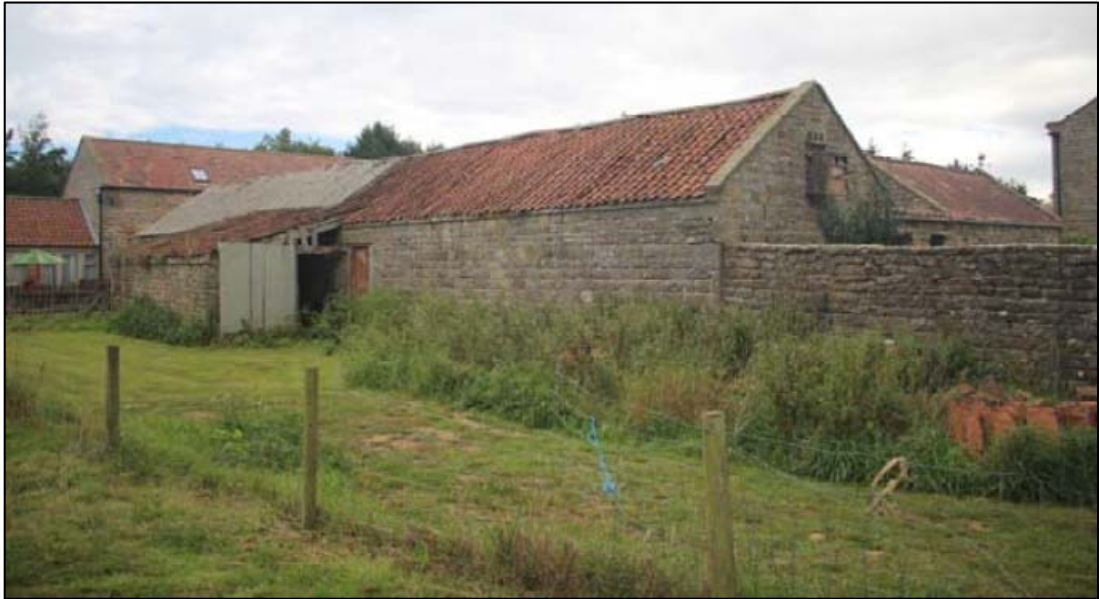
archaeology survey, with a bank of soil built up against the base of the building (Plate 23). The ground surface had been much reduced by the time of the later NAA survey (Plates 21-22).

*Plate 23: oblique view of west elevation showing build-up of ground deposits along the base of the wall. (Photo by CS Archaeology).*

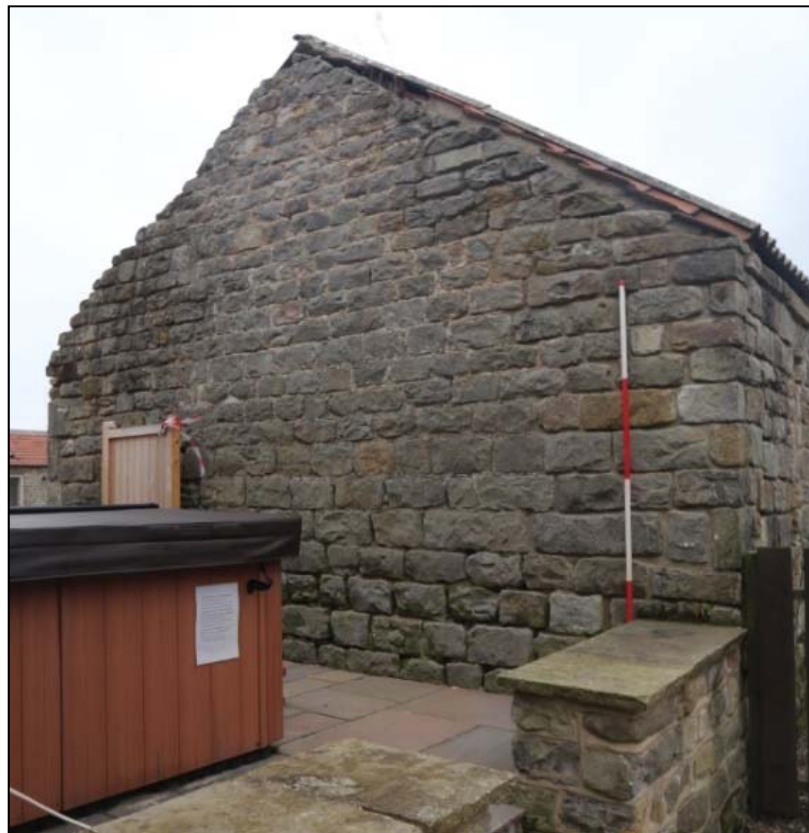
*Plate 24: north elevation (1400) of the west range looking south-east.*

- 5.25 The north gable end elevation (1400) is largely devoid of any features. The quoins visible at the north end of the east elevation (1010) only partially survive in-situ and there are no quoins defining the north-west corner (Plate 24). The roof coping and kneelers are also missing, indicating that the end wall has been either extensively modified or rebuilt at a later stage.

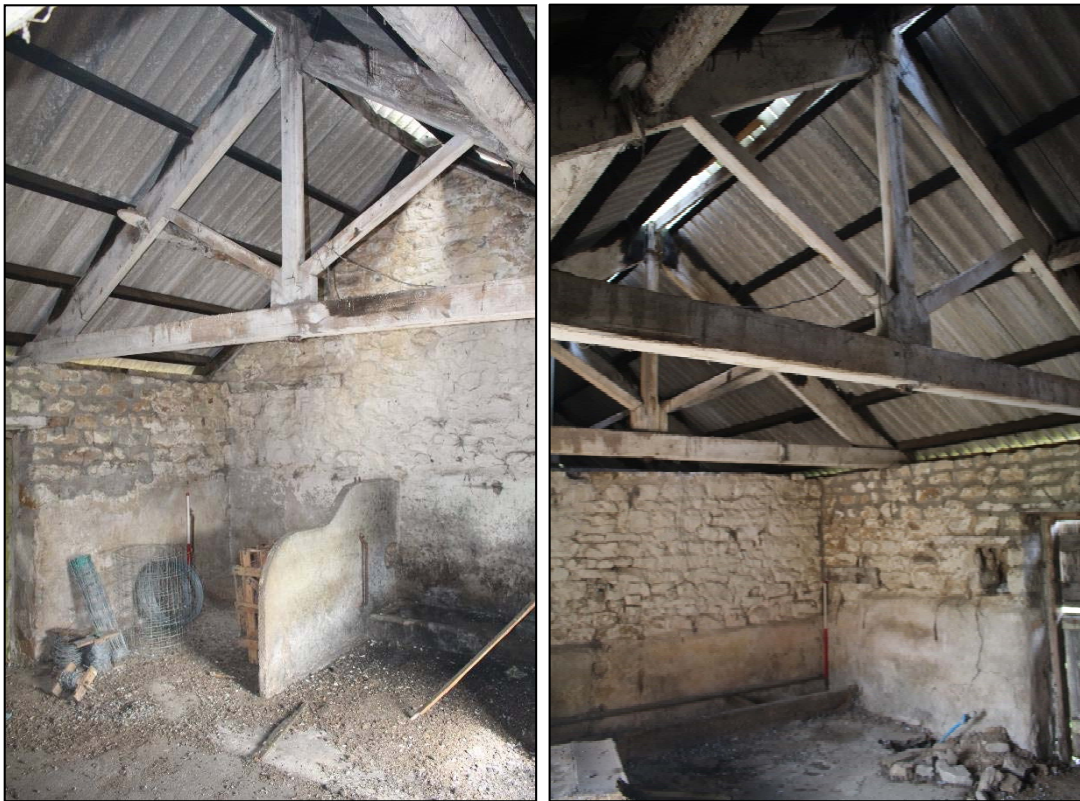
*Plates 25 and 26: (left) in-situ stalls and trough along the north wall of room 100, and (right) feeding trough on the south wall (right). (Photos by CS Archaeology 2018).*

- 5.27 The walls are render up to a height of 1.0m to 1.5m, corresponding with the height of the former stall locations except in the north-east corner. On the north wall are a set of joist holes (111), marking the location of the stall divisions (112) (Plate 27). Similar holes are visible on the south wall, indicating that stalls were formerly arranged against both walls, although only those on the north wall survived in-situ at the time of the CS Archaeology survey. Stalls of this kind are typically associated with cattle use rather than horses. Stalls associated with the latter are generally more spacious, and the feeding trough placed at a higher level, accompanied by a hay rack. A metal bar (runner) (109) along the west wall was probably used to tether the animal. A second bar was located on the stall division (Plate 25).

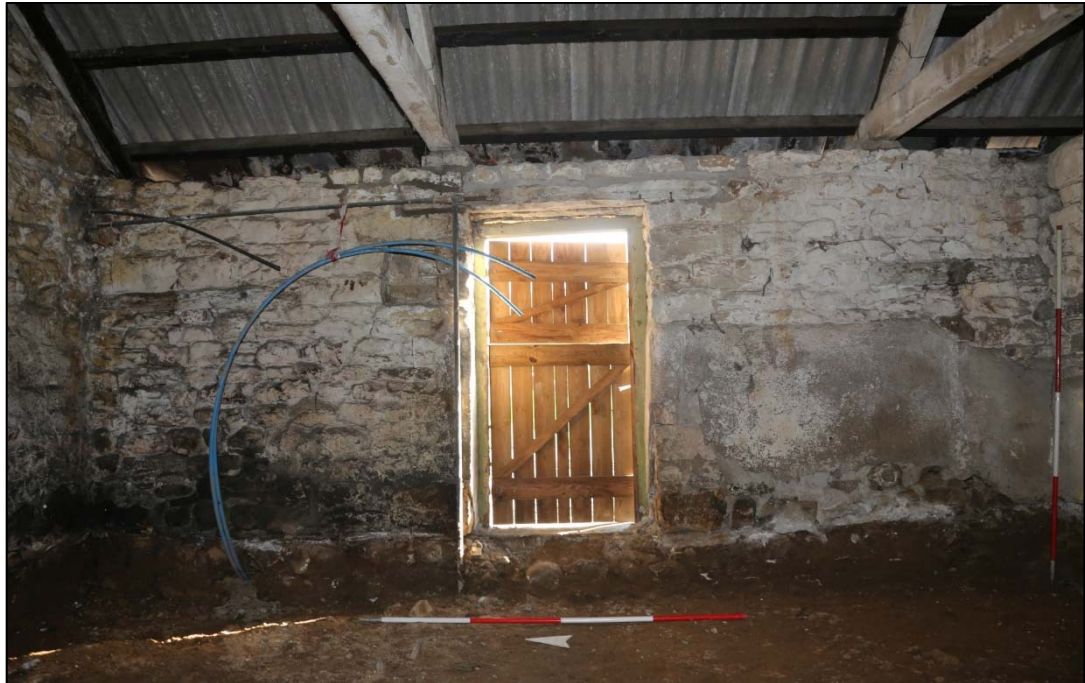
*Plate 28: east door (101) with lamp niche (103) visible to the left. The west door (102) has the same layout.*

- 5.29 The east and west doors (101 and 102) featured wooden frames with a stone threshold set approximately 0.5m above floor level, indicating the depth of the internal ground reduction (Plate 28). The earlier survey recorded a concrete screed surface extending across the whole room which, it was noted, might have obscured a surviving in-situ historic floor surface (CS Archaeology 2018, 5.2.2). However, all archaeological surfaces had been reduced by the time of the NAA survey.
- 5.30 Lamp niches or keep holes (103 and 104) are associated with both doors (Plate 28; Fig. 5). Two kingpost trusses (108) span the room, with the carpenter's mark 'VI' on the north truss and 'V' on the south truss (Plates 25, 26 and 27).

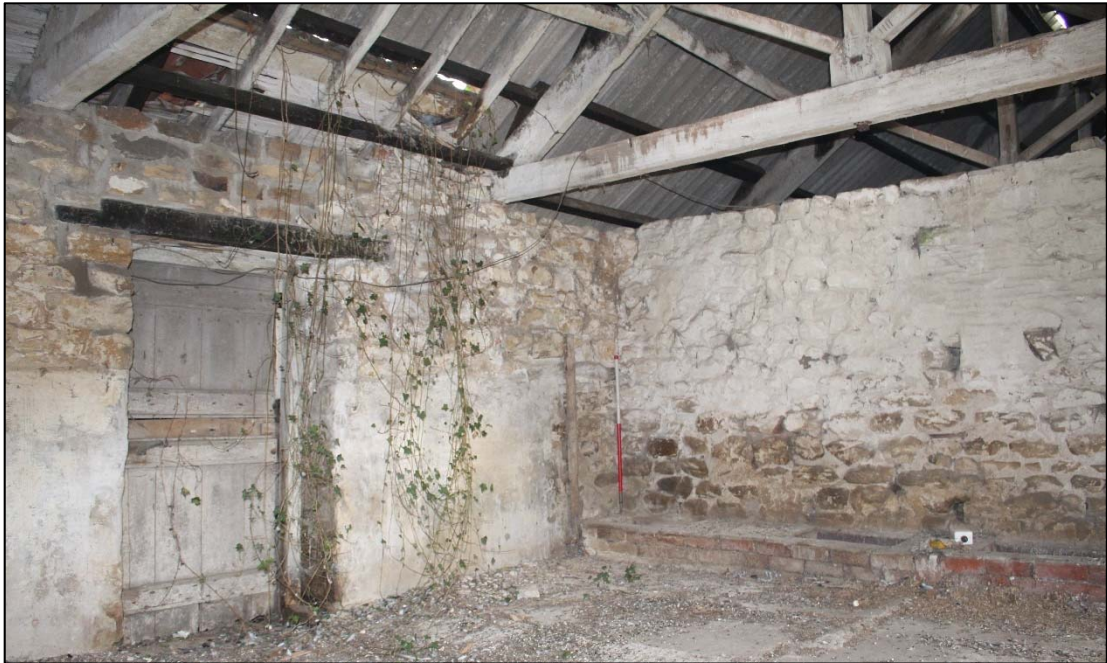
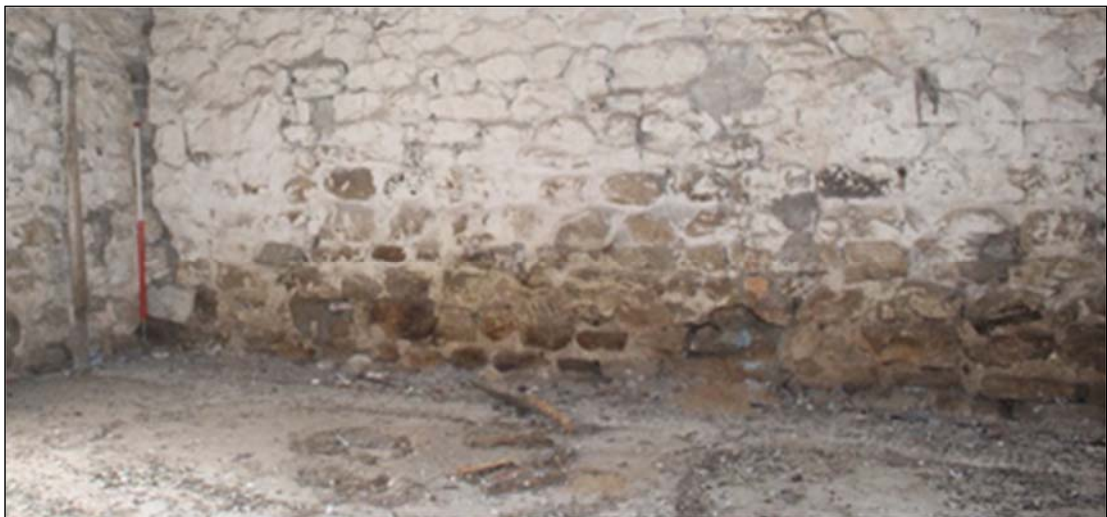
similar in layout to 100, with four concrete/brick feeders (207) in-situ along the north wall. Evidence of a wooden feeding trough survived as a scar on the south wall (208) and concrete floor, and set of timber uprights (205). No stall divisions remained (CS Archaeology 2018, 5.2.3; Plates 29 and 30). The brick trough and floor surface had been removed by the time of the later NAA survey.

*Plates 29 and 30: photograph taken during the earlier survey showing (top) in-situ brick feeding trough lining the north wall, looking north-west and (bottom) the scar in the floor showing the former location of a wooden feeding trough along the south wall, looking south-east, note the timber upright (205) to the left. (Photos by CS Archaeology 2018).*

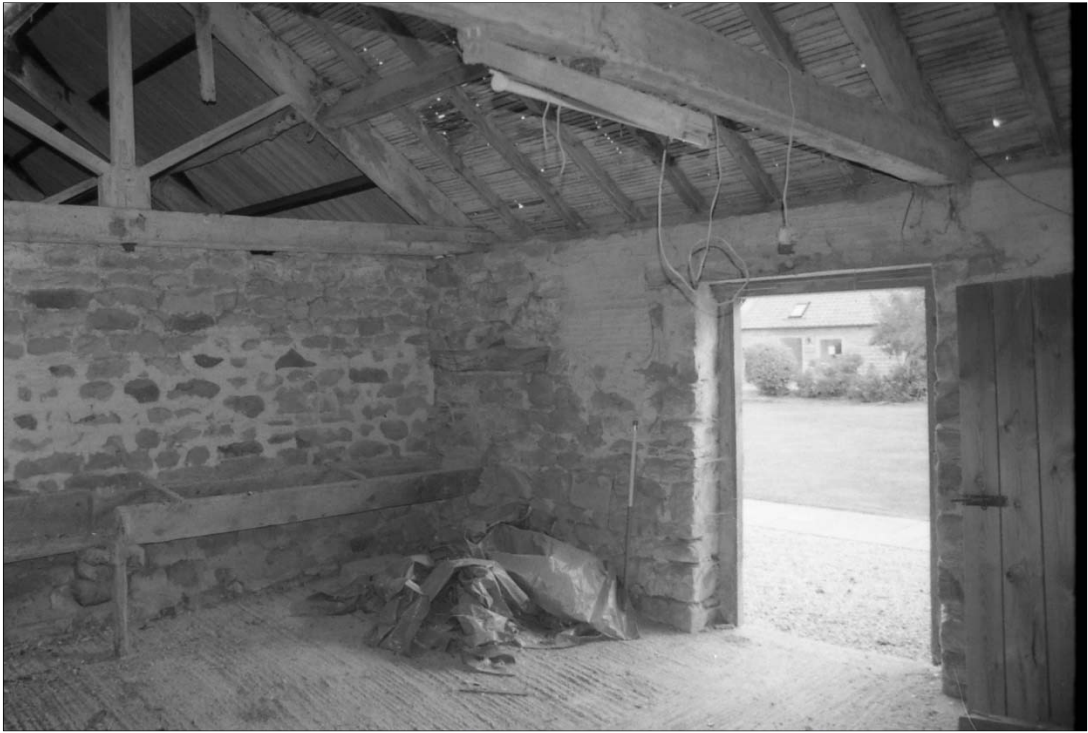
- 5.35 Like rooms 100 and 200, the room is accessed both from the east and west via doors 301 and 302, both of which are set into wooden frames. These are raised above the present ground surface by approximately 0.25m, the original floor having been removed prior to survey. A modern concrete screed surface was recorded during the CS Archaeology survey, again this may have overlain an earlier historic floor layout (2018, 5.2.4) (Plate 33).

*Plate 33: room 300 looking north-east with the feeding trough visible along the north wall and the concrete screed floor in-situ. (Photo by CS Archaeology 2018).*

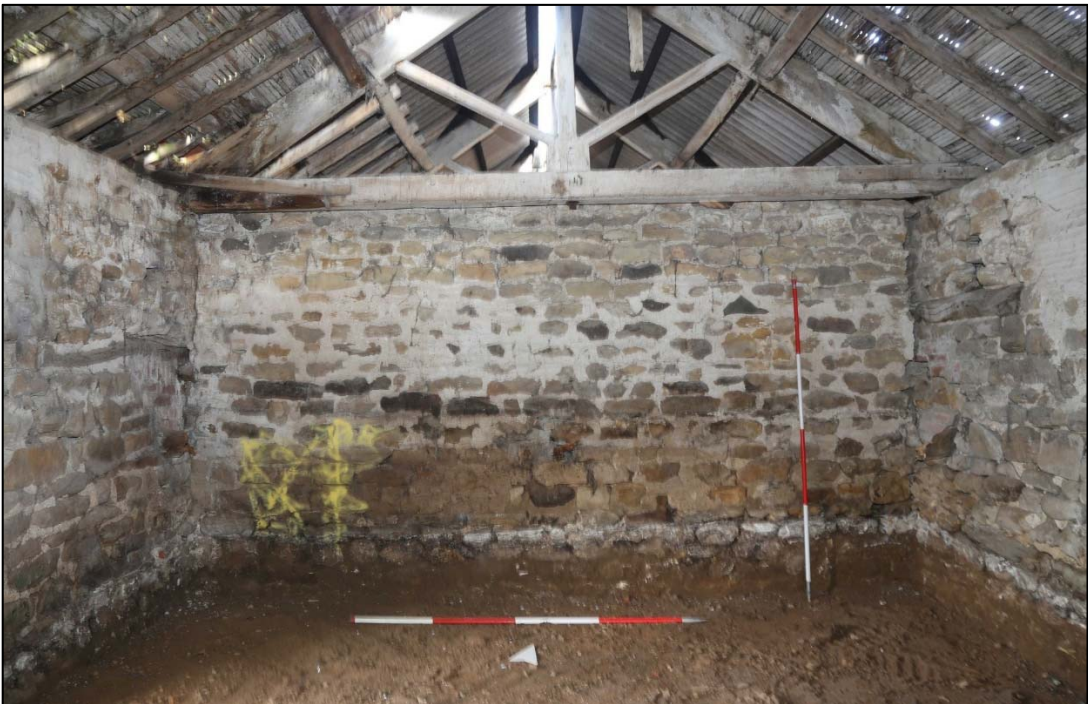
- 5.36 Timbers 303 and 305 on the north side of the room extend south from room 200 and measure 1.5m and 1.0m respectively, set at a height of 1.3m and 1.7m above the ground surface at time of survey. These form part of the wall above a feeding trough (304), which was in-situ at the time of the CS Archaeology survey (2018) (Plate 33). Evidence of trough fittings were visible as an upside down, semi-trapezoid frame of wood inset into the north corner of both east and west walls, and a single wooden support jutting out from the centre of the north wall (Plates 34 and 35). Timbers 303 and 305 also related to the trough structure.

*Plate 34: north wall of room 300 with evidence of the feeding trough still visible.*

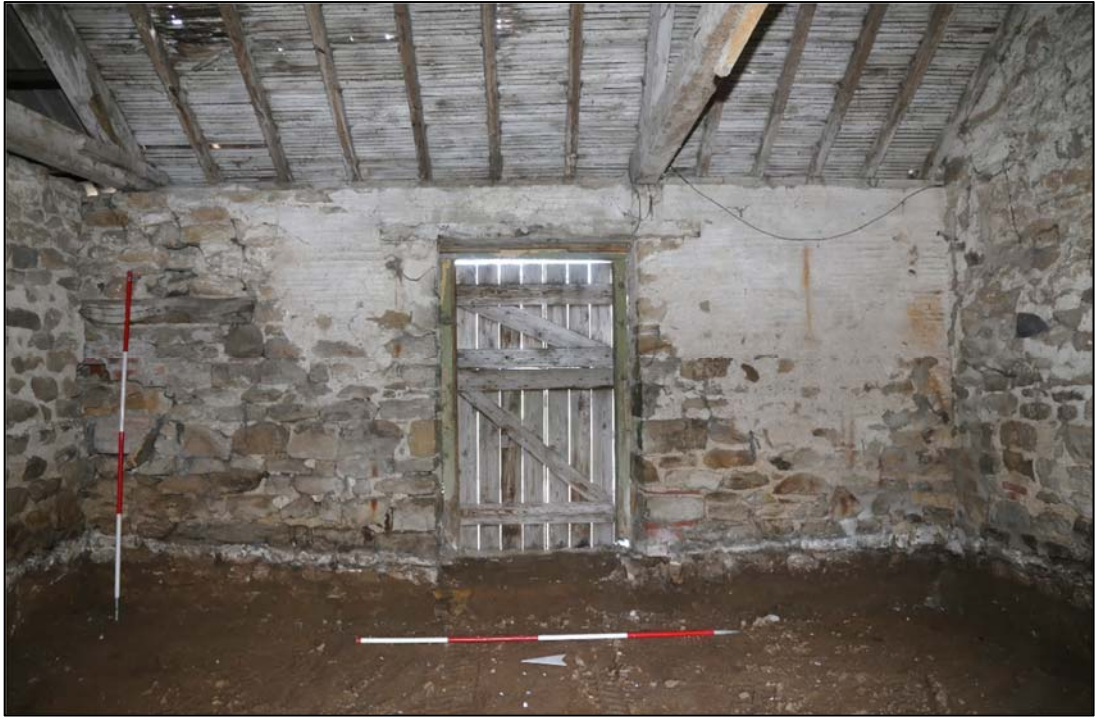
*Plates 35: east wall featuring door (302). Evidence of feeding trough (304) still visible in north-east corner, to the left.*

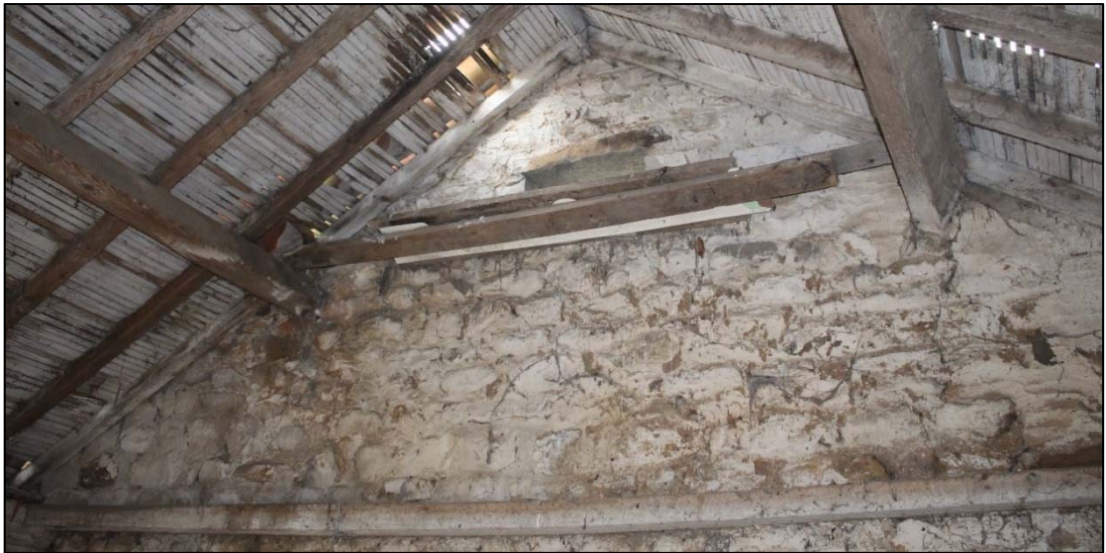
*Plate 38: opening (506) on the south gable associated with the dovecot (1201). Below is the protruding tie-beam (504) which supported the hay loft floor. (Photo by CS Archaeology 2018).*

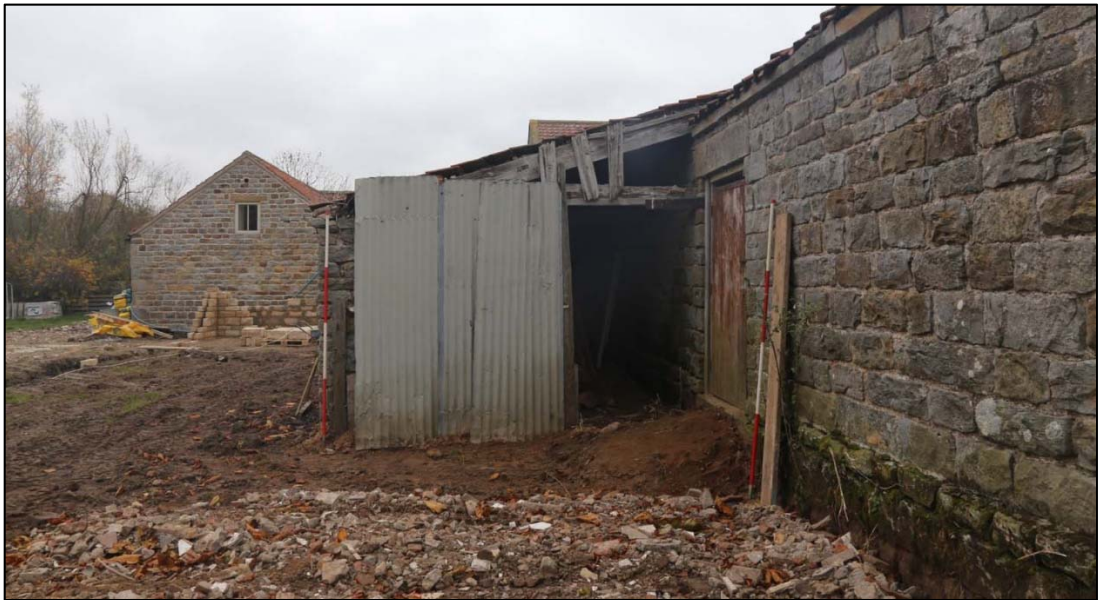
and is set with a catslide roof. The structure is a later addition to the main range and is first shown on the 1893 OS map (Fig. 4). It is open to the south, the original door having been replaced by a corrugated metal sheet, although parts of the wooden frame remain in-situ (Plate 41). A door to the east (201) leads into the west range north central room (200) (Plate 29). At the time of survey, the room was obscured by equipment, but a hay rack (601) was clearly visible along the west wall (Plate 42).

*Plate 41: entrance into outshot from the west side of the range, looking north.*

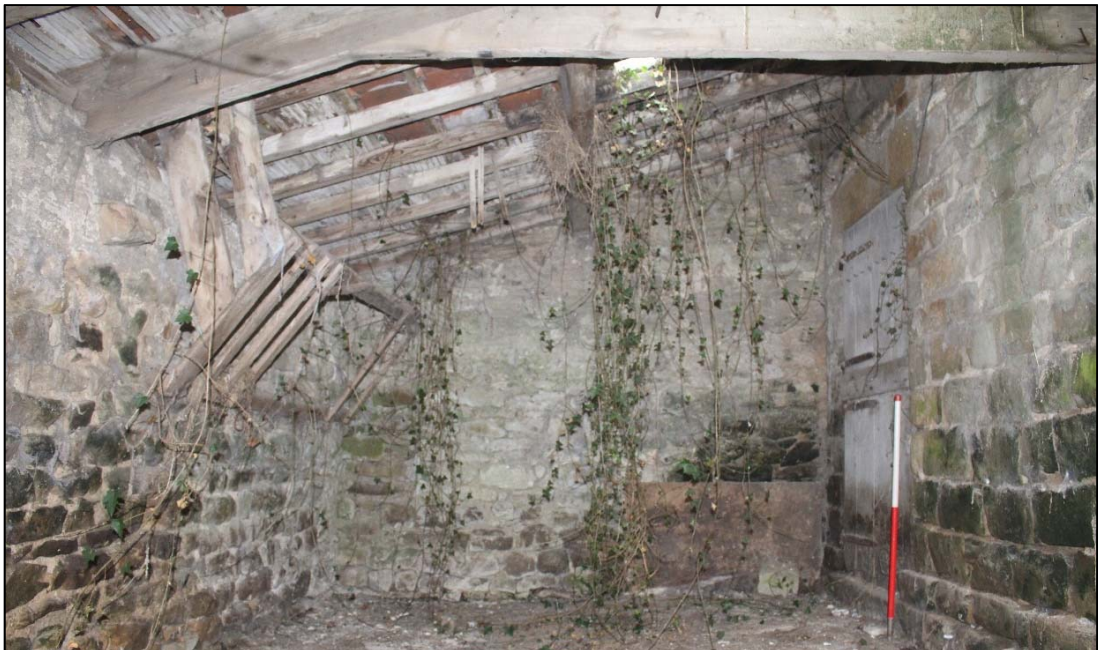
*Plate 42: view of the outshot looking north. The hay rack is visible on the west wall along with the roof structure. (Photo by CS Archaeology 2018).*

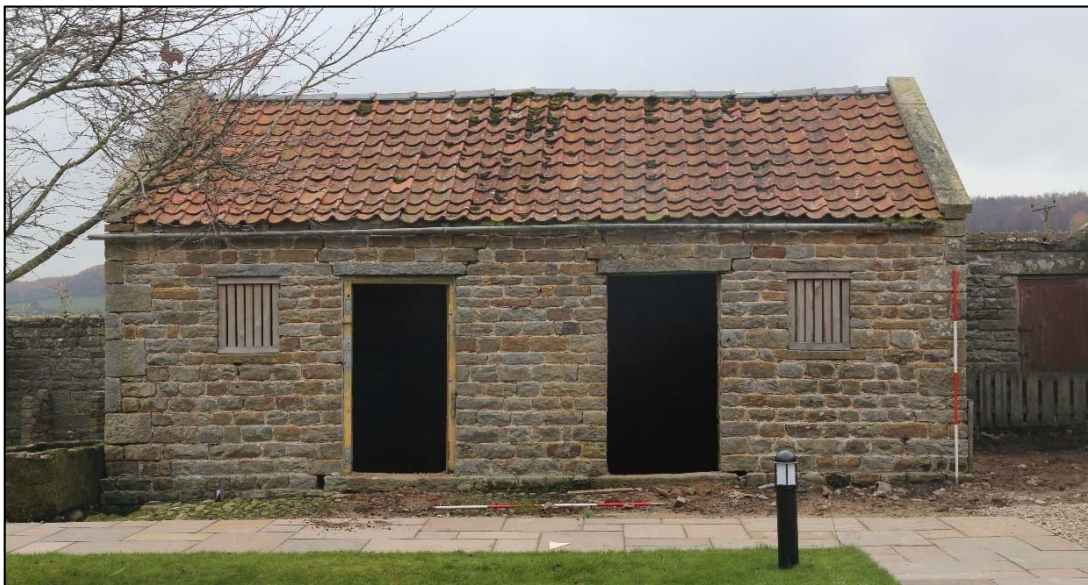
*Plate 43: north (front) elevation of the south range (2300). The cobbled pavement (2301) is visible to the left of and behind the horizontal ranging rod.*

- 5.45 The north elevation is of coursed sandstone with corner quoins. It features two stable half doors flanked on each side by a window (Plate 43; Fig. 7). The doors (2101 and 2201) have thin stone lintels and the remains of wooden latches. On either side is a wooden louvred window for ventilation (2102 and 2202). On the west corner of the building stands a post (2302) belonging to what may have been a fence or gate. Similarly, wooden fragments in the wall, aligned vertically between both doors, may

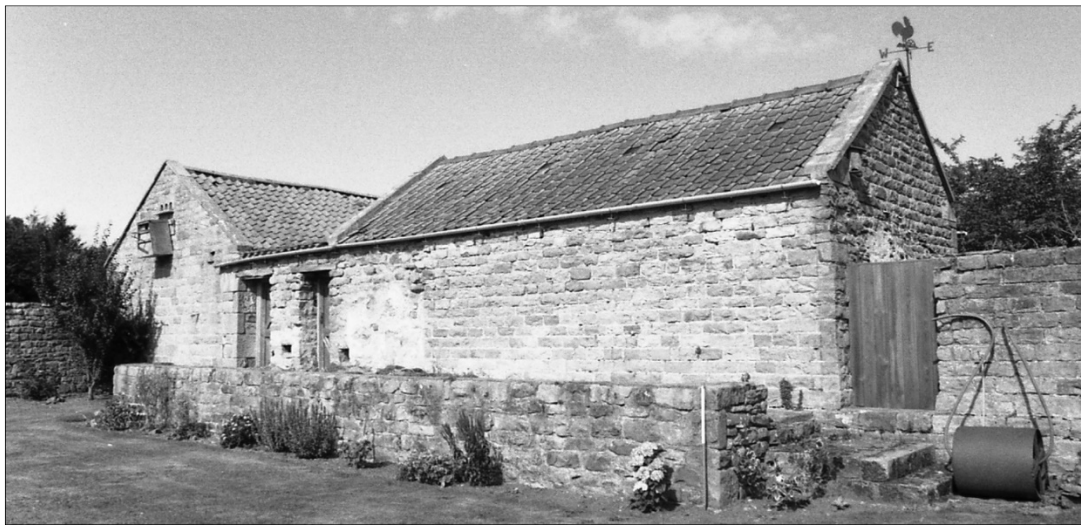
- 5.49 Historic Google Earth imagery (Fig. 9) indicates that the structure was later converted for use as a greenhouse. A wall standing 1.00m high and associated with the greenhouse was extant at the time of the CS Archaeology survey (Plate 45). This was evident only as footings (2704) by the later NAA survey.

*Plate 45: former greenhouse (2700) built against the southern wall of the south range (2000). This structure served as a greenhouse during its final phase of use, the associated wall (2704) can be seen standing 1.00m high at the time of the CS Archaeology survey. (Photo by CS Archaeology 2018).*

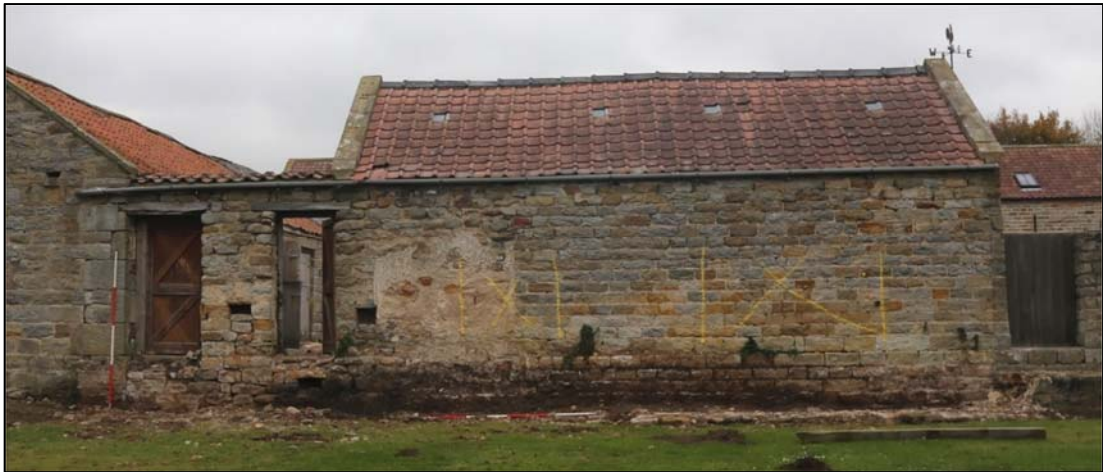
*Plate 46: south facing elevation (2500) of the south range, showing the wall footings (2704) of demolished range (2700).*

5.53 There are four rooflights (2501) on the south side of the extant range (Plate 46).

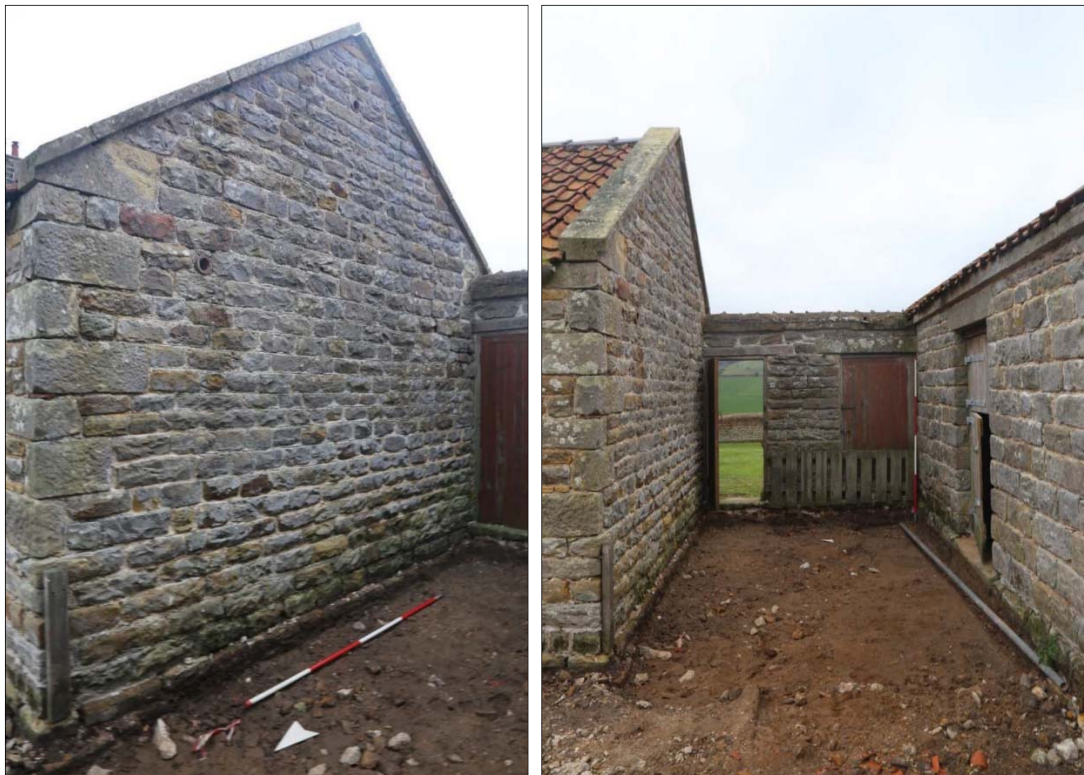
*Plates 47 and 48: (left) west facing elevation (2600) of the south range, and (right) north facing elevation of 2700, showing doors 2701 and 2702.*

- 5.54 The west elevation (2600) is plain with few archaeological features of note except for two round terracotta pipe vents (2601) (Plate 47). Similar vents appear on the east elevation (2402).

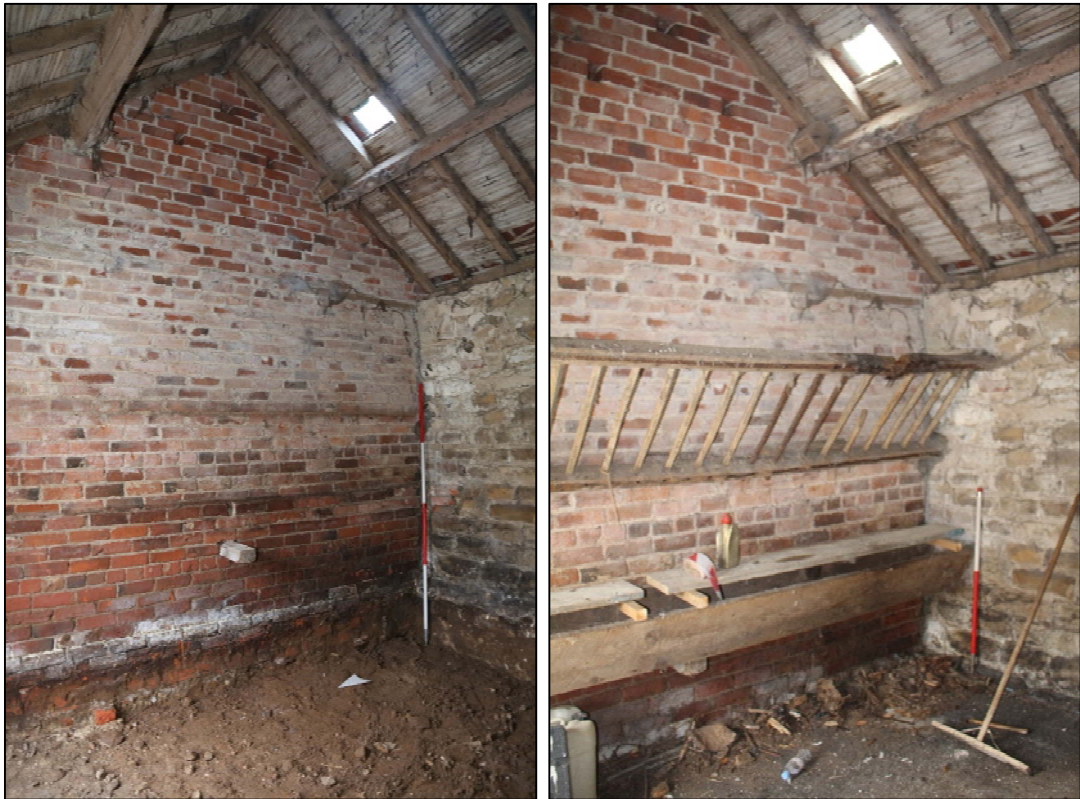
*Plates 49 and 50: (left) the east partition wall of the west room is brick whereas the south is stone. The remains of a trough (2103) and hay rack (2105) are evident as wall scars and (right) both recorded by CS Archaeology 2018. (photo by CS Archaeology 2018).*

- 5.56 At the time of survey, the original floor surface had been removed but is shown on the CS Archaeology survey as comprising a concrete screed floor (Plate 50). It is a common rafter roof without intermediate trusses, with the purlins supported on the internal brick partition. Lath and plaster work support the pantile roof (Plate 51).
- 5.57 A timber trough was formerly in-situ on the east wall, with hay rack above (CS Archaeology 2018, 5.2.8) (Plate 50). Evidence of both rack (2105) and trough (2103) were observed and recorded during the NAA survey. Two horizontal timbers (2107) were recorded on the east wall at the height of the top of the north and south walls. They may have originally served as structural support for the trough or hay rack. Above these are three vents (2106).

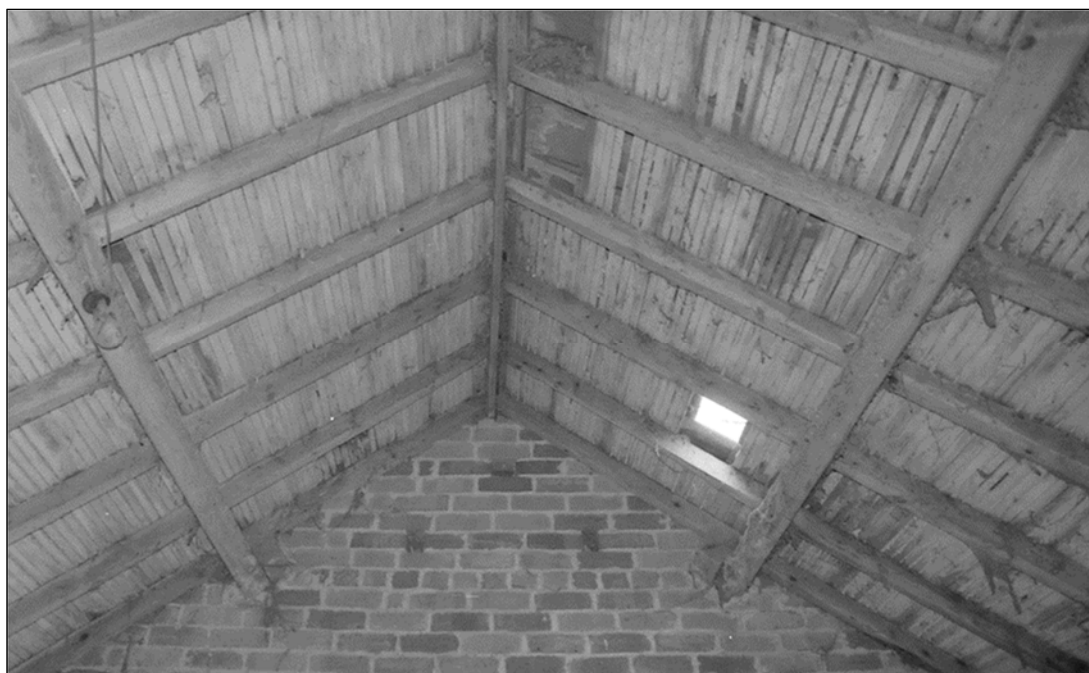
*Plate 51: room 2100 roof structure, also visible are the three ventilation holes (2106) and a skylight (2501). (Photo by CS Archaeology 2018).*

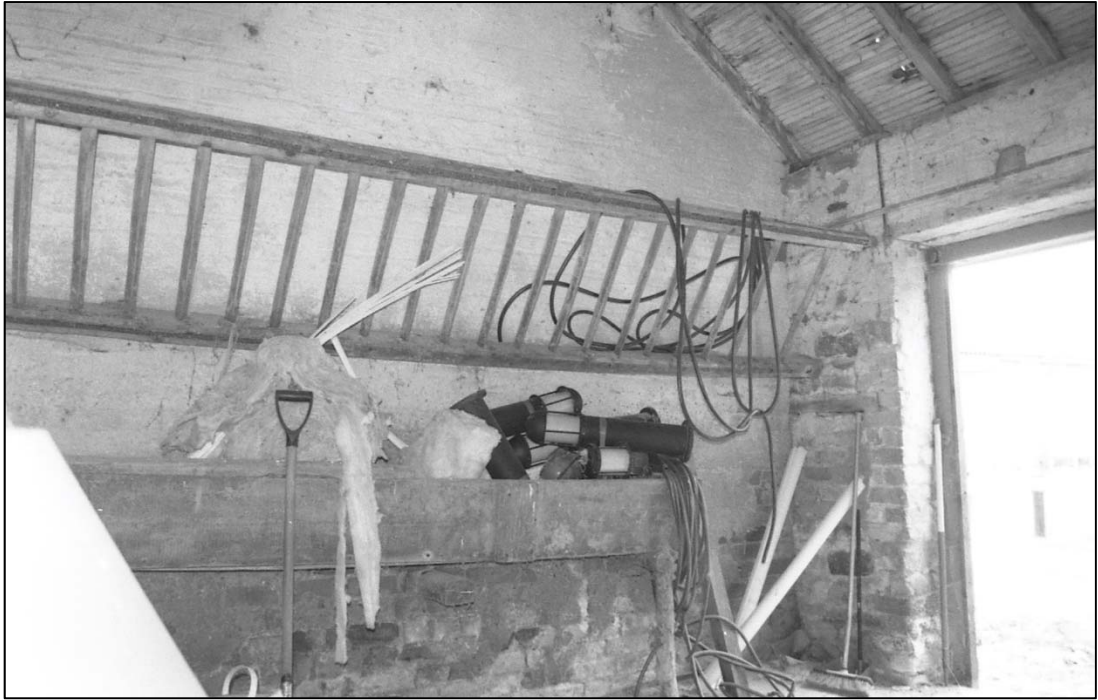
- 5.58 The east room is the same in size and layout as the west. The west brick partition wall features the remains of a trough (2203) and a wall scar associated with a hay rack (2204), both recorded at the time of the CS Archaeology survey (CS Archaeology 2018, 5.2.10) (Plate 52). There are two horizontal timbers visible in the west partition wall (2107) aligned with the top of the north and south walls. Notably the partition wall is both rendered and lime washed, in contrast to that in the west room. Like the adjoining room, 2200 also formerly featured a concrete screed floor surface.

*Plate 52: room 2200 showing location of former trough (2203) and hay rack (2204). (Photo by CS Archaeology 2018).*

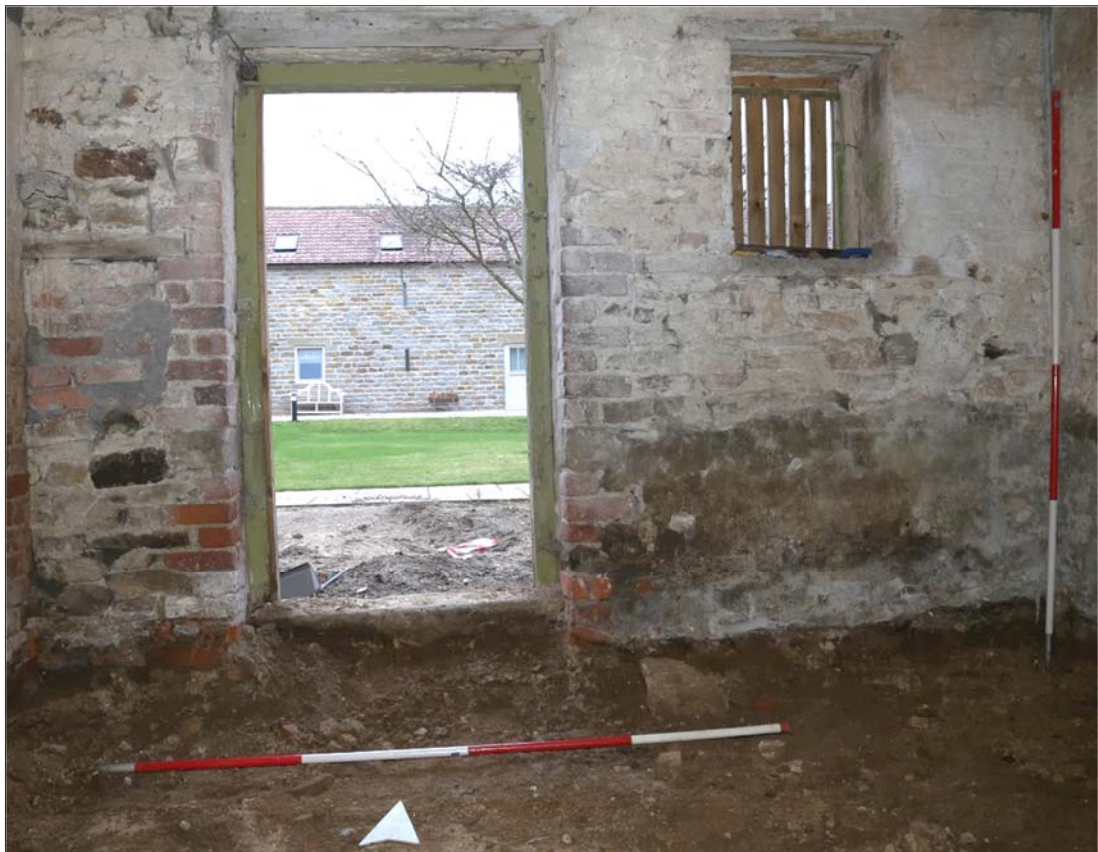
*Plate 53: room 2200 looking north, showing door 2201 and window 2202. Note bullnose brick around the door frame.*

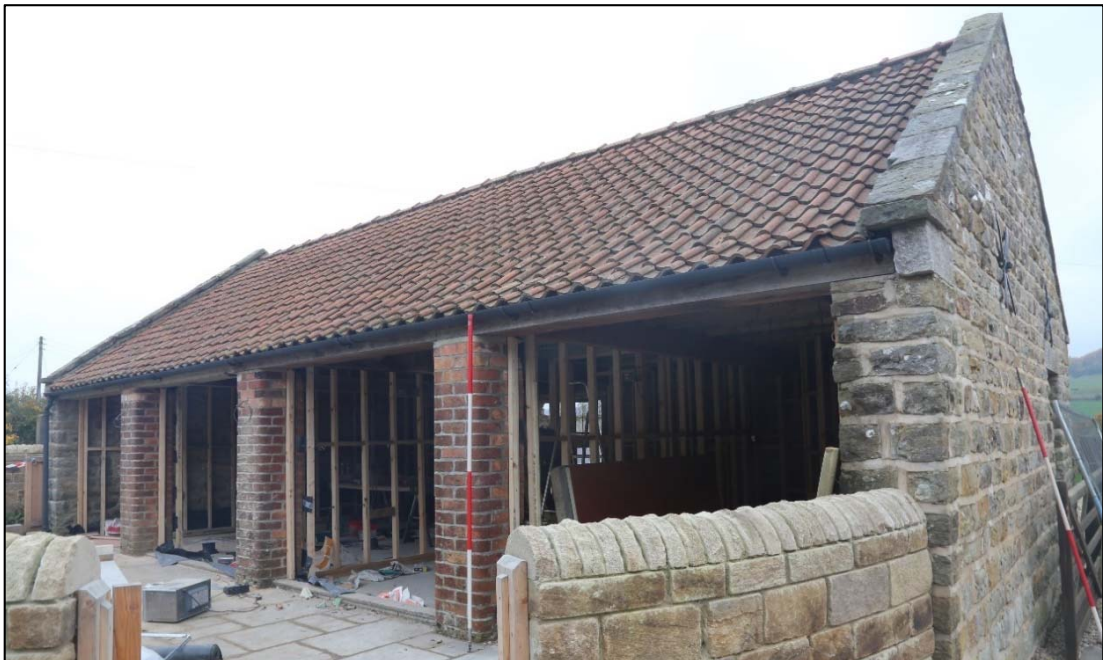
*Plate 54: north elevation of the cart shed.*

The north elevation (front) comprises four bays separated by three brick piers (3201). Bullnose bricks are used at the corners to prevent damage to the valuable farm equipment. Each pier stands 1.80m high (Plate 54; Fig. 8).

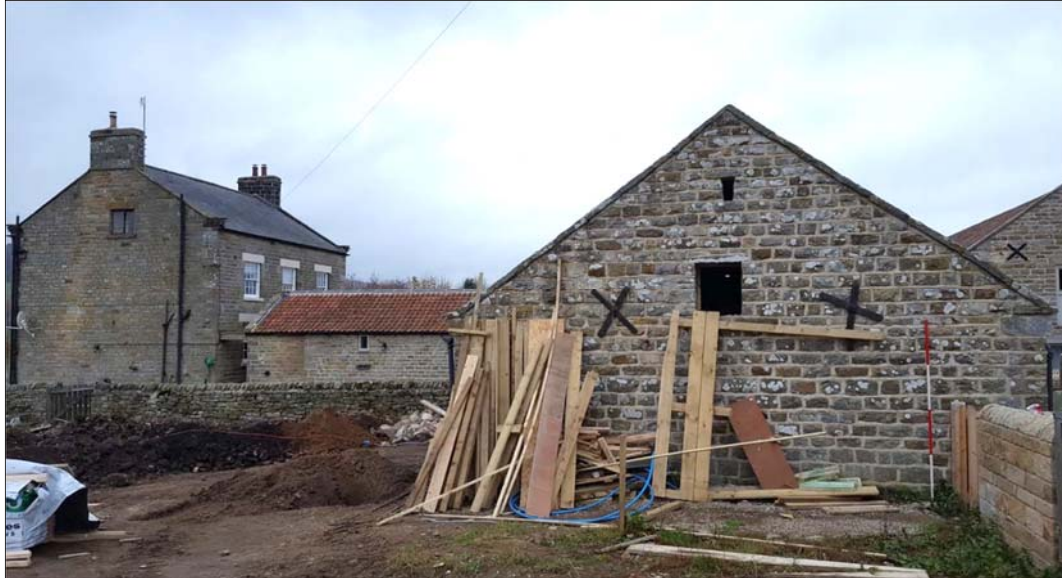
- 5.61 The east elevation (Plate 55) features a single square window (3301), above which is set a narrow owl hole or ventilation slit (3302). There are two cross-shaped anchor-plates

(3303) located below the window. These correspond with similar anchor-plates on the west elevation (3503). These secure either end of two metal tie-rods (3102) which run through the building from gable to gable just above the level of the wooden roof tie beams (Plates 58, 59 and 60). The cross-shaped anchor-plates are of the same design as those that can be seen on the east elevation of the main barn and may have been inserted at the same time, possibly as part of a later stabilisation scheme.

*Plate 55: east facing elevation (3300) of cart shed.*

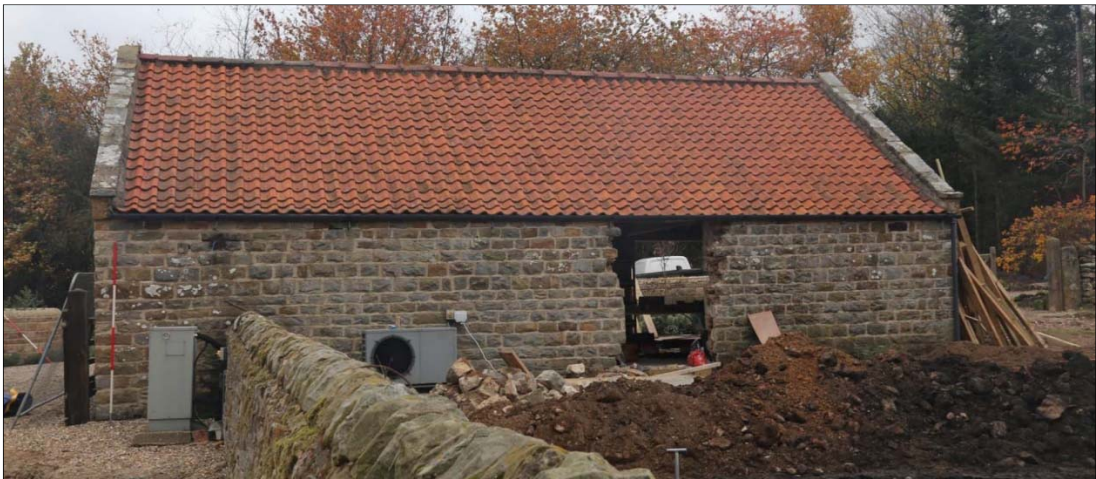
- 5.65 The south elevation (Plates 56 and 57) is of regular coursed sandstone with no archaeological features of note. At the time of survey an opening (3401), measuring approximately 1.20m wide, had been inserted without planning permission at the eastern end of the building. This will be restored to an approved standard.

*Plate 56: south elevation (3400) of the cart shed, showing opening on east side.*

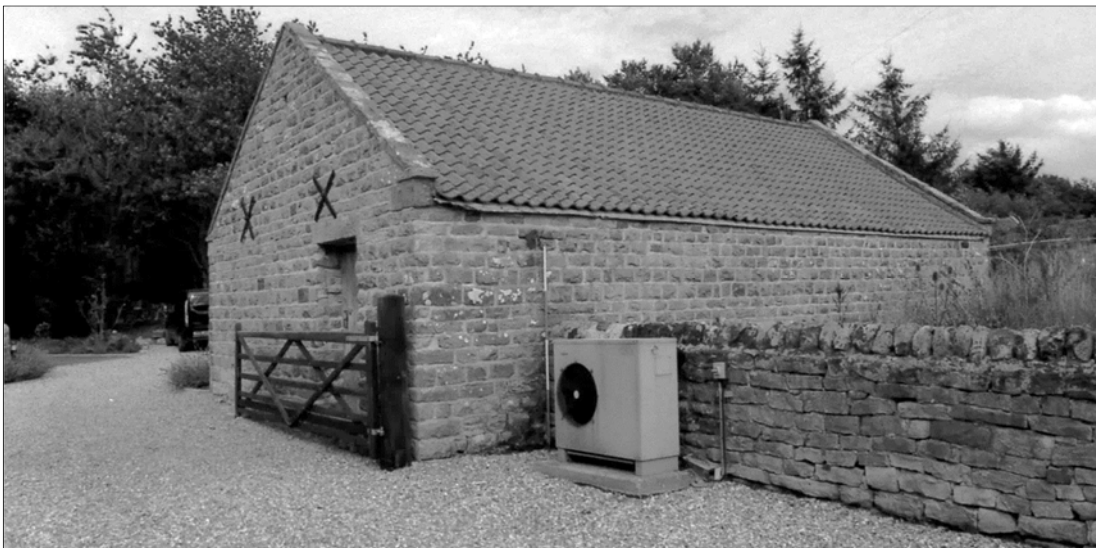
*Plate 57: south (3400) and west (3500) elevation of the cart shed prior to the commencement of works. (Photo by CS Archaeology 2018)*

rudimentary kneelers, and a second owl hole or vent (3502) just below the apex (Plate 57), as well as a set of cross-shaped anchor-plates (3503). There is a door (3501) on the south side providing access into the interior. This is set with a large stone lintel.
