BUILDING RECORDING

THIRLEY COATES FARM  
HARWOOD DALE  
NORTH YORKSHIRE

Report No: **NAA 19/07**

# THIRLEY COTES FARM, HARWOOD DALE, NORTH YORKSHIRE

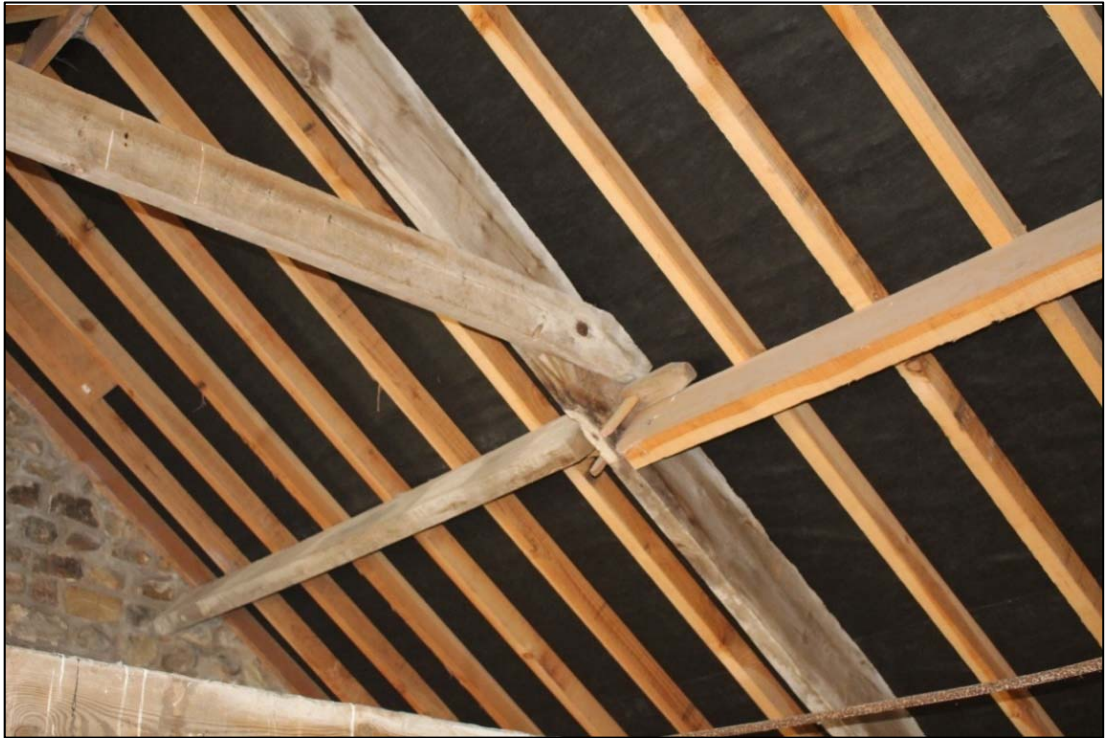
*Plate 58: roof truss looking south-east (3301). (Photo by CS Archaeology 2018).*

- 5.67 The interior of the cart shed measures 10.50m by 7.00m and stands 2.30m high. The roof has been largely restored, with new purlins tied into historic trusses. The surviving original timbers indicate it was supported on three tie-beam trusses (3101; Fig. 8) with upper collars (Plate 58). No carpentry marks or decoration were evident.
- 5.68 At the time of the earlier survey the west bay was partitioned off from the main body of the building to form a garage with a modern door on the north side, inserted between the brick pillars (CS Archaeology 2018; Plates 59 and 60). This had been removed prior to the NAA survey. There were no other features of note in the interior of the building.

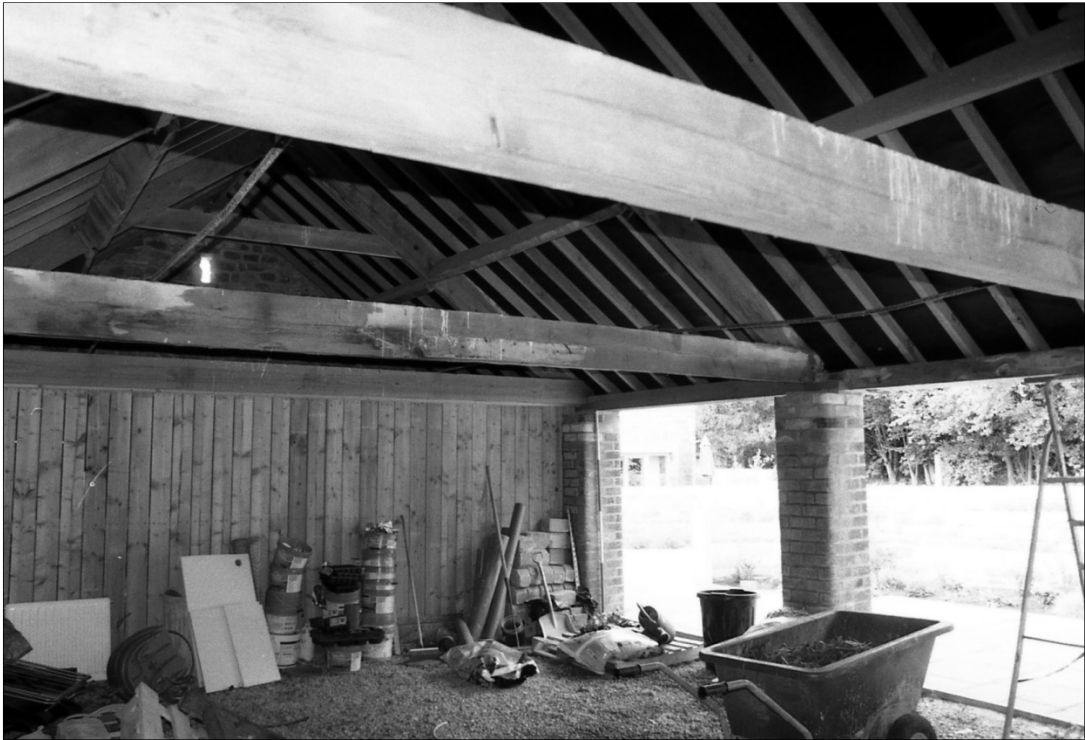
*Plate 59: interior of the cart shed looking north-west. (Photo by CS Archaeology 2018).*

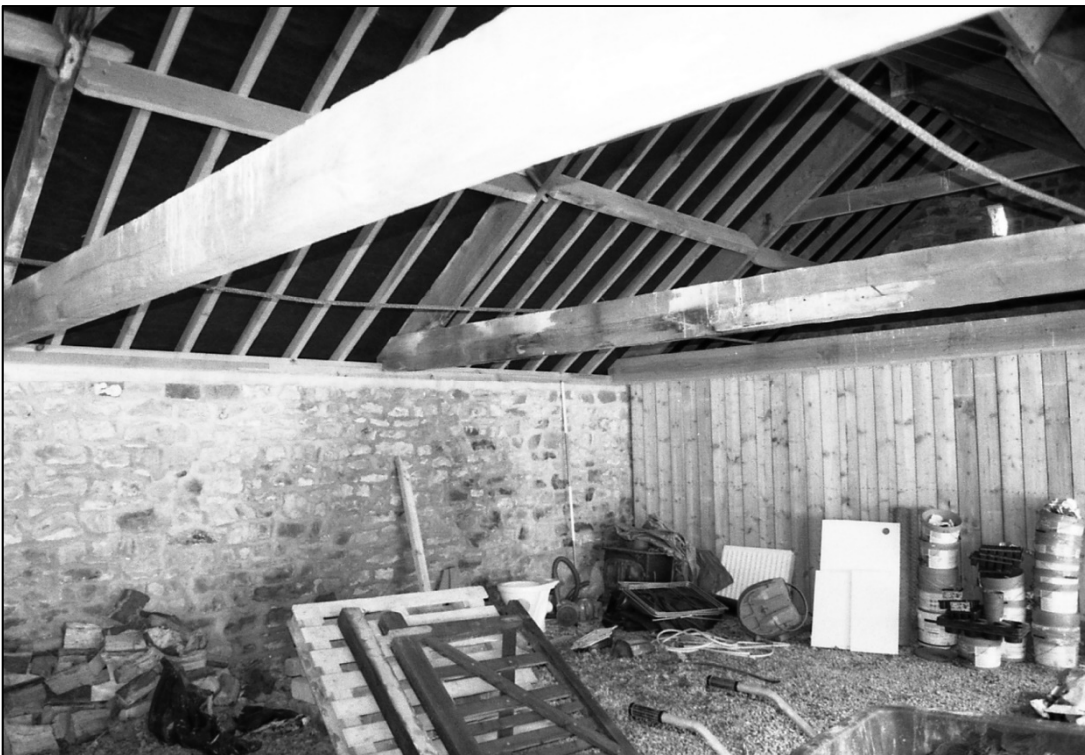
*Plate 60: interior of the cart shed looking south-west. (Photo by CS Archaeology 2018).*

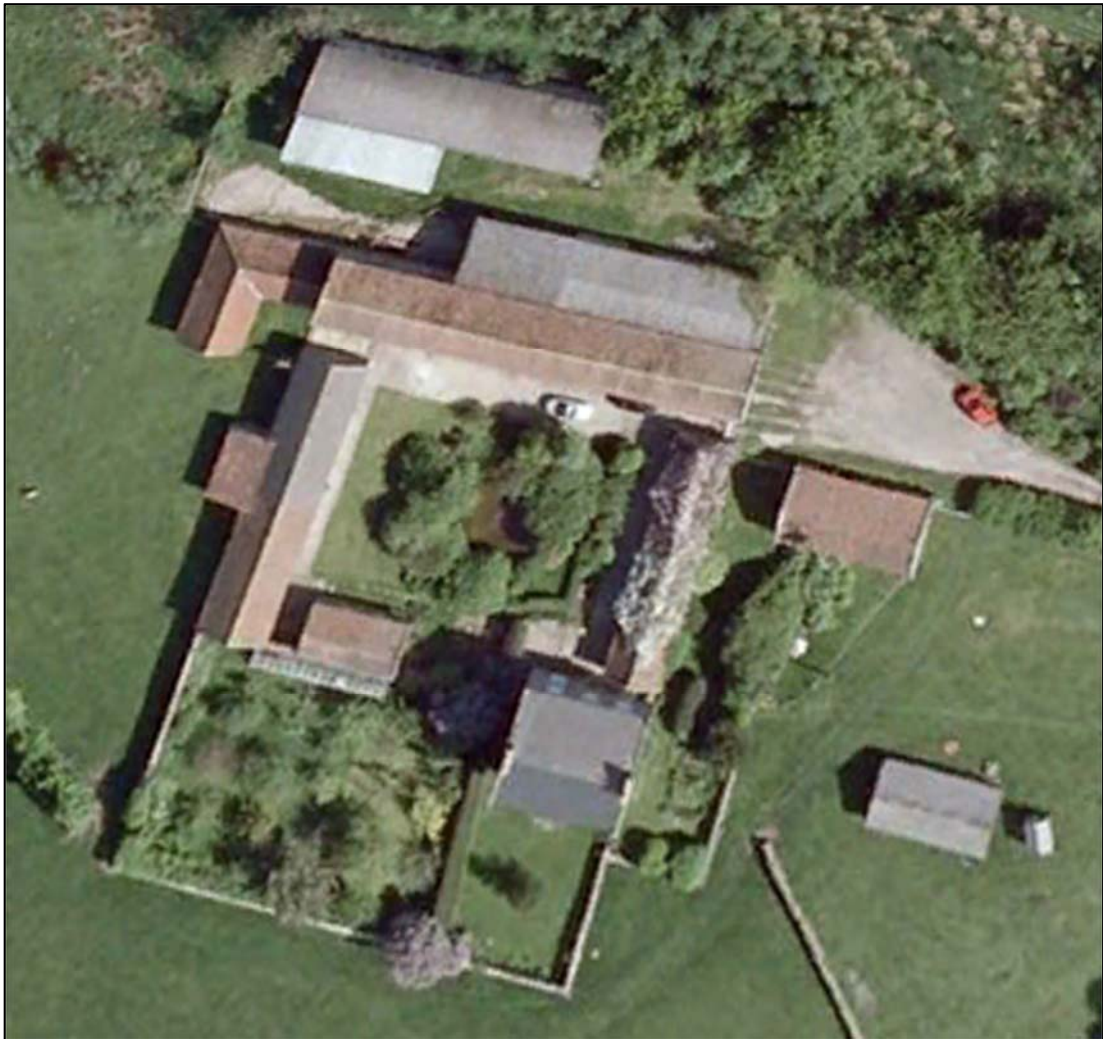
- 6.7 Cartographic evidence indicates that the demolished building abutting the south range to the rear (south) was originally smaller than those footings that remain in-situ today would suggest (Fig. 4). At some stage the building was extended east, probably in the mid to late 20th century and converted for use as a greenhouse. This was demolished between 2009 and 2017. At the time of the NAA survey only the lower wall footings

*Figure 9: historic Google Earth imagery (2009) of Thirley Cotes farm prior to its development as holiday accommodation. The demolished 'greenhouse' building is visible extending to the rear of the south range. Also visible are a series of modern agricultural building with corrugated roofs, all of which have since been demolished.*

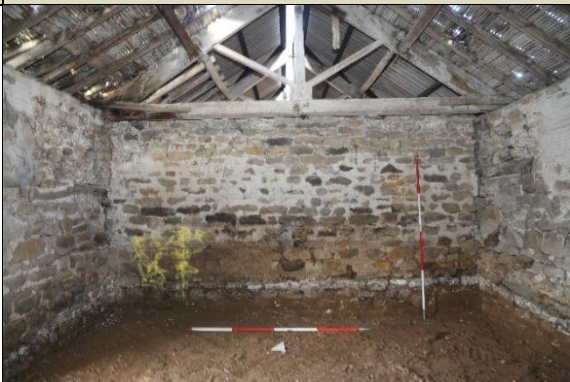
No.	Name	Description	Related Feature	Date	Significance	Photo
300	South-central room	South room - stabling. This room has been rendered with lime wash and lime plastering and still retains the original lath and plaster roof structure.	301 west door 302 east door 303 horizontal timber 304 trough remains 305 horizontal timber 310 north wall 320 east wall 330 south wall 340 west wall	Early 19th century	Moderate evidential value indicating former use.

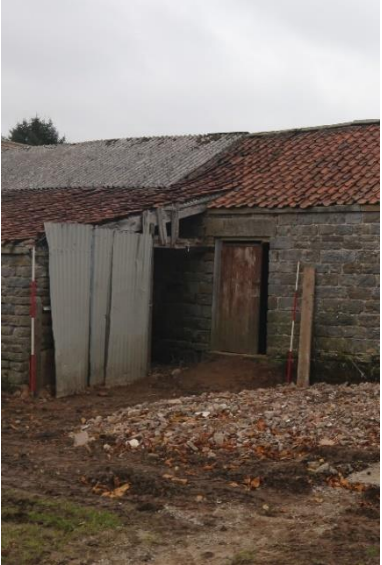
301	West door	The west door is the only other door to open directly to the fields to the west of the range. It has a large stone lintel and a single stone threshold.	101 west door 102 east door 201 west door 202 east door 302 east door 401 south loosebox door 501 north loosebox door	Early 19th century	High evidential value as an original feature of the building

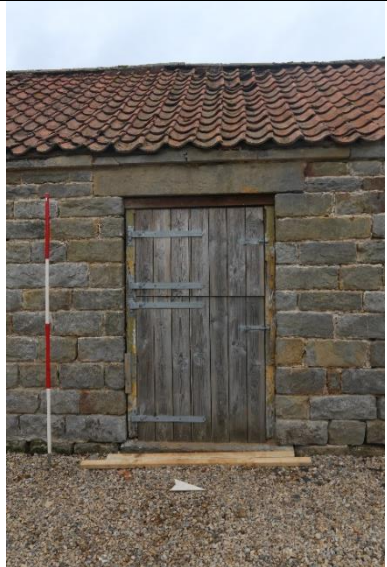
No.	Name	Description	Related Feature	Date	Significance	Photo
302	East door	The east door is wider than all other doors. It opens onto the foldyard and has a long stone lintel and threshold.	101 west door 102 east door 201 west door 202 east door 301 west door 401 north loosebox door 501 south loosebox door	Early 19th century	High evidential value as an original feature of the building.

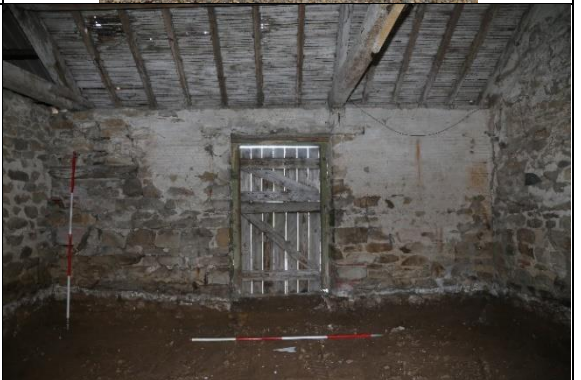
303 305	Horizontal timber	Similar to those in the north room (105, 106, and 107).	105 horizontal timber 106 horizontal timber 107 horizontal timber 110 horizontal timbers	19th century	Moderate evidential value indicating feeding trough.

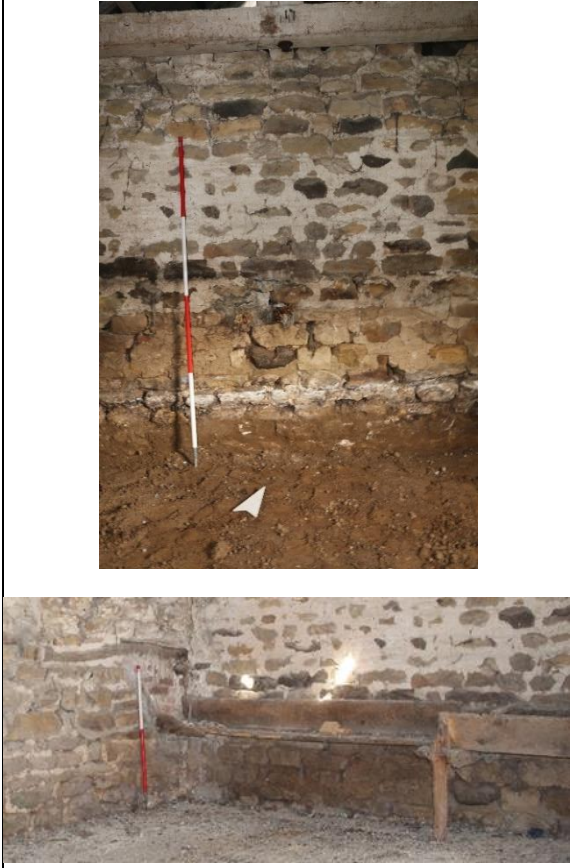
No.	Name	Description	Related Feature	Date	Significance	Photo
304	Trough remains	<p>Wooden remains of a trough set into the north wall. An upside-down, semi-trapezoid of wood is set into the north corner of both east and west walls indicating the original shape of the trough. It would have been centrally held by a wooden support set into the centre of the wall (top photo).</p> <p>Recorded by CS Archaeology, no longer present during NAA survey.</p> <p>Bottom photo by CS Archaeology 2018.</p> <p>A mid-height wooden feeding trough with a central supporting horizontal beam and leg.</p>	<p>403 trough remains 503 trough remains 2103 trough remains 2203 trough remains</p>	19th century	High-moderate evidential value as provides indication of original room function.

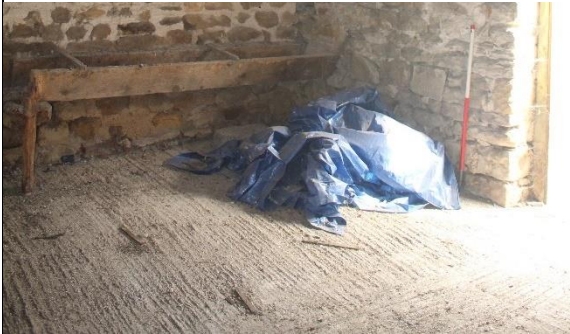
No.	Name	Description	Related Feature	Date	Significance	Photo
306	Manure / access passage	<p>Recorded by CS Archaeology, no longer present during NAA survey.</p> <p>Photo by CS Archaeology 2018.</p> <p>There are two opposing doorways (301 and 302), which are centrally located within the west and east walls, suggesting a combined access and manuring passage or walkway. The floor appears to have been raised by the addition of a concrete screed and this has been used to define and demarcate the manure / access passage between the two doorways.</p>	<p>115 manure / access passage</p> <p>209 manure / access passage</p> <p>301 west door</p> <p>302 east door</p>	19th – 20th century	Moderate–low value as evidence for the use of the space but related to the final use of building.

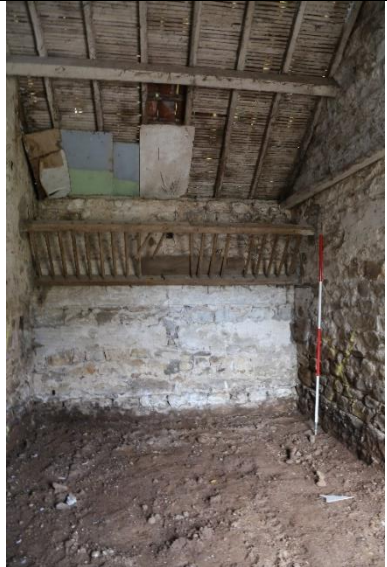
No.	Name	Description	Related Feature	Date	Significance	Photo
400	North loosebox	A narrow room accessed only from a single door onto the foldyard. It would have had two floors with a hay loft over. The hay rack and trough remains along the west wall provide proof of its use as stabling.	401 door 402 hay rack 403 trough 404 niche 405 hay loft window 406 floor beams 410 north wall 420 east wall 430 south wall 440 west wall 500 south loosebox	Early 19th century	High evidential value as it a very well-preserved example of a loosebox.

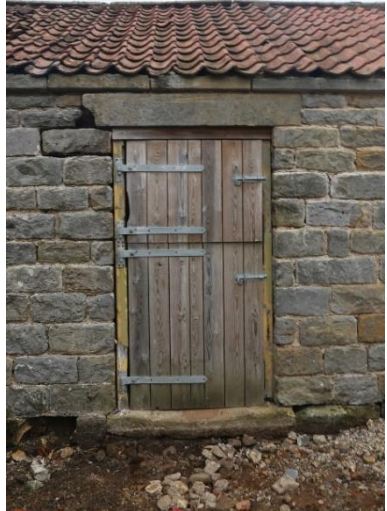
401	East door	The only access into the north loosebox, it opens onto the foldyard. It has a broken stone lintel and a large stone threshold.	101 west door 102 east door 201 west door 202 east door 301 west door 302 east door 501 south loosebox door	Early 19th century	High evidential value as an original feature of the building.

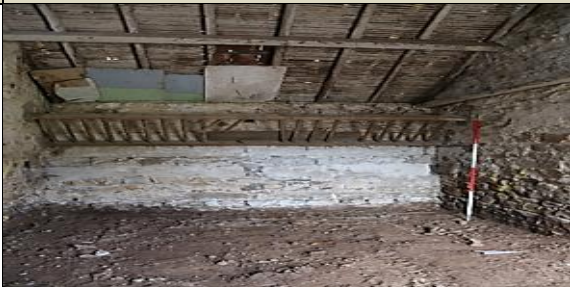
No.	Name	Description	Related Feature	Date	Significance	Photo
402	Hay rack	A large triangular wooden rack at the west end of the loosebox.	502 hay rack 601 hay rack	19th century	High-moderate evidential value as a clear indication of the use of room.

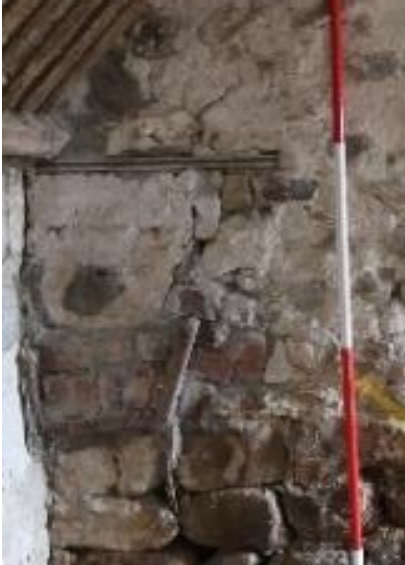
403	Trough remains	An upside-down semi-trapezoid of wood on the west corner of both the north and south wall indicating the location of the trough. The trough has been walled in with brick. Above the wooden trough remains is a wooden tie. It is unknown what purpose it served.	304 trough remains 503 trough remains 2103 trough remains 2203 trough remains	19th century	High-moderate: provides evidence for the use of this room.

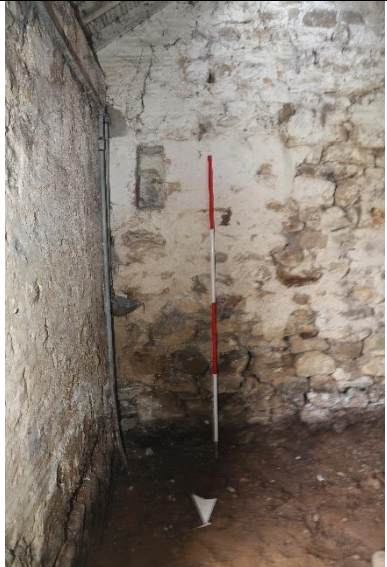
No.	Name	Description	Related Feature	Date	Significance	Photo
404	Niche	A small rectangular niche in the south-east corner. This niche has been partially filled by brick. It may originally have served for storage.	505 niche	Early 19th century later blocked	High evidential value as part of the original fabric of the building. It has since been modified.

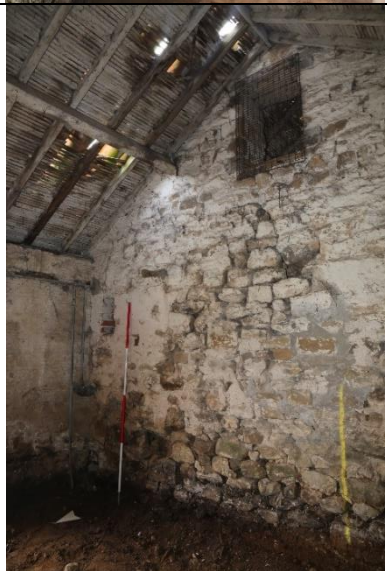
405	Hay loft window	Located on the wall at the top of the south wall, this window would have provided access between the hay lofts above both looseboxes.		Early 19th century	High evidential value as proof of the hay loft above the loosebox.

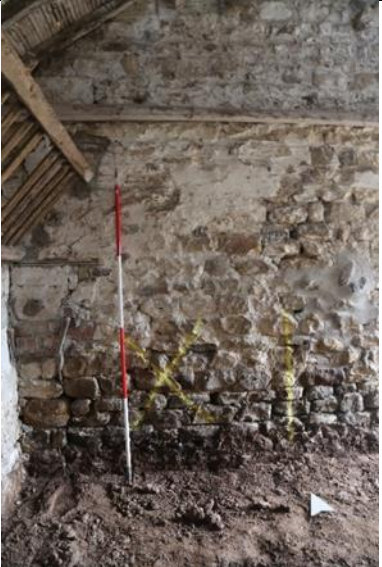
No.	Name	Description	Related Feature	Date	Significance	Photo
406	Floor support	Timber support located along the north wall used to hold the floor of the hay loft.	504 beams	Early 19th century	High-moderate evidential value as it indicates the presence of an upper floor.

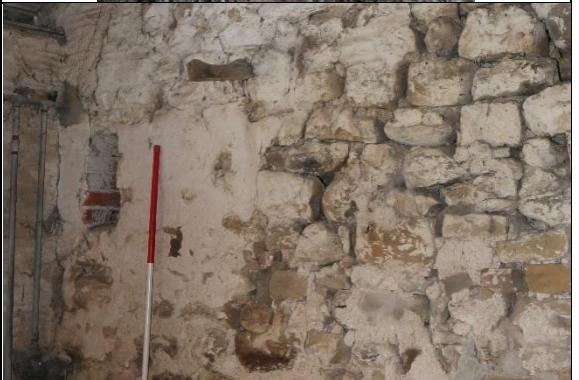
407	Floor support	Timber support projecting from the south wall used to hold the floor of the hay loft.	406 north loosebox beam	Early 19th century	High-moderate evidential value as it indicates the presence of an upper floor.

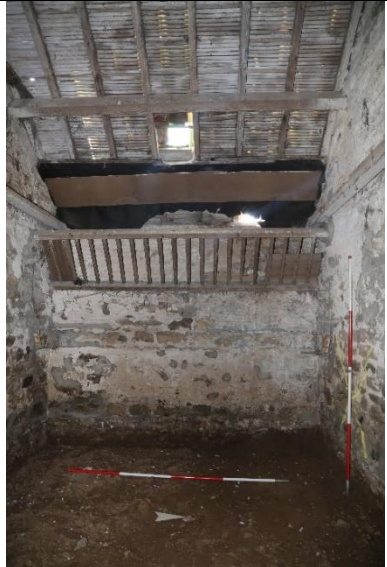
No.	Name	Description	Related Feature	Date	Significance	Photo
500	South loose box	A narrower room accessed only from a single door onto the foldyard. It would have had two floors including a hay loft. The hay rack and trough remains along the west wall.	501 south loose box door 502 hay rack 503 trough remains 504 beams 505 niche 510 north wall 520 east wall 530 south wall 540 west wall 400 north loosebox	Early 19th century	High evidential value as it a very well-preserved example of a loosebox.

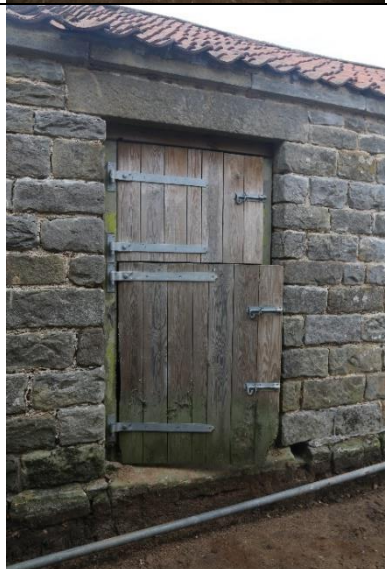
501	East door	The only access into the north loosebox, it opens onto the foldyard. It has a wide stone lintel and a large stone threshold.	101 west door 102 east door 201 west door 202 east door 301 west door 302 east door 401 north loosebox door	Early 19th century	High evidential value as an original feature of the building.

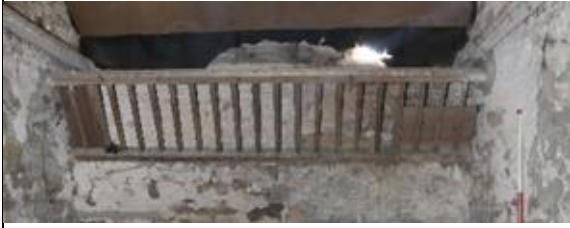
No.	Name	Description	Related Feature	Date	Significance	Photo
502	Hay rack	A large triangular wooden rack at the west end of the loosebox.	402 hay rack 601 hay rack	19th century	High-moderate evidential value.

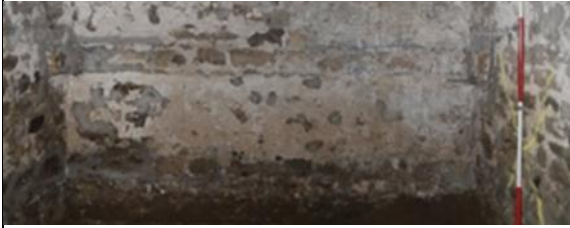
503	Trough remains	An upside-down semi-trapezoid of wood on the west corner of both the north and south wall indicating the location of the trough. There is also a scar along the west wall.	403 trough remains	19th century	High-moderate evidential value providing evidence for the use.

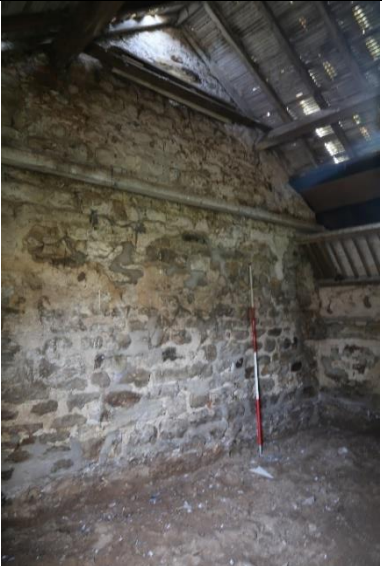
504	Beams	Projecting tie-beam located along the north and south wall used to hold the floor of the hay loft.	406 north loosebox beams	Early 19th century	High-moderate evidential value as it indicates the presence of an upper floor.

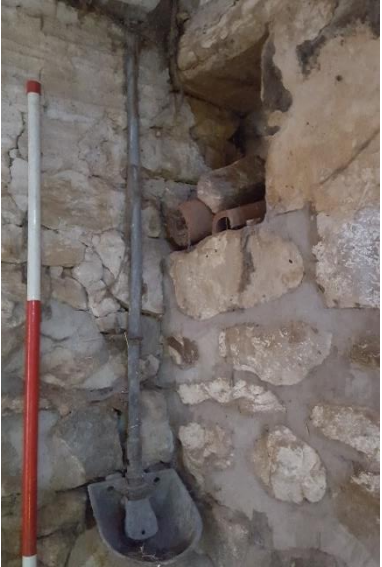
No.	Name	Description	Related Feature	Date	Significance	Photo
505	Niche	Niche partially filled with clay tiles, bricks, and pipe.	404 niche	19th century	Moderate evidential value as part of the original building fabric but poor condition.

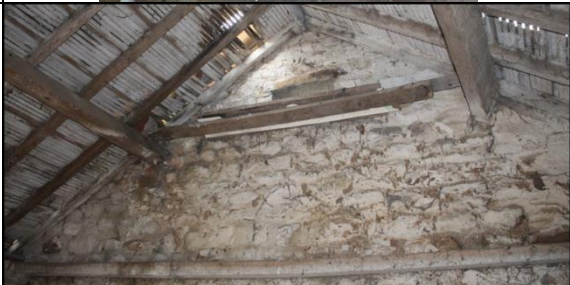
506	Opening	Short rectangular window on the gable of the south wall associated with the dovecot on the other side.	1201 Dovecot	Early 19th century	High: dovecote an important feature.

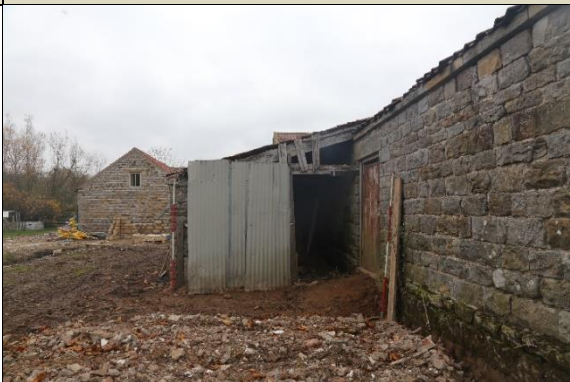
No.	Name	Description	Related Feature	Date	Significance	Photo
600	Outshot	A small outshot on the west side of the west range. Later addition, first shown on 1893 OS.	201 door 601 hay rack 602 truss 610 north wall 620 east wall 630 south wall 640 west wall	Late 19th century	High-moderate evidential value as late Victorian modification.

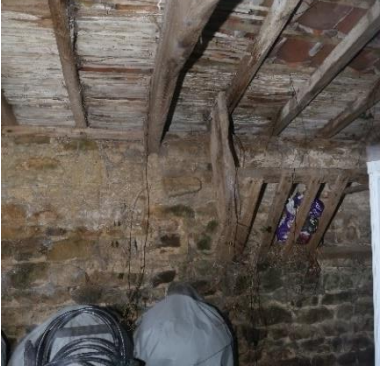
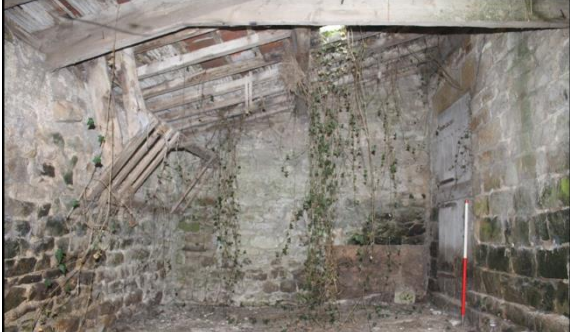
601	Hay rack	A partially dismantled hay rack located in the north-west corner of the outshot. It is tied into the wall and also hangs from the roof rafters.  The hay rack was obscured during the NAA survey.  Bottom photo by CS Archaeology 2018.	402 hay rack 502 hay rack	Late 19th century	High evidential value as indicates outshot was used for stabling.

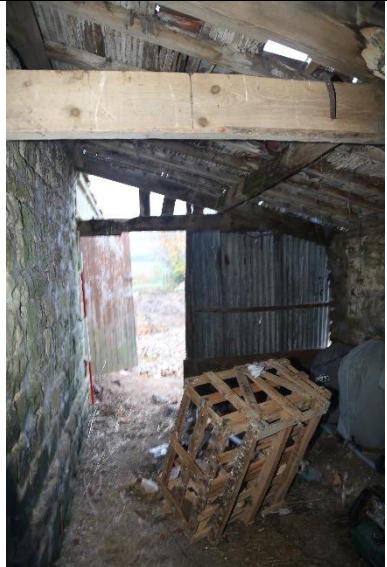
No.	Name	Description	Related Feature	Date	Significance	Photo
602	Tie beam truss	A half truss that supports the catslide roof of the outshot.		Late 19th century	High-moderate value as part of the original fabric.

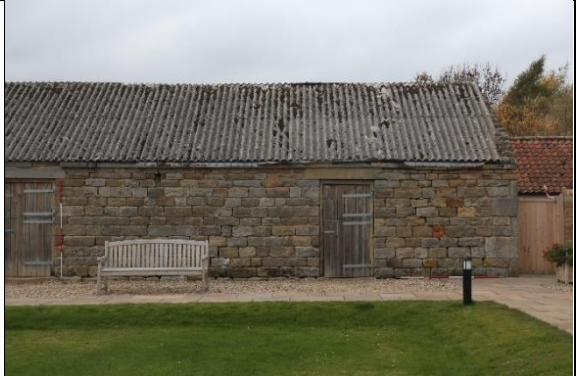
1010	East elevation	Front elevation of the west range facing onto the foldyard with primary access to all rooms of the range through five separate doors.	1011 blocked holes 1012 wooden remains 1013 ventilation slits	Early 19th century	High evidential value as primary access from foldyard and to looseboxes. Some aesthetic value.

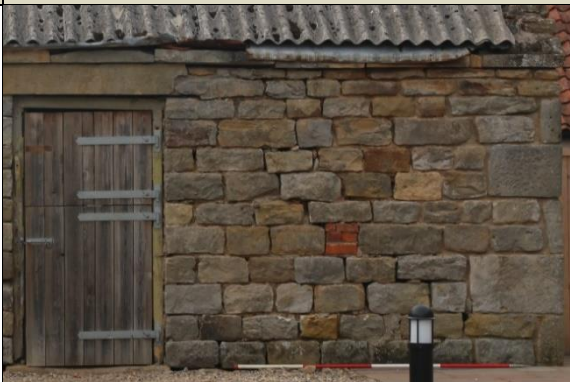
No.	Name	Description	Related Feature	Date	Significance	Photo
1011	Blocked holes	Square holes along the east elevation blocked either by stone or brick. Their use is unknown.		Early 19th century, later blocked	Moderate evidential value as indicative of specific use or structure at north end of building—exact function unknown.

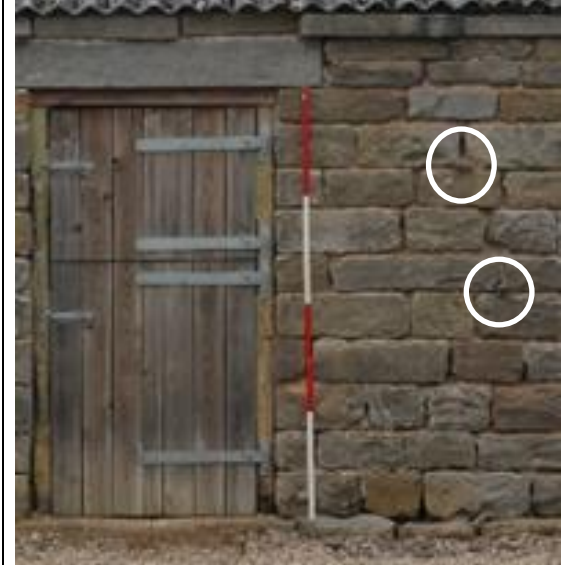
1012	Wooden fragments	Several wooden fragments protrude from the wall at various places along the elevation. Two examples are highlighted on the photo.	2302 wooden post 2303 wooden remains	19th century	Moderate evidential value although function is unclear.

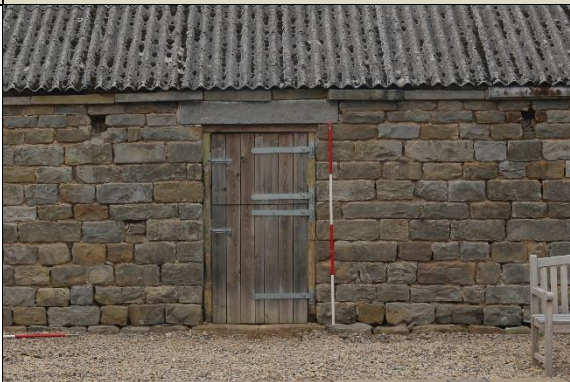
No.	Name	Description	Related Feature	Date	Significance	Photo
1013	Ventilation holes	On either side of door 302, two narrow ventilation niches flank the door. Could be putlogs for an external structure.		19th century	Moderate-low evidential value. Exact function is unknown but related to specific function at north end of building.

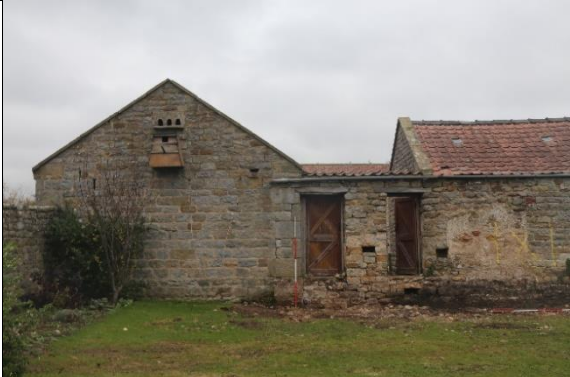
1200	South elevation	The wall is of plain stone with larger quoins. A dovecot is located near the top of the gable.	1201 dovecot 506 south loose box opening	Early 19th century	High evidential and moderate aesthetic value.

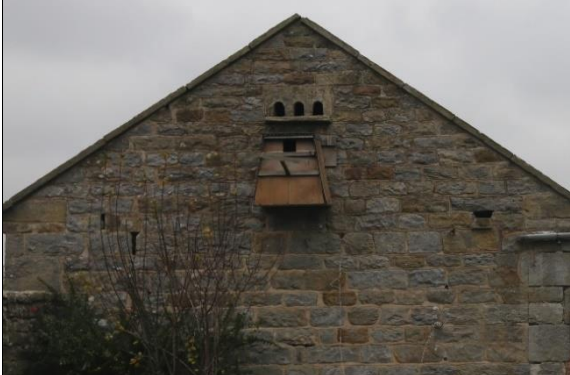
1201	Dovecot	The dovecot is composed of a single stone with three small arches over a stone ledge. Below it is placed a modern nesting box.	506 south loosebox opening	Early 19th century	High evidential and aesthetic value indicating the keeping of doves or pigeons.

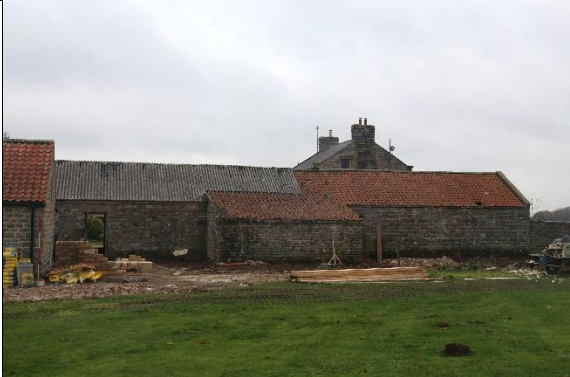
No.	Name	Description	Related Feature	Date	Significance	Photo
1300	West elevation	The west elevation includes two doors, one from 100 and another from 300. In the centre of the elevation is an outshot (600). Save the doors (101 and 301) the west elevation has few archaeological features.	101 west door 301 west door 600 outshot	Early 19th century	High evidential value as part of the original fabric.

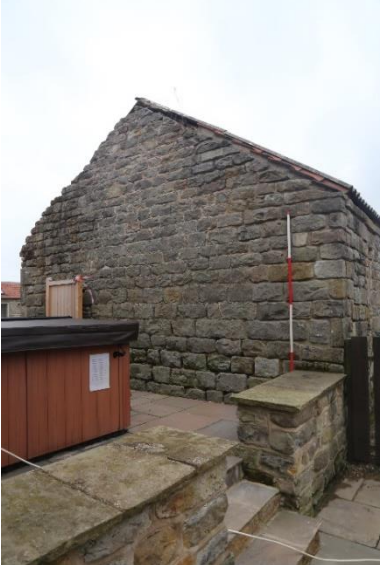
- 5.25 The north gable end elevation (1400) is largely devoid of any features. The quoins visible at the north end of the east elevation (1010) only partially survive in-situ and there are no quoins defining the north-west corner (Plate 24). The roof coping and kneelers are also missing, indicating that the end wall has been either extensively modified or rebuilt at a later stage.

1400	North elevation	A plain elevation with no archaeologically significant features. The absence of defined quoins indicates that the gable was partially rebuilt.		Early 19th century	Moderate evidential value of change over time.

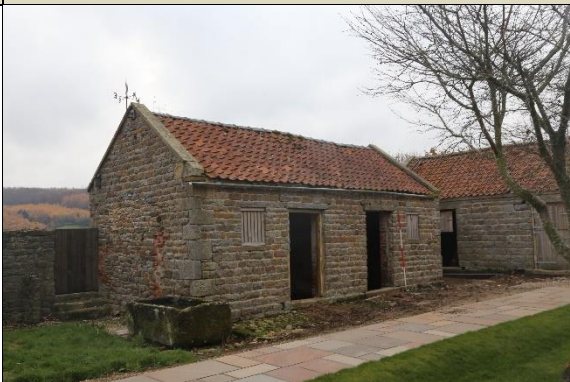
No.	Name	Description	Related Feature	Date	Significance	Photo
2000	South range	A small building used as a stable, first shown on 1912 OS map. To the rear was another, recently demolished, structure, formerly a greenhouse.	2100 west room 2200 east room 2300 north elevation 2400 east elevation 2500 south elevation 2600 west elevation 2700 greenhouse	Early 20th century	High evidential value as later development of the farmstead.

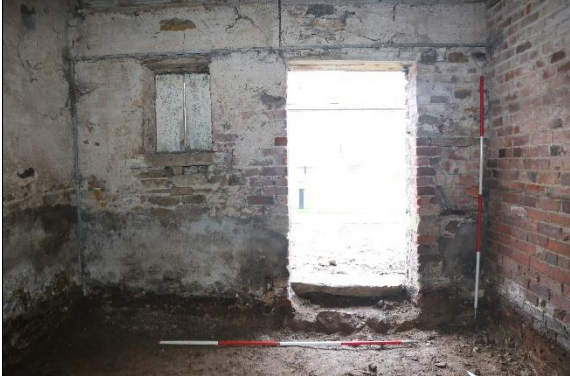
2100	West room	Accessed from the foldyard to the north. Louvre also facing north. Along the west wall, of brick rather than stone, was a hay rack and trough.	2101 west door 2102 louvre window 2103 trough remains 2104 swallow holes 2105 wall scar 2106 ventilation holes 2107 horizontal timbers 2110 west wall 2120 north wall 2130 east wall 2140 south wall	Early 20th century	High evidential value as evidence of the original fabric of the building.

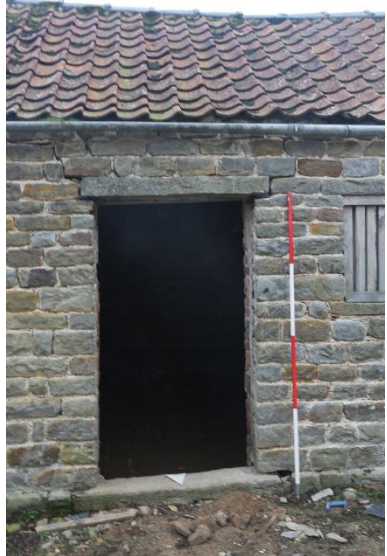
No.	Name	Description	Related Feature	Date	Significance	Photo
2101	West door	Door with a stone lintel and stone threshold. The interior lintel is of wood. The doorway currently has no frame or door.	2201 east door	Early 20th century	High evidential value as evidence of the original fabric of the building.

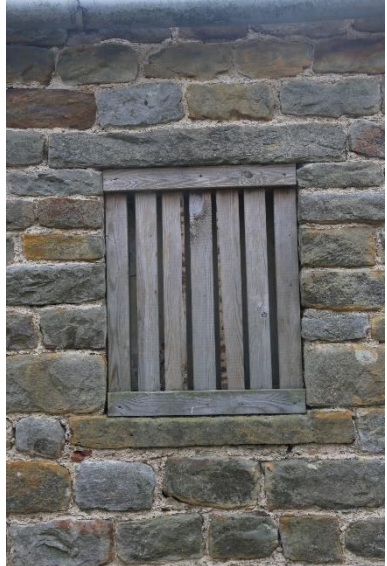
2102	West louvre window	A wooden louvre composed of seven vertical slats held by two horizontal slats on either end. This louvre is boarded up on the inside.	2202 east louvre window	Early 20th century	Moderate evidential value as evidence of the original use of the building for horses.

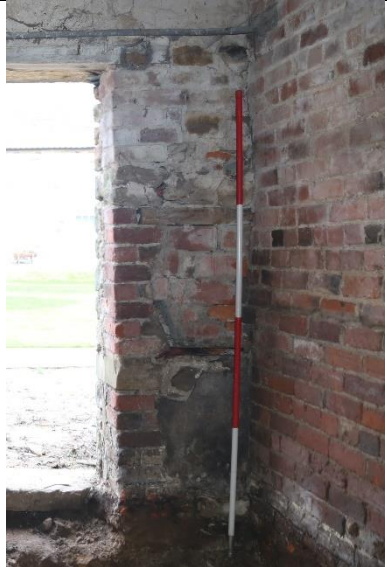
No.	Name	Description	Related Feature	Date	Significance	Photo
2103	Trough remains	An upside-down semi-trapezoid of wood fit into the bricks in the walls. It would have spanned the whole length of the wall with the help of a wooden support extending from the centre of the wall. A scar can be seen running along the length of the wall.	304 trough remains 403 trough remains 503 trough remains 2203 trough remains	Early 20th century	Moderate evidential value as evidence of use of the building.

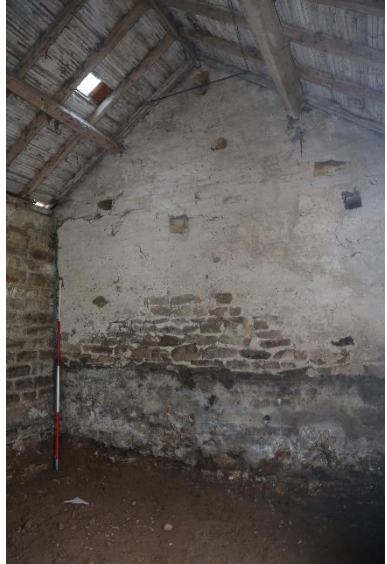
2104	Swallow holes	Small holes in the walls for birds.		Early 20th century	Moderate evidential value as it is not associated with historic use or phasing of building.

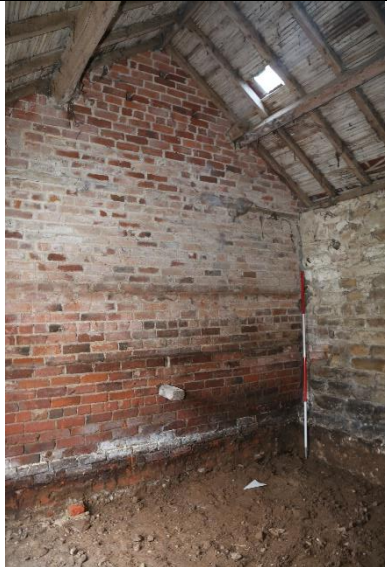
No.	Name	Description	Related Feature	Date	Significance	Photo
2105	Wall scar associated with hay rack	Two wall scars can be seen. The top one is associated with a hay rack.	2204 hay rack wall scar	Early 20th century	Moderate evidential value as provides evidence for the presence of a hay rack.
