BUILDING RECORDING

NEWBIGGIN HEARSE HOUSE,
NEWBIGGIN,
COUNTY DURHAM

19/64
June 2019

**NEWBIGGIN HEARSE HOUSE
NEWBIGGIN, COUNTY DURHAM
BUILDING SURVEY**

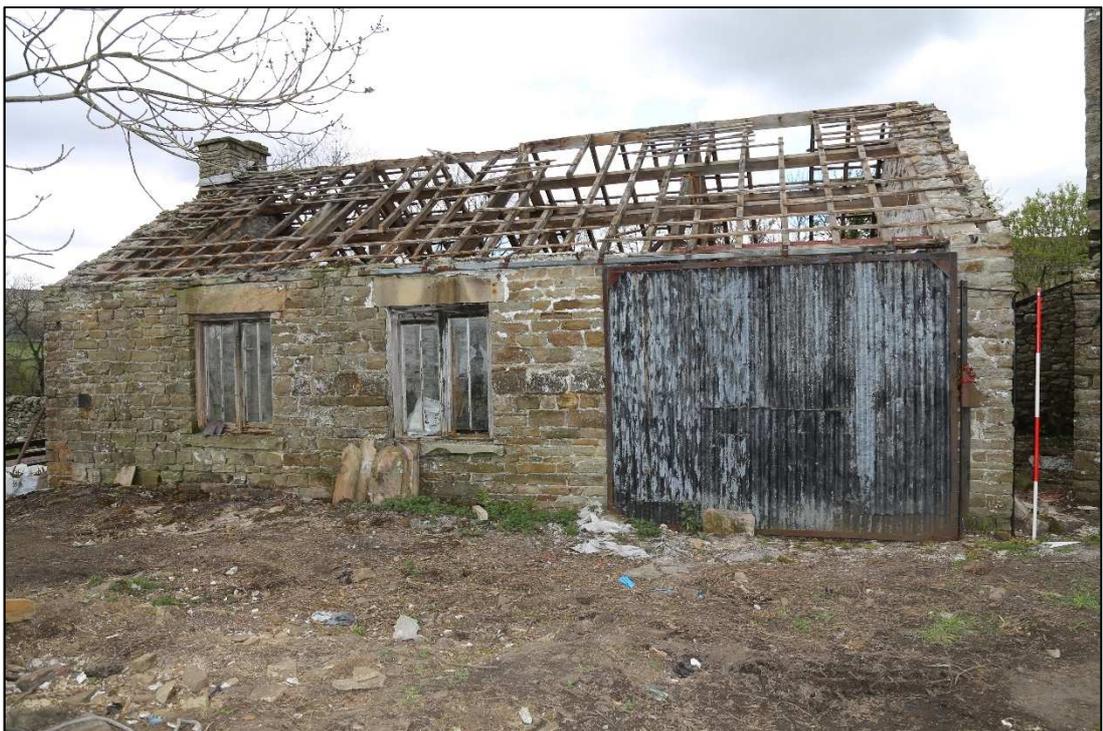
Plate 14: east elevation of the workshop.

- 5.12 The east elevation (Plate 14; Fig. 8) is the front of the workshop. A large sliding corrugated-metal door **2121** provides the only access into the building. Beside it are two windows **2122** and **2123** with stone lintels and sills. The north window **2122** has round holes cut into the north half of the sill (Plate 15) which may have been used for a shutter. These holes are not replicated elsewhere.

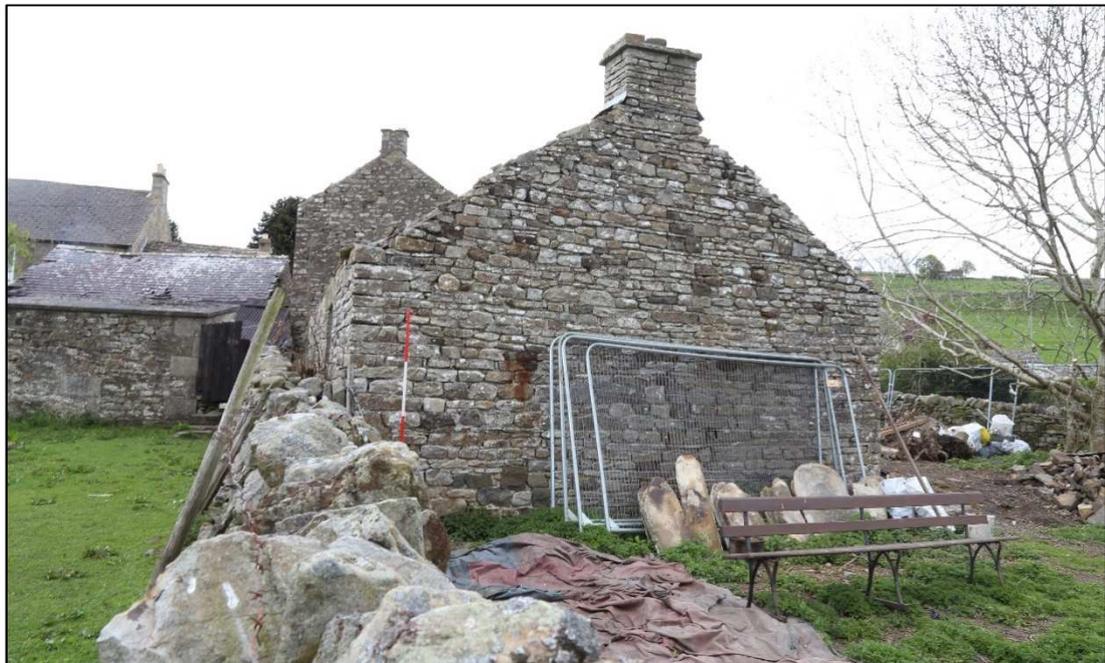
Plate 16: south and west elevations looking north-east.

- 5.13 The south elevation (Plate 16; Fig. 9) is gabled, and topped with a chimney **2131**. A single small vent is located in the centre of the wall and would have provided ventilation for the forge on the other side of the wall.

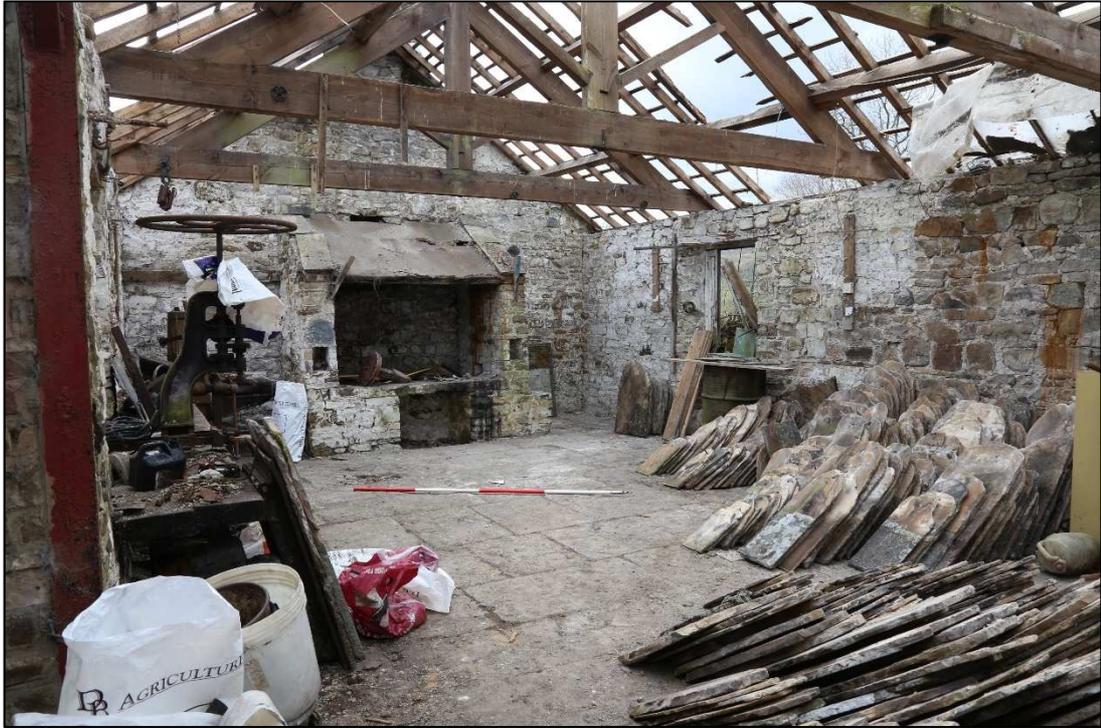
Plate 17: interior of the workshop looking south-east. A drill press is located on the table along the east wall.

- 5.15 The workshop was once protected by a stone-flagged roof, which has now been removed due to safety concerns with the flags now stacked on the flagstone floor **2101** (Plate 17). The roof structure **2102** remains and consists of three king-post trusses with offset purlins that join at the middle truss (Fig. 11; Plate 18).

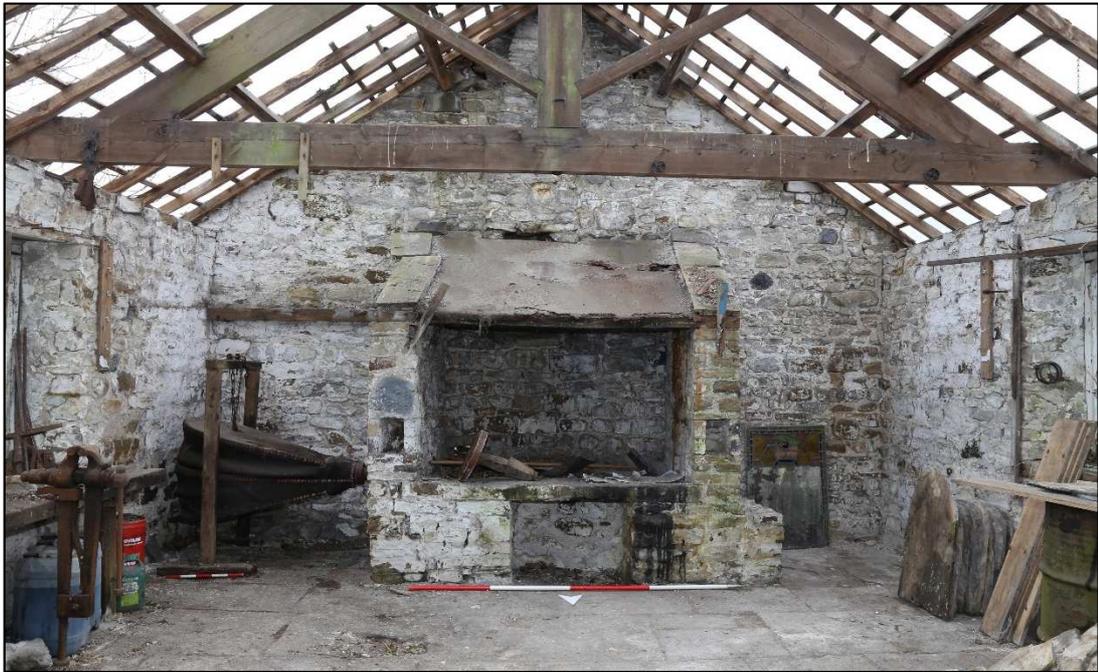
Plate 21: forge and bellows located on the south wall of the workshop.

5.18 Most of the south wall is covered by the forge and bellows (Plate 21; Fig. 12). The forge consists of a large stone hearth **2131**, which is capped by the chimney **2132** (Plate 22). The hearth measures approximately 2.5m across the south wall at a height of 2m and is typical of a blacksmith's forge. The key to a successful forge is being able to control airflow in order to control the heat of the fire (Bealer 1995). Air comes from the *tuyere* **2138** (Plate 23), which is attached to the bellows (it serves as a connector between the forge and the bellows). Vents in the rear of the forge **2133** (Plate 24) or to the side **2135** (Plate 25) may have also been used for extra ventilation or to remove excess ash or debris in the hearth. Two niches on either side of the forge **2134** may have been used for storage along with the one below **2136** (Plate 26). On the side of the forge is a long bench **2137** (Plate 27), which may have held a water trough for cooling tools and creations.

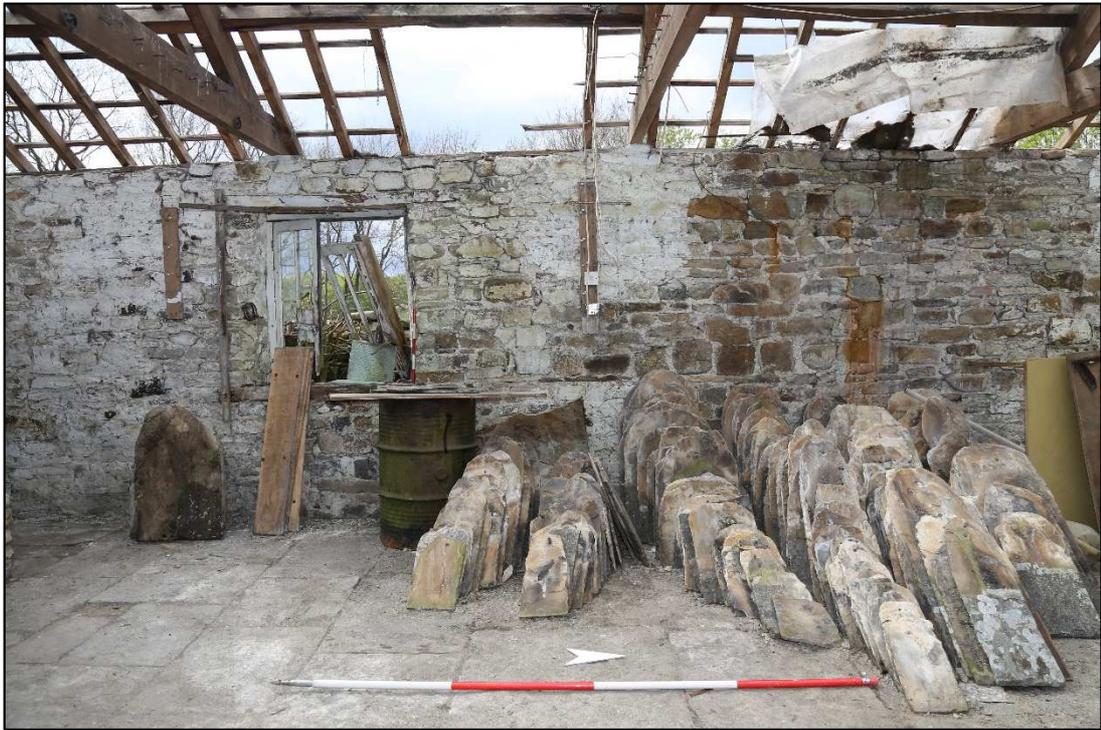
Plate 28: west wall of workshop.

- 5.19 The west wall (Plate 28) contains a single window **2141**, with wooden sills and lintels partially splayed. Some parts of the wall are limewashed. More limewash appears on other wall and would originally have covered most of the building due to its antibacterial properties.

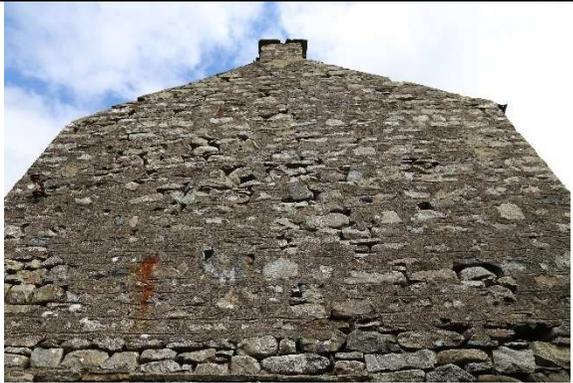
Context	Name	Description	Related Features	Photograph
1032	horizontal scar	The horizontal scar is formed from pointing and may have originated as the seam between a temporary shelter and the walls of both the hearse house and workshop. The scar is approximately 1.75m long and approximately 2.5m above the ground.

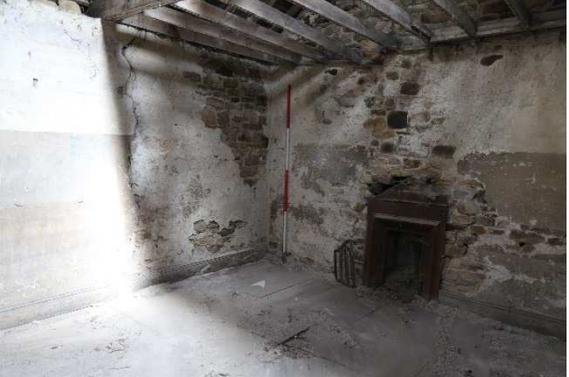
Context	Name	Description	Related Features	Photograph
1210	north-east wall	The north-east wall contains a small fireplace with skirting board running along the east side of the wall between the fireplace and the south-east wall. Some of the plaster has fallen away above the fireplace.	1211 – fireplace 1204 – skirting board
