HISTORIC BUILDING
RECORDING

ONE STRAWBERRY PLACE
NEWCASTLE UPON TYNE

prepared for
BAM

NAA 20/70
August 2020

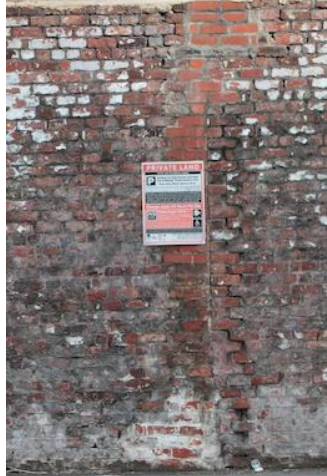
Plot	Number	Name	Description	Phase	Photo
A	100	North car park wall	South retaining wall of Plot A. The wall is composed of brick with several phases of alteration and repair.	Pre-1830 with subsequent alteration	See Fig. 12
A	110	South elevation	South elevation standing 5.11m above Plot C and is 29.5m long. This elevation is largely in English Garden Wall bond, with building scars and filled in holes.	Pre-1830 with subsequent alteration	See Fig. 12
A	111	Vertical scar	A vertical building scar that descends most of the length of the wall. It is located 5.36m from the west end of the wall. The bond and brick type are similar on both sides.	Pre-1830

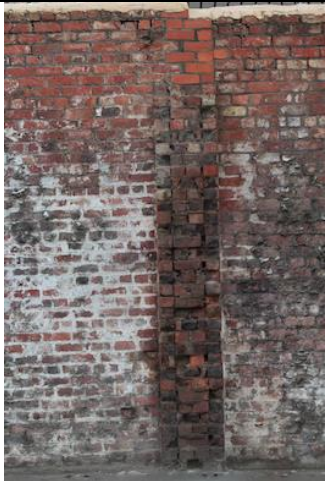
A	112	Wall remains	Scar from wall now removed. May have started as a yard wall but later became an internal wall of depot. The remains are 0.68m wide and protrude 0.25m from wall A110.	Pre-1860 with subsequent alteration

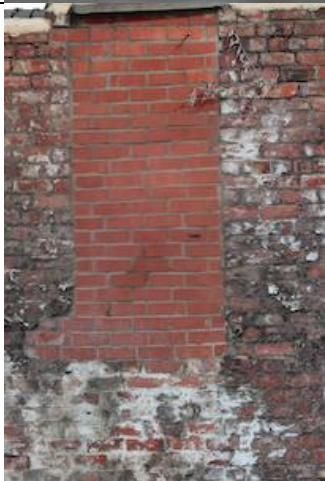
A	113	Blocked doorway	Blocked doorway once providing access between depot and alley to Strawberry Place. It is 1.22m wide and 2.9m high.	Pre-1860 with subsequent alteration

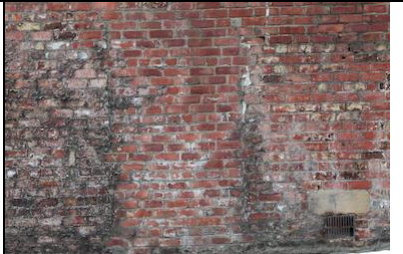
- 6.5 The OS 25-inch 1940 map shows the demolition of the stable. It is likely that the repairs in the wall at **A114** occurred at this time. The east access would also have been blocked up, but that section of the wall was later destroyed and rebuilt with the modern construction of the student accommodation block, as evidenced by the remaining footings **A116**. The 1940 map shows retention of the access to the building from the alley to Strawberry Place, so the blocking of door **A113** would have occurred after the demolition of the depot to make way for the car park. This is most likely the date for the demolition of the internal depot wall **A112**

A	114	Wall repair scar	Wall scars on east side of A110 showing the possible west stable access. At the base of this wall the width of the scar is 1.76m. The opening was later blocked and repaired in two subsequent phases of intervention	Pre-1896 with subsequent alteration

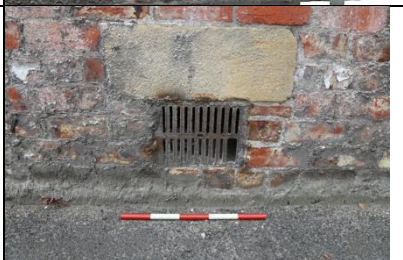
A	115	Wall vent	Vent in wall is 0.43x0.33m. The vent probably dates to the walls use as a stable.	Pre-1896 with subsequent alteration

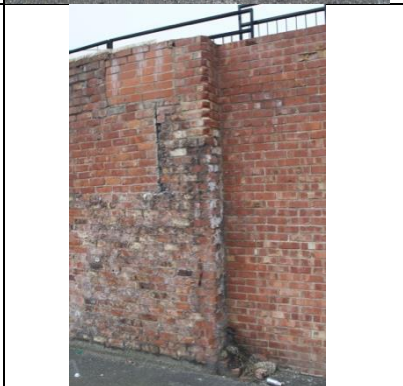
- 5.5 The joint **A116** between walls **A110** and **A120** has a slight offset; elevation **A110** is set 0.43m out from wall **A120** (Plate 2). The bricks of wall **A110** are rounded-off near the joint indicating that the wall would have culminated naturally prior to the addition of wall **A120**. However, the presence of a few bricks at the base of this joint indicate a wall footing of another addition prior to the modern wall **A120**. However, the footings abut wall **A110**, demonstrating that whatever wall these bricks belonged to, it post-dated wall **A110**.
- 5.6 The north elevation **A130** of the wall is 0.89m high and is alike the south elevation **A110** showing bricks in English bond, with occasional repairs of modern brick to match those of elevation **A110**.

A	116	Wall joint	Wall joint and footings. Joint between modern wall and east end of wall A110. A line of historic rounded brick protrudes 0.03m from the modern abutting wall. At the foot of this joint are a couple of wall footings that post-date wall A110, but pre-date the modern brick wall A120 that abuts it.	Pre-1896 with evidence of mid-20th century alteration

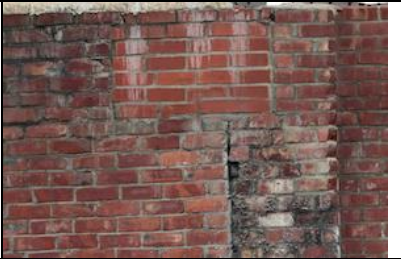
A	117	Blocked opening	A small opening in the top of wall A110 has been blocked with modern brick. It is 1.25x0.83m and may be a blocked window from the mid-20th century.	Mid-20th century with modern alteration

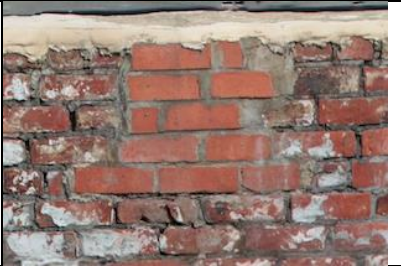
A	118	Blocked openings	A series of three blocked openings near the top of the wall. These were probably used to accommodate wall furniture and later blocked. The holes average 0.74m wide and 0.54m high.	Unknown

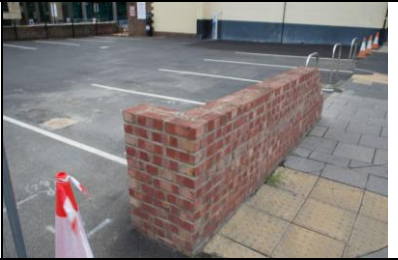
- 5.7 On the north boundary of Plot A is a short section of brick wall **A200** that separates the car park from the pavement (Plate 3). This wall is constructed of similar brick and bond to wall **A120** and is likely to date from creation of the car park.

A	200	North wall	Modern wall built concurrently with the car park.	Modern

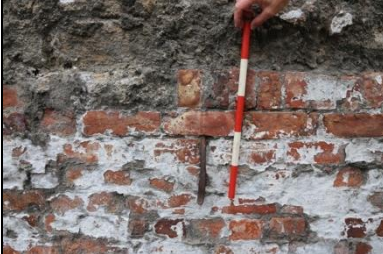
B	141	Metal rod	A metal rod embedded in the brick base of wall B100. The rod (c.0.2m long) has been bent over and may have been used for tying or holding items to the wall.	Unknown

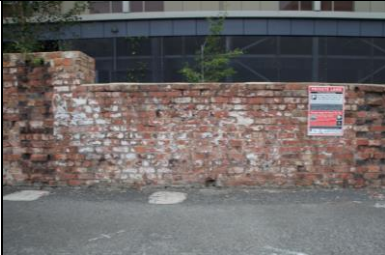
C	111	Vertical building scars	Two scars 5m apart, each 0.64m wide These are likely to be the vestiges of internal division walls in the depot.	Pre-1896 with subsequent alteration

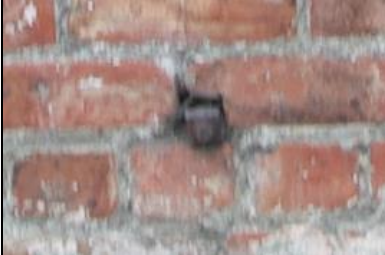
C	112	Bolts	A series of 4 bolts each spaced 2.3m apart. They are roughly 1-inch diameter bolts that extend out c.0.2m from the east elevation.	Unknown

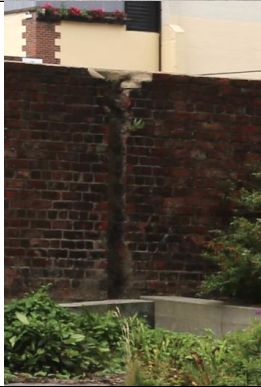
C	141	Grooves	Two long grooves extend down the length of the wall. These are c.0.15m deep and 0.15m wide. They may have been used to hold a gutter.	Unknown

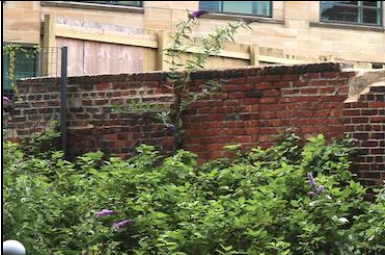
C	151	Wall scar	Faint wall scar between two sections of English Garden Wall bond, 1.5m from north end of wall section. The scar is more prominent on the east elevation.	Post-1896

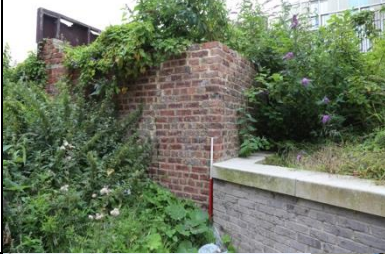
C	200	South wall of car park	A short c.3.75m section of wall standing c.2.5m high of brick in English Garden Wall bond showing several repairs of unknown date.	Pre-1830 with subsequent alteration

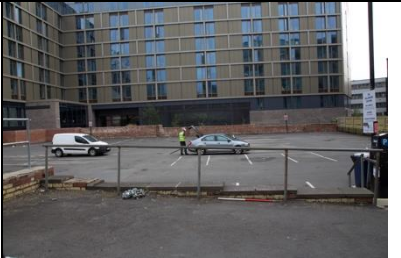
D	210	West elevation	West elevation. This wall contains only two courses of glazed yellow brick, now stepped down to accommodate the slant in the car park. At the end of each stepped course is a red brick addition.	Pre-1896 with subsequent alteration

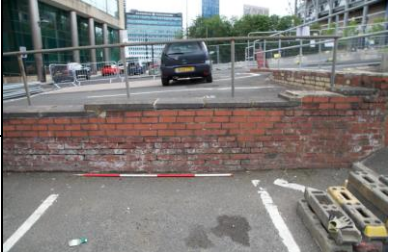
D	220	East elevation	The lower courses are composed of older red brick in a variant of common bond. Upper courses contain more recent brickwork in stretcher bond.	Pre-1896 with subsequent alteration

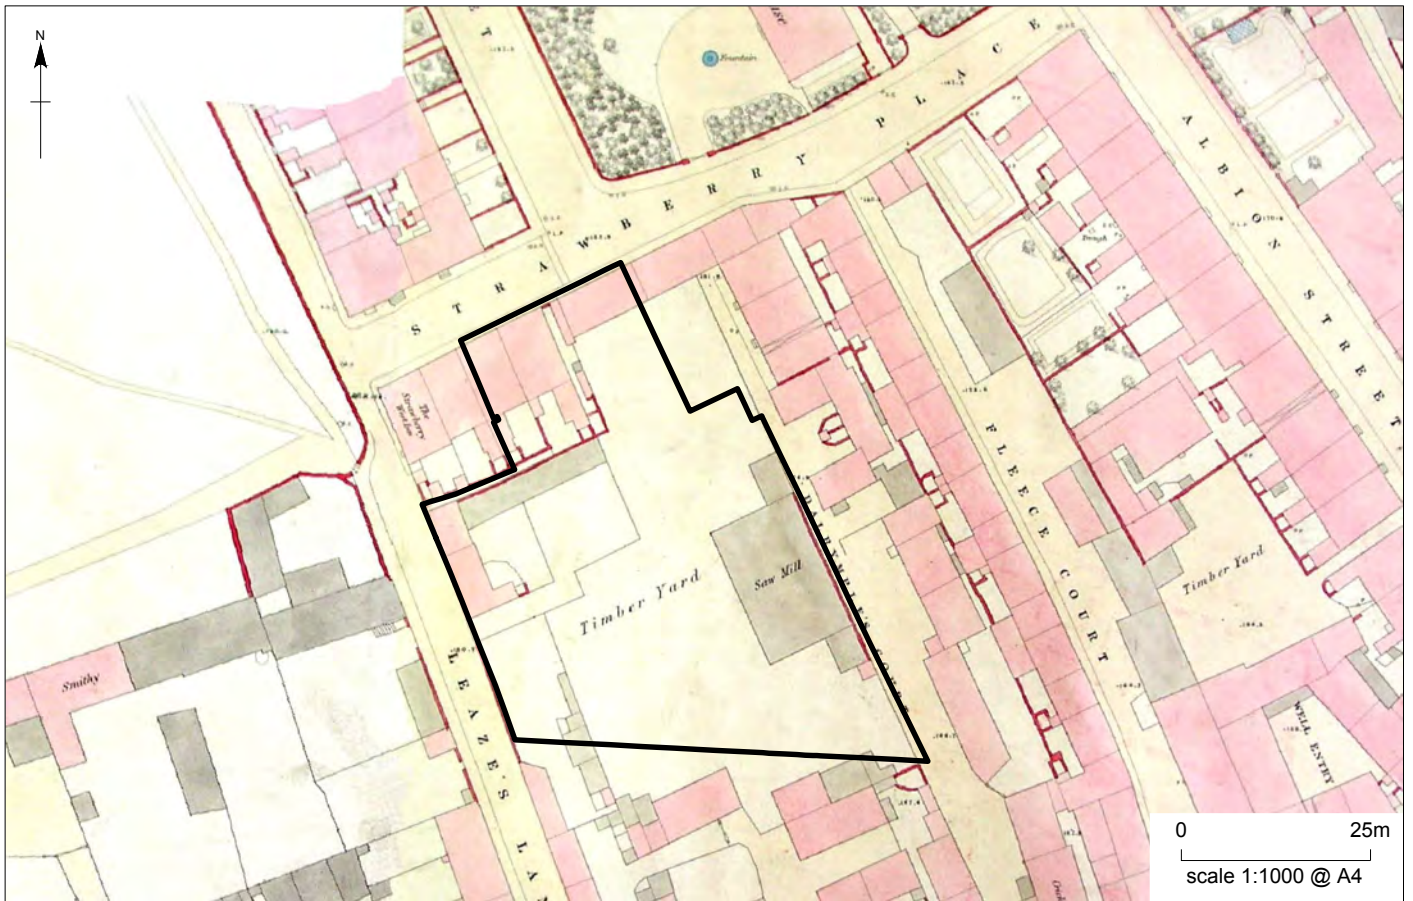
Figure 6

6.1 Wall **A100** is first visible on the 1830 map (Fig. 6) running behind the properties fronting Strawberry Place. It separated the alleyway and house garden from the main gardens in the rear (now Plot C). This map shows three properties in what is now Plot A. Of these, the two plots to the west, adjacent to the pub, stretched north–south the whole length of Plot A. These buildings were reached by a small alley that ran along the rear to the central building in Plot A. The garden wall **A100** separated this snicket from the garden to the south. Another alley ran perpendicular to wall **A100**, right through the centre of what is now Plot A. East of this alley, another building lay perpendicular to it with a garden in the rear. This garden was separated from the larger garden to the south by a garden wall **A100**. The map does show a small gap in the length of the wall, but the scar of such a gap is not present on the current wall and may instead have been a door. Considering the whole of wall **A100** was most likely present by 1830, the repair scar **A111** must therefore pre-date this period. There is no documentary evidence for this repair.

- 6.11 Wall **C100** is first visible in Oliver's 1830 map (Fig. 6) and once separated Dalrymple Court from the gardens to the west. However, the First Edition OS map (Fig. 7) seems to imply that only a section of this wall, the eastern boundary of the sawmill, was made of brick. It is therefore uncertain when the wall was constructed. Yet, most of wall **C100** appears of a similar construction and likely dates from a single phase. The adjacent wall to the south, **C200** was potentially built at a similar time. It too appears on both the 1830 and 1860 map, although it is specifically drawn as brick on the 1860 OS map (Fig. 7).

- 6.14 Wall **C200** served many purposes. It is first depicted in 1830 as separating the gardens of Plot C from the back yards of houses fronting Gallowgate (Fig. 6). It remains in 1860 (Fig. 7) as the division between the sawmill yard and the domestic yard of Gallowgate houses. It then seems to have been severely reduced by 1896 as it forms a short division within the van yard south of the furniture depot. By 1930, it separates the warehouse to the south from a midden to its north.

One Strawberry Place, Newcastle: extract from Oliver's map of 1830

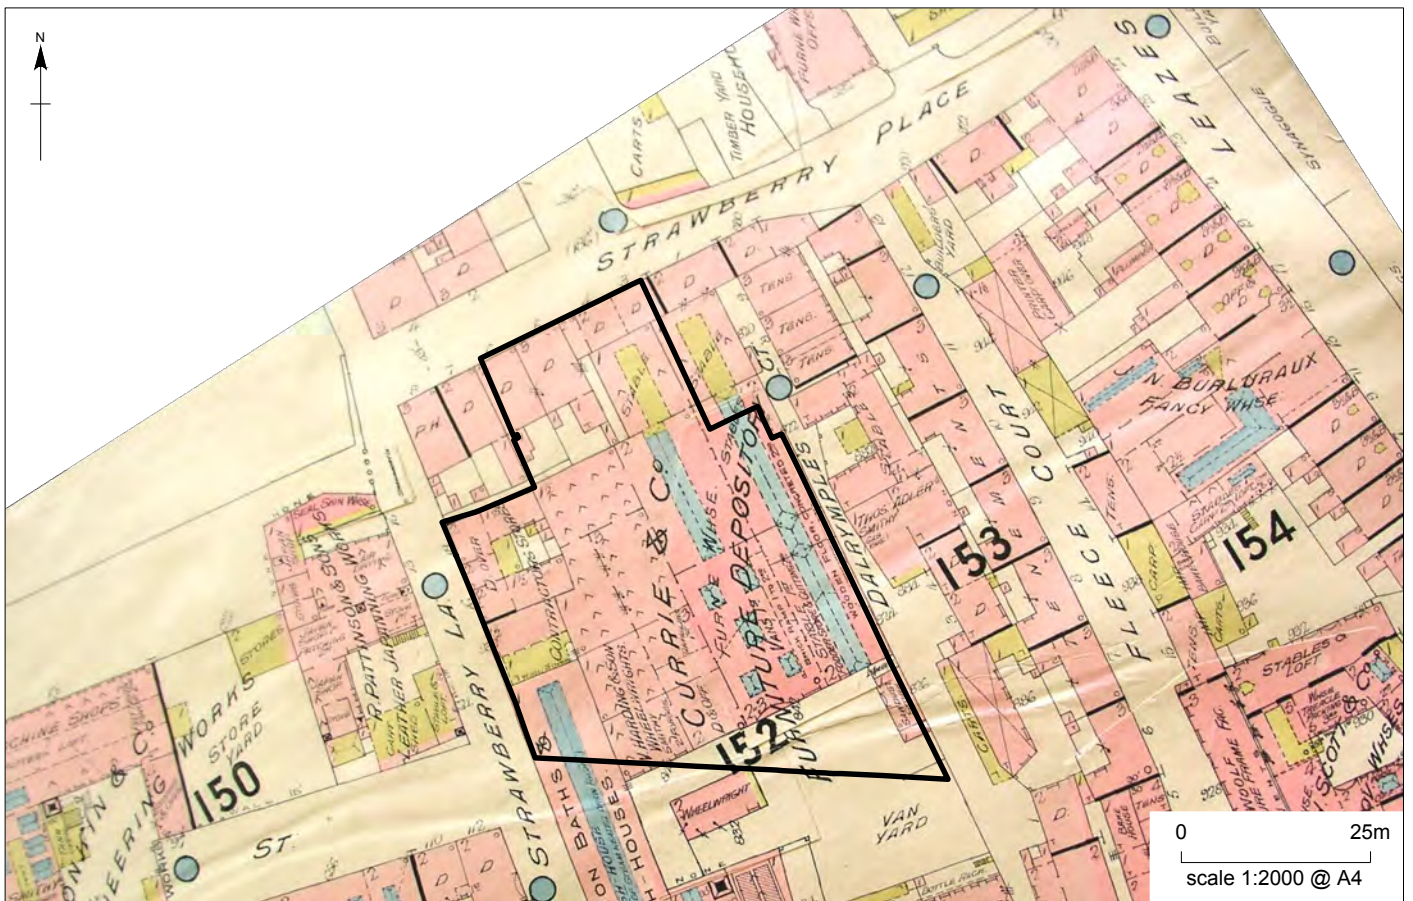
Figure 7

6.3 By the time of the First Edition 25-inch OS map in 1860 (Fig. 7), the layout of the buildings remained the same except for the gardens to the rear. These had been replaced with a series of walls creating yards behind the buildings fronting Leazes Lane. The eastern-most of these walls joined with wall **A100**. This wall is likely to be the source of the wall remains **A112**. The use of this wall in 1860 is uncertain, but on the Goad Insurance map of 1896 (Fig. 8) it appears as an internal division within the furniture depot. To the left of this wall, the small alley running to Strawberry Place visible in 1830 is still in place. This alley may have culminated in an access door, now blocked **A113**, connecting the furniture depot with Strawberry Place.

- 6.6 Wall **B100** first appears in documentary evidence in the First Edition 25-inch 1860 OS Map (Fig. 7) where the garden visible on the 1830 Oliver's map (Fig. 6) was replaced by two buildings fronting what was then Leazes Lane. Behind these buildings was a long shed of either wood or metal and a small yard. On the First Edition OS map, brick walls were denoted as red (e.g. **A100**), but the black colour of this boundary indicates it may have been a fence, over which a brick wall was built by the time of the Goad Insurance map of 1896 (Fig 8).

One Strawberry Place, Newcastle: Ordnance Survey
First Edition map of 1860

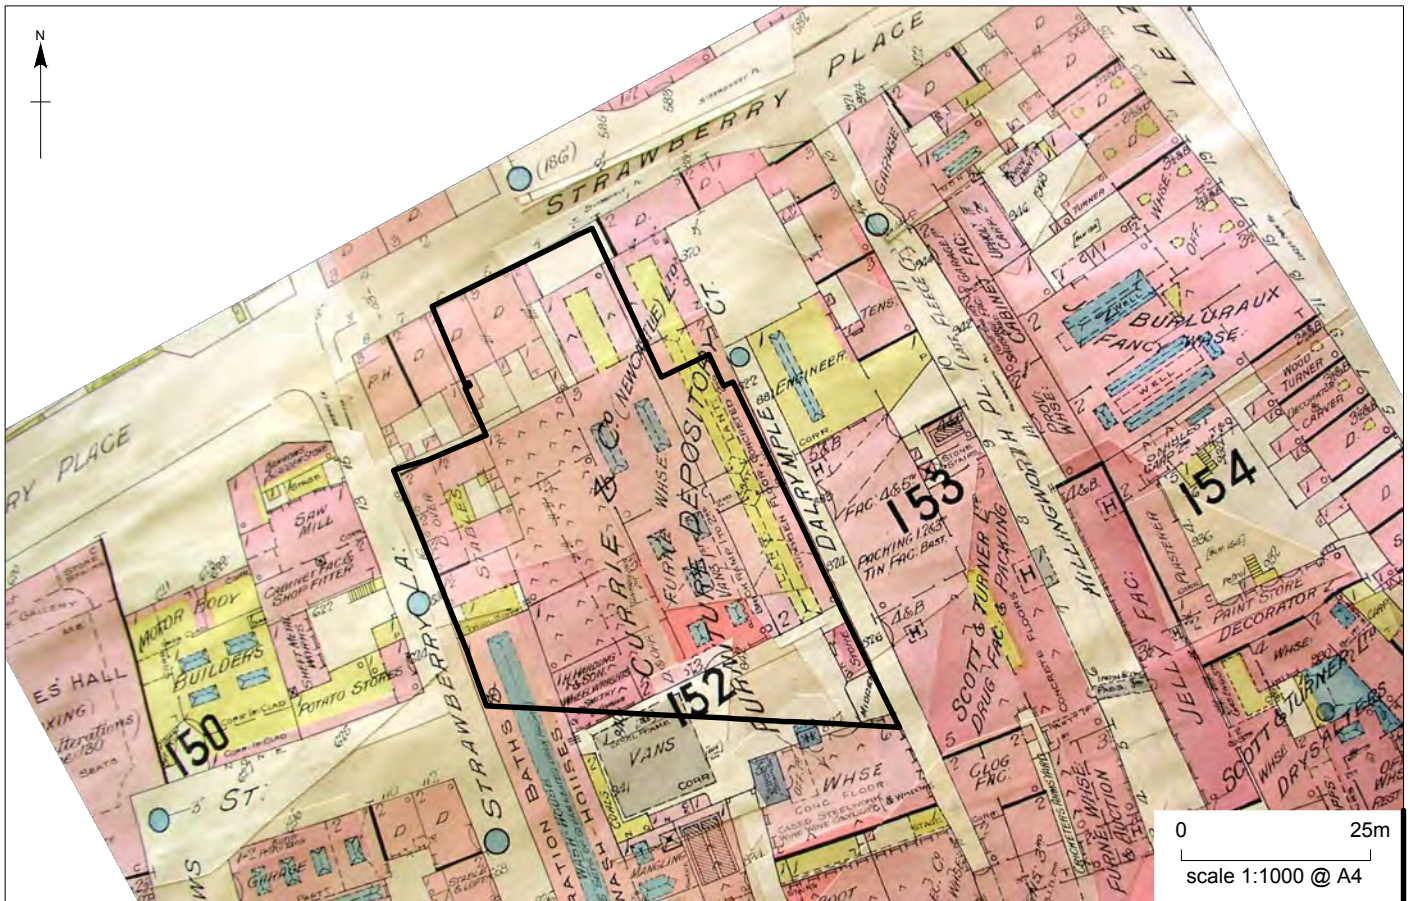
Figure 8

- 6.16 The walls of the south and west elevations of Plot D have glazed brick. These would have been used internally in what was once the Corporation baths and wash houses. The baths building first appeared on the Goad Insurance map in 1896 (Fig. 8), prior to which the area was part of a yard for buildings fronting Leazes Lane (Fig. 7). The presence of glazed brick matches the use of the building as baths. The later addition of red bricks occurred in the demolition of the building and the capping of walls to create the car park.

One Strawberry Place, Newcastle: extract from the Goad Insurance
plan of 1896

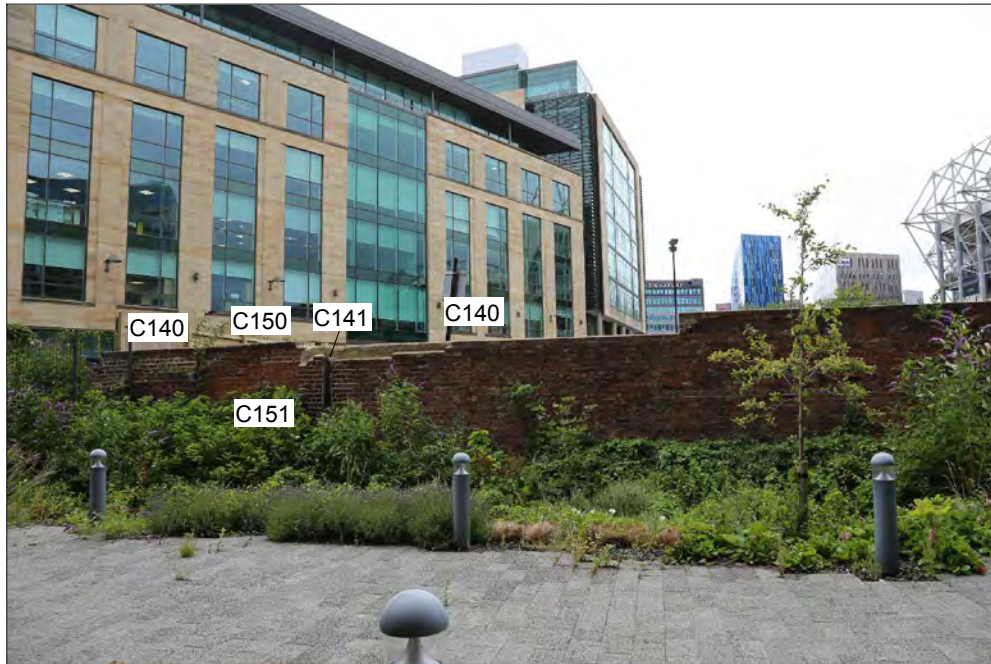
Figure 19

One Strawberry Place, Newcastle: photo of east-facing elevation of wall C100

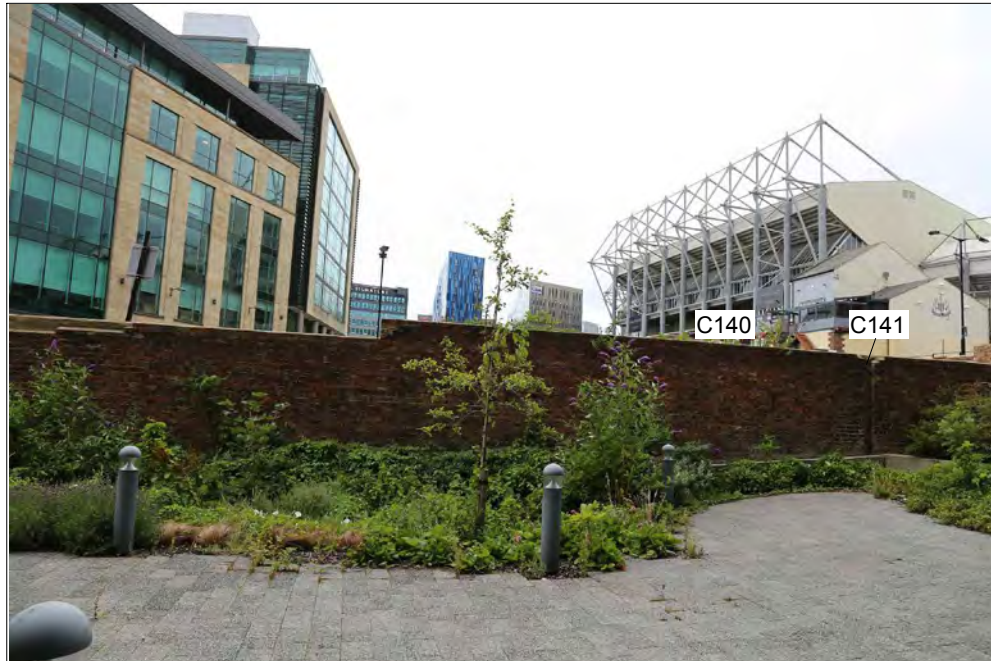
Figure 20

One Strawberry Place, Newcastle: photo of east-facing elevation of wall C100
