CHURCH OF OUR LADY,
SEATON DELAVAL HALL
ARCHAEOLOGICAL MONITORING
OF REPAIRS TO THE
SOUTH-WEST BASTION
AND HA-HA WALLS

Mosedale Gillatt Architects
for Historic England

NAA 21/74
August 2021

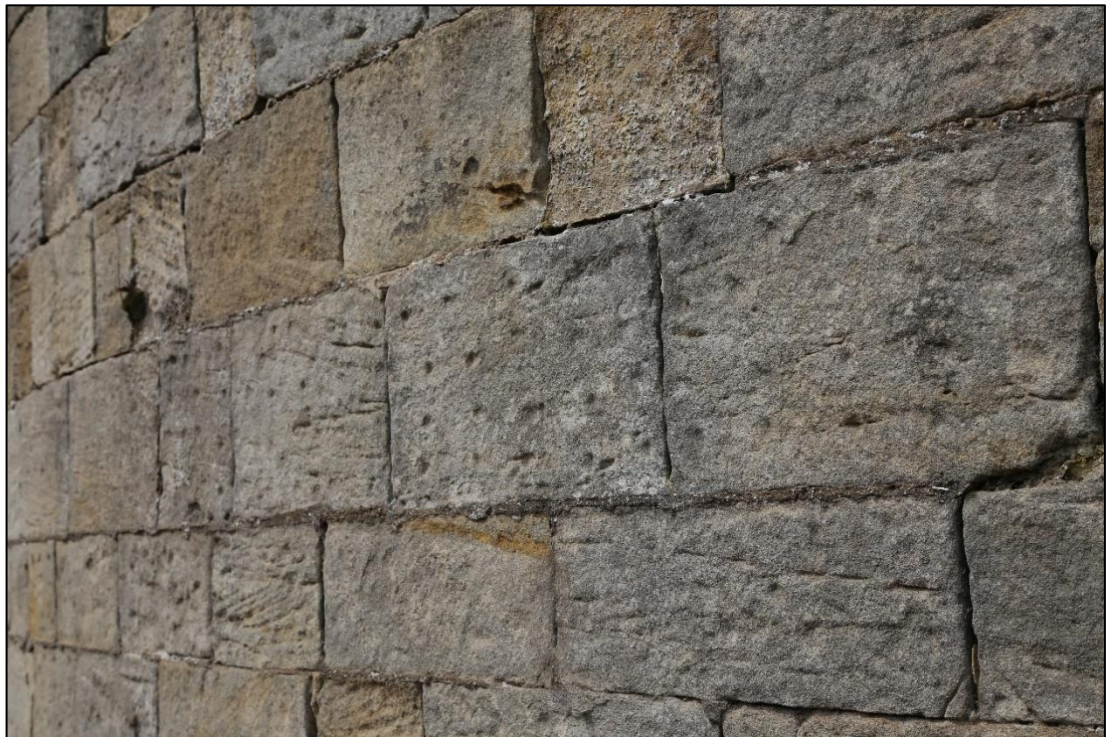
Plate 6: example of circular toolmarks recorded on the ashlar facing stones of the south-west bastion.

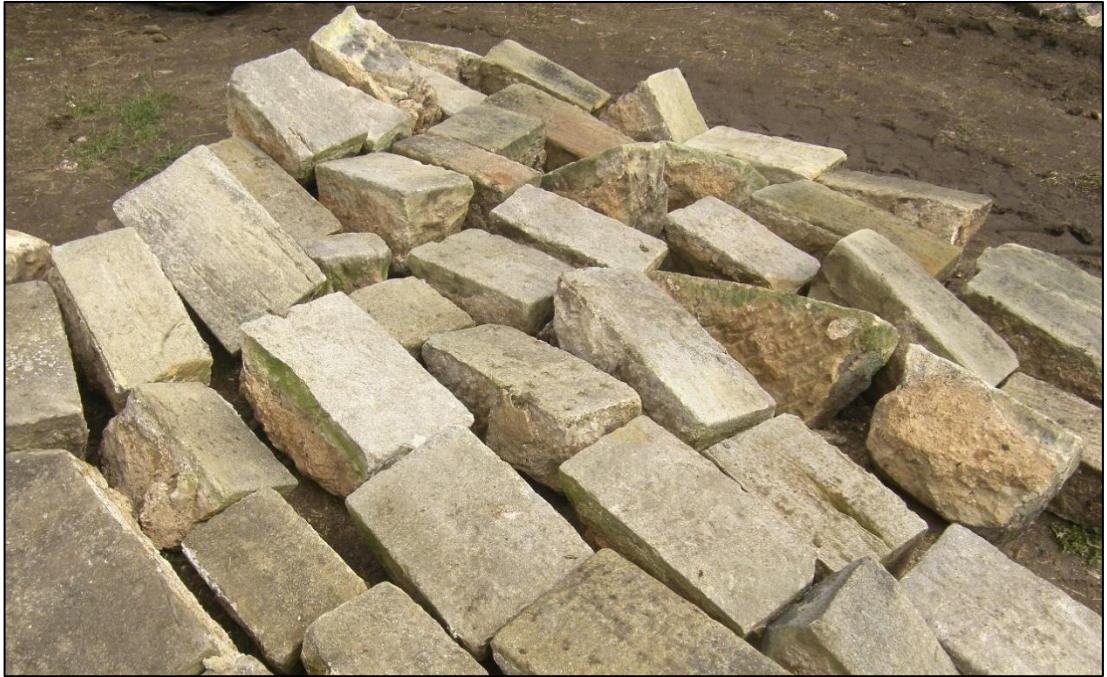
Plate 7: south-west bastion ashlar, stored in courses and displaying trapezoidal form of blocks with roughly tooled rear faces.

- 8.8 Although laid in regular courses, the ashlar blocks varied in length from 0.15m to 0.8m. On removal, the rear faces of the blocks were found to be rough-hewn, meaning overall the stones were trapezoid in shape. The rear faces, too, had been deliberately scored with diagonal tool marks, presumably to aid the adhesion of the mortar bond (Plate 7).

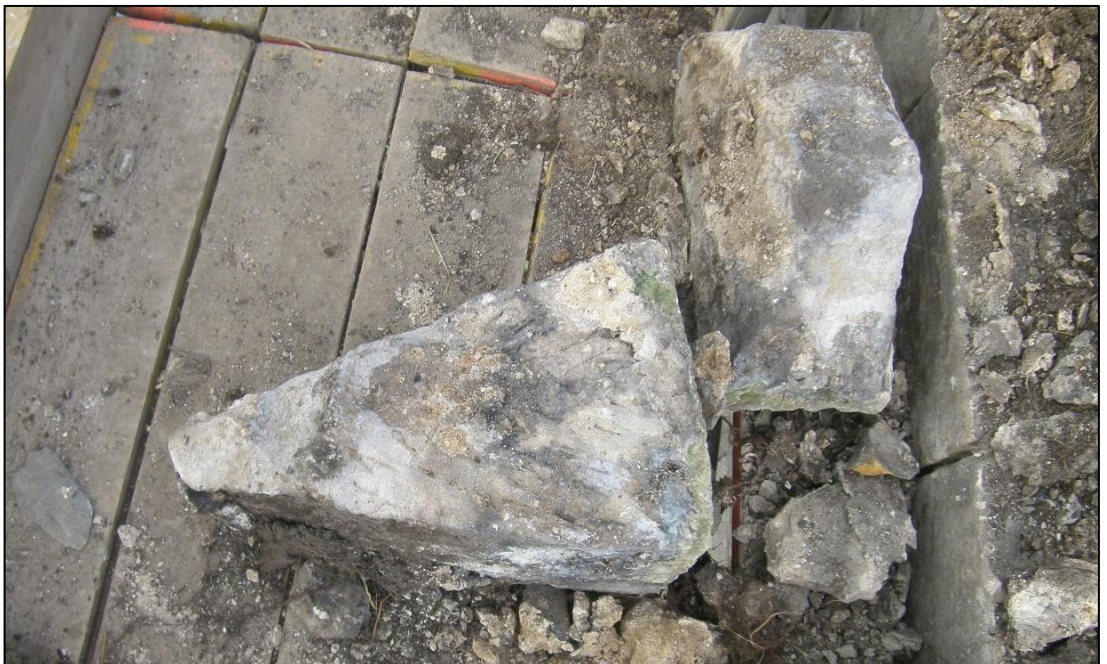
Plate 8: example of a tapering, triangular through-stone.

- 8.9 A series of long, triangular through-stones was distributed throughout the upper four courses of the structure (Plate 8). The shape of the triangular stones helped to facilitate the curving form of the bastion and tie the structure through to the rubble core.

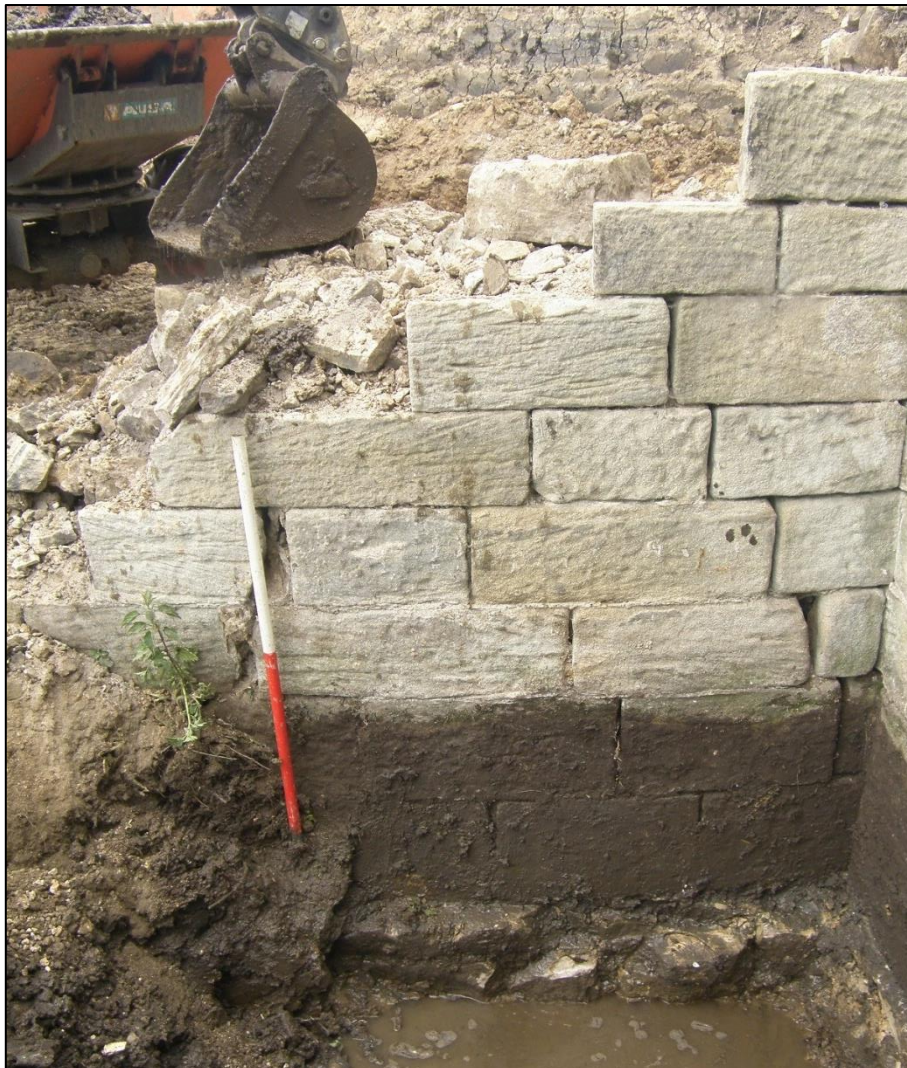
- 8.10 Once the facing-stones were removed to ground level and the scaffolding taken down, a trench was excavated by machine around the exterior of the bastion to reveal the external foundation (Plate 9). This involved removing the infill of the associated ditch (15), which measured c.3m wide and 0.8m deep. Two further ashlar courses were revealed below the modern ground level, with the foundation footing stepping out 0.1m at what would originally been the base of ditch 15. The below-ground foundation was of rubble and lime mortar and was rather insubstantial, measuring just 0.3m high. Adding the height of the buried courses and foundation to the above-ground wall gave an overall height of the structure of 4.2m.

Plate 9: external foundation of the south-west bastion and southern ha-ha at the base of ditch 15.

- 8.11 The profile through ditch 15 revealed that it had been initially filled by a 0.2m-thick colluvial, waterlogged deposit of greenish-grey silty clay (09). Later, it had been deliberately backfilled with dumps of relatively modern refuse (08), comprised primarily of concrete blocks and bricks as well as a notable quantity of post-medieval refuse, including glass bottles, ceramic jars, transfer-printed pottery and tin cans. The ditch was then topped by a layer of hardcore to consolidate the farm track that runs past the bastion to the south.

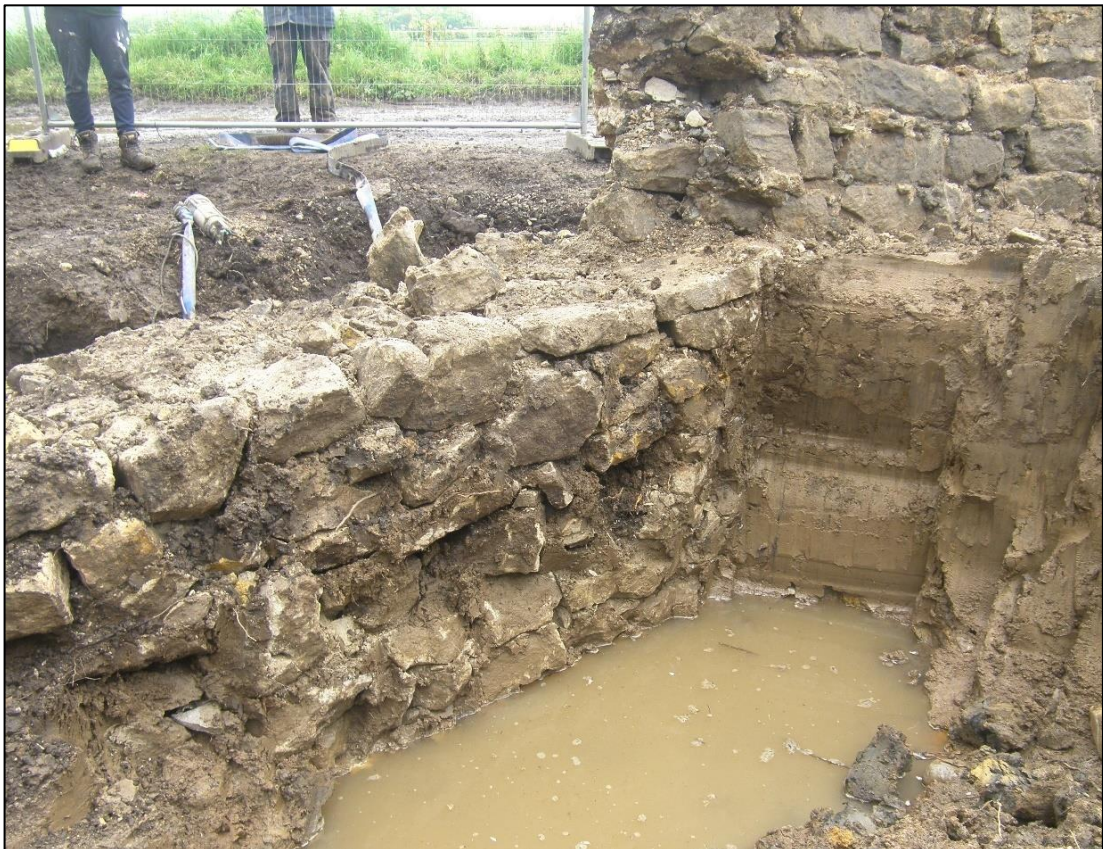
Plate 10: inner foundation of the south-west bastion, cut into natural clay.

buried beneath the infill of the bastion. The first was a 1.1m-wide and 2.3m-high foundation, of which the initial 0.5m was bedded into the natural pinkish-brown clay (10, Plate 10).

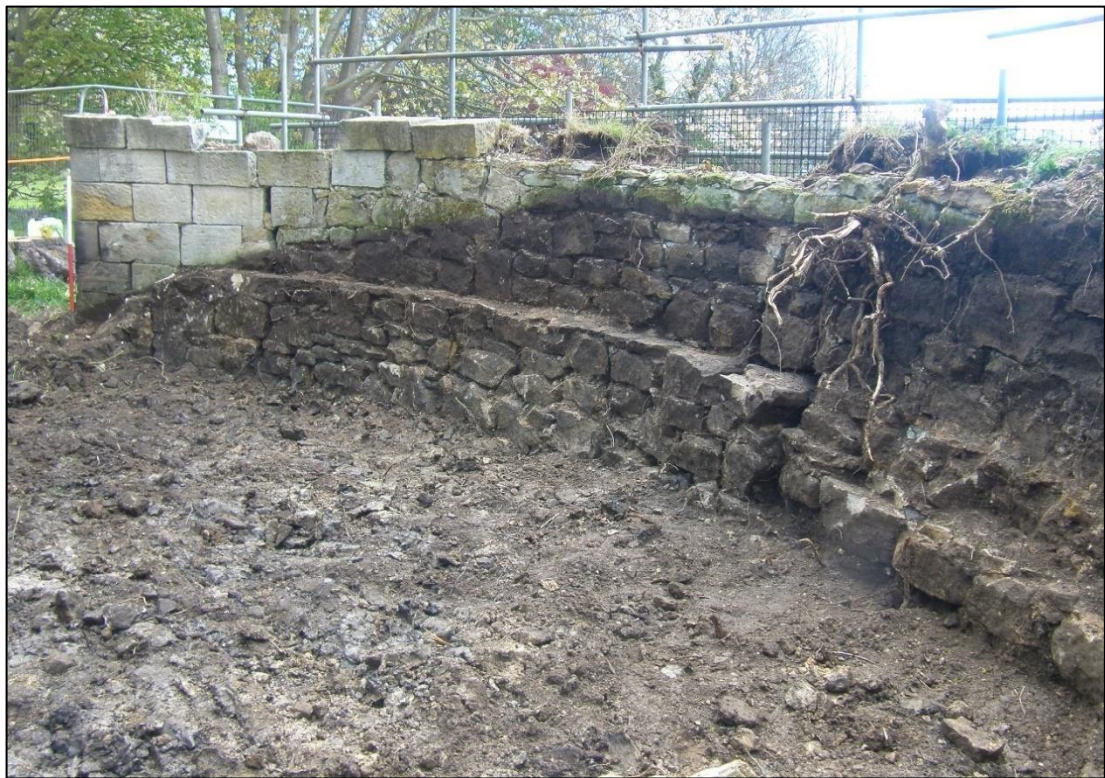
- 8.14 The mid-section stepped inwards from the first and measured 0.8m wide and 1.4m high (Plate 11). Within this second step, the triangular blocks mentioned previously were recorded (see 6.8–6.9, Plate 6). The final stage was an upper wall of dressed ashlar, topped with coping. This comprised two courses, 0.4m wide and 0.6m high, around the majority of the span of the bastion, except at each end where the ashlar was stepped down to 8 courses (c.2m high), level with the top of the ha-ha walls, reflecting the intended original slope of the landscaped interior.

Plate 11: internal elevation of the east side of the south-west bastion, showing partially exposed foundation step, mid-section, and upper ashlar courses. The original level of the internal deposits is denoted by the dark staining.

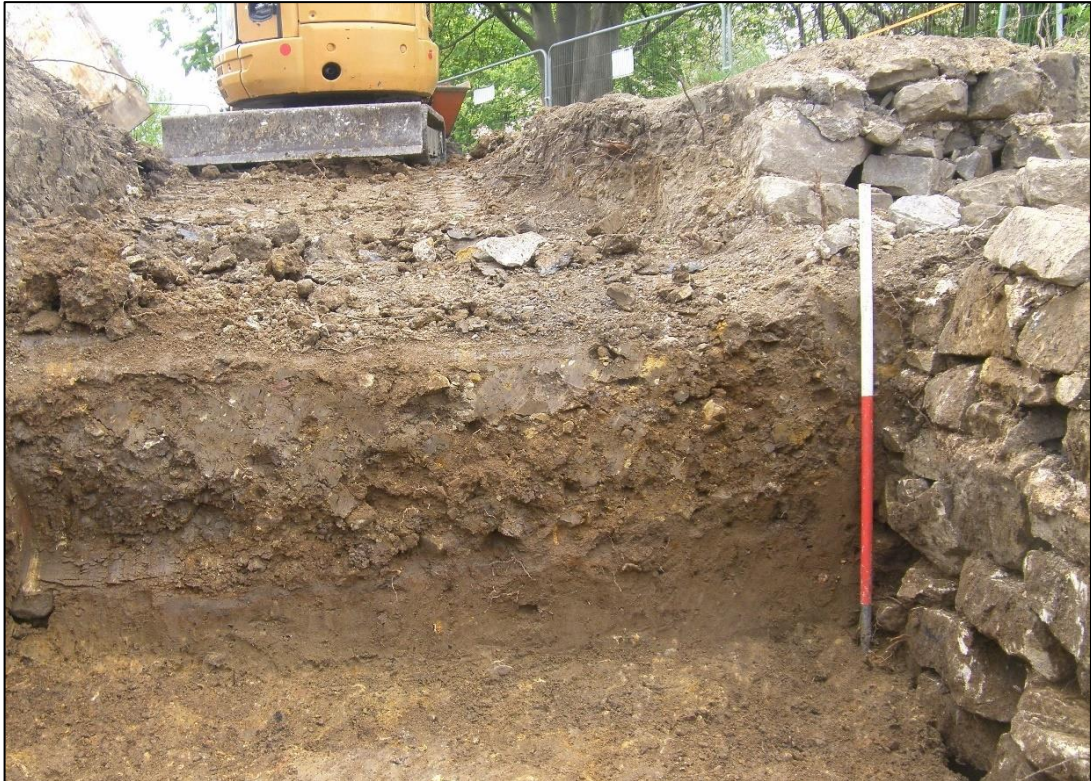
- 8.15 After construction, the area within the bastion was infilled with a sequence of deposits, built-up to create an artificial slope leading from ground level to the bottom of the upper ashlar wall. Evidence of this sequence was visible in the west section of the trench. The natural clay (10) had been stripped of topsoil prior to the construction of the bastion foundations. On top of the natural clay there was a mixed deposit of clay, sandy soil and degraded sandstone fragments (11). This was overlain by a 0.4m-

thick layer of greyish-brown sand that contained lenses of orange sand and charcoal flecks (07, Plate 12).

Plate 12: south-facing section through the infill of the south-west bastion, showing (from bottom to top) deposits 11, 07 and 06.

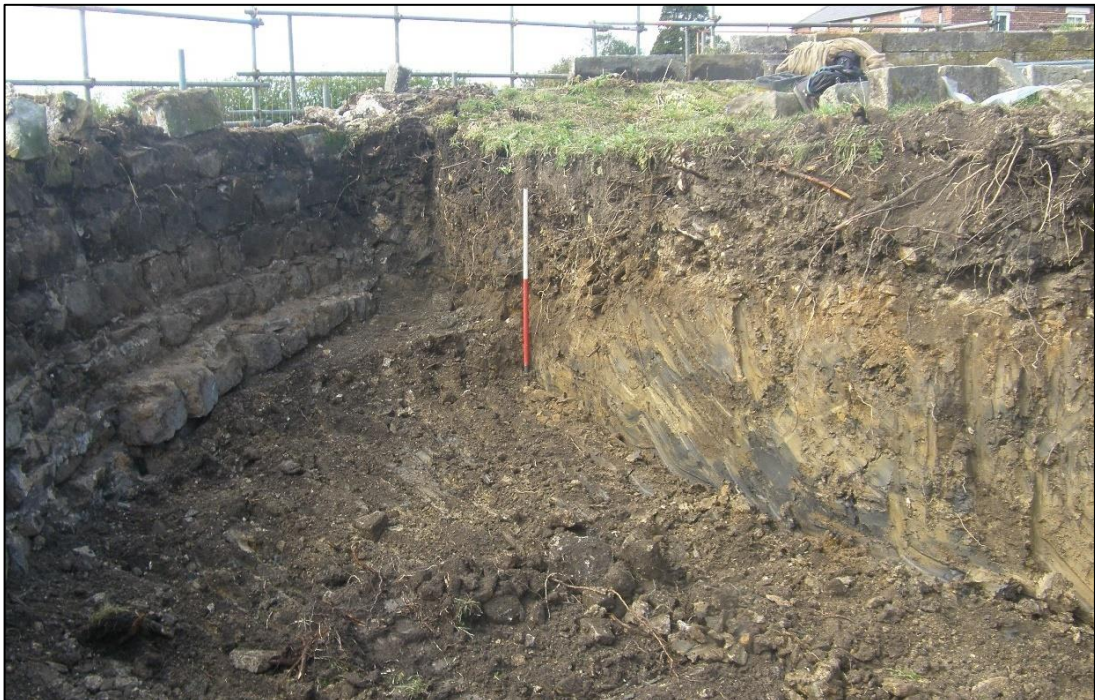
Plate 13: east-facing section through the infill of the south-west bastion, showing (from bottom to top) deposits 03, 02 and topsoil 01.

- 8.16 Above sandy deposit **07** there was a substantial layer of pinkish-brown clay (**06**), up to 0.8m thick, which contained fragments of coal and slag, seemingly resulting from both iron and glass production. Deposit **06** was overlaid by mixed clay (**03**), which was variously yellow, with lenses of brown, bluish-grey and black and measured up to 1.7m thick against the internal face of the masonry (Plate 13). It appears that clay **03** was a levelling deposit for a subsequent layer of compacted clay and sandstone rubble (**02**), up to 0.8m thick onto which topsoil and turf (**01**) had then been laid.

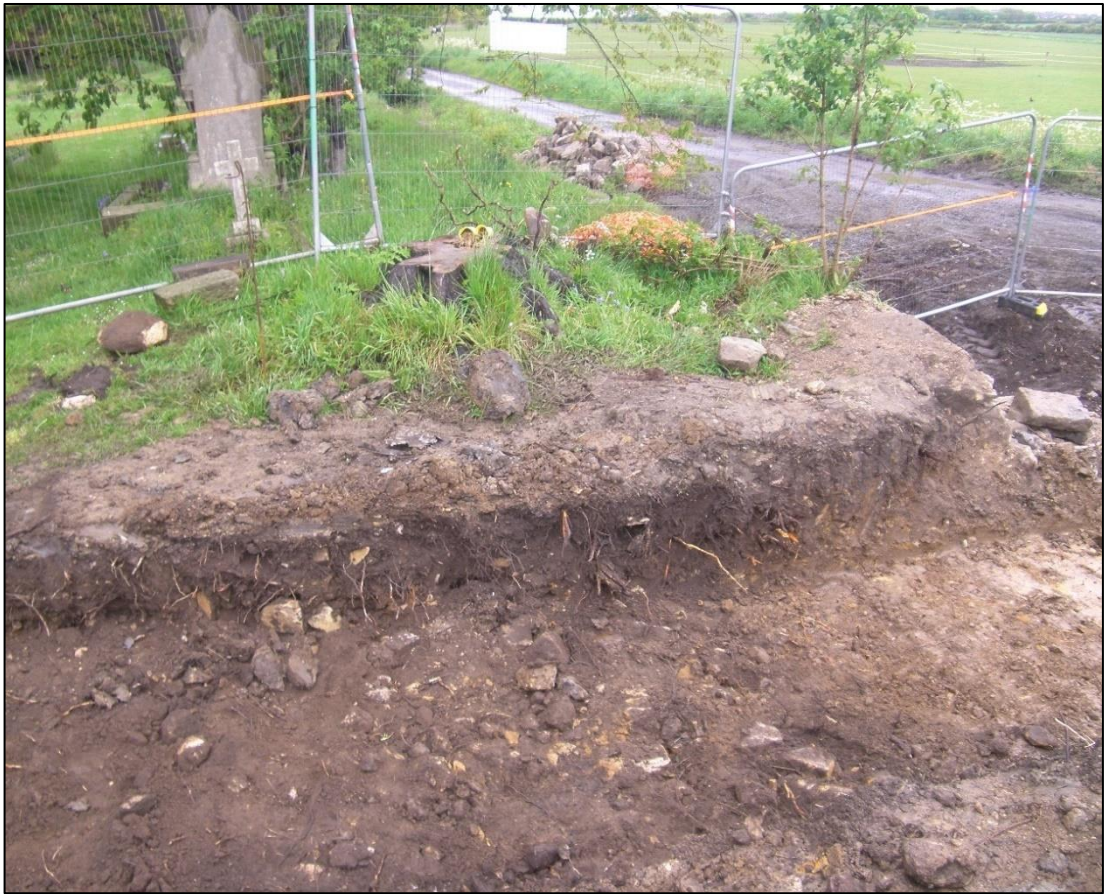
- 8.18 Further modern interventions were recorded within the access ramp into the interior trench, where an east to west linear feature (**13**), 2m wide, cut through the topsoil immediately beneath the turf (Plate 14). The cut was infilled with sandstone rubble and black soil (**14**) that contained elements of early 20th-century grave furniture, fragments of white ceramic edging, an iron wreath and green glass fragments, as well as modern plastic refuse. To the north, beneath the boards of the access track, the top of white ceramic edging marking a previously unrecorded grave was recorded. No further disturbance to the grave occurred, but the same decorative edging can be seen on graves immediately to the south, dating to the early 1900s.

Plate 14: feature 13 cutting through topsoil and deposit 02, looking south-east.

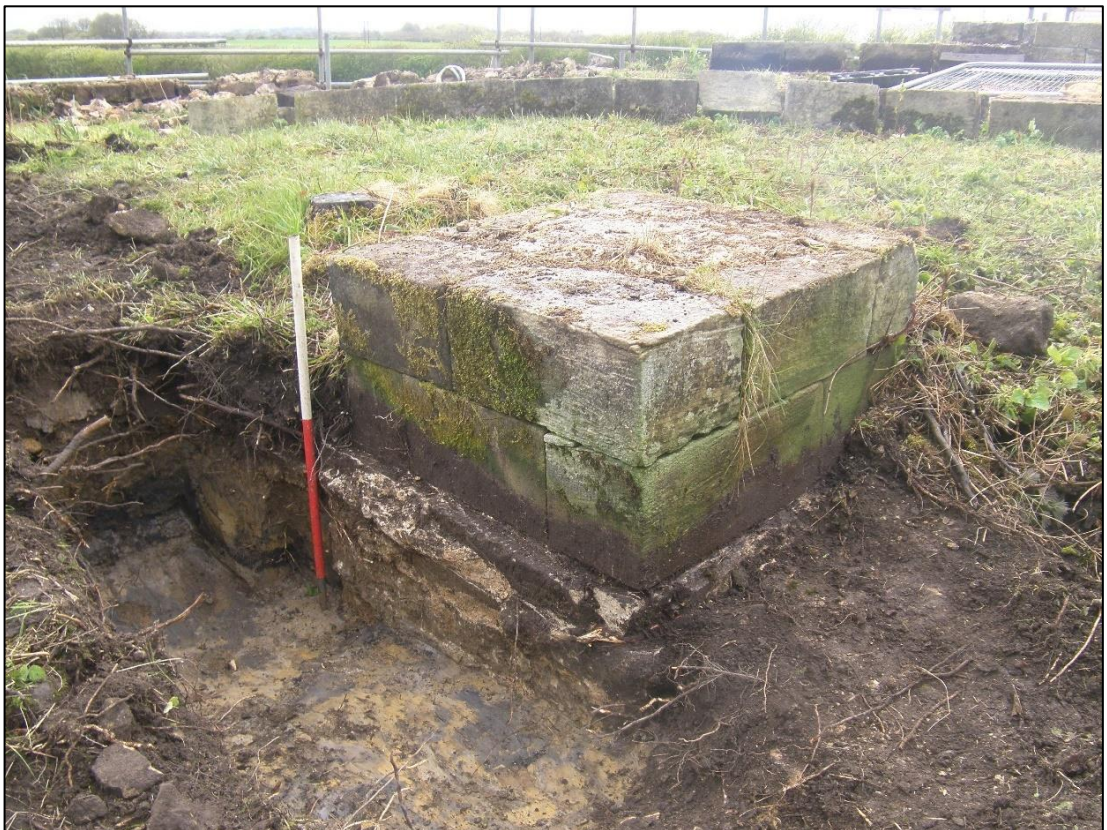
Plate 15: slot excavated along the eastern face of the statue plinth foundation.

- 8.19 The base of the central statue plinth (04) was visible within the interior of the bastion. It measured 1.05m by 1m square, and comprised two courses of rectangular ashlar, 0.53m high, surrounding a rubble core. The ashlar sat upon a 0.15m-thick sandstone slab on top of a rubble and lime mortar foundation. An exploratory slot along the eastern edge of the plinth showed that the foundation was at least 0.5m high (Plate 15).

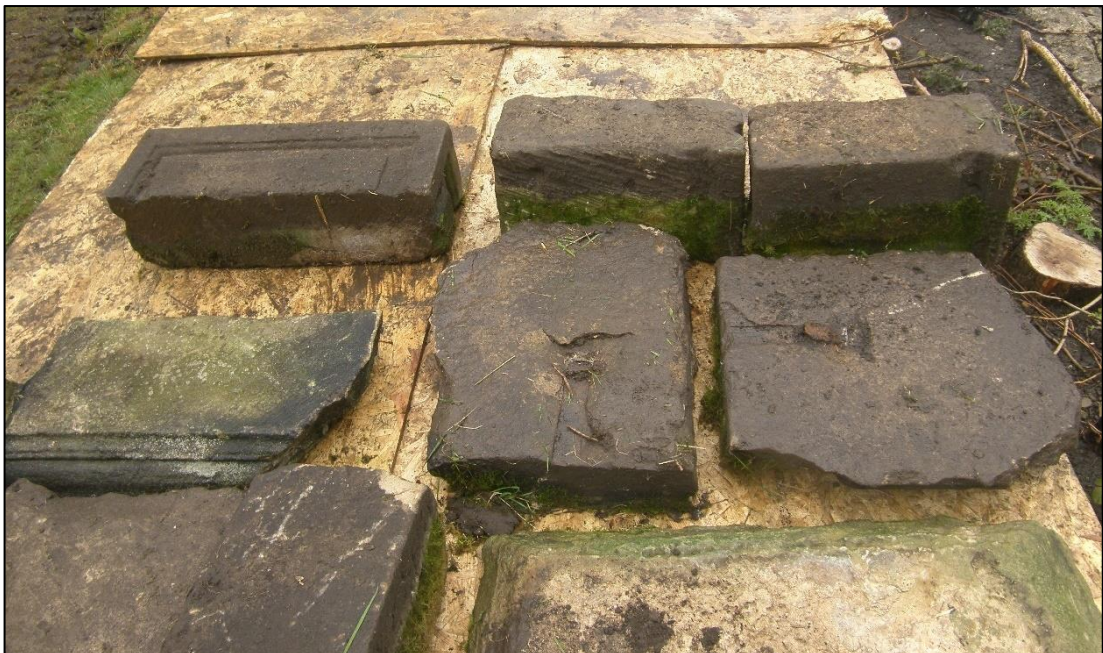
- 8.21 The upper courses that would have formed the decorative element of the plinth superstructure were scattered around the base in a haphazard fashion (see Plate 5). The plinth would have been constructed of three courses of dressed stone that, when assembled, featured a rectangular plaque on each face of the base. Chamfered stone slabs with moulded edges were placed along the top and bottom of the structure. There were notches in the upper slabs, some of which featured in situ fragments of iron that presumably once anchored the statue to the plinth (Plate 16).

Plate 16: fragments of the statue plinth superstructure from the south-west bastion. The statue anchor points can be seen on the blocks at the centre.

- 8.22 From comparisons with the in situ plinth within the north-west bastion (Plate 17), it appeared that most of the pieces were present to facilitate a full reconstruction. The blocks were removed from around the foundation and placed on boards to the north of the bastion, with the intention to reconstruct and reinstate the plinth on completion of the works.

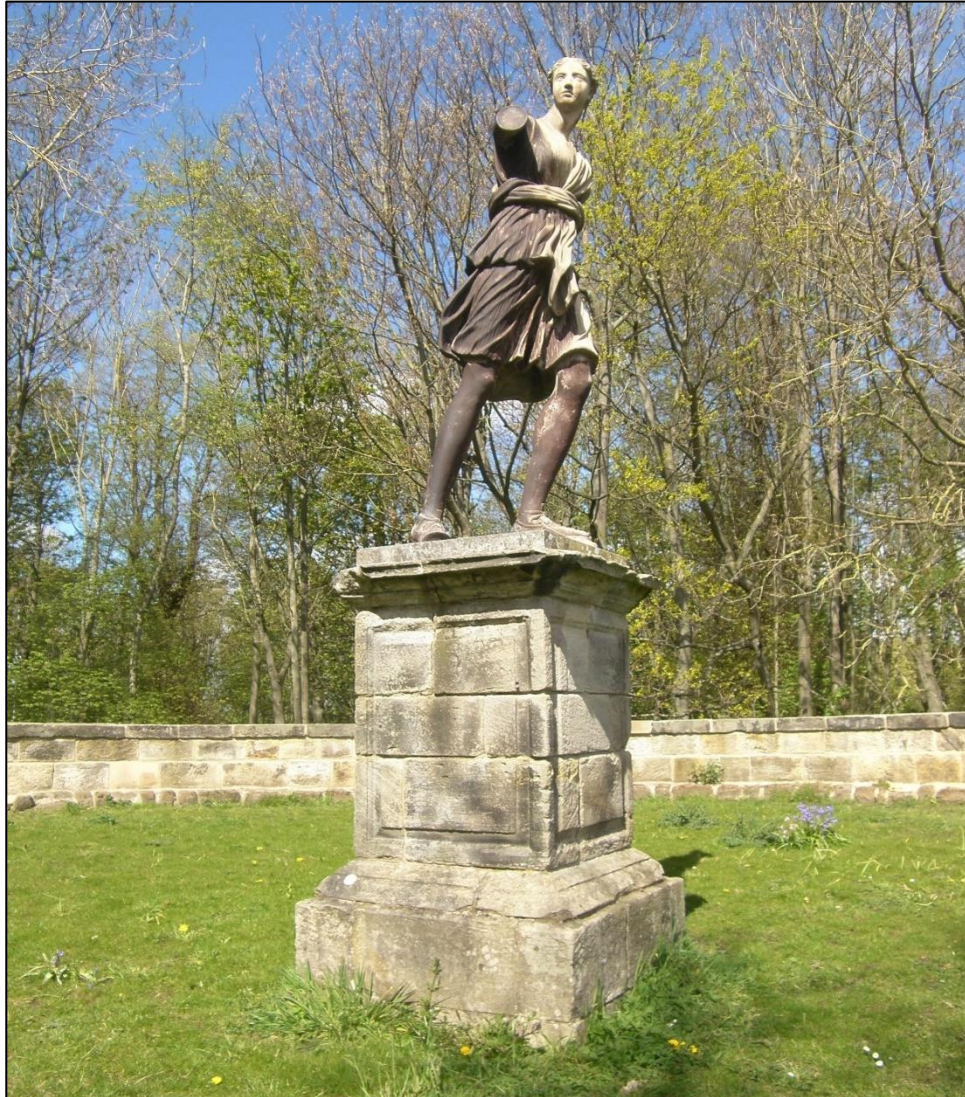
Plate 17: statue plinth and surviving statue of Diana within the north-west bastion.

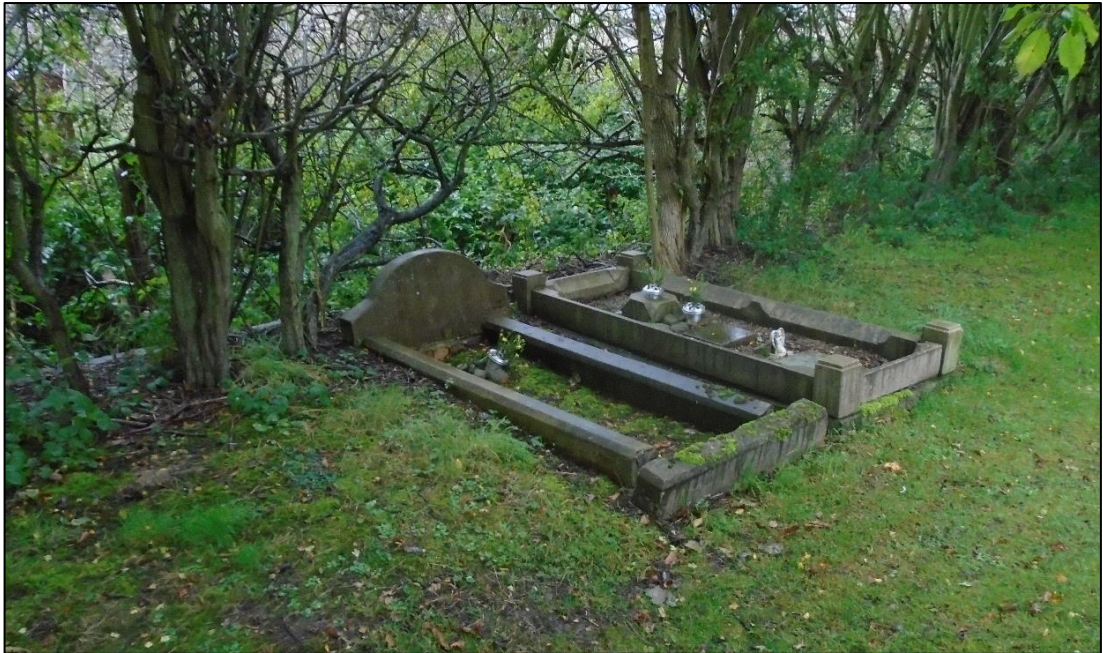
disturbance from mature trees planted along the top of the ha-ha wall, around the perimeter of the graveyard. In the case of Section 5, the disturbance probably originated from the excavation of two graves directly behind the wall during the late 20th century (Plate 16), although no human remains were exposed during remediation works. The stone facing of Section 3 had also suffered disturbance, probably during the installation of a modern septic tank within the ditch, adjacent to the ha-ha wall.

Plate 18: two graves directly behind the western ha-ha wall.

8.26 In all instances, the ashlar facing was removed along with the old mortar, the roots of the trees were cut back and treated to prevent regrowth and then the facing replaced, with each course being topped with wire mesh and lime mortar to tie the facing into the rubble revetment behind.

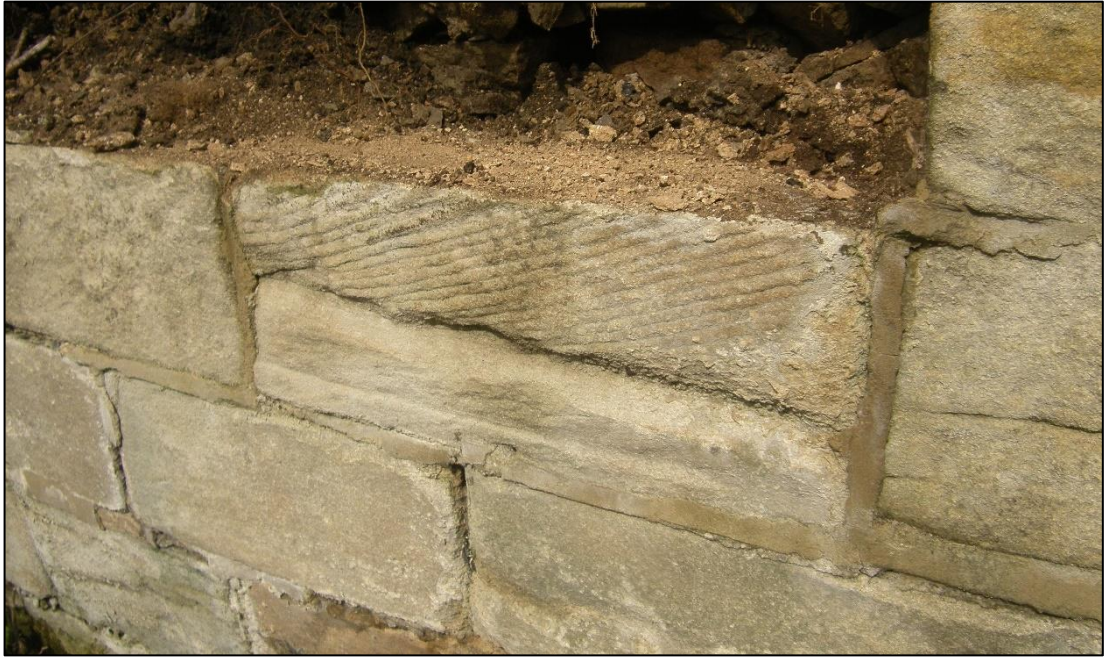
- 8.31 A single ashlar facing-stone within Section 4 of the west ha-ha was the only example in the entire south-western quadrant to indicate potential reuse. It displayed two horizontal incised lines with the upper portion of the face filled by closely set diagonal lines, which most likely formed part of a larger scheme of decoration (Plate 27). Otherwise, the only markings noted were on occasional stones showing rows of horizontal dashes or circular depressions, as recorded on blocks within the bastion.

Plate 27: potentially reused facing stone in Section 4 of the west ha-ha.

- 9.5 No evidence of reused tracery or moulding was found during the renovation works, except for a single block from the west ha-ha wall, which featured a linear groove and diagonal droved tooling (Plate 27). However, a number of stones were dressed with horizontal dashes or rows of circular depressions, though there did not appear to be uniformity in the distribution of the marks, which would be expected if they were decorative. Furthermore, such decoration would seem rather redundant on a wall that was largely screened from view. Similarly, there would seem to be no reason to tool the surface of the ha-ha to improve plaster adhesion, given there is little to suggest the ha-ha was ever rendered. This may be evidence, therefore, of the reuse of stone from an earlier building. Alternatively, the material may have been tooled at the quarry for an alternative purpose and simply been redirected for use on the ha-ha.

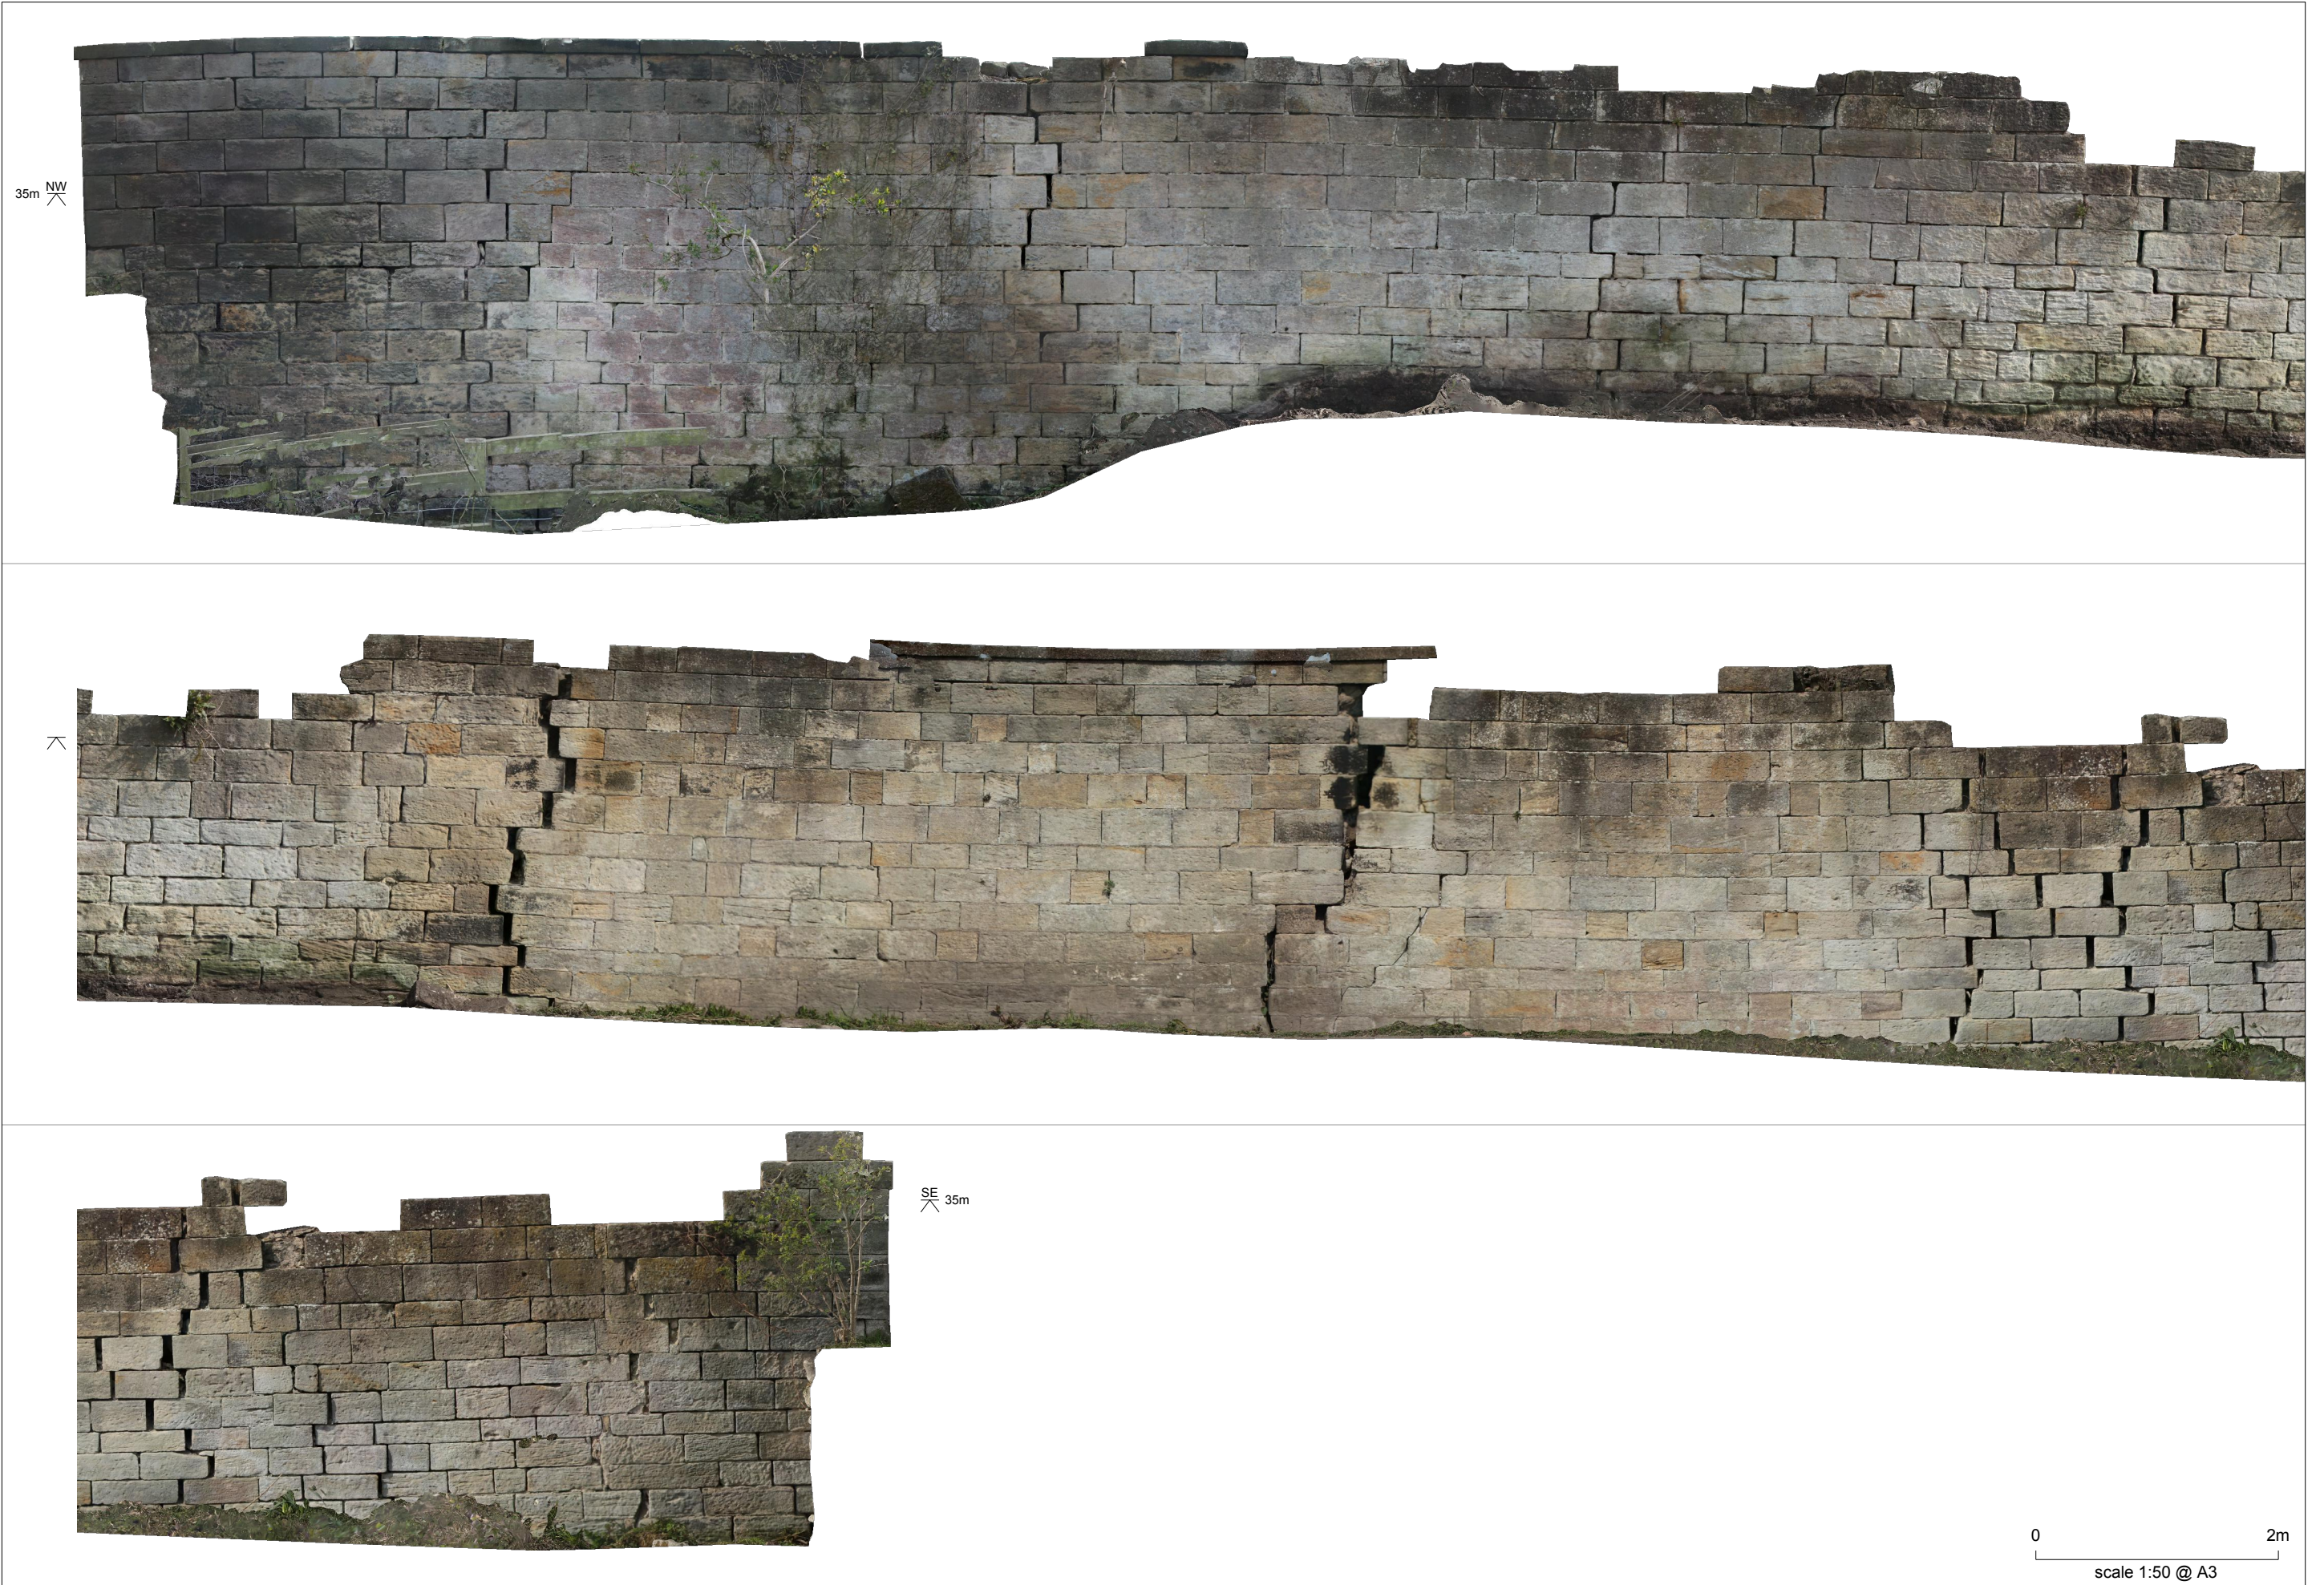
Church of Our Lady, Seaton Delaval: pre-intervention survey, south-west bastion external elevation

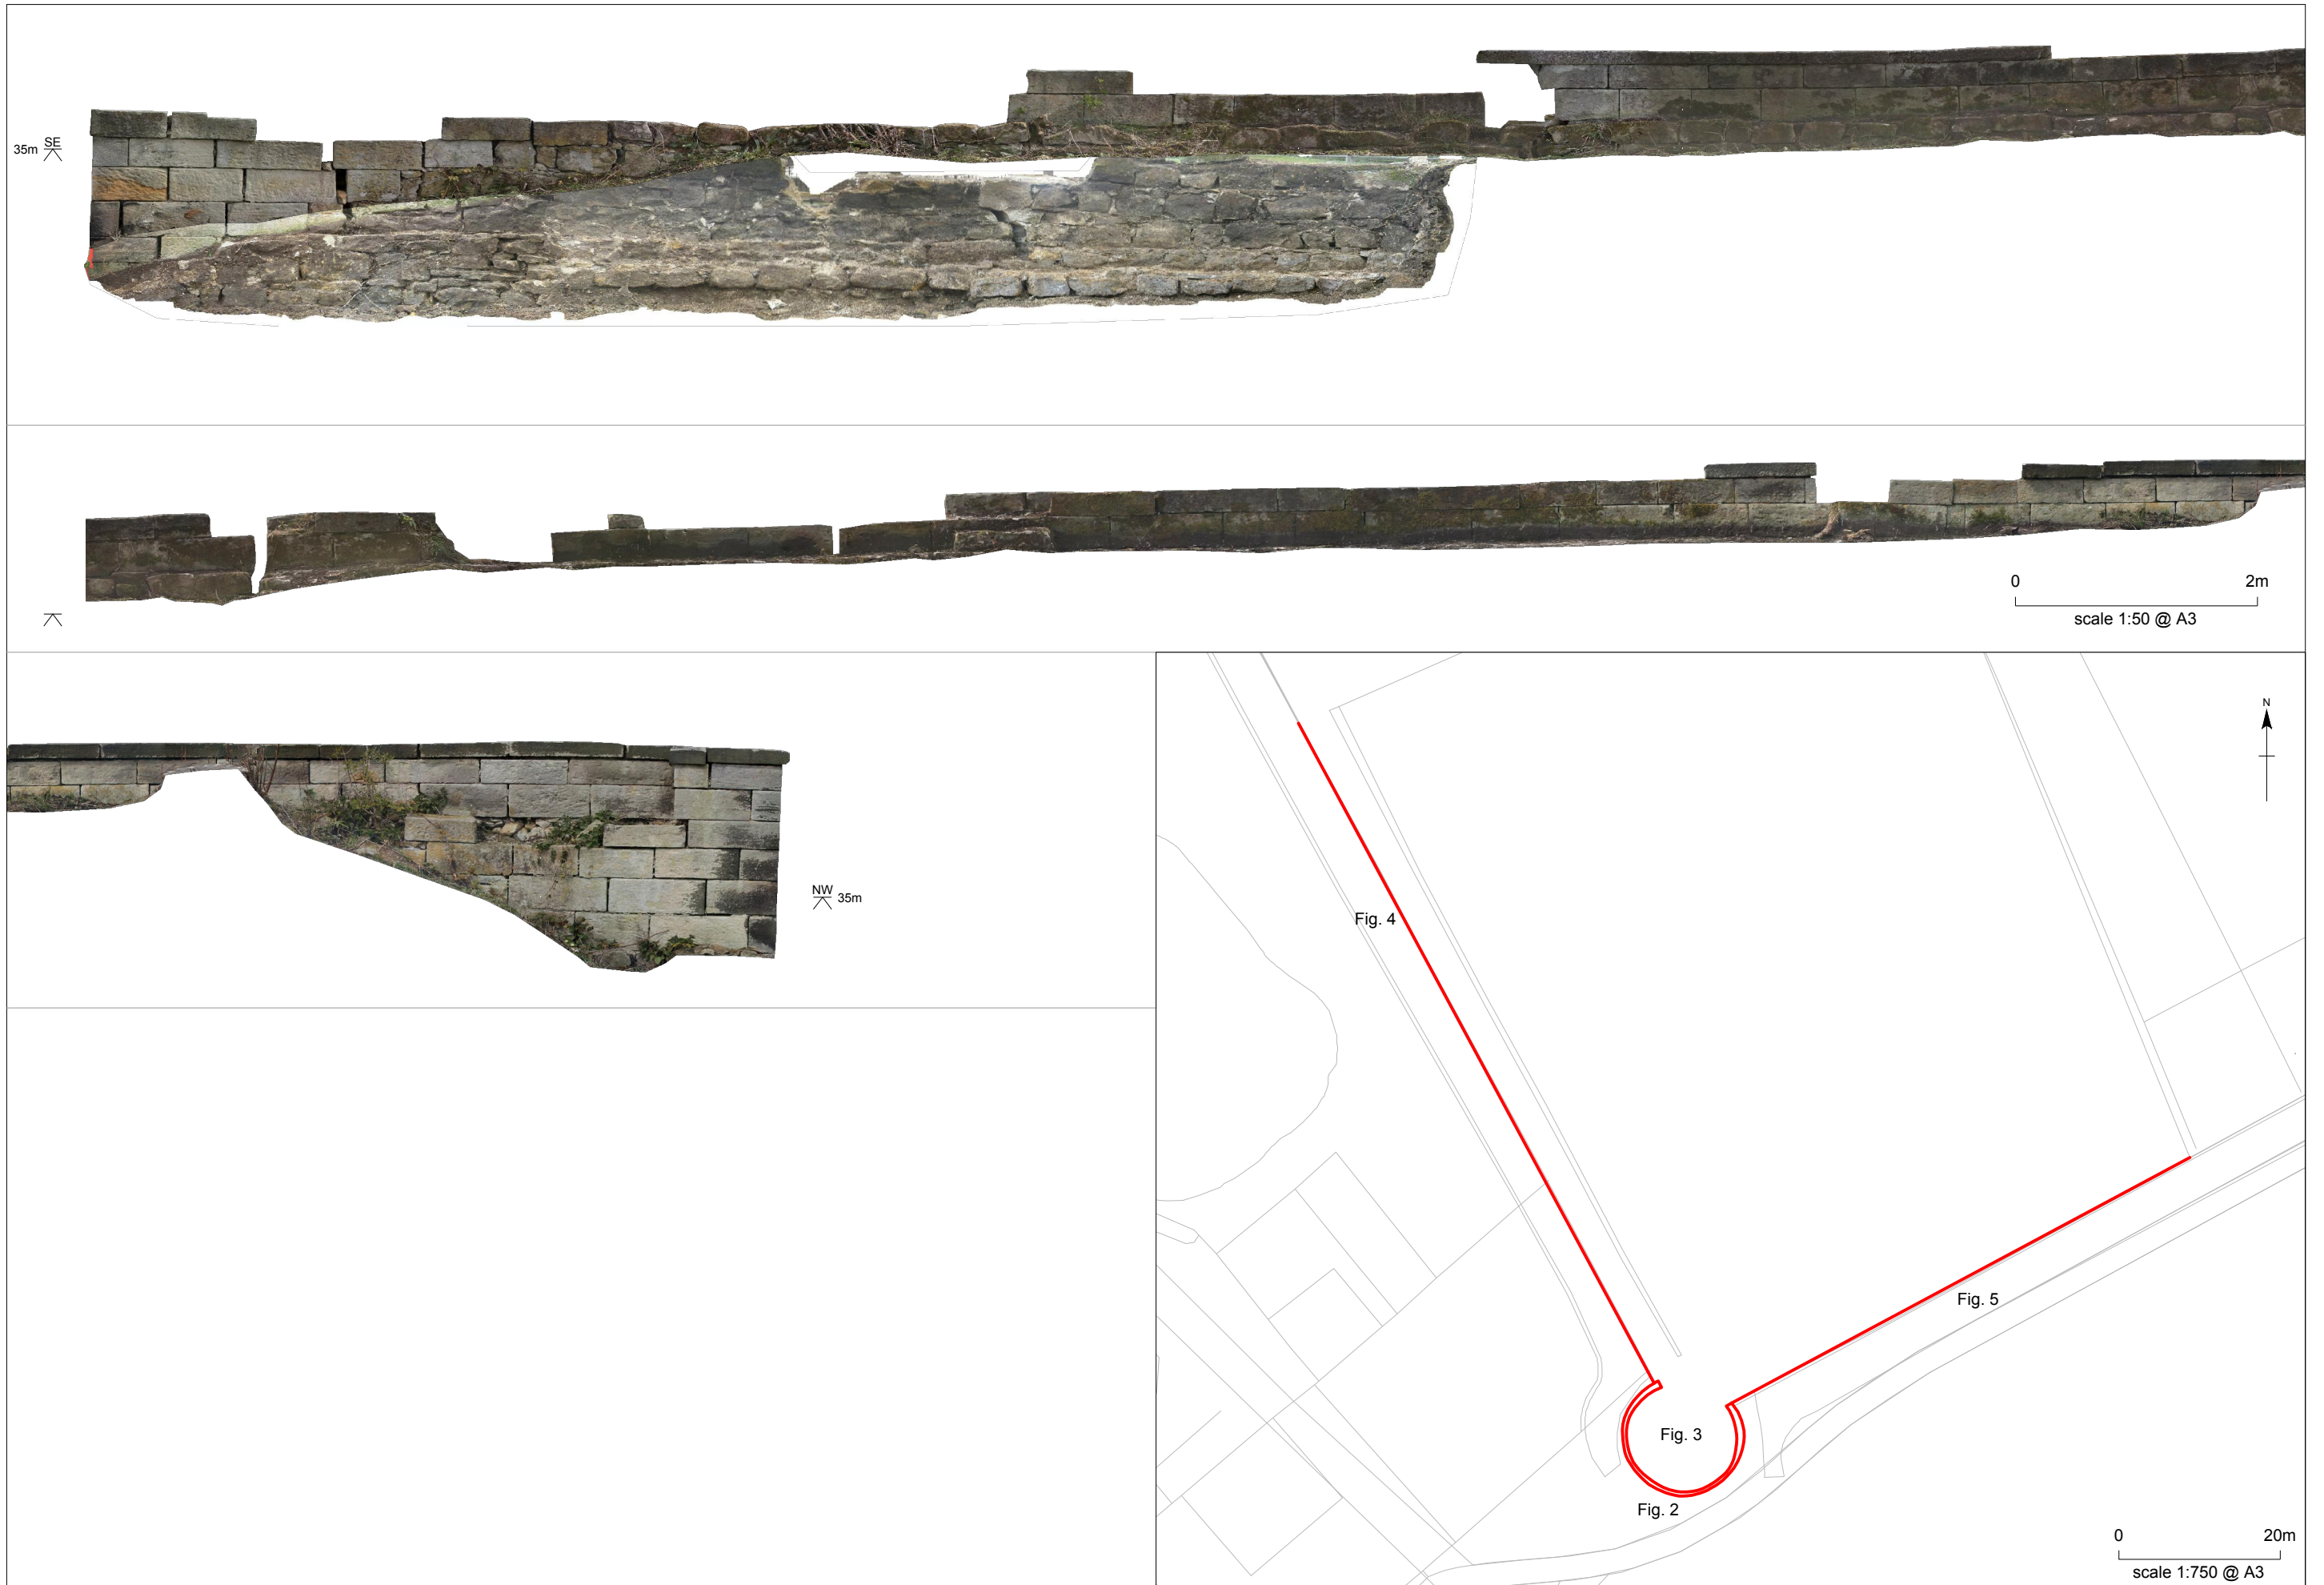
Figure 3: pre-intervention survey, south-west bastion internal elevation
