CHURCH OF OUR LADY,
SEATON DELAVAL HALL
ARCHAEOLOGICAL MONITORING
OF REPAIRS TO THE
SOUTH-WEST BASTION
AND HA-HA WALLS

Mosedale Gillatt Architects
for Historic England

NAA 21/74
August 2021

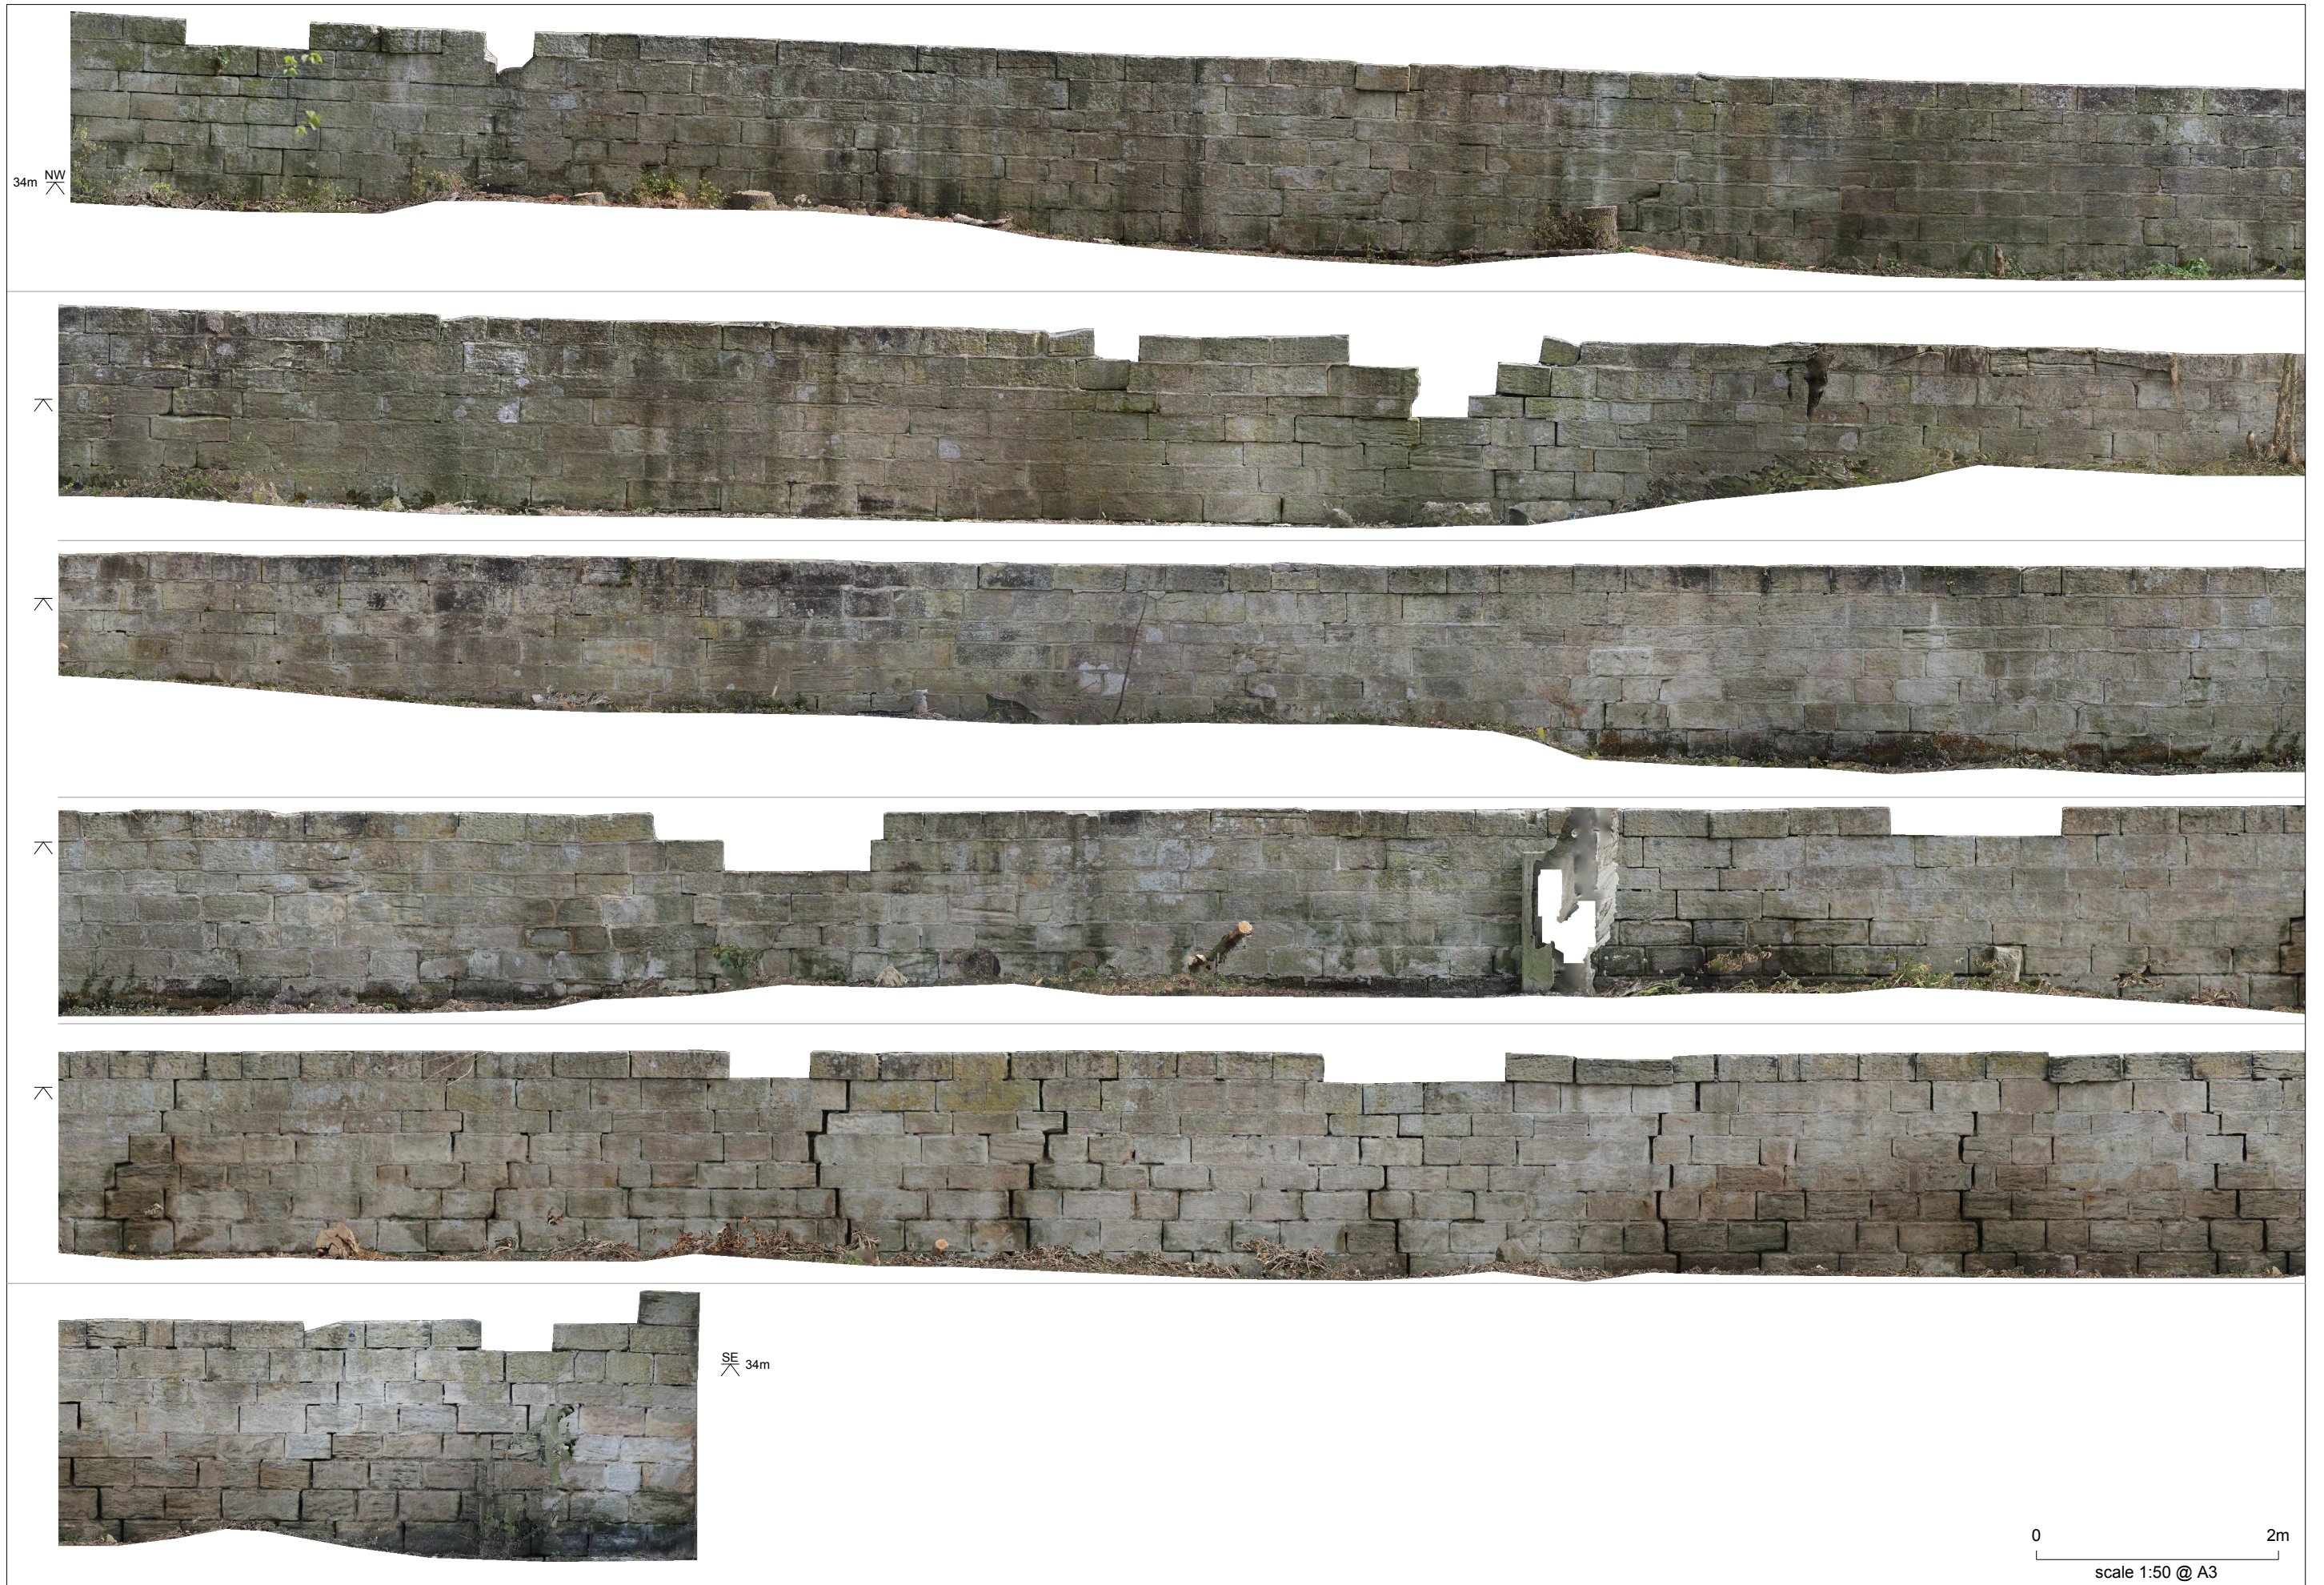
Church of Our Lady, Seaton Delaval: pre-intervention survey, west-facing elevation of west ha-ha wall.
