ARCHAEOLOGICAL WATCHING
BRIEF REPORT

**NENTHEAD LEAD MINES,
NENTHEAD, CUMBRIA**

NAA 15/91
February 2016

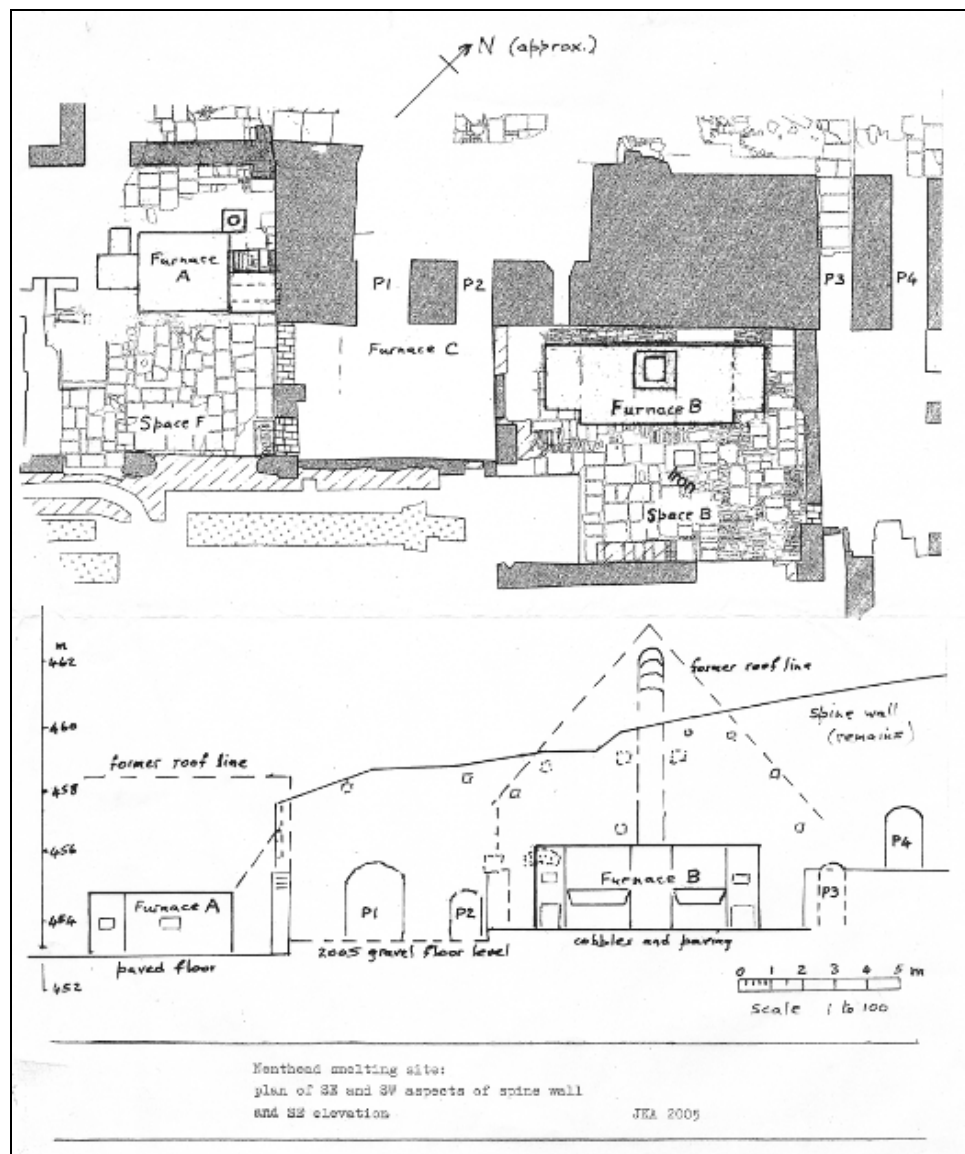
- 4.33 Building B measured 10.0m by 7.35 m and was constructed along the spine wall, which formed the northern wall of the structure, Plate 15. The original use of Building B is not known, though it was probably constructed to house a furnace, as there is a 1.0m wide area of heat-affected burnt stone

that runs the full height of the Spine Wall, located in the centre of the building. The survey carried out by Lancaster University Archaeological Unit (LUAU) states that the shape of the burning, coupled with the occurrence of two recesses to the southwest and one to the northeast, suggests a free-standing flue held in position by timbers would have been housed in these recesses (LUAU, 1997, 81). This suggests that a flue was affixed to the outside of the wall, and turned inwards to the main flue carried by the spine wall just above the surviving lip. These flues may have been metal ducts (Almond 2003a). The type of furnace in this building is not known; Almond (2005) suggests that it later housed a large refractory furnace for cupellation, a process for separating silver from lead ore through treatment under extremely high pressure and temperatures. Although the surviving archaeological evidence for this is scanty, some features of the building do accord with this interpretation.

Plate 15: Plan and elevation of Building B (after Almond 2005).

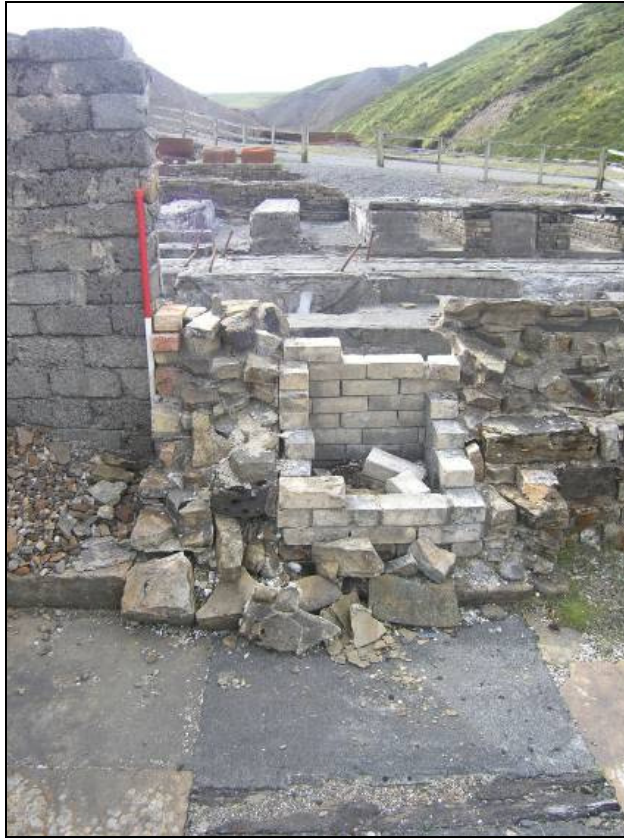
- 4.41 Feature C1, Plate 17, was located at the southern corner of Building C (Pattinson House) at NY 78406 43269 and measured 0.75m by 0.55m by 0.84m high (Countryside Consultants 2013, fig. 24). The structure had suffered severe loss of mortar and was vulnerable to loss through natural erosion.
- 4.42 The chimney structure consisted of up to thirteen courses of lime mortar bedded Walker Corbridge bricks up to a height of 0.45m. The outer skin of the chimney was constructed of roughly faced limestone blocks of various sizes arranged in a roughly squared coursing pattern.

Plate 17: Feature C1 (Pattinson House) pre-intervention.

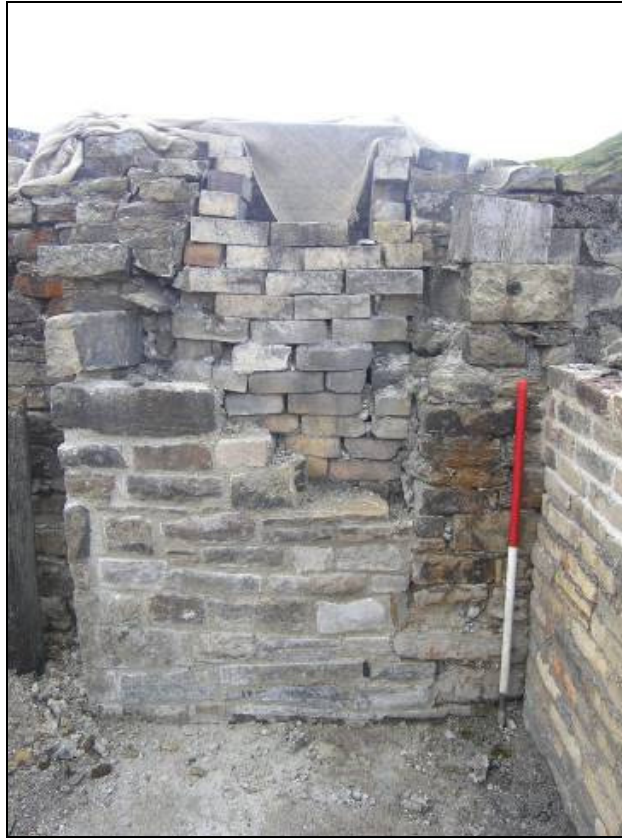
- 4.46 No consultation was undertaken prior to the consolidation of this structure. As a result the outer skin of limestone blocks has been partially rebuilt to 1m high exposing a large section of the inner chimney. The chimney itself has suffered extensive mortar loss and is vulnerable to further loss, Plate 20.

Plate 20: Feature C2 post intervention.

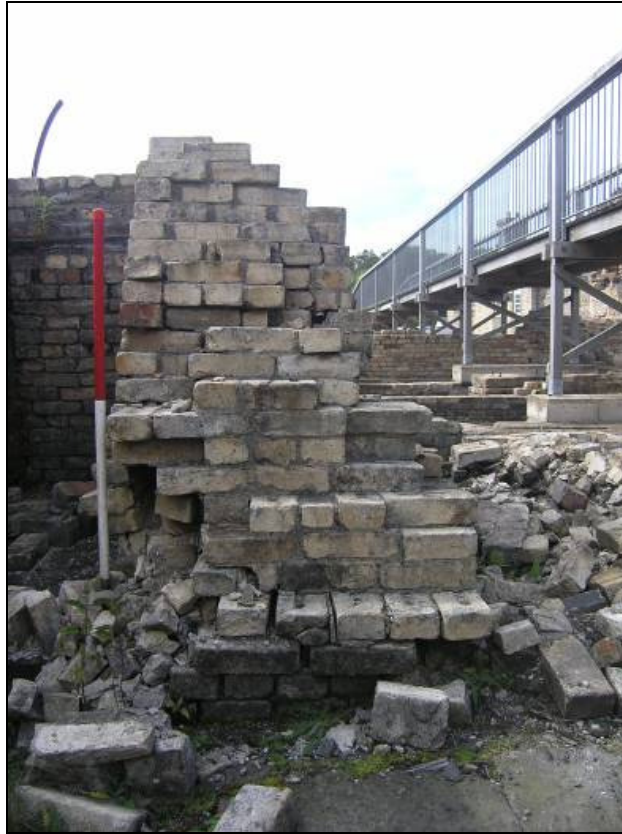
- 4.62 Feature H3, Plate 27, represented the northwest elevation of the side of the chimney associated with the Lancashire boiler house at NY 78417 43261 (Countryside Consultants 2013, fig. 20).
- 4.63 The side of the chimney was in a similar state to the front face of the chimney discussed in Feature H1. The structure had suffered significant mortar loss causing deep open joints in the wall. The bottom corner of the structure had collapsed entirely, putting the structure as a whole in significant danger of collapse.
- 4.64 The collapsed area was subsequently raked out, cleaned off down to a solid bearing and the whole structure re-pointed. The bottom corner was rebuilt using the bricks from the debris around the chimney, Plate 28.

Plate 28: Feature H3 post intervention.

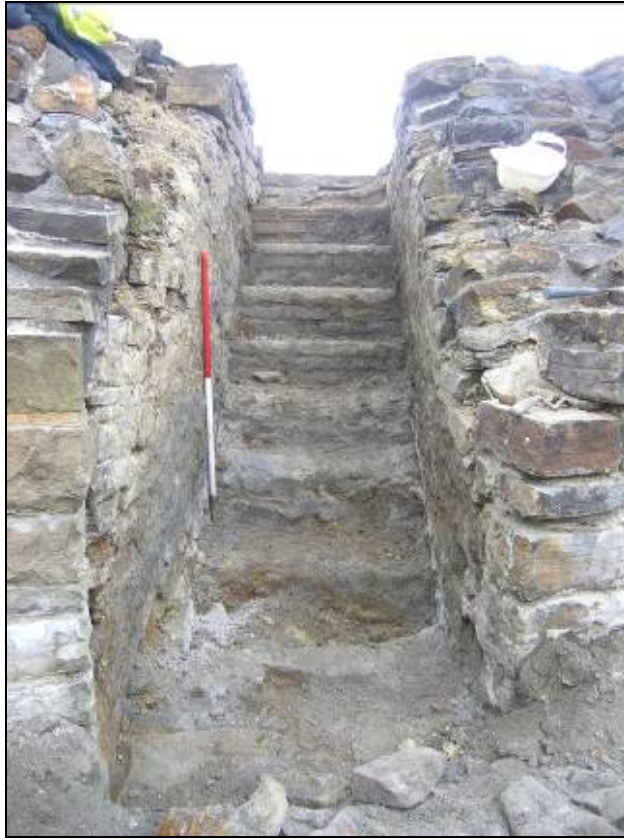
- 4.76 Further to the consolidation work on the areas mentioned above, it was proposed that the material infilling the staircase be removed to inspect the underlying structure. An archaeological watching brief took place to monitor the removal of debris from the staircase, Plate 32. The exposure of the staircase revealed that the structure had been deliberately blocked up, which is backed up from photography from 1975 (see Plate 33).
- 4.77 The staircase infill was composed of fine grained bluish grey silt and a slightly oily yellow residue with coarse rubble at the top. The grey and yellow residue had bonded securely to the bottom three steps whereas the coarse rubble sat loosely on top suggesting these two layers were deposited separately.

Plate 32: Spine Wall Feature 3 showing cleared staircase.

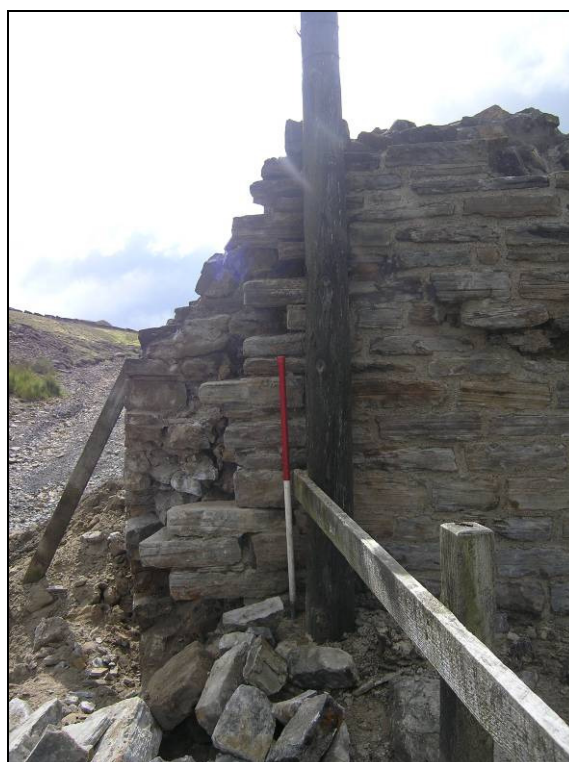
- 4.83 A watching brief took place on the 17th of July 2014 to monitor the corner depicted in Plate 37, (Countryside Consultants 2013, fig. 40) as the corner was dismantled ready for re consolidation. No features of further archaeological interest were uncovered behind this corner, only further rubble infill was observed.

Plate 37: Spine Wall Feature 5 – corner - during dismantling.

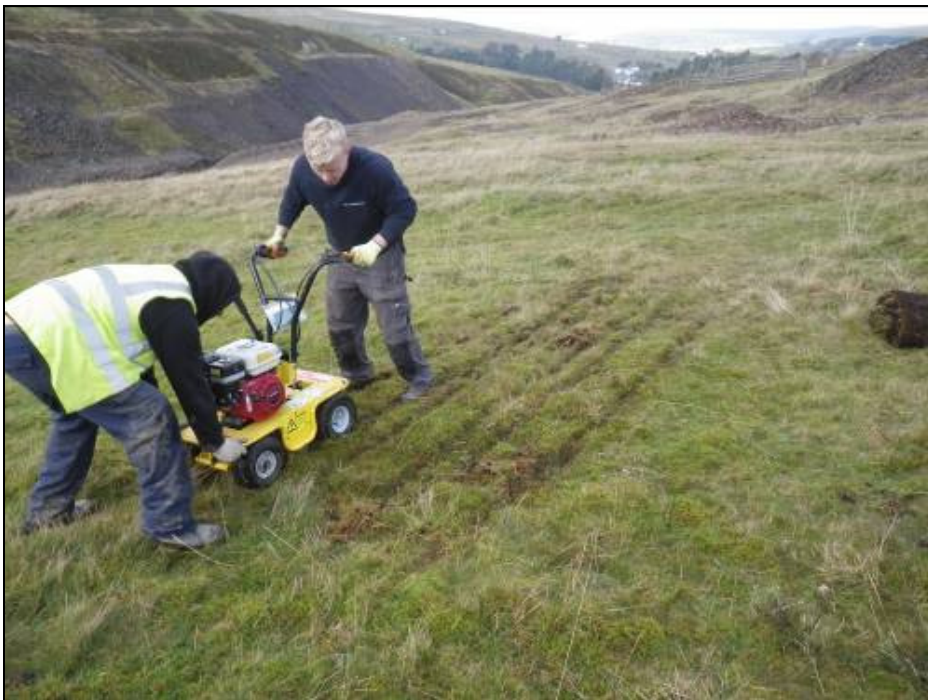
Plate 43: Turf removal for spine wall soft capping.

- 4.91 An archaeological watching brief was carried out for the removal of turf on land in between Smallcleugh Level and Handsome Mea reservoir, Plate 43 (Countryside Consultants 2013, figs. 56 and 56A). This area of land was thought to be the location of a dressing floor.

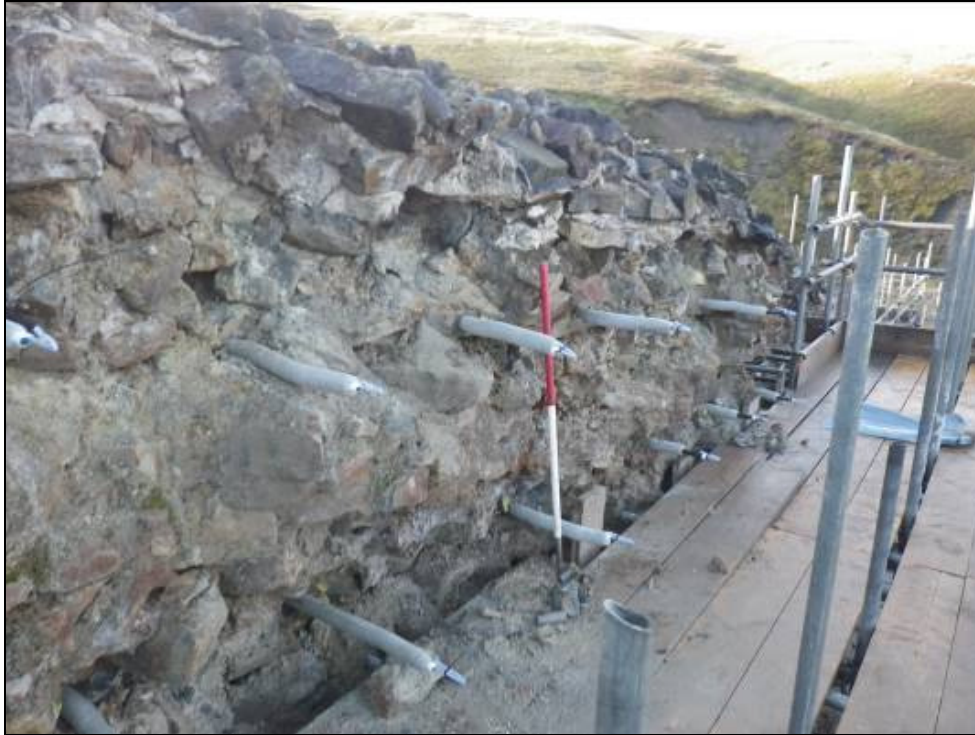
- 4.93 A brief program of watching briefs was undertaken for the installation of the Cintec anchors into both faces of the smelt mill spine wall, Plate 45 (Countryside Consultants 2013, fig 43). The installation involved the drilling of holes through the face of the spine wall. A watching brief was deemed

- 4.94 Due to the small size and large quantity of holes to be drilled into the spine wall, only a small sample of holes were monitored. No features of further archaeological interest were discovered during monitoring of the drilling for these holes.

Plate 45: Section of spine wall facing northwest showing series of anchor holes.

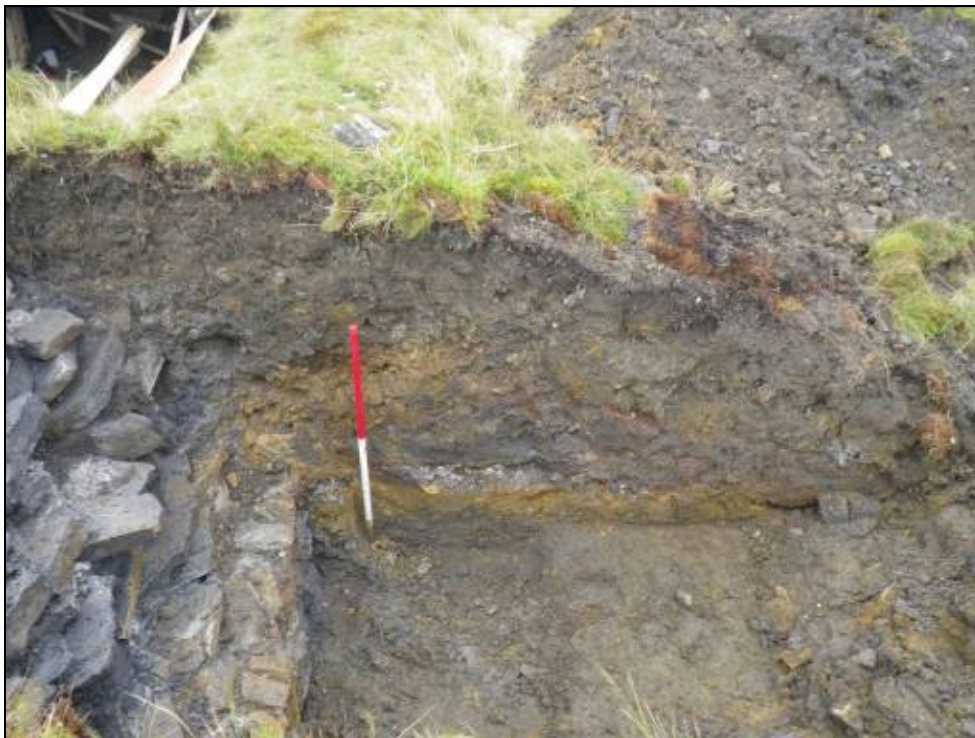
- 5.13 The section through the bank, Plate 48, showed that it was built in numerous phases. The first phase was the construction of the supporting walls cut into the natural bedrock. The material from cutting into the bedrock was cast to one side above the natural boulder clay. Above this layer the bank starts to take shape. A layer of mixed limestone gravel (027) was lain down followed by a dump of thick bluish grey clay (028) in a lozenge shape which forms the bank shape. Above this deposit are layers of gravel material (029) and mixed gravelly re-deposited subsoil. Interestingly it seems that the original bank for the flue only reached as far as the supporting wall for the arch. The vault may have been left exposed for a period of time possibly during construction. A separate phase of bank building fills in the gap between the bank and the vault completely enclosing the flue.

Plate 48: Section through flue bank.

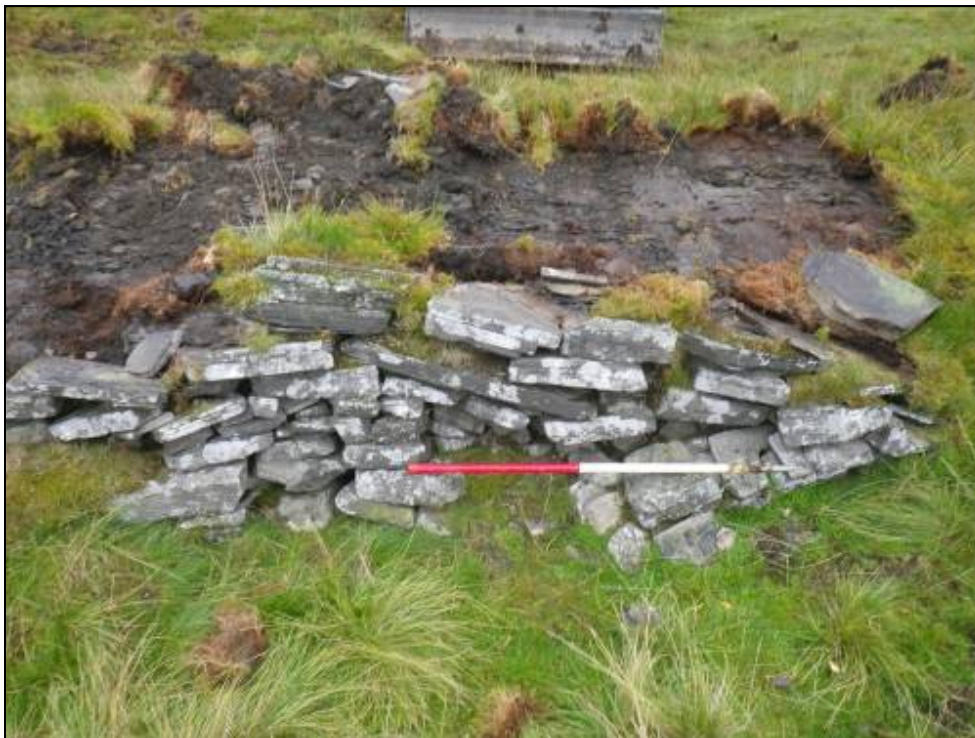
- 5.17 A watching brief took place on the 20th of August 2014 to monitor the soft cap removal around both structures. A JCB with a toothless ditching bucket was used to strip back the soft capping for reinstatement after the consolidation had been completed, Plate 49. No further features of archaeological interest were uncovered during the watching brief.

Plate 49: Soft capping removal to expose the extent of wall.

- 5.16 It was proposed that the soft capping around both structures be removed to expose the entirety of both walls. Both structures were dismantled down to a solid bearing and rebuilt back up to the original height using salvaged blocks from nearby.

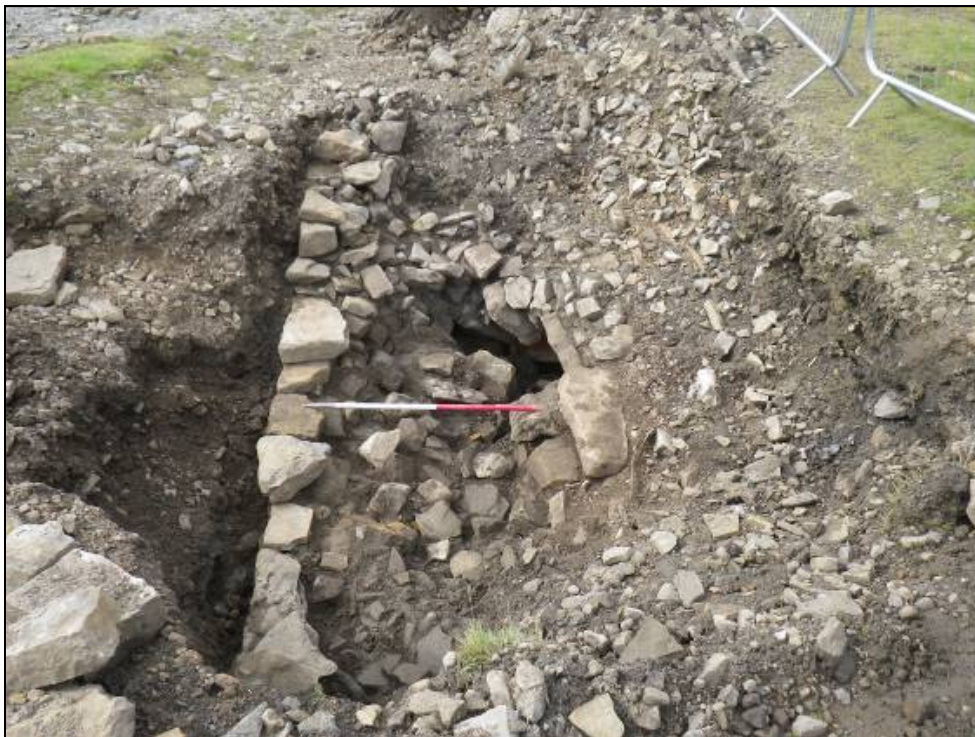
Plate 55: Exposed wall (017) running parallel to culvert.

- 6.11 The wall exposed in this section was visible as three courses of large faced limestone blocks in an even coursed pattern with no bonding. At either end of the trench the wall appears up to five or six courses high. Initially it was thought that this wall represented the earlier retaining wall for the leat that passed through this area before it was culverted. However, the wall exposed is faced on the outside meaning that it could not be part of the original leat. It is therefore more likely that this wall is a retaining wall inserted during the construction of the culvert, shown in Plate 54.

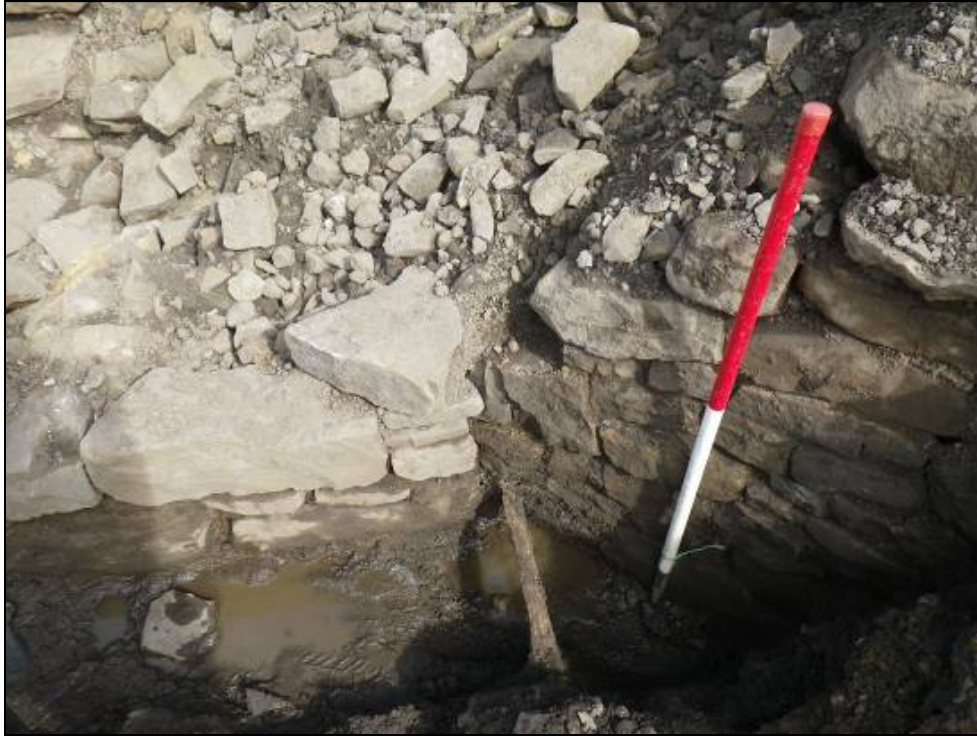
exposed a further length of retaining wall. This exposed section of wall (022) represented an earlier building phase, possibly an earlier south eastern outflow for the culvert. What is clear from the junction between the two sections of walls is that the long section of exposed wall (017) butts up against wall (022) (Plate 56). Interestingly a datum level was observed at the junctions of the two walls. Most likely this was used in the construction of wall (017) to keep the wall level.

Plate 56: Earlier phase of wall to the right of image with datum level in between both walls.

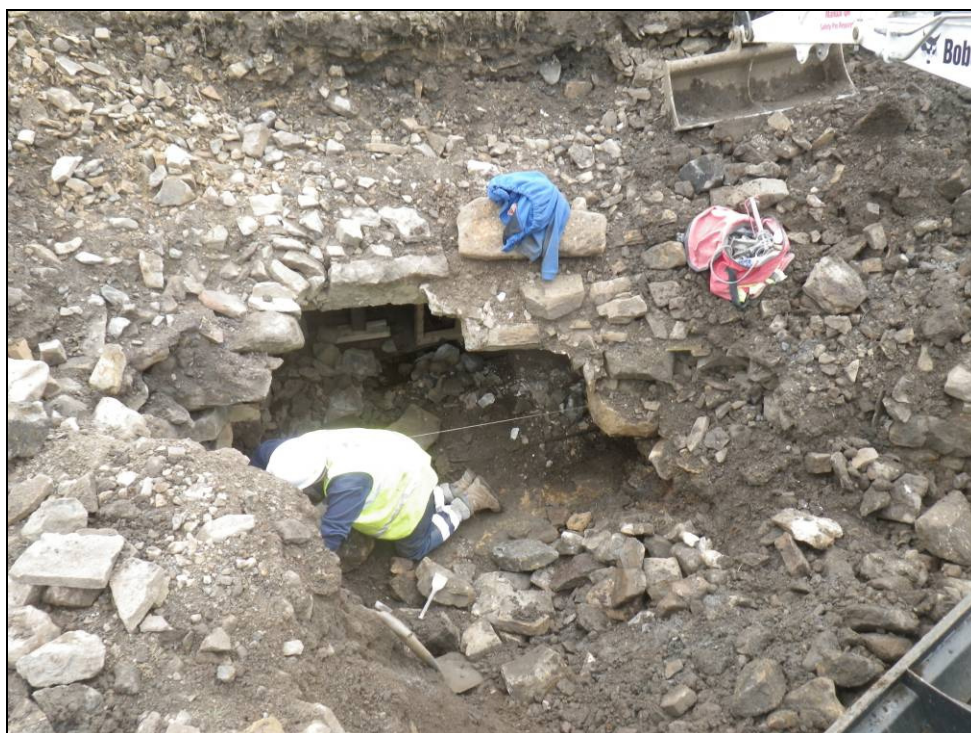
- 6.14 Once both walls were recorded it was necessary to remove wall (017) by hand, under archaeological supervision, to allow access into the collapsed culvert, Plate 57. No further features of archaeological interest were uncovered after the removal of the wall, only more rubble infill and collapsed sections of vaulting were encountered. Once the bed of the culvert was established the vaulting was rebuilt around the timber former and wall (017) was reinstated.

Plate 57: Wall (017) removed down to the bed of the culvert.

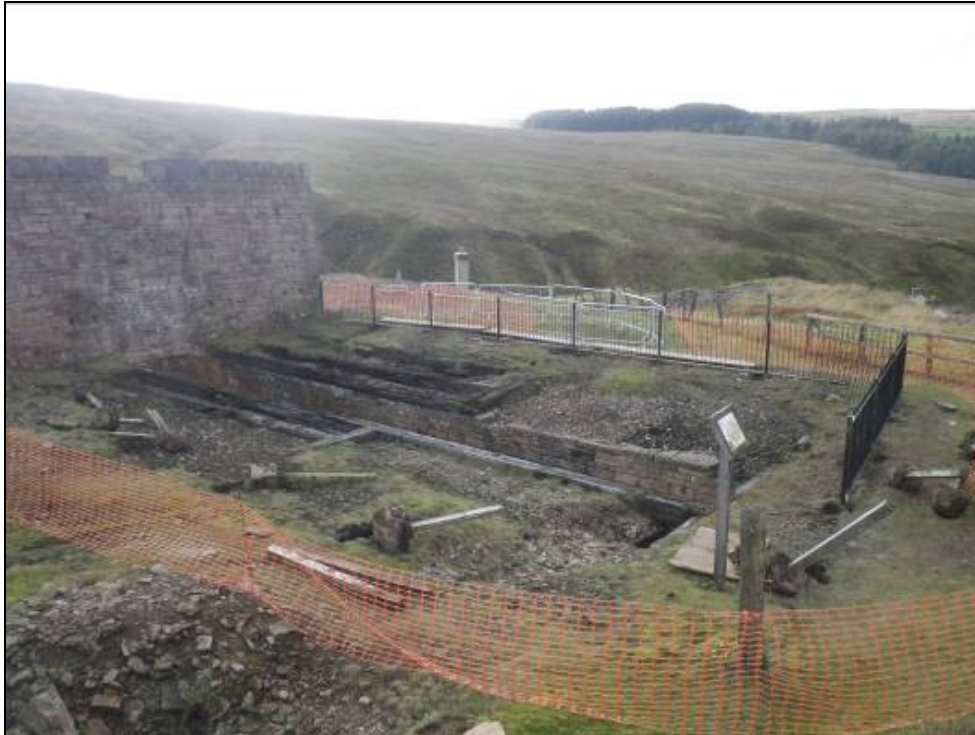
- 7.3 A watching brief took place to monitor the removal of fence posts ahead of the installation of a new iron fence around the perimeter of the Stagg wheel pit, Plate 59. Due to the small size of the fence post holes no features of further archaeological interest were uncovered during monitoring.

Plate 59: Photograph taken during fence installation.

- 7.4 However, it was later decided under further consultation that the fence would not be cut into the ground at the north-eastern end in order to keep the railings level. Instead the railings were stepped up at this point to avoid disturbing any archaeological remains underneath.

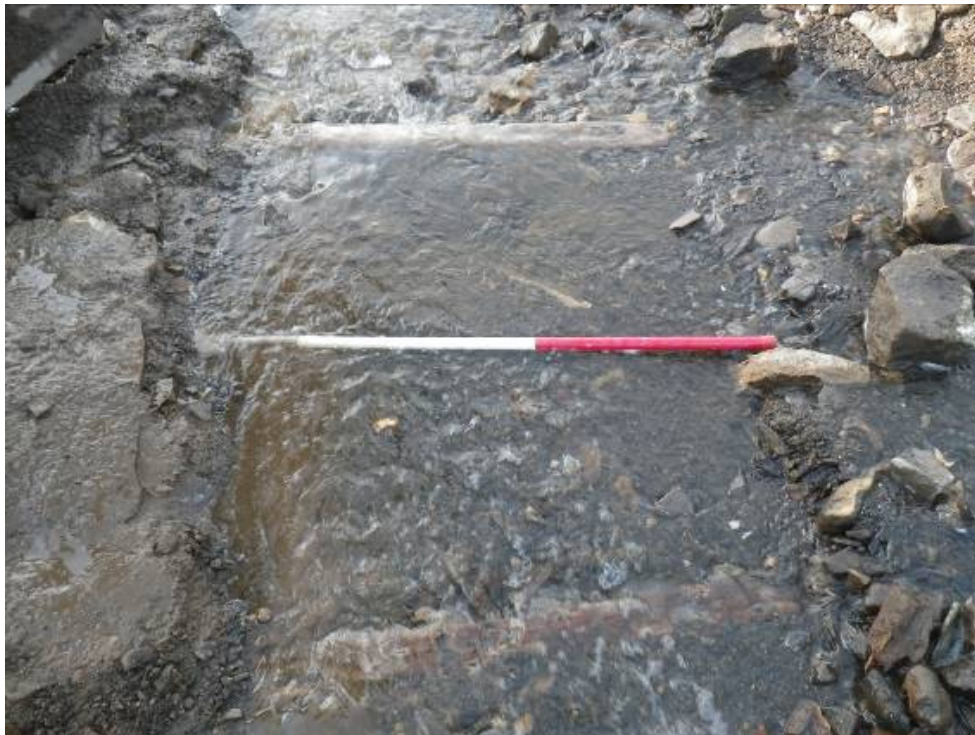
- 8.9 Once the damaged section of wall was dismantled, the clearance of the river bed began. The same JCB was used to remove the fallen masonry, taking care not to disturb the underlying cobbled base. During monitoring of the removal of the debris from the river bed, two timbers were uncovered in the base of the culvert, Plate 63. Each timber was set into the footing for the culvert walls. It is unclear as to the purpose of these timber beams, but it is possible that they were inserted as an attempt to catch debris in the base of the culvert as it flowed through.
- 8.10 These timbers were removed by hand as to not destroy them during excavation of the remainder of the culvert base. Once the removal of debris was finished the beams were bedded back into their original positions taking care to reincorporate them back into the footing of the culvert wall.

Plate 63: In situ timber set into wall footing.

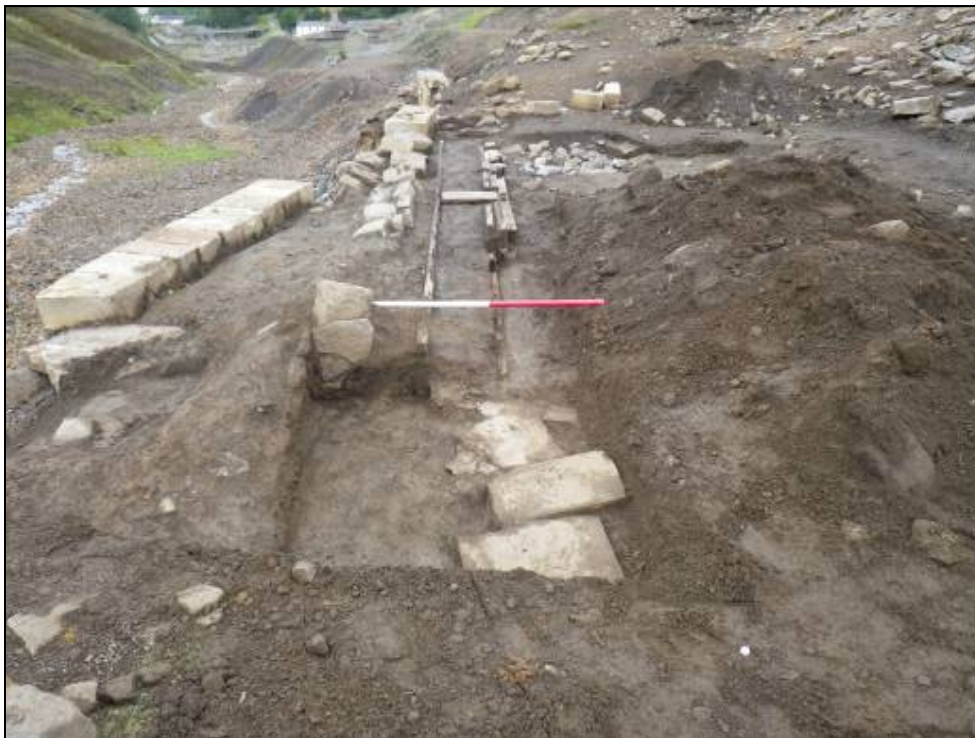
- 9.6 The position of all features discussed relating to the washing floor and retaining wall can be found on Figure 5.
- 9.7 Numerous watching briefs were undertaken along this section of wall. Initially the top layer of hill washed material was removed using a JCB with a toothless ditching bucket. As this deposit was removed two timber posts were observed immediately behind the retaining wall. Care was taken not to disturb these posts as they were believed to form part of a larger structure underneath. Machining stopped once the top of a timber chute was revealed and the area was subsequently cleaned by hand to expose the full length of the structure, Plate 66.

Plate 66: Timber chute looking northwest towards smelt mill complex.

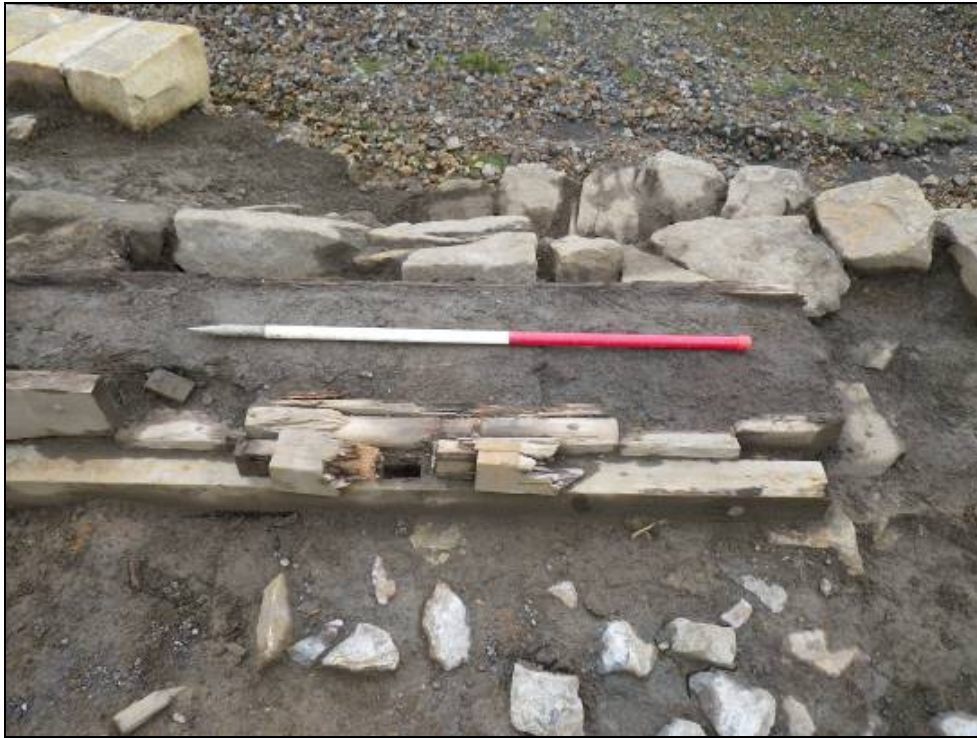
Plate 67: Timber structure butting against sludge chute on north-western end. Note two timber posts observed before machining commenced.

- 9.11 The timber structure adjoining the northwest end of the chute probably supported a super-structure that would have controlled the intake of material into the chute from the side, Plate 67. Three entrances into the side of the chute were observed (two of which can be seen in the above plate) with a series of post holes either side. It is likely that the chute was fed from the side at this point. Once the chute fill was excavated, scratch marks on the base of the chute were noted radiating outward further suggesting material was entering the chute at this point (Plate 68).

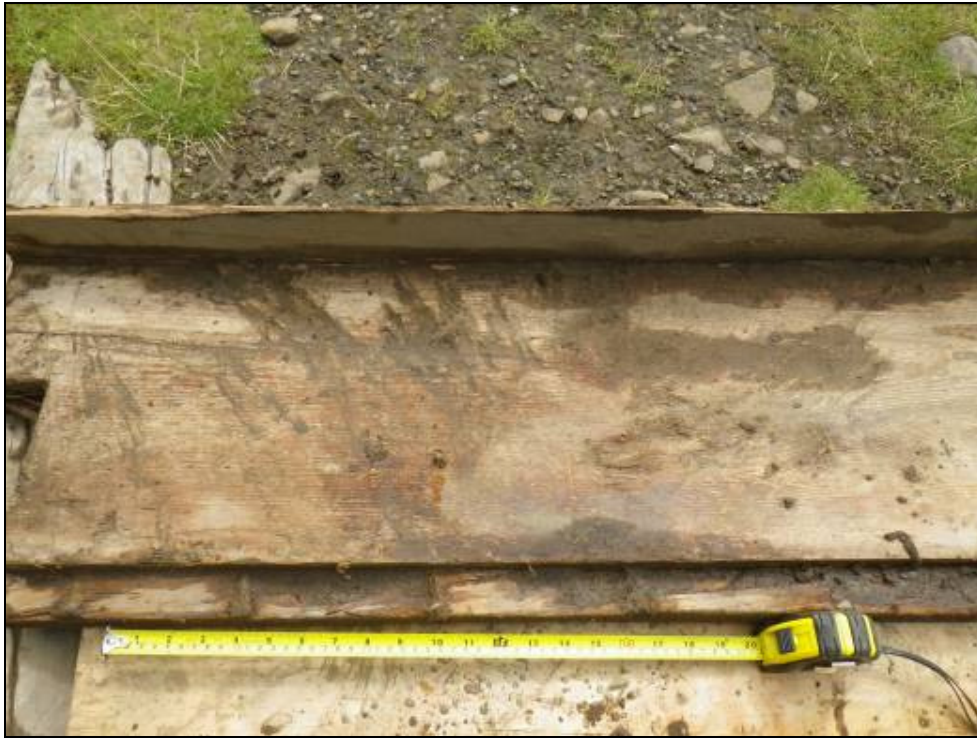
Plate 68: Radiating scratch marks at base of chute at side intake.

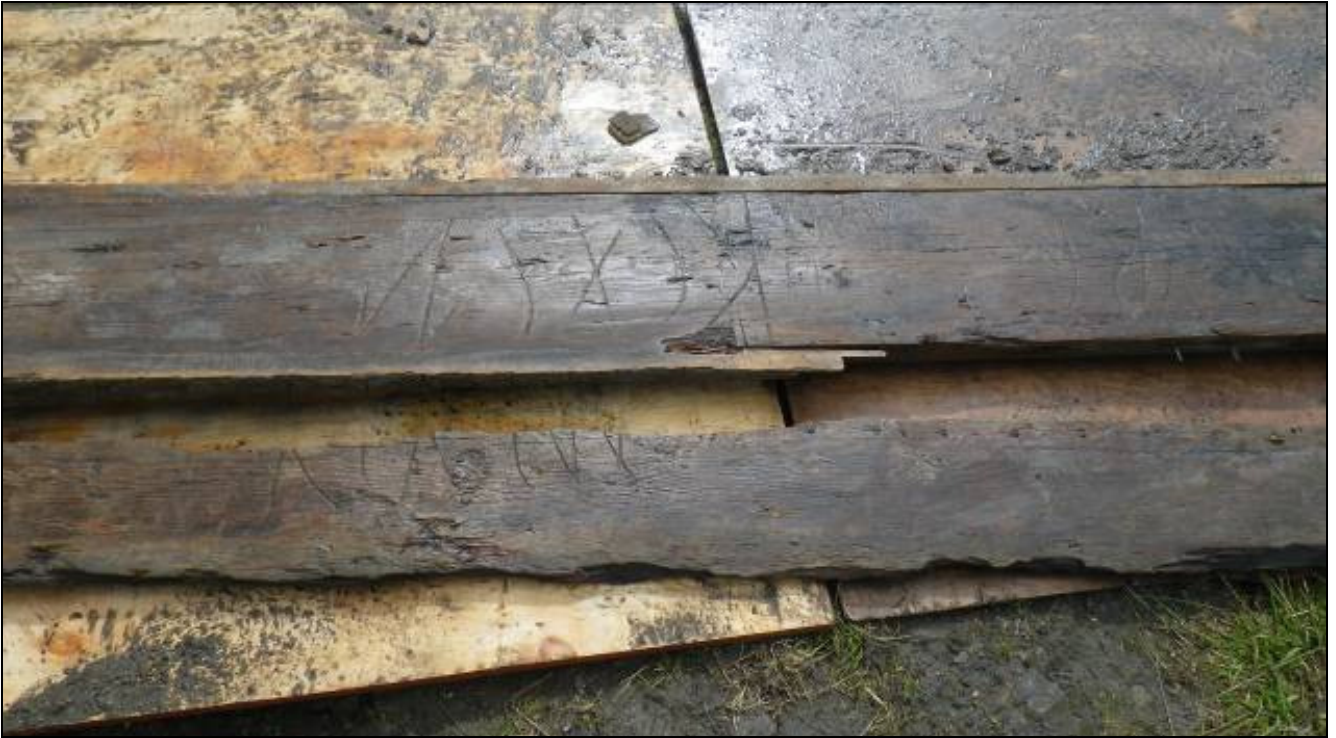
- 9.13 After the removal of the chute a number of inscriptions were noted on the side and base. The inscription on the base reads "NRI KCXIV". "NRI" likely relates to initials of the carpenter or an area, "CXIV" relating to the roman numerals for 114. It is unclear as to the meaning of the K, but it likely relates to some numbering system related to the processing of the planks. The inscription on the side of the chute is difficult to read as it has been truncated once the plank was cut to fit the chute. What is left of the inscription reads "KCXIVV NRI". "CXIVV" does not make sense as a roman numeral but if split up could mean 114, 5 and the "NRI" likely relates to initials again.

- 9.14 It is likely that these inscriptions were used as carpenter's marks to number and initial the planks of wood before they were used in the construction of the chute. The inscriptions did not occur after the construction of the chute as the side inscription is cut in half laterally.

Plate 69: Base of chute at top of image with side inscription underneath.

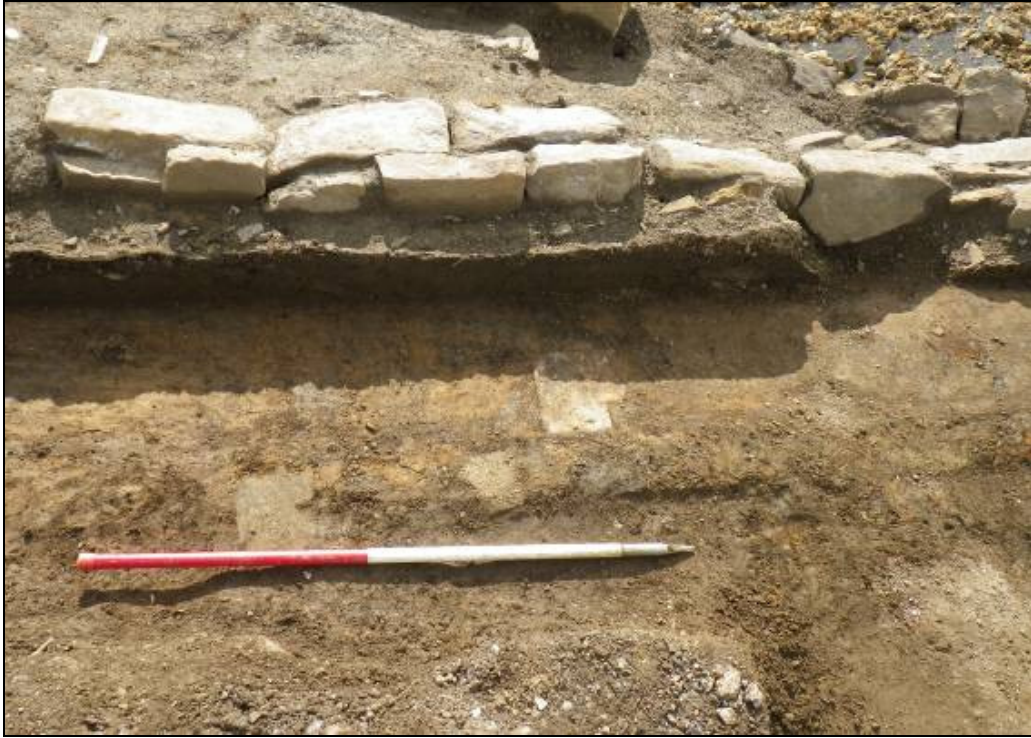
- 9.15 Running parallel to the chute is a section of horizontal retaining wall, which butts up against and ties into the main retaining wall for the dressing floor, Plate 70.
- 9.16 This retaining wall was likely put in to counteract the pressure from the side intakes of the chute from pushing the chute over the edge of the dressing floor. The wall itself consisted of roughly faced limestone blocks laid on edge up to six courses wide in places that slope down and ties into the main retaining wall. The horizontal retaining wall stretches for the entirety of the length of the timber chute, which suggests the chute was not under pressure from the side past this point.

Plate 70: Retaining wall for chute.
