**FORMER
MINISTRY OF DEFENCE DEPOT**

**KILLINGWORTH
NORTH TYNESIDE**

NAA 14/24
September 2014

**FORMER MINISTRY OF DEFENCE DEPOT
KILLINGWORTH, NORTH TYNESIDE
BUILDINGS SURVEY AND ASSESSMENT OF SIGNIFICANCE**

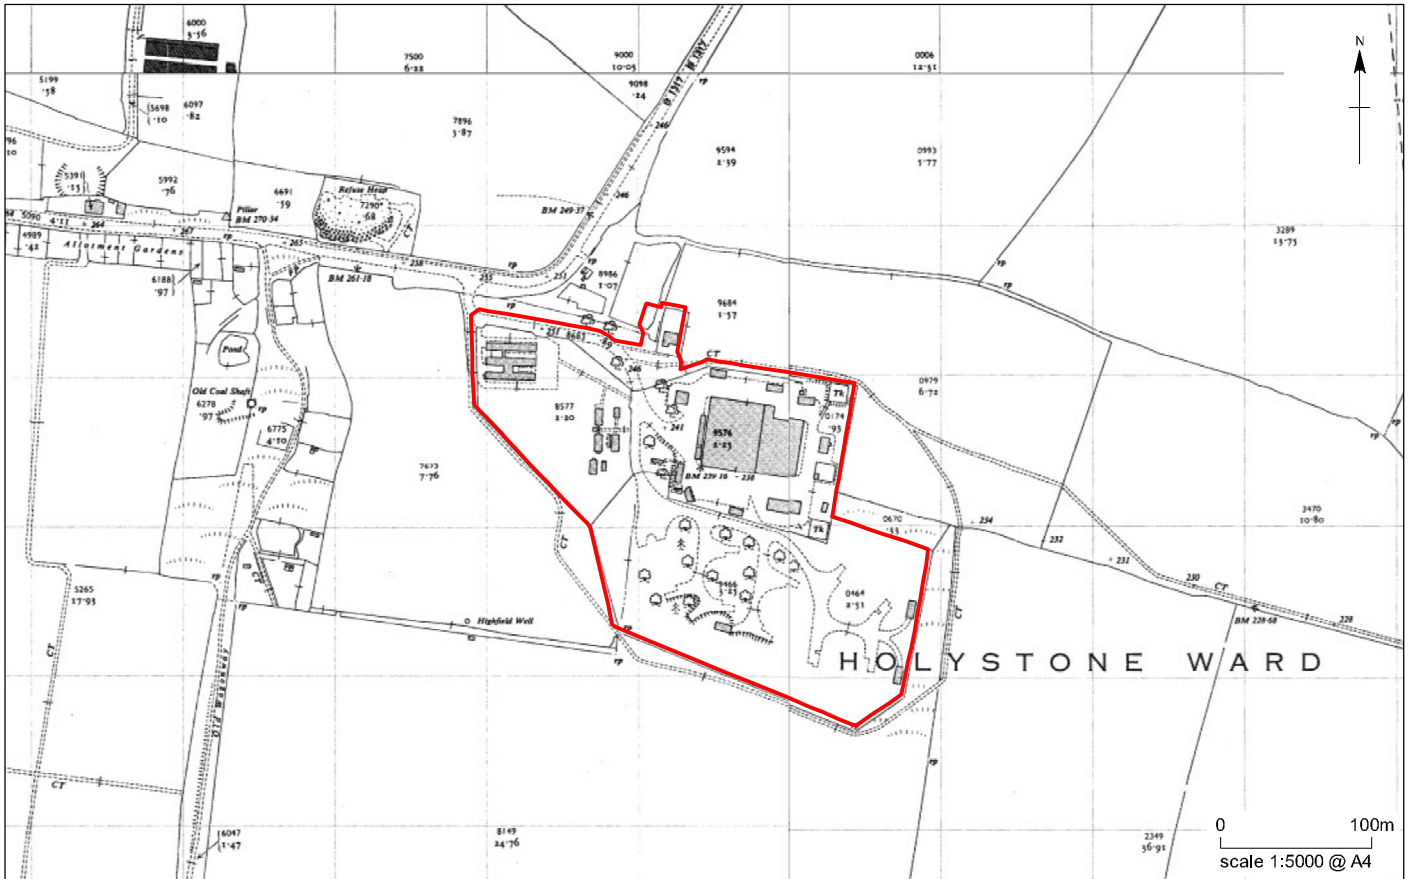
Figure 4

- 7.88 This small structure appears on only the 1952 Ordnance Survey (**Fig. 4**) but not on the aerial photograph of 1948 (**Plate 2**). It comprised a rectangular structure, clearly built during the occupation of the site by the REME in the post-war years. The structure has since been demolished and its form and purpose remain unknown.

Former Killingworth Stores: 1952 Ordnance Survey map

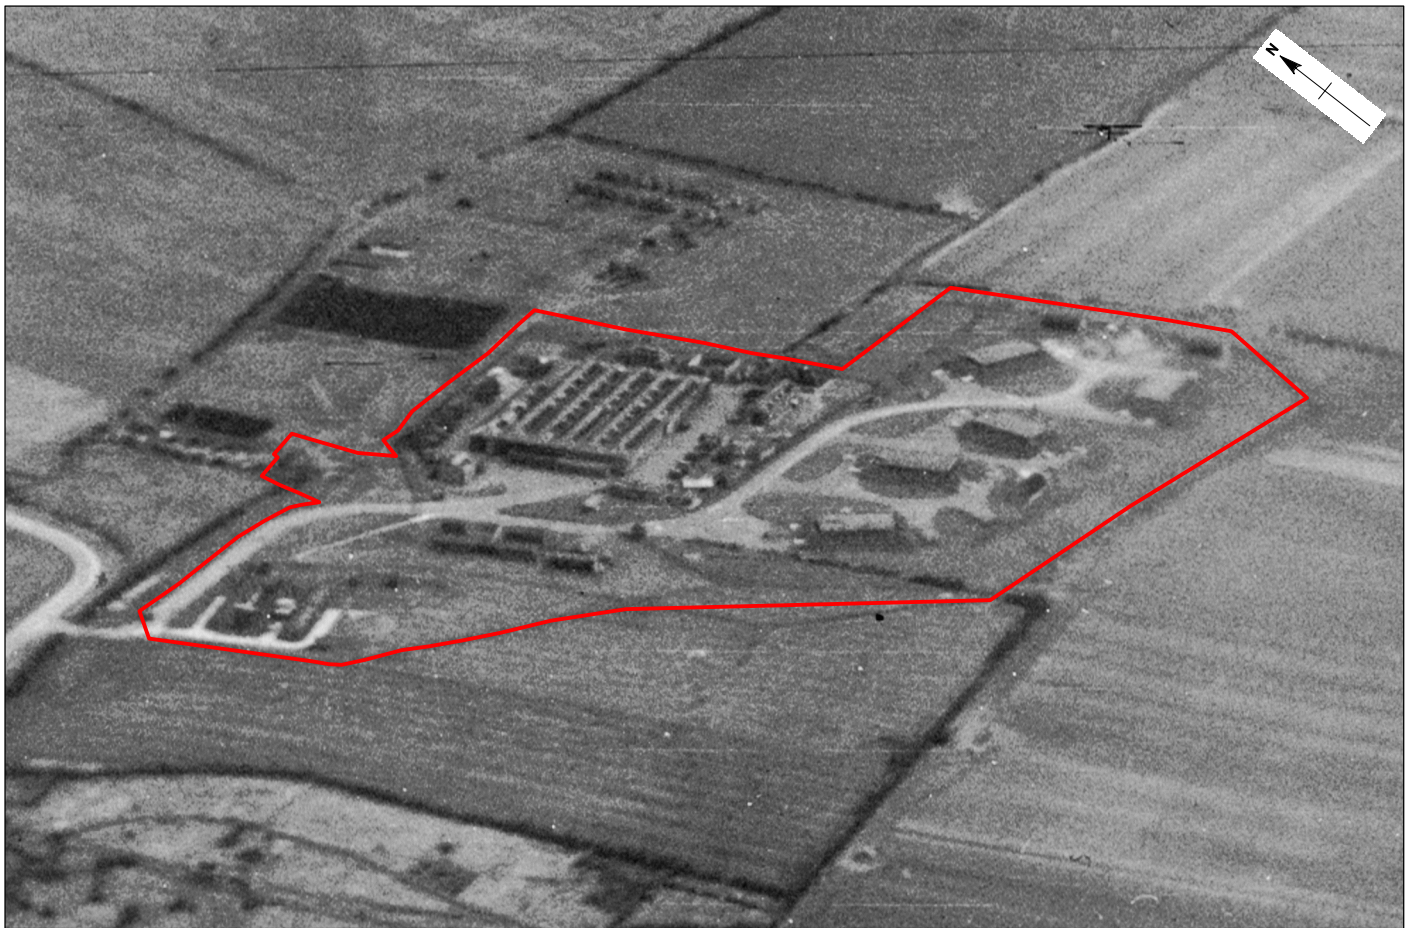
Plate 1

- 6.26 The earliest photograph selected for inclusion in this report is an oblique view dating to March 1945 (**Plate 1**). This image not only serves to provide evidence for the complex during the war years, but is perhaps the only evidence for some form of activity occurring in the field to the north and north-east of the complex at that time.

*Former Killingworth Stores: oblique aerial photograph of the complex,
3rd March 1945 (RAF_106g_1a_160_psfo_0012)*

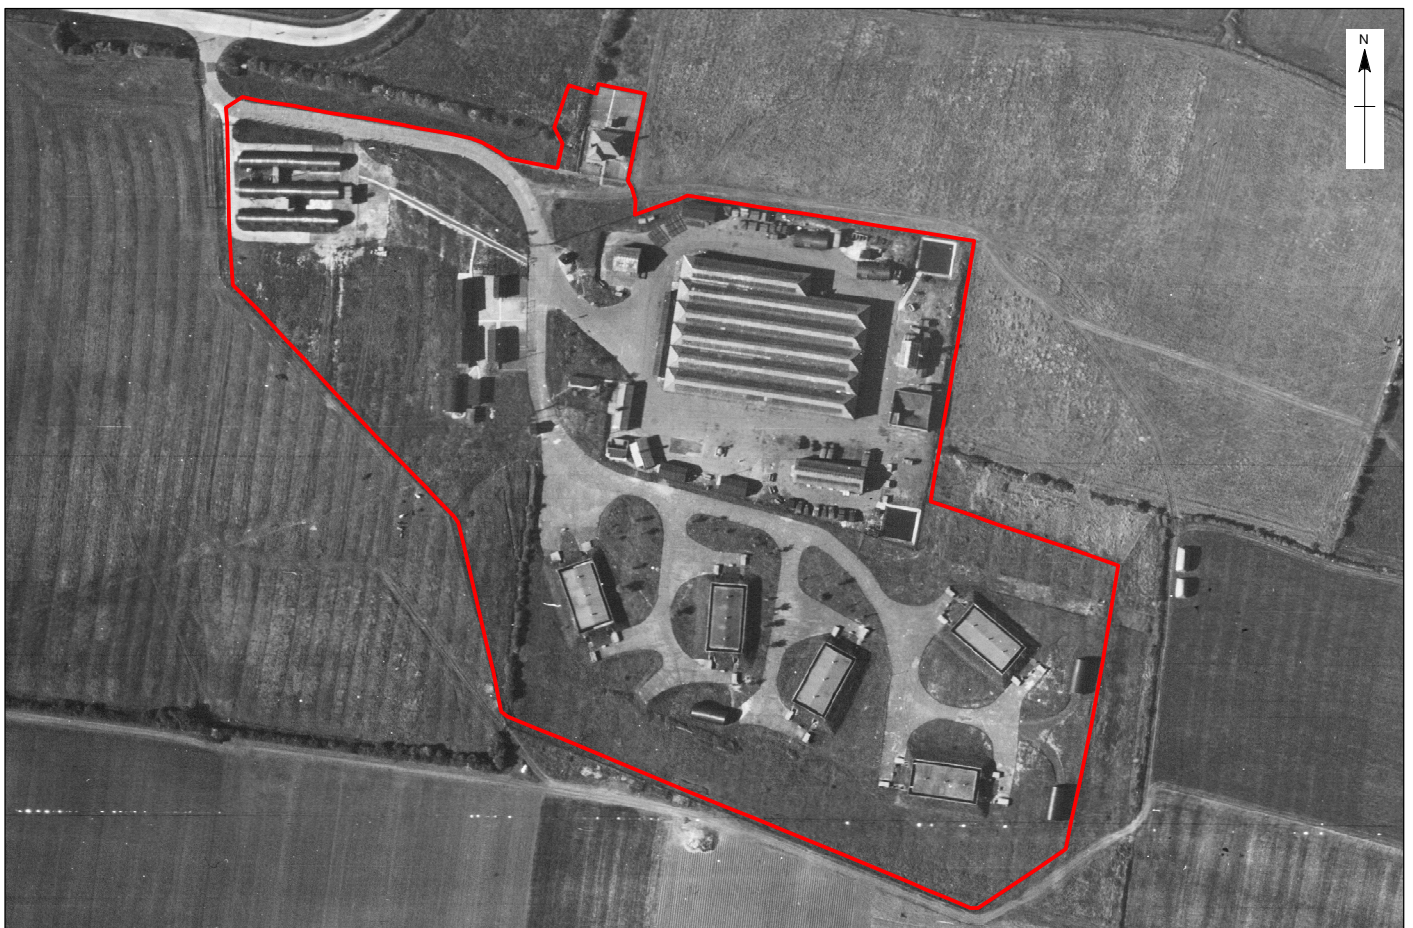
- 8.3 Figure 2 provides a plan of the depot complex showing the totality of all the buildings recorded on aerial photographs dating to 1948 (**Plate 2**). It also shows which of these buildings have been demolished and which survive today. Whilst it is likely that the majority of these buildings were present by 1945, the oblique and distance view of the site on Plate 1 makes it difficult to view with certainty those buildings present within the Buildings 2 complex and around the perimeter of Building 12.

*Former Killingworth Stores: vertical aerial photograph of the complex,
16th May 1948 (RAF_58_b_32_v_5696)*

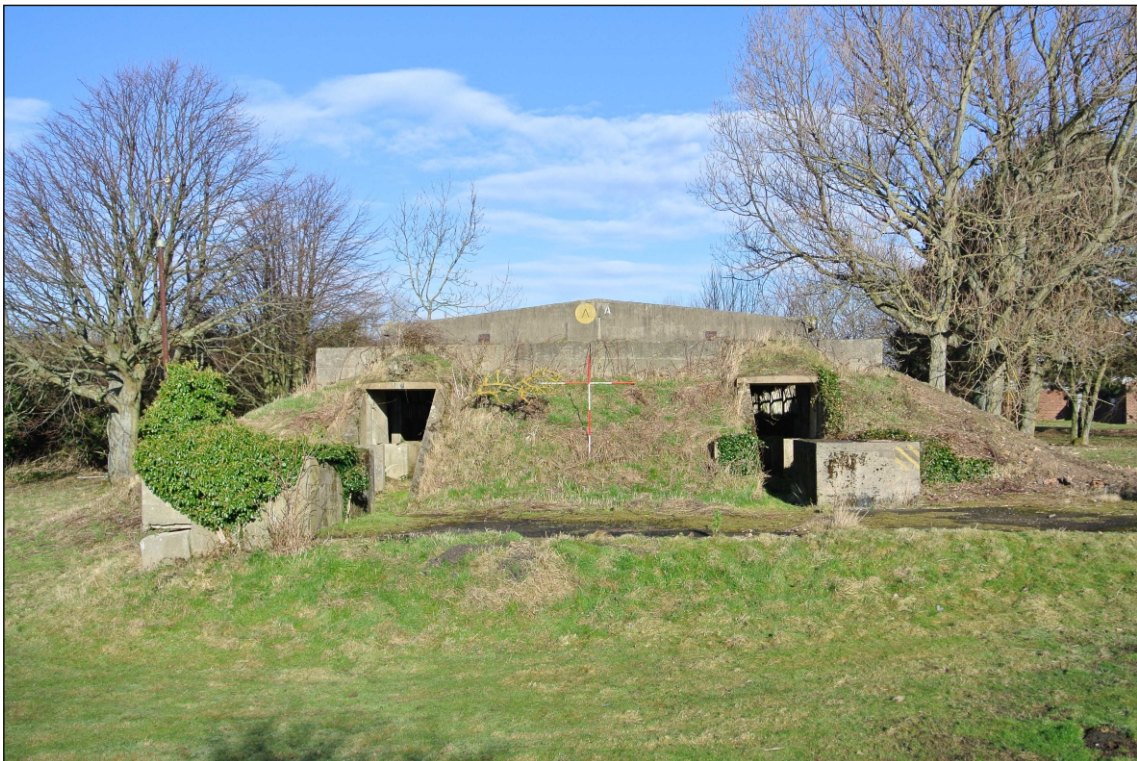
Plate 18

- 7.156 With the exception of the internal and external fittings, the bunkers are constructed of shuttered, reinforced concrete. Each comprises what is essentially a large shed with a door in the corner of each gable wall. They measure 20.72m by 9.75m (68' by 32') externally, with vertical walls and a shallow-pitch roof which is approximately 4.10m (13'6") high. They are surrounded by shuttered concrete blast-walls, externally buttressed. The blast-walls are earth-bunded and the bunds have slumped through time and no longer extend to the tops of the blast-walls (**Plates 18, 19 and 26**).

Former Killingworth Stores: Bunker A, southern end

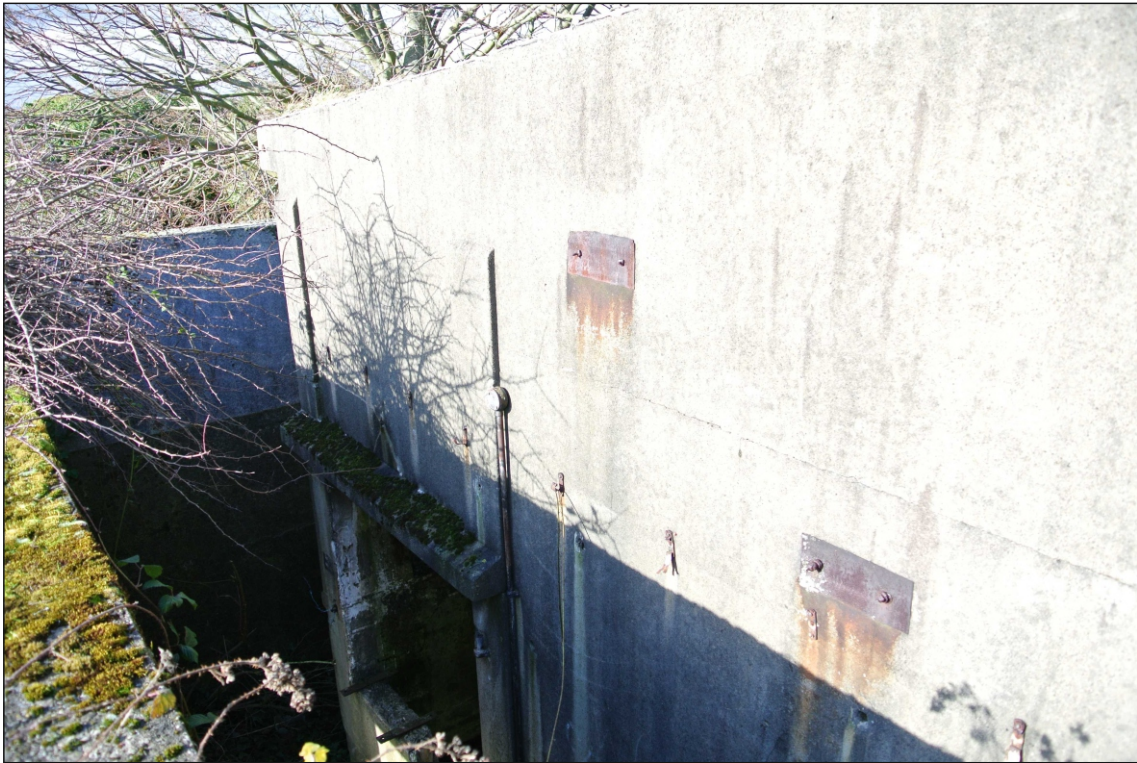
*Former Killingworth Stores: Bunker A, south-west corner, showing Plate 19
blast wall around entranceway into the structure*

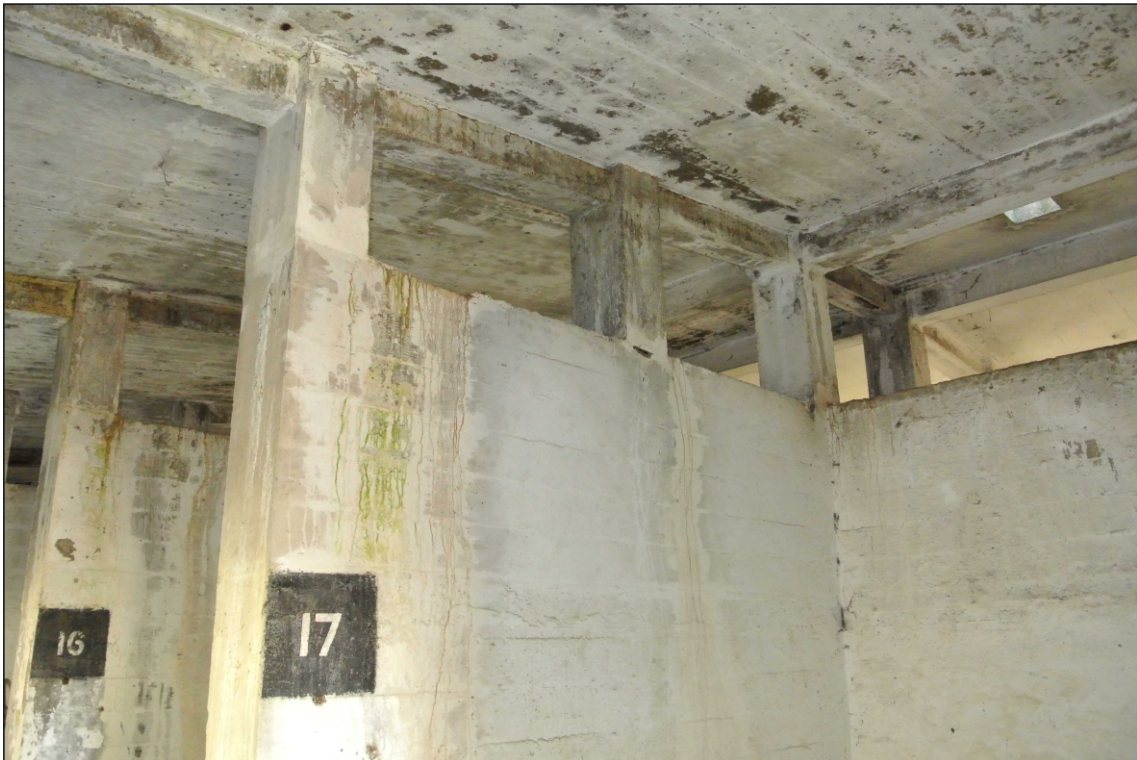
- 7.158 The bunkers have four entrances, each positioned at the corner of the gable walls. Each bunker is divided longitudinally into two aisles by a shuttered concrete wall, approximately 3.04m (10') high and 1.52m (5') thick but not extending fully to the roof of the structure (**Plates 20 and 21**).

*Former Killingworth Stores: Bunker A, interior showing numbered Plate 20
bays, roof supports and ventilation*

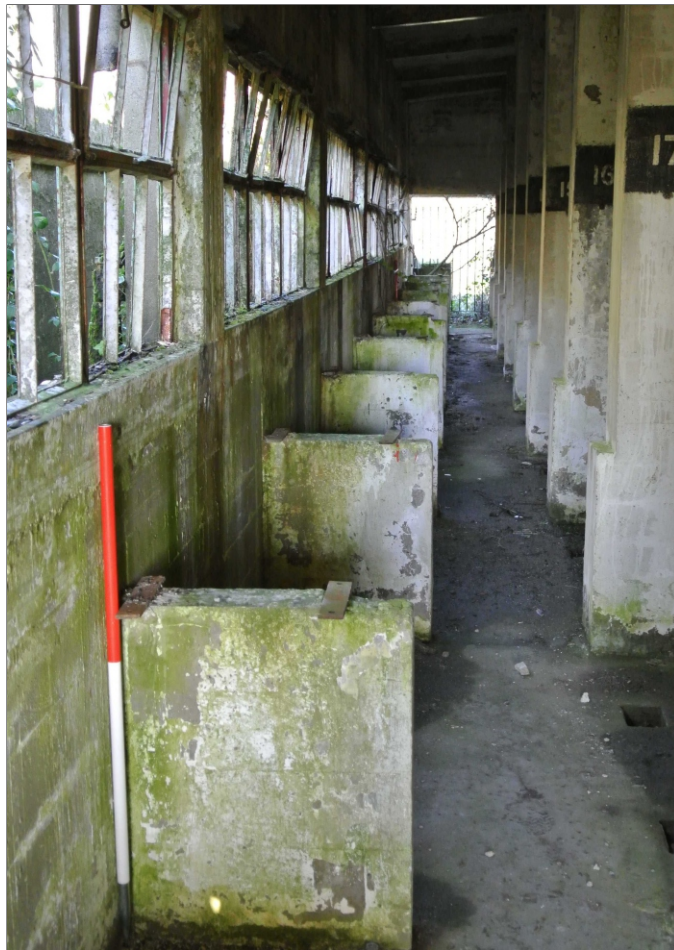
- 7.160 Each bay has four rectangular post settings in its floor (**Figs. 15 – 17**). Most have an in situ wooden lining. The long walls of each bunker contain a series of six window apertures, 3.03m by 0.92m (10' by 3') containing steel-framed windows (**Plates 21 and 22**). Each window is divided into three identical subsections containing 16 small glass panes and each subsection has an opening upper half. The windows in Bunkers A, C, D and E are at mid-height 1.24m (4') above floor level (**Fig. 16**). Those in Bunker B are in the upper section of the wall 2m (6'6") above the floor (**Fig. 17**). There is a flaring in the casting on the external walls over the windows, and they have precast concrete cills.

- 7.161 A row of low concrete plinths are positioned against the exterior walls, opposite each bay division (**Plate 21**). They are 0.64m by 0.16m (2' by 6") and stand 0.77m (2'6") high. These plinths continue out through the doorways of the bunker and the entranceways, then on through the blast wall, to the loading platforms situated outside. A pair of steel brackets are fixed to the top of each plinth, originally supporting a conveyor or rollers (which have been removed).

*Former Killingworth Stores: Plate 21
Bunker A, showing concrete plinths for
conveyor, and position of windows*

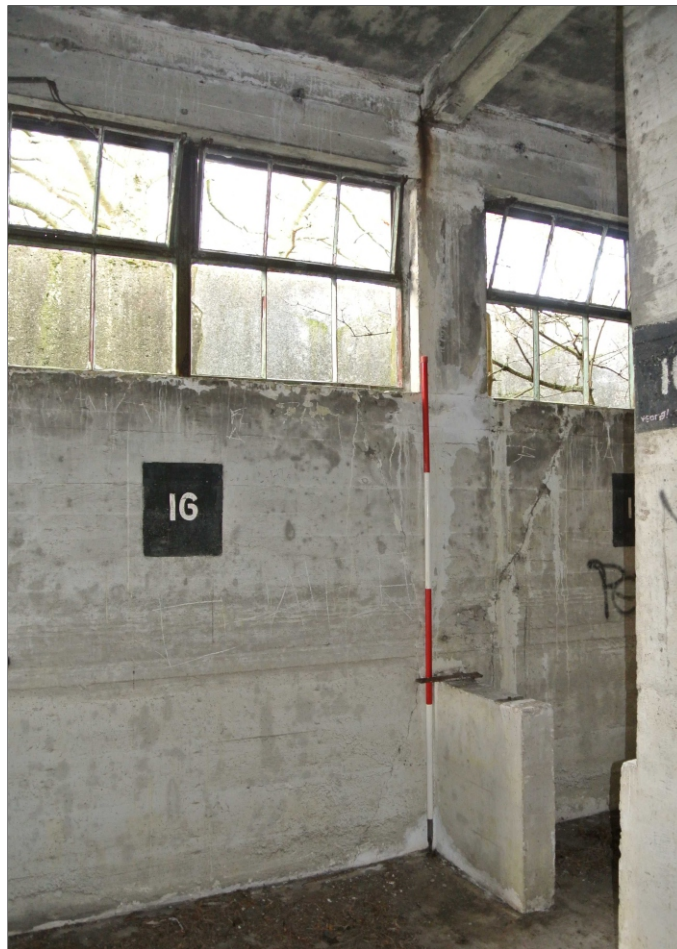
*Former Killingworth Stores: Plate 22
Bunker B, showing position of windows*

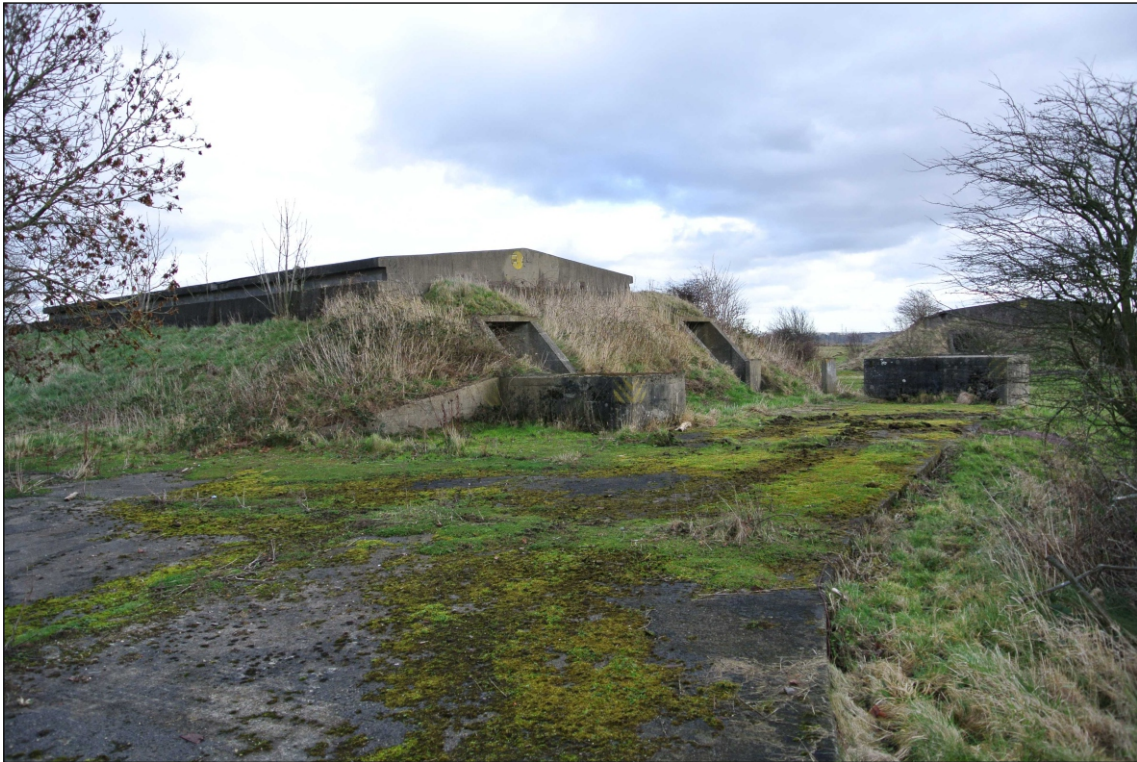
Former Killingworth Stores: Bunker C, south end, showing asymmetrical positioning of external loading platforms
