**PHASE 2 BUILDINGS SURVEY
AND
WATCHING BRIEF**

**FORMER
MINISTRY OF DEFENCE DEPOT

KILLINGWORTH
NORTH TYNESIDE**

NAA 15/70
February 2016

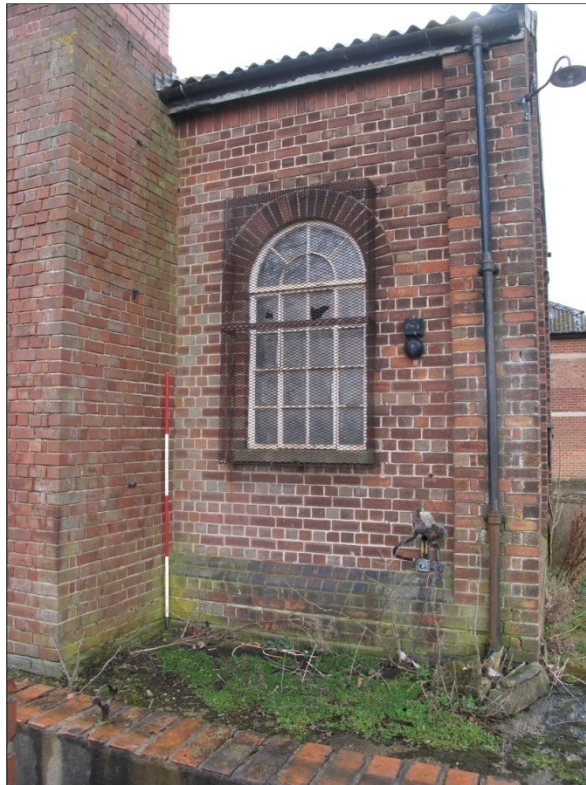
Plate 17: one of the ornate original windows of Building 10, in its east wall

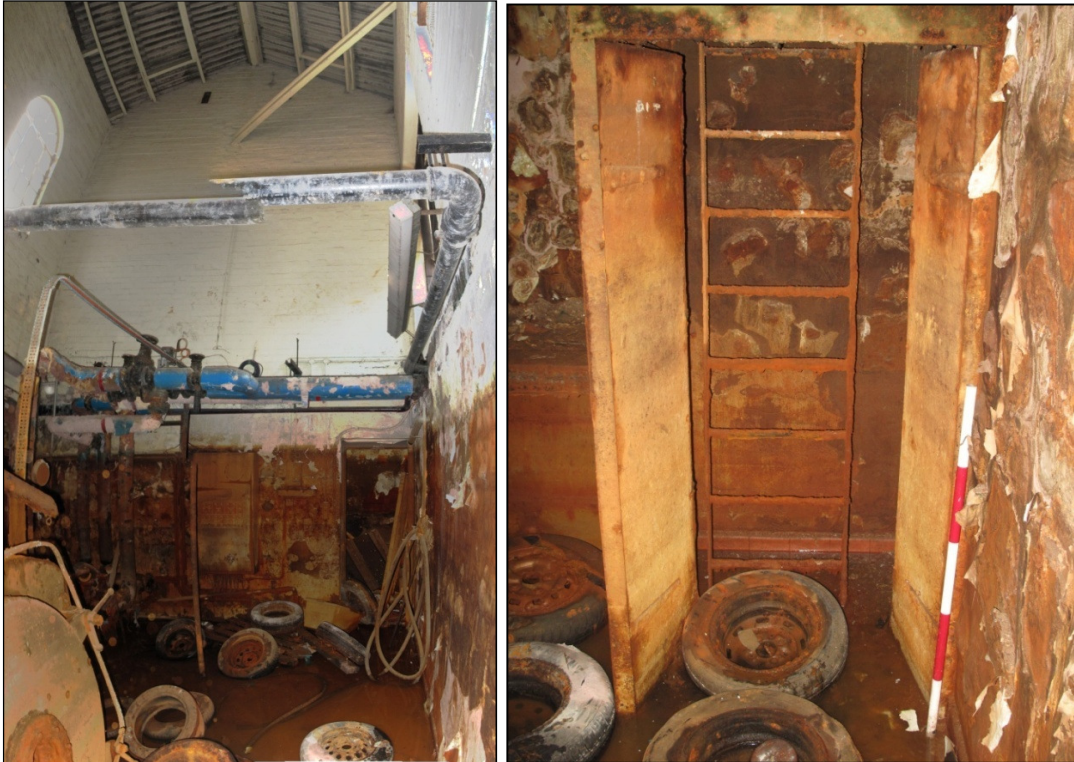
Plate 18: south-facing photomontage of the interior of Building 10, taken from below ground floor level (left), and fire escape ladder in the north-west corner, facing west (right)

floor of the cellar was not visible due to previous flooding, but was likely to be concrete. Within the enclosure for the fire escape (see below), the wall was bordered at the base with red tiles (visible in Plate 18). The same tile border is visible at the foot of the east wall, and probably extended around the entire building, but was obscured at the time of survey by flooding and debris. This feature is further evidence to the quality of building, and attention to detail, above that which might normally be anticipated for a boiler room on a military base, and above other buildings on site. In the north and south interior elevations were pairs of vents, set high up on the wall, which had been blocked externally using brickwork.

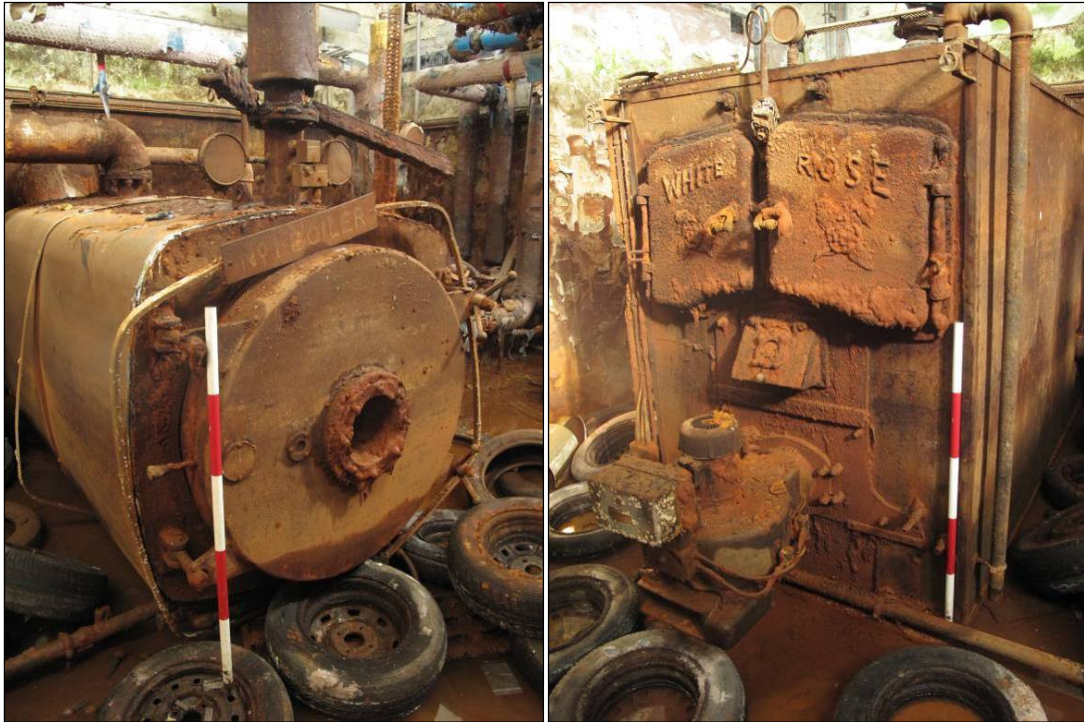
Plate 19: 'Boiler No. 1' (left) and 'Boiler No. 2' (right), facing east

- 5.77 The cellar included two large boilers – labelled ‘Boiler No. 1’ and ‘Boiler No. 2’ – which appear to have been installed around the early 1950s (Plate 19). ‘Boiler No. 1’ has no identifying maker’s plate, and is difficult to date. The boiler was made of iron and originally painted blue. The boiler was broadly cylindrical, with a cylindrical access door at the front, into which would have been fitted a forced draft burner through a circular hole. This burner had been removed by the time of the survey. The boiler was enclosed by three straps, which presumably minimised lateral movement during the running of the boiler.

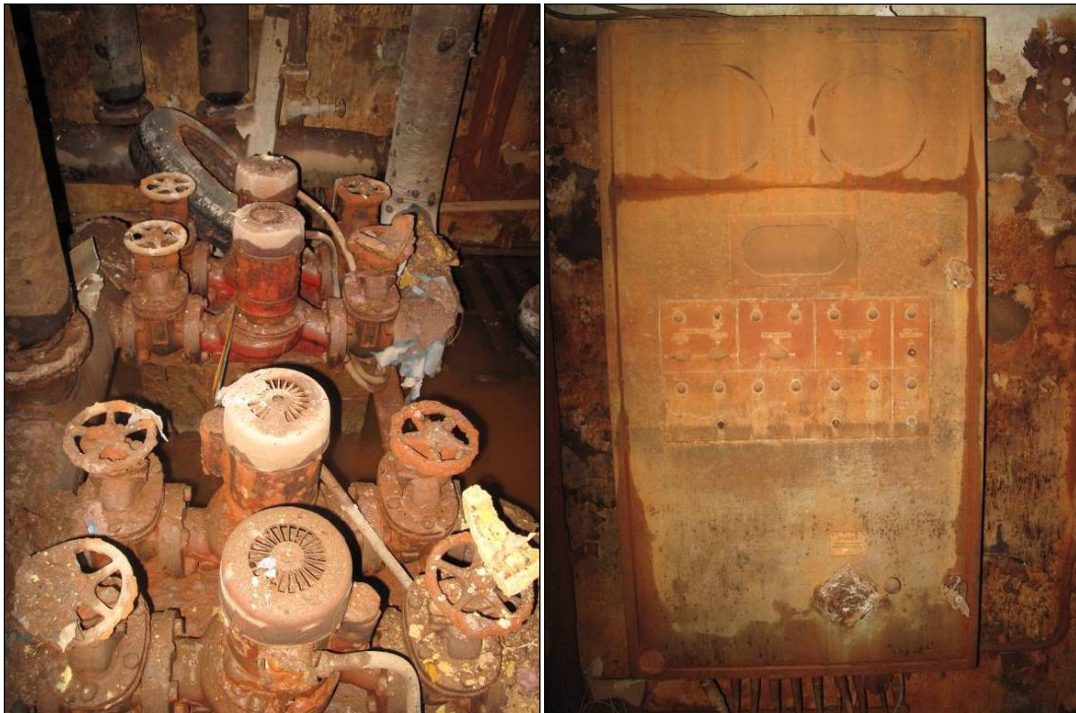
Plate 20: hydro-electric dynamo generators (left) and switchgear (right)

- 5.80 The pipework also incorporated four hydro-electric dynamo generators, which used the returning water to generate electricity. These generators seemed to have been only used to supply electricity for use within the boiler house itself. Electrical switch-gear on the southern wall controlled the burners, heat-pumps, convector units and oil tank alarms (labelled 'No. 1 Oil Tank and 'No. 2 Oil Tank'). The switches were made of Bakelite. The wall also included a fuse box and light-switches, and a network of metal cable channels extended around the walls. All the electrical switchgear looked to be of mid-20th century date, and probably contemporary with the installation of the oil-fired boilers. A hydro-electric substation was also identified at East Boldon, which was clearly later than the original complex, and probably served a similar function.

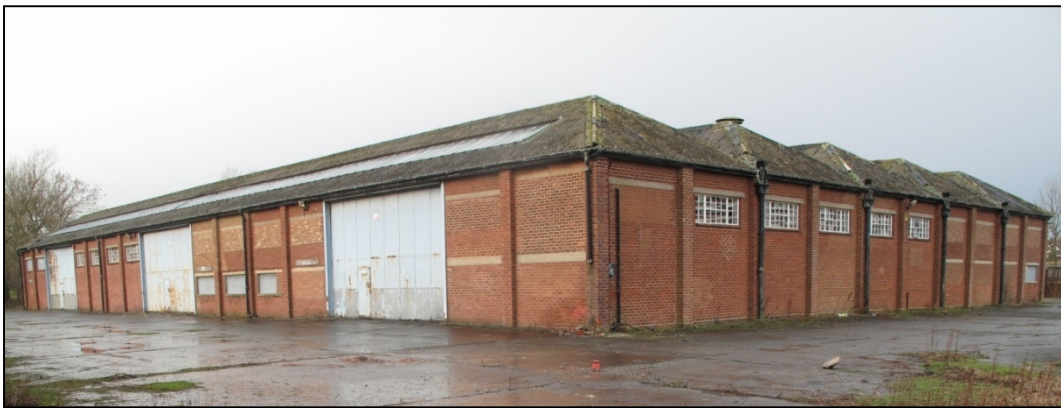
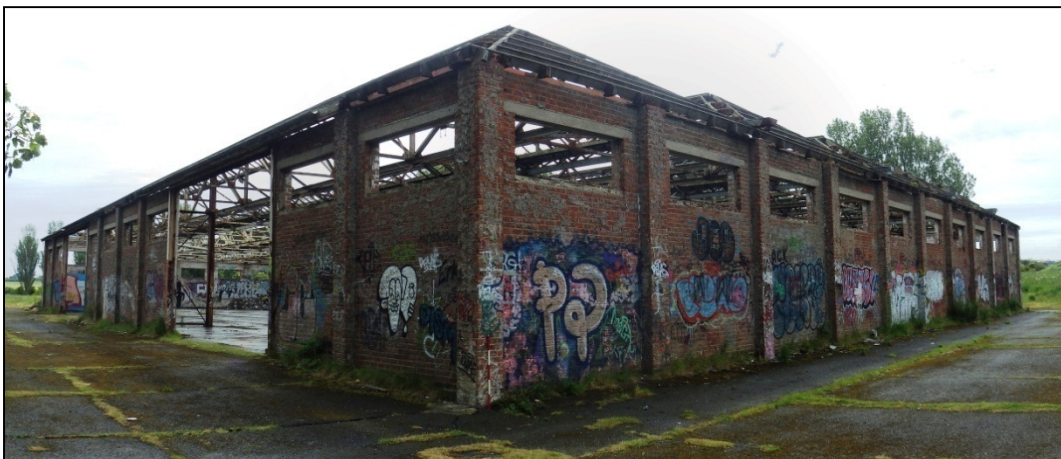
Plate 21: the south and east elevations of Building 12, showing the three large vehicular access doors, the roof structure and considerable alteration to the window positioning (above). A comparable view of the main store at East Boldon (below)

- 5.100 On the east elevation, there were originally ten upper level windows, positioned in each aisle (Plate 21). However, six of the original upper windows had been blocked: five of these towards the northern end of the elevation, and another at the southern end. The remaining original windows were uncovered at the time of survey. The blocking brickwork was again of undecorated brick in stretcher bond. The three northern aisles also featured ground floor windows, which were seemingly later additions, three of which were also blocked when this survey was undertaken. All of the lower windows had grey pebbly concrete lintels, and the northernmost two had a concrete sill. The blocking brickwork of the lower windows is in stretcher bond with horizontal line-decoration.

- 5.101 The south elevation featured twelve upper level windows (Plate 21). The six windows to the western half remained unaltered at the time of survey, although the two westernmost windows were covered. The six upper level windows to the east had been blocked, with plain brick, and replacement windows of the same size had been installed at ground floor level (many of which exhibited signs of further alteration). Four of the lower windows had yellow, pebbled lintels and

precast grey sills. Lintels were surviving on the two easternmost lower windows, and were of thick, precast concrete. The three eastern lower-level windows had been blocked, and the window to the west of these had been narrowed. The blocking was with brick featuring horizontal decoration. The lintel of the original upper-level window of the easternmost bay had also been replaced with a thicker yellow precast concrete. The brickwork surrounding this had also been replaced using a plain brick. The thicker materials and blocking presumably reflect structural instability at this end of the structure.

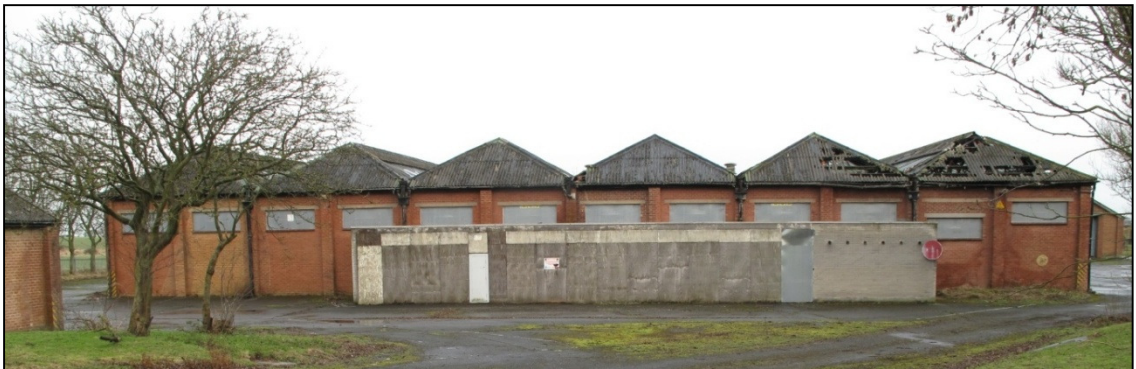
Plate 22: the west elevation of Building 12, with the non-original extension in the foreground, and the altered window second from the right

- 5.91 A later, single storey rectangular extension had been built against the west wall, obscuring the lower portions of the three central aisles (Plate 22). This measured 23.64m by 4.58m (77'6" by 15') and 3.18m (10'6") in height. The extension was constructed of grey-cream undecorated brick, in stretcher bond, and had a flat roof with concrete copings at the wall-heads. This later building had two doorways in its western side and a third in its southern side, all sealed at the time of survey. A structure of identical dimensions but with a ridged roof is visible in this position in the aerial photograph of 1948, indicating that there was a structure in this position by this date, though the present structure appears more modern. The modern extension appears to have been a discrete space, internally, with no access from the main building. The 1978

- 5.98 On the west elevation, each aisle incorporated two windows which were arranged symmetrically about the central pillars (Plate 22). There were twelve windows in total. Each was surmounted by a simple concrete lintel and featured edge-laid brick sills. At the time of survey, these windows were covered by steel-mesh security grills, which obscured the details of the window frames. The second window from the south had been partly blocked and lowered. The blocking brickwork had horizontal line decoration, and the replacement lintel was slightly thicker than the original, constructed in precast grey concrete. The original sill appeared to have been reused.

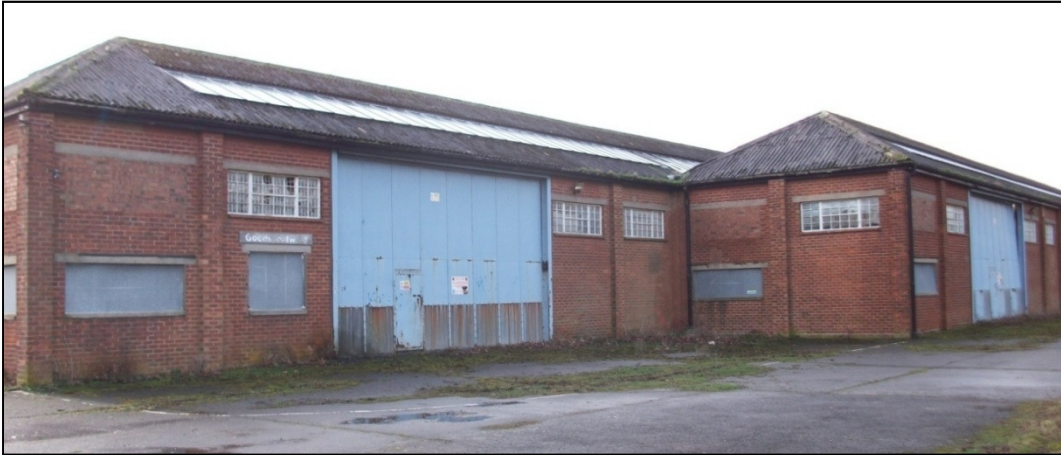
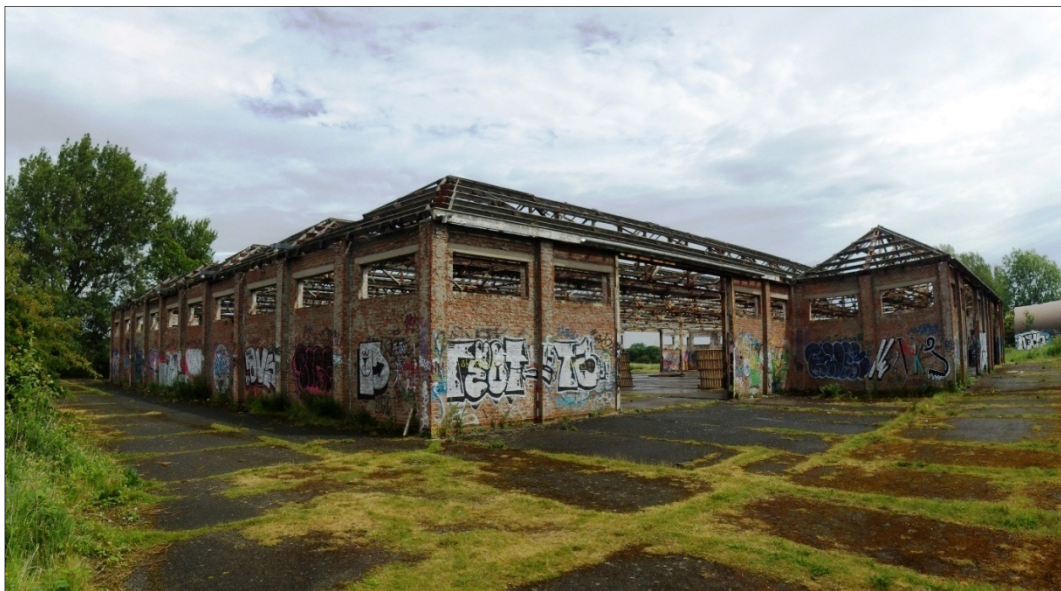
Plate 23: the north elevation of Building 12, showing two of the large vehicular doors, considerable window alteration and some markings on the concrete paving slabs (above). A comparable view of the main store at East Boldon (below)

- 5.99 The bays of the north elevation each featured windows originally positioned at a high level (Plate 23). There were twelve windows in total, and two further windows in the east elevation of the protruding block. The western two windows (on the protruding element) had modern metal covers, and the eastern window of this element had its original window blocked, with plain brick in stretcher bond. A replacement window, of the same size (and possibly using the original frame and glass) was positioned below it at ground-floor level, with a lintel and sill both of cream concrete. The easternmost window of the elevation had also been blocked (again with undecorated brick). This bay, and that immediately west, had two later windows at ground level, both featuring grey concrete lintels and sills. The easternmost window was of the same dimensions as the original; the westernmost being nearly square, 1.44m by 1.22m (4'9" by 4') in size. It had been covered, but projecting metal hinges were visible and the window appears to be metal-framed. It also had a wooden 'GOODS OUTWARD' sign fixed to the wall above it.

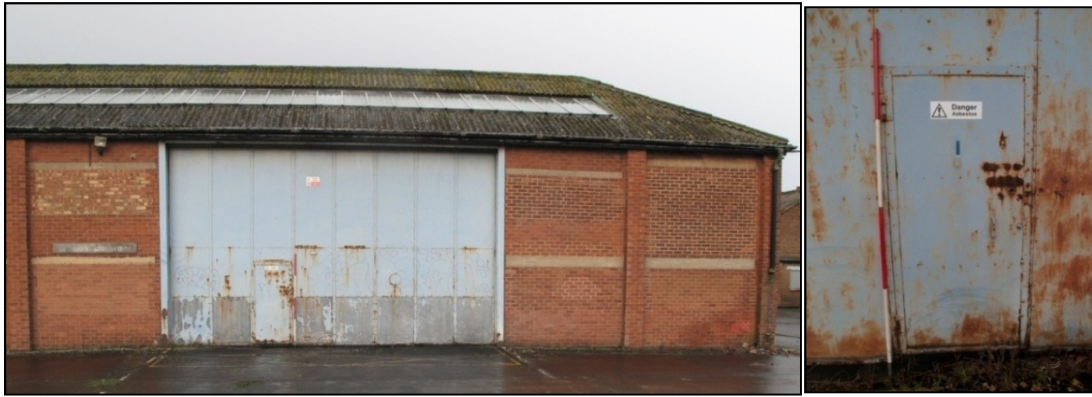
were riveted (Plate 24). The lockable pedestrian access door was located within either the third or fourth vertical panel from the left. Pedestrian access on the northern elevation was in the third panel from the east (in the easternmost door) and in the fourth on the remaining two doors. In the south elevation, pedestrian access was in the fourth panel from the west (in the west and central doors) and in the third panel in the eastern door.

Plate 24: the south-eastern vehicular access door (left), and a detailed view of the pedestrian access (right). The brick panels surrounding the door had been significantly altered

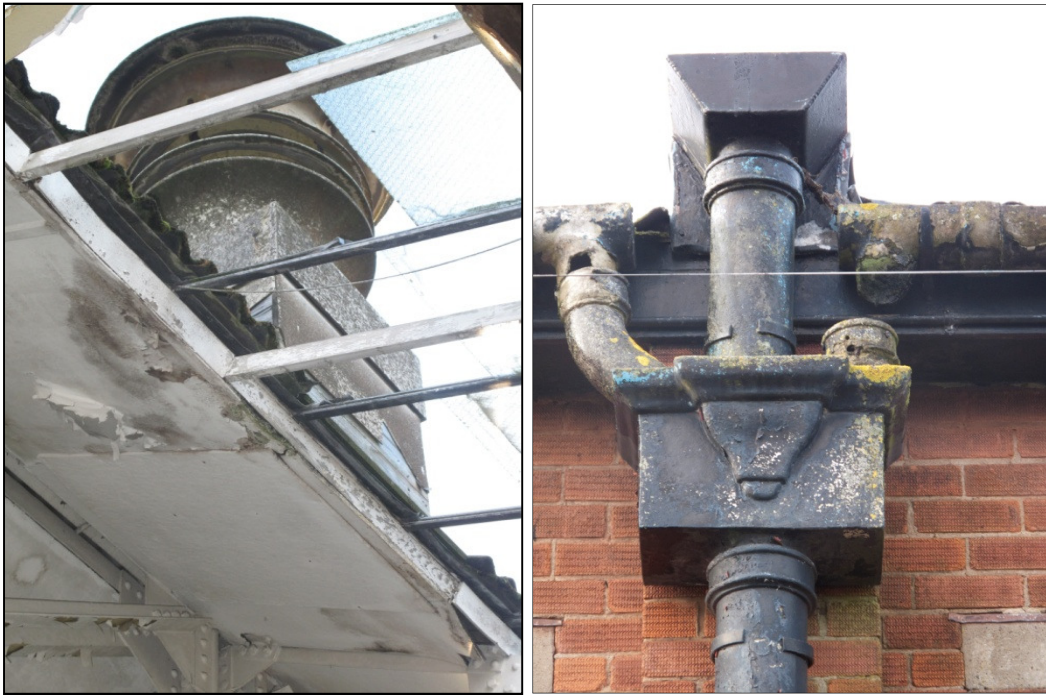
- 5.105 There were a number of asbestos ventilation stacks situated at intervals on the roof slopes, above the roof lights (Plate 27). Their connection to the interior had been boarded off (see below) but the external feature remained. These did not appear to be original, and don't appear on the 1945 aerial photograph of the depot (Plate 2); the stacks appear to be positioned to form a roughly rectangular arrangement within the centre of the eastern section of the building, and were probably installed during the REME occupation of the depot in the post-war period. Building 14 includes later ventilators (albeit of a different style), seemingly installed in the same period. Similar ventilation stacks were recorded at the McCormick Tractor Factory near

Plate 27: (left) one of the ventilation stacks on the roof of Building 12, with interior access blocked. (Right) decorative trough on down-pipe, connecting valley gutters and eaves guttering

- 5.106 There were cast iron down-pipes located at each valley gutter, and fixed to the brick pillars, on the west and east elevations (Plate 21, 22). The head of each down-pipe had a decorated rectangular trough (Plate 27). On the west elevation, two of the down-pipes had been damaged by construction of the later extension. The northern elevation featured two down-pipes (one now plastic) fixed to the pillars, one close to the ventilation pipe, the other at the eastern end of the aisle forming this part of the elevation. The southern elevation similarly featured four regularly spaced down-pipes fixed to the brick pillars.

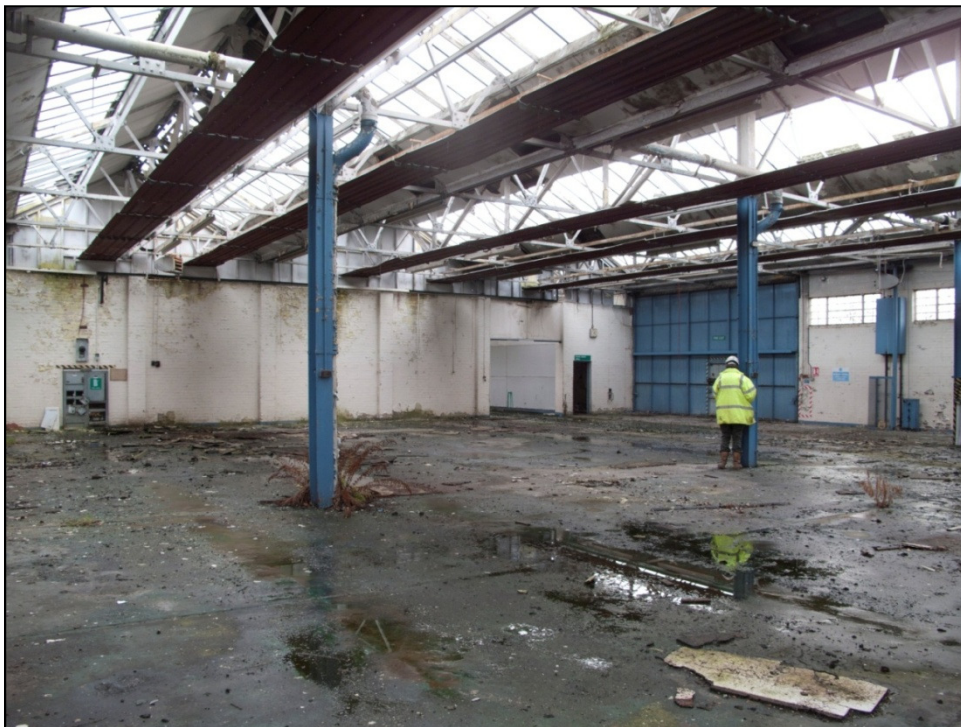
Plate 28: Area 12A, looking south-east toward the central vehicular access door and partition wall. Note down-pipes from valley gutters connected to RSJs, and integrated radiator panels in the roof space

- 5.118 The main partition wall dividing areas 12A and 12B reached the height of the roof truss, but would have offered negligible structural support, and comprised brick columns and panels, similar in construction to the external walls (Plate 28). It is likely that this partition wall was not original, but was added to the building, perhaps during the post-war period; the overhead radiators pass through the wall in a way which suggests they predate the wall, and no foundations were observed for it in the watching brief, discounting it as an important structural feature. The comparable building at the East Boldon depot shows no evidence of this partition.

- 5.119 There were two doorways in the main partition wall, enabling access between the two large internal areas (Plate 28). These openings measured 2.42m (7'11") wide (the northernmost door) and 3.26m (10'8") (the opening to the south). At the time of the survey, the southernmost door had a metal frame inserted, and a rubber screen. The door to the north was left as an open archway. Additional brick columns reinforced the brick panels either side of each doorway. Above each opening was a timber/plasterboard screen, rather than brickwork, suggesting that previously the spaces in between the brick columns may have been entirely open.

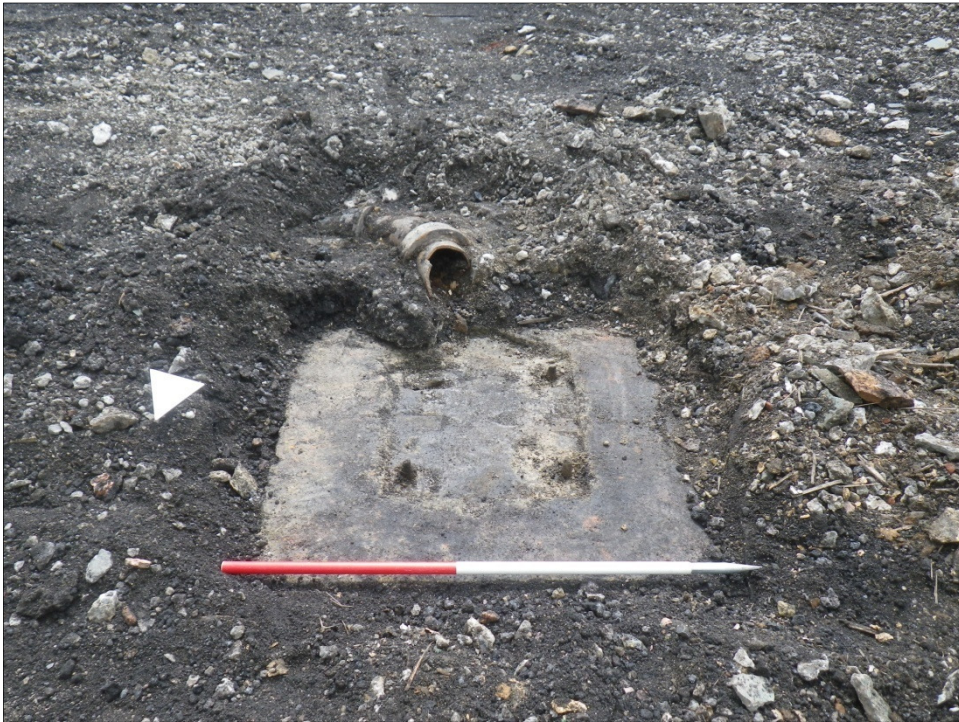
Plate 29: concrete RSJ foundations with remains of down-pipe on south side

- 5.113 During the watching brief, the removal of the concrete slabs identified that the down-pipes connected to sub-floor drains which exited to drains running around the outside of the building (visible as brick man-holes). The concrete base of each RSJ was connected by a brick wall foundation, which provided lateral support and prevented movement of the pillar. The brick walls and manholes included Hotspur Rustic bricks, which were manufactured near Backworth (north Tyneside) in the 1930s; production of these ceased immediately after World War 2¹¹.

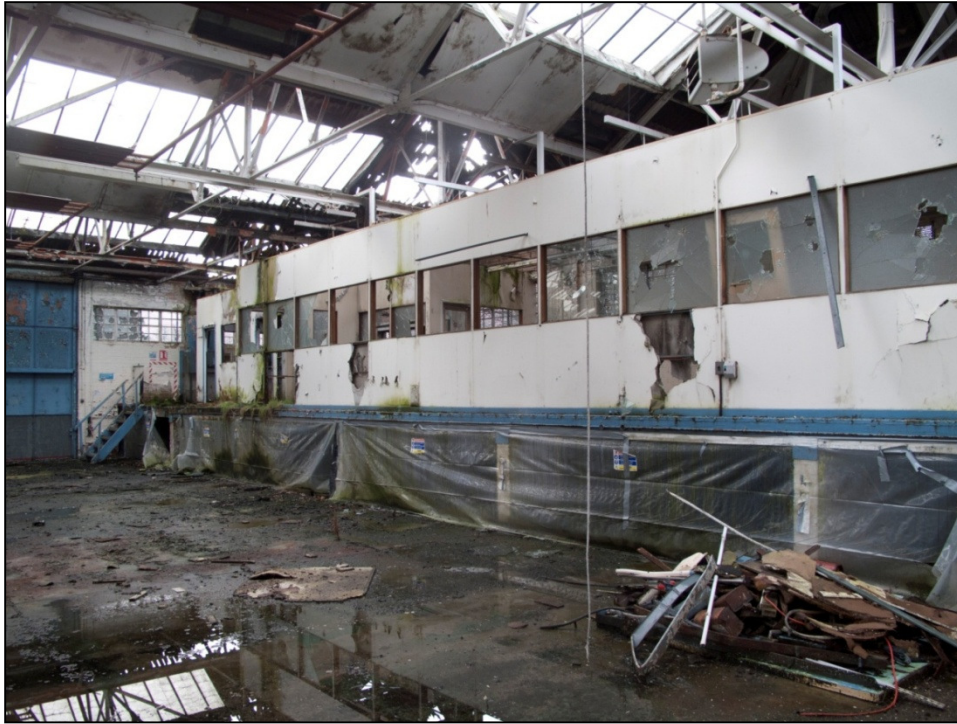
Plate 30: the western end of Building 12, showing the raised platform supported on brick columns, with wood and plasterboard office walls above

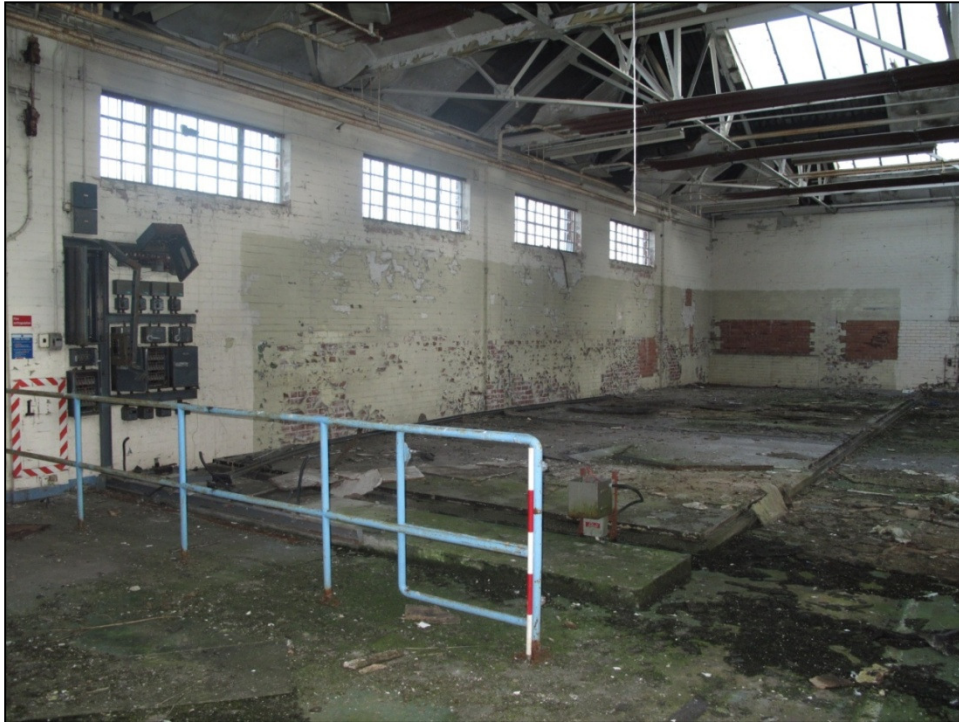
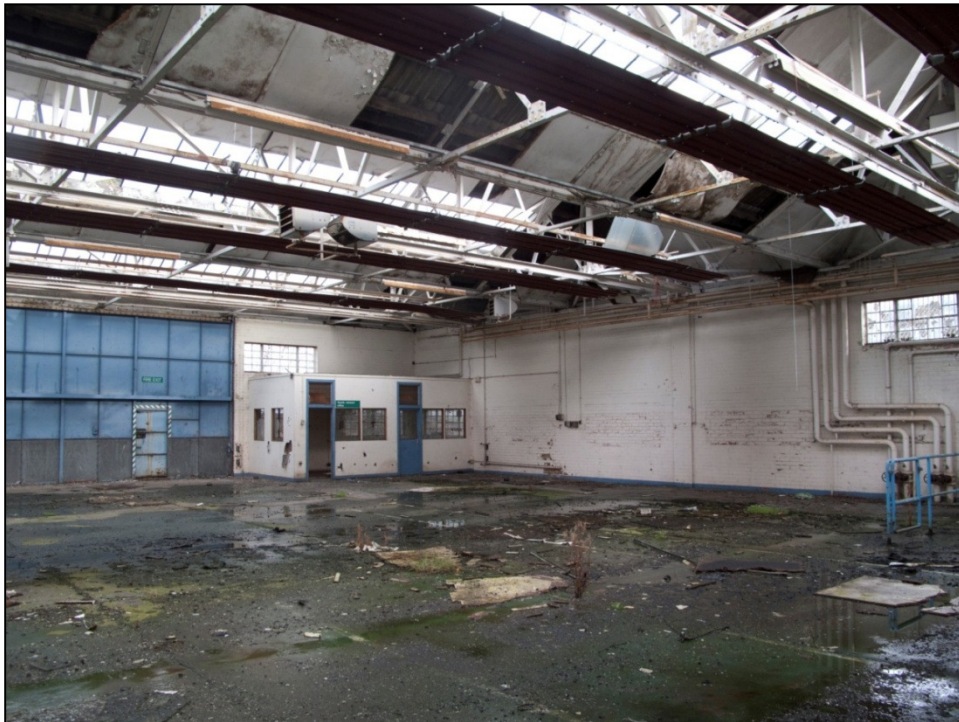
Plate 31: the internal feature in the south-east corner of area 12B (above), and 'Goods Outward Office' in the north-east corner (below). Note hot water pipes entering building to right of plate

- 5.128 Iron railings were present, at the time of survey, in two locations in Area 12B. First, there were railings parallel to the wall east of the southeastern lift mechanism. Second, railings positioned perpendicular to the eastern wall separated the heating pipes from the former machine base (Plate 31).

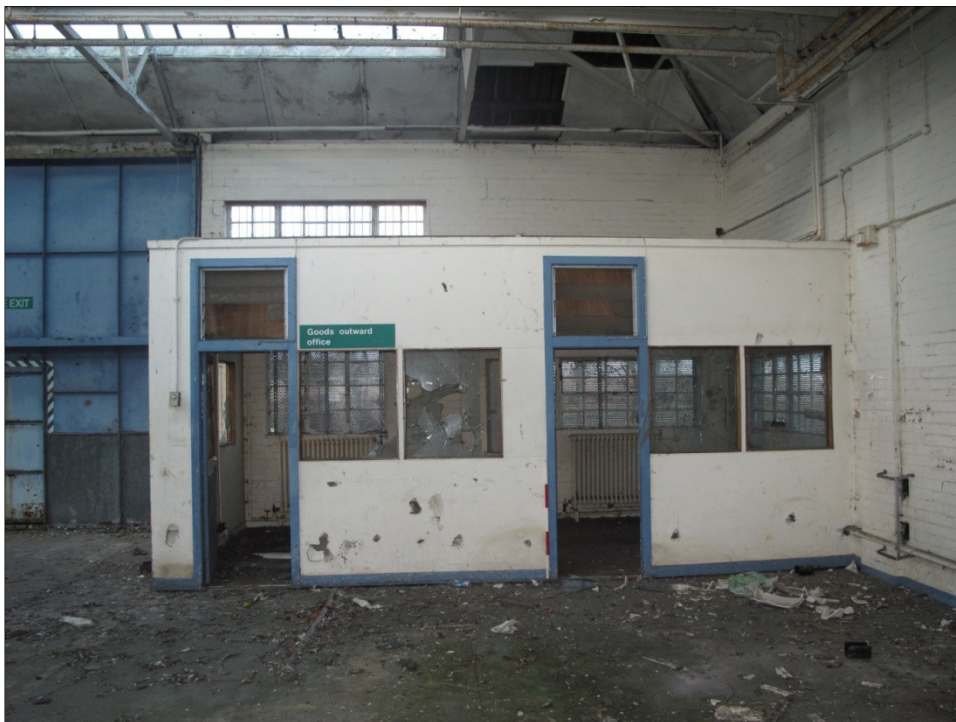
Plate 32: the office in the north-eastern corner of area 12B, showing the ground floor windows in the external wall, radiators within and the modern Area Health Authority signage

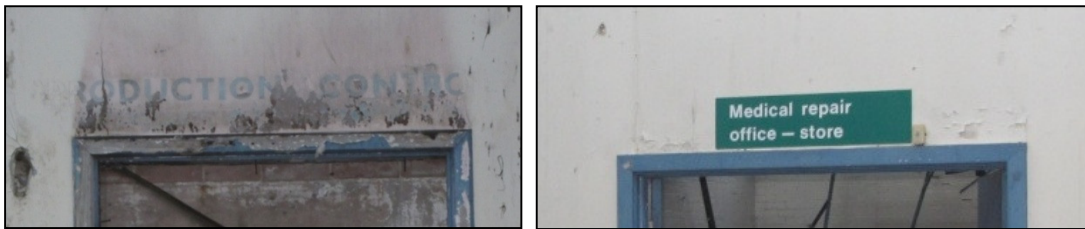
Plate 33: an earlier sign, possibly original, above one of the doorways on the raised platform to the west (left), and a sign which dates from Area Health Authority occupation

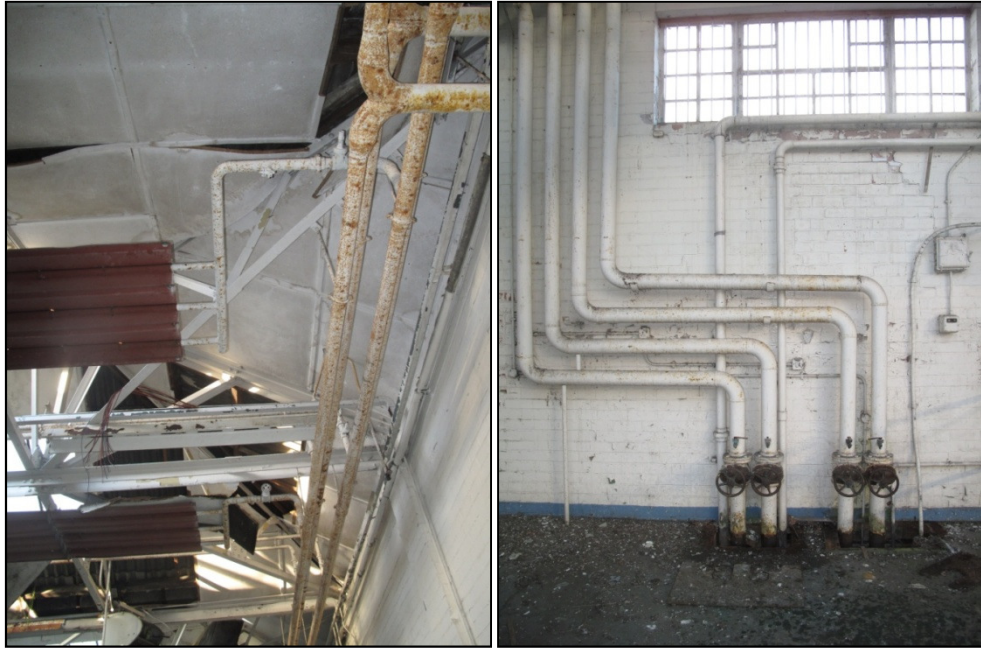
- 5.125 The building featured a number of electrical and mechanical fittings internally, relating to its previous uses. Seemingly, the building was extensively heated for its original function. The heating system would have been fed directly from Building 10 (see above), to the east; pipes connecting these two buildings survived at the time of survey (Plate 34). Large overhead radiators, with metal insulation above, spanned the length of the building east-west. These were positioned beneath each roof light, and secured to the top chord of the roof trusses. More modern heating had also been installed, in the form of convection heaters at various locations suspended from the roof. These were connected both to the original water heating system, as well as to electrical power. There were, in addition, two iron radiators in the *'Goods Outward Office'* (in the northeast corner of 12B), situated below the ground-level windows. It is not entirely clear why this building was so extensively heated, but presumably dry conditions were needed for the maintenance of the vehicles and guns.

Plate 34: the ends of the overhead radiators, connecting to the heating system (left) and the main heating pipes entering the building to the east, from Building 10 (right)

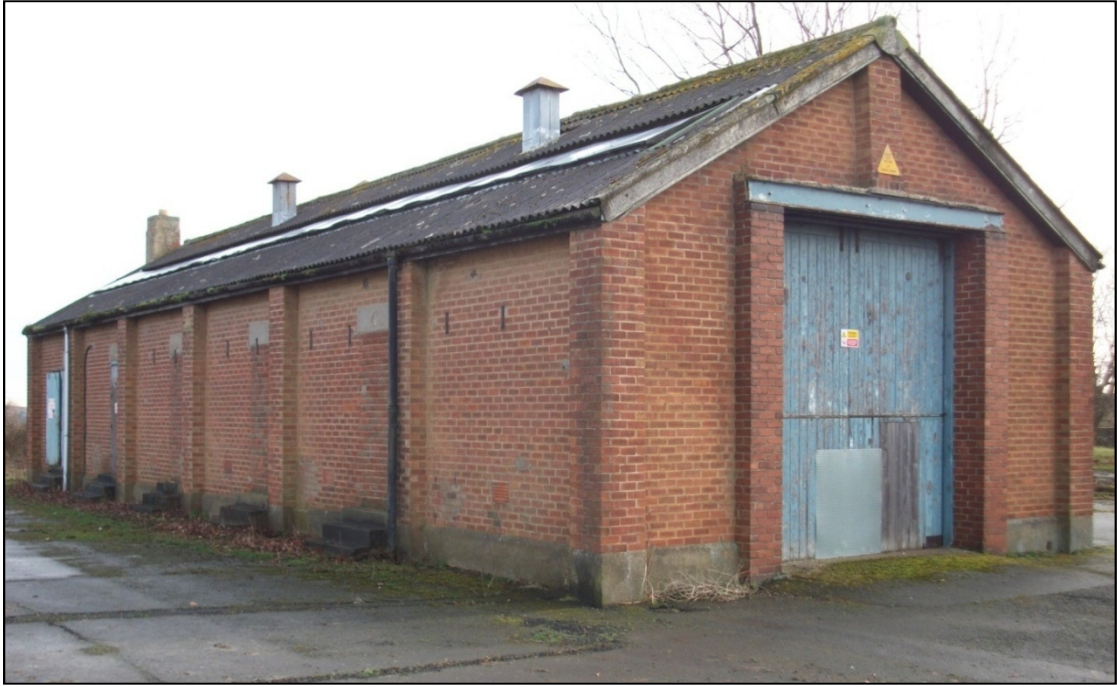
Plate 36: the north-west corner of Building 14, showing the blocked pedestrian doorways on the northern elevation, and the vehicular access door to the west

- 5.137 The original building seems to have featured one large opening for vehicular access, and five pairs of opposing doors on the north and south elevations. Many of these pedestrian doors were blocked when the survey was undertaken (Plate 36). There were an additional three doors on the west and east elevations of the later extension.

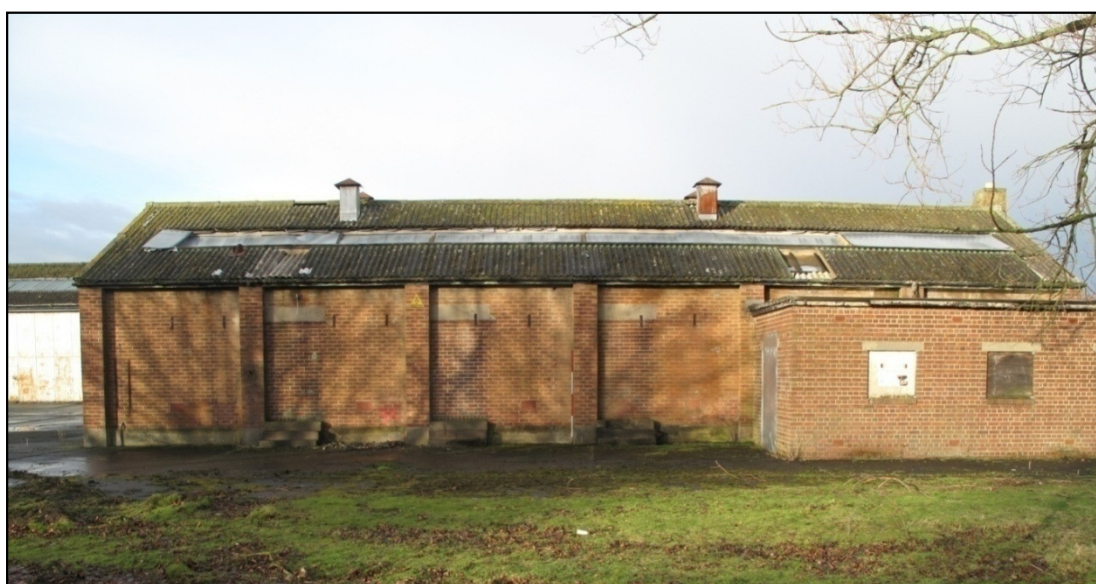
Plate 37: the southern elevation of Building 14, showing the later extension to the east

- 5.146 There were air bricks, or vents, on the north and south elevations located in each of the bays of the building positioned approximately mid way between the doorway and the eastern column (Plate 37). These were at a low level, four brick courses above the chamfered concrete footing (approximately 1m above ground level). There were no vents on the west elevation, but there were two air bricks positioned centrally within the bays on the east gable end (obscured at the time of survey, externally, by the extension). The vents on the original building corresponded in style with those observed on Building 4.

- 5.150 The western four bays of both the north and south elevations each featured a pair of flat steel brackets fixed to the wall at approximately lintel height (Plate 37). Two of these on each elevation overlie the blocking brickwork, demonstrating that they were a later addition. A number of small patches of cement on the wall may indicate the former positions of other brackets but these do not form a regular pattern. The brackets may indicate the positions of internal fixtures added when the original function of the building changed. In the western bay,

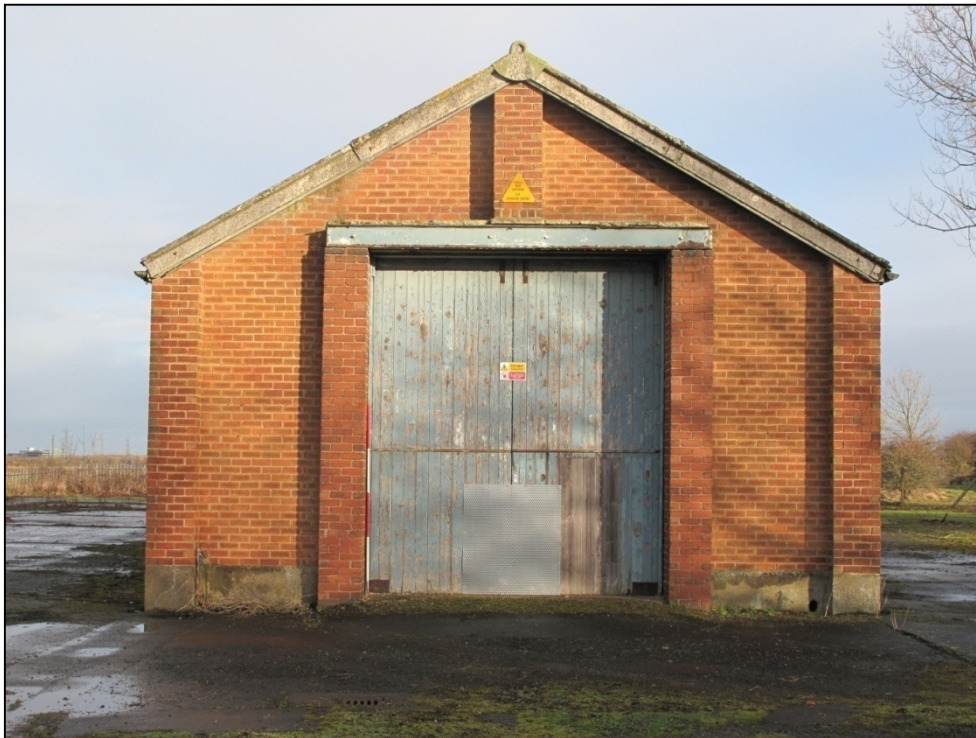
Plate 38: the western elevation of Building 14, showing the reinforced door surround

all sides, excepting the pillars where it was flush (Plate 38). This detail did not extend to the more recent part of the building.

- 5.138 The west elevation of the original building was dominated by a pair of blue-painted wooden doors, 3.96m (13') high and 3.35m (11') wide, positioned centrally in the wall (Plate 38). The doors reached to the height of the wall heads and were presumably this size to allow vehicle access. The central brick pillar beneath the ridge terminated at the top of the door jamb, which consisted of a precast lintel flush with the wall, and two I-profile steel girders projecting forward of the wall-line. These were supported on brick pillars either side of the door aperture. The pillars, in plain brick, seemed to have been later additions, suggesting that the steel girders were also secondary, presumably to strengthen the doorway.

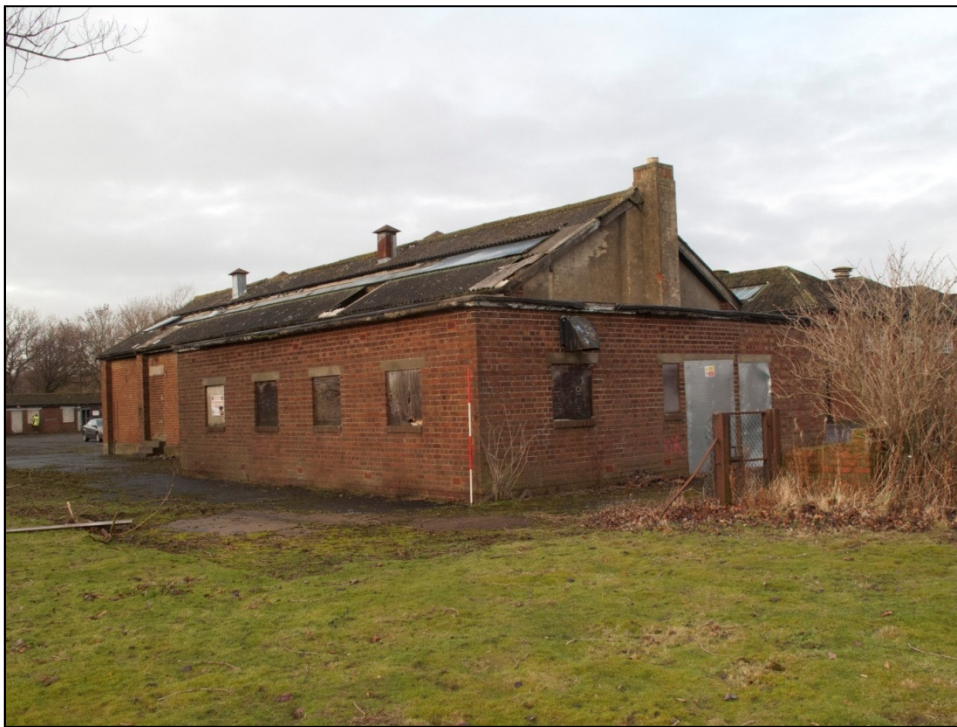
Plate 41: the later extension on the south-eastern corner of Building 14

- 5.144 There were no windows on the walls of the original building block, only two extended roof-lights, one on each roof slope (see below). The extension had four evenly sized square windows along its south elevation (Plate 41). There were a further two windows, of unequal size, on the east elevation and one very small rectangular window on its north. All of the windows featured pre-cast grey concrete lintels and projecting sills of edge-laid header bricks. A sheet metal ventilation cowl had been fitted to the wall above the southern window on the east elevation. All openings had been covered with sheet metal or plywood.

- 5.145 Externally, the roof was covered with corrugated asbestos-cement sheets and each roof slope contained a continuous row of roof-lights, running for nearly the full length of the building and situated mid-way up the slopes (Plate 41). The ridge tiles and fascias of the roof were similarly made of asbestos cement. Four galvanised ventilation stacks were located near the ridge line of the roof, positioned in pairs. They were square-sectioned, with pyramid-shaped cowls. The roof of the L-shaped extension was flat and appears to have been similar in construction to that of Building 10.

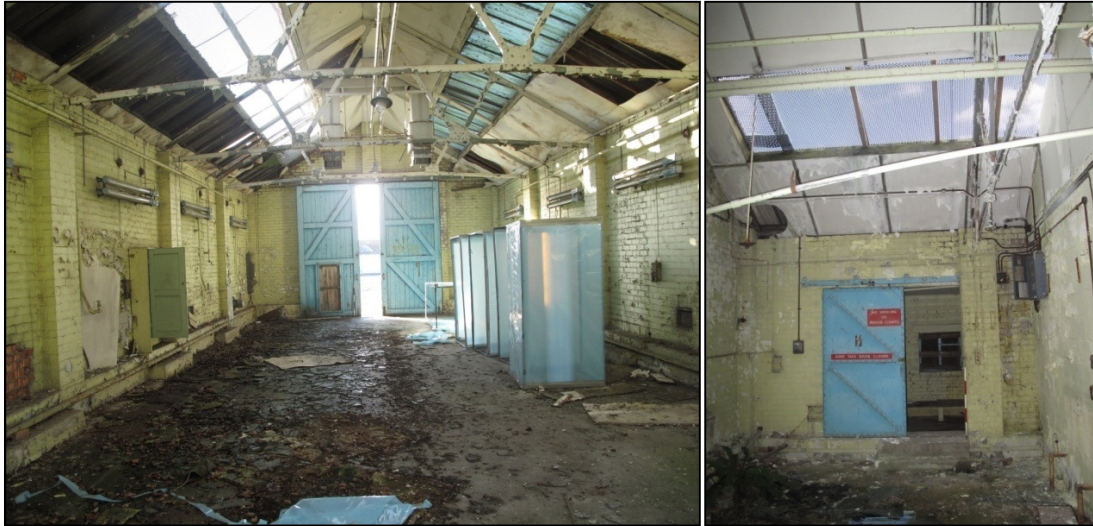
Plate 42: (left) inside Building 14, looking west towards the sliding doors. (Right) surviving sliding door on the easternmost opening in the south wall, with later blocking wall to right of photo

- 5.153 At the time of the survey, the eastern bay had been divided off with a breeze block partition (Plate 42), and access was no longer possible from the main building interior. This appears to have occurred sometime in the late 1940s, as evidenced by the internal fittings.

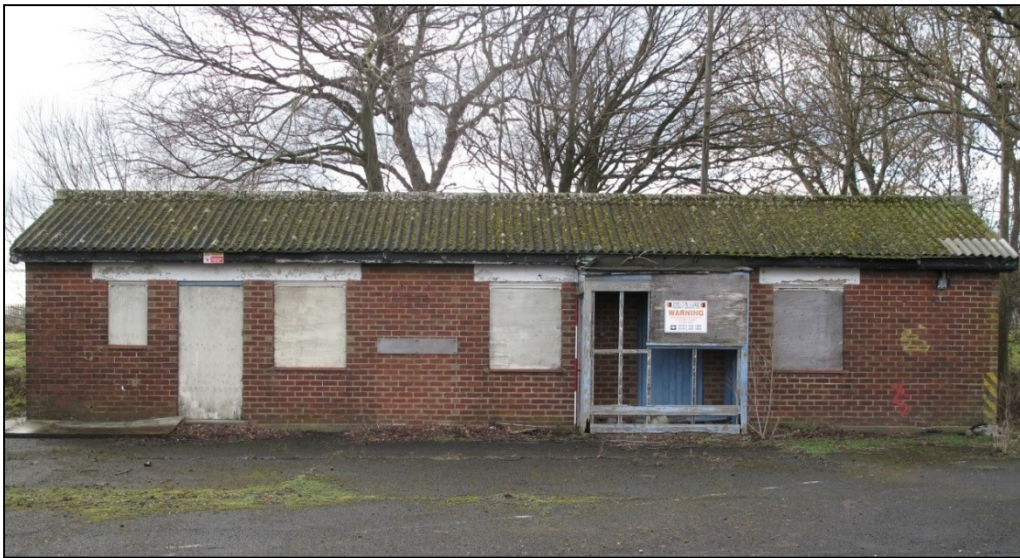
Plate 45: (top) the eastern elevation of Building 16, featuring two entrances. (Bottom) equivalent building at East Boldon, facing north-east

- 5.177 A section of the east elevation, to the south of the vertical line of header bricks, exhibited a brick colour distinct from the rest of the building (Plate 45). It is likely that this section of the wall has been covered for a prolonged period. This was supported by the existence of a horizontal plank affixed to the wall across the width of this area, to which a larger cover may have been attached.

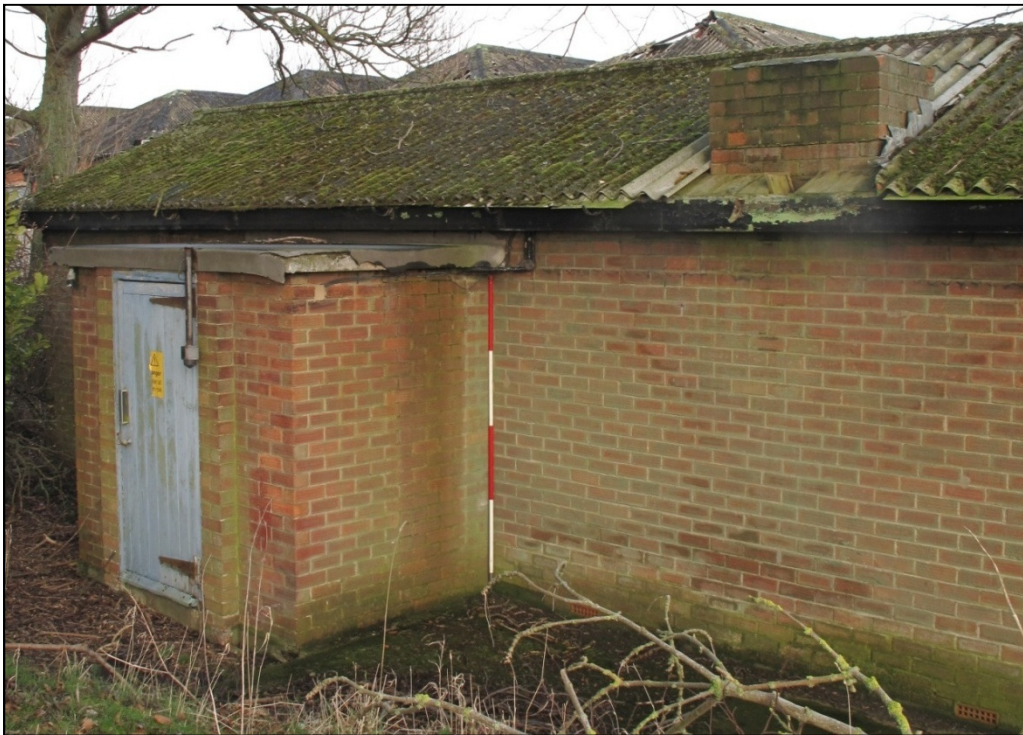
Plate 47: the rear extension, and the chimney, on the western elevation

- 5.163 Building 16 was orientated north-south, and was a single-storey brick structure. It was essentially rectangular in shape, but had a small brick projection on the west wall and a wooden porch protruding from the east wall. The brick-built block on the rear of the building (Plate 47) measured 2.65m by 1.75m (8'9" by 5'9") in size, and 2.1m (6'9") in height. This was not present on the 1948 aerial photograph, and was therefore a more recent addition, although it was built in the same brick as the remainder of the building.

- 5.166 The walls of Building 16 did not feature the external brick pillars seen on many of the other buildings, but were again built of the zigzag decorated brick, in stretcher bond. There was a strip of cement rendering over the lowest course of exposed brick. A line of header bricks was visible in alternate courses of brick, running up the wall approximately half way along the structure (Plate 45). Internal inspection confirmed that, as with other buildings on site exhibiting this feature, this was the location of an internal wall keyed into the brickwork in the east wall.
- 5.167 The western elevation exhibited four small repaired holes in the brickwork (Plate 47); the reason for these repairs was not clear, but may just have been patching of failed bricks.
