**PHASE 2 BUILDINGS SURVEY
AND
WATCHING BRIEF**

**FORMER
MINISTRY OF DEFENCE DEPOT

KILLINGWORTH
NORTH TYNESIDE**

NAA 15/70
February 2016

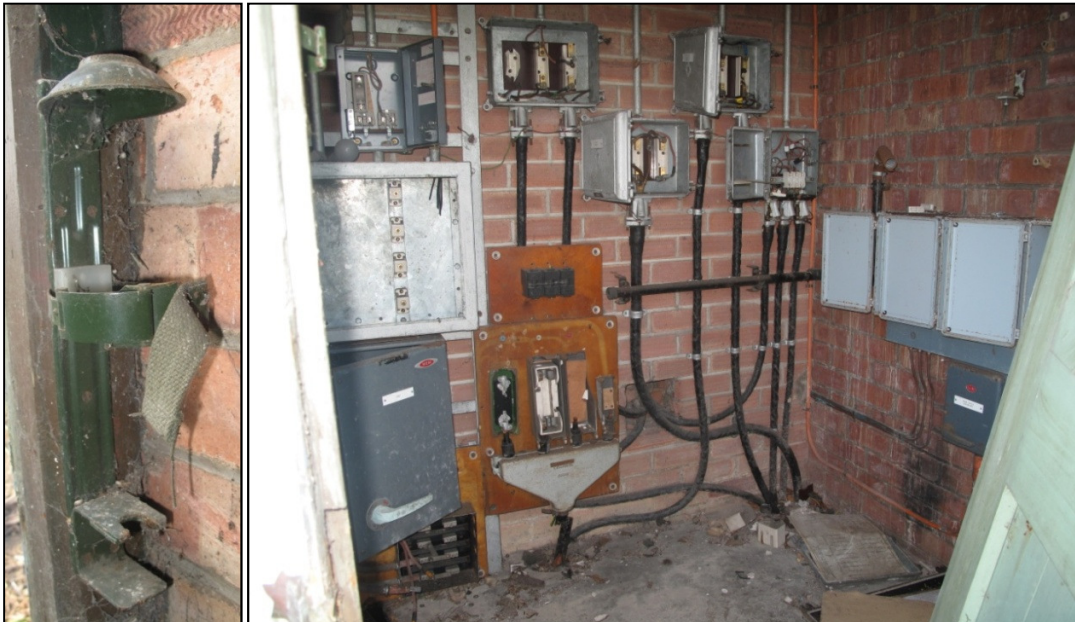
Plate 52: fire extinguisher bracket (left) and circuitry (right), extension, Building 16

Authority tenure show how the network was arranged, and it would appear that the depot was electrified sometime after the mid 20th century. A number of the circuit boards and breakers looked to be 1950s in date, though most of the electrical switch gear was clearly a modern replacement. There was a military fire extinguisher bracket affixed to the door frame just inside the rear extension entrance (Plate 52). There was no sign of a fire extinguisher in the building. Similar fittings have been dated to the 1970s, and this style of extinguisher may originally have been vehicle-mounted.

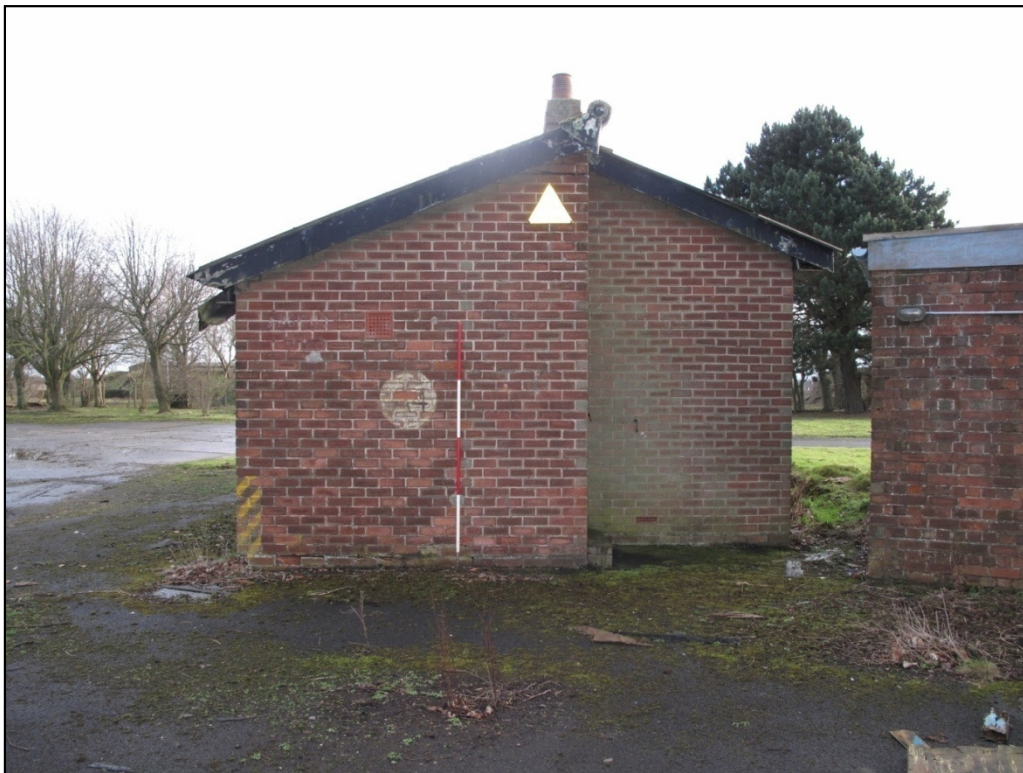
*Plate 54: the north-western elevation, showing the asymmetrical roof slopes.
Building 19 can be seen to the right*

- 5.196 Building 17 was built in stretcher bond using the zigzag decorated brick common across the site. Exceptions to this were the southeast and northwest elevations. In each, there was a vertical line of header bricks, corresponding with internal partition walls. The same structural element was observed in the front (east) wall of Building 16. The same elevation featured two small cement repairs. Similarly, the northwest wall showed evidence of five brick repairs (Plate 54).

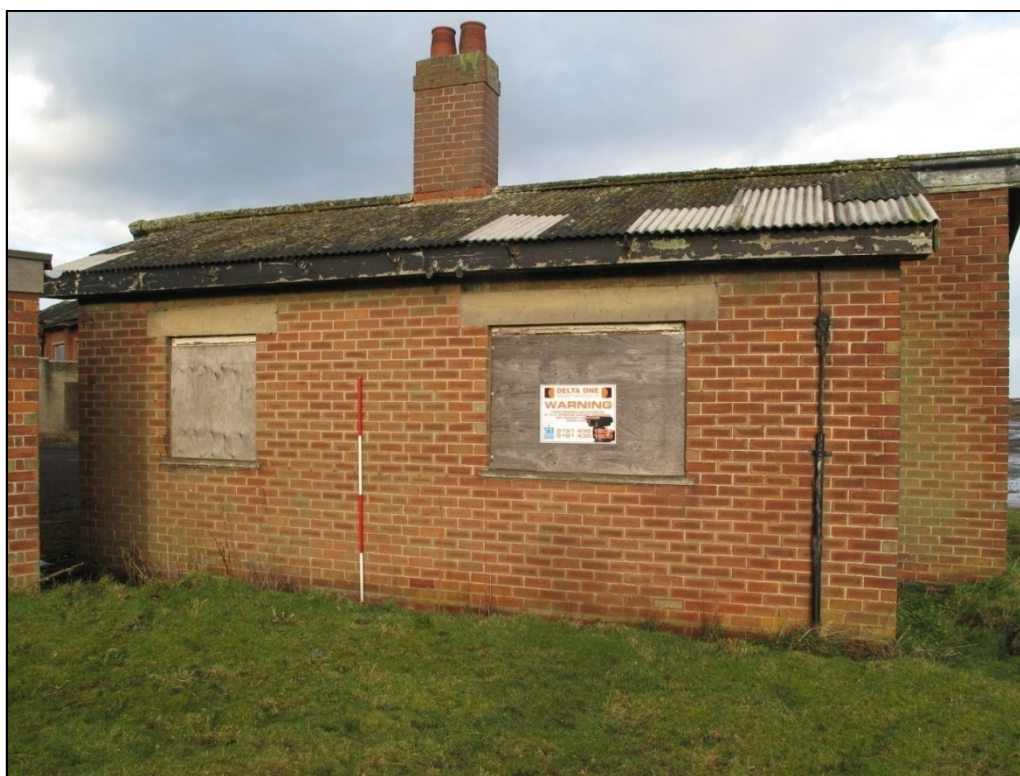
Plate 56: the south-west elevation, showing the two rear windows, low level vents and chimney. Building 19 is to the left

- 5.202 The building featured a number of airbrick vents, in keeping with most other buildings on site. Each gable end had, on the projecting section, a larger airbrick about 2m from ground level, offset from centre away from the ridge. The other section of the northwest gable end also featured an airbrick the size of a single brick, two brick courses from the concrete foundation.
- 5.203 Three further examples of these smaller vents were observed on the southwest elevation at the same level and evenly spaced, however the two outer vents had been cemented over (Plate 56).

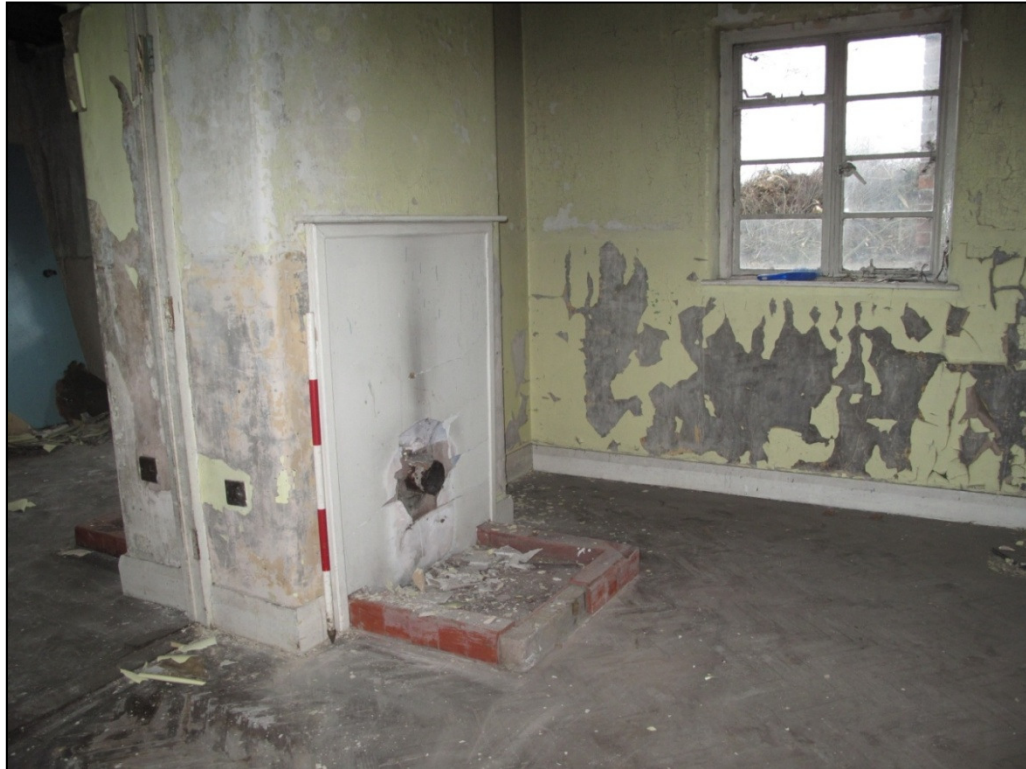
Plate 58: inside Building 17, looking south towards the central wall, and through the smaller of the rear windows

contrast, the offices featured parquet flooring in a herring bone pattern (Plates 58 and 59). This alludes to the building's design for administrative use, rather than production or storage areas elsewhere on the site which consistently featured concrete flooring.

- 5.208 The chimney was located in the partitioning wall between the two offices, provided heating to both through a fireplace at each side. At the time of survey, the fireplaces were simple timber surrounds (Plate 58). The boarding on both fireplaces exhibited a break in the centre from where, in the smaller office, a metal flue pipe protruded. This suggests that the fireplaces were not open fires but more likely housed a small stove for each office. The sizes of the hearths in both offices support this possibility, these measured 0.7m (2'3") out from the chimney breast and 0.84m (2'9") across, with quarry tile borders. Given that the two offices shared this relatively small chimney (measuring 0.86m in depth between the two offices), it is likely that there would not have been space for an open fire on each side receding into the chimney

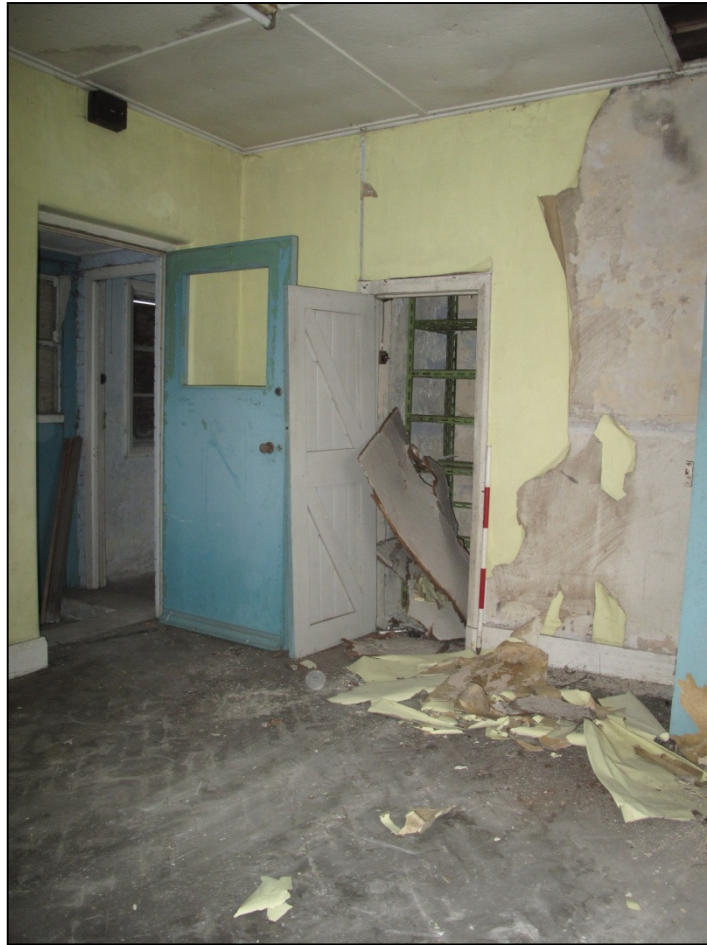
Plate 59: the southern office, looking south-east, towards doors to storage (left), the corridor (centre) and the office storage (right)

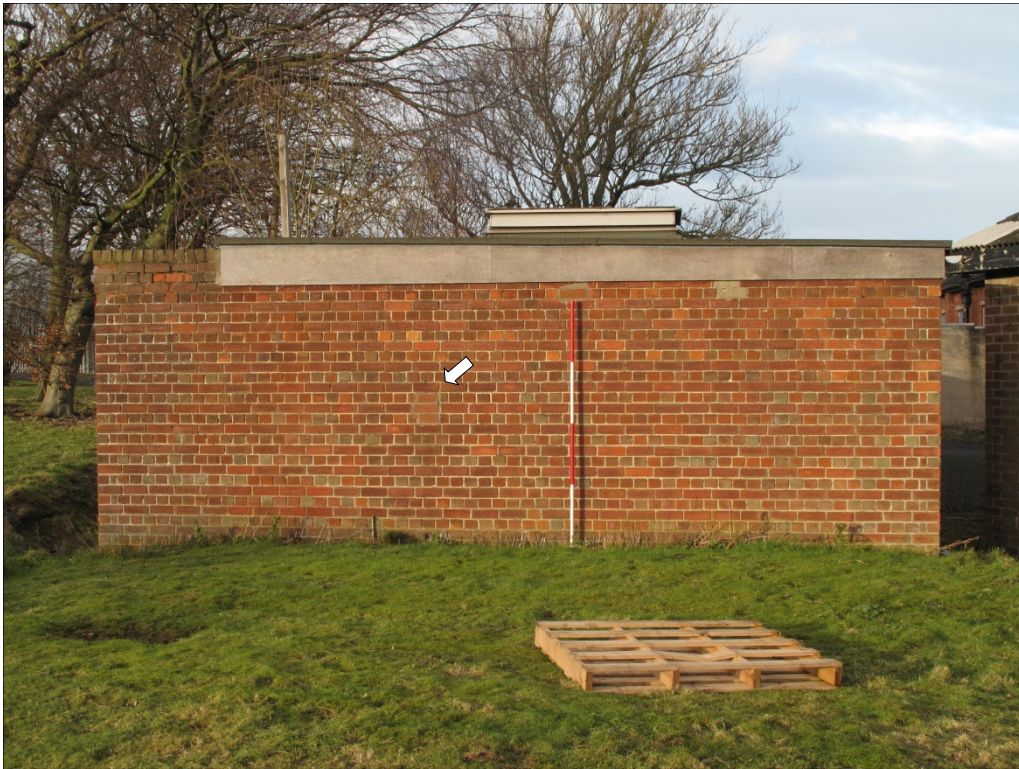
Plate 61: the southern elevation of the toilet block; note blocked hole (centre left) for flue pipe

cement patch repair; the south elevation included the (now blocked) exit hole for a flue pipe for a stove (Plate 61).

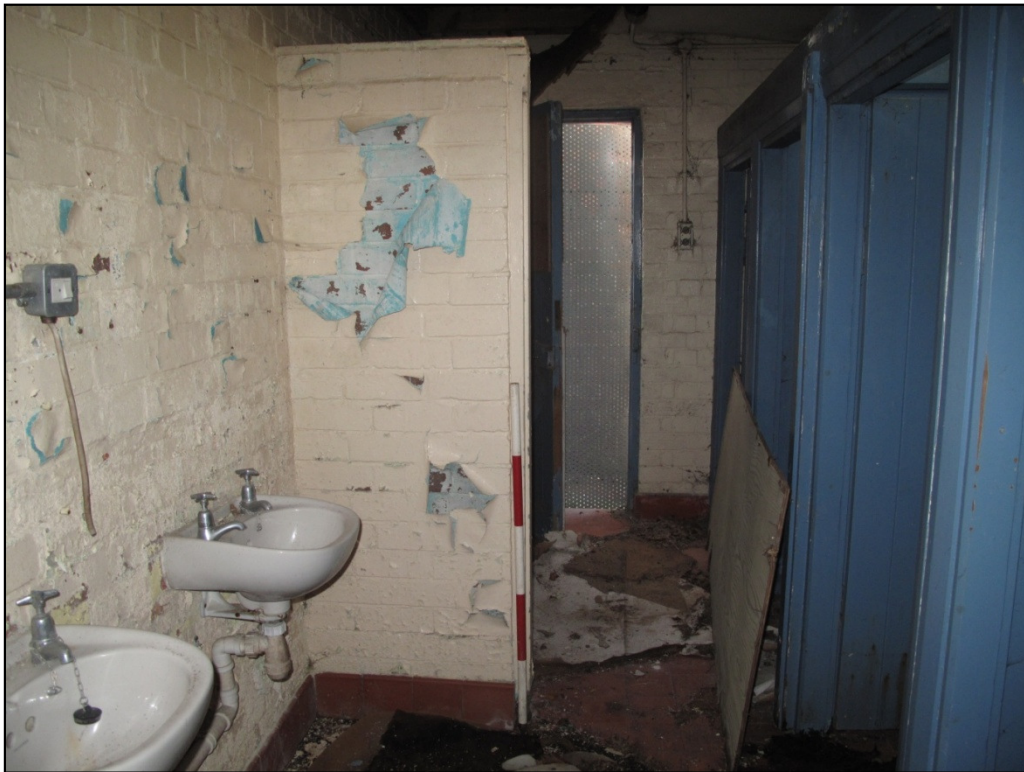
Plate 62: interior of Building 19, looking west, with the toilet cubicles to the right, basins and dividing wall to the left

- 5.222 Internally, the building comprised a simple rectangular room. On the northern wall, starting from the western corner, were four toilet cubicles of equal size, built in timber with partitioning boards and thin plank doors (Plate 62). A roof light was positioned over the two eastern-most cubicles, providing light to the entire interior. There were three urinals on the eastern wall. The southern wall featured basins, opposite the eastern-most cubicles. West of this, behind a brick

partition wall perpendicular to the south wall, was a stove. The small partition wall protruded from the southern wall by 0.7m (2'3"), as was finished on its northern end with a carved timber post matching those of the cubicles. The foot of the wall around the building's interior was tiled with a single row of square red quarry tiles (Plate 62).

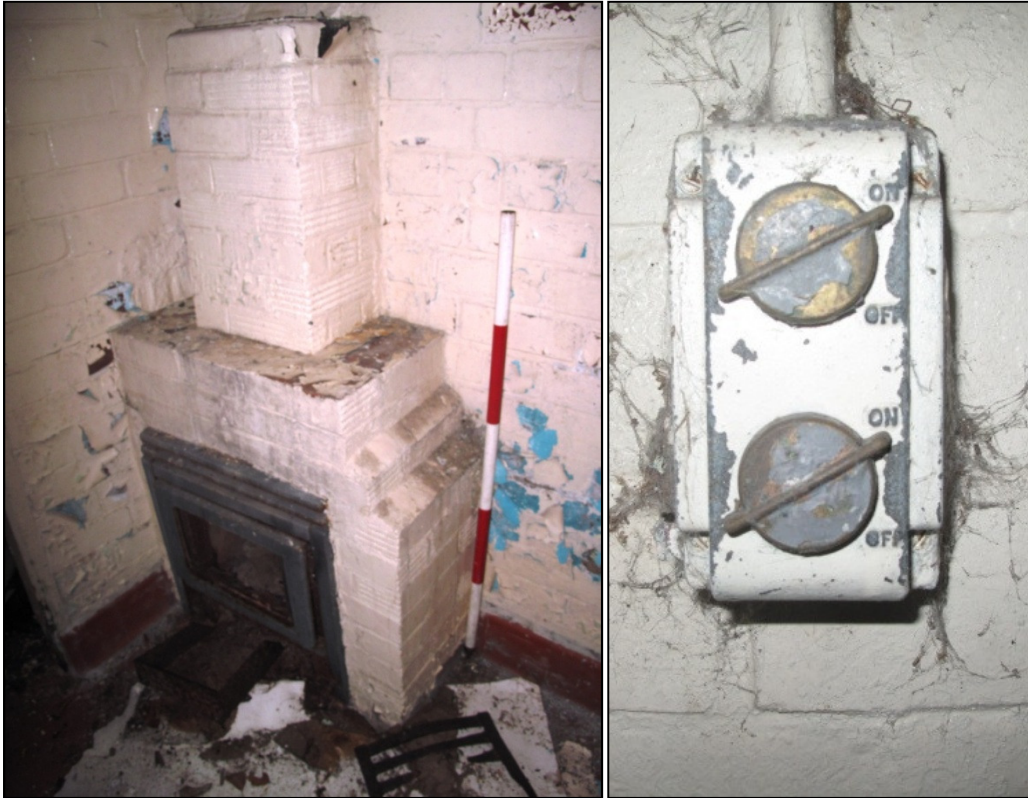
Plate 63: the stove on the southern wall, showing the small dividing wall to the east (left), and a covered switch inside Building 19 (right)

- 5.224 A small stove was positioned in a corner formed at the apex of the southern wall and a perpendicular partition wall (Plate 63). The squat metal stove was built into a stepped brick surround, comprising alternating plain and horizontally scored bricks. This was asymmetrical, stepped only on its western side, and built into the small partitioning wall to the east. The stove surround measured 0.76m (2'5") in width (excluding the partition wall), and 0.4m (1'3") out from the south wall.
- 5.225 The flue for this stove appears to have originally exited through the southern wall, evidenced externally by a recent brick repair (Plate 61). This might indicate that the stove was not an original feature. Supporting this possibility further, the brick of the stove surround is different to

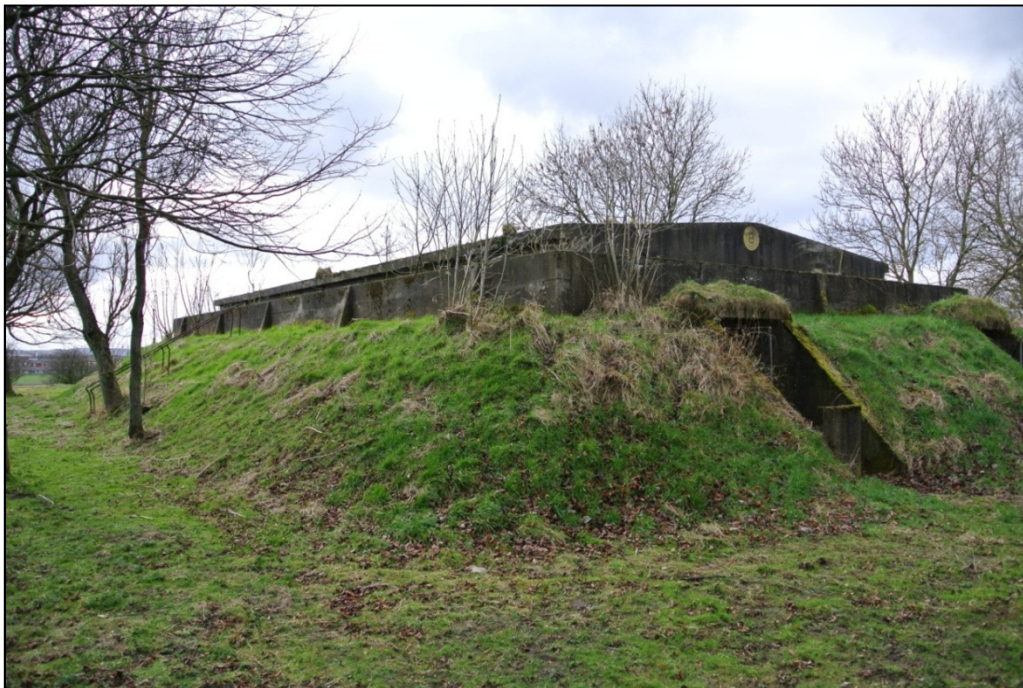
Plate 65: (above) the bunkers at East Boldon – with L-shaped blast walls. (Below) Bunker B, showing the slumped earth bunding, and entrances at the gable end

- 5.232 With the exception of the internal and external fittings, the bunkers were constructed with shuttered, reinforced concrete. Each comprised what was essentially a large shed with a door in the corner of each gable wall (Plate 65). They measured 20.72m by 9.75m (68' by 32') externally, with vertical walls and a shallow-pitch roof which was approximately 4.10m (13'6") high. The structures were surrounded by shuttered concrete blast-walls, with concrete buttresses. The blast-walls were then earth-bunded. By the time this survey was undertaken, the bunds had slumped through time and no longer extended to the tops of the blast-walls (Plate 65).

- 5.238 The enclosing earthen bunds would originally have reached the full height of the blast wall, though at the time of the survey, slumping had occurred (Plate 65). There was no evidence of an earth cover to the bunker roofs. Bunker B had opposed flights of steps midway along each side of the bund. These were made of precast concrete, with handrails composed of scaffolding-like tubes, and may not have been original.

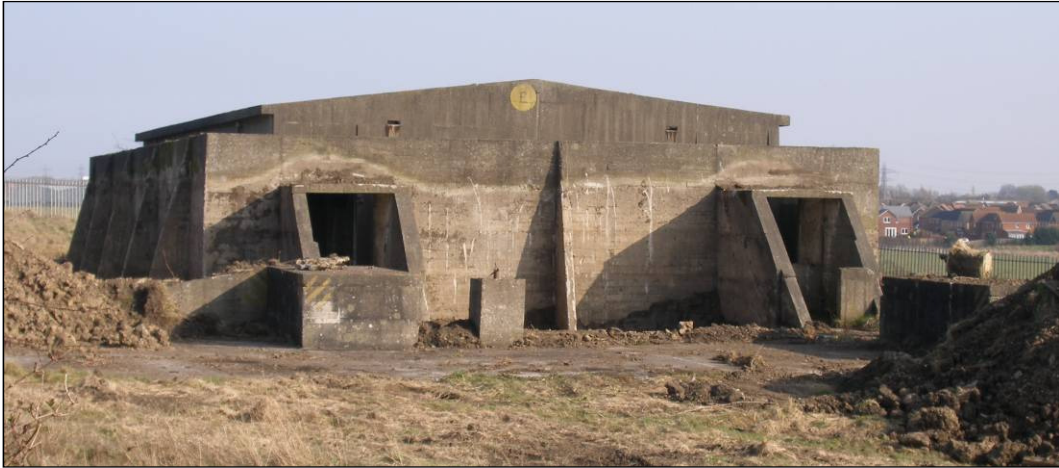
- 5.239 A watching brief was carried out on the removal of one bund (surrounding Bunker E, the southwestern most bunker – Plate 68) to record information relating to the bunker's construction. The watching brief was carried out over two days (3rd and 4th March 2015). Removal of the bund revealed five concrete buttresses on each of the long sides, with a single central buttress on the shorter sides, between the entrances. The buttresses, broadly triangular in profile, tapered out from the top of the retaining wall to a concrete base 1.2m (4') in width, which extended around the edge of the structure, and formed the main foundation (the bunker effectively sits on a concrete raft). The foundation measured 0.70m thick, and this in turn lay directly on a thick layer of natural clay.

Plate 68: (top) Bunker E after the removal of bund, revealing the underlying concrete structure. (Below) denuded bunker at Banstead, Surrey, 2003 (courtesy Roger Thomas)

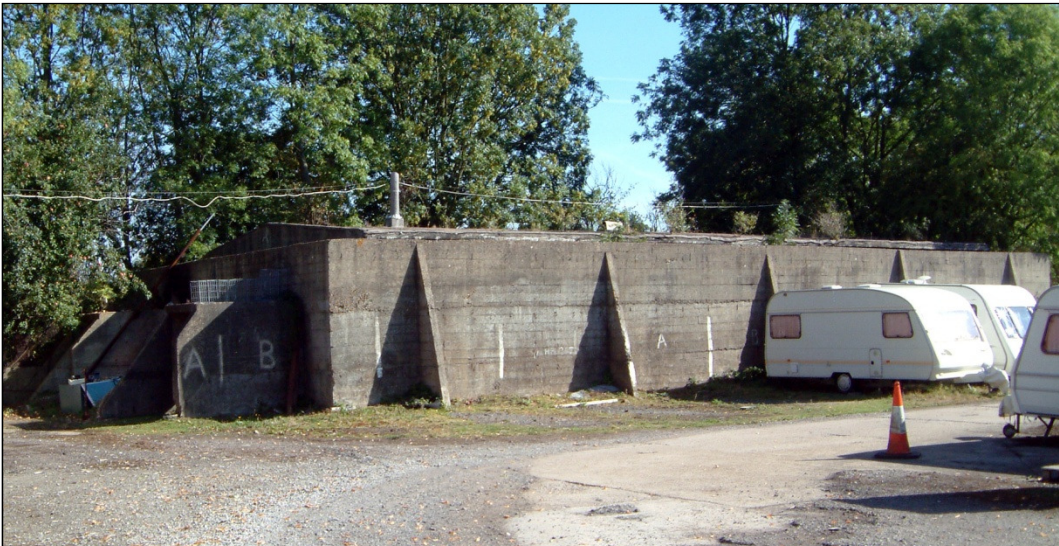
- 5.240 In between each buttress a single skin of loose brick was observed (Plate 69). Each skin of brickwork was poorly constructed with very little bonding and collapsed shortly after machining. These extra skins of brick appear to have been stacked up against the sides of the retaining walls, and were presumably put in position to minimise damp soil lying directly on the concrete walls, so as to aid drainage. The bricks themselves were all frogged with either a central Seghill stamp (Seghill Colliery Brickworks) or an HMC stamp (Hartley Main Colliery – NAA 2014, 19).

Plate 69: south facing elevation of retaining wall after removal of bund (left) and stacked bricks against retaining wall (right)

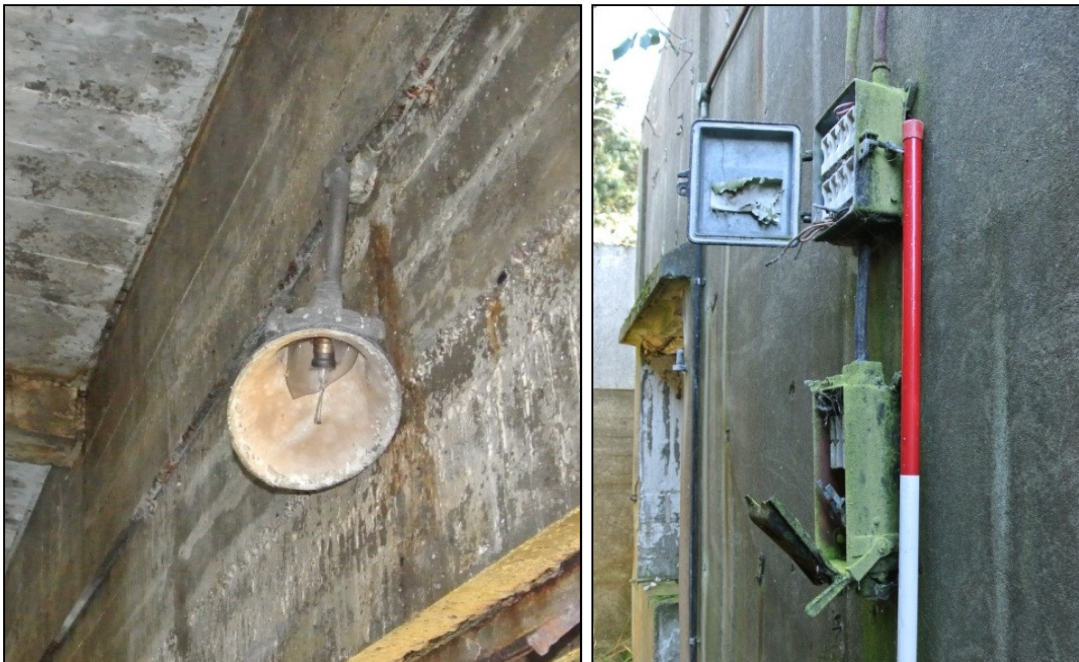
Plate 70: the light fitting (left), and -preserved fuse box (right), Bunker A

through the bunds and on the interior of one cheek wall. The example at the northwest corner of Bunker A was the most complete example of a light fitting (Plate 70). This was circular, with a hinged, domed pendant, mounted vertically on the wall. A rubber seal was visible around the edge of the metal frame, making the light waterproof. The light contained a ceramic insulator fitting. Below this, there was a double light switch, comprising waterproof push switches. The switch was connected to the lamp by a vertical metal electrical conduit.

- 5.244 The exterior gable walls exhibited the remains of conduits linking the external lighting in the entranceways (and the lamp posts, Plate 70) with the interior lights. An external fuse box and a circuit breaker were observed on the north gable of Bunker A. The fuse box was marked with the manufacturers brand-name - 'REVO' – see below.
- 5.245 Some signage survived on the exterior of the bunkers. This included black and yellow chevrons on the loading platforms, and the building identifiers. The signs comprised a yellow circle painted onto the building, containing the appropriate capitalised letter in white.

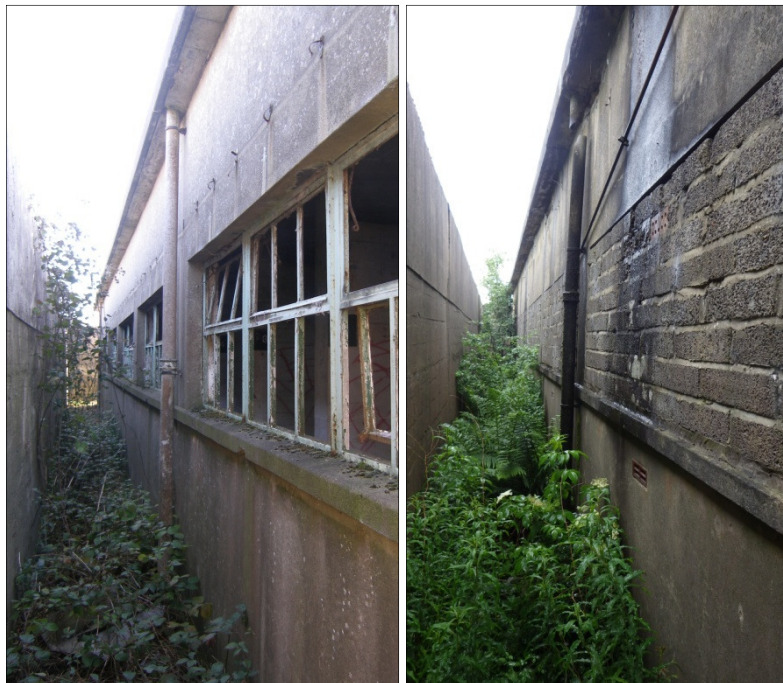
Plate 72: windows, Bunker C (left), and walled up windows, East Boldon bunker

- 5.249 The long external walls of each bunker contained a series of six window apertures, 3.03m by 0.92m (10' by 3'), holding steel-framed casement windows. Each window was divided into three identical subsections, each containing 18 small glass panes (Plate 72). The upper half of each subsection was an opening section. The windows in Bunkers A, C, D and E were at mid-height 1.24m (4') above floor level. Those in Bunker B were in the upper section of the wall 2m (6'6") above the floor. There was a flaring in the casting on the external walls over the windows, and they had precast concrete sills.
- 5.250 A row of low concrete plinths were positioned against the exterior walls, opposite each bay

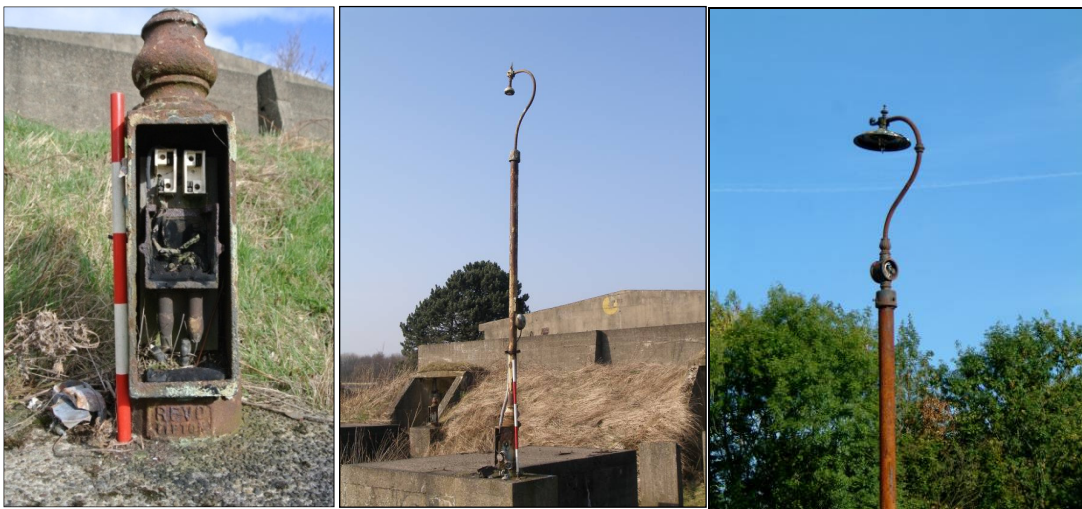
Plate 75: stamped base of lighting column, Bunker B (left) and full lamp-post (right); comparative lamp post from Banstead, Surrey, in 2003 (courtesy Roger Thomas)

- 5.256 Most of the lamp posts were in a bad state or had been removed entirely; where they survived, they were heavily corroded but had clearly been painted a dark 'military' green, though most of the paint had long faded. The lamps are difficult to date, but examination of parallels online suggests an early to mid-1940s date, and it would seem sensible that these were installed following the end of the Second World War and the blackout restrictions. The lamps certainly seem to post-date the loading bays of the bunkers, with a number of the lamps fitted to purpose-built concrete bases abutting the bays, or free-standing adjacent to the entrances. This arrangement was seen at other depots also – in particular East Boldon. It was notable that there were no lamp posts around the remainder of the complex, or fittings attached to the buildings, which implies the complex was originally meant to be kept dark. Lamp posts were evident in photographs from a number of other AAODs, and it appears likely that these were installed at the same time, and probably immediately after the war ended.
