THE CURTAIN RISES  
THE WALLED GARDEN

ARCHAEOLOGICAL  
INVESTIGATIONS

NATIONAL TRUST  
SEATON DELAVAL HALL  
NORTHUMBERLAND

NAA 21/31  
October 2021

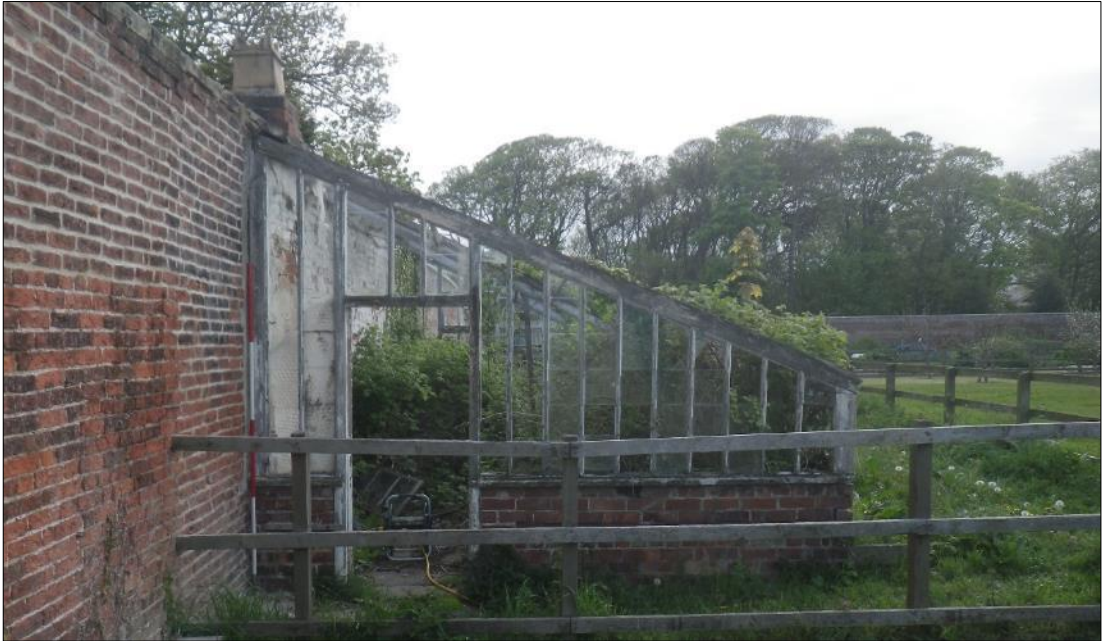
- 6.6 Within the interior of the garden the early 20th-century greenhouse (58) shown on the 1920 OS (Fig. 9) was in a state of collapse and overgrown with brambles (Fig. 11; Plate 4). This presented a potential safety hazard and was of limited historic significance. The structure was carefully dismantled under archaeological supervision as part of the AWP 5 works. The greenhouse was 9m by 3.8m in plan comprising a superstructure of timber and glass sitting on a 0.75m-high modern brick wall, laid in common bond. It had an entrance (175) to the south-west (Plate 5).

*Plate 5: greenhouse viewed from the north-west, looking east.*

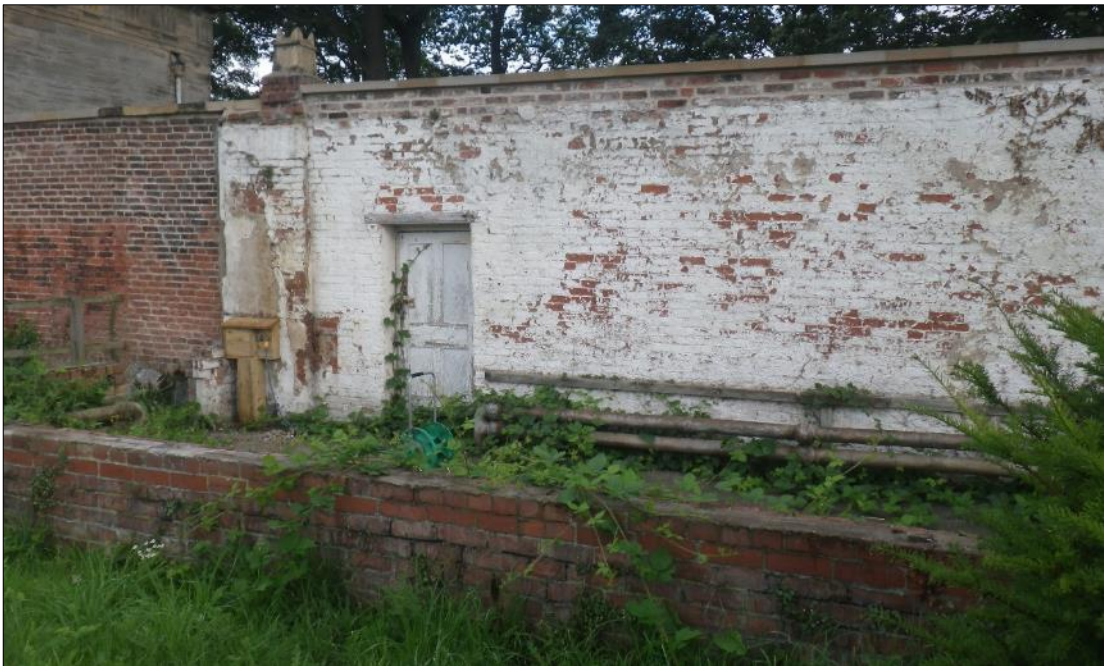
*Plate 6: greenhouse site after demolition with chimney and cast-iron pipes.*

- 6.7 At the back of the greenhouse, a door (176) had been cut through the garden wall to connect with a boiler house (177) built against the north-facing elevation of the wall (Fig. 11). The boiler house measured 3.5m by 2.7m, with a deep pit in the northern half of the floor (Plate 7), a coal chute (178) in the north-west wall, and exterior door (179) in the north-east wall (Plate 6). A flue (180) had been inserted into the garden wall above the pit, with brick stack constructed on the interior. Cast-iron pipework (181) ran

from the boiler house through the wall and around the greenhouse (Plate 6), and a standpipe for water was situated to the west of the chimney.

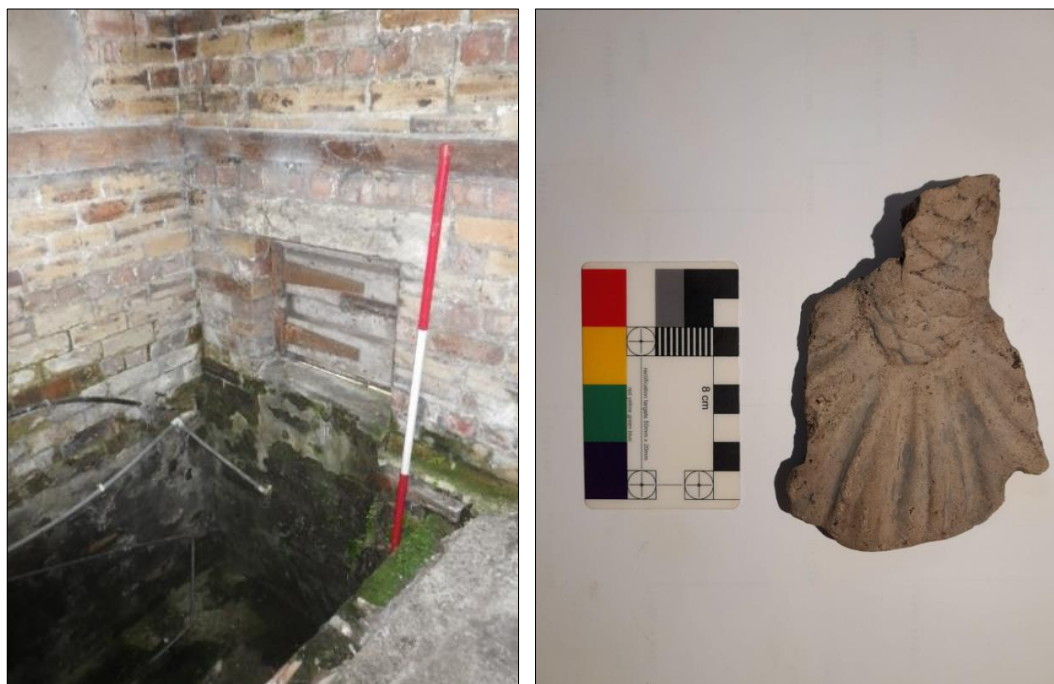
- 6.8 A cast concrete fragment of a fish sculpture was recovered by the contractor during work just outside of the walled garden. This was identified by National Trust volunteers as belonging to a statue which had, until the latter half of the 20th century, stood in the centre of the garden pond (76). Only the tail was recovered, which included a metal armature for fixing to a pedestal or stand.

*Plates 7 and 8: (left) pit in the greenhouse boiler room; (right) fragment of fish sculpture (76).*

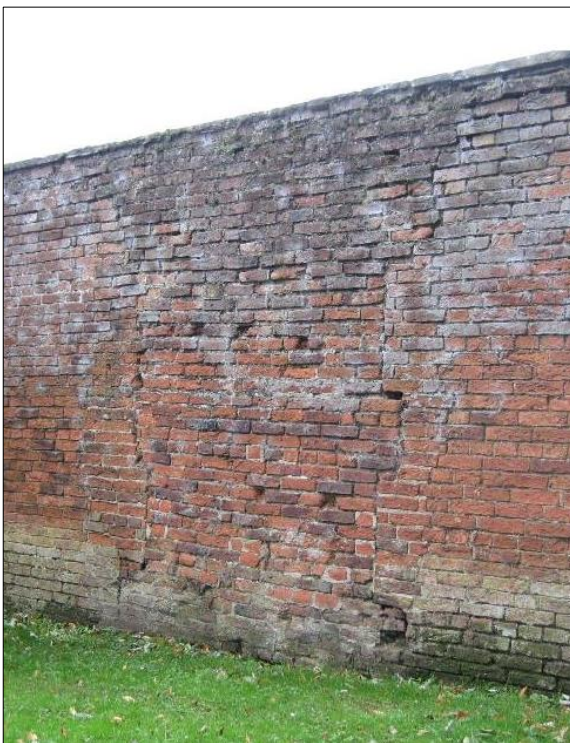
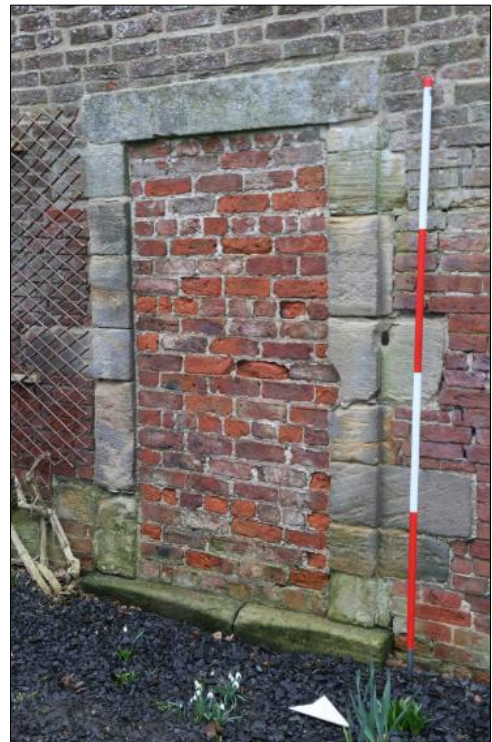
in width and 2.2m high with no evidence of a door frame or case (Plates 11 and 12). However, the shape of the blocking – larger at the base, centre and top sections – suggests it may very likely have originally featured a stone architrave similar to that of the door 311 at the southern end of the east wall (Plate 13).

*Plates 12 and 13: (left) blocked doorway (211) prior to consolidation. Reproduced with kind permission Mosedale Gillatt Architects; (right) door at the southern end of the east wall (311).*

- 6.19 No entrance in this location is shown on the 1781 plan, on which only the west (vehicular?) entrance is depicted. Similarly, nothing appears on the 1818 plan or 1855 OS map, although a path is shown in association with **311** to the east. It is possible that both **211** and **311** date to the late 18th century but pedestrian access routes were not shown on the 1781 plan. Alternatively, the door case from **211** may have been moved from north-west wall to the south-east wall (**311**) in the mid-19th century, perhaps when the Gardener's House became the Vicarage.

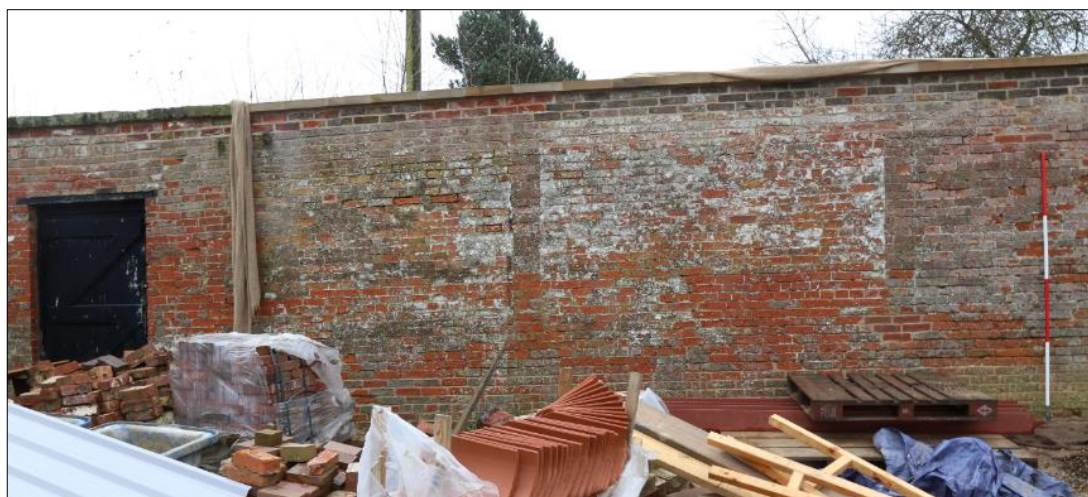
- 6.20 East of the blocked door was a modern garage block (**212**) which was of no architectural or historic interest. East of this there was evidence of lime wash on the north-facing external elevation, together with evidence of former cross walls (**213**) (Plate 14). These are all associated with the dwelling and/or utility buildings, shown in this location on the 1920 and 1941 OS maps, that were demolished in the later 20th century before the garage was erected. Also relating to these buildings was door **214** and the possible blocked window or aperture **231**, visible as a line of header bricks east of this.

*Plate 14: wall render, wall scars (**213**) and door (**214**); all evidence of early 20th-century buildings which formerly stood against the north-facing elevation at the west end of the walled garden.*

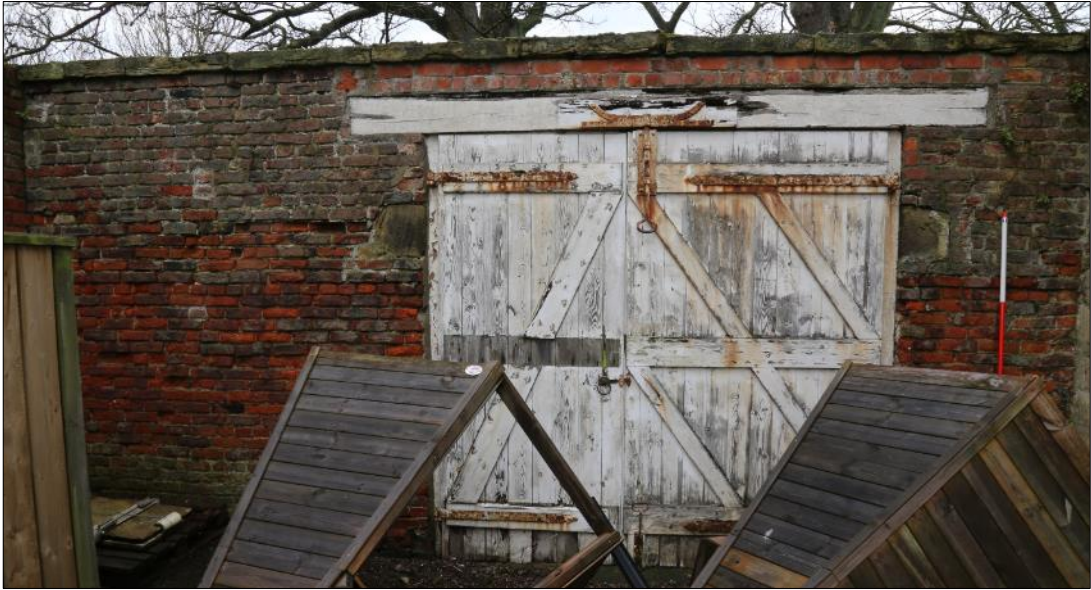
- 6.21 The brick wall (**232**) between the 19th-century cottages and the Orangery was the only surviving section of the wall that formerly connected the small building marked dog kennels on the 1808 plan and the Orangery. Like the Orangery, this section of wall does not appear on the 1781 plan but appears to be similar in build to the rest of the west section of the wall—being set in English Garden bond.

*Plate 15: section of wall between the cottages and Orangery (232).*

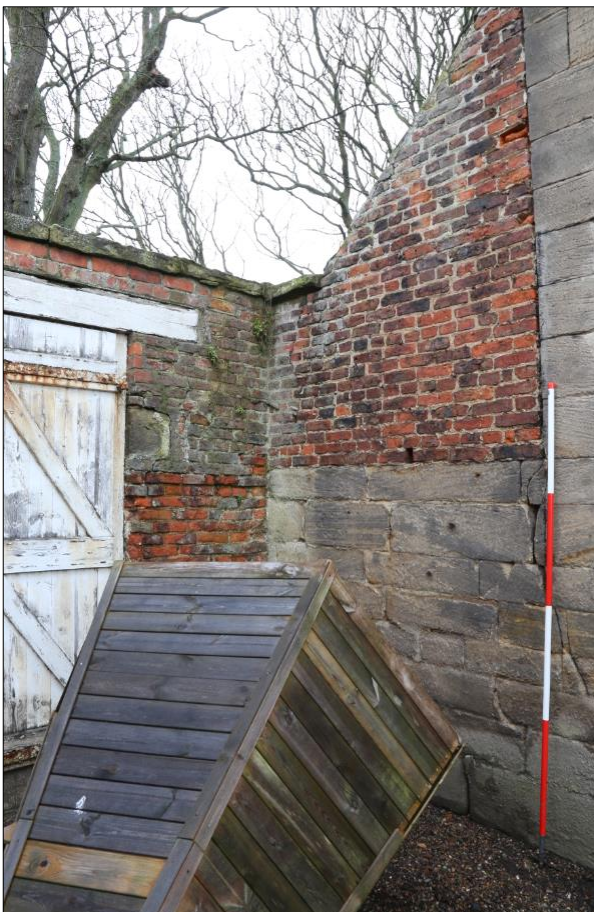
*Plate 16: brick section on west-facing elevation of Orangery wall.*

6.22 The same brickwork formed part of the west-facing gable of the Orangery which appeared to be contemporary with the ashlar stonework associated with that building, although further assessment would be required to confirm this. The double gate (Plate

15) was a later insert, possibly replacing an entrance rather than being a new opening. The wall may have formed part of a sun terrace, which might account for the use of brick on this side of the orangery – brick radiating heat – in contrast to the east elevation of the building which is ashlar built (Plate 16).

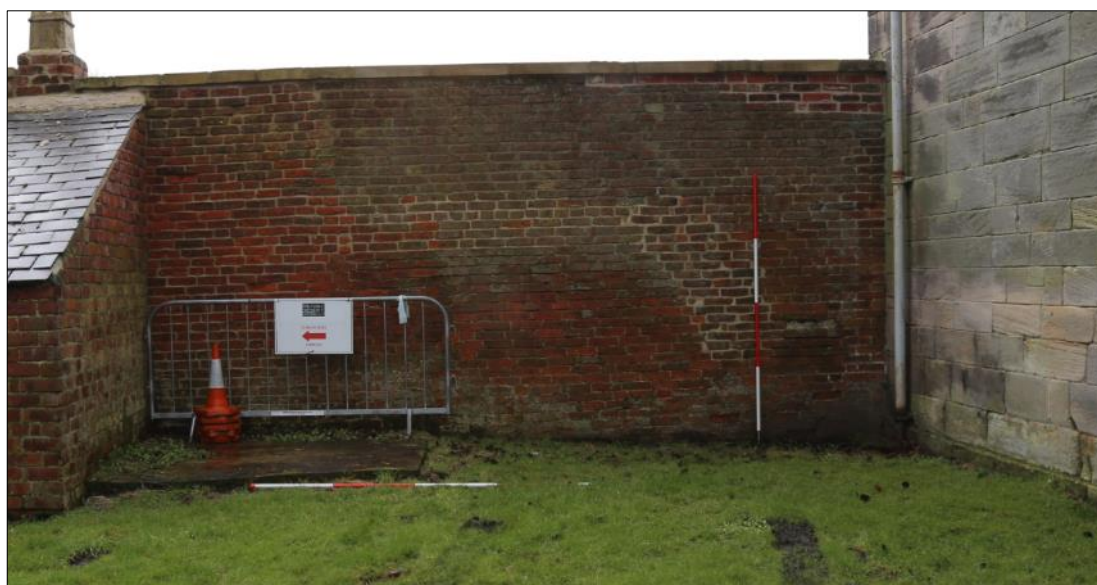
- 6.23 The eastern section of the north wall abuts directly against the ashlar east-facing elevation of the Orangery. Analysis of the Orangery forms part of a separate AWP (AWP 12) and the building is therefore not discussed here. As previously mentioned, the east section of the north wall was not shown on the 1781 plan and varies slightly from the west section of the north (210), east (230) and west (500) walls.

*Plate 17: section of wall east of the orangery (facing south) showing scarring associated with building on 1818 plan (221).*

- 6.24 The 1818 plan shows the 18th-century glasshouse extending for c.32m from approximately the west side of the extant 20th-century boiler house (225), to blocked doorway 222 towards the eastern end of the wall. At a point c.32m from the east wall of the Orangery was a linear variation in the brick (226), located c.1m west of the second new buttress (FP2; Plate 18). This comprised a c.2m section of the wall set slightly forward from the wall face at a height of c.1.1m above current ground level. The reason for this is unknown but may relate to the structure shown against the north face of the wall on the 1818 plan (Fig. 6). This was probably a furnace or boiler house of some form. A cross wall (57) associated with this was found during the excavation of FP1 (para. 6.3). However, based on the 1818 plan, 226 would have been located outside the furnace house. It may therefore relate to the roof of a low structure adjacent,

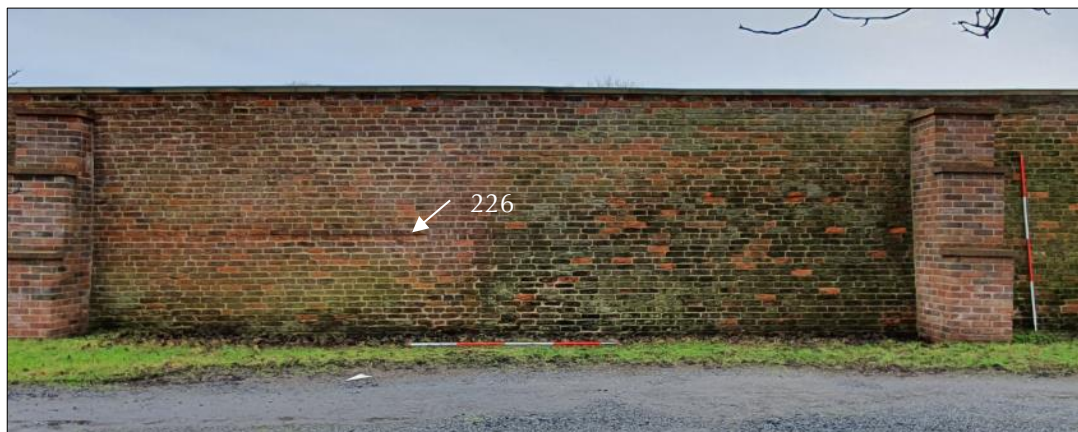
perhaps a cold frame situated to utilise the residual heat from the furnace, although there is no cartographic evidence for such a feature. Alternatively, **226** may relate to a bench, although again there is no evidence of any associated joist holes.

*Plate 18: section of wall east between the first and second of the new buttresses, showing feature 226.*

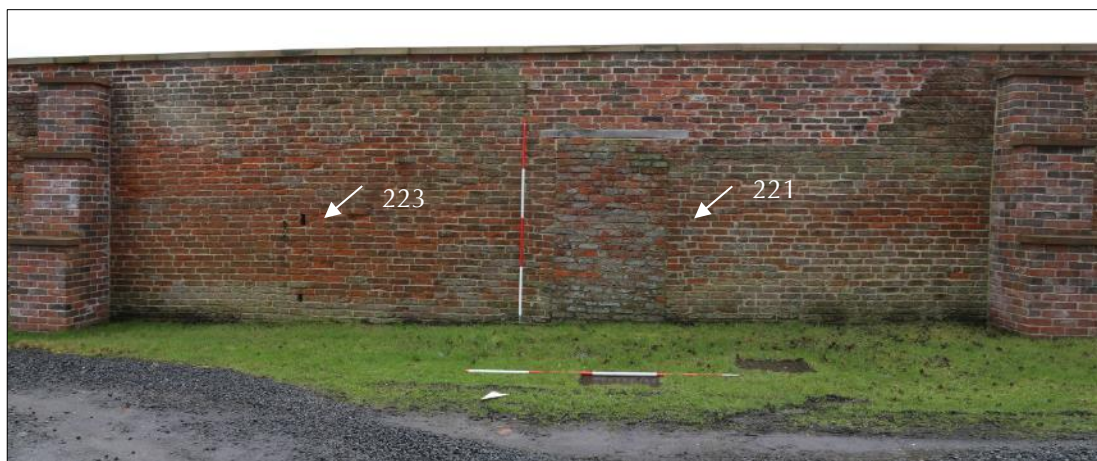
*Plate 19: blocked doorway 221 with the two joist holes (223) visible to the left.*

- 6.25 Blocked doorway **222** at the eastern end of the wall was the northern entrance into the garden first shown on the 1855 OS map (Plate 19). A path is shown leading to the door on the 1818 plan, suggesting it was inserted soon after this date (or not depicted clearly on the plan). The door had clearly been cut through the earlier brickwork and comprised a simple rectangular opening with timber lintel. Approximately 2m to the east of the door were two joist holes (**223**) possibly associated with mounting a wooden gatepost.
- 6.26 Wall **224**, a coursed small ashlar and rubble-built cross wall, butted wall **220** at the east end. This was the boundary division between the main estate and the plot of land associated with the Gardener's House. It seems probable that this was always a separate

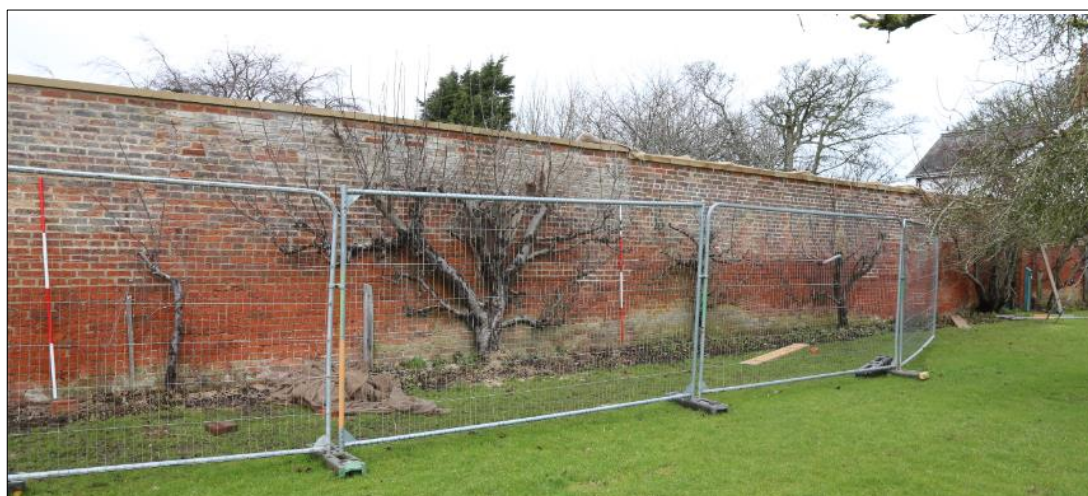
*Plate 20: south-facing elevation (230) of wall 200 showing espaliered fruit trees.*

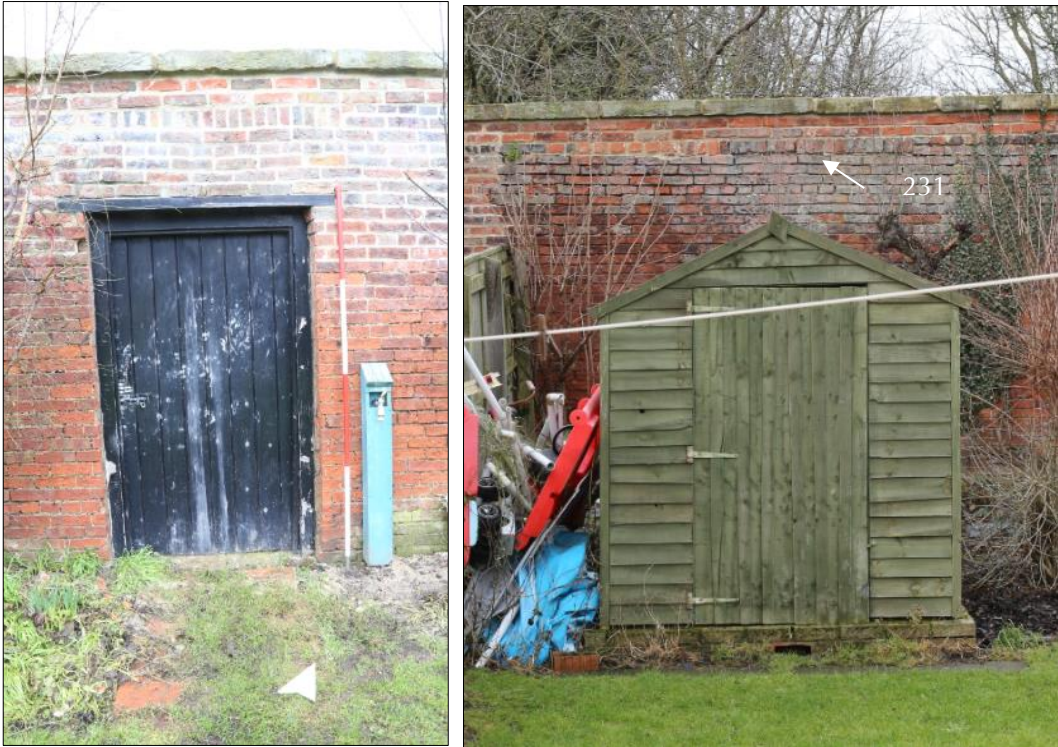
- 6.27 Many of those features observed in relation to the external wall continue through into the interior, beginning at the west end with blocked door **211**, blocked probably by the early 19th century. East of this was a series of espaliered fruit trees extending up to the cottage garden enclosures (Plate 20). On the other side was door **214** (Plate 21), which was clearly more recent than **211** and provided access from the garden to the utility buildings shown on the early 20th century OS maps. There was a relieving line of slightly protruding header bricks above the door. A similar line was observed further to the east (**231**), possibly related to an opening of some form, although there was no obvious disturbance in the brickwork below (Plate 22).

*Plates 21 and 22: (left) doorway 214; (right) line of slightly protruding headers (231).*

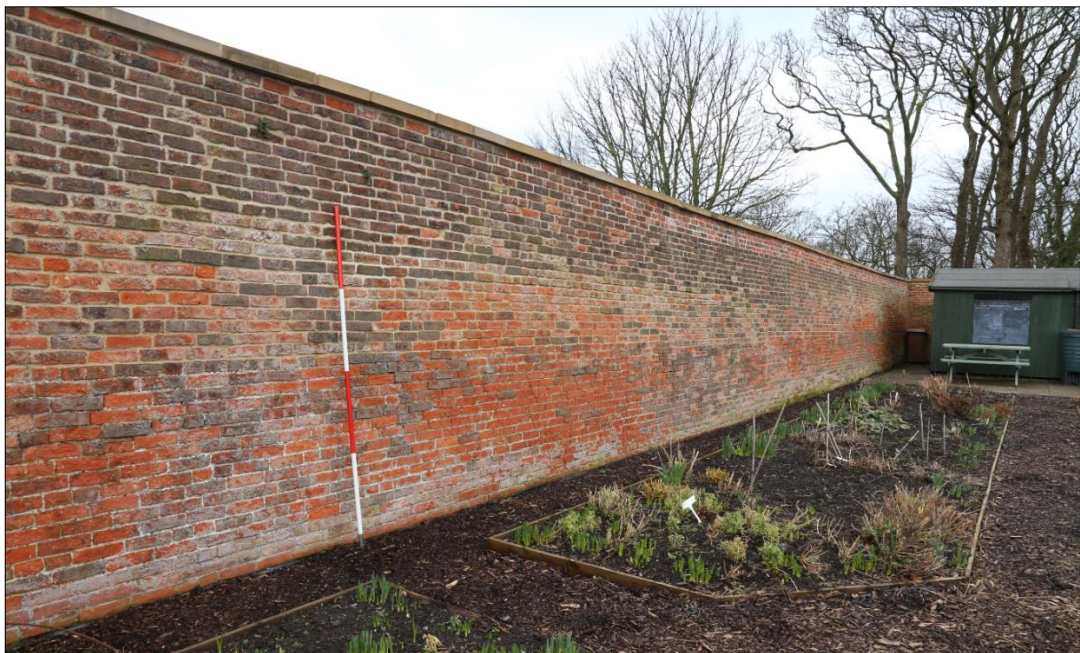
- 6.32 Beyond door 221 the rest of the south-facing elevation was fairly uniform in terms of wear patterning and without any significant features (Plate 26), apart from fixtures which may be evidence of further espaliered trees, similar to those surviving at the west end of wall. The south-facing elevation would have provided the best growing conditions in the garden for the cultivation of fruit trees.

*Plates 26: east end of the south-facing elevation of the north wall.*

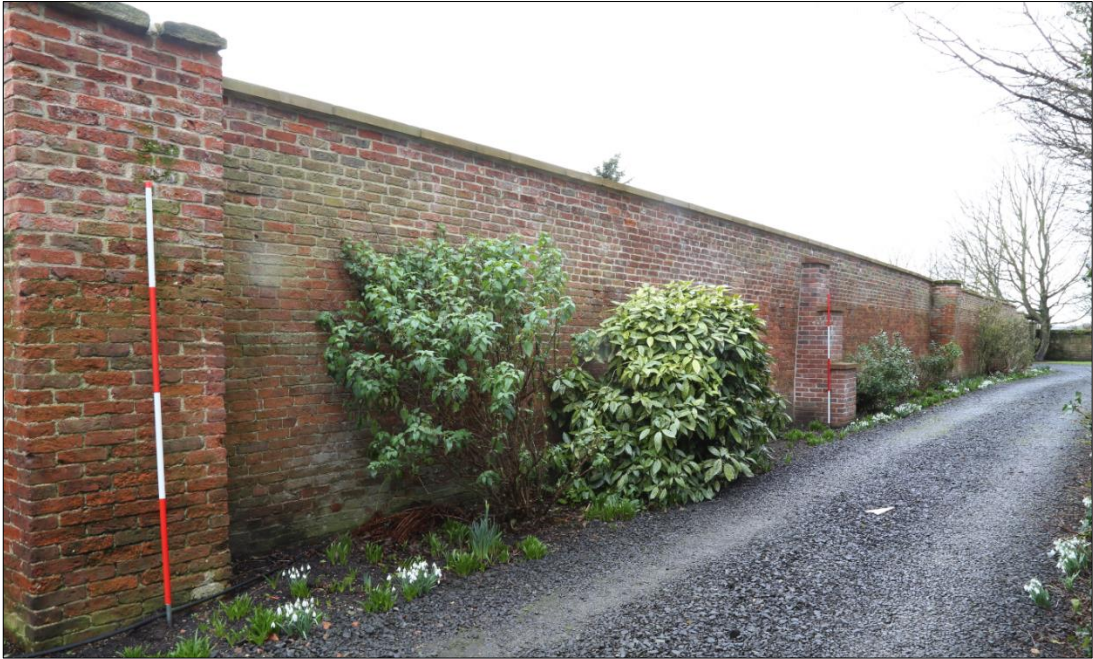
- 6.33 The east-facing elevation (310) of the east wall (300) was fairly uniform, the only features of note being the blocked doorway at the southern end (311) and two brick buttresses (312, 313) (Plate 27). The latter were shown on the 1855 OS map and were substantial square buttresses, constructed of red clamp brick and extending the full height of the wall. Two further stepped buttress were added as part of the conservation work.

*Plate 27: east-facing elevation (310) of east wall (300) with the two square buttresses visible (312, 313) and new stepped buttress in between.*

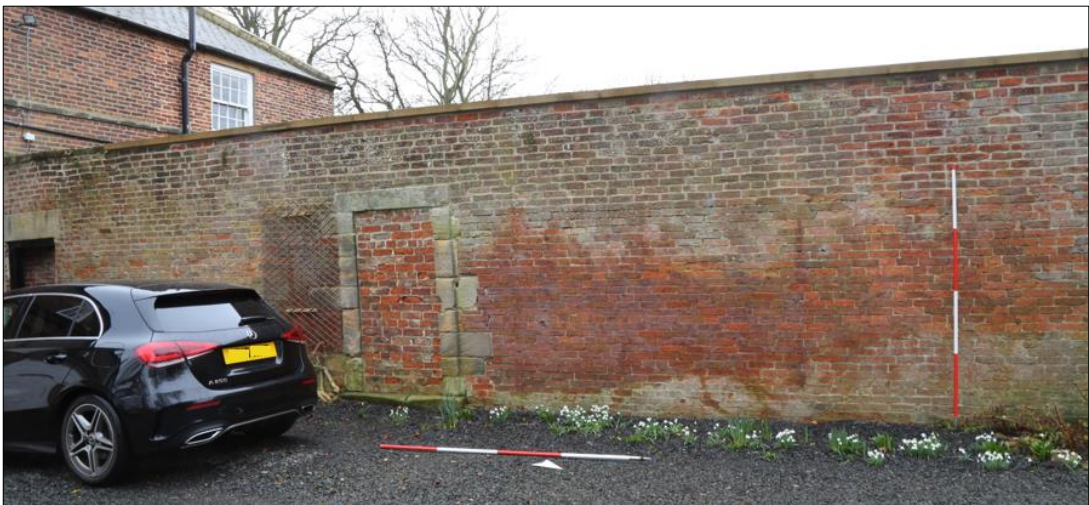
*Plate 28: doorway 311 and opening 314 just visible behind the car.*

- 6.35 Just south of door **311** was a second door (**314**) (Plate 28) which provided access through into what would have previous been the south slip. This looked to be a later insert, although the lintel was similar to those of the Gardener's House.

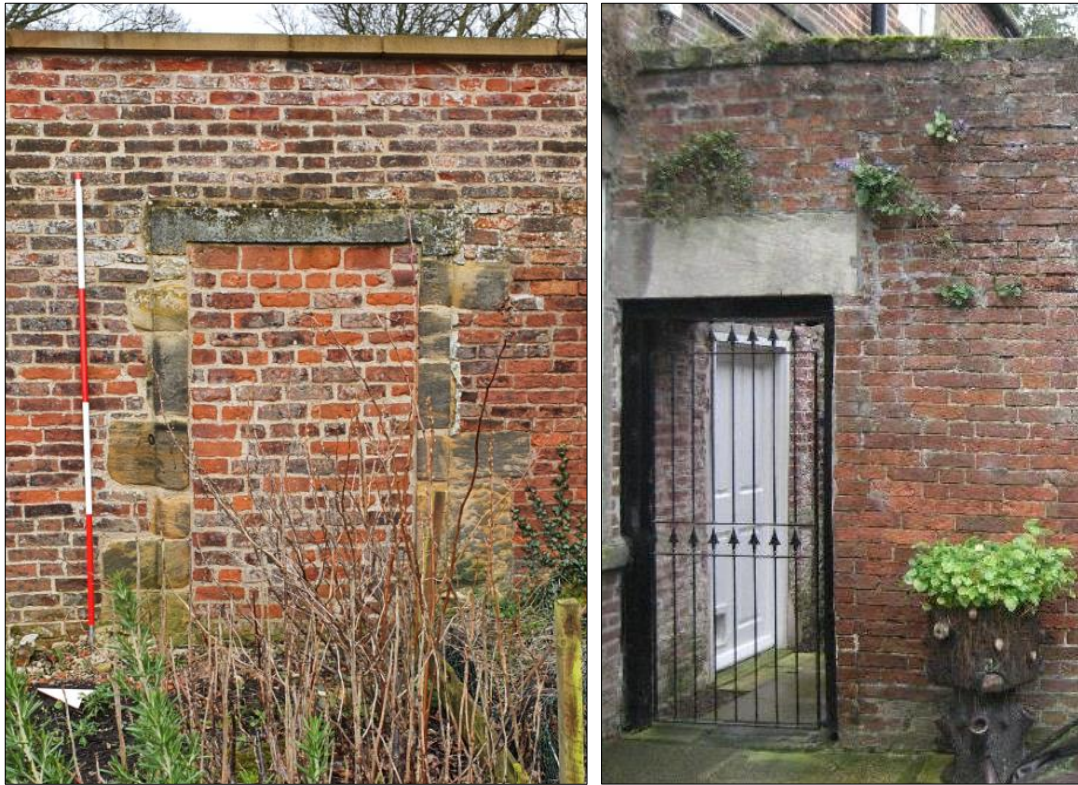
- 6.34 Door 311 measured c.2m by 1.2m and featured a single, squared-stone lintel with slightly projecting, long and short ashlar surround and a stone threshold (Plates 29 and 30). On the north side, the fifth ashlar from the base featured a recessed metal bolt, associated with a loop on the west-facing (internal) side of the feature. This was of unknown function, there being no wear on the stonework to suggest a securing bolt of any form. The lintel was much less worn than the surrounds and looked to be of a different type of stone, suggesting either a later replacement or the reuse of materials

from a different source at the time of construction. The brickwork around the door aperture was disturbed indicating the door was a later insert.

*Plates 29 and 30: (left) west-facing (internal) elevation of east wall showing doorway **311**; (right) doorway **314** leading to the Gardener's House garden. Reproduced with kind permission Mosedale Gillatt Architects.*

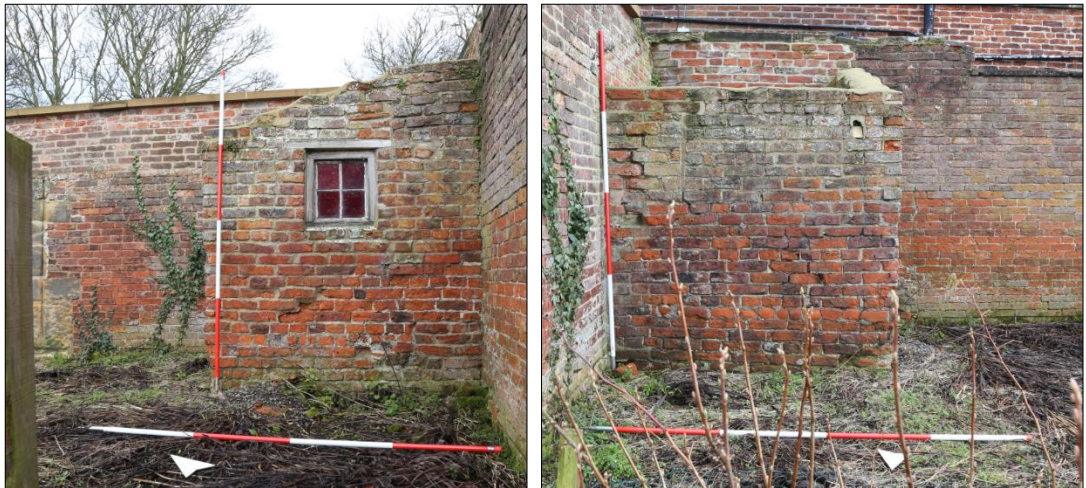
- 6.36 Apart from door **311**, the only feature of note associated with the west-facing elevation of the east wall was the small, square structure in the south-east corner of the garden (**321**) (Plate 31 and 32) which was first shown on the 1818 plan. This measured c.1.5m by 1.5m and stood 2.2m high at the south end (the full height of the garden wall) dropping to c.1.5m at the north end, with a sloping cat-side roof. It was constructed of red clamp brick of the same type used elsewhere in the garden. The structure was entered from the former south slip, but there was no access to this area during the survey.

- 6.37 On the north-facing elevation of the structure was evidence of a blocked window, with a second *in situ* but modified window on the west-facing elevation. The function of the building is unknown but was probably related to the Gardener's House. The large window on the east side suggests it is unlikely to have been a privy or coal hole. The tinted red glass might indicate that the building has been use as a photographic dark room at some point in the 20th century (Newman *pers. comm.*)

*Plates 31 and 32: structure 321 (left) west-facing elevation; (right) north-facing elevation.*

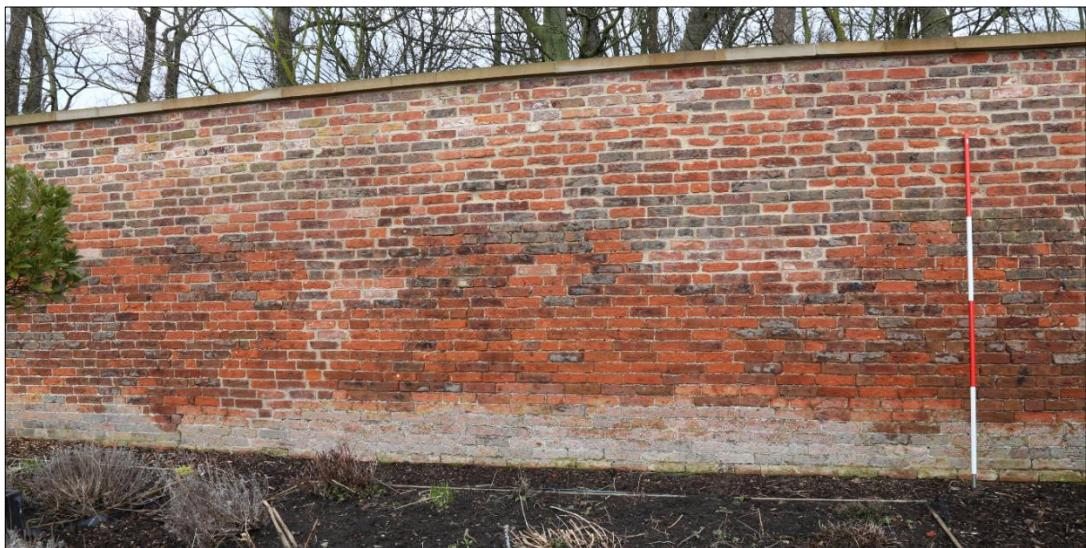
- 6.38 The rest of the elevation was uniform with no features of archaeological interest (Plate 33).

*Plate 33: example section of west-facing (internal) elevation of east wall, showing brickwork.*

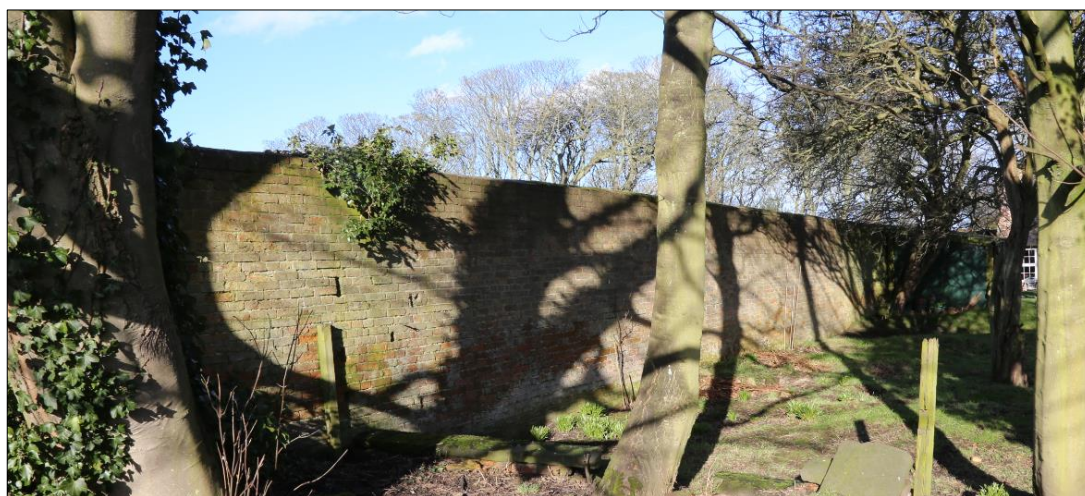
- 6.40 The east end of 410 formed the rear wall of the garden of the Gardener's House (Plate 34). This was not inspected as access could not be obtained and instead it was photographed from a distance. No obvious features of significance were apparent but further investigation would be desirable. The 1941 OS map (Fig. 10) clearly shows that the area now occupied by the house gardens formed the eastern end of the south slip.

*Plates 34: east end of south-facing elevation (410) of south wall (400). Section forms the rear wall of the Gardener's House gardens.*

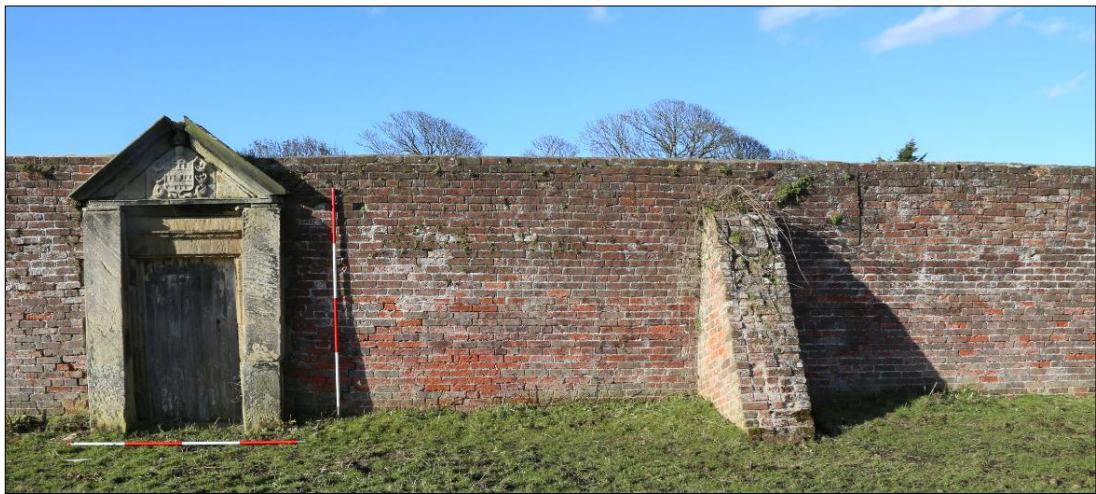
*Plate 37: doorcase 413, buttress 411 and infill section 412.*

- 6.45 Approximately 5m east of the ornamental door was a raked buttress (411) (Plate 37), which measured c.0.5m in width and stood to a height of c.2m. It was built of handmade brick, the brickwork angled downwards. Unlike the buttresses on the east (312, 313) and north walls (418–19, 423), 411 does not appear on the 1855 25-inch OS map but was clearly of some antiquity.

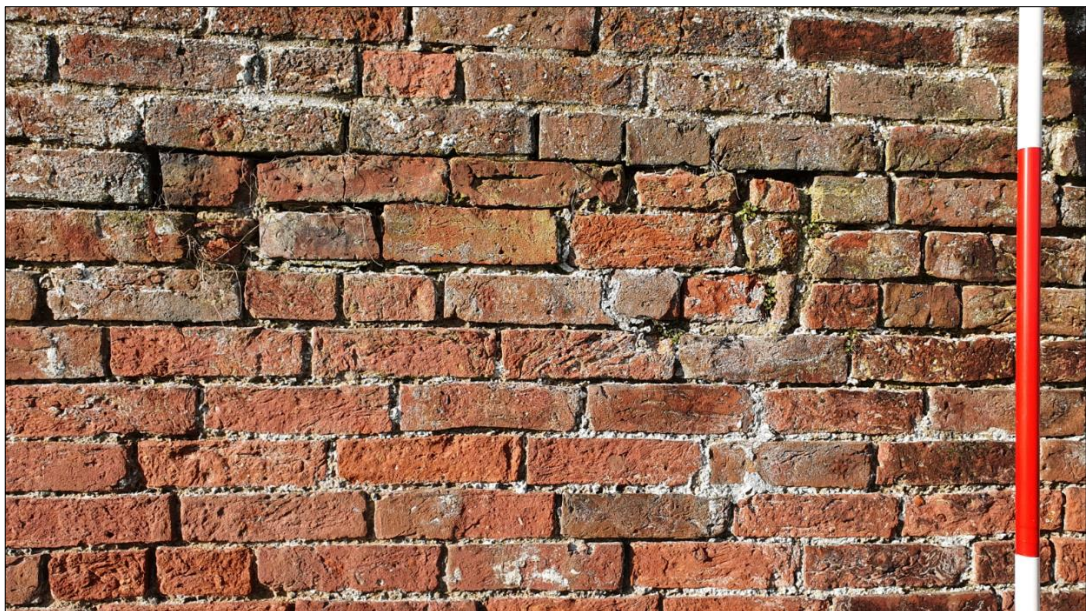
- 6.47 A second blocked opening (414) was located further to the west (c.12.5m west of the door 413) (Plate 39). This was a small slot, infilled with brick, measuring c.0.6m by 0.2m, and of unknown function. In the bottom east corner was a shaped piece of tile and running along the top a single flat stone, possibly suggesting a vent or flue, although there was no visible evidence of burning on the brick.

*Plate 39: rectangular opening (414) in south-facing elevation of wall 400.*

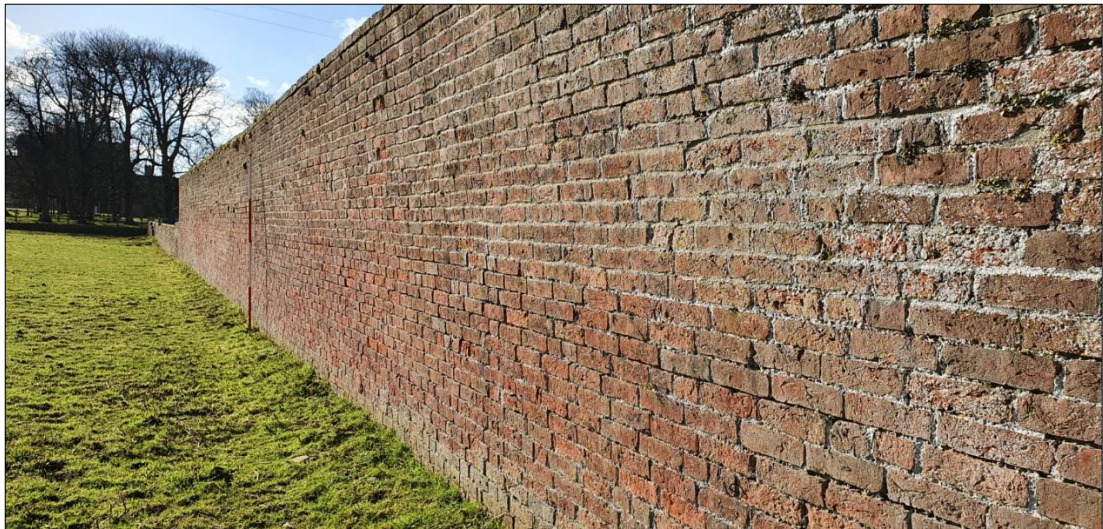
of the ha-ha, and c.28m west of door **213**, the wall height dropped from 2.2m to 1m (Plate 40). The transition between the two was marked by wall pier **422**; the main body of which was on the north side, visible only as line of recessed bricks on the south side (Fig. 9). This point marked the eastern extent of the former 18th-century hothouse, as shown on the 1896 OS map. The hothouse extended c.40m west, **400** forming the rear wall of the structure.

*Plate 40: south-facing elevation of the south wall looking west with variation of wall height visible in the distance.*

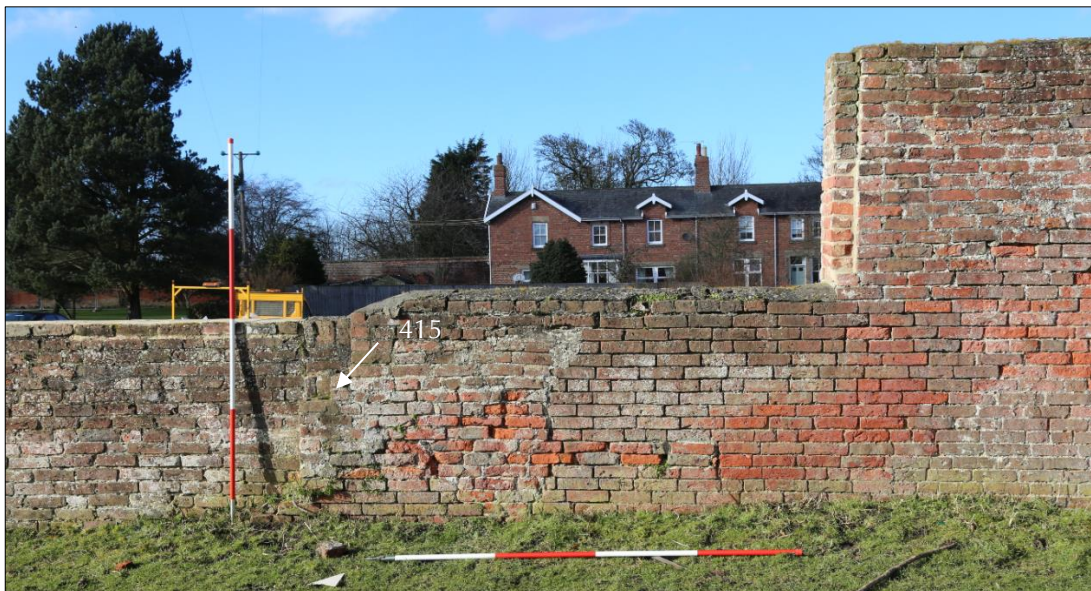
*Plate 41: change in wall height and section of blocking **415**.*

Approximately 2.6m west of **422** a vertical joint was visible (**215**). East of this, between the joint and the wall pier, the brickwork was damaged on the internal, north-facing elevation. This included a roughly central area filled with brick and mortar (Plate 42). However, the brickwork on the south-facing side (Plate 41) shows little sign of disturbance.

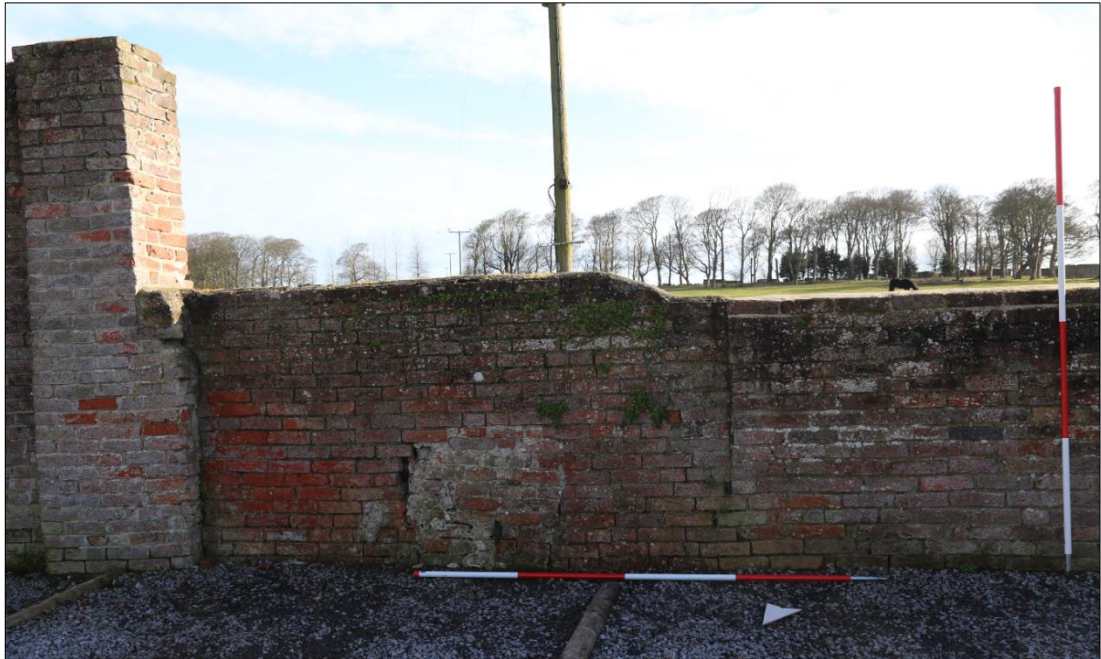
- 6.49 Wall pier **422** may have formed part of the hothouse structure, or more likely was erected following the demolition of the building to provide additional support.

*Plate 42: north-facing elevation of the south wall showing wall pier **422** and vertical joint with section of blocking to the east (**415**).*

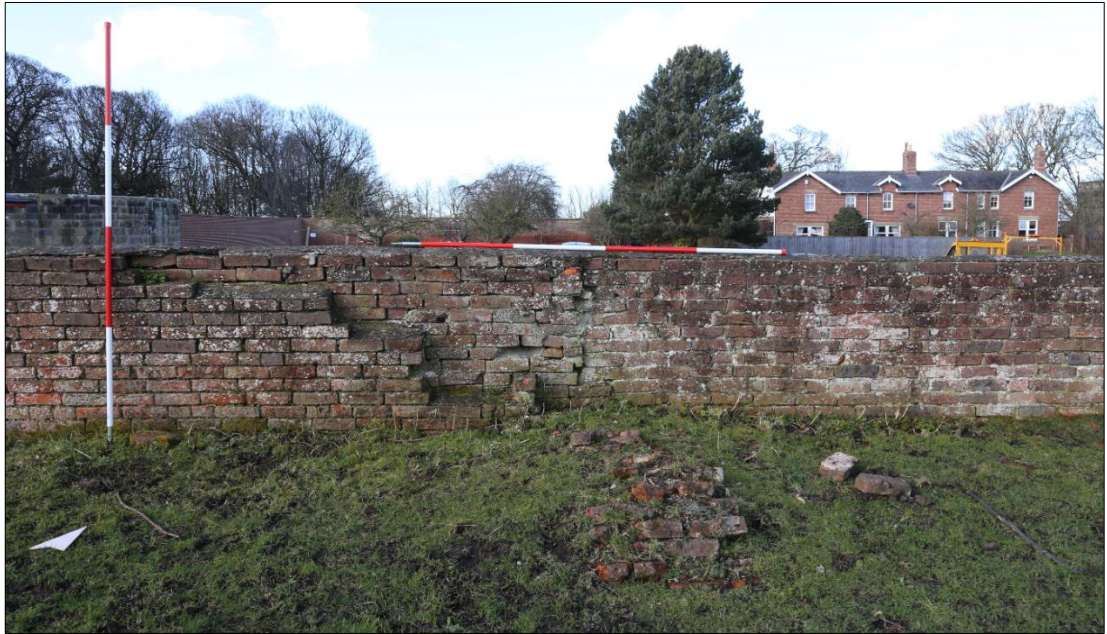
*Plate 44: stepped brickwork (417) and buttress 418.*

- 6.51 Approximately 15.5m east of the west gate pier (421) located at the terminal of the south wall, was an area of stepped brickwork that marked the western extent of the rebuilt wall (416). West of this was the remains of a buttress (418); one of three first

shown on the 1855 OS map. Only the base of the feature survived, extended 1.4m south of the wall. The buttress measured 0.6m in width. The bricks were raked at an angle, similar to those of **411**. A second buttress (**419**) (Plate 41) was located c.6m to the west (c.7.5m from the gate post). This was slightly smaller, measuring just 1m north to south, and 0.5m in width. A third buttress (**423**), surviving only as a grassed mound, was recorded c.21m east of the west gate pier (Plate 43).

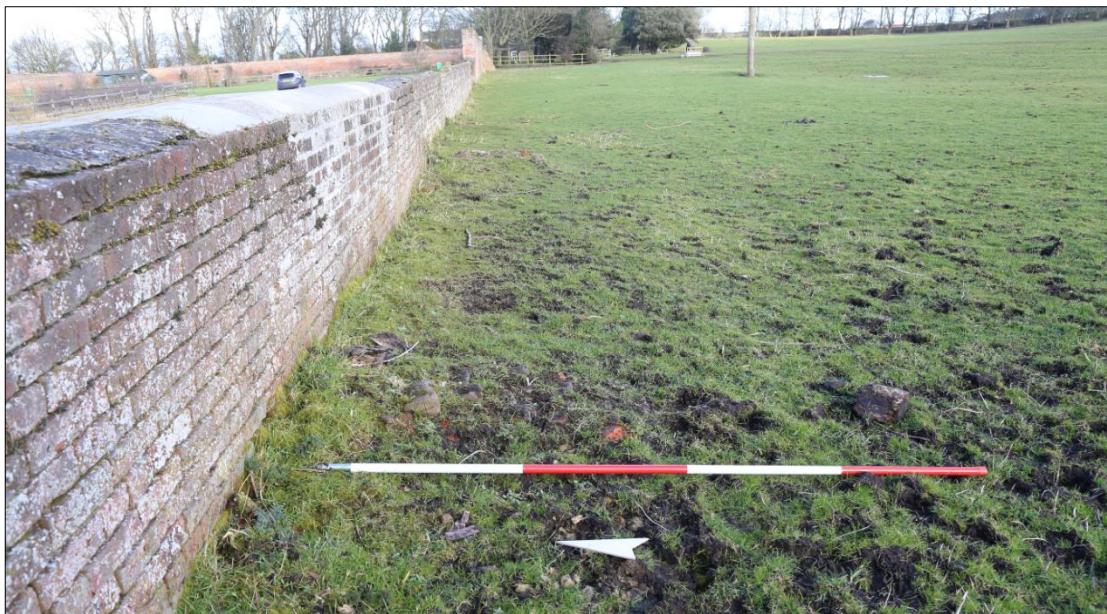
*Plate 45: buttress 419 on south side of south wall.*

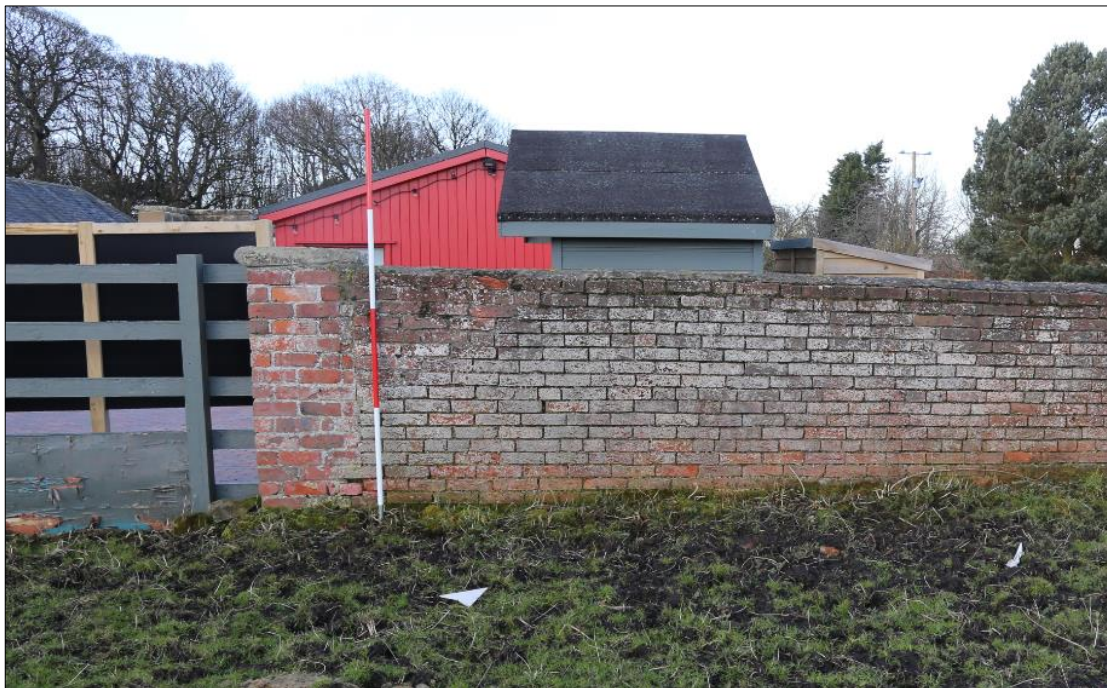
*Plate 46: gatepost **421** at the west end of south wall.*

- 6.53 The west end of the wall terminated in a squared gatepost (**421**) (Plate 46). This was a fairly recent construction, the brick being distinctly different from that used elsewhere. The gatepost stood c.1.3m high and was c.0.5m wide, capped with a sandstone slab. There was a 6.3m gap between the end of the gate post and the east-facing elevation of the ha-ha wall which formed the southern end of the west boundary. The south wall never originally adjoined the west boundary (where it would have encountered the now infilled ha-ha ditch) although later OS maps show the wall was extended in the early

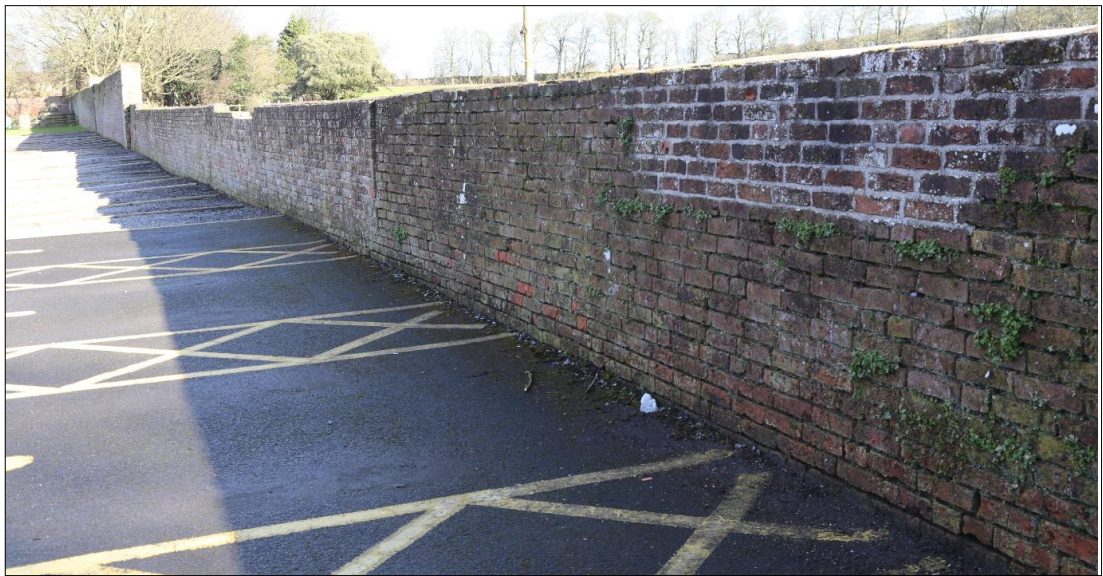
- 6.54 The section of rebuilt wall (416) was even more obvious on the north-facing elevation (Plate 47). At the east end of this section was a 2m area of damaged wall (415), discussed previously. Pier 422 stood 2.25m high and measured 0.5m in width. It appeared to post-date the wall, abutting the earlier structure and was only bonded into it at certain points.

*Plate 47: north-facing elevation showing rebuilt section of wall at the west end, associated with the demolished glasshouse.*
