THE CURTAIN RISES  
THE WALLED GARDEN

ARCHAEOLOGICAL  
INVESTIGATIONS

NATIONAL TRUST  
SEATON DELAVAL HALL  
NORTHUMBERLAND

NAA 21/31  
October 2021

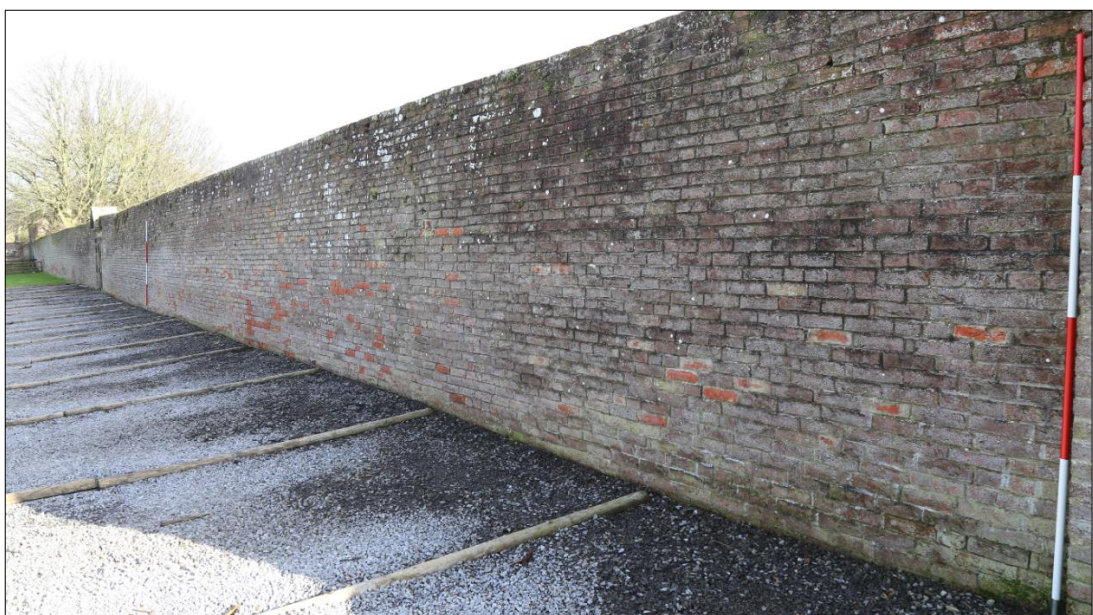
*Plate 48: north-facing elevation with door 413 just east (left) of second ranging rod.*

- 6.55 The eastern end of the north-facing elevation was devoid of any significant legible features (Plates 48, 49), apart from door **413**.

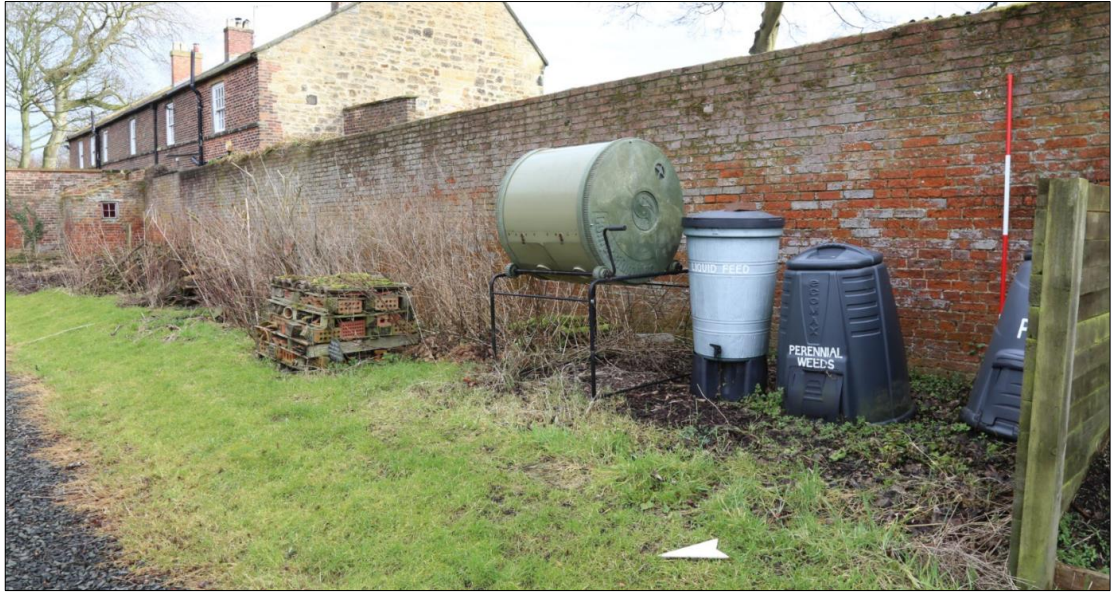
*Plate 49: east end of north-facing elevation.*

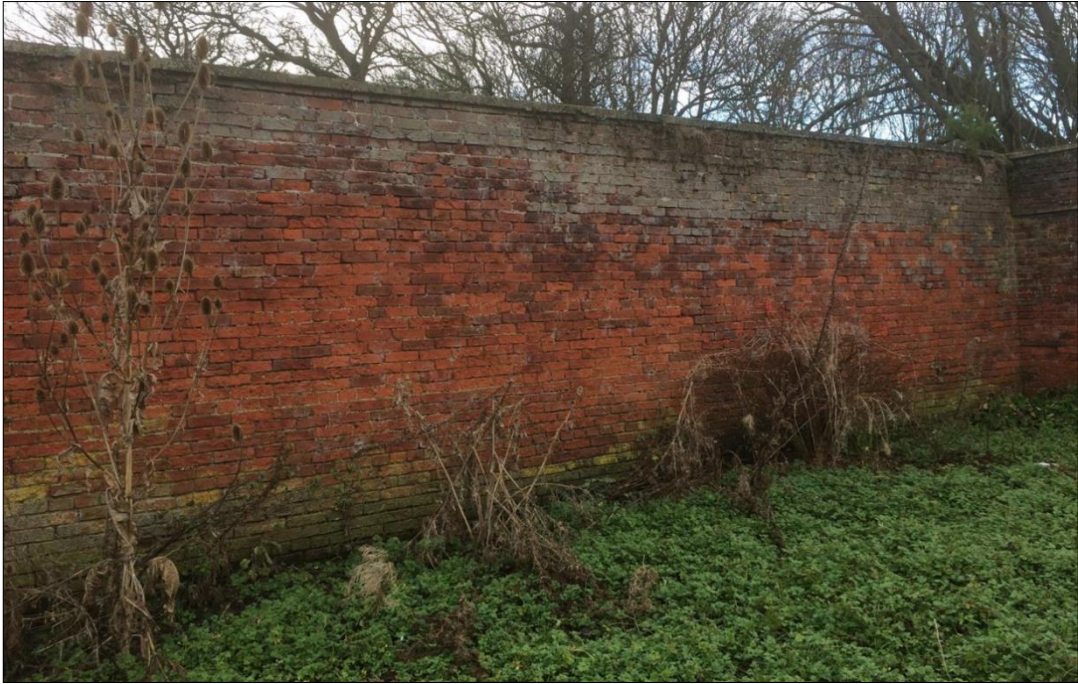
- 6.57 The northern section of the west wall comprised a brick wall which measured 26.30m in length, was 0.5m wide, and 3m high. It was laid in English Garden Wall bond, the same as the west section of the north wall (**210**) (Plates 50-52). The wall head was capped with concrete coping.

- 6.58 The wall had become unstable and was dismantled and rebuilt as part of the conservation works, with recording of the wall (**500**) and monitoring during ground works being undertaken as part of AWP 3. A visual inspection of the wall was conducted prior to demolition, this indicated that the build was all one phase, although with evidence of later repair and repointing (Plate 52). The upper courses were slightly darker in colour which was attributed to uneven weathering and the loss of mortar along the joints rather than any evidence that the wall had been heightened. No other features of note were identified.

*Plate 50: north section of the west wall (500); internal east-facing elevation (north end).  
Reproduced with kind permission Mosedale Gillatt Architects.*

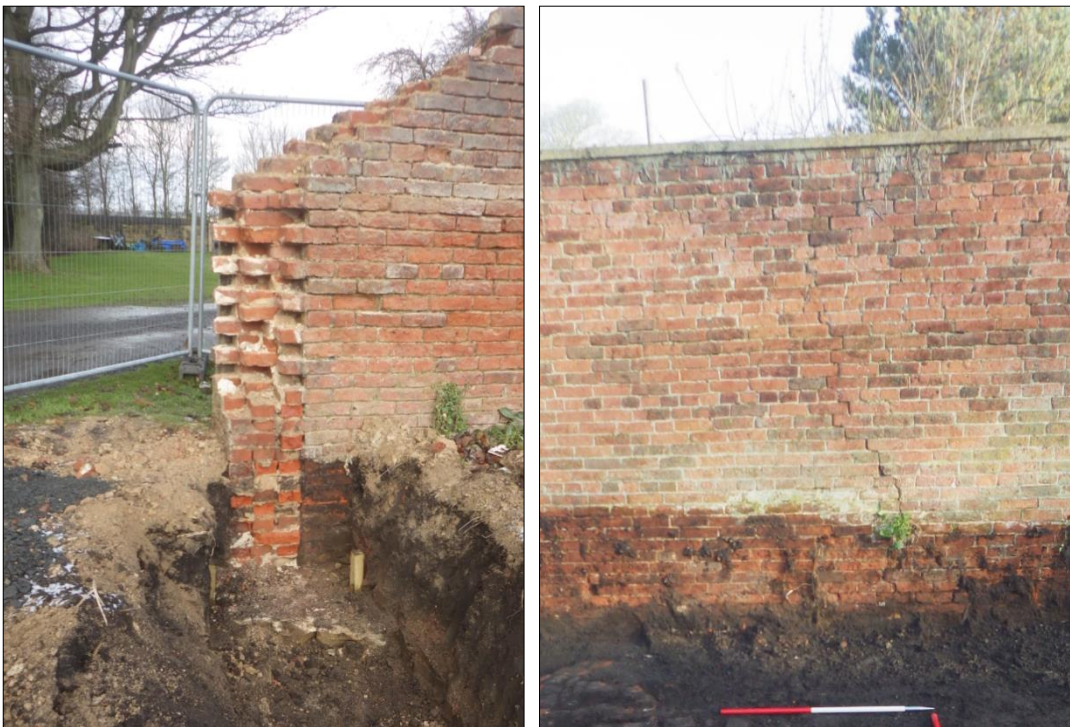
*Plates 51 and 52: (left) cross-section through the wall exposed during dismantling;  
(right) sample section of brickwork with concrete capping.*

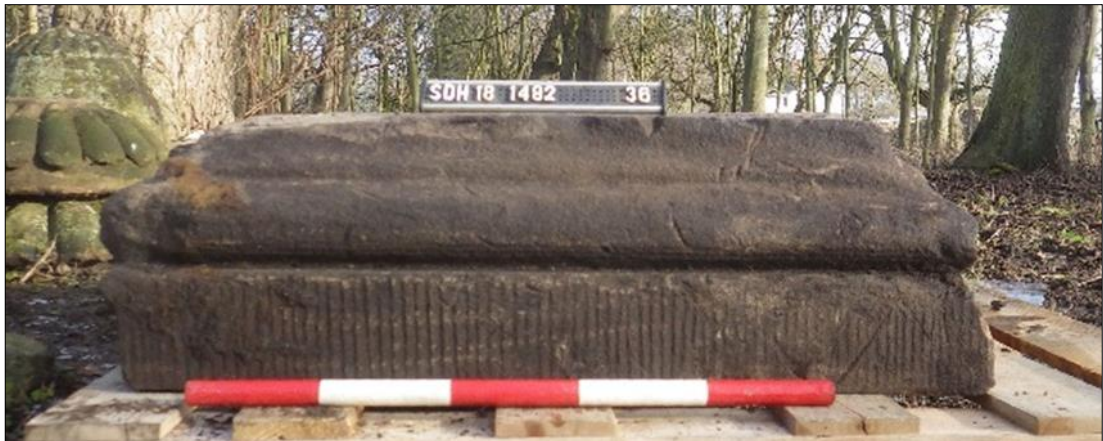
- 6.59 A large, squared stone plinth (Plate 53) was discovered during monitoring of a foundation trench for the rebuilt wall. This was buried under the edge of the modern

access road at the south end of the wall. The stone plinth was square with sides of 0.75m and height of 0.23m and would have formed the base of a pillar at the entrance to the walled garden. Inspection of the outer wall of the north-east bastion revealed two carved insets measuring 5cm by 7cm which would have supported the ironwork for a gateway (Plate 54).

*Plate 53: stone plinth belonging to gate pier.*

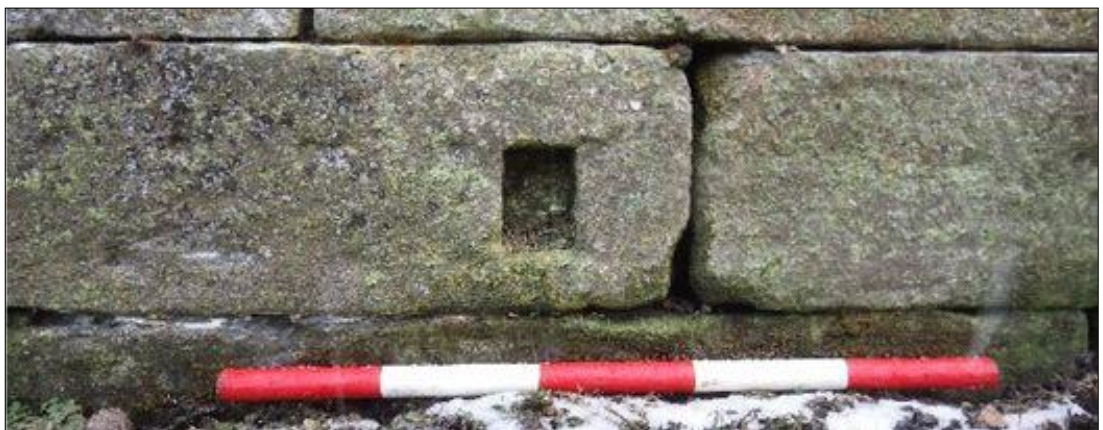
*Plates 54: carved recess in north-east bastion wall for gate.*
