Hallmark Developments (Northwest) Ltd

Dexine Rubber Works, Rochdale

Level 2 Archaeological Building Survey

22 November 2019

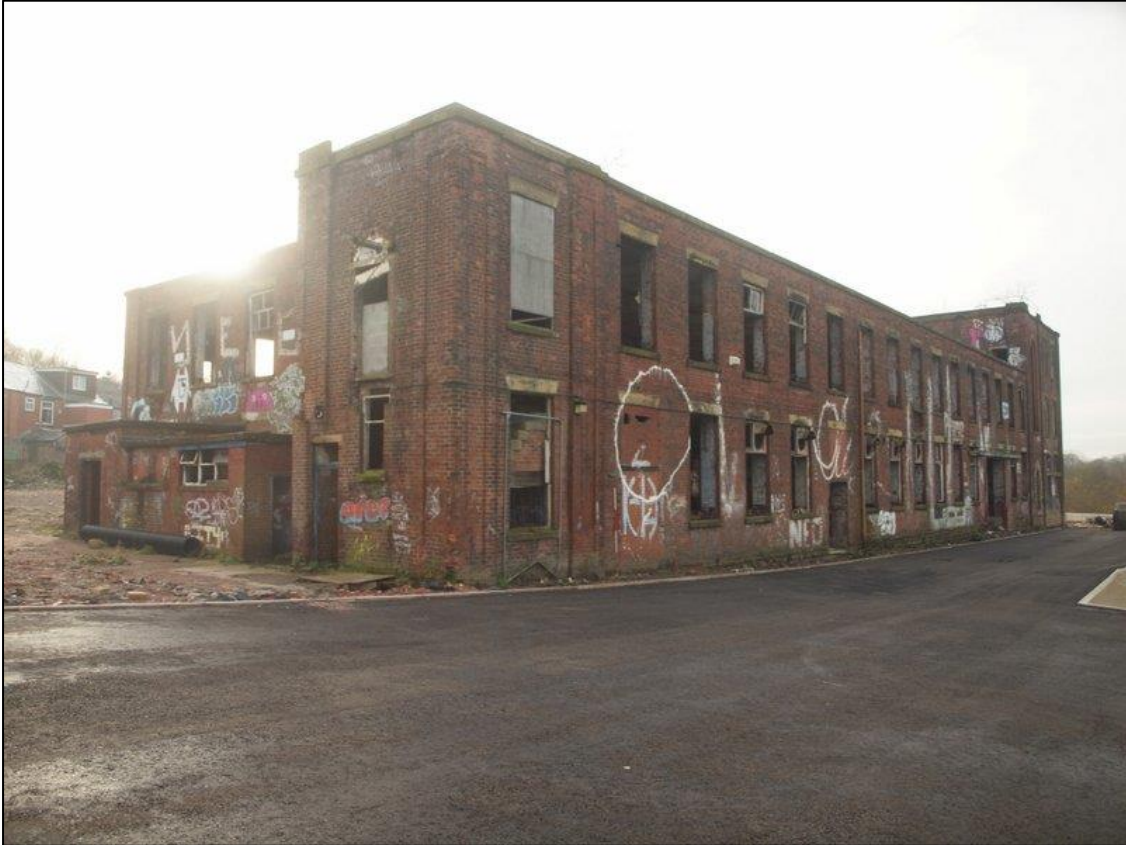
6.2 (Plate 1). The building is rectangular and aligned roughly northwest – southeast. It is brick built in English Garden Wall bond over a sandstone plinth and is two stories high with a flat roof and sandstone coping. To the southeast end was a three story engine house (1 bay

Plate 1: General shot of the mill

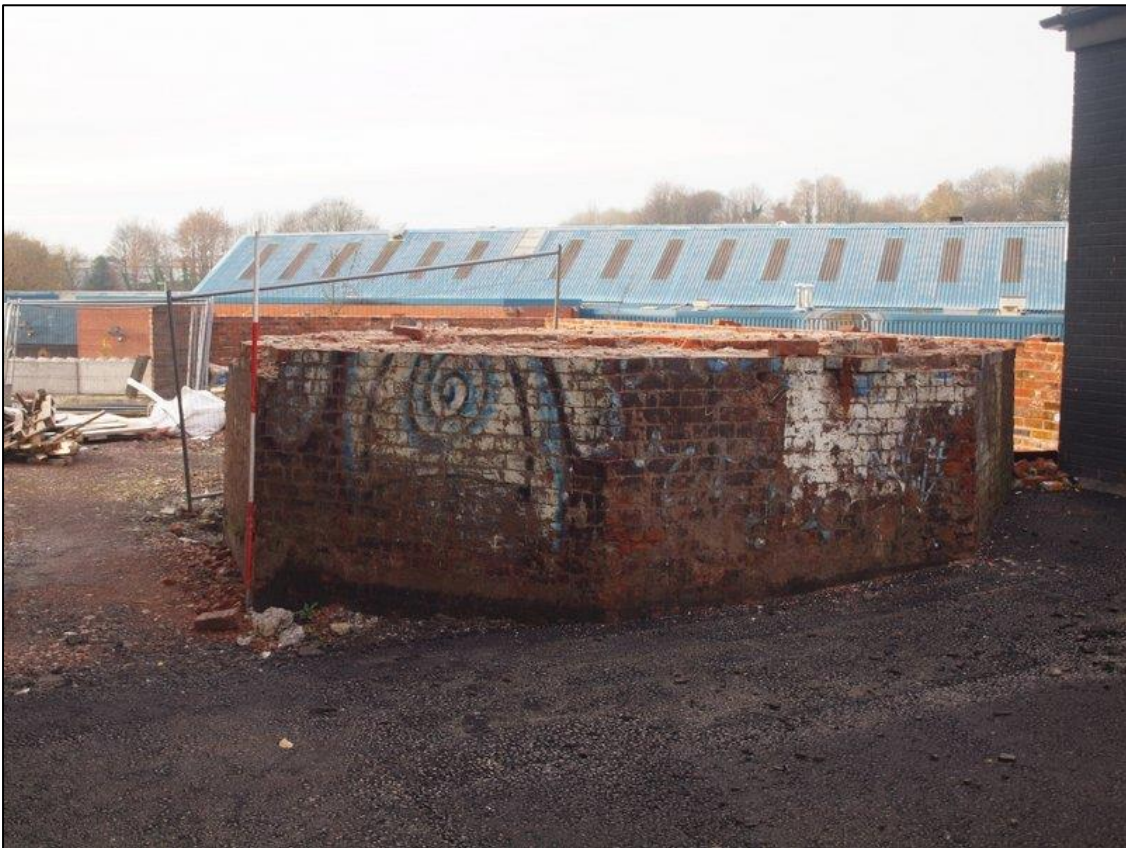
wide) and boiler house (2 bays wide). Italianate pilasters on the long elevations demark the different areas of the building; the stair tower in bay 1, the engine house and the boiler house. The base of the octagonal chimney (plate 2) lies to the southwest of the mill, opposite the boiler house, and has been reduced to c. 1.5m high.

Plate 2: Octagonal chimney base

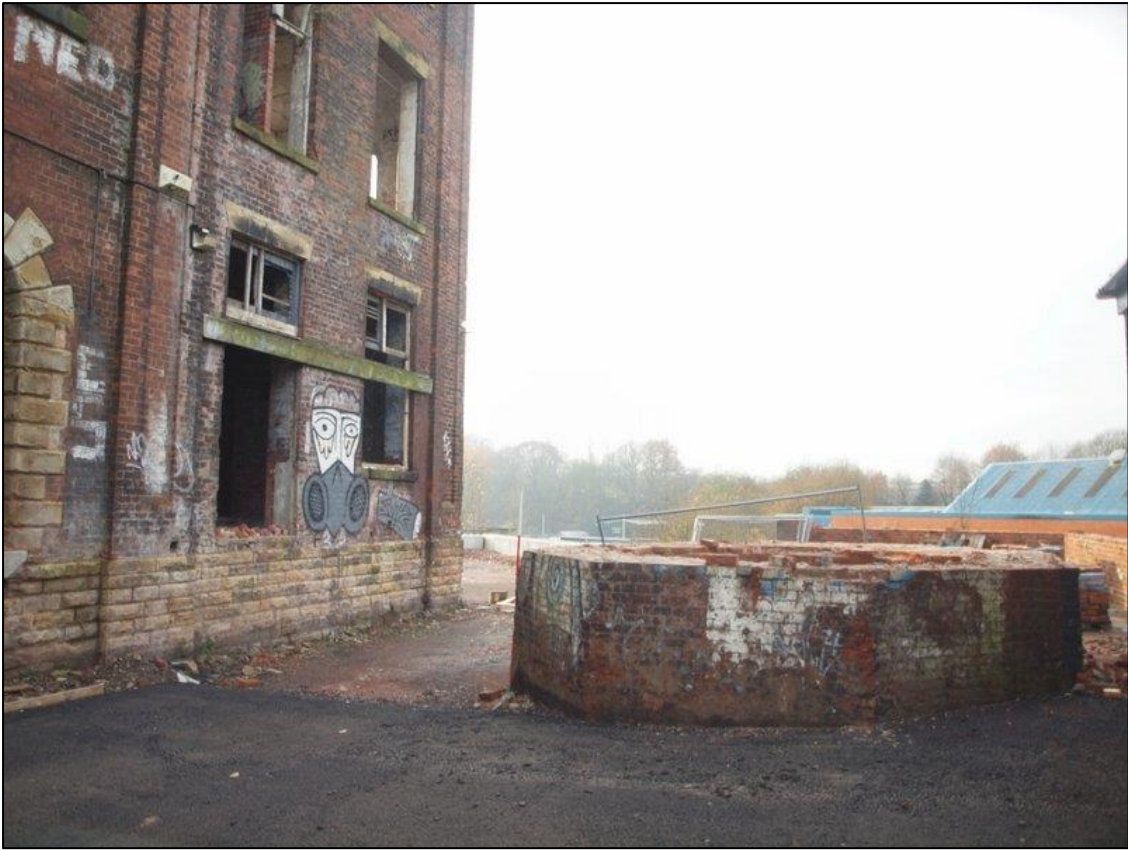
Plate 3: Chimney base in relation to the boiler house
Northwest Elevation

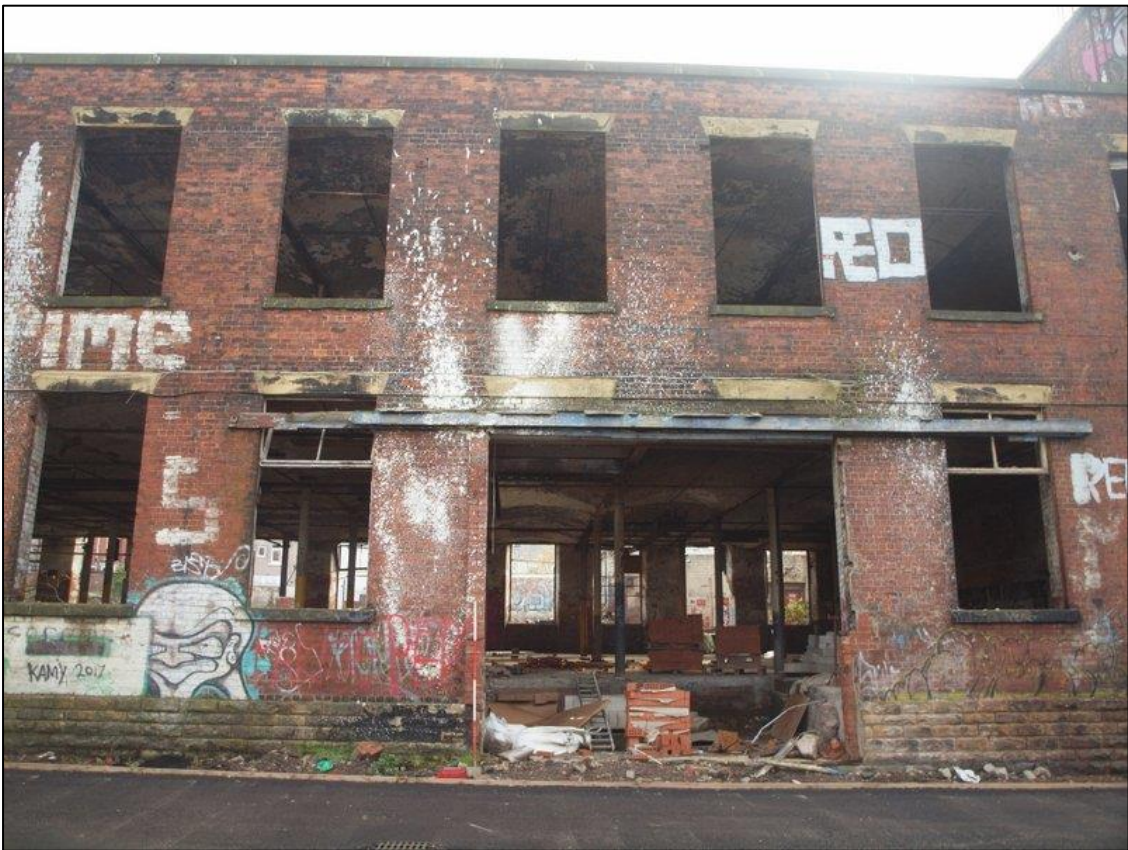
Plate 8: Northwest elevation bays 11 - 15

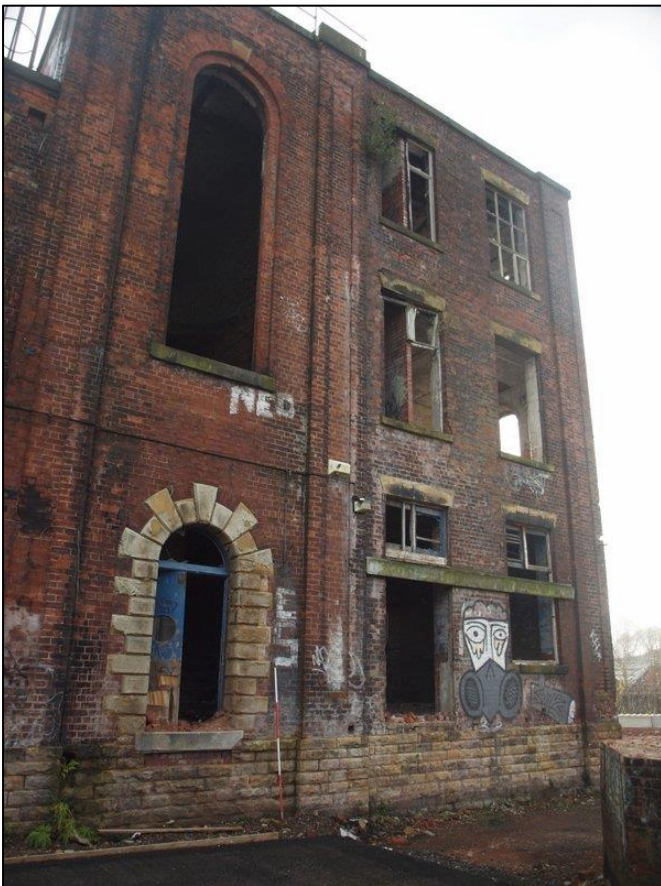
Plate 10: Engine house (left) and boiler house (right)

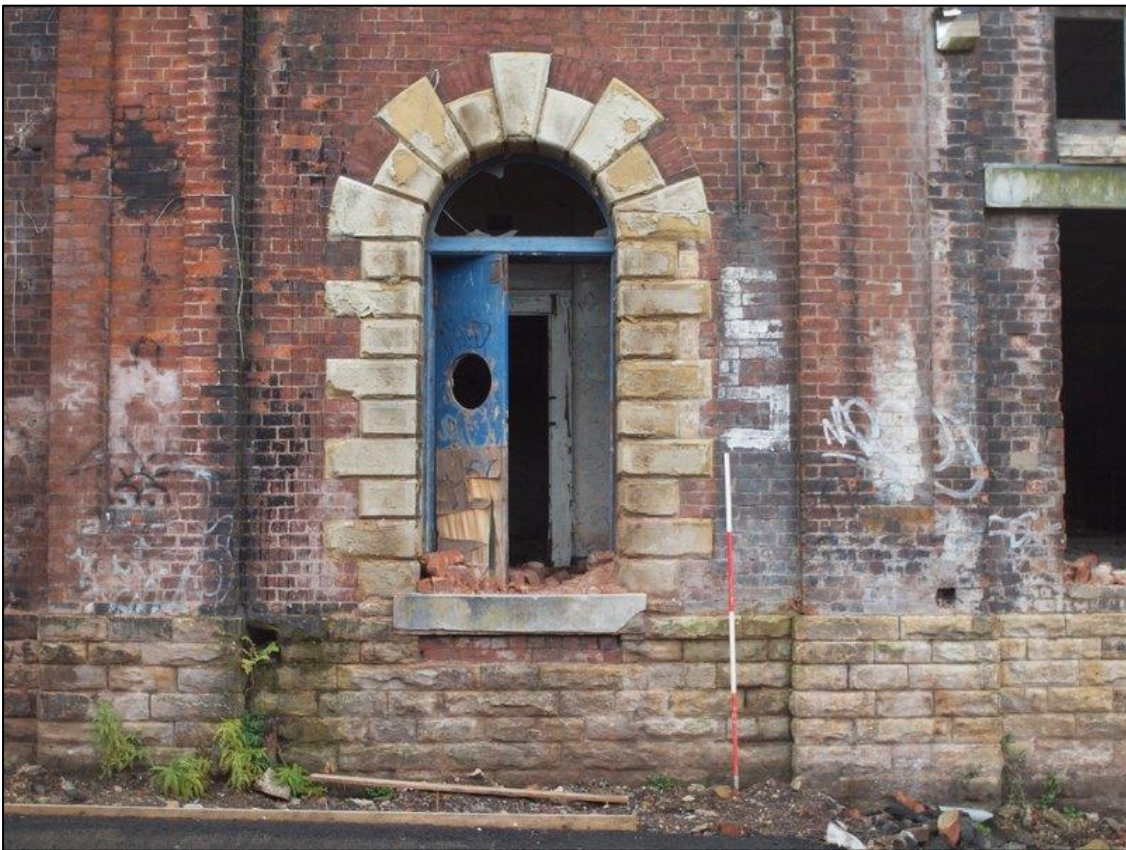
Plate 12: Detail of personnel door to engine house with steps removed

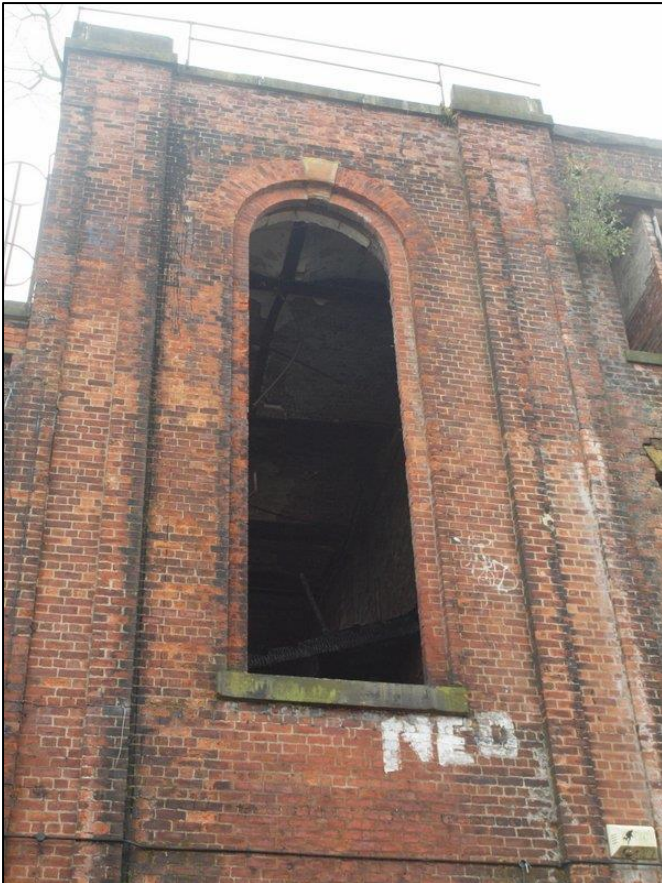
Plate13: Detail of first and second floor engine house window

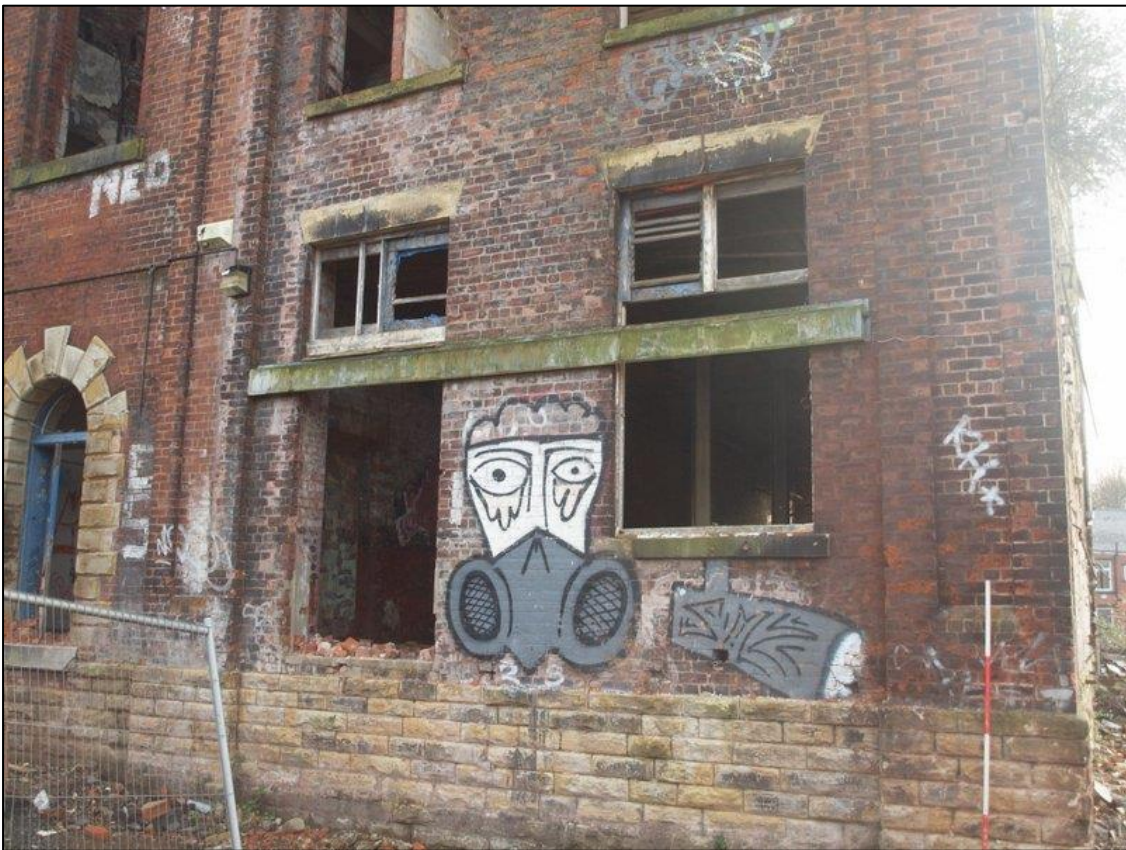
Plate 14: Detail of boiler house ground floor

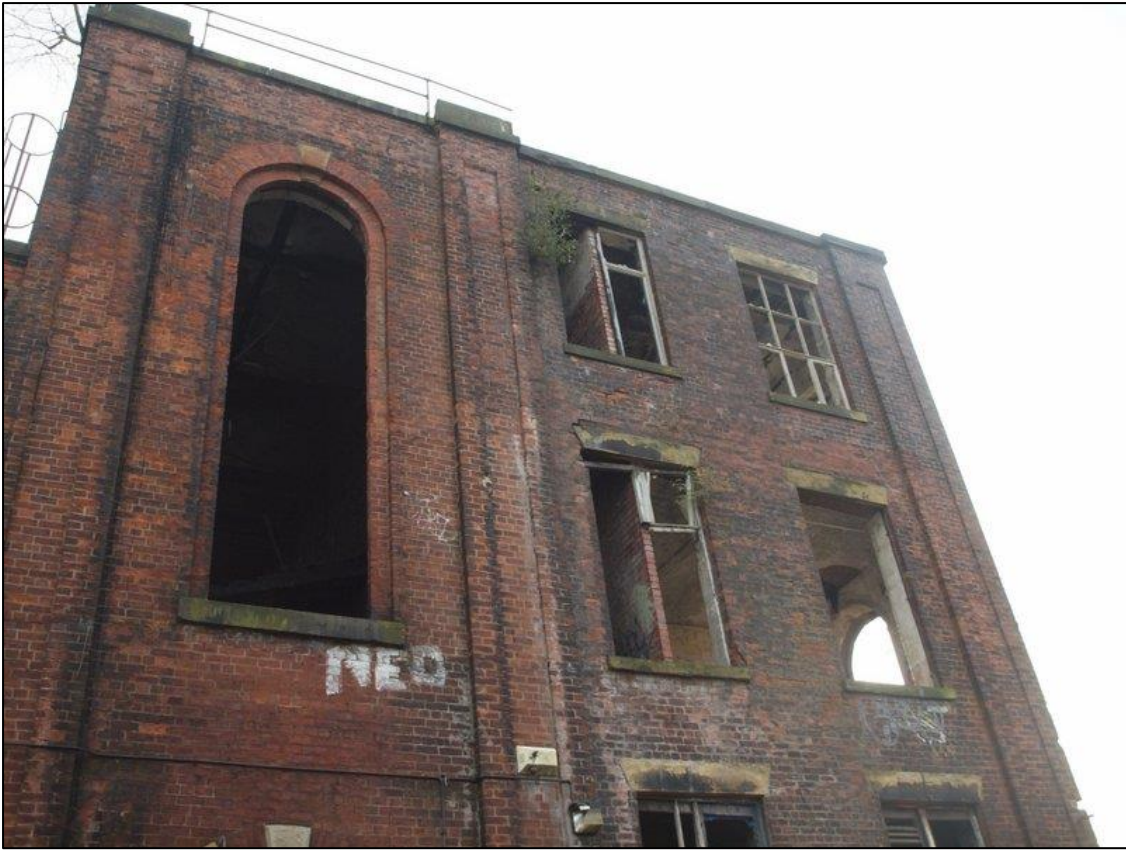
Plate 15: Boiler house upper floor windows shown in relation to the engine house window.

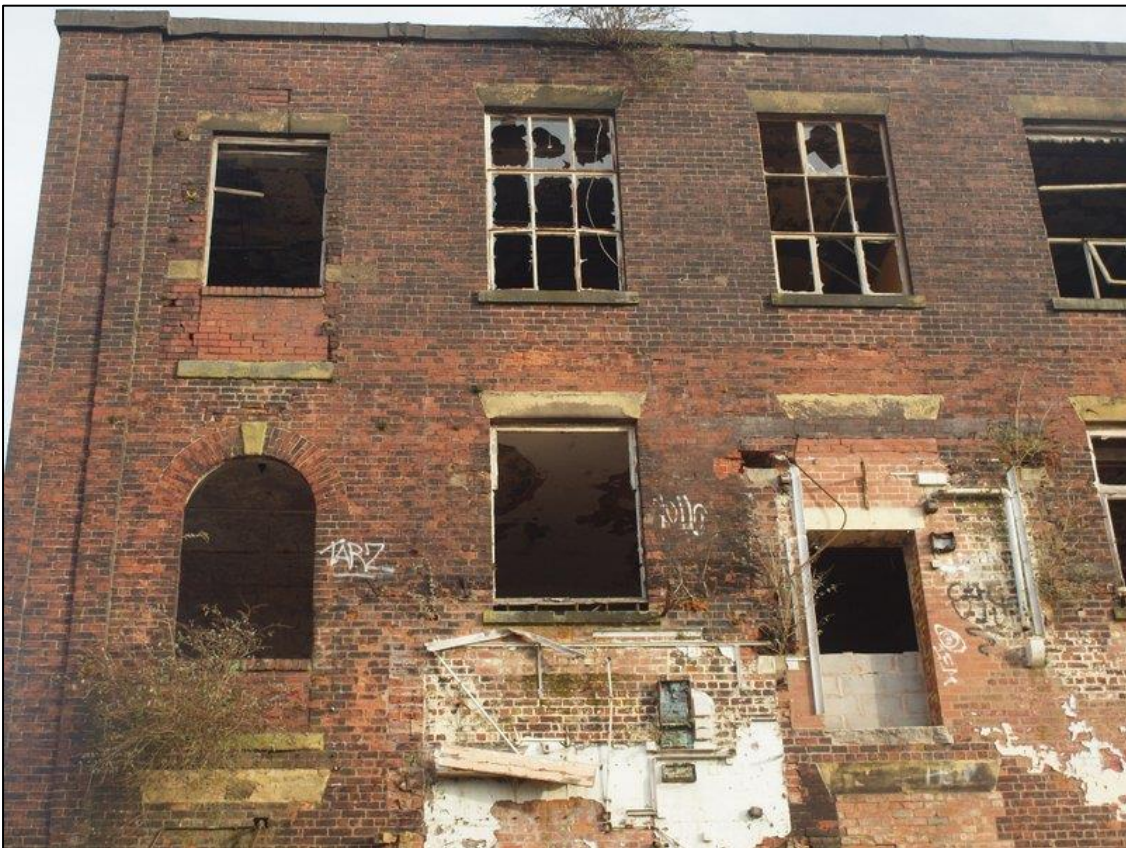
Plate 18: Southwest elevation bays 1 – 3 at first and second floor levels

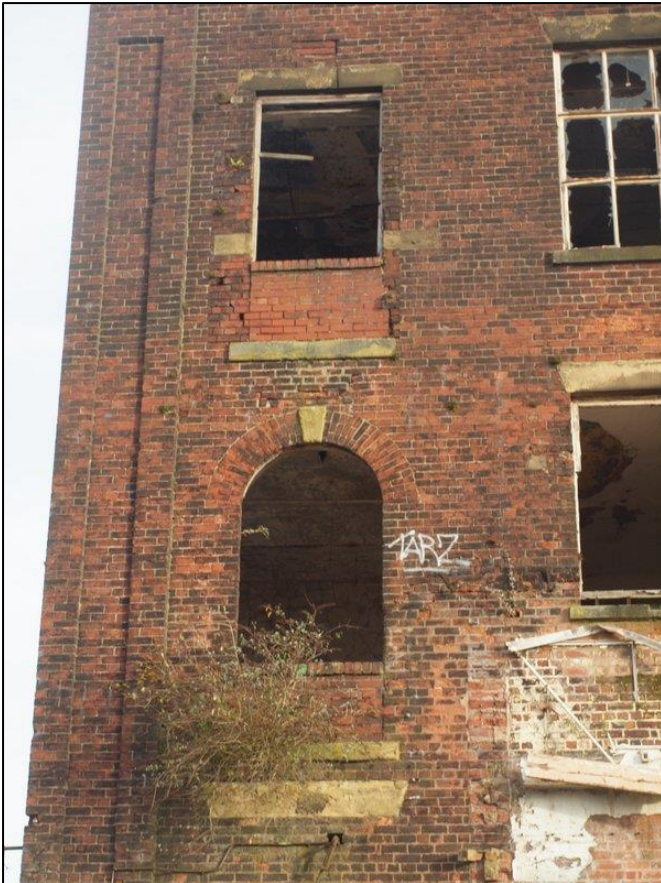
Plate 19: Detail of bay 1 showing doorway converted to window at first floor level, with rounded lintel and keystone, with doorway converted to window above

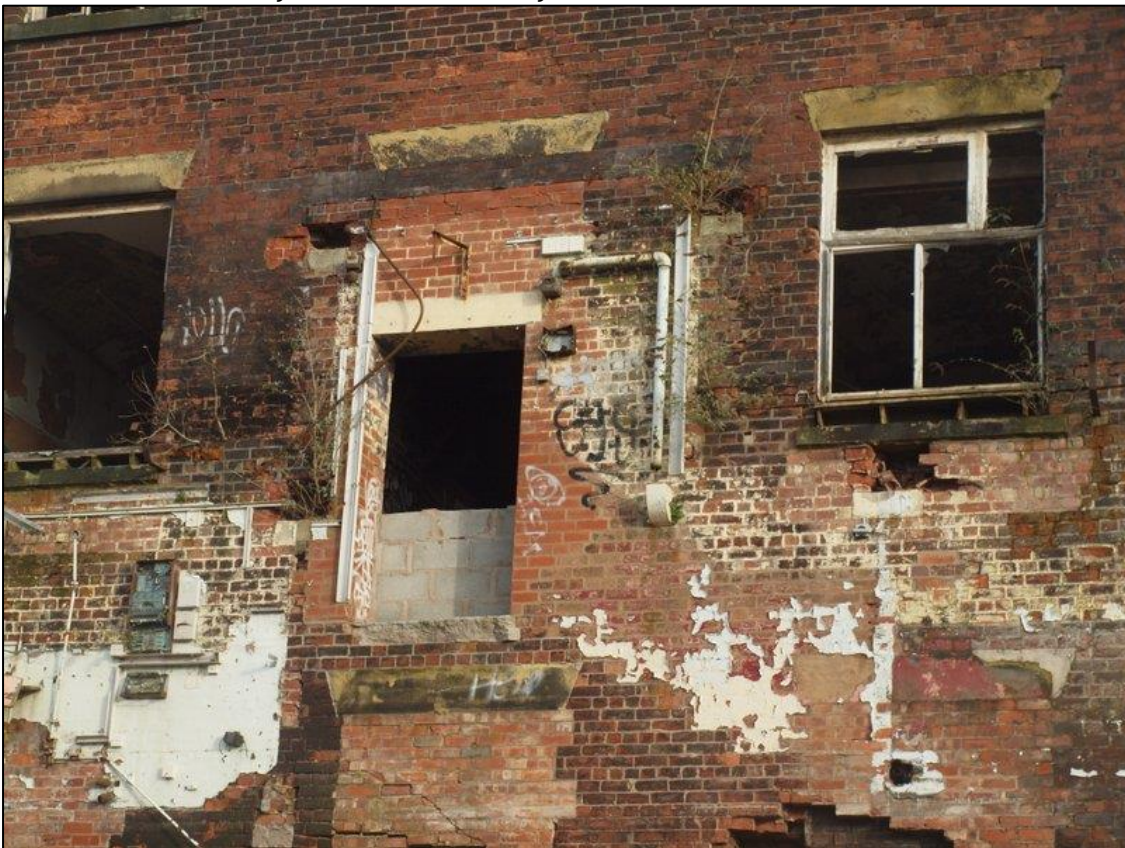
Plate 20: Detail of blocked window with doorway inserted in bay 3 at first floor

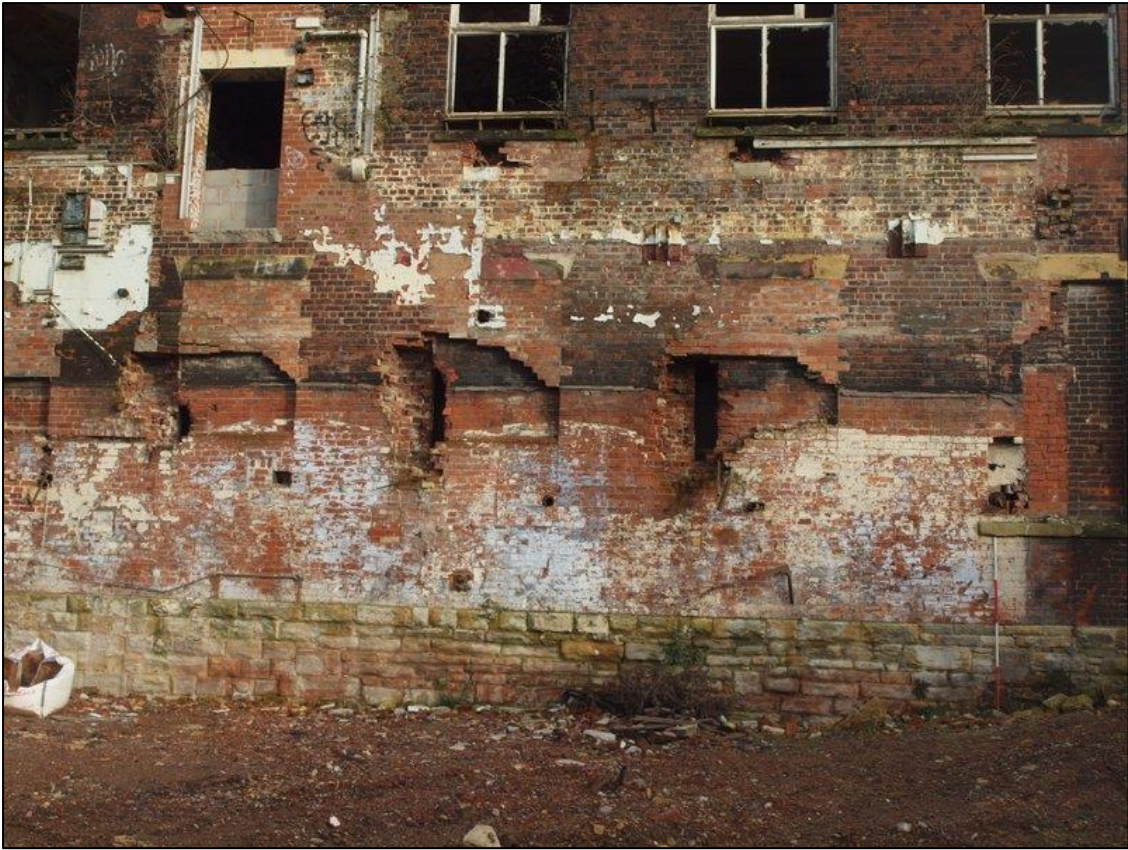
Plate 21: Southwest elevation showing ground floor bays 3 - 6

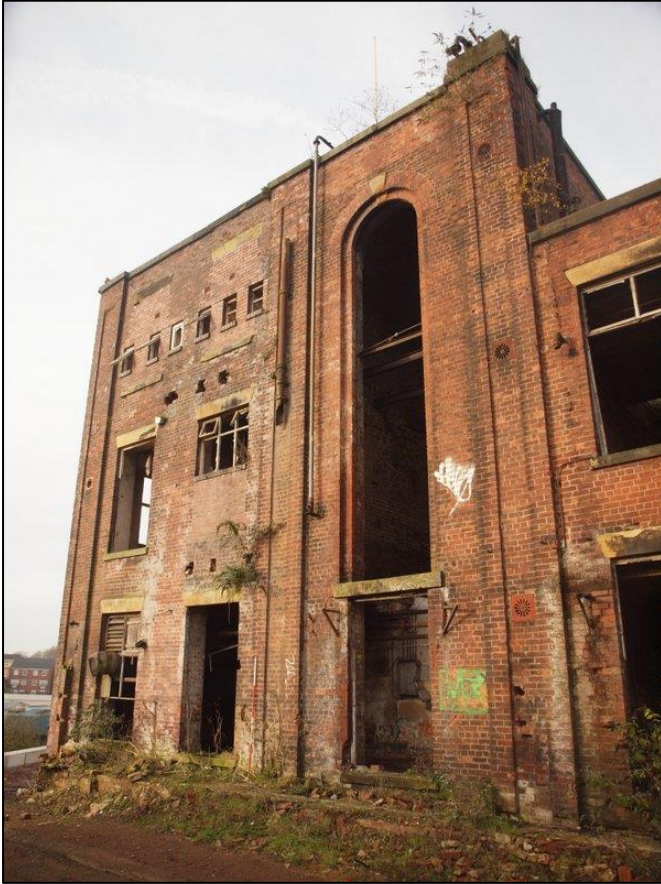
Plate 23: Southeast elevation showing boiler house (left) and engine house (right)

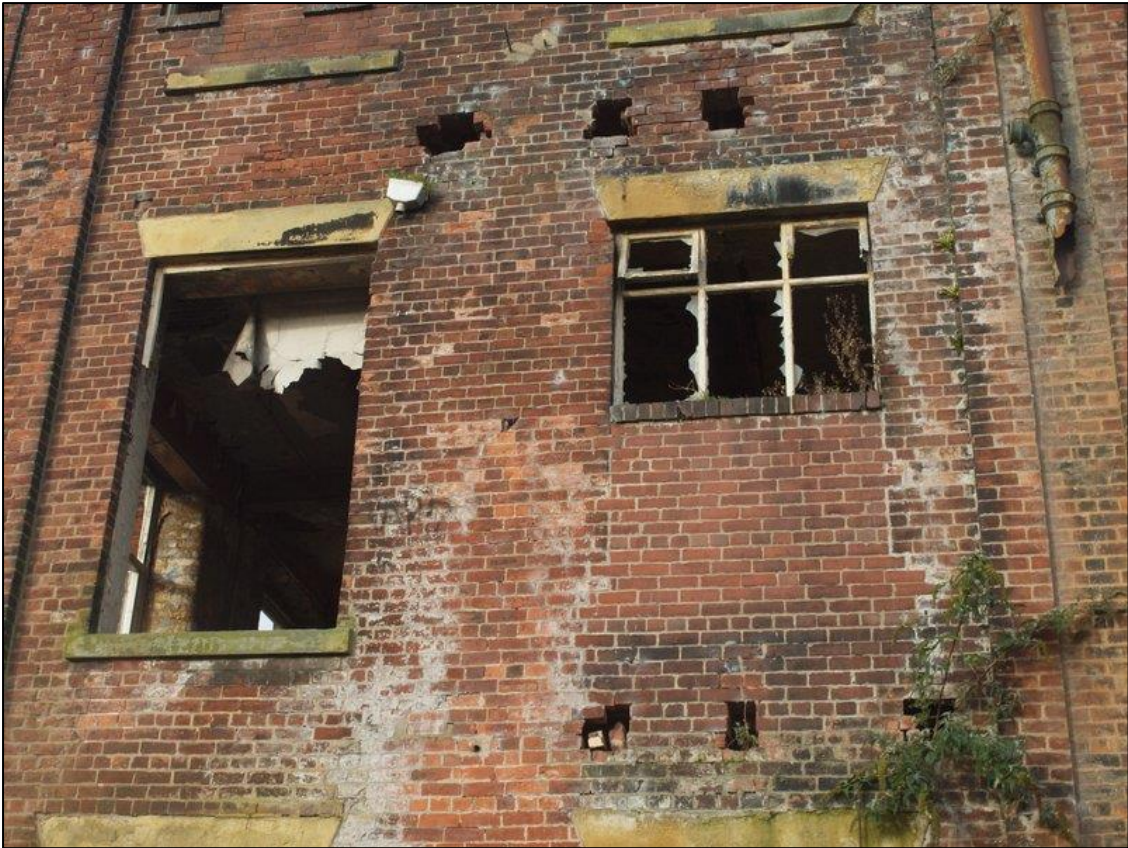
Plate 25: First floor windows of boiler house

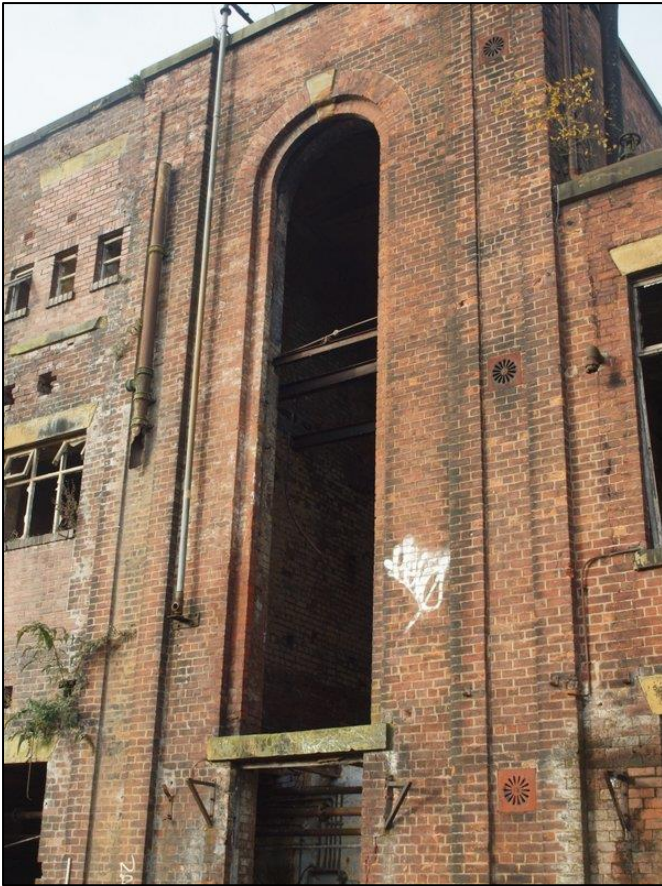
Plate 27: First floor of engine house showing two story window

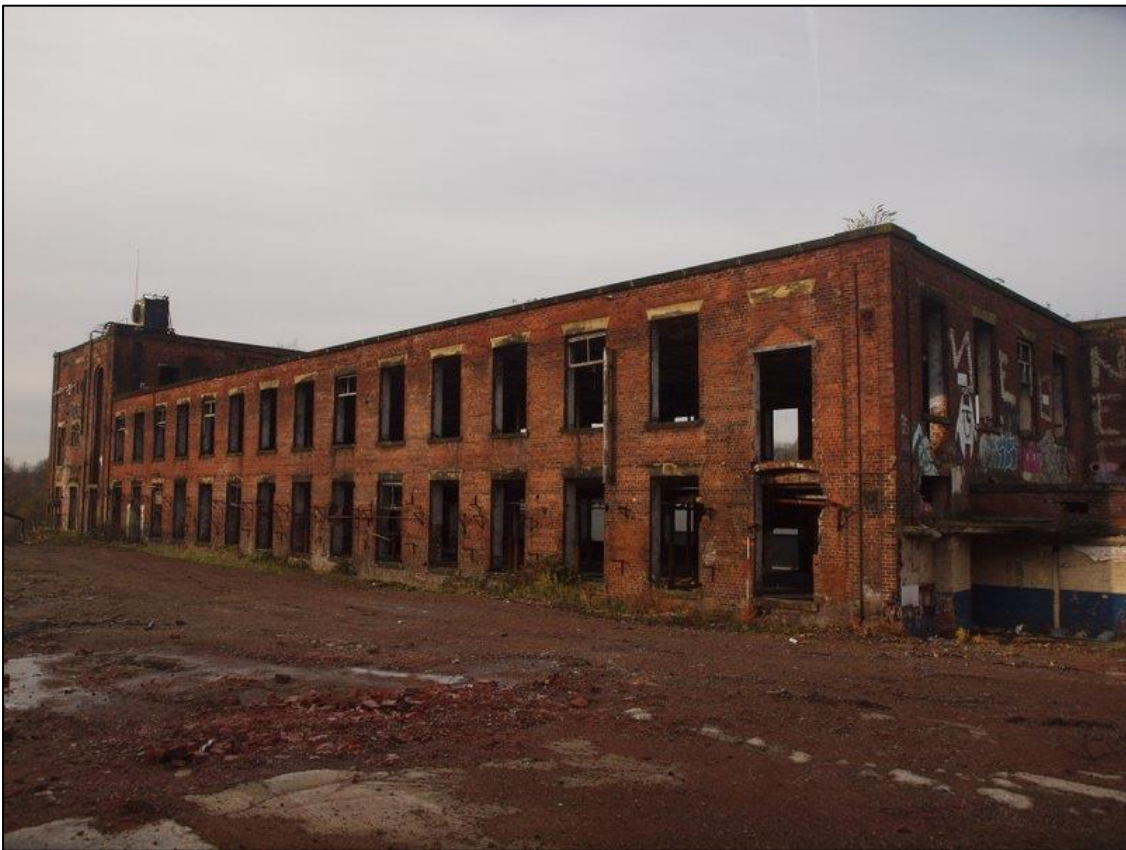
Plate 28: General shot of southwest elevation

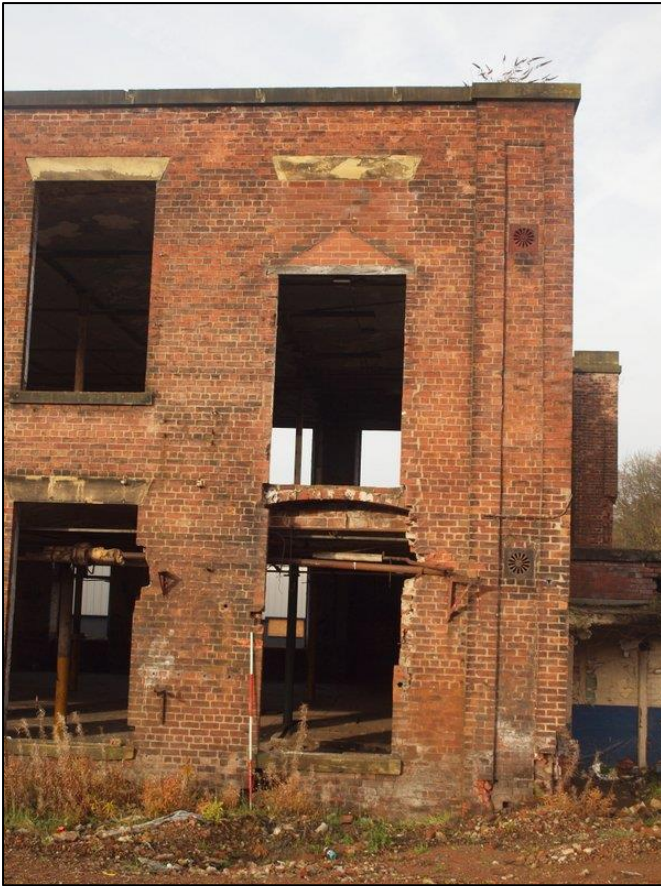
Plate 31: Southwest elevation bay 15 detail showing inserted first floor doorway
Northeast elevation

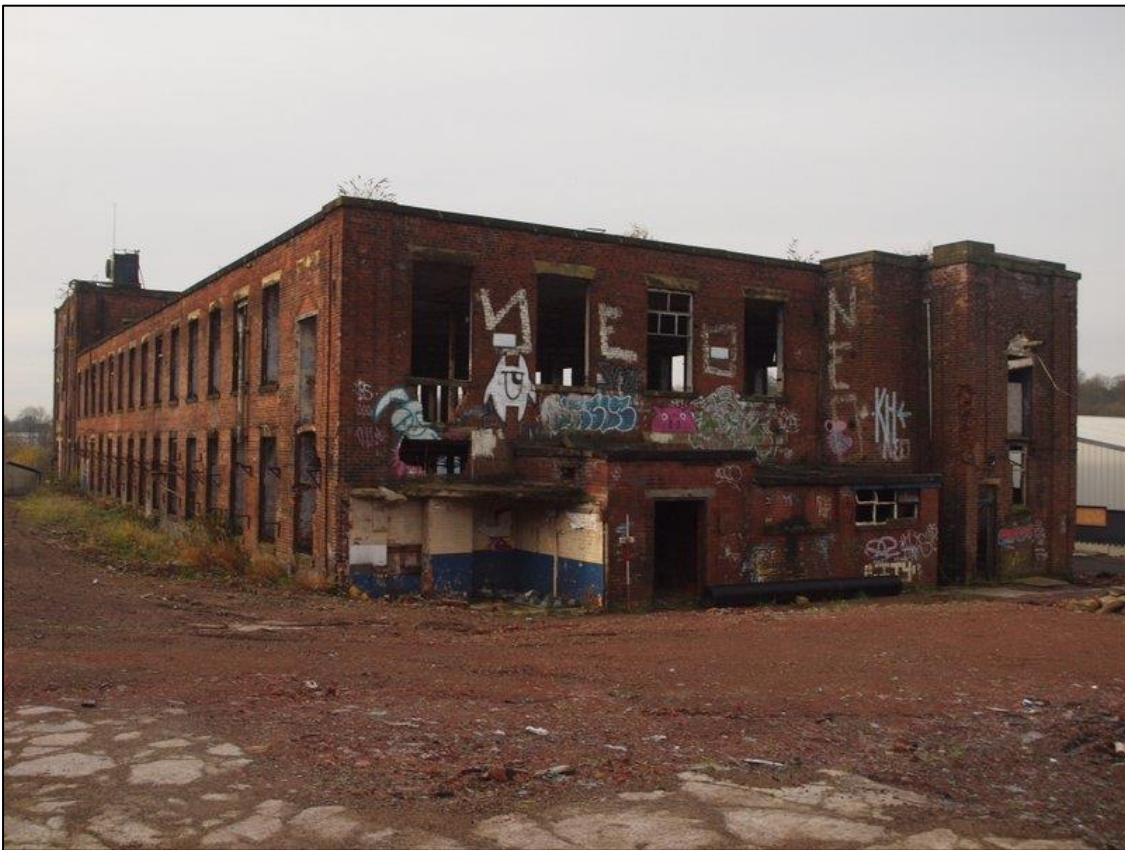
Plate 32: General shot of northeast elevation

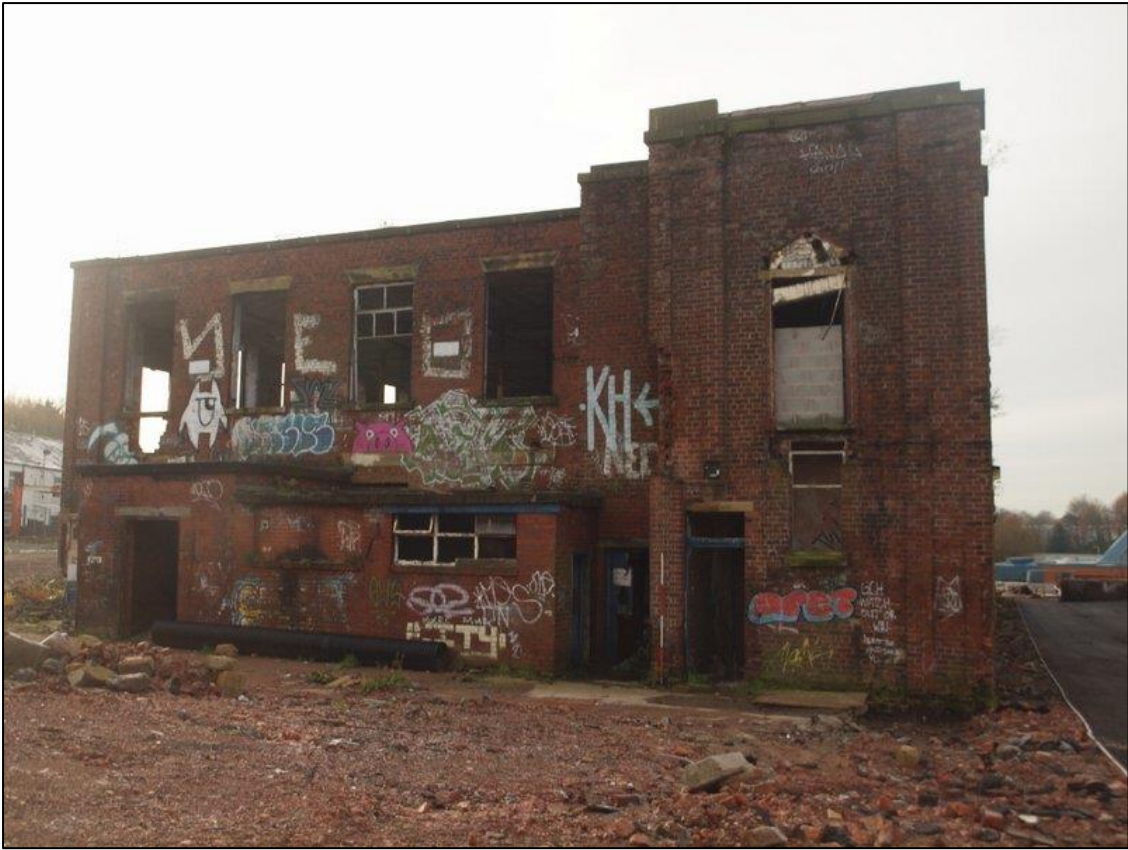
Plate 33: General shot of northeast elevation

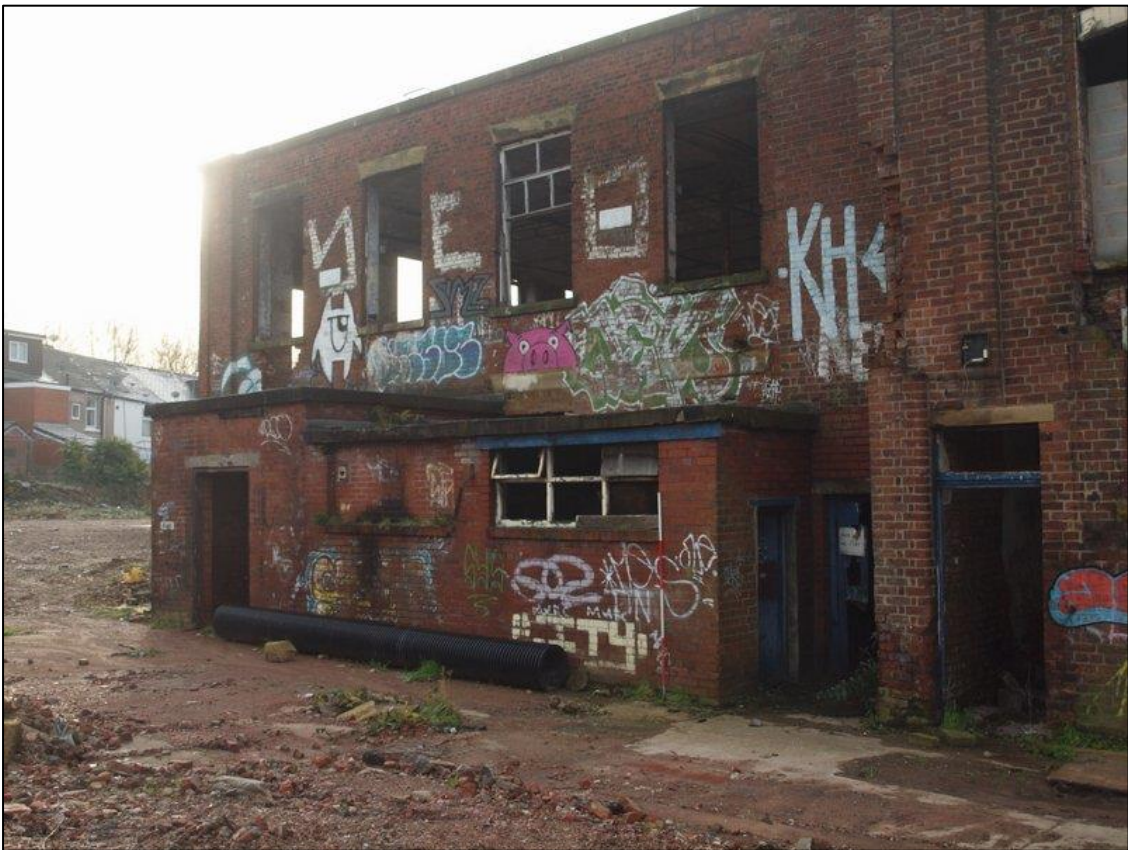
6.6 Northeast elevation (Plates 32 - 35). This elevation is 6 bays wide with bays 1-4 having tall portrait windows at first floor level, matching those on the northwest elevation. At ground floor level the face is butted by a later single story building with flat roof. In bay one this has collapsed. Bay 2 contains a large personnel doorway with sandstone lintel, whereas bays 3 and 4 each have landscape windows. However, that in bay three is blocked whereas bay 4 retains its 6 light timber casement frame. Bay 5 projects from the main face, matching the stair tower and is the lift shaft. A doorway has been inserted into this at ground floor level with the first floor level featureless. Bay 6 is the stair tower. This has a personnel doorway to the left side with a small portrait window in the centre, both at ground floor level. At first floor level is a blocked window.

Plate 34: Single story extension on northeast elevation

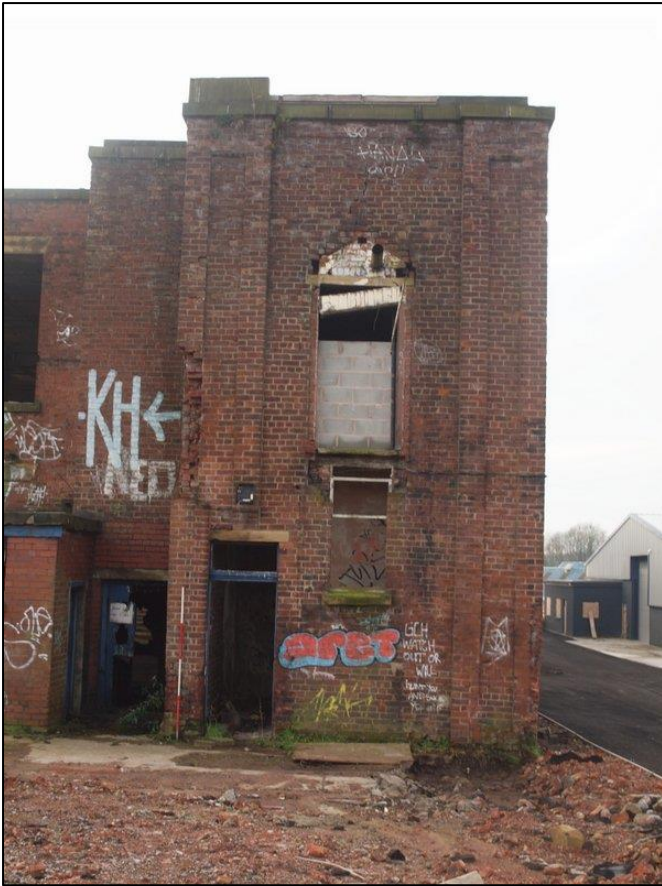
Plate 35: Detail of stair tower in bay 6
Interior – Ground floor

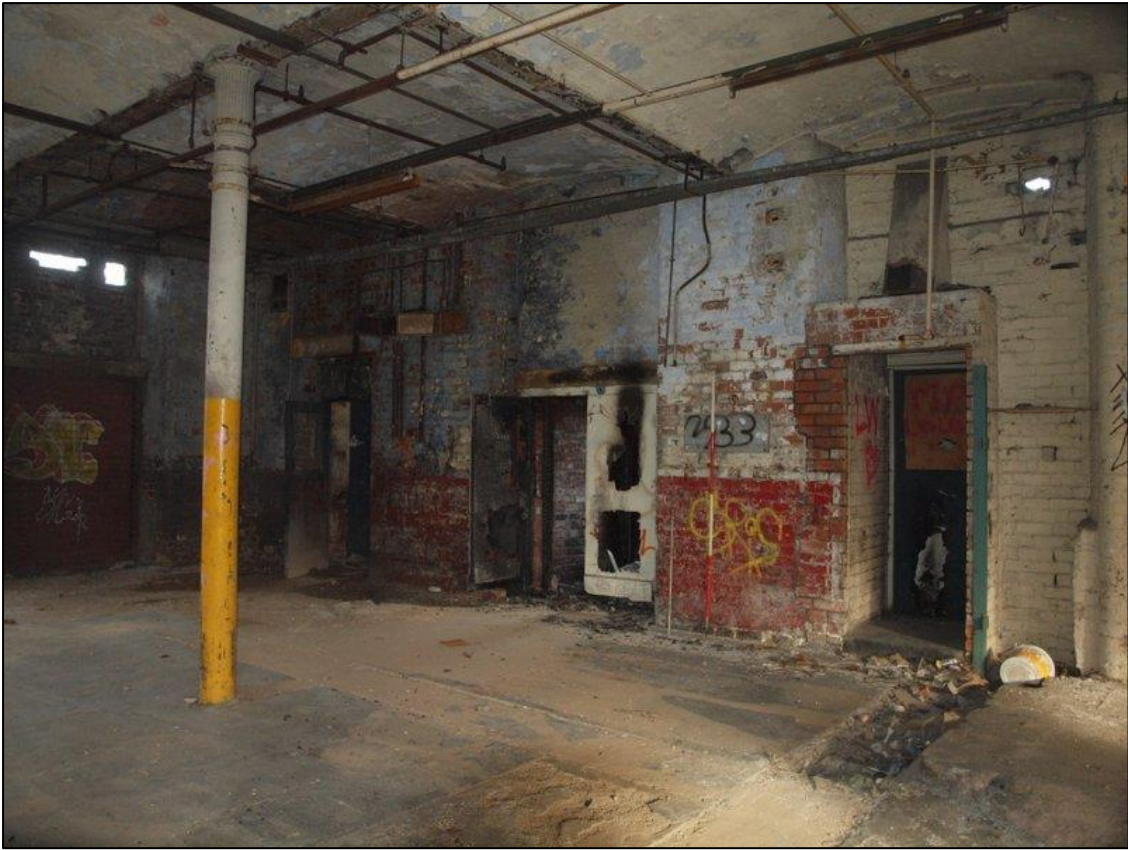
Plate 39: Detail of northeast wall showing openings to stair tower (left) and extension (right)

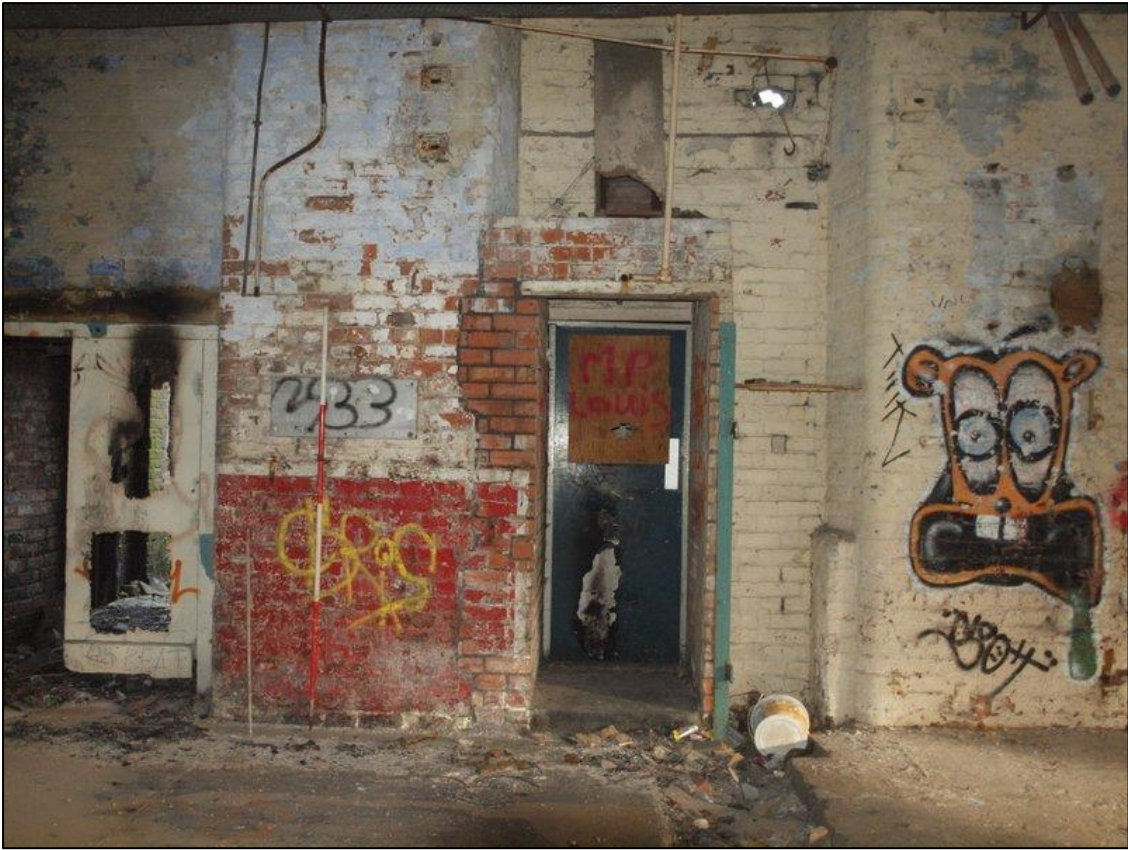
| 41 | PB197797 | Detail of inserted doorway shown in plate 39 | NE |

Plate 41: Detail of inserted doorway shown in plate 39

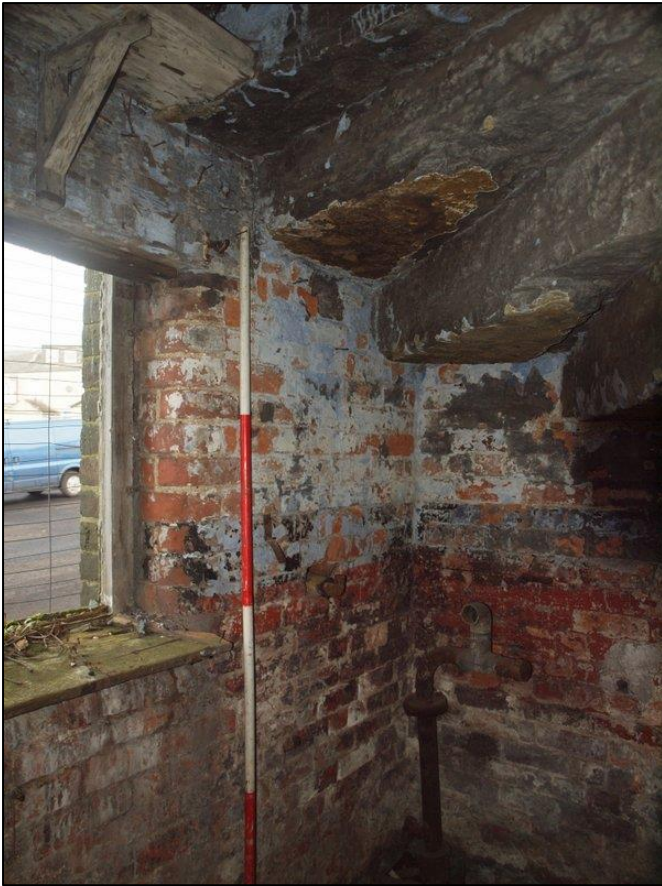
Plate 45: Room below staircase

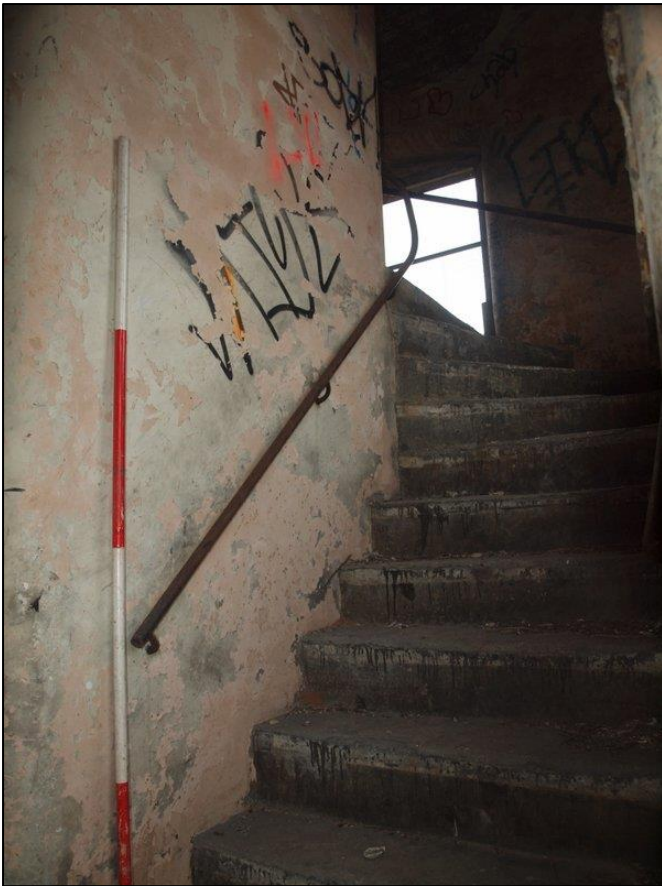
Plate 46: Detail of staircase
