Hallmark Developments (Northwest) Ltd

Dexine Rubber Works, Rochdale

Level 2 Archaeological Building Survey

22 November 2019

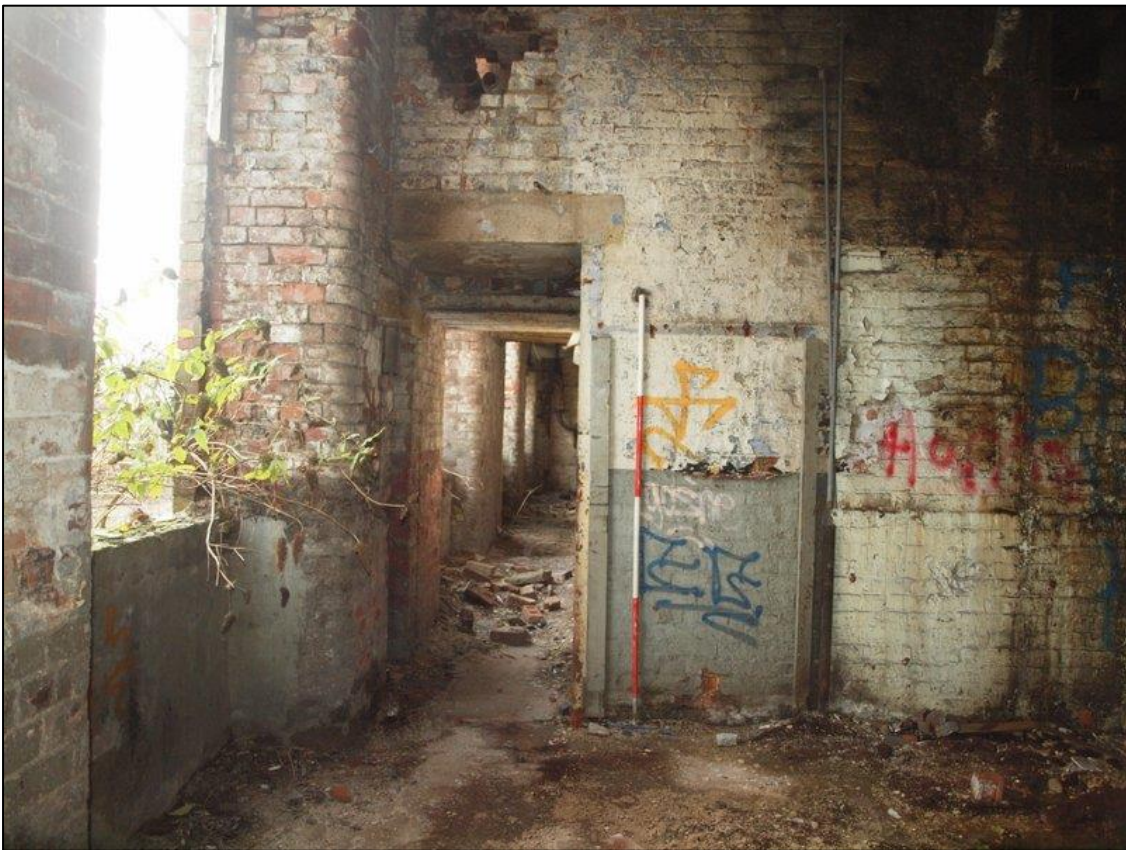
Plate 50: Doorway at eastern end leading directly to boiler house

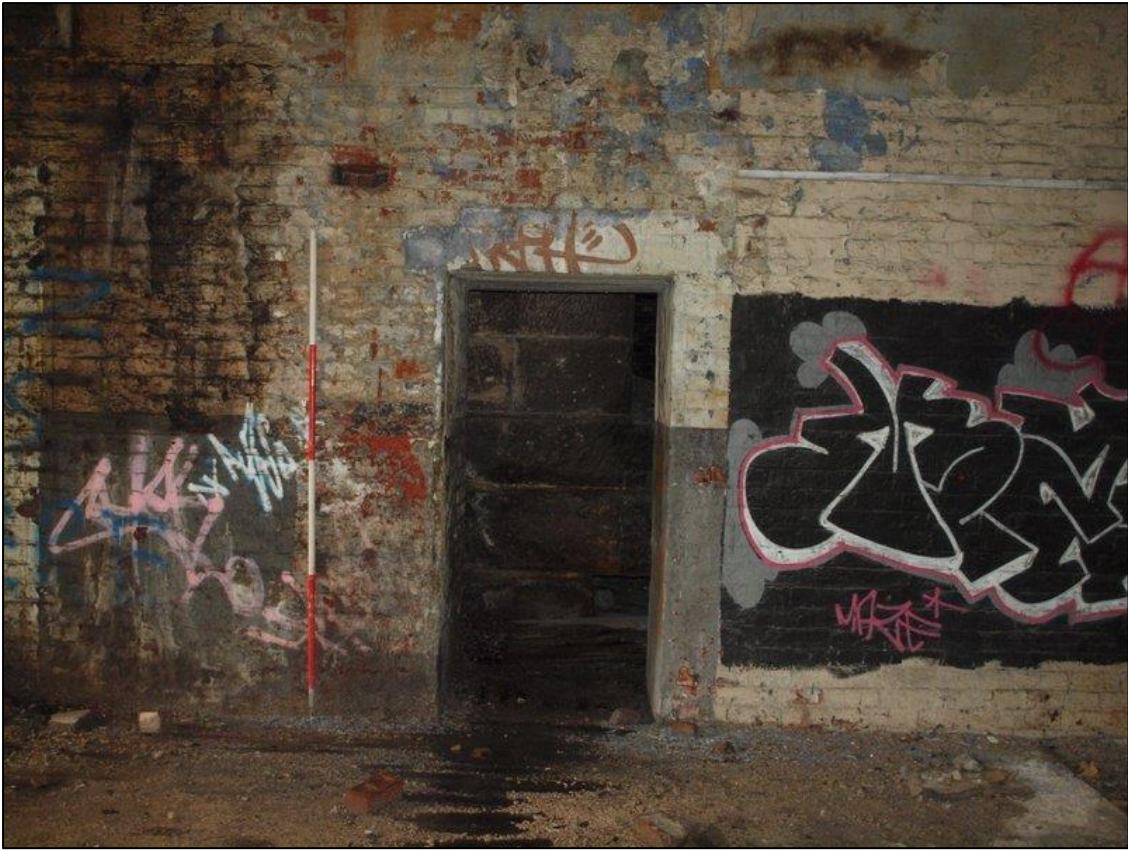
| 51 | PB197818 | Doorway shown in plate 48 opening onto the stone face of the engine base | SW |

Plate 51: Doorway shown in plate 48 opening onto the stone face of the engine base

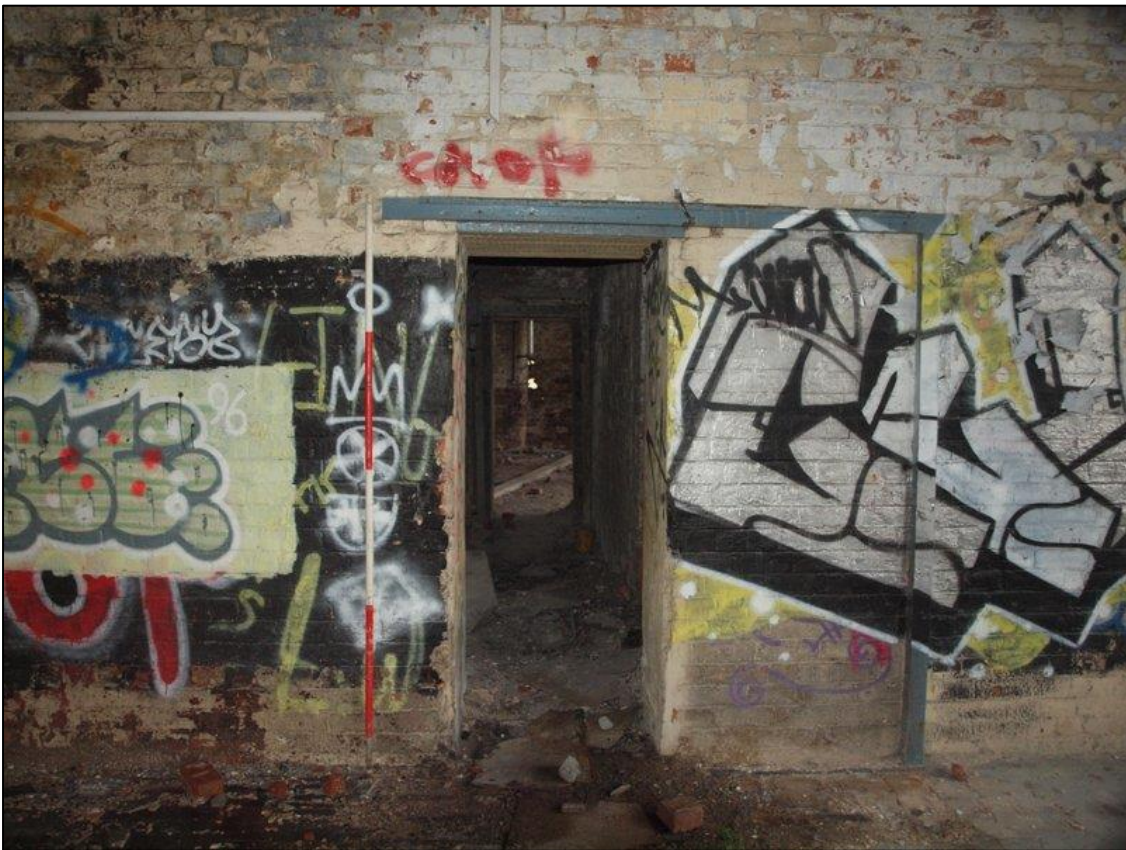
Plate 54: Detail of doorway into passage through engine room

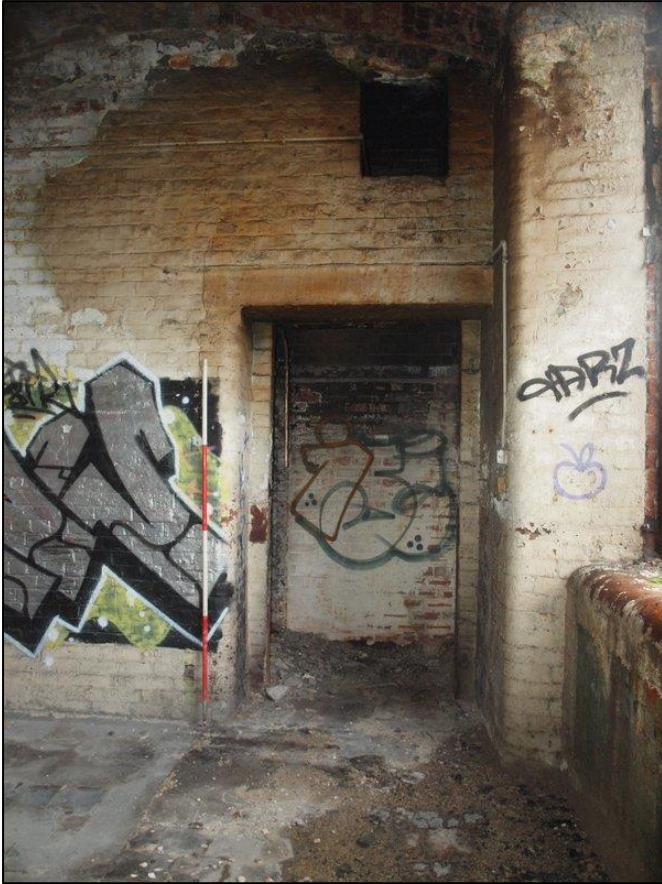
Plate 55: Detail of blocked doorway to boiler house

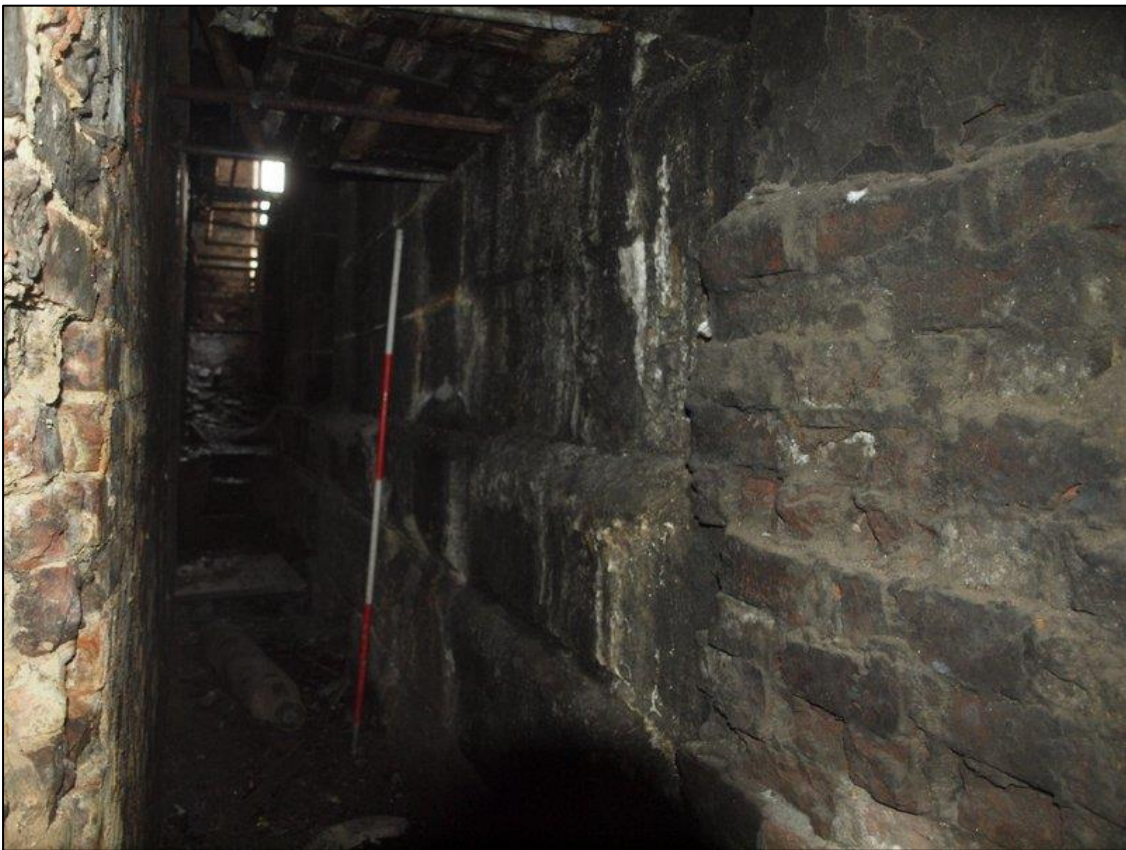
Plate 56: View down passageway between party wall (left) and stone engine base (right)

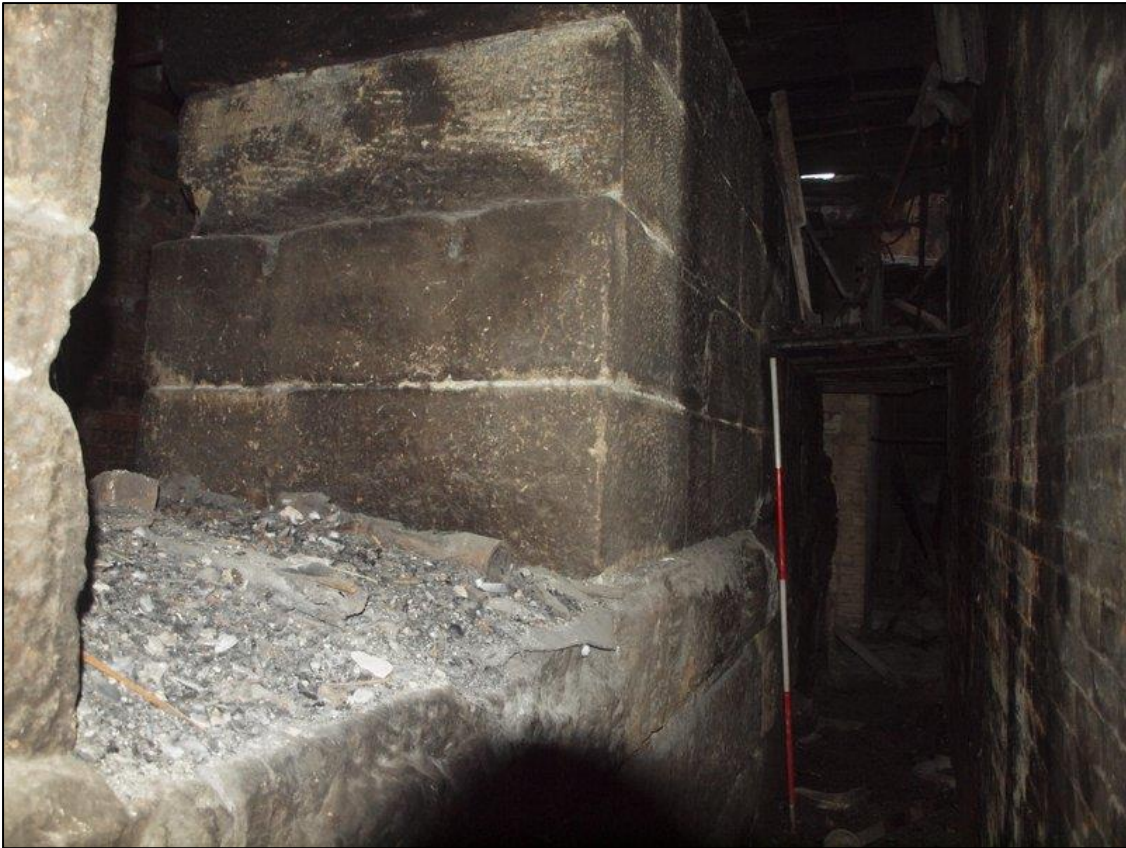
Plate 57: As above viewed from the other direction, showing inset for high pressure cylinder

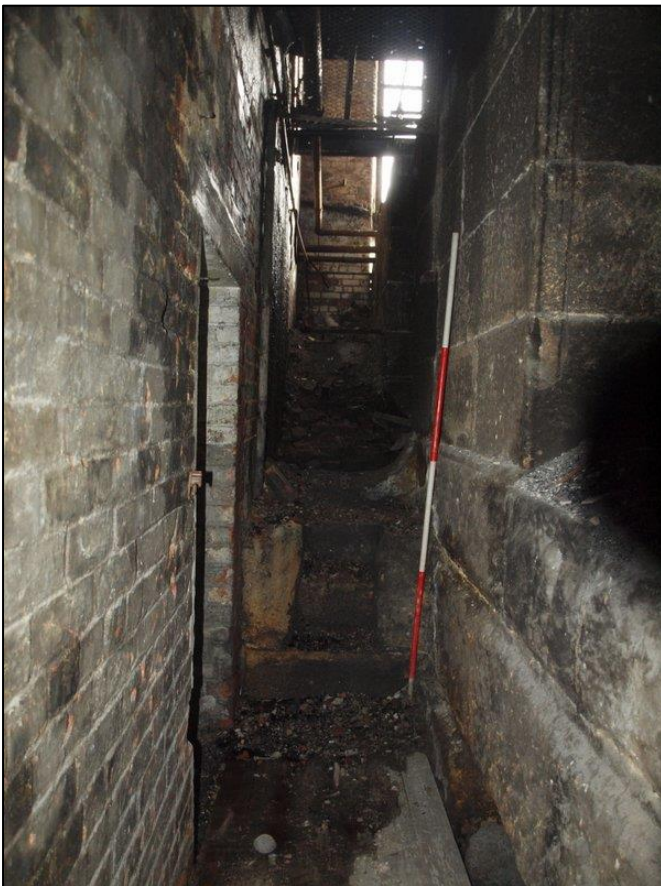
Plate 58: West end of passageway above, showing doorway to mill (left) and stone steps up

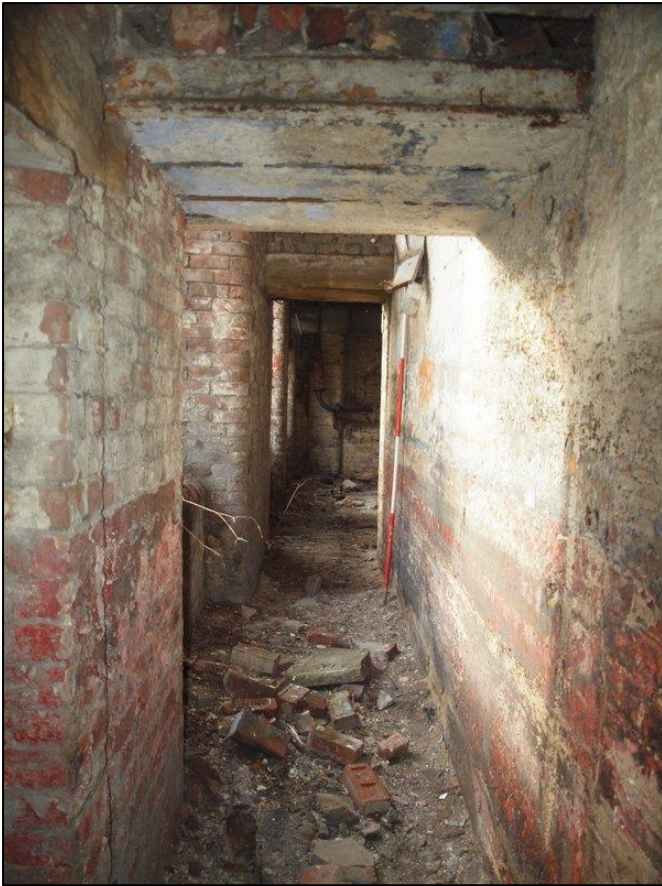
Plate 59: Passage at east end leading into boiler house

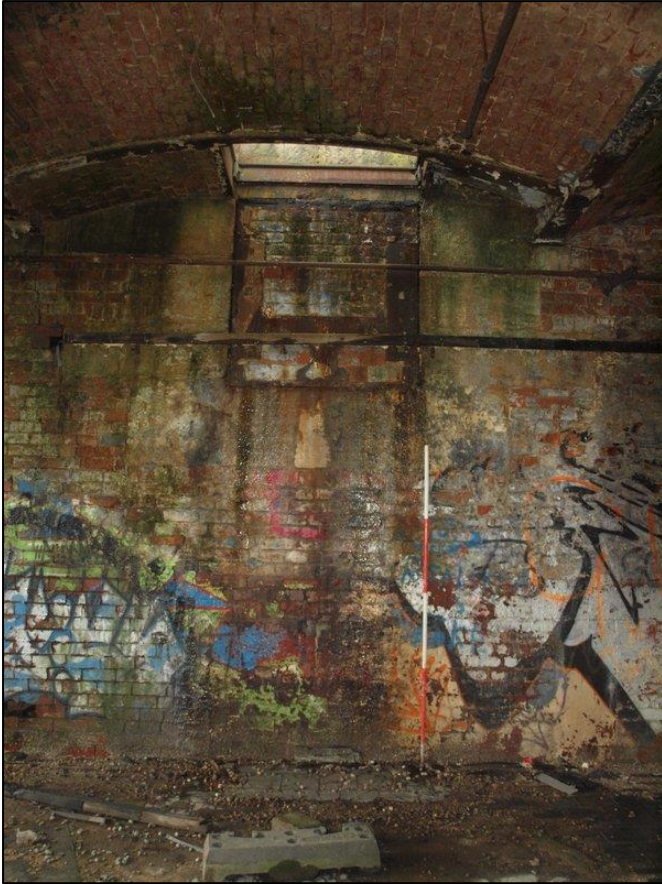
- 6.8 (Plates 66 - 90). At first floor level the main body of the mill is similar to the ground floor, comprising a single open space. A hatch in the floor is located at the southwestern end (plate), above the entrance to the loading bay in bay 13. To the northeast end is the stair tower and the lift shaft. Blocked transmission windows are again found in the wall of the engine house. A hole in the ceiling is evidence of a now defunct vertical line shaft. A

Plate 73: Detail of transmission window with hole in ceiling above

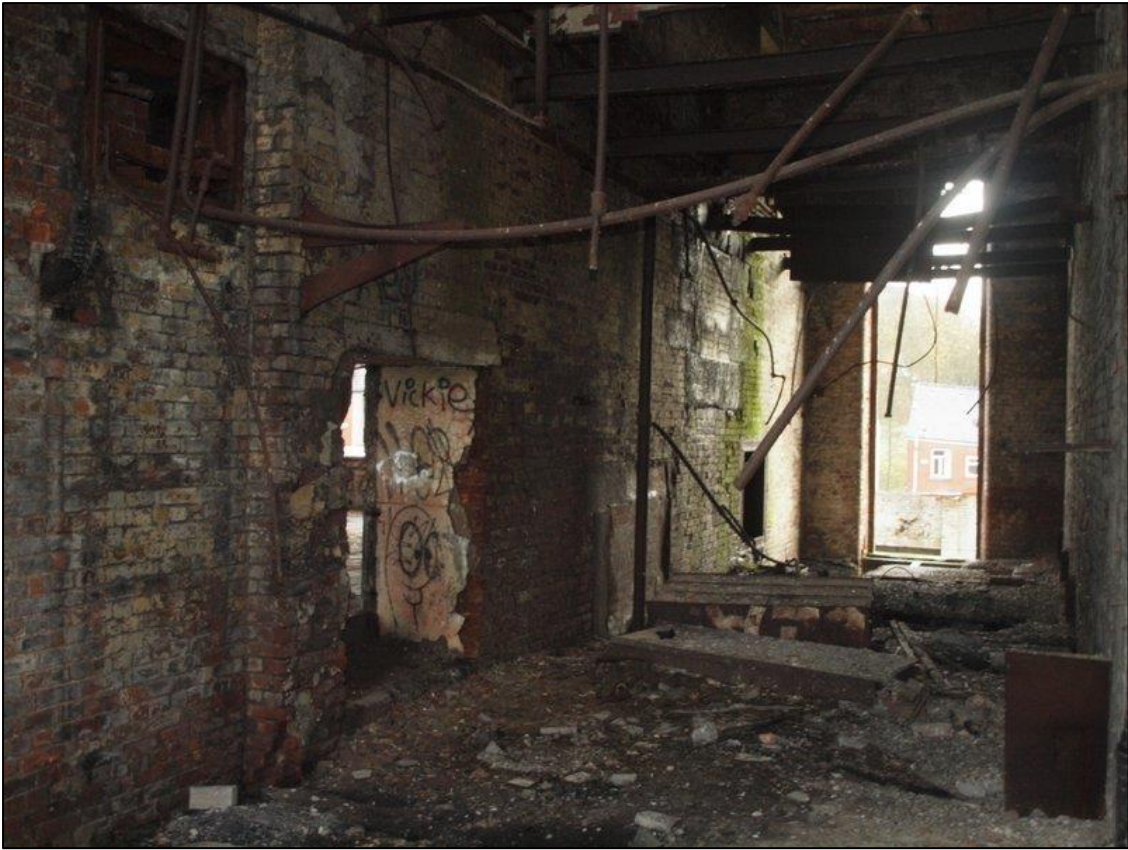
Plate 81: General shot of engine house

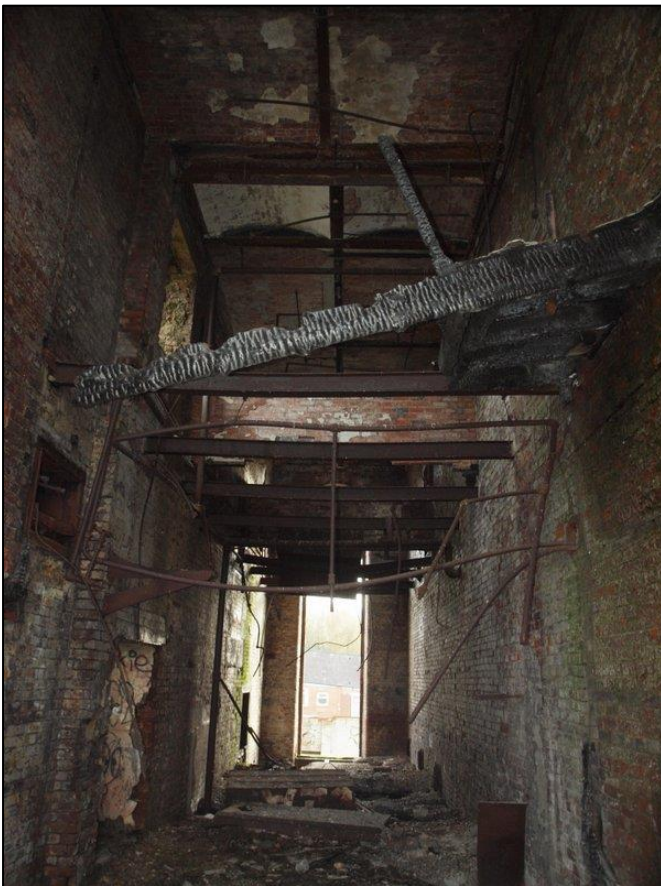
single story extension was unsafe in several rooms due to vandalism; the engine house was only accessible at the western side at first floor level, the second floor having collapsed; the boiler house had no access to second floor level.

Plate 82: Upper floors of engine house showing collapsed floor

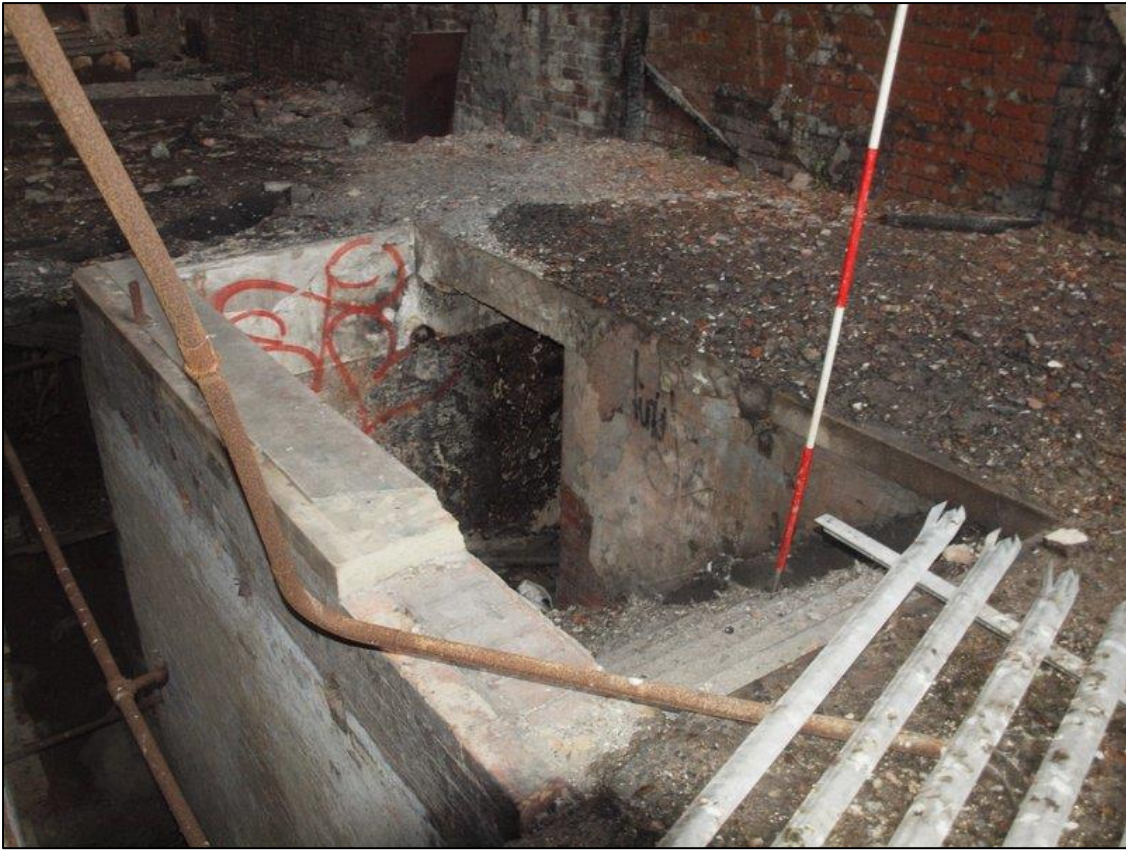
Plate 83: Concrete staircase to ground floor

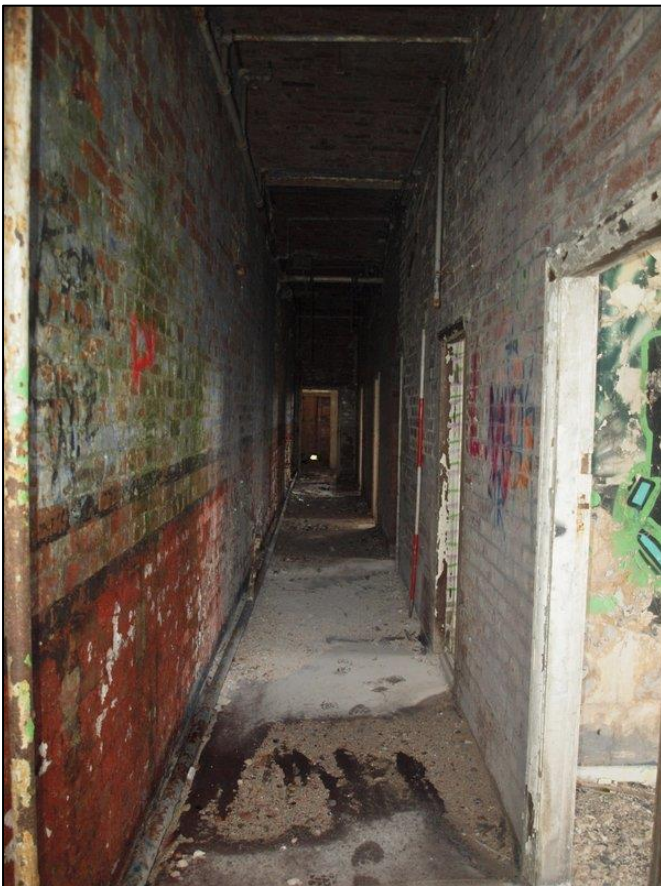
Plate 84: Inserted corridor along first floor of boiler house
