North End Farm

Wase Homes Limited

Archaeological Building Survey

28 September 2022

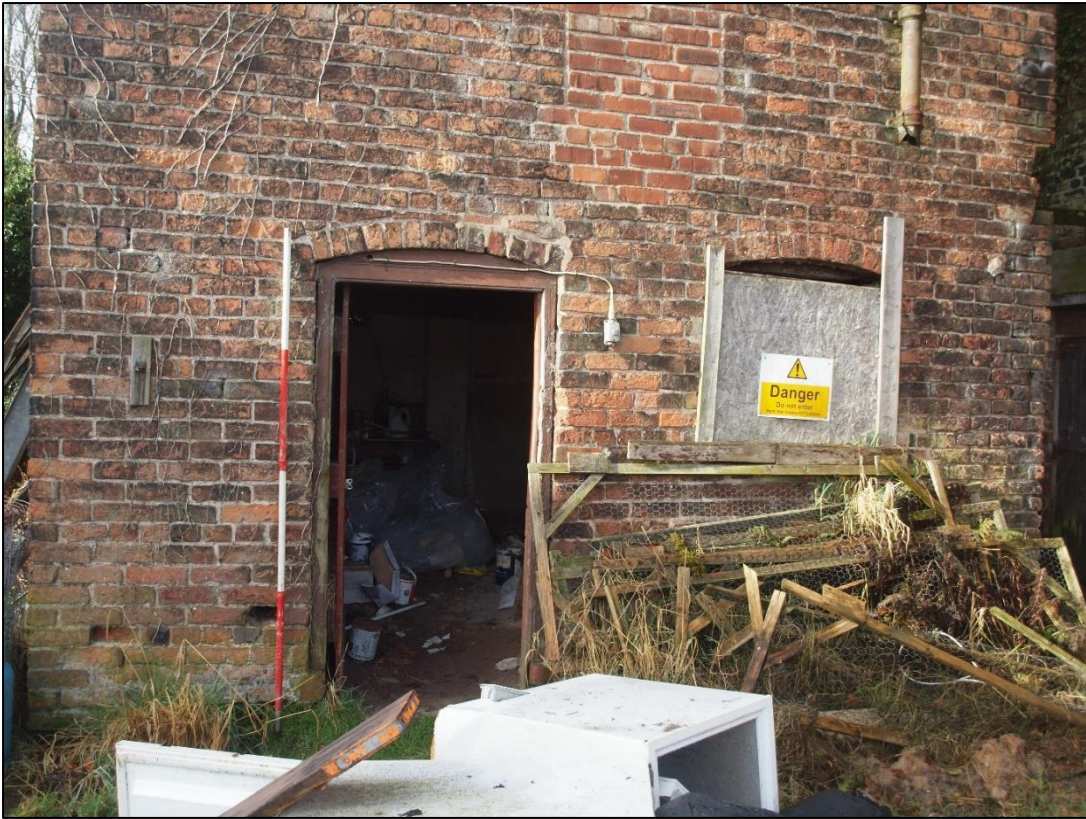
- 6.10 Northeast elevation (plates 36 - 39). This forms the main frontage of the building. At ground floor level is a personnel doorway with depressed arch lintel of brick to the south side. North of this is a portrait window, with matching lintel, although this has been blocked with ply. Above, at first floor level, a blocked window lies in the centre of the face. Finally, above the doorway, close to the level of the eaves a small tear had been rebuilt between three small vent holes.

Plate 37: Detail of ground floor of northeast elevation

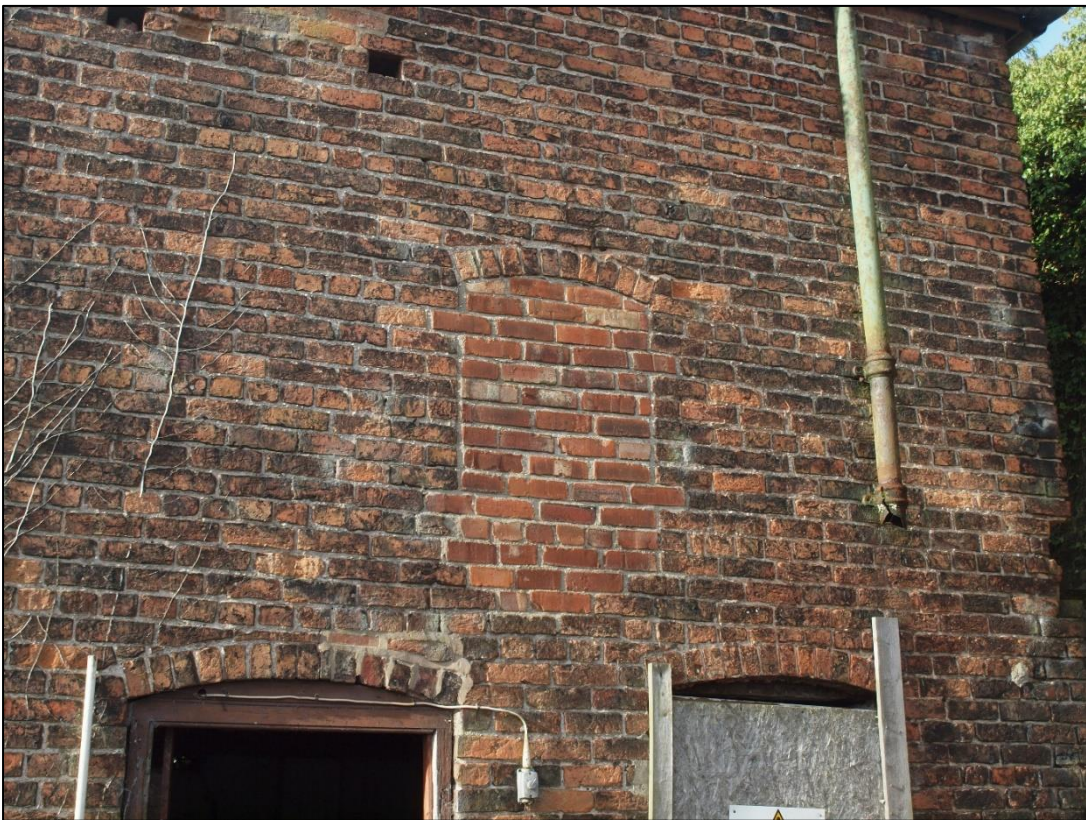
Plate 38: Blocked window at first floor level

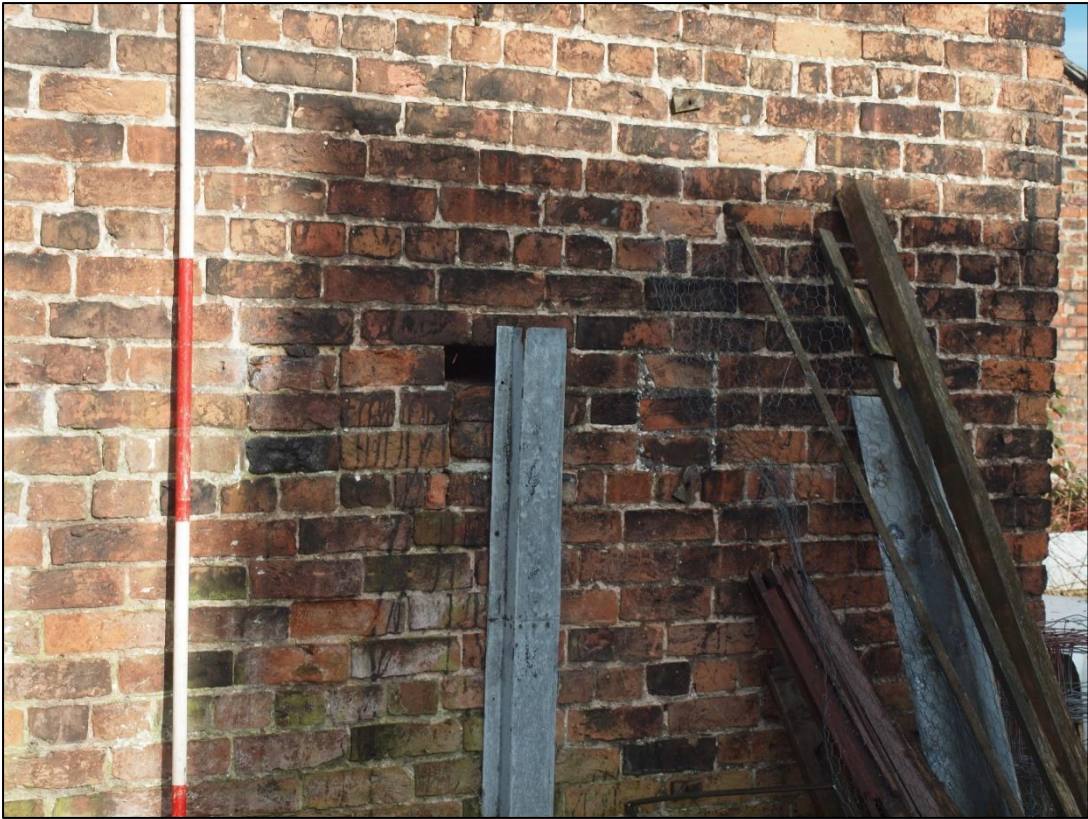
- 6.11 Southeast elevation (plates 36, 40 - 42). This elevation is featureless with the exception of six rectangular blocked ventilation holes at ground floor level. The lead flashing of a removed lean-to was present above them.

Plate 41: Blocked ventilation holes

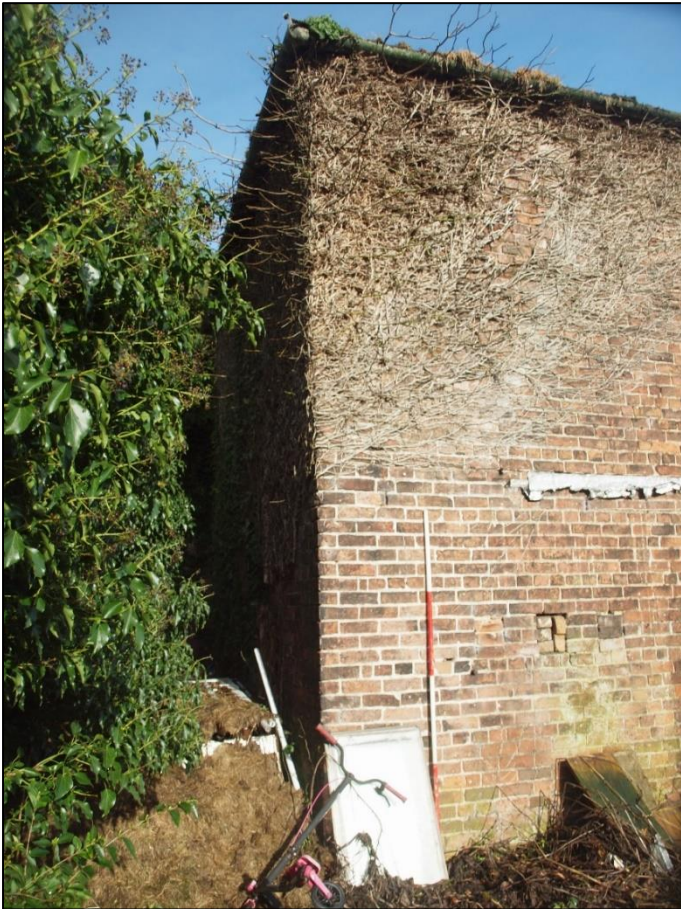
- 6.12 Southwest elevation (plate 42). This elevation faced onto the site boundary and was featureless.
- 6.13 Northwest elevation (plates 43 - 44). This elevation faced the barn and was also featureless with the exception of a timber beam protruding and connecting to the barn.

Plate 42: Southeast and southwest elevations

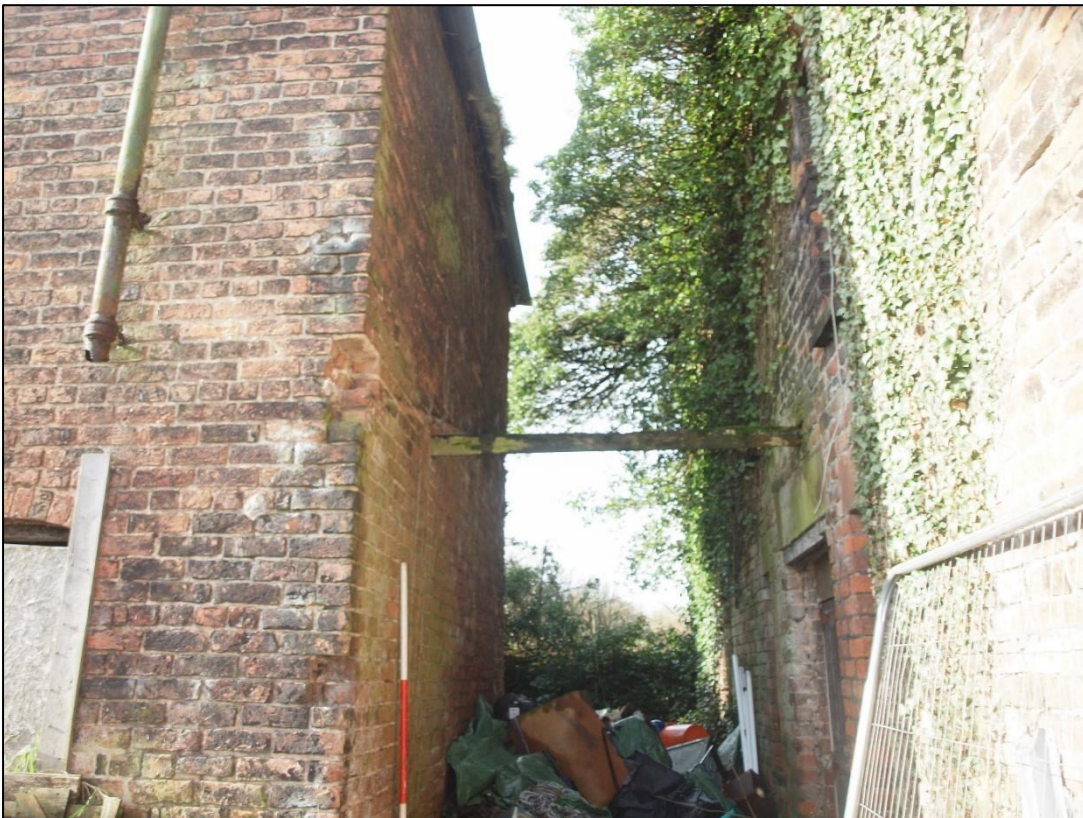
Plate 44: Relationship between building 1 and 2

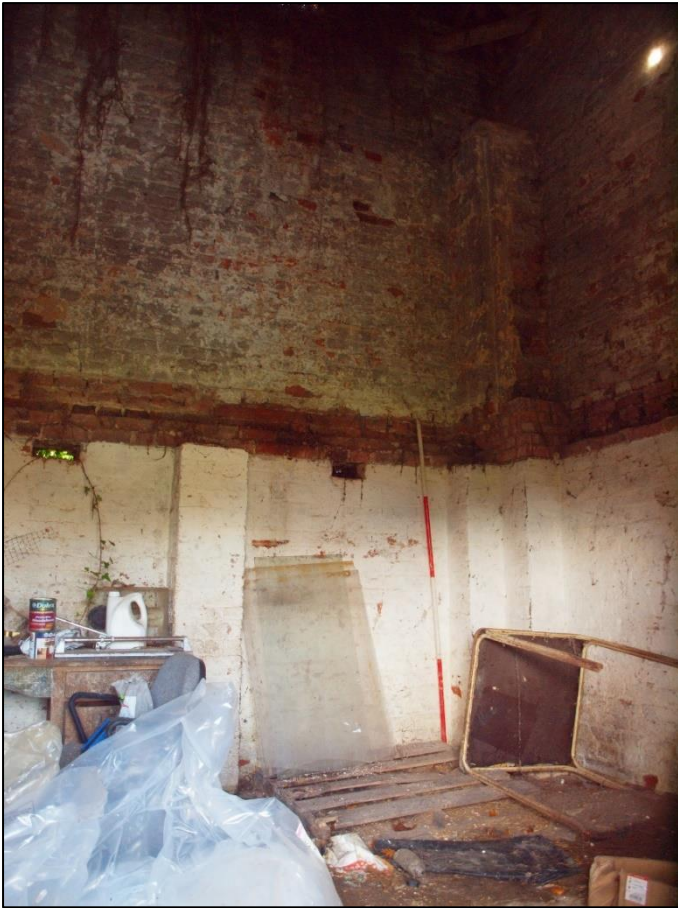
- 6.14 (Plates 45 - 49). The interior comprised a single open space with the ceiling open to the machine cut timber roof beams above. Brick pillars were located to each corner and the centre of each wall, with a gap in the whitewash showing the location of a removed first floor. At ground floor level, in the southeast wall, a timber cover had been put in place over an electric box. Above this a crosshatch pattern was visible in the whitewash, showing removed features. These were also present to the northeast wall, up to the blocked window. The brick pillars to the corners continued to rise at first floor level, each with a series of horizontal grooves with them, evenly spaced. The floor was concrete throughout.

Plate 45: Interior showing brick pillar to ground floor

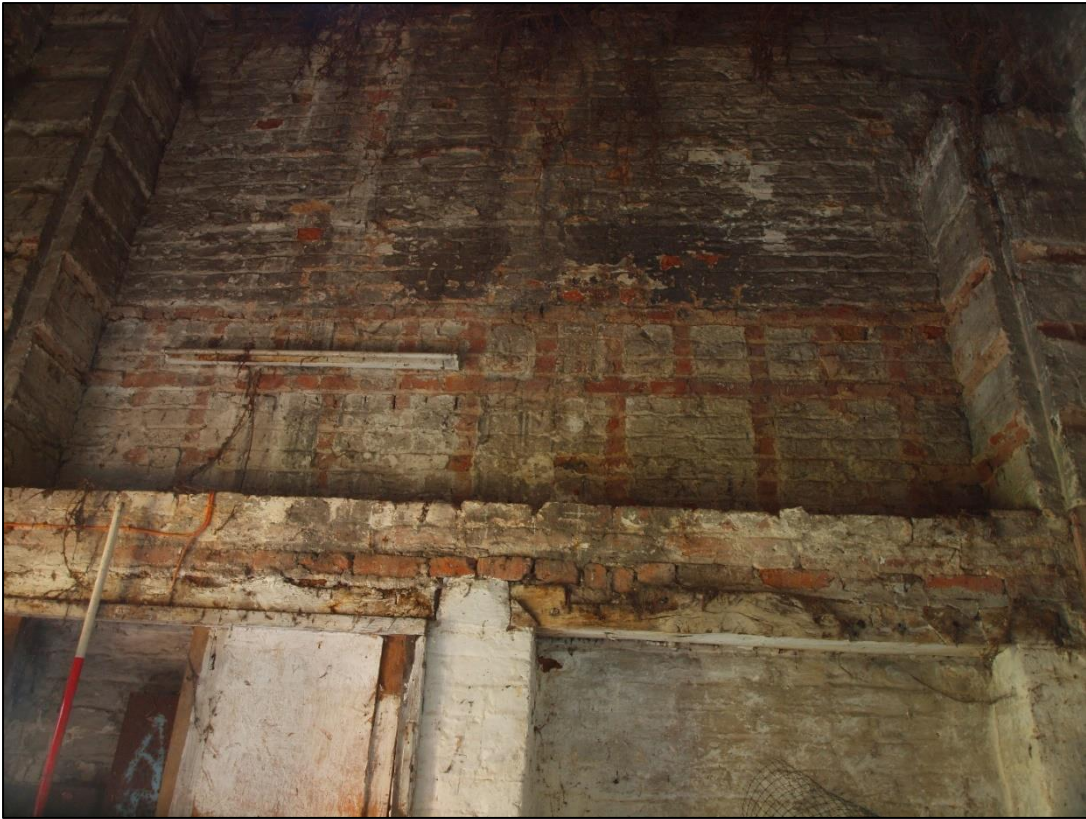
Plate 47: Whitewash showing pattern of removed boxes

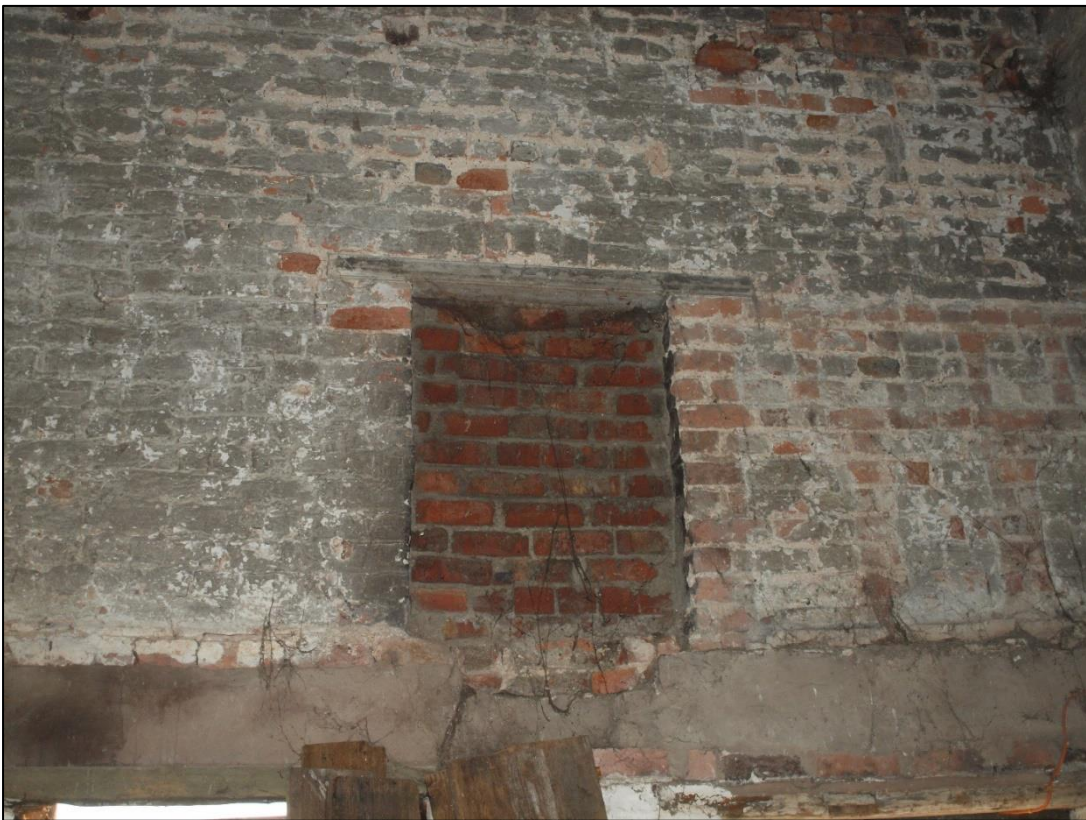
Plate 48: Blocked first floor opening

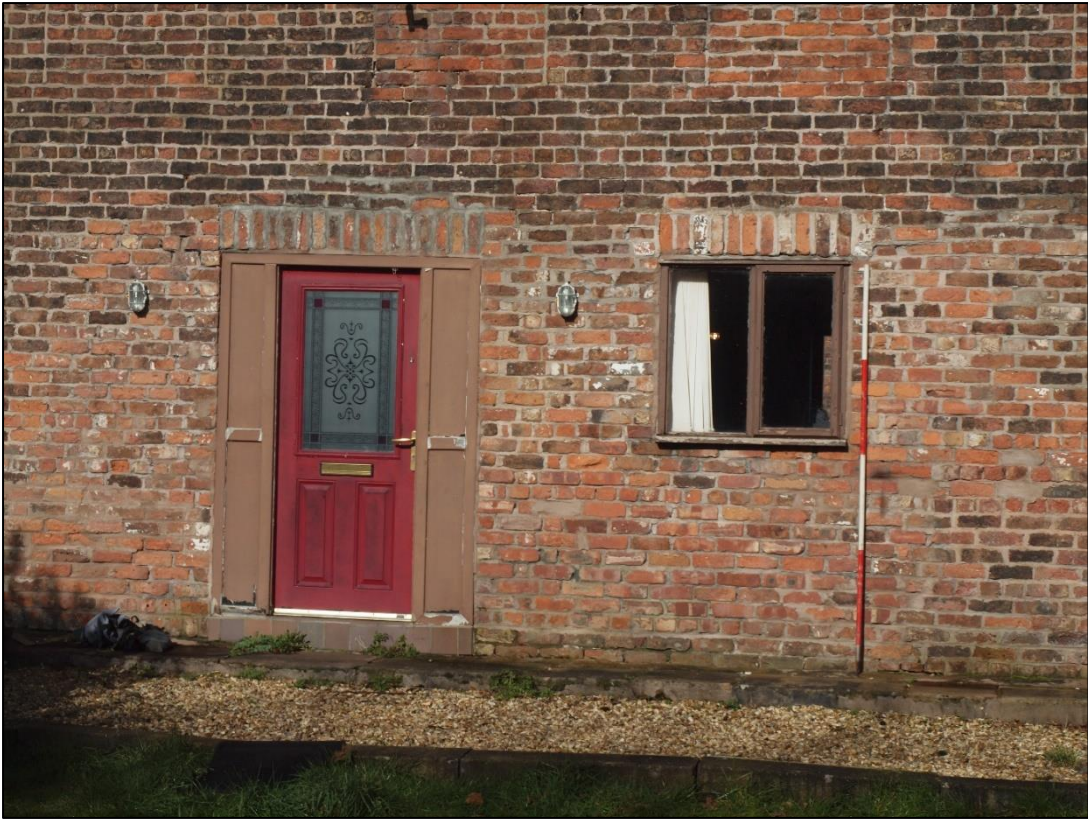
- 6.16 Southeast elevation (plates 50 - 54). This forms the main 6 bay frontage of the building. Bay 1 contains an inserted window at each level, with that at first floor level having been inserted with a blocked window. Bay 2 contains a further blocked portrait window at first floor level, with rebuilding shown at ground floor. The third bay contains the personnel door entrance to the building, set within a wide opening, flanked with timber panelling. Above, is a further blocked window. Bay 4 contains a square window at both ground and first floor levels. That at first floor has been inserted in place of a blocked window, and the ground floor shows evidence of rebuilding. This rebuild appears across bays 2 – 5 at ground floor level, with the brick being a much lighter orange than the rest of the building, which is an orange brown. At first floor level bay 5 contains a further blocked portrait window. Bay 6 contains a square window at first floor level, with a portrait window at ground floor level. The latter has been inserted in place of a former doorway. Finally, to the left side, a rough joint runs up the face close to the corner

Plate 51: Rebuilt ground floor section of wall

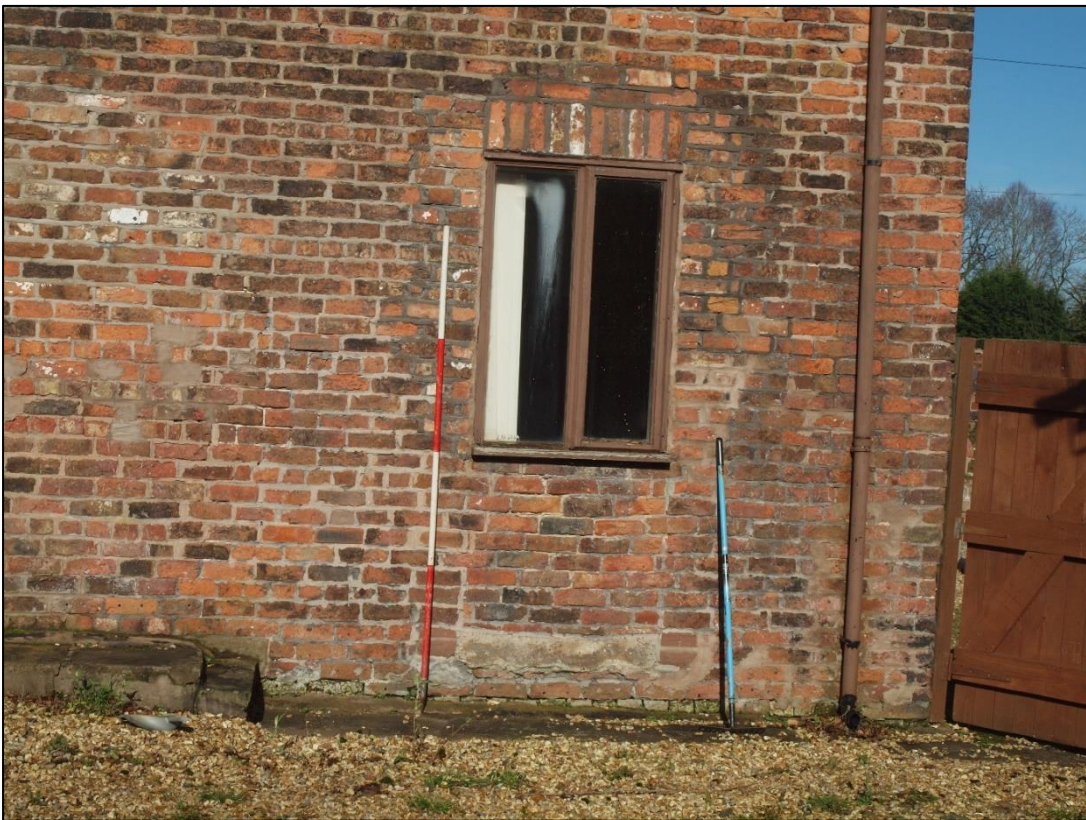
Plate 54: Blocked doorway with window inserted

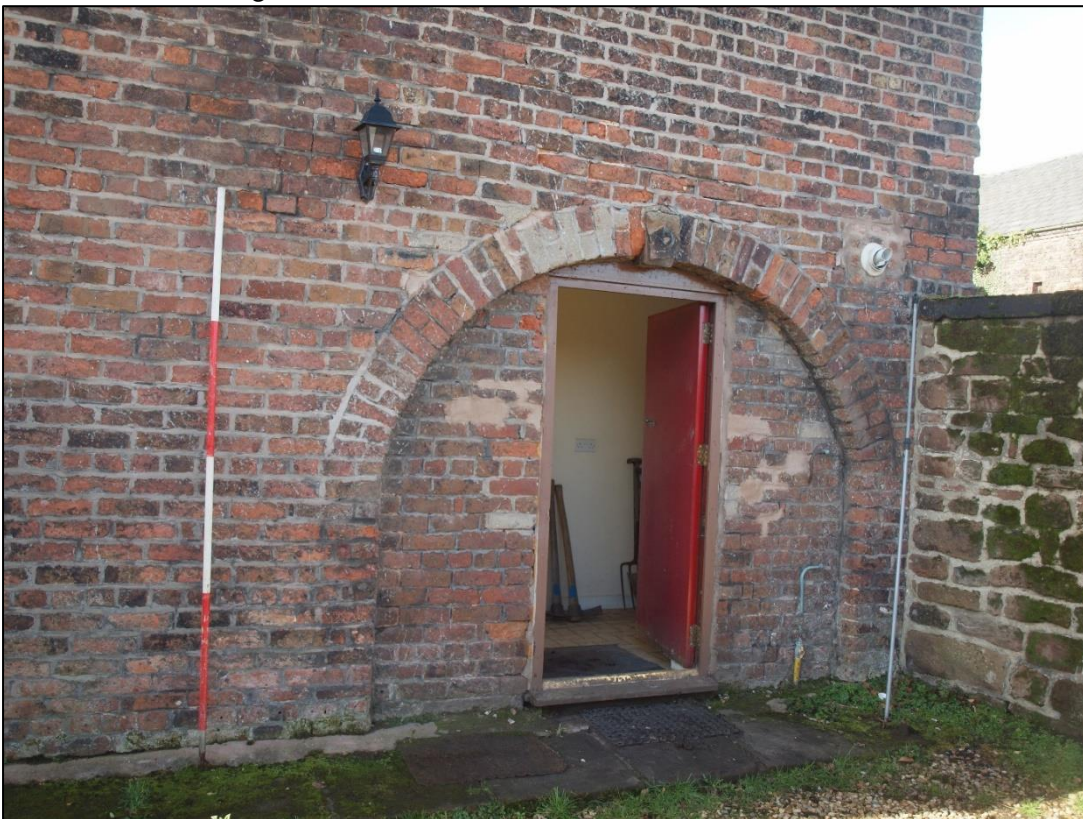
- 6.17 Northeast elevation (plates 55 - 58). This forms the gable end of the building. At the southern end a portrait window has been inserted. To the north a wide opening is present with large rounded arch lintel of brick. The opening has been blocked and a personnel doorway set within it. At first floor level a pair of square windows have been inserted, set closer to the centre of the face than the openings below.

Plate 56: Blocked arched opening with doorway inserted

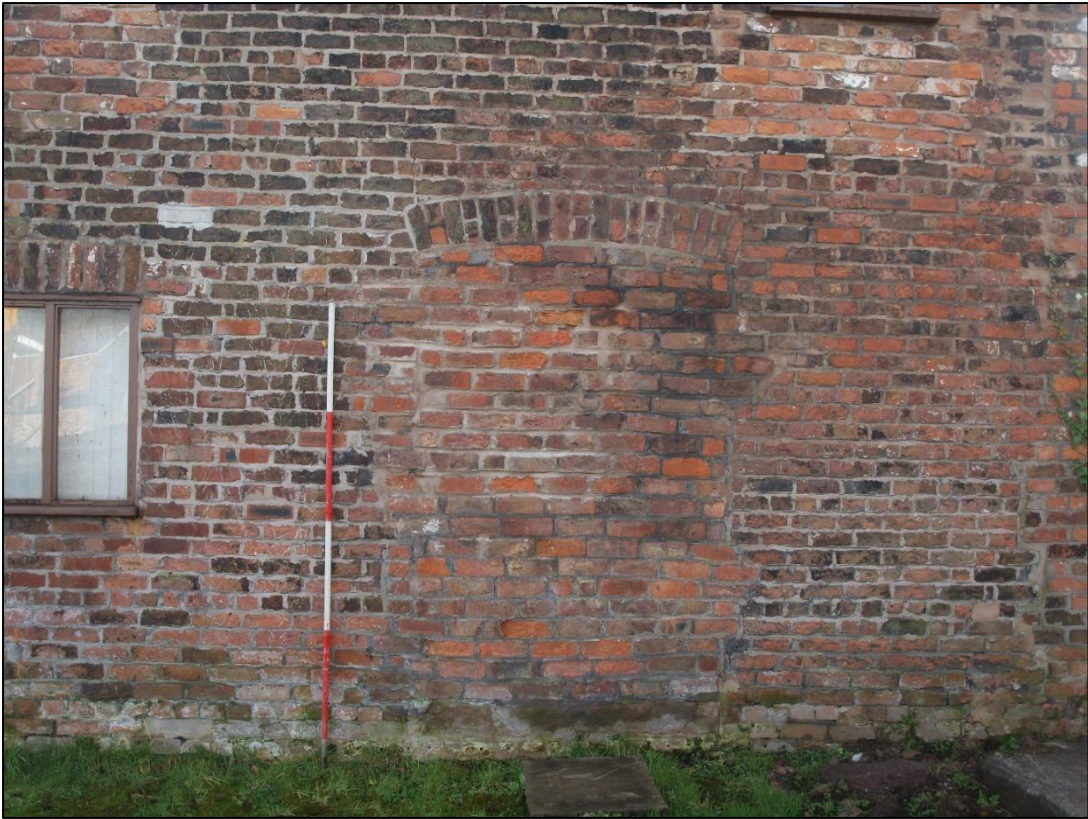
- 6.18 Northwest elevation (plates 59 - 65). This forms the rear of the building. Bays 1 and 2 each contains a square window at ground floor level, with bay 1 having another at first floor level. Bay 2 contains a blocked portrait window. Bays 3 and 4 likewise have windows at ground and first floor levels, with those at first floor level each showing rebuilding below, suggesting they replaced earlier windows. Bay 5 contains a blocked doorway at ground floor level, with a depressed arch lintel of brick. The first floor is featureless. The final bay is featureless at ground floor level with a window at first floor level. This appears to have been inserted in place of an earlier window, with rebuilding below. Finally, a rough joint runs up the right hand side of the building, close to the corner.

Plate 61: Blocked doorway detail

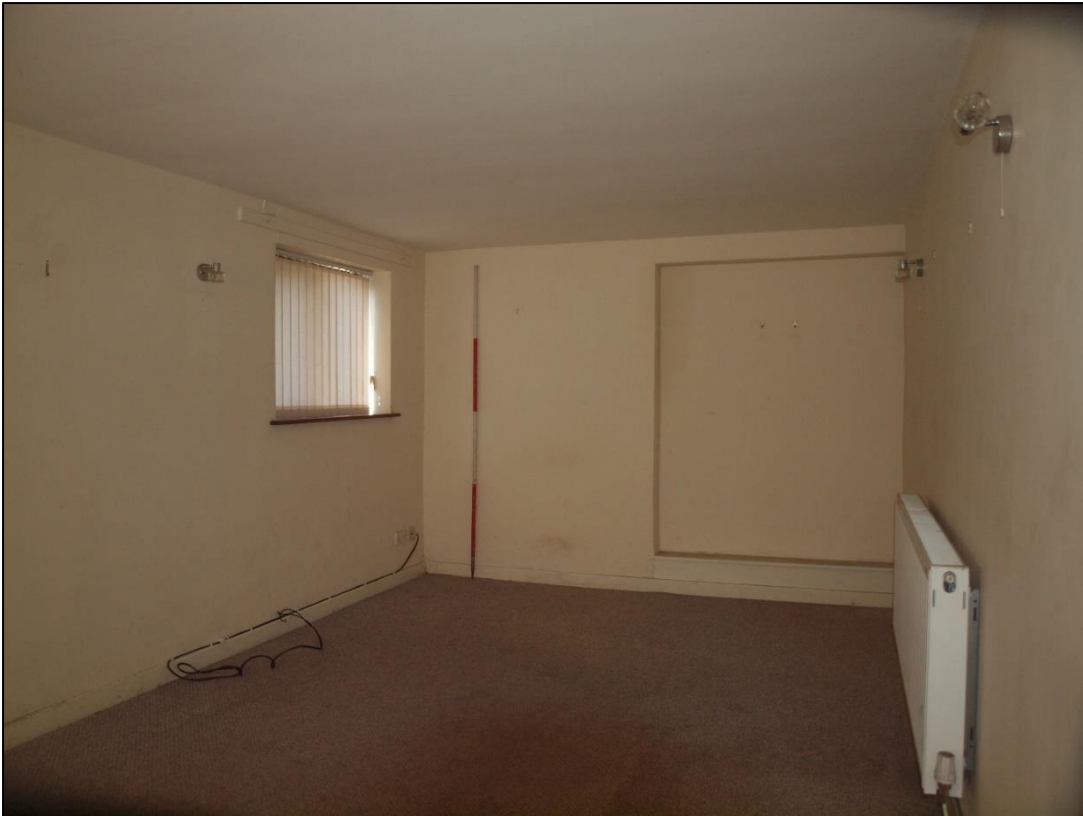
- 6.20 Ground floor. The doorway in the northeast gable leads into a small room, fitted out as a modern kitchen (plate 68), with toilet to the north corner. A set of steps in the southwest wall lead up to an opening giving access to a large room spanning the width of the building (plates 69 - 71). Windows lie in the northwest and southeast walls. The walls are plastered and painted along with the ceiling and the floor is carpeted. In the south end of the western wall a set of double doors lead through to a hallway and staircase (plates 72 - 74). The staircase is modern and rises up to the northwest. This lies opposite the doorway in the southeast elevation. Beyond the staircase to the northwest is a small toilet room. Adjacent to the bottom of the stairs is a further wide doorway leading to a further room, at the western end of the building (plates 75 - 76). This matches the others, with plastered walls and ceiling and carpeted floor. A recess lies in the northwest wall, in the location of the blocked doorway seen externally.

Plate 75: Western room showing recessed blocked opening of former doorway

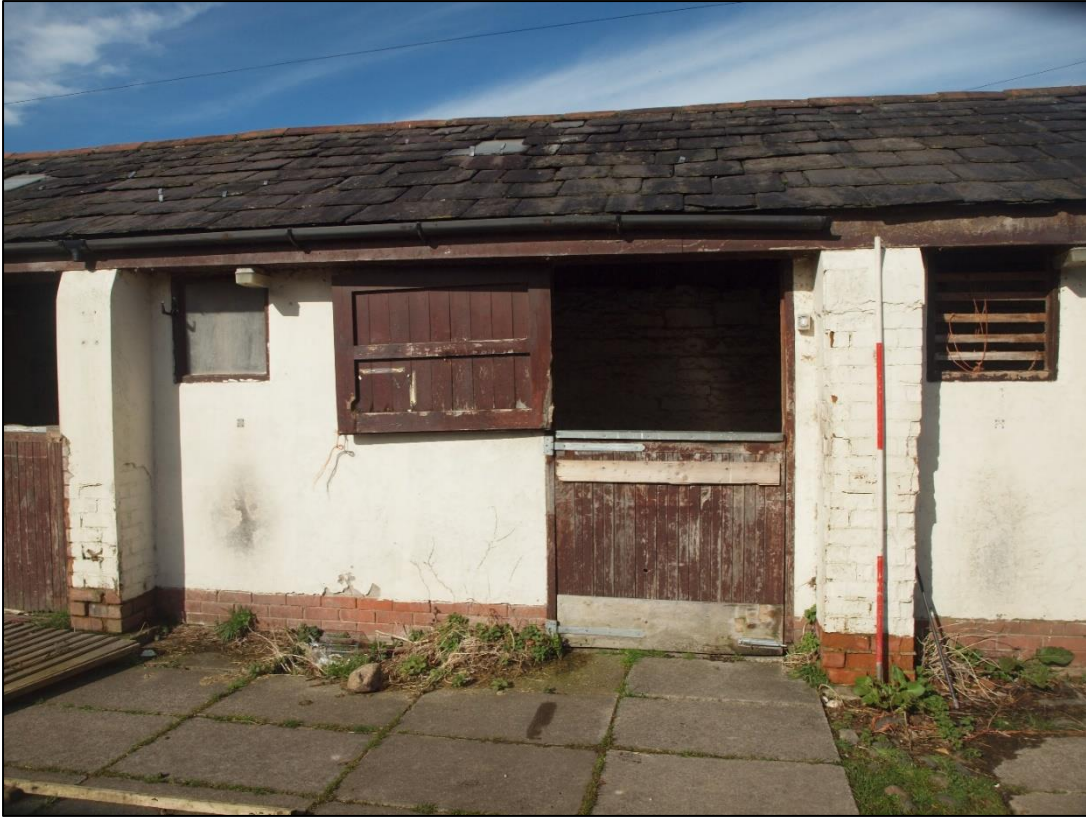
Plate 91: Inserted wall, brick piers and doorway detail

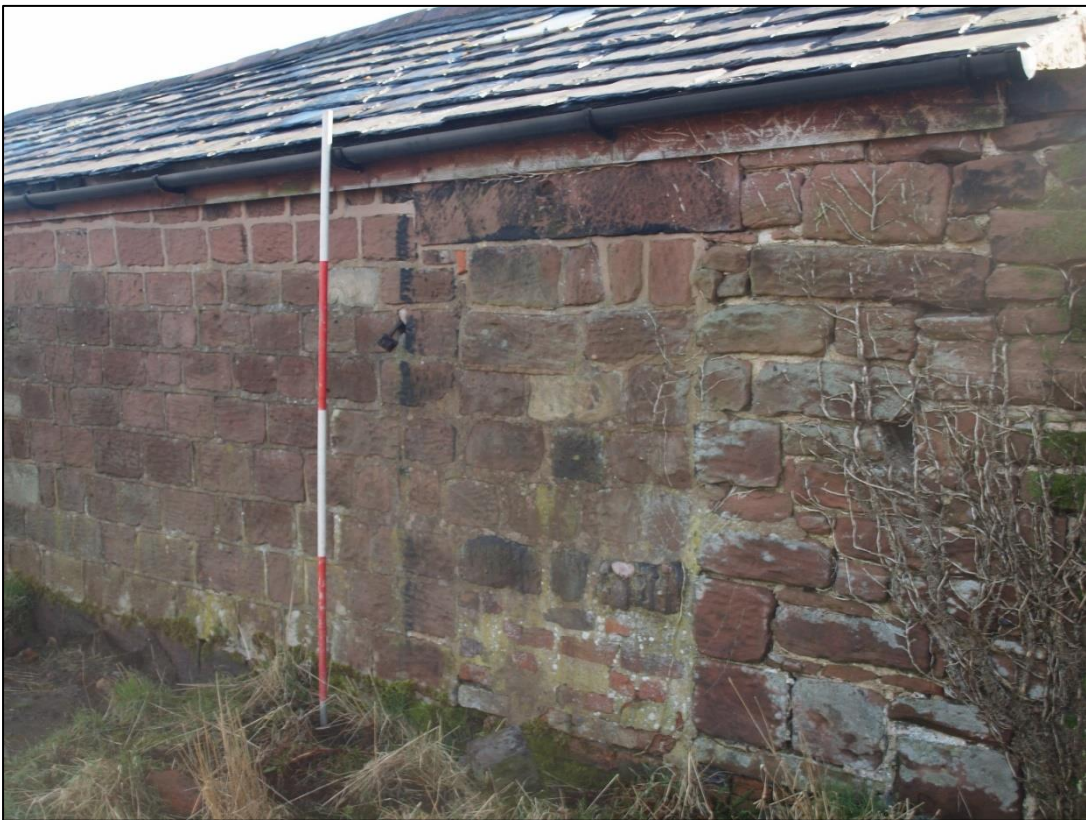
- 6.25 Northwest elevation (plates 95 - 97). This comprises the rear elevation of the building. It is again shown to be constructed of shaped and coursed sandstone rubble. A blocked personnel doorway lies at the western end with sandstone lintel over. The face is otherwise featureless.

Plate 96: Blocked doorway detail

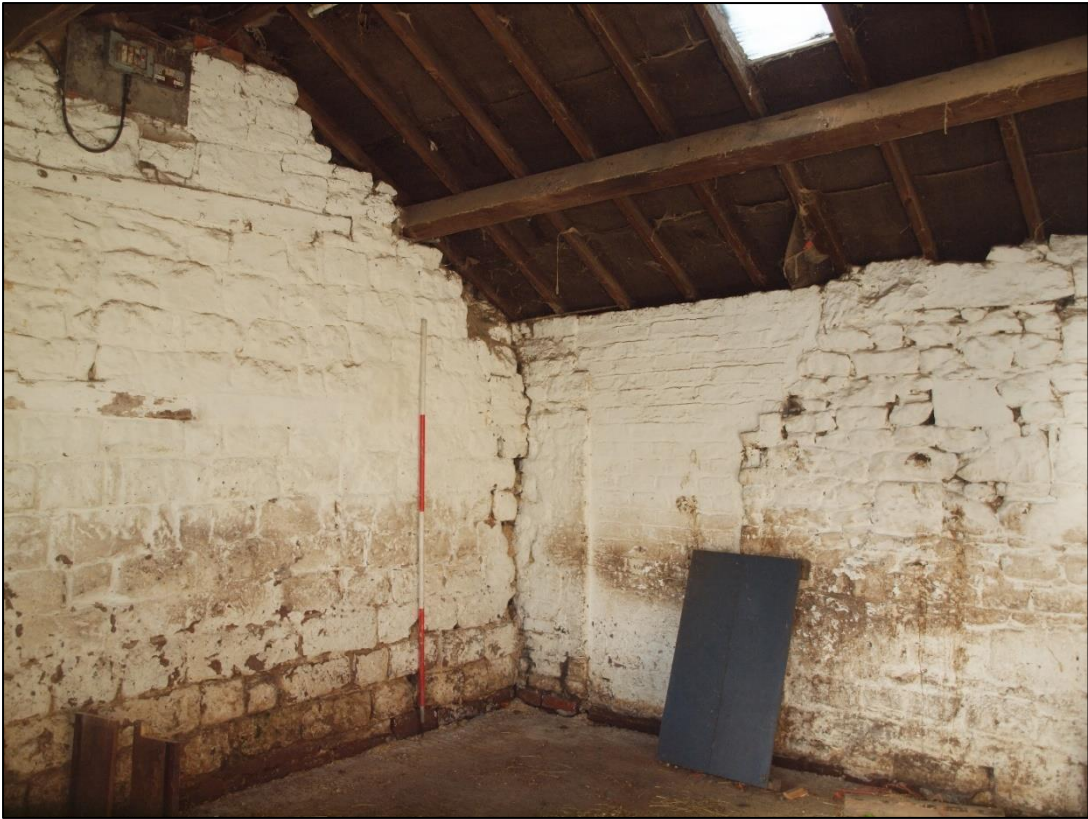
6.27 (Plates 99 - 104) The interior is divided into four identical separate units, each separated by an inserted concrete block wall. These walls lie directly below the machine cut timber trusses. The walls are all whitewashed, with the stone being visible to the northwest and the brick to the south east. The floor is concrete throughout.

Plate 99: Interior showing blocked doorway in northwest elevation

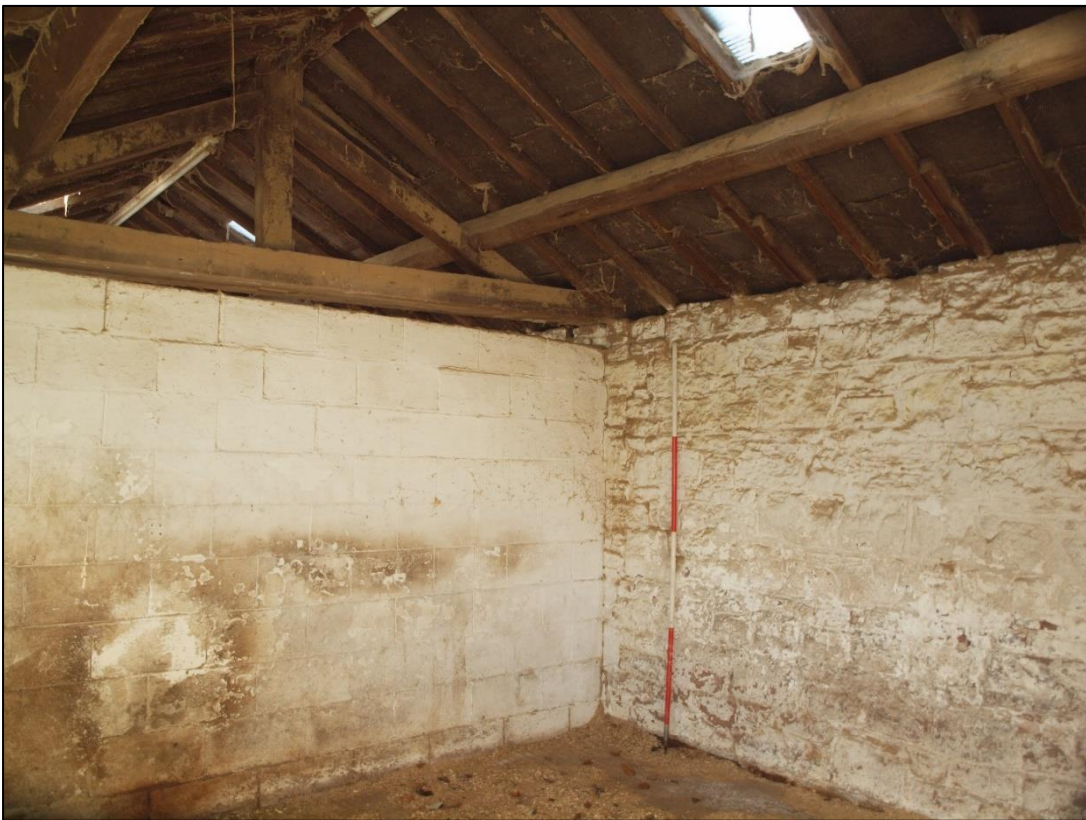
Plate 102: Inserted dividing wall below truss

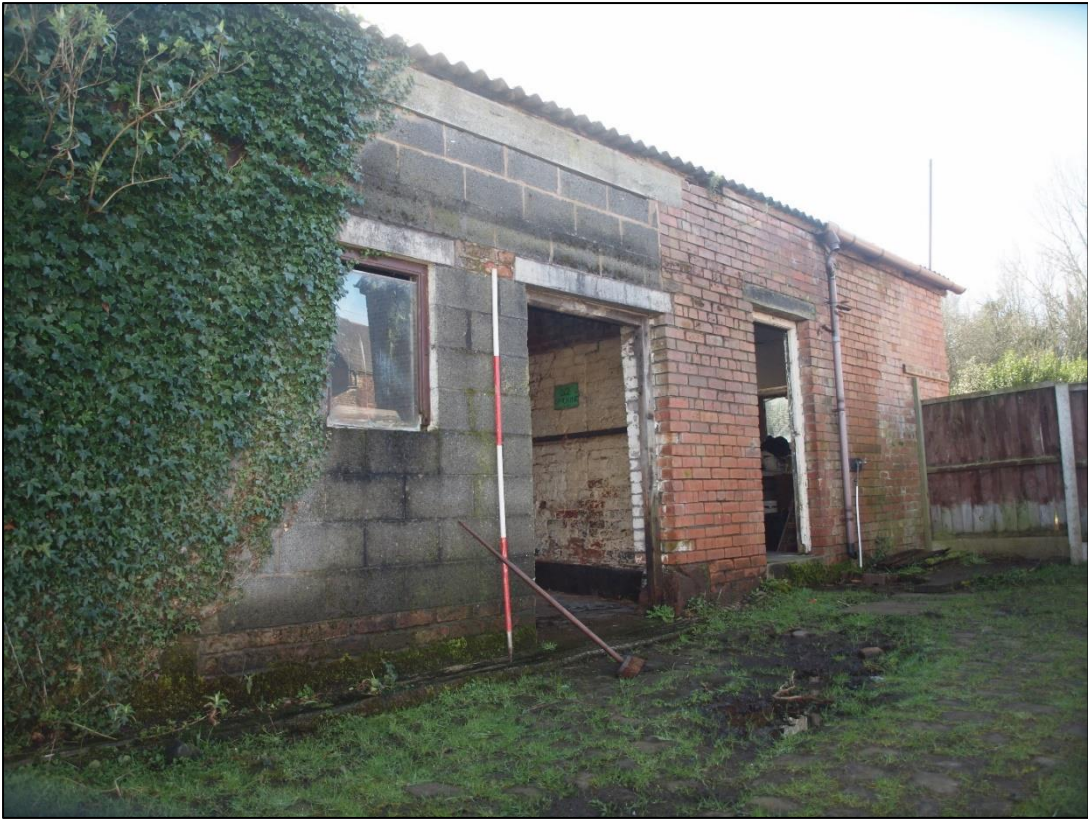
Plate 107: Central section built in concrete block

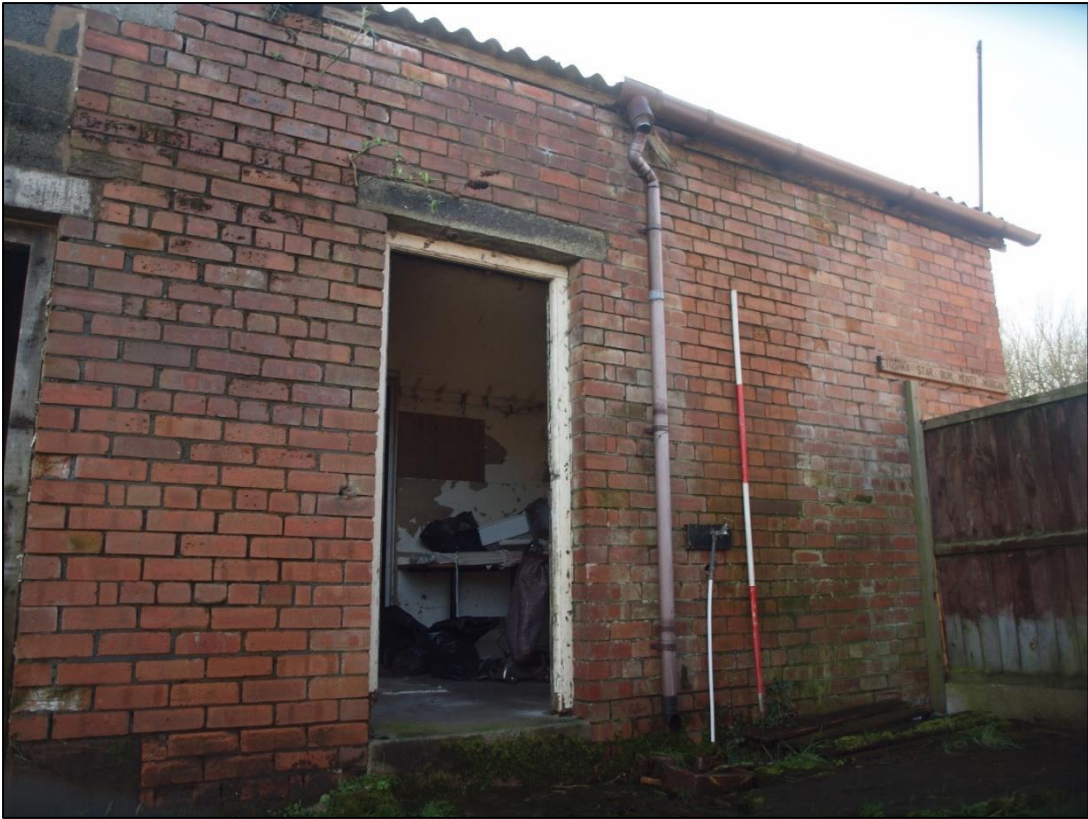
Plate 109: Western end constructed of modern brick

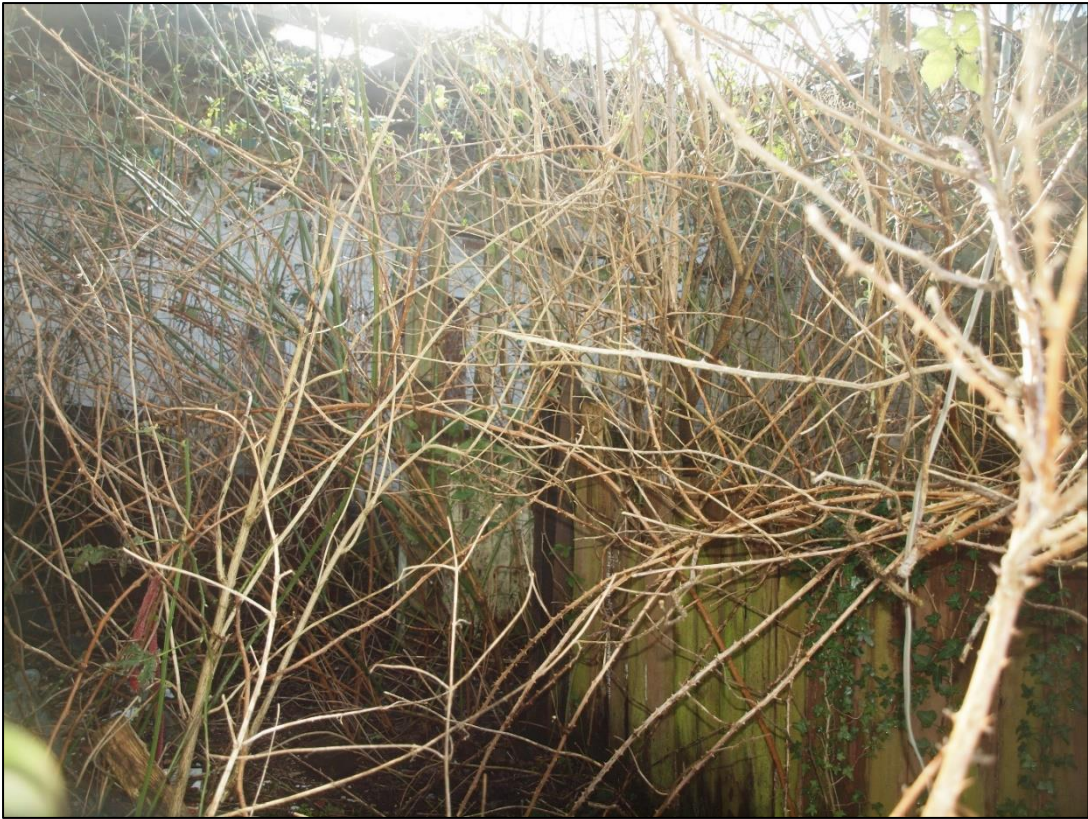
6.33 The interior is divided into the units. At the eastern end the unit is derelict, overgrown and inaccessible (plate 115). A timber panel is barely visible to the west side of the doorway. The central unit (plates 116 – 124) is accessed via the wide doorway in the concrete block section of walling. This leads into a single room with whitewashed brick walls and ceiling open to the machine cut timber beams of the single pitched roof. To the east are a pair of stalls, formed of timber and concrete posts. The floor is concrete and slopes up from northwest to southeast. Several blocked openings are visible in the walls. A blocked doorway lies to the southwest wall, directly adjacent to the main entrance. Opposite this, in the northeast wall is a large blocked opening, the brick header lintel visible close to the level of the timber beams. Directly adjacent to this is a wall scar. Two further blocked doorways lie in the southeast wall, either side of a square window. Finally, a further blocked doorway, this one blocked with a more modern brick, lies in the southern end of the southwest wall. The third unit (plates 125 – 127) is accessed via the doorway in the modern brick section of the northwest elevation. This leads into a rectangular room with stud wall to the southeast and a corrugated asbestos ceiling. A doorway within the stud wall leads into a larger room. The ceiling here is inserted, covering the timber beams above. The walls have been plastered and painted.

Plate 115: Derelict eastern unit showing timber stall

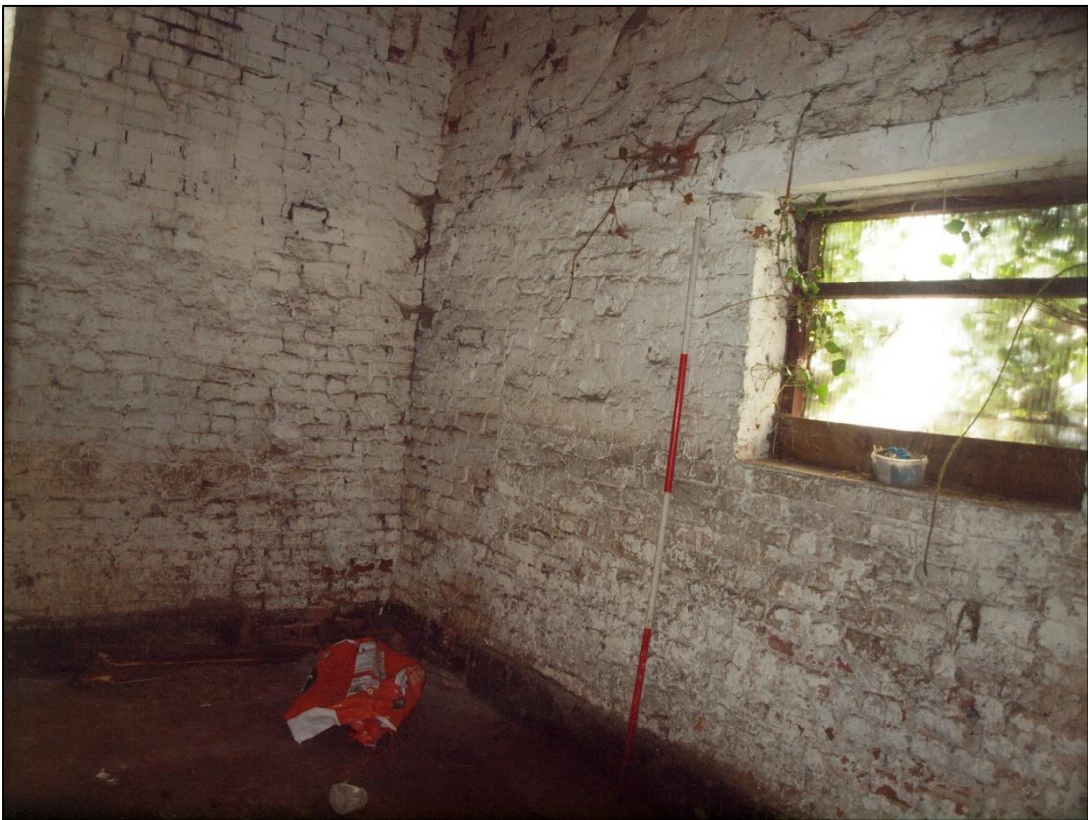
Plate 118: Blocked doorway in east end of southeast wall

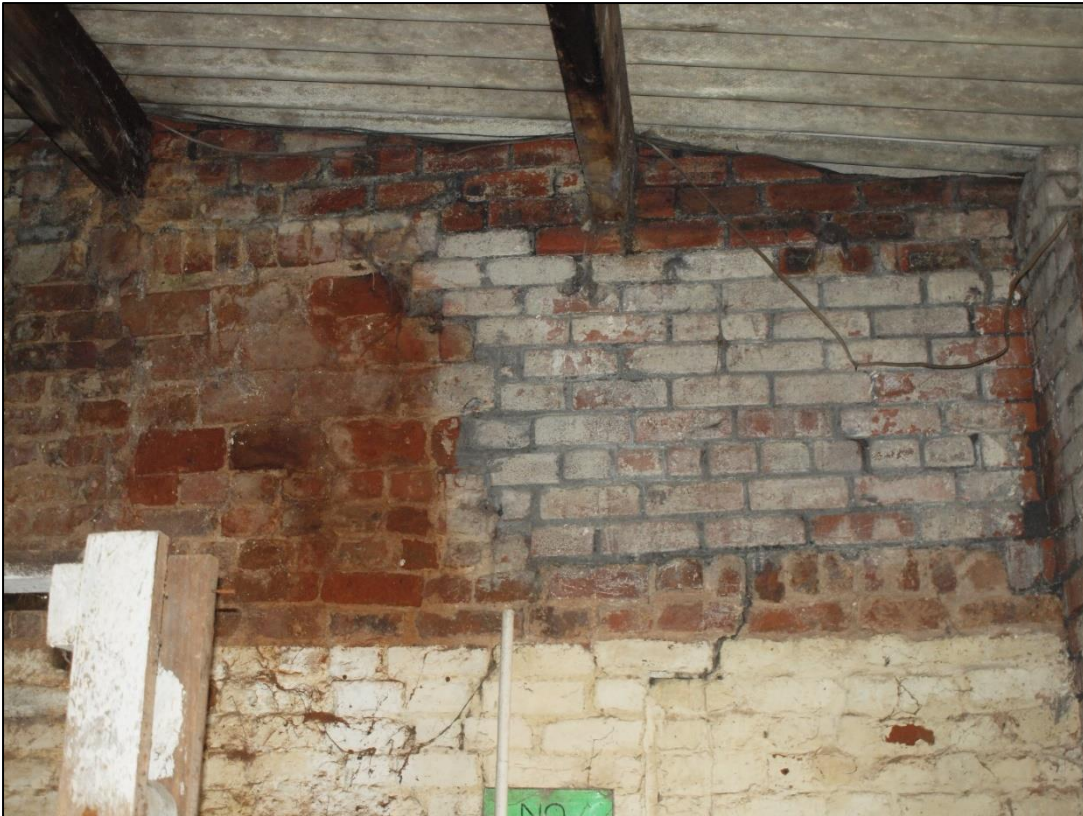
Plate 121: Blocked opening high in face to west of entrance

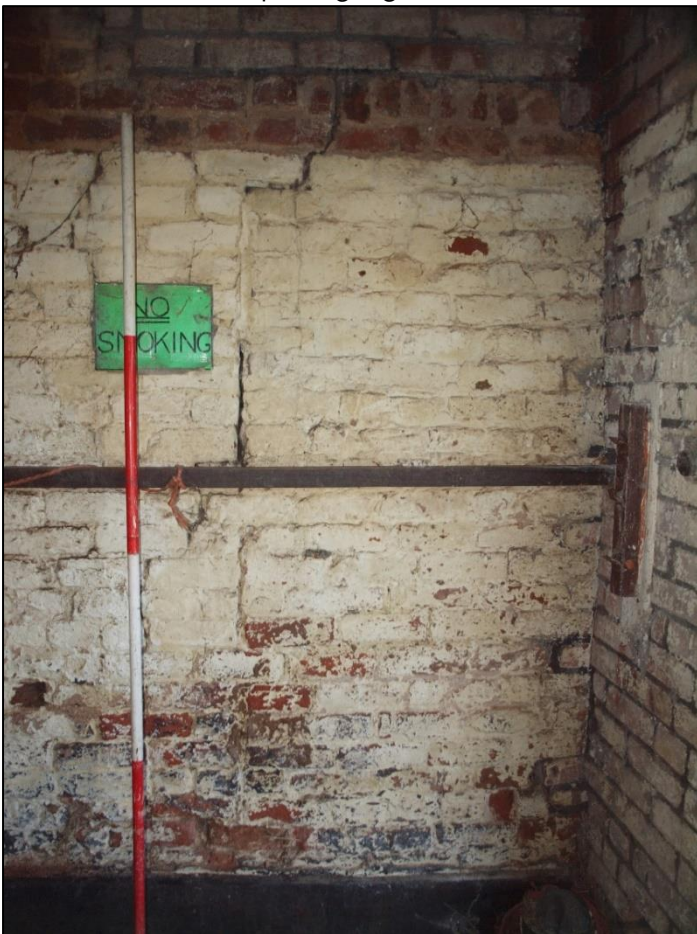
Plate 122: Blocked doorway directly below above

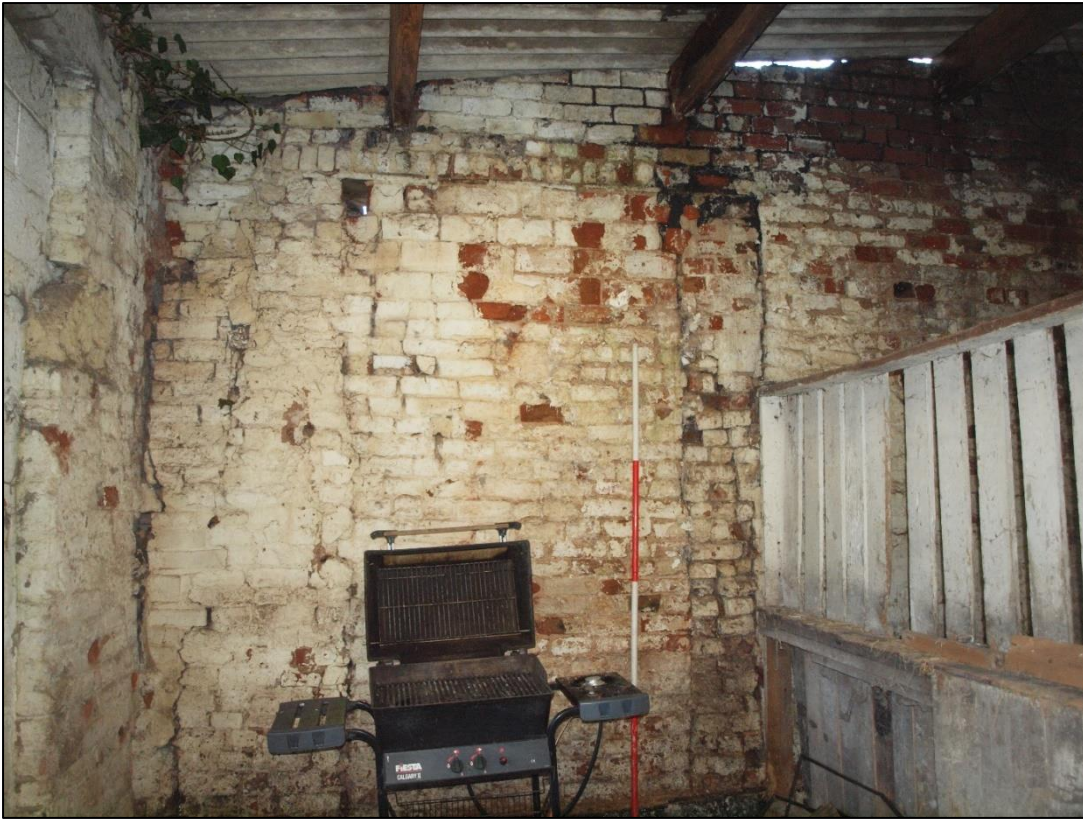
Plate 123: Large blocked opening from eastern unit with wall scar to the right
