North End Farm

Wase Homes Limited

Archaeological Building Survey

28 September 2022

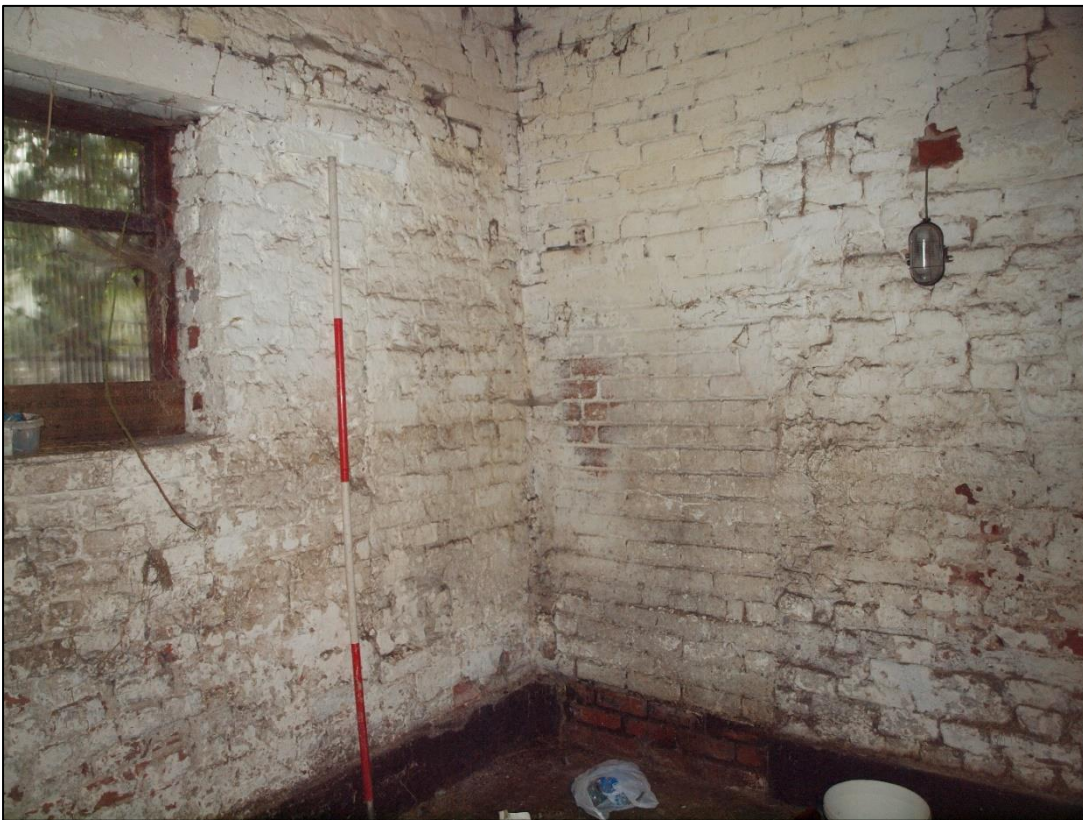
Plate 124: Pair of blocked doorways in southern corner of room

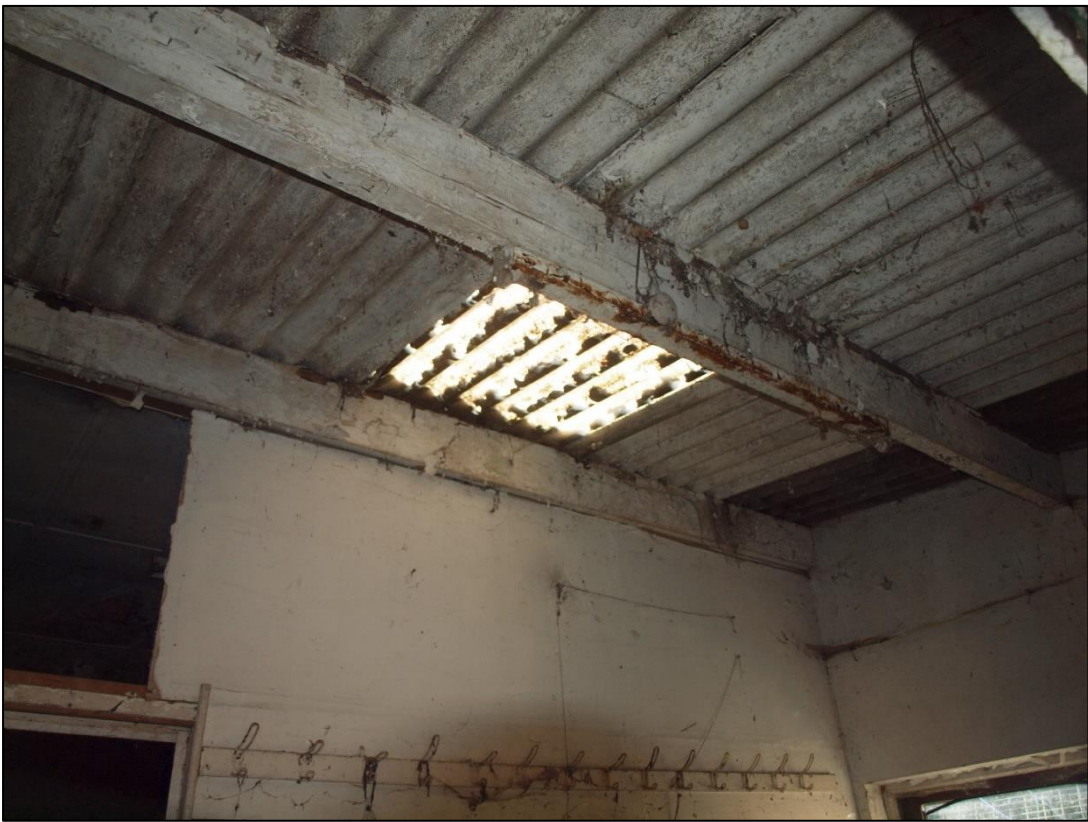
Plate 126: Detail of ceiling

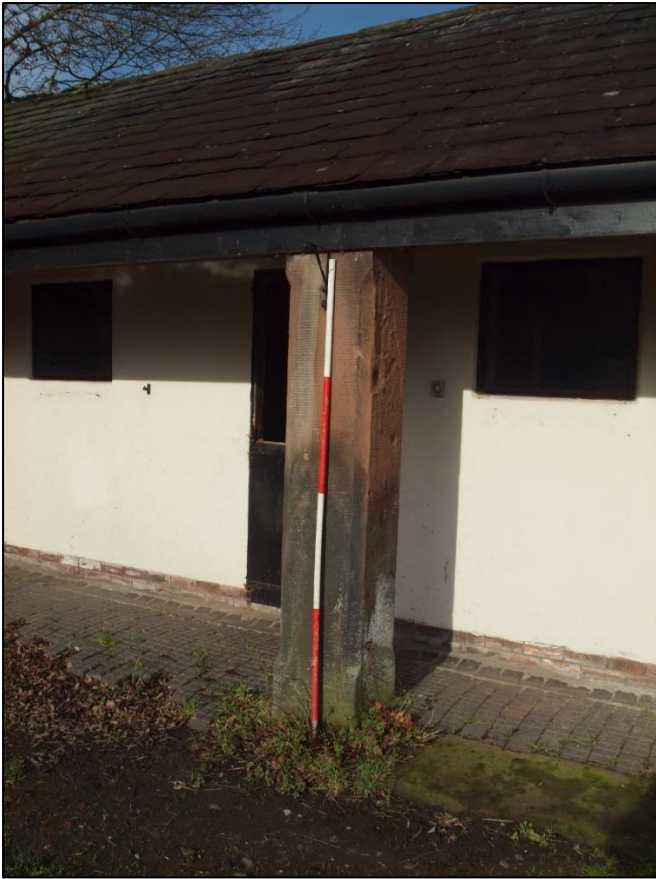
- 6.35 Southeast elevation (plates 128 - 130). This forms the main 4 bay frontage of the building. Each bay is identical, having an inserted rendered concrete block wall with a window to the west and stable door to the east. The roof line projects forward, beyond the rendered wall, and rests on three sandstone columns, each one having chamfered and stopped corners.

Plate 129: Detail of sandstone pier

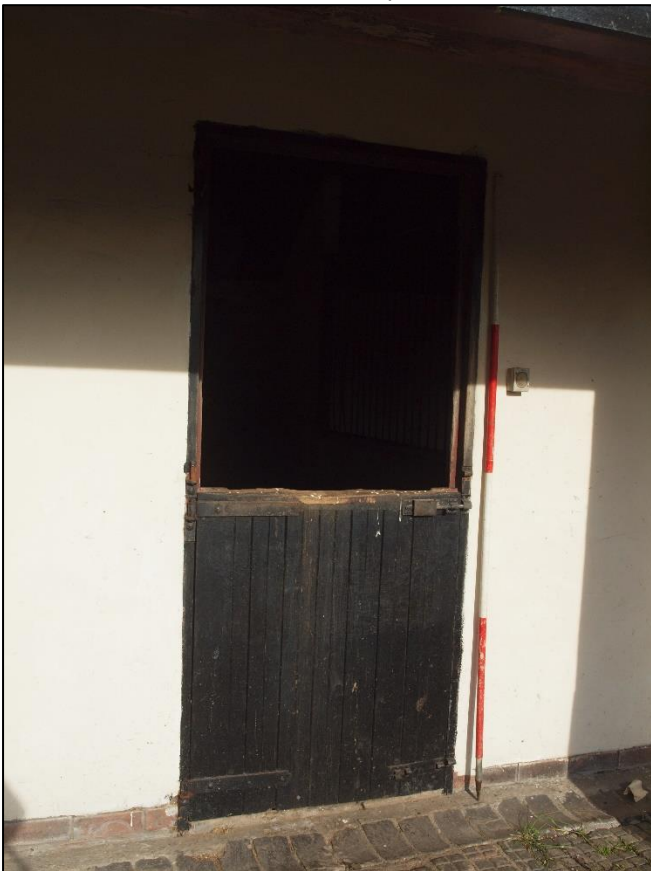
Plate 130: Doorway in inserted wall detail

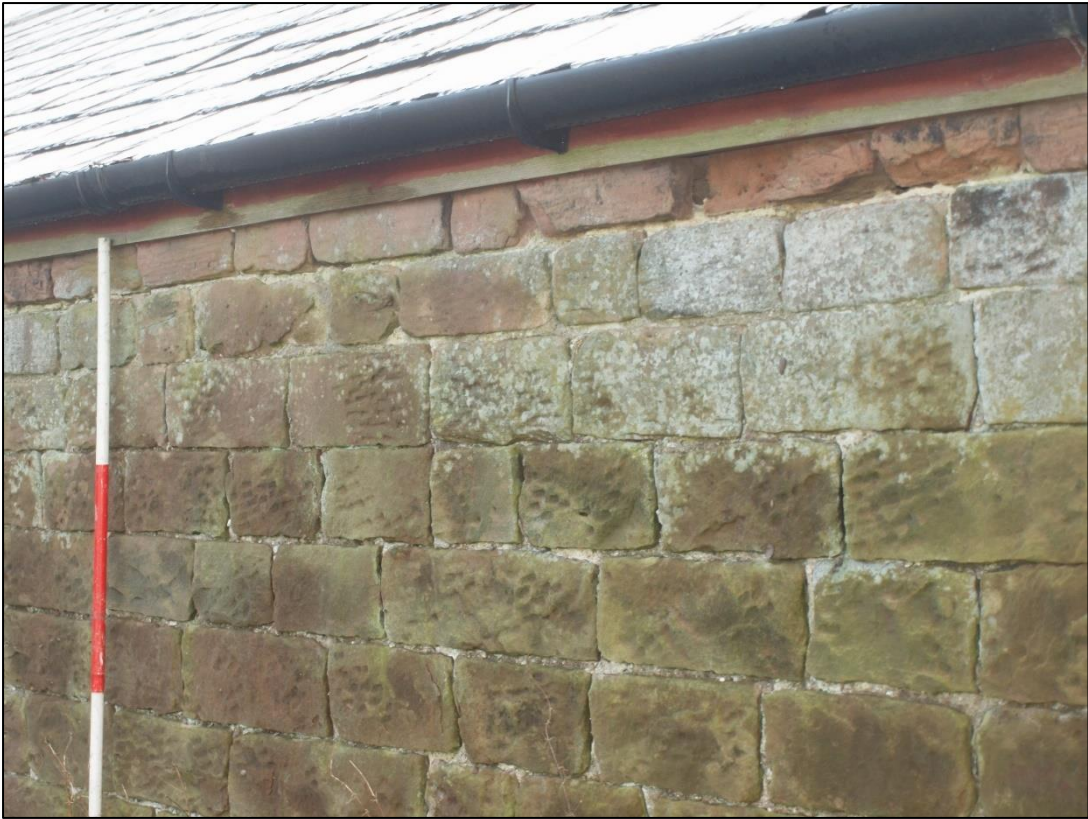
- 6.37 Northwest elevation (plates 132 - 133). This forms the rear elevation of the building and northern boundary wall. This is constructed in the shaped and coursed sandstone rubble, with brick visible at the level of the eaves. The sandstone again shows rustication marks. The face is otherwise featureless.

Plate 133: Detail of stonework to northwest elevation
