**The Ha Ha, Cowdray Ruins, Easebourne, nr.
Midhurst, West Sussex**
Report on an Archaeological Investigation
January 2006

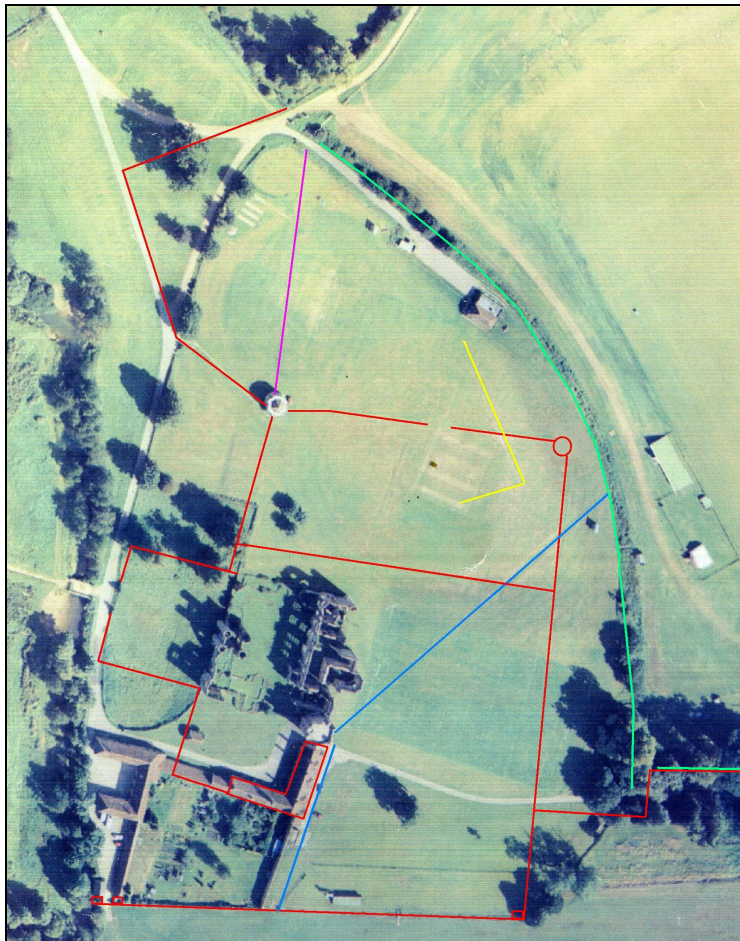
Fig.3 2001 aerial photograph of the ruins (© WSCC), with (in red) elements of the pre-Brown landscape, and (in purple) the Brown park fence, and (in green) the Poyntz ha ha. In blue are two suspected brick conduits linked to the house.

7. Figure 3 attempts to combine the aerial photograph and map evidence in order to give a visual picture of the three phase landscaping associated with Cowdray Park. In red are marked the principal elements of the pre-Brown design, with a large enclosed garden surrounding the house, which sits almost centrally within it. At each corner of the garden are pavilions, those to the north probably a matching pair, while those to the south, probably in a separate part of the garden, seem to have been rectangular not octagonal, if that surviving in the south-west corner is typical. The aerial photograph suggests at least one internal wall running east-west sub-dividing the garden. The park pale appears towards the base of the image as it comes in from the east, and then continues north from the west side of the north-west pavilion.

south wall, south-western pavilion and the north-west pavilion which were retained. A new western boundary to the park was formed by a fence which ran from the north-west corner of the house, to the remaining north-western pavilion and then northwards (seen in purple on figure 3) until it hits the south end of an avenue of chestnut trees. Under this scheme it appears that the park deer and sheep were free to roam right up to the house, as seen in several late 18th century prints.
