Holywells Park, Ipswich, Suffolk
Stable block refurbishment, remodelling of Cliff Lane
entrance and continuing work on the icehouse
IPS 768

Archaeological Monitoring Report

SACIC Report No. 2015/016

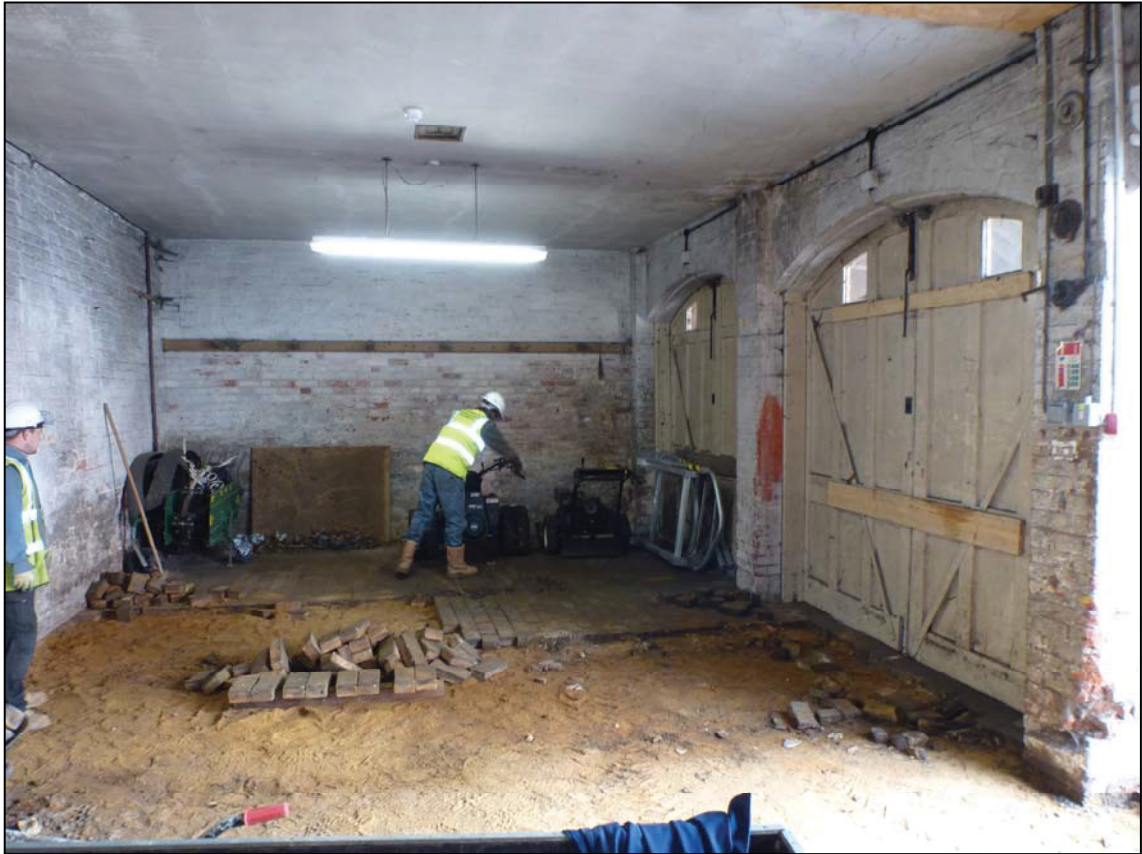
Monitored groundwork within the stable block was restricted to the lifting and relaying of a floor in what was originally a storage area for coaches. The floor consisted of thin yellow bricks/tiles laid on a base of clean yellow sand (plate 3). No significant excavations under the floor were planned and consequently no earlier features were revealed. The floor was subsequently relayed.

Plate 3. Stable block, coach house floor refurbishment, camera facing S

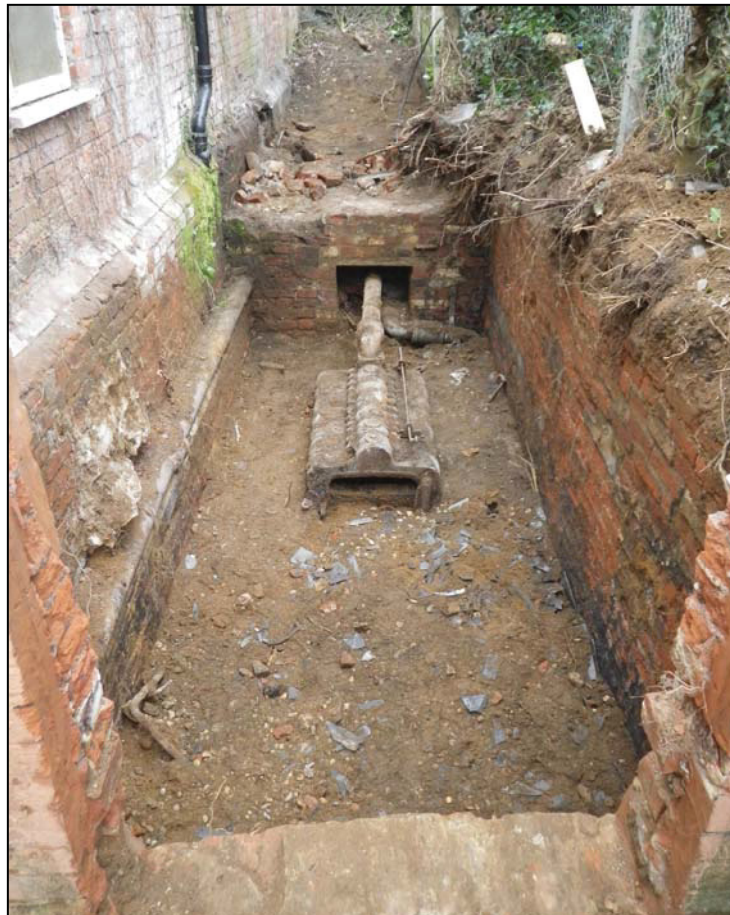
Plate 6. General view of Boiler House 1 through the newly opened access, camera facing S

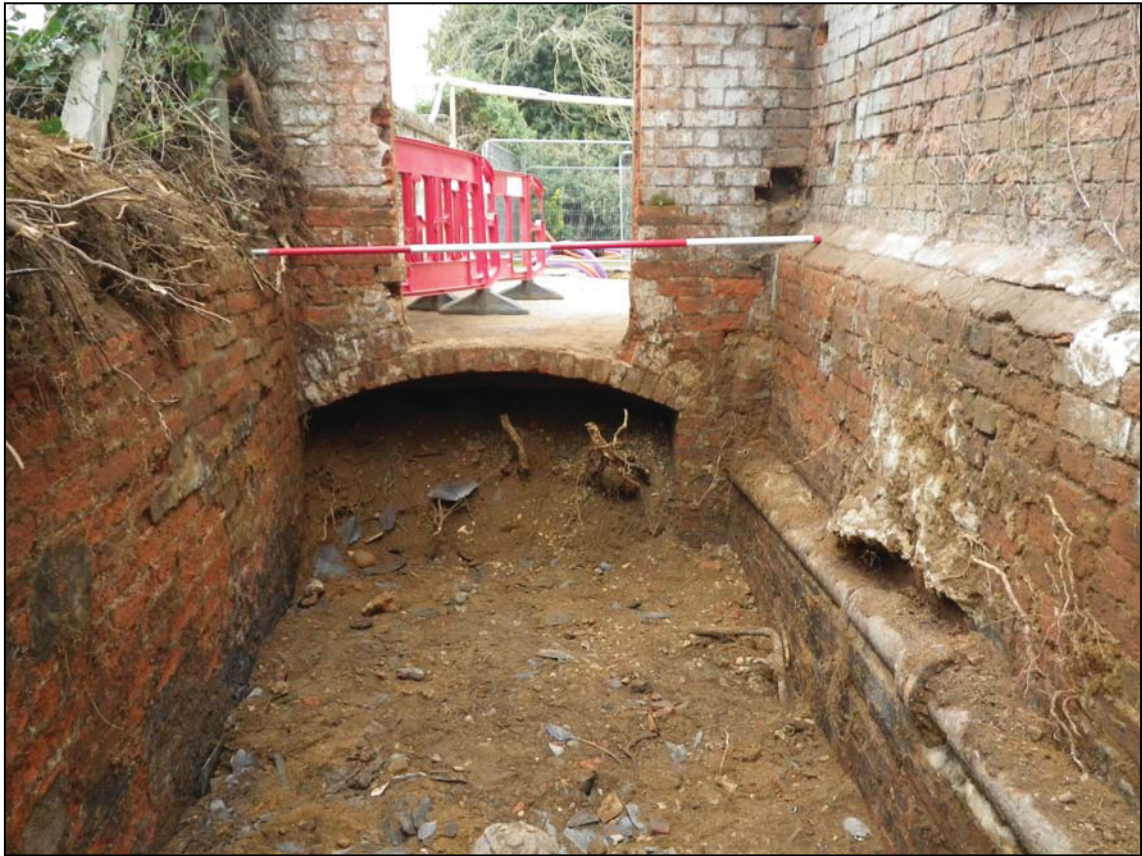
The boiler was presumably coal or coke fired by an operative standing in the space to the north of boiler. The additional space to the north, which may have been for fuel storage, was covered over by what appeared to be a relatively modern concrete slab. No evidence for the method of roofing over the main part chamber was identified. It was noted at the time that an area of the stable block wall immediately above the boiler house and the remains section of the east-west wall at the northern end of the chamber bore traces of having been whitewashed (visible in plate 7).

Plate 7. View of the arched opening in the northern wall

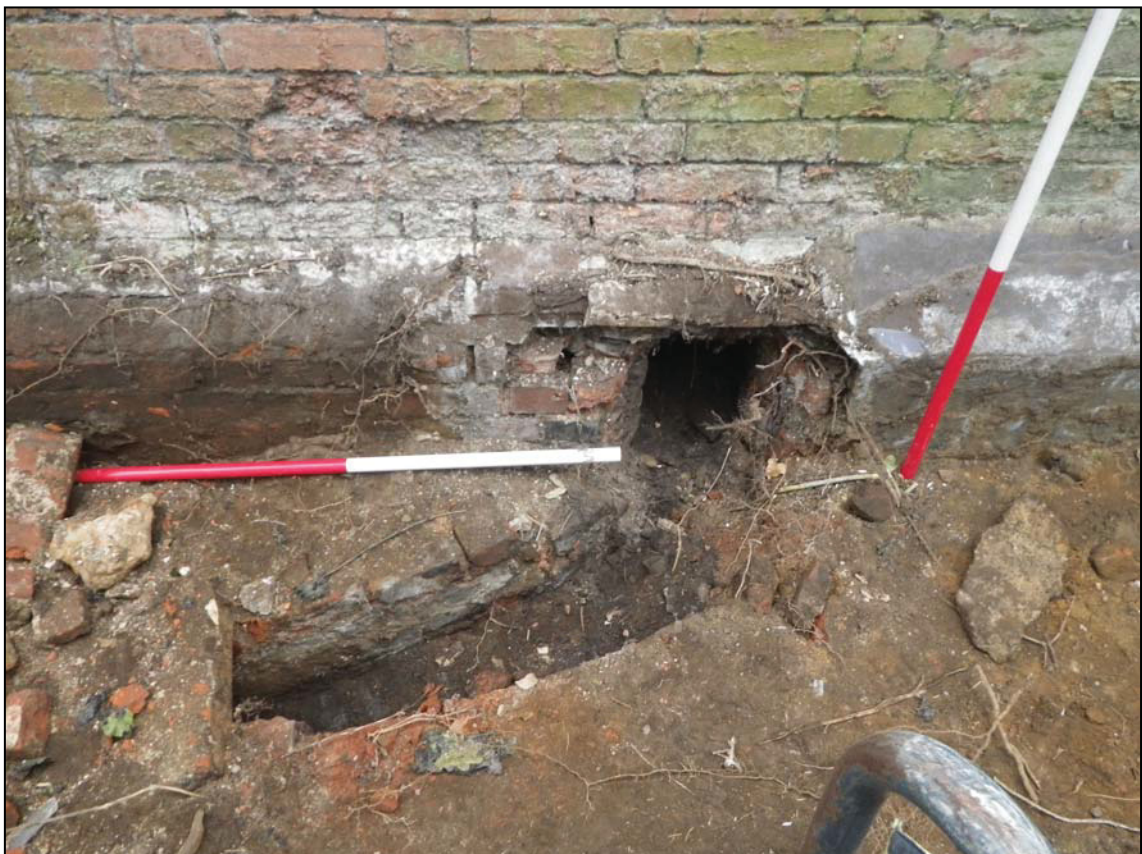
Plate 10. Flue from boiler house to west wall of stable block, camera facing E

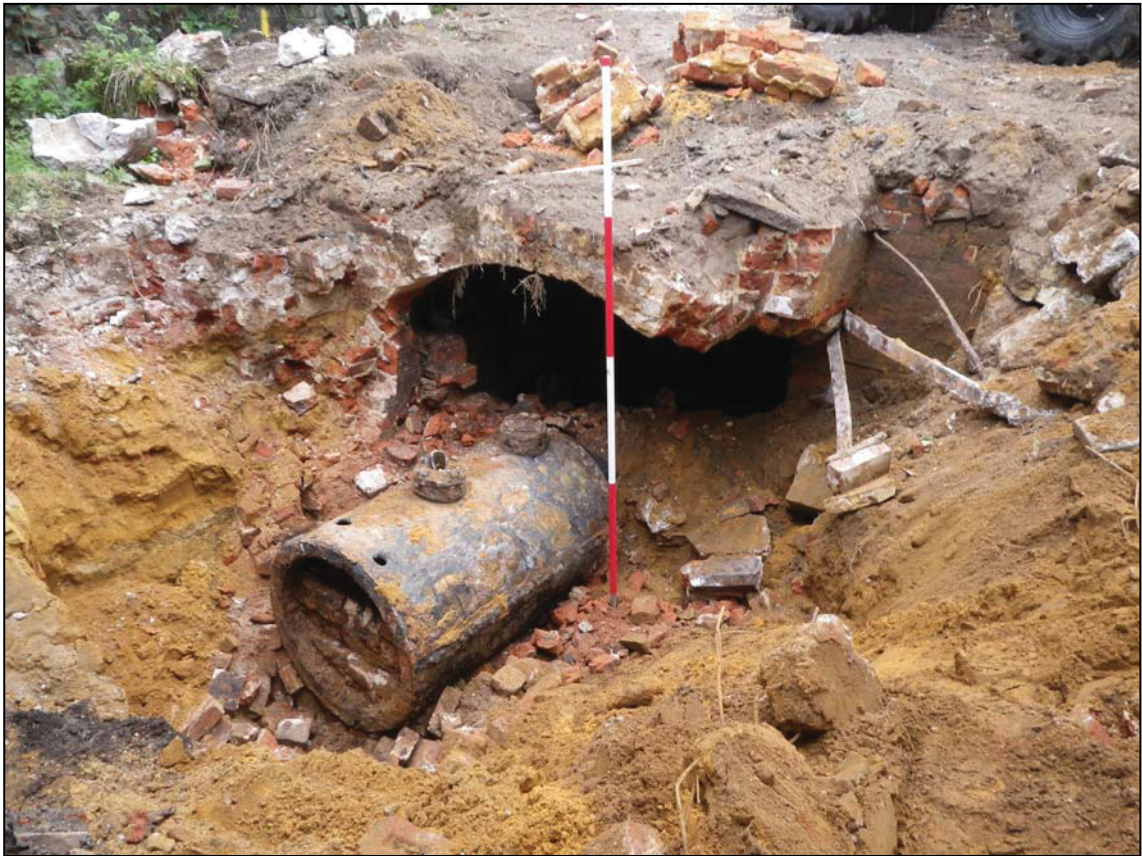
Plate 11. General view of boiler house 2, camera facing SE

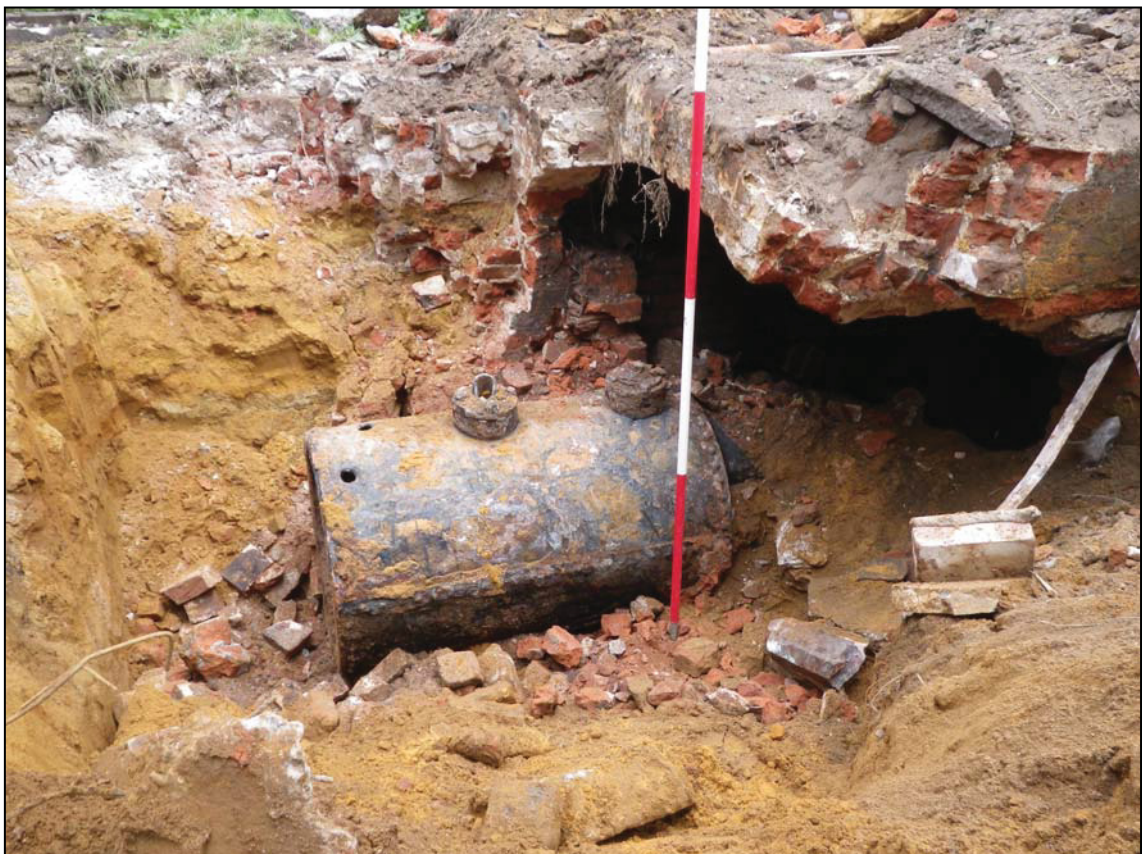
Plate 12. General view of boiler in boiler house 2, camera facing E

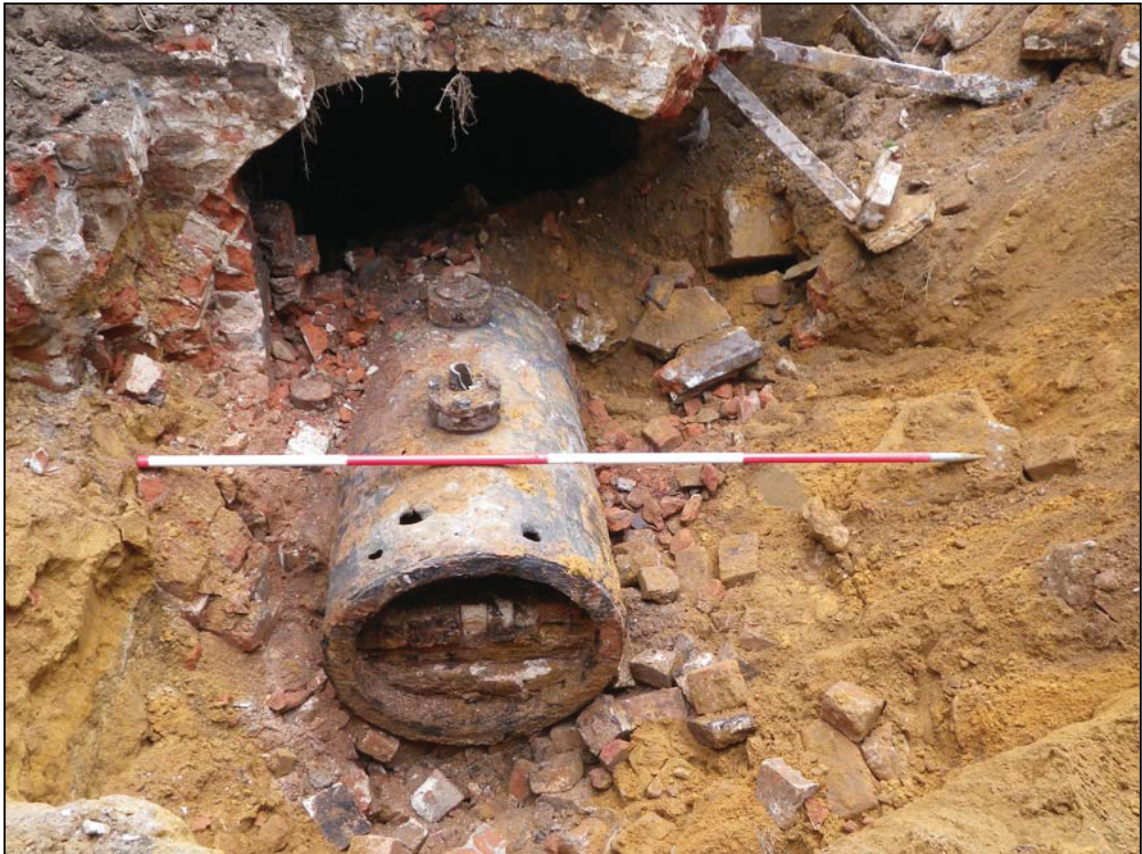
Plate 13. General view of boiler house 2, camera facing S

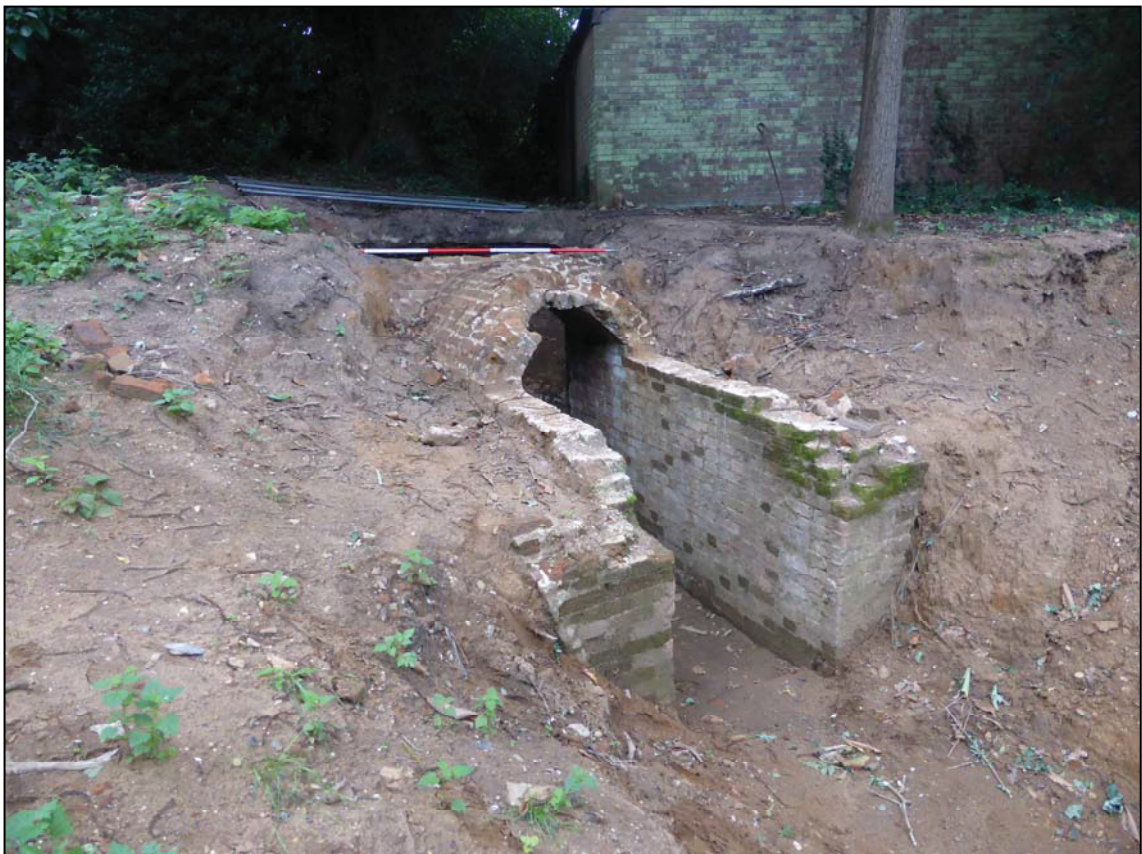
The presence of a 19th century icehouse within the park was confirmed during earlier exploratory works undertaken as part of the 'Parks For People' project (HER ref. IPS 749). The top of the brick dome over the ice chamber was found to be broken and the chamber itself was entirely filled with soil. The entrance portal and tunnel had also been damaged and the area landscaped hiding the icehouse completely. The fill material is being removed by hand by volunteers from the Friends of Holywells Park group. The aim of this phase of the project is to restore the structure's damaged brickwork and to then present it to the general public.

Plate 18. General view of the icehouse, camera facing SW

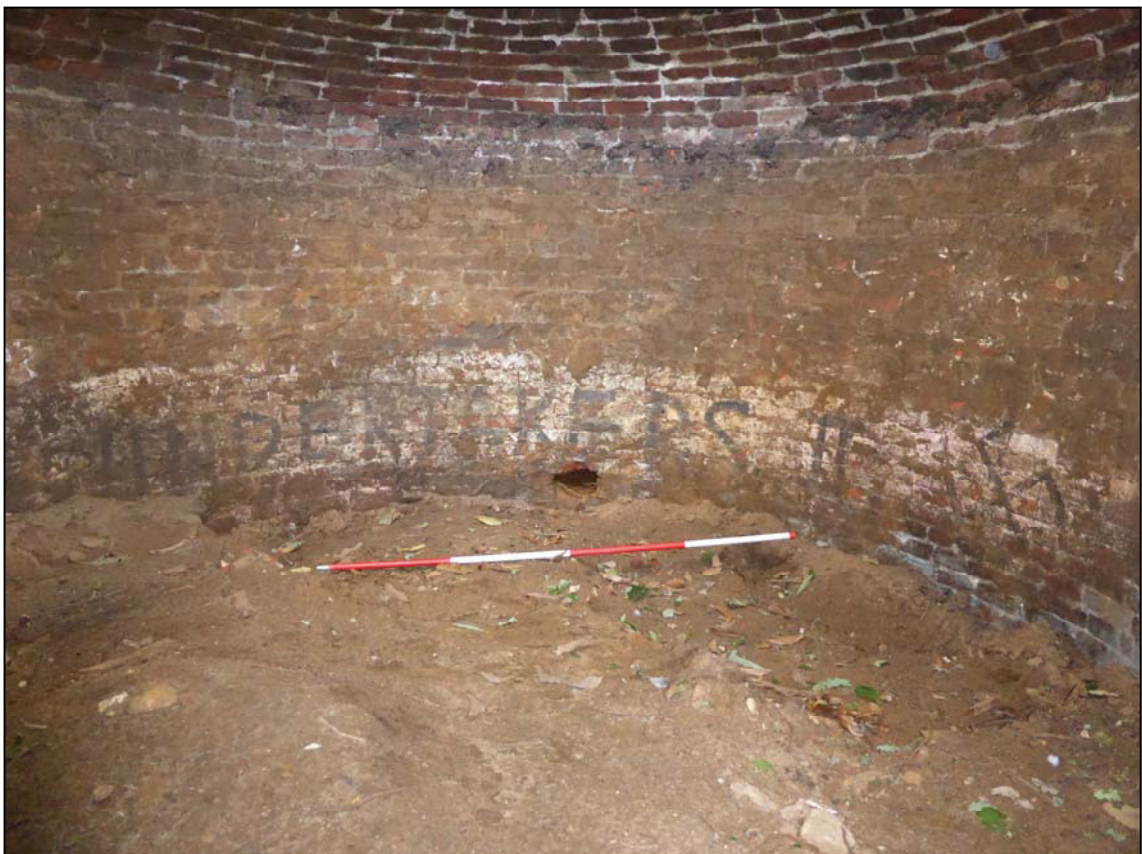
Plate 20. Graffiti exposed within the icehouse, camera facing S

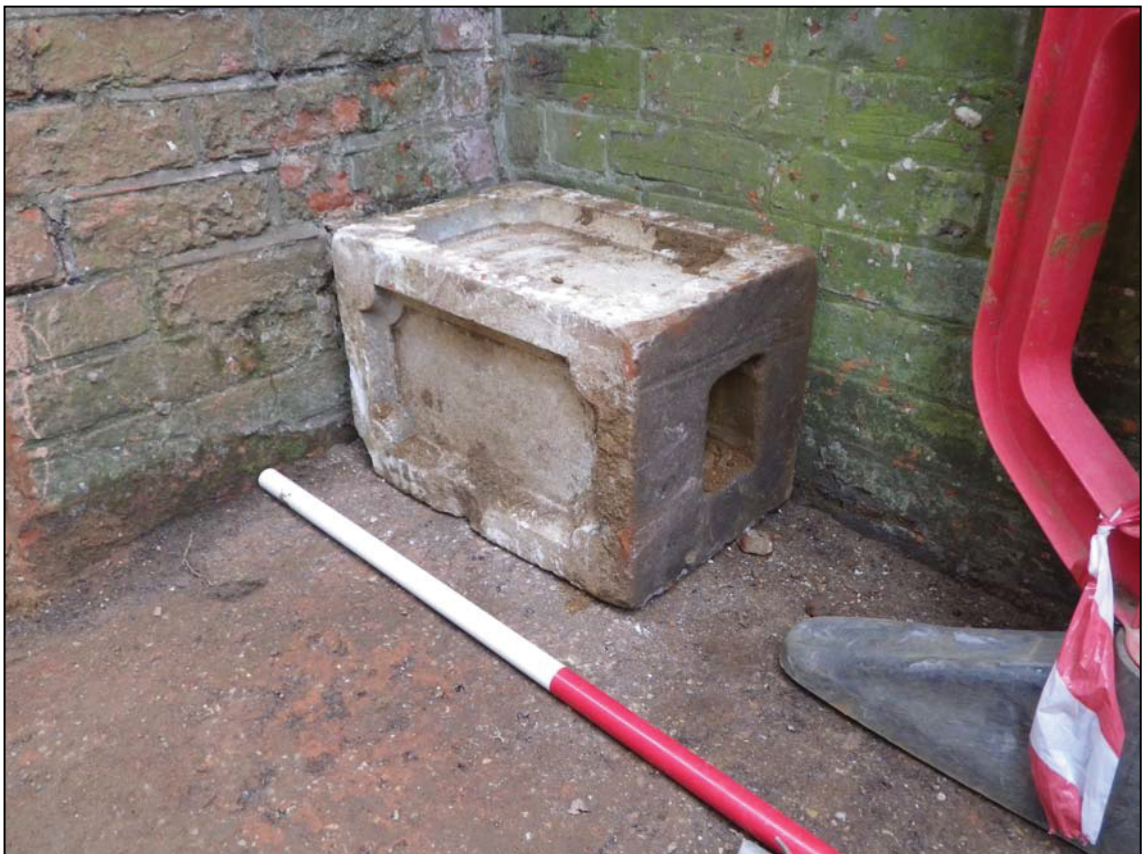
Plate 22. Dressed stone block recovered from fill in boiler house 1

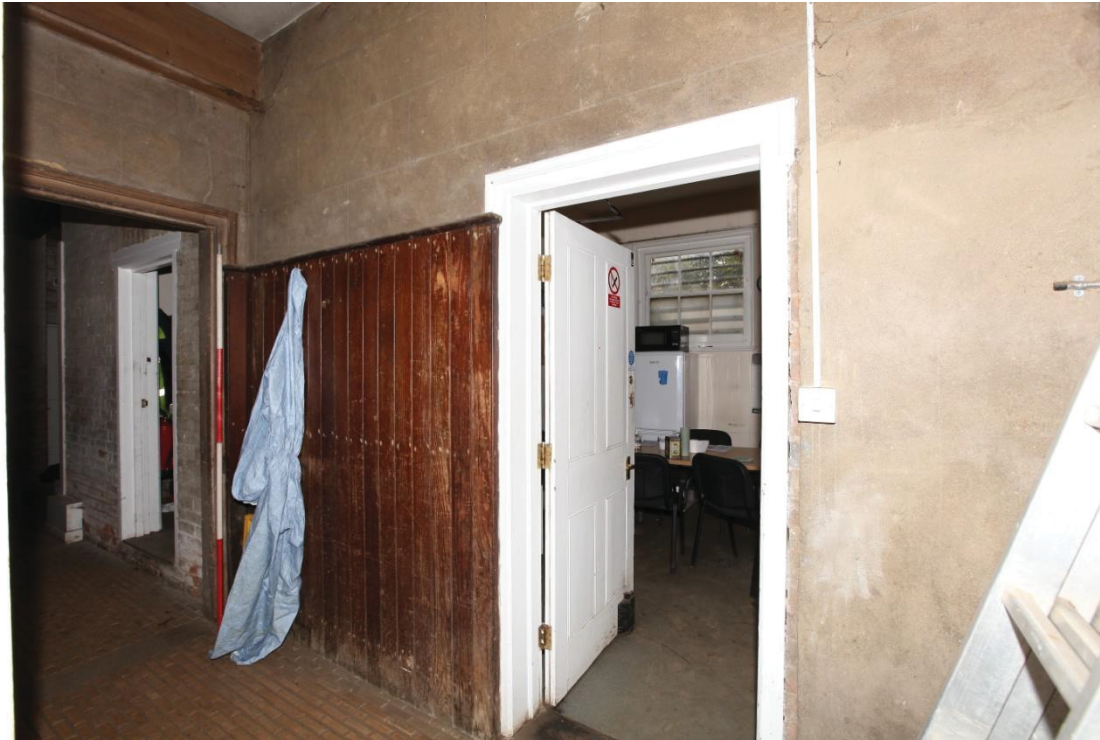
Illus. 11. The corridor of the western range (15) viewed from the north-east and showing the doors of the northern and southern offices (14 and 13 to right and left respectively). The wainscot and imitation ashlar matches that of the stables but these rooms were heated and probably used by the stablemen.

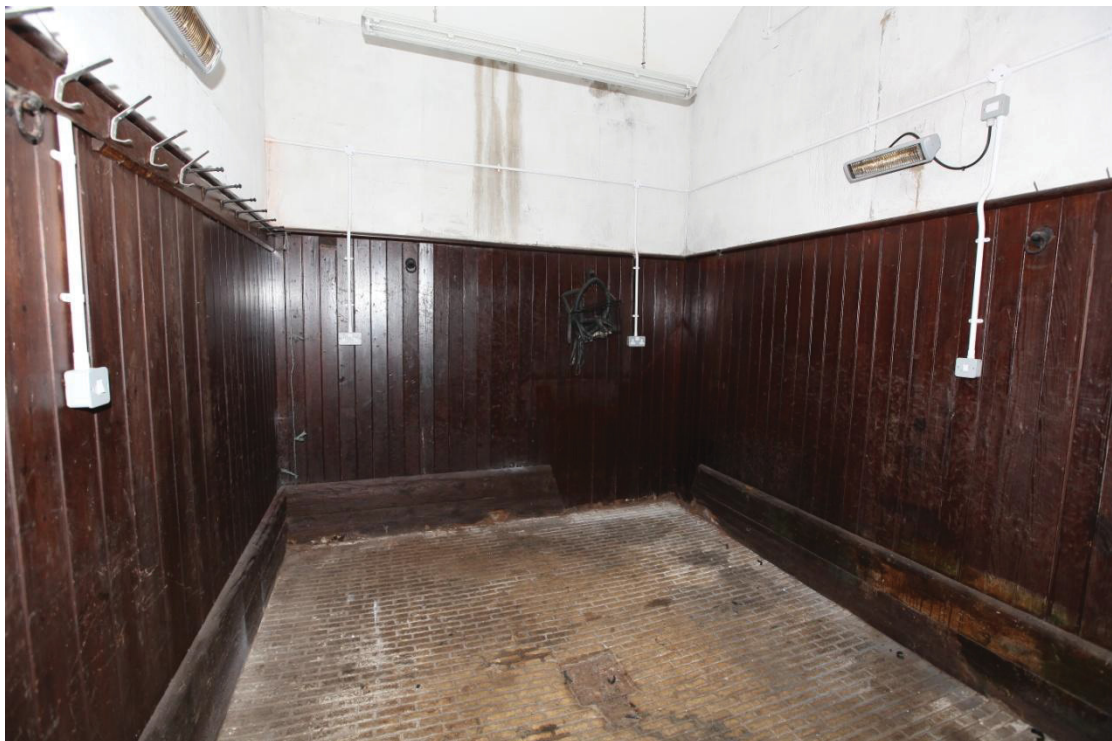
9. A single stall or loose box with its original gault-brick floor and wainscot built in conjunction with its identical neighbour on the east (8). An interruption in the skirting board in its south-western corner indicates the position of a missing corner trough (A2.10).

Illus. 12. The interior from the north of the later westernmost stall of the southern range (9) showing its ostensibly original wainscot and gault brick floor. The scar of a trough is visible above the interruption in the skirting board in the south-western corner.

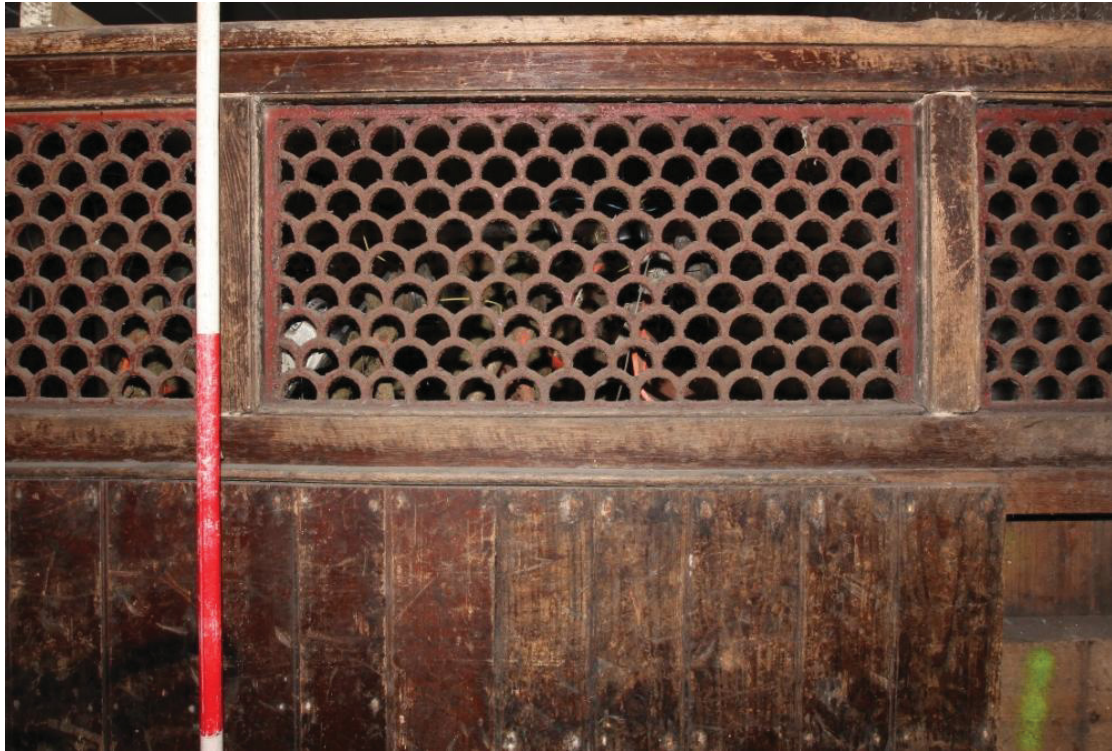
Illus. 13. A detail from the east of an original stall division in the triple stable (3) showing its red-painted decorative pierced iron grill.

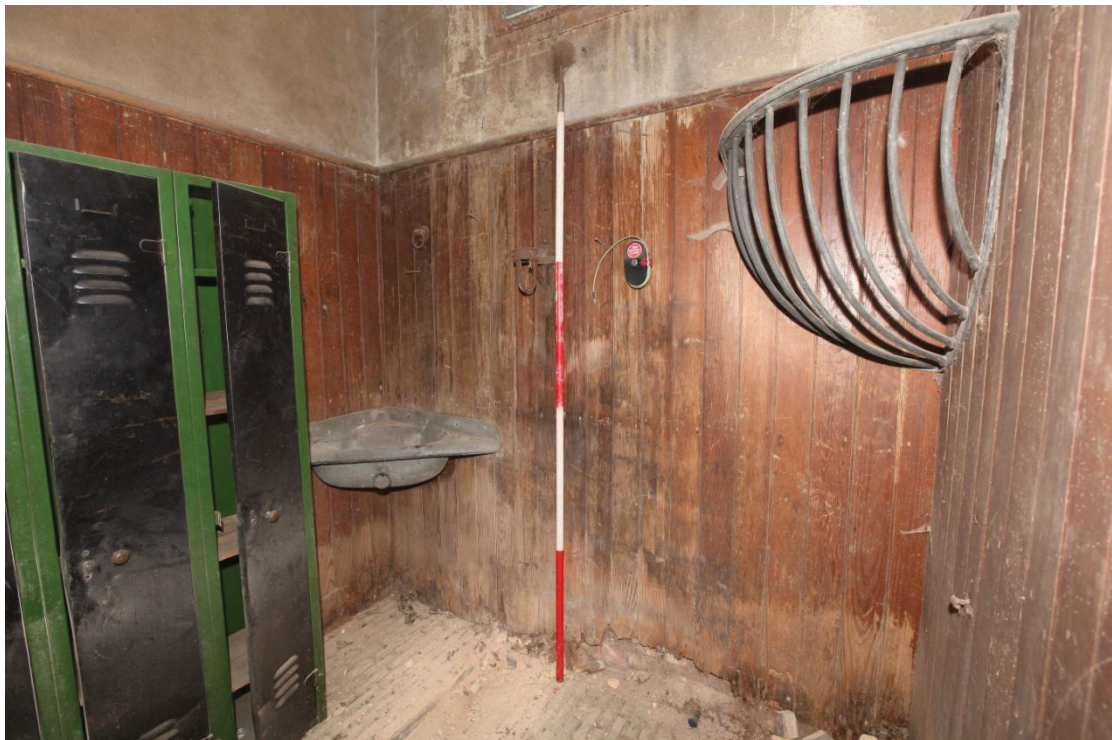
Illus. 14. The eastern internal elevation of the single stall (4) at the northern end of the single-storied eastern range showing its iron hay basket to the right and a pressed metal trough in the opposite corner.
