**West Villa,  
Woodbridge Road, Ipswich  
IPS 771**

**Historic Building Record**

# **West Villa (Formerly Ipswich Workhouse), Woodbridge Road East, Ipswich, Suffolk**

## **Historic Building Record**

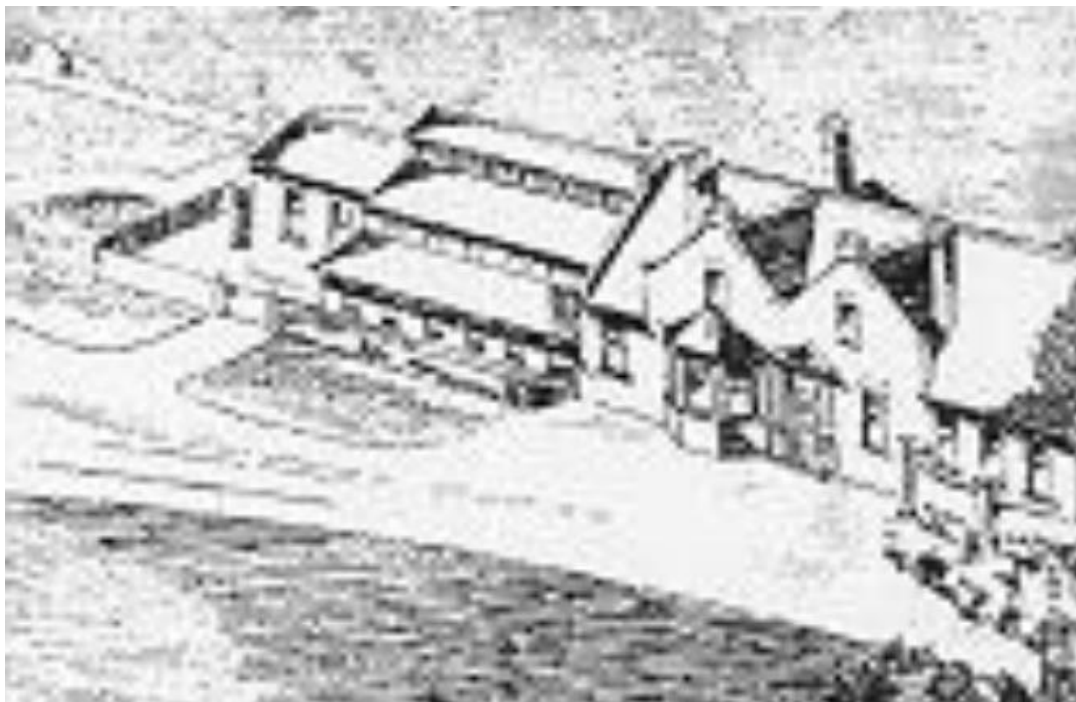
**Figure 2a. A detail of figure 2 showing the detached northern block of the workhouse which forms the subject of this report. The shape of this original structure is still recognisable although the narrow upper tier of windows has been lost, and the position of its principal entrance to the south (left) as indicated by a gate remains unaltered.**
