HISTORIC BUILDING PHOTOGRAPHIC SURVEY
AT THE BARN,
UPPINGHAM ROAD,
MEDBOURNE, LEICESTERSHIRE.

National Grid Reference: SP 8012 9364
Leicestershire Museums Service Accession No.: X.A130.2014
Planning Reference: 14/00965/FUL (Revised Scheme of
13/01295/FUL)

PREPARED FOR MR. BILL JONES

September 2015

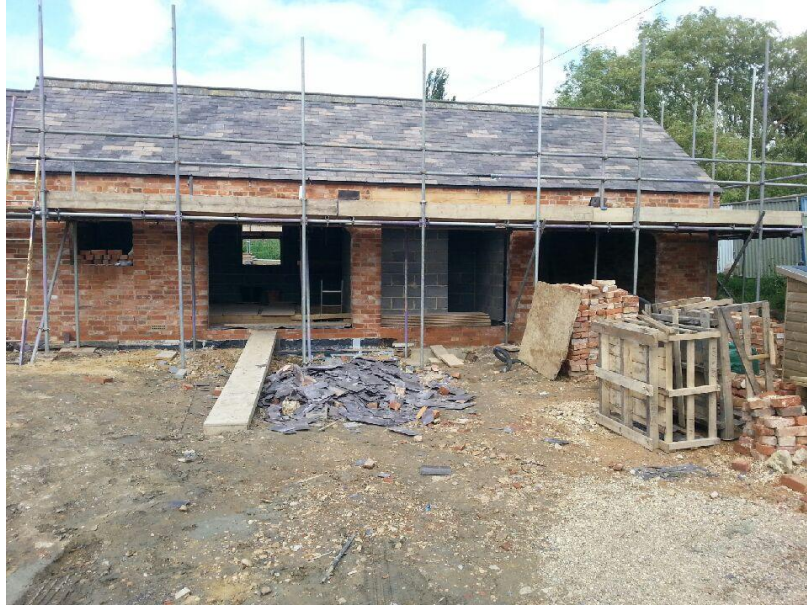
Plate 27: View of the new South Elevation, from the south

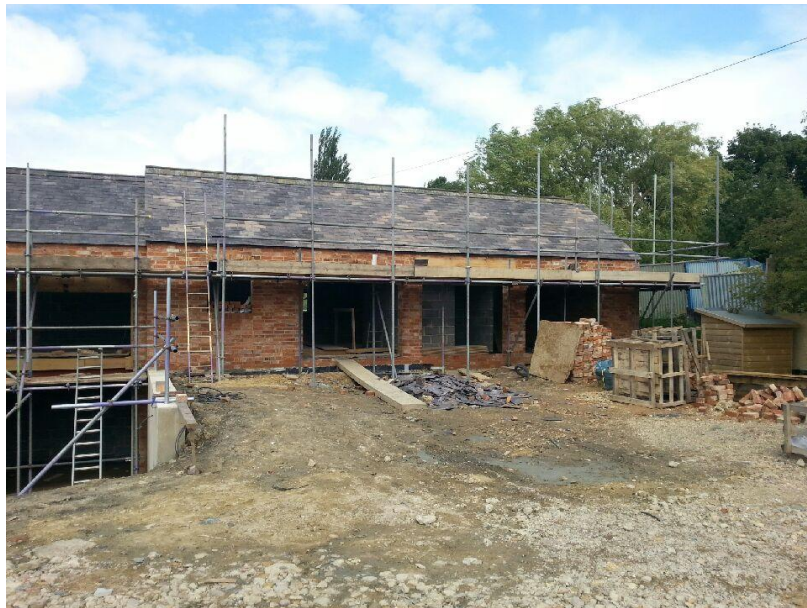
Plate 28: View of the new South Elevation and extension, from the south

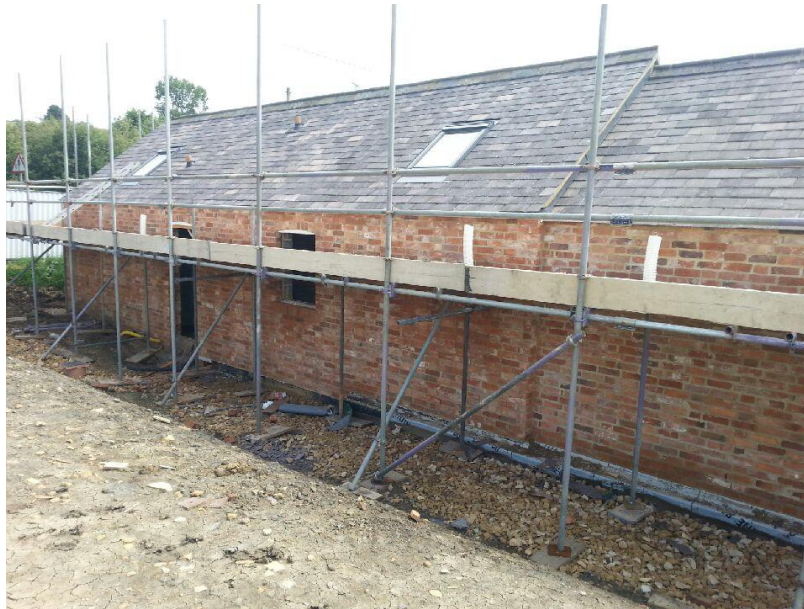
Plate 29: View of the new North Elevation, from the north-east

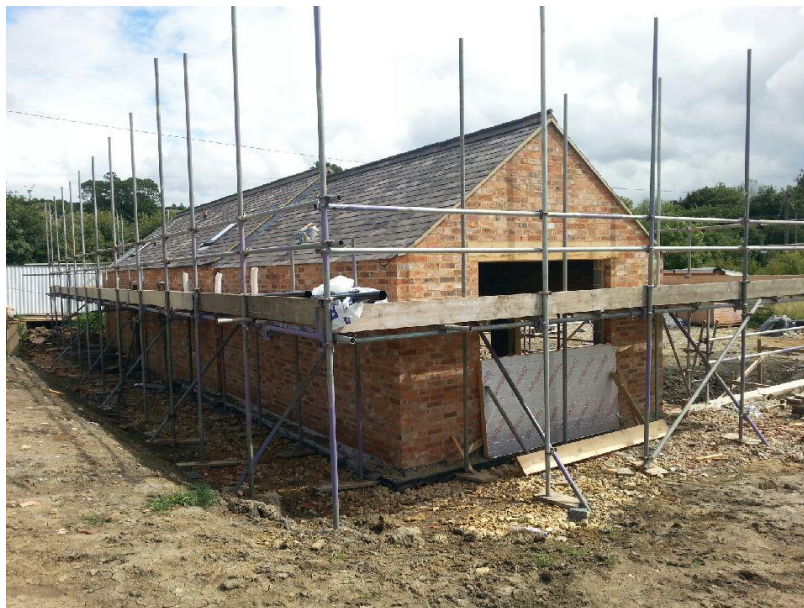
Plate 30: View of the new build, from the west

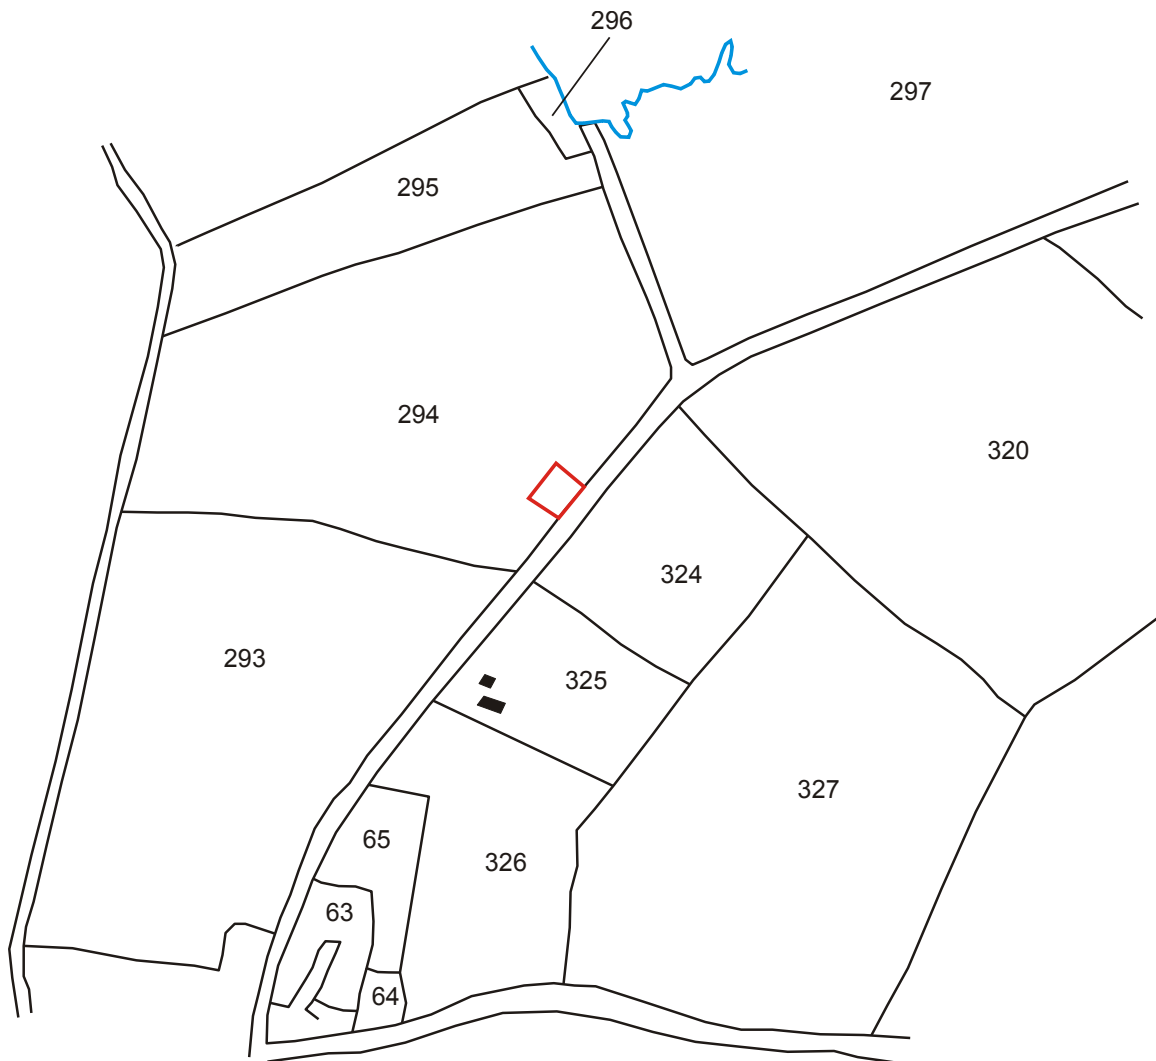
- 5.2 The earliest map consulted comprised an extract from the tithe map for the parish of Medbourne of 1847 (Archive ref: Ti/218/1) [Figure 4]. This map shows the area of the development site as lying within a large open field, which fronts onto the Uppingham Road to the east. There is no sign of the barn in this field, apparently not having yet been constructed.

Figure 4: Extract from the tithe map for the parish of Medbourne of 1847 (Archive ref: Ti/218/1). The approximate location of the site is shown outlined in red.

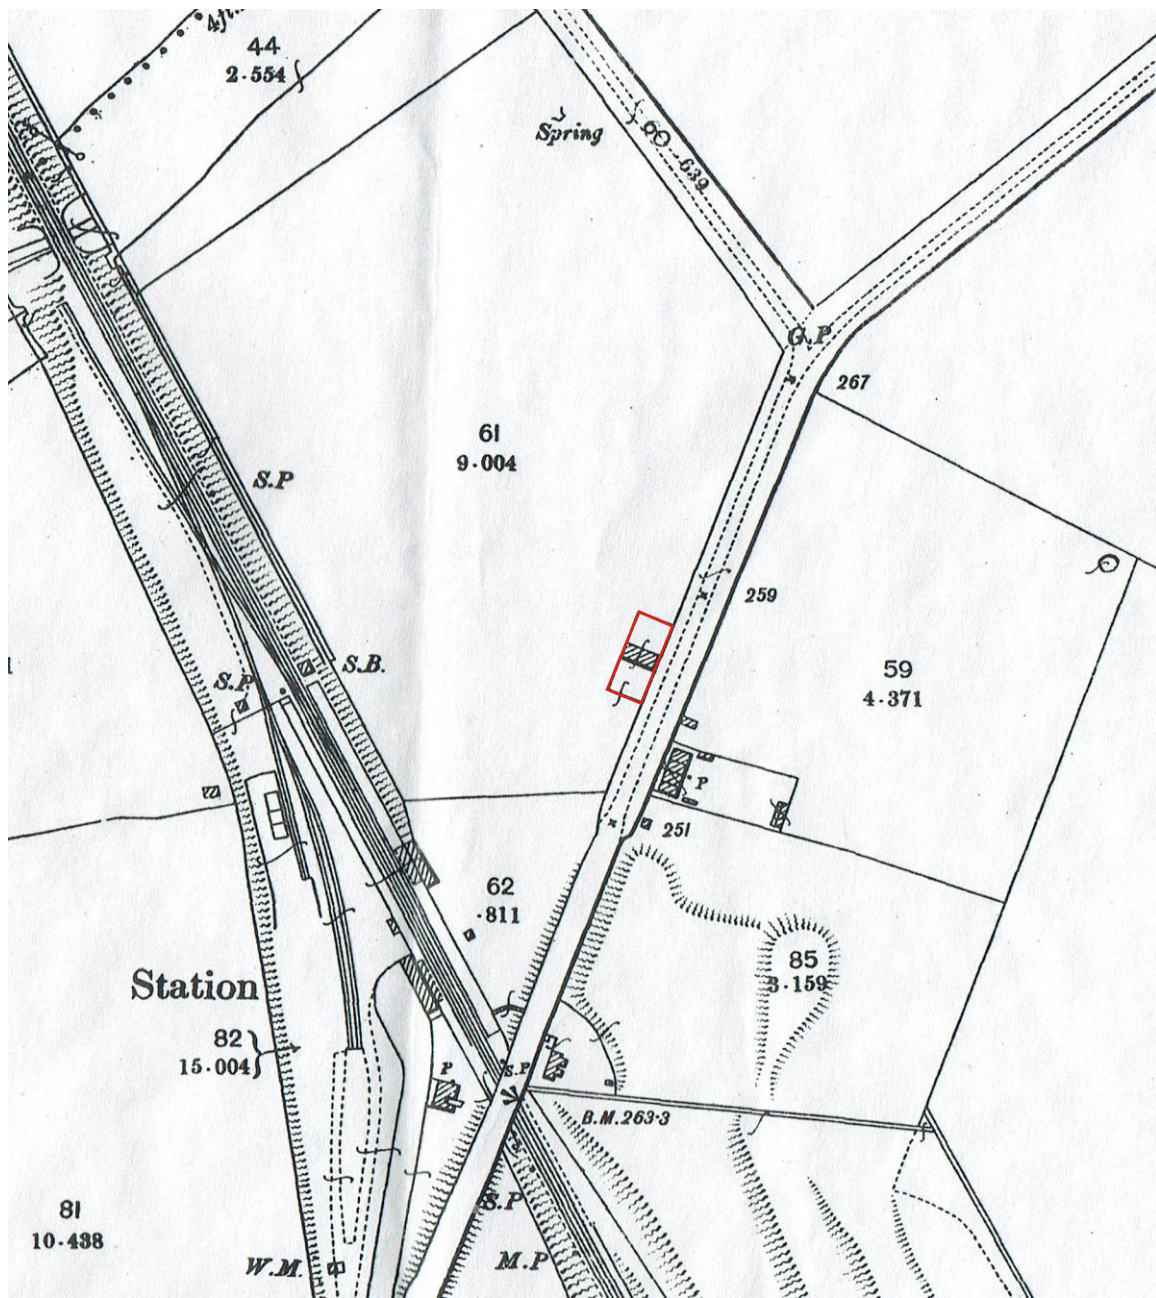
- 5.3 An extract from the Second Edition 25 inch to one mile scale Ordnance Survey (O.S.) map of 1904 shows the barn at its present location on the western frontage of the Uppingham Road and also located within a small rectangular shaped enclosure [Figure 5].

Figure 5: Extract from the Second Edition 25 inch to one mile scale Ordnance Survey (O.S.) map of 1904, map sheet no. Leicestershire 46.7. The site is shown outlined in red.

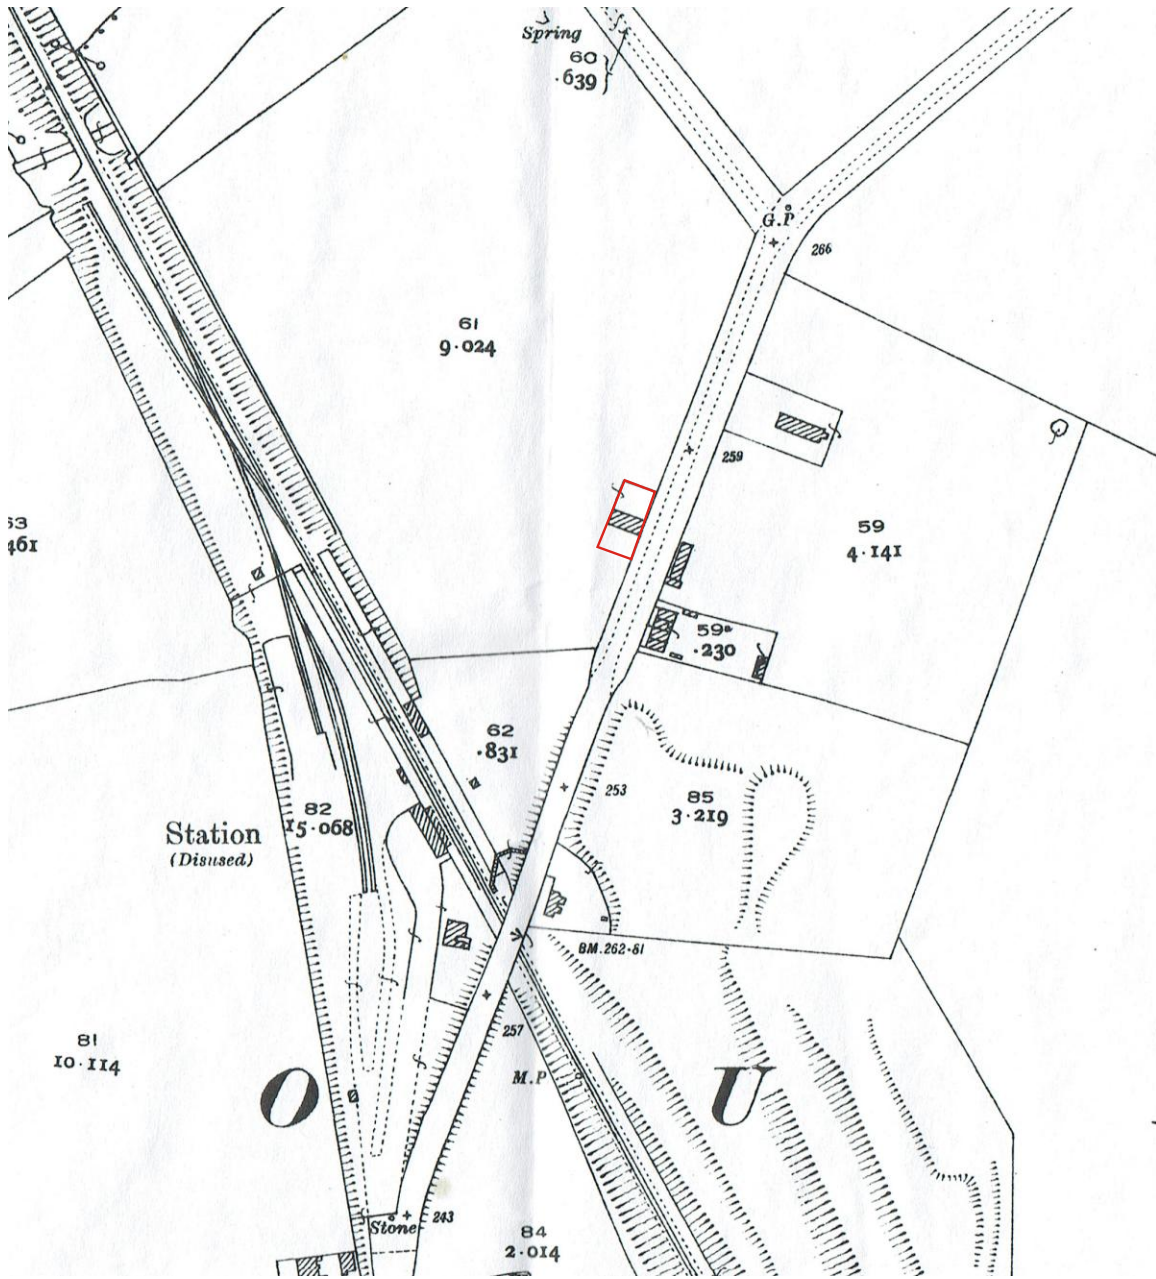
- 5.4 An extract from the Provisional Edition 25 inch to one mile scale Ordnance Survey (O.S.) map of 1929 features the barn now within a smaller rectangular shaped enclosure, which is located to the north of the barn [Figure 6].

Figure 6: Extract from the Provisional Edition 25 inch to one mile scale Ordnance Survey (O.S.) map of 1929, map sheet no. Leicestershire 46.7. The site is shown outlined in red.

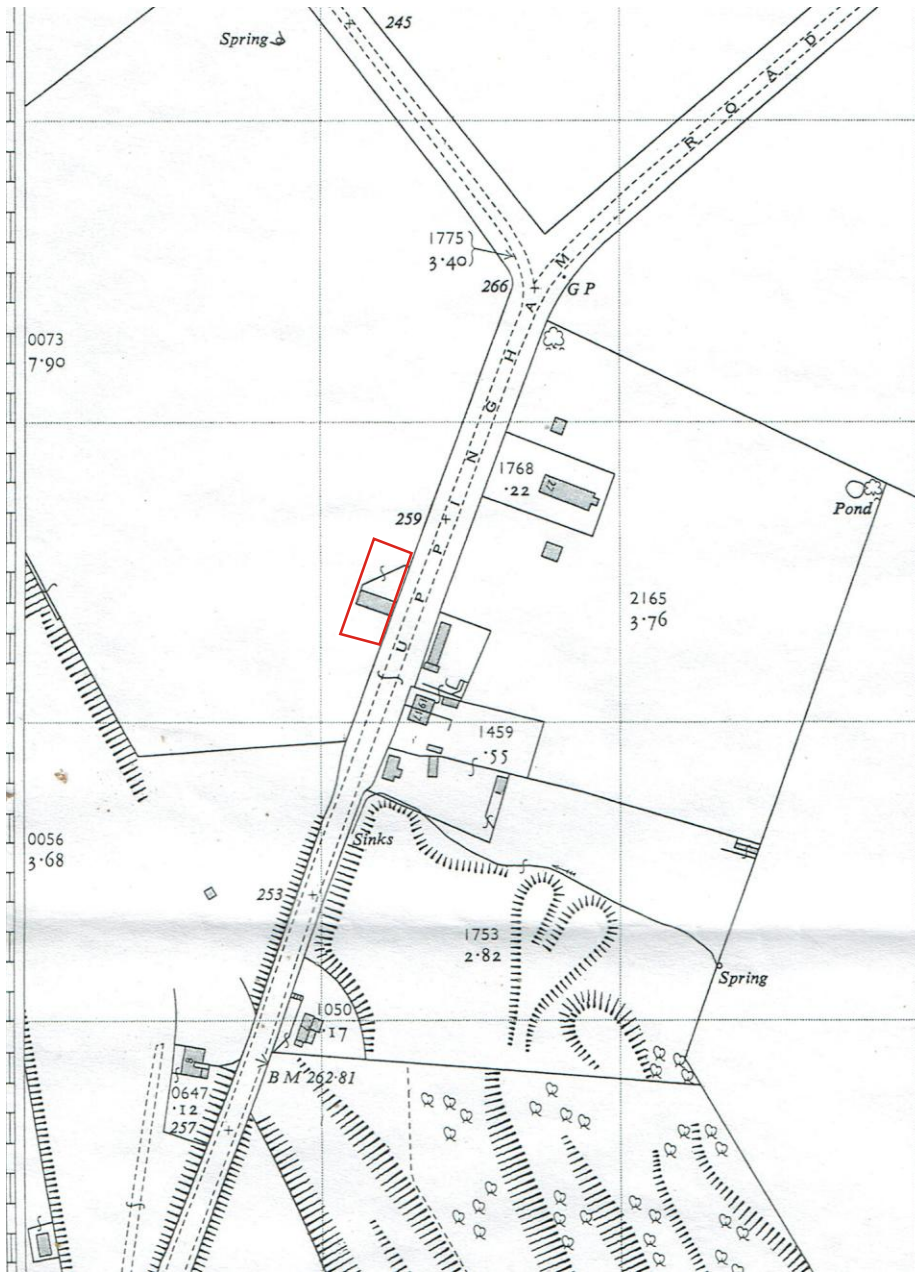
- 5.5 An extract from the 1:2,500 scale Ordnance Survey (O.S.) map of 1960 shows the barn on the western frontage of the Uppingham Road with a triangular shaped enclosure to the north [Figure 7].

Figure 7: Extract from the 1:2,500 scale Ordnance Survey (O.S.) map of 1960, map sheet no. SP8093. The site is shown outlined in red.
