HISTORIC BUILDING RECORDING AT
PRIORY FARM,
HOWSHAM ROAD, KETTLEBY,
LINCOLNSHIRE

National Grid Reference: TA 0368 0712
Planning Reference: 133407
Site Code: PFKE15
Accession Number: LCNCC: 2015.248

January 2016

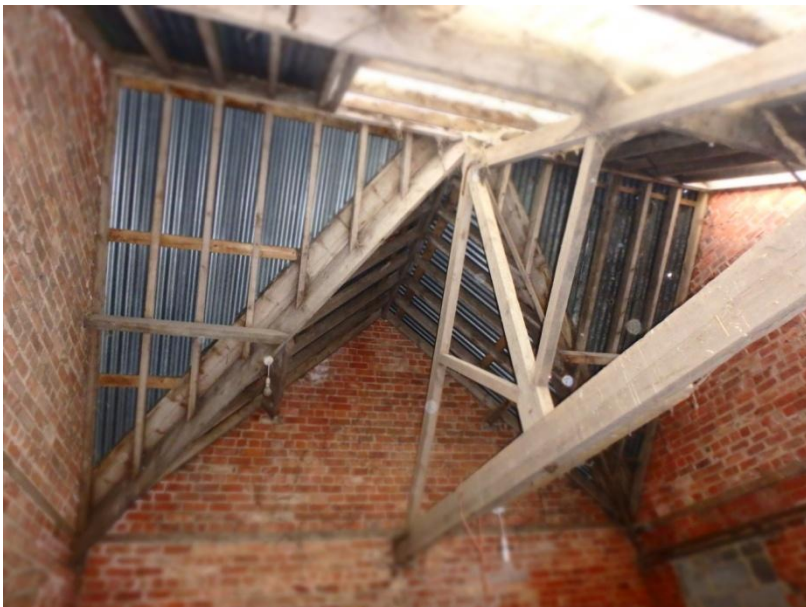
Plate 80: View of the roof supporting structure of Cell 3, from the north

Plates 79 and 80-82 provide further views of this king post roof truss and also feature the nature of the roof supporting structure within **Cell 3** consisting of an horizontal timber wallplate along the upper levels of the north wall, a series of common rafters and horizontal principal purlins and

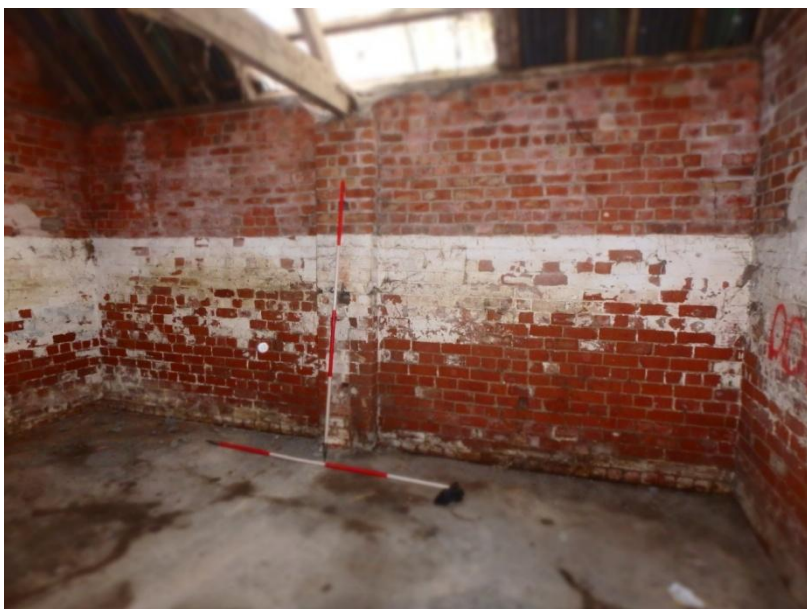
Plate 83: View of the north wall of Cell 3, from the south

Plate 83 features a portion of the north wall of the North Range. The brickwork wall fabric in English Garden Bond matches that of the external face of this wall. At ground floor ceiling level is an horizontal timber wallplate. At the centre of this north wall is a vertical column in brick also in English Garden Wall Bond. This column supports in turn the king post roof truss above. The floor of **Cell 3** is of modern concrete.

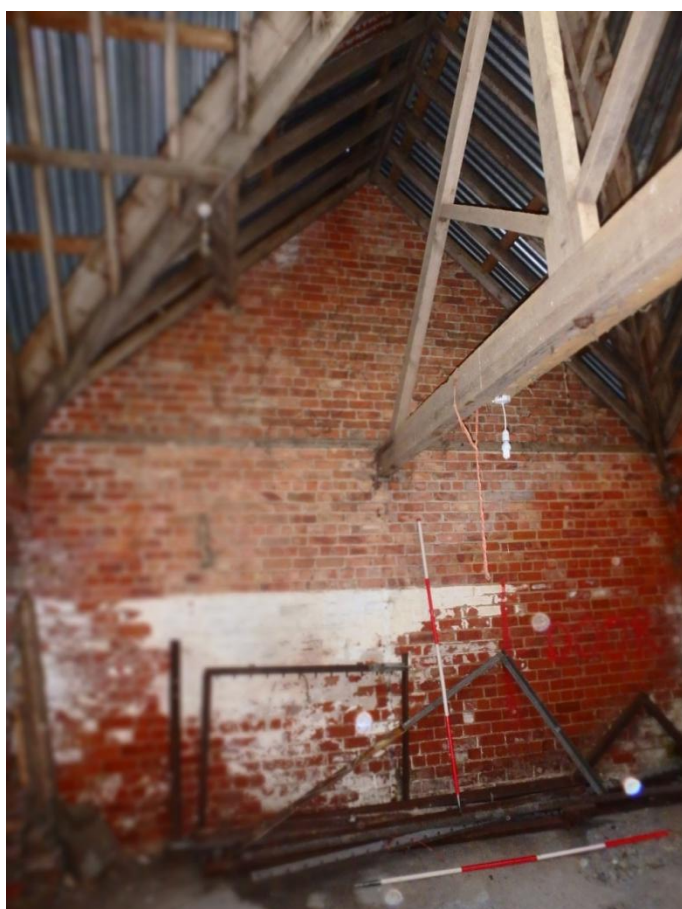
Plate 84: View of the south wall of Cell 3, from the north

Plate 84 provides a view of the south wall of **Cell 3**, which is an internal dividing wall with the north wall of **Cell 2** to the south. The brickwork wall fabric in English Garden Bond also matches that of the brickwork wall fabric of the opposing north wall of **Cell 3**. There is an horizontal timber wallplate at ground floor ceiling level. There is also an absence of an opposing vertical brick column in this wall with the tie beam of the king post roof truss inserted into the brickwork fabric of this wall.

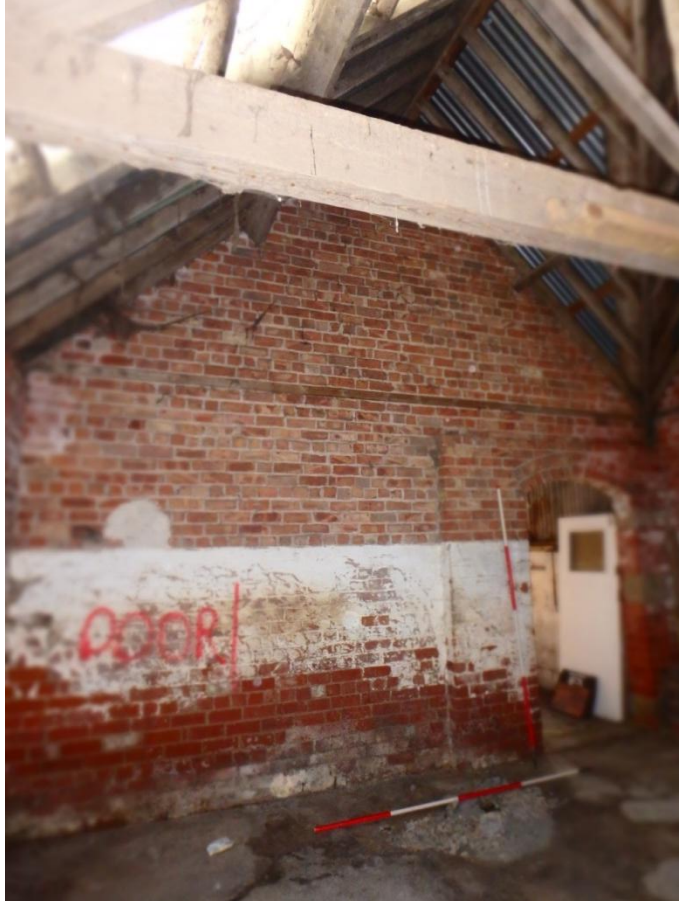
Plate 85: View of the east wall of Cell 3, from the west

Plates 85 and 86 provide images of the east wall of **Cell 3**, which is the internal dividing wall between **Cell 3** and **Cell 4** within the North Range. The brickwork wall fabric here consists of three courses of brick stretchers which alternate with a course of brick headers in English Garden Wall Bond. The bonding material is the light buff sandy mortar. There is in addition an horizontal timber wallplate at ground floor ceiling level. To the right (south) is a doorway which extends onto **Cell 4** to the east, which is occupied by a modern door. The curved door head is of two courses of brick headers. The doorway is also contained within a small brick alcove with the brickwork in matching English Garden Wall Bond.

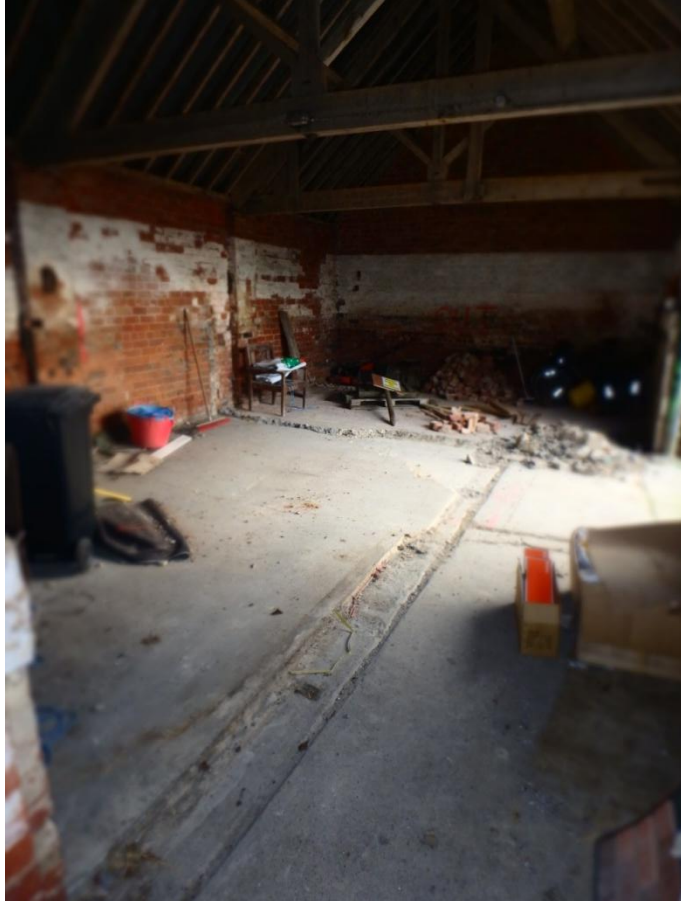
Plate 87: View of Cell 4, from the west

Plate 87 provides a general view of **Cell 4**, featuring the modern concrete floor.

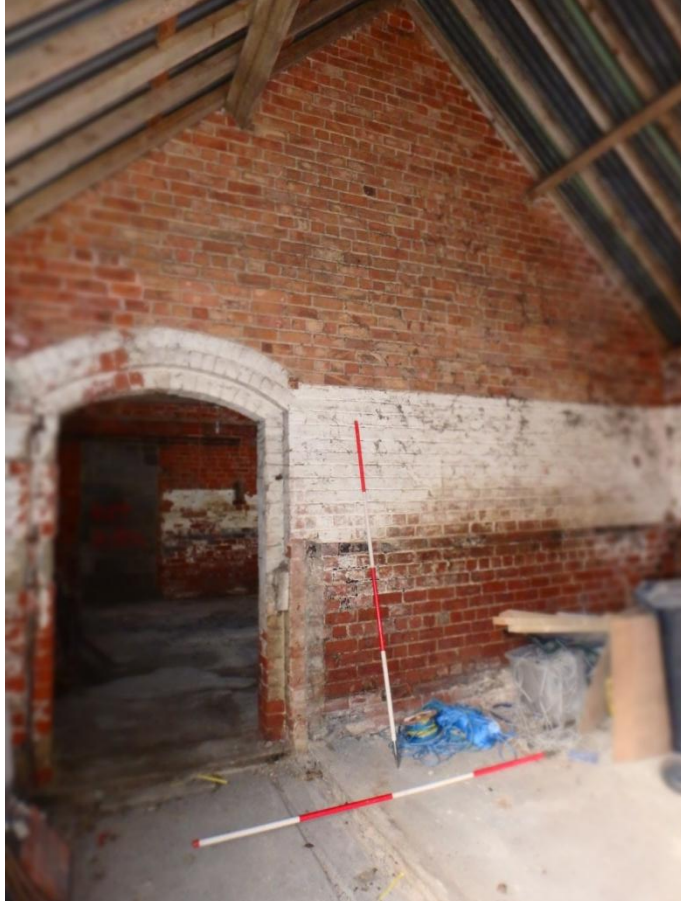
Plate 88: View of the west wall of Cell 4, from the east

Plate 88 features the west wall of **Cell 4**. The brickwork wall fabric of this west wall comprises three courses of brick stretchers which alternate with one course of brick headers in English Garden Wall Bond. To the left (south), is an original internal doorway, which extends onto **Cell 3**

to the west. The curved door head is composed of two courses of brick headers. The doorway is also slightly recessed with the surrounds in brick headers with a secondary recessed door head composed of a single course of headers. To the left (south) are a series of three worked, shaped and faced stone ashlar into which the original door hinges were fixed to, and which are incorporated into the surrounding brickwork wall fabric.

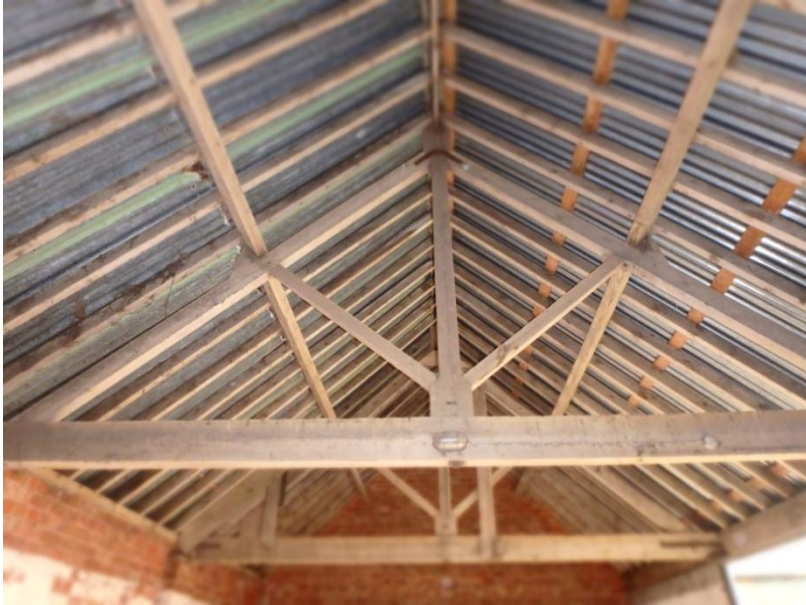
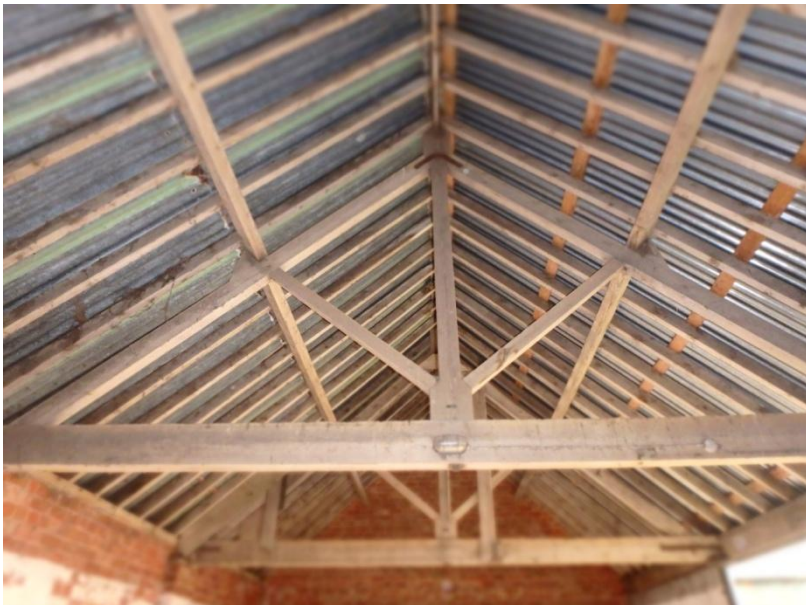
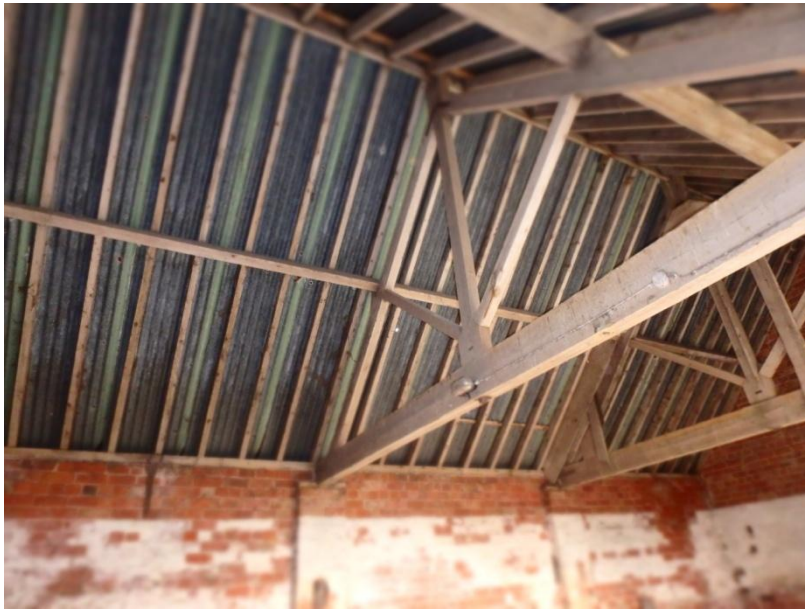
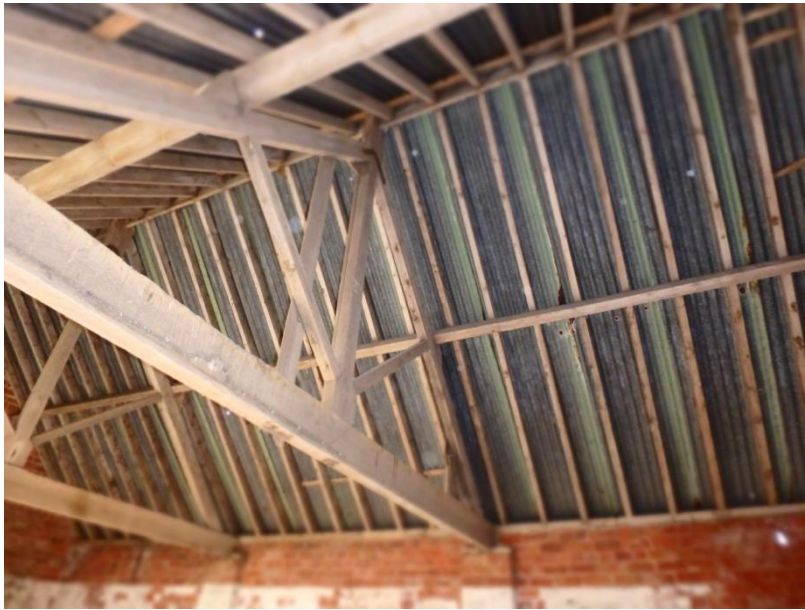
Plates 90-93 provide various views of the roof supporting structure of **Cell 4**, the most distinctive portions of which are two additional king post roof trusses. These provide the major structural elements to this roof supporting structure, which is composed of horizontal timber wallplates along the upper levels of the north and south walls. To these are attached a series of common

rafters. Fixed to the rafters in turn are a series of horizontal principal and secondary timber purlins. The common rafters extend upward to horizontal timbers at the roof apex. This overall structure supports the roof covering of sheets of modern corrugated metal.

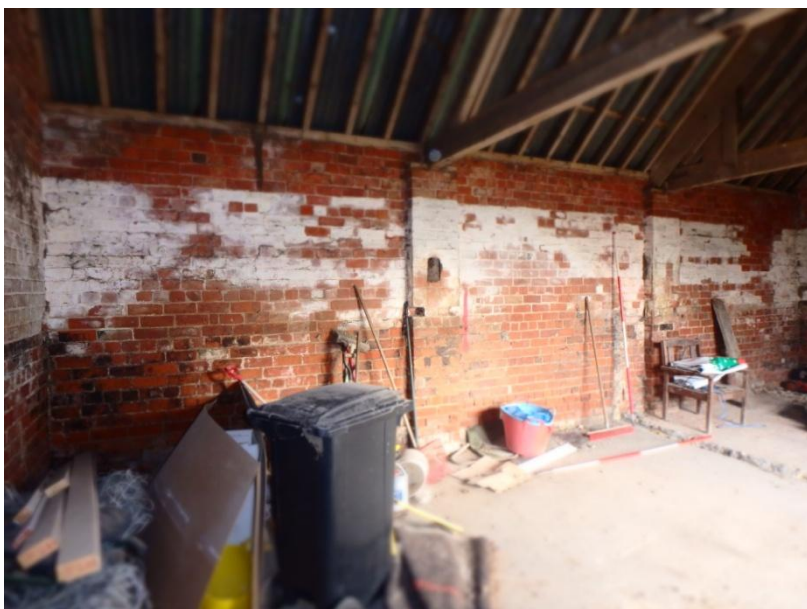
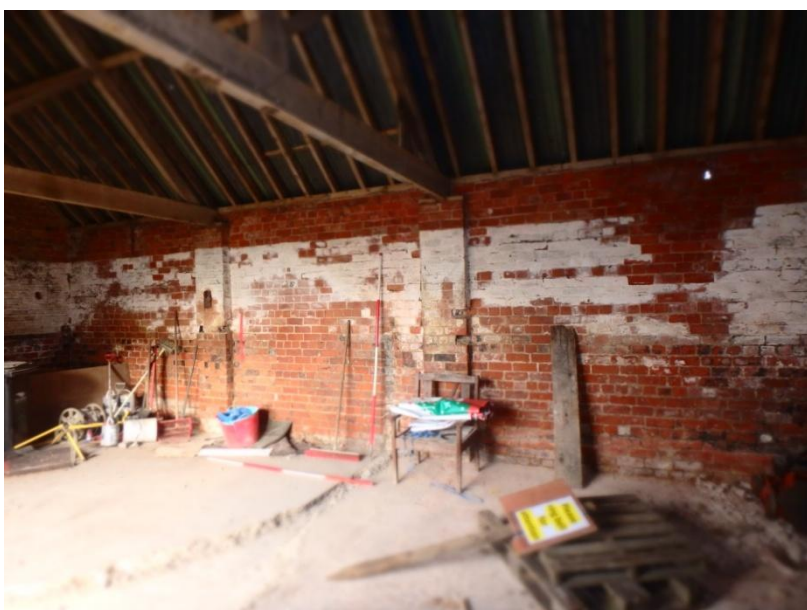
Plates 94 and 95 feature the north wall of **Cell 4**. The brickwork wall fabric here comprises three courses of brick stretchers which alternate with one course of brick headers in English Garden Wall Bond. The bonding material is the light buff lime mortar. There is an horizontal timber wall plate at ground floor ceiling level. There are in addition two vertical columns in brick which support the aforementioned two king post roof trusses. The brickwork of these two columns match that of the surrounding wall fabric.

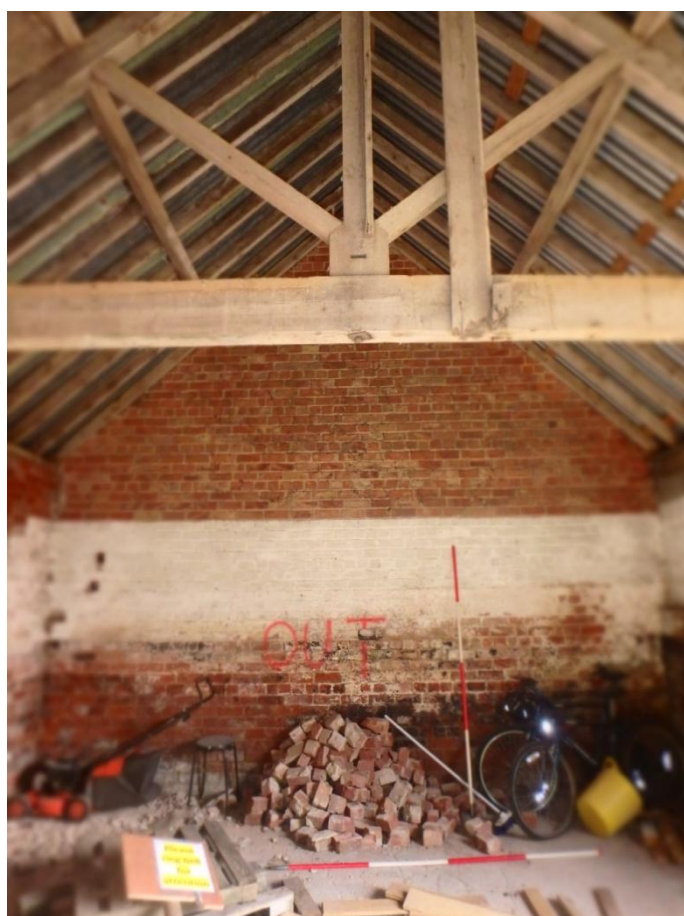
Plate 97: View of the east wall of Cell 4, from the west

Plate 97 features the east wall of **Cell 4**. The brickwork wall fabric here matches that of the opposing face of this wall which is the East Elevation of the North Range consisting of three

courses of brick stretchers which alternate with one course of brick headers in English Garden Wall Bond. The bonding material consists of light buff sandy mortar.

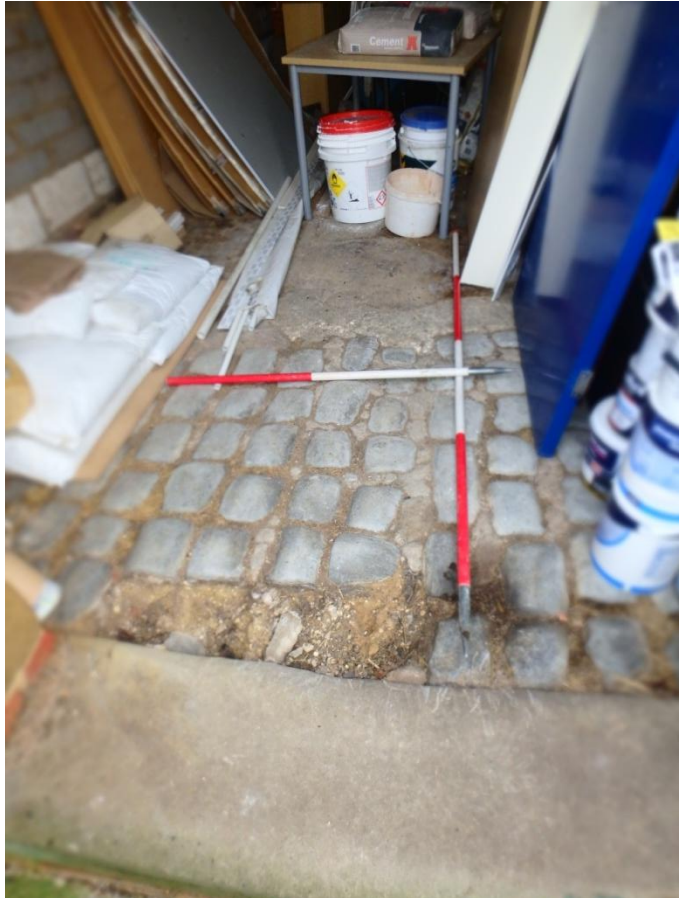
Plate 98: View of the floor of Cell 5, from the west

Plate 98 features the floor of **Cell 5**, which is composed of courses of stone cobbles or setts within a bed of a light buff sandy mortar. These are flush against the stone threshold featured in the foreground. A half wall of modern breeze block work bisects **Cell 5**.

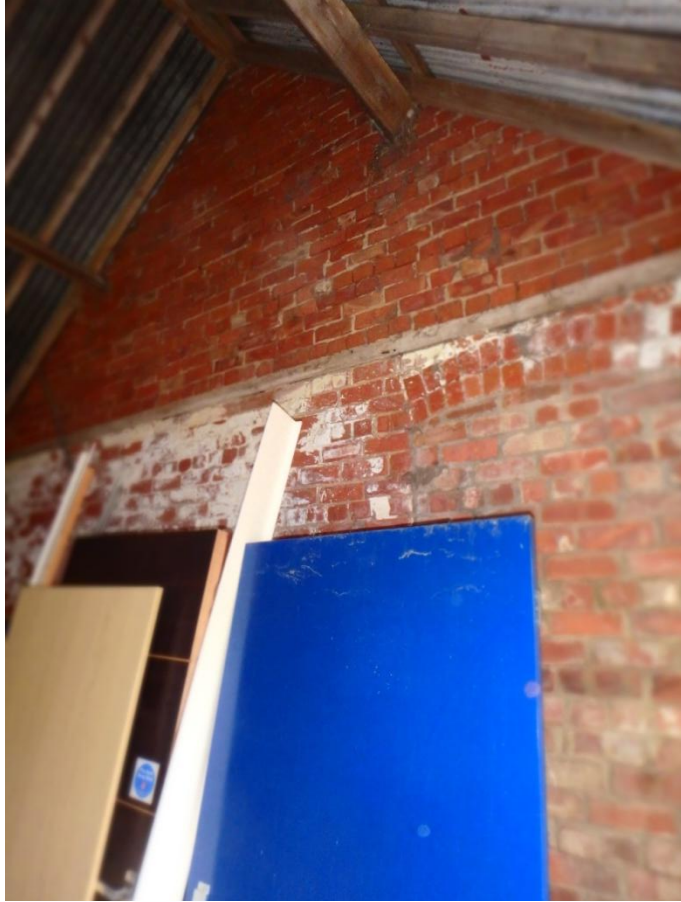
Plate 99: View of the south wall of Cell 5, from the north-west

Plate 99 provides a view of the south wall of **Cell 5**. The brickwork wall fabric of this south wall of three courses of brick stretchers which alternate with one course of brick headers in English Garden Wall Bond is identical to that previously recorded on the opposing external South Elevation of the East Range. There is an horizontal timber wallplate at ground floor ceiling level. The inner face of the infilled original former window opening which was also previously recorded on the opposing South Elevation has a curved head of two courses of brick headers with the brick infill matching that of the surrounding brick wall bonding. The bonding material is of a light buff sandy mortar.

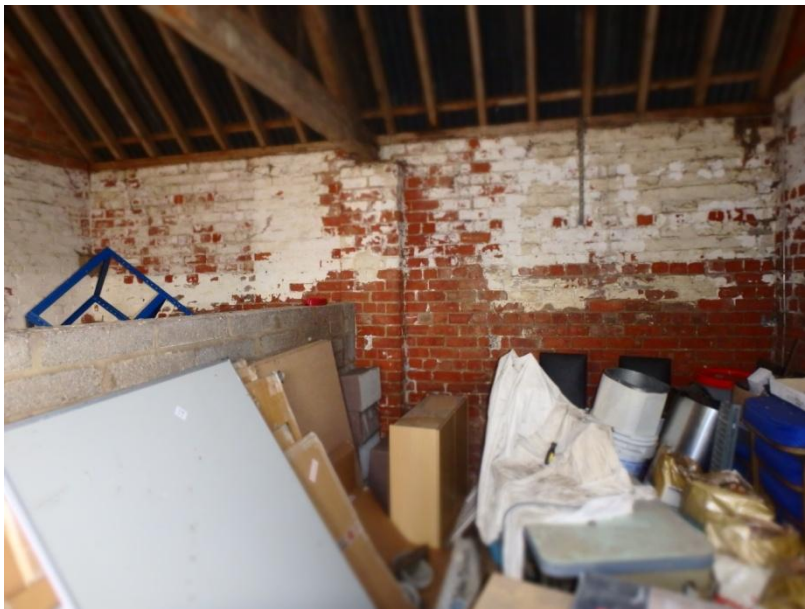
Plate 100: View of the east wall of Cell 5, from the west

Plate 100 features the east wall of **Cell 5**. The brickwork wall fabric of this south wall of three courses of brick stretchers which alternate with one course of brick headers in English Garden Wall Bond is identical to that previously recorded on the opposing external east wall of the East

Range. There is an horizontal timber wallplate at ground floor ceiling level. There is also a central vertical column in brick (which is also in English Garden Wall Bond), which supports the king post roof truss.

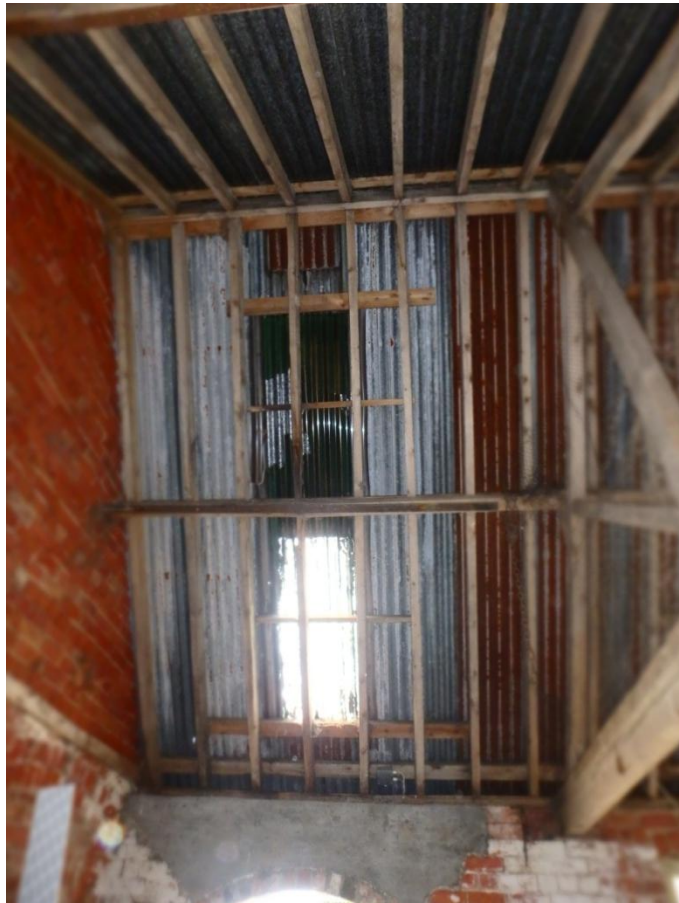
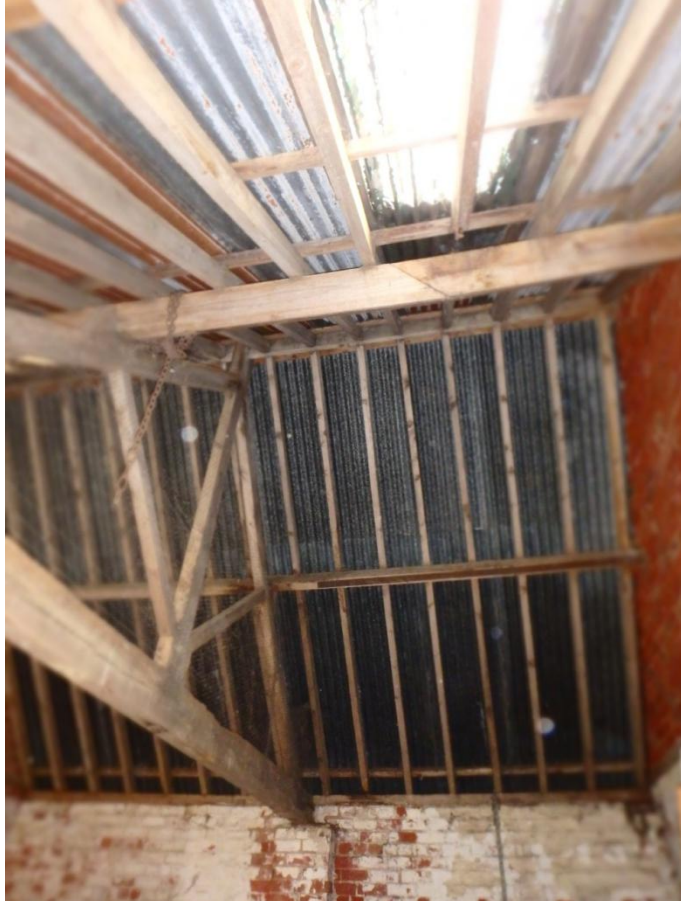
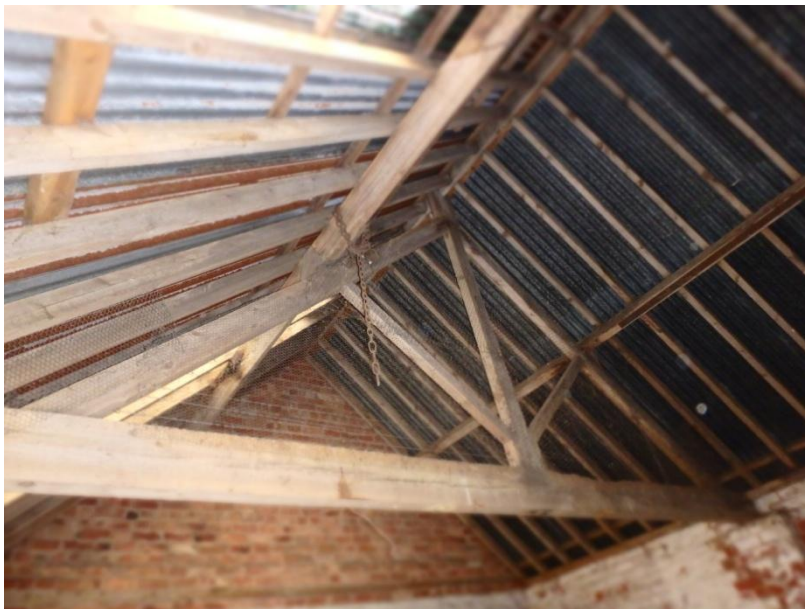
Plates 102-104 provide images of the roof supporting structure of **Cell 5**. The king post roof truss is attached to the principal rafters and horizontal principal purlins of this roof structure, which also consists of horizontal timber wallplates at the upper levels of the east and west wall, along with a

series of common rafters and horizontal secondary purlins. The rafters in turn extend upwards to horizontal timbers at the roof apex.

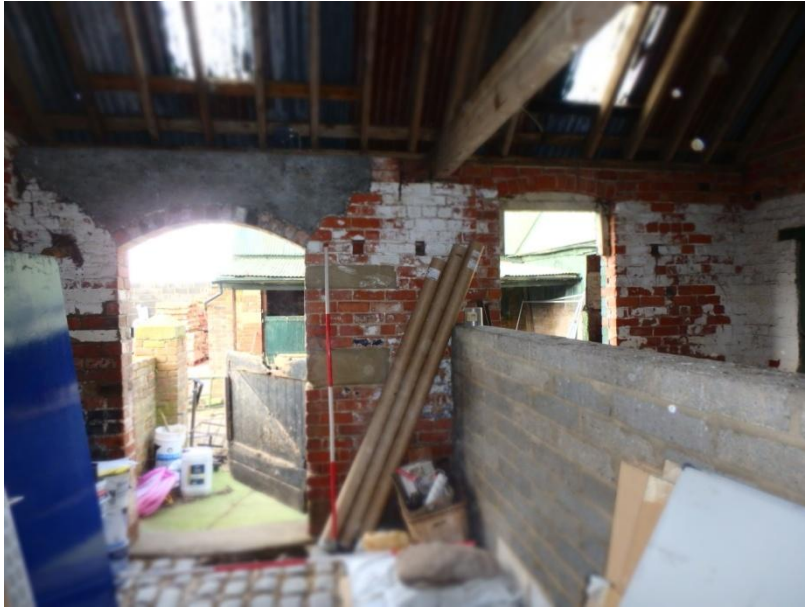
Plate 105: View of the west wall of Cell 5, from the east

Plate 105 features the west wall of **Cell 5**. The brickwork here is also of English Garden Wall Bond, which is identical to that of the external opposing East Elevation of the East Range. The inner face of the southernmost door opening is also featured to the left (south). This recessed entrance is within an alcove upon which the king post roof truss rests. There is an inner curved door head of two courses of brick headers and the three stone ashlar which were also previously recorded on the external East Elevation are also shown to the right (north). The timber half door also featured is constructed on an internal frame of angled and horizontal timbers.

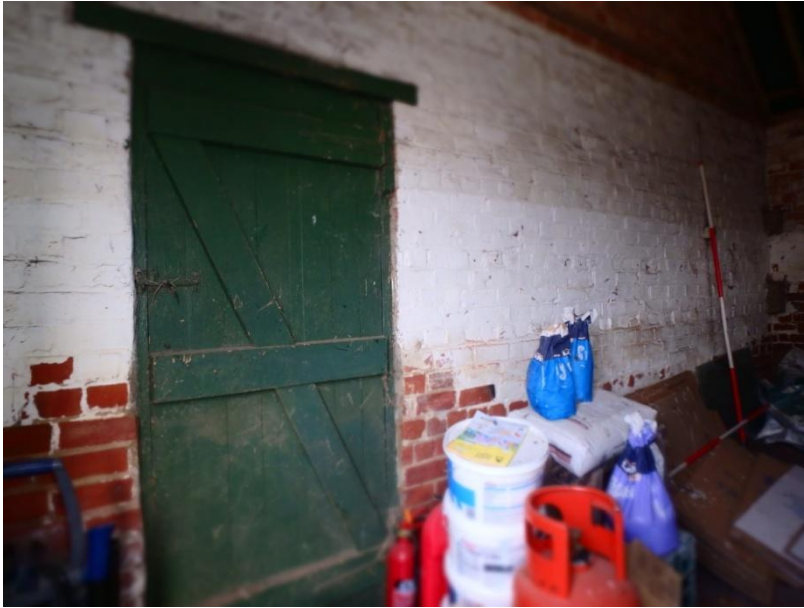
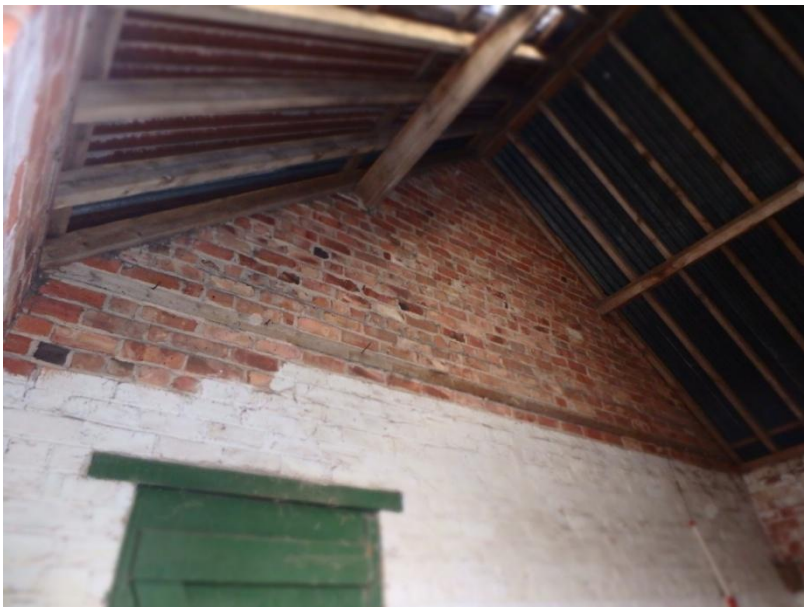
Plates 107-108 provide views of the upper and lower levels of the north wall of **Cell 5** respectively which is the internal dividing wall between **Cell 5** and the adjoining **Cell 6** of the East Range to the north. The brickwork wall fabric of this north wall is composed of three courses of brick stretchers which alternate with one course of brick headers in English Garden Wall Bond. The bonding material is the same light buff sandy mortar. There is an horizontal timber wallplate at ground floor ceiling level. To the left (west) is a door opening which leads onto **Cell 6** to the north. The door is composed of a series of vertical tongued and grooved planks constructed on an internal frame of angled and horizontal timbers. The door opening has a horizontal timber lintel with simple surrounds and head also in wood.

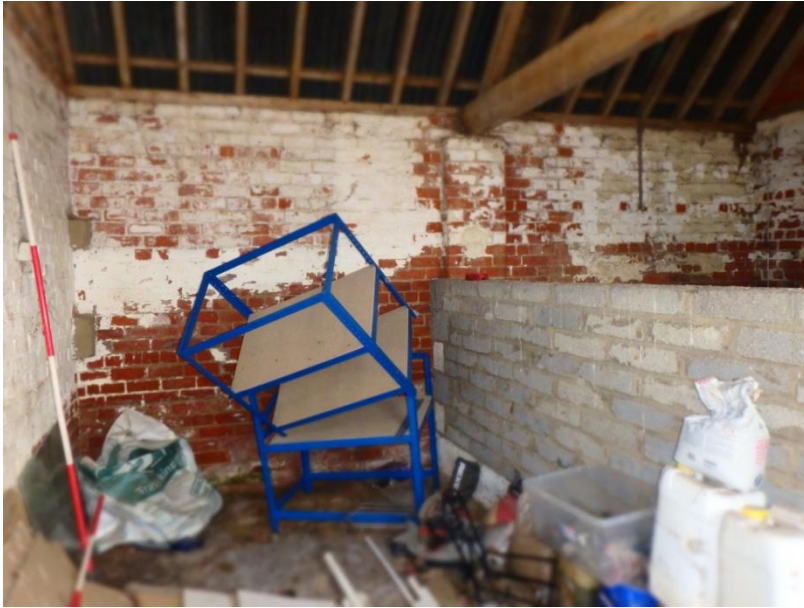
Plate 109: View of the east wall of Cell 5, from the west

Plate 109 features the east wall of **Cell 5**. The brickwork wall fabric of this south wall is composed of three courses of brick stretchers which alternate with one course of brick headers in English Garden Wall Bond identical to that previously recorded on the opposing external east wall of the

East Range. The bonding material is of the light buff sandy mortar. There is an horizontal timber wallplate at ground floor ceiling level. There is also a central vertical column in brick (which is also in English Garden Wall Bond), which supports the king post roof truss.

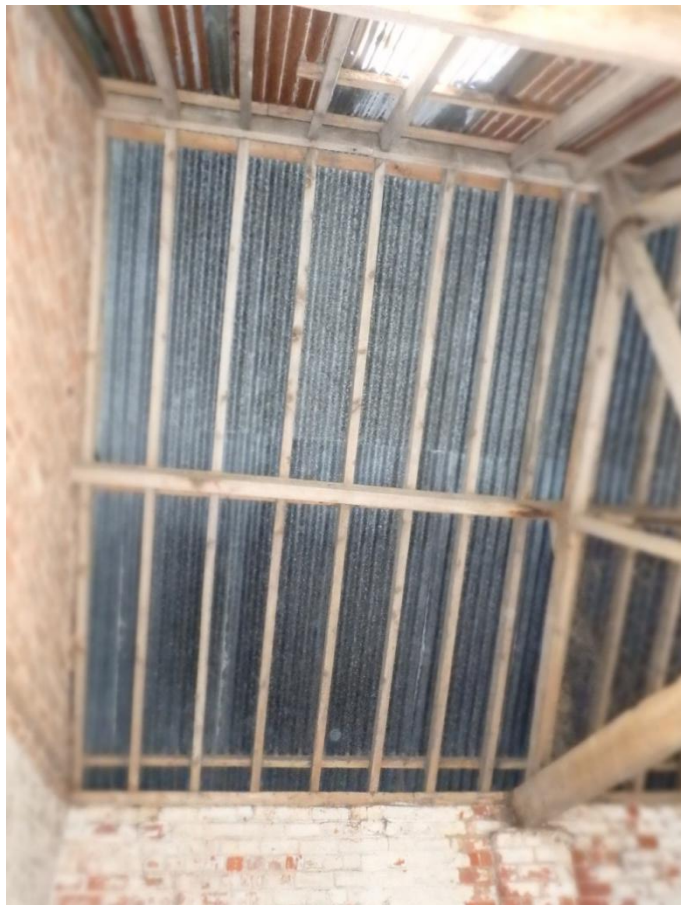
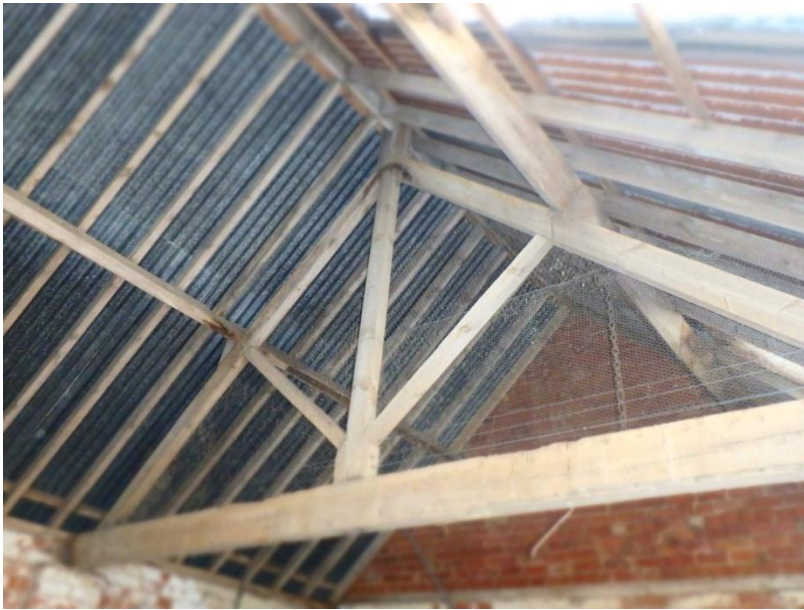
Plates 110-111 provide further views of the roof supporting structure of **Cell 5**. The king post roof truss is attached to the principal rafters and horizontal principal purlins of this roof structure, which also consists of horizontal timber wallplates at the upper levels of the east and west walls, along with a series of common rafters and horizontal secondary purlins. The rafters in turn extend upwards to horizontal timbers at the roof apex.

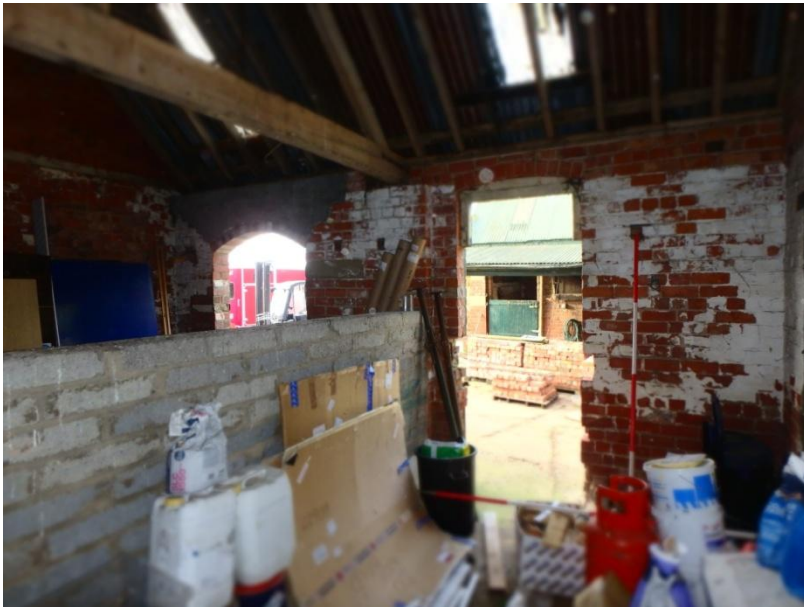
Plate 112: View of the west wall of Cell 5, from the east

Plate 112 provides a further view of the west wall of **Cell 5**. The brickwork wall fabric of this wall is also in English Garden Wall Bond. The inner face of the central entrance in the East Elevation

of the East Range is also shown with an inner brick head of one course of brick headers. There is a horizontal timber wallplate at ground floor ceiling level.

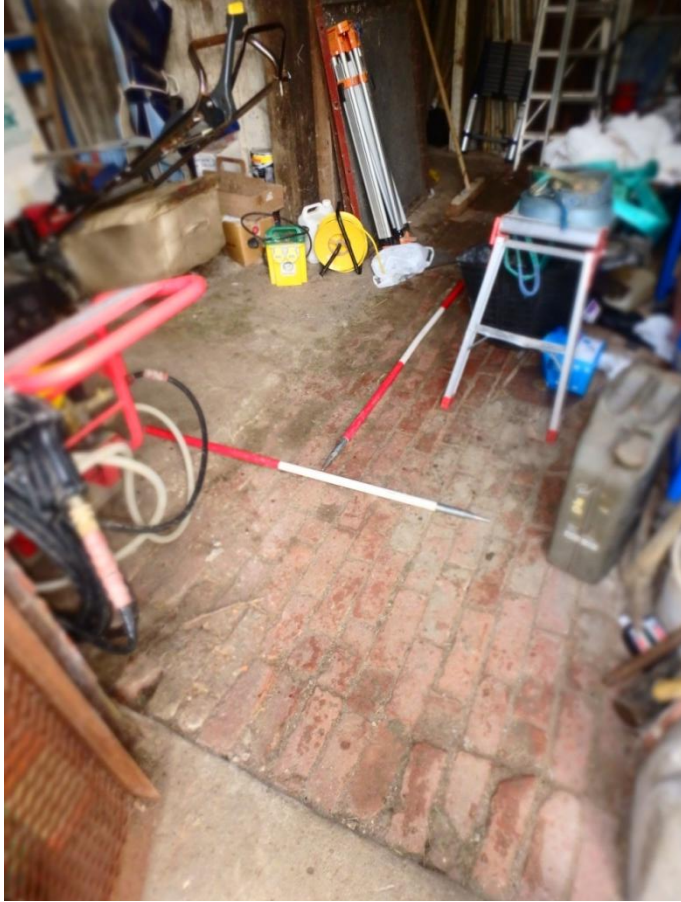
Plate 115: View of the floor of Cell 6, from the west

Plate 115 features the floor of **Cell 6** composed of courses of brick stretchers which are laid on side.

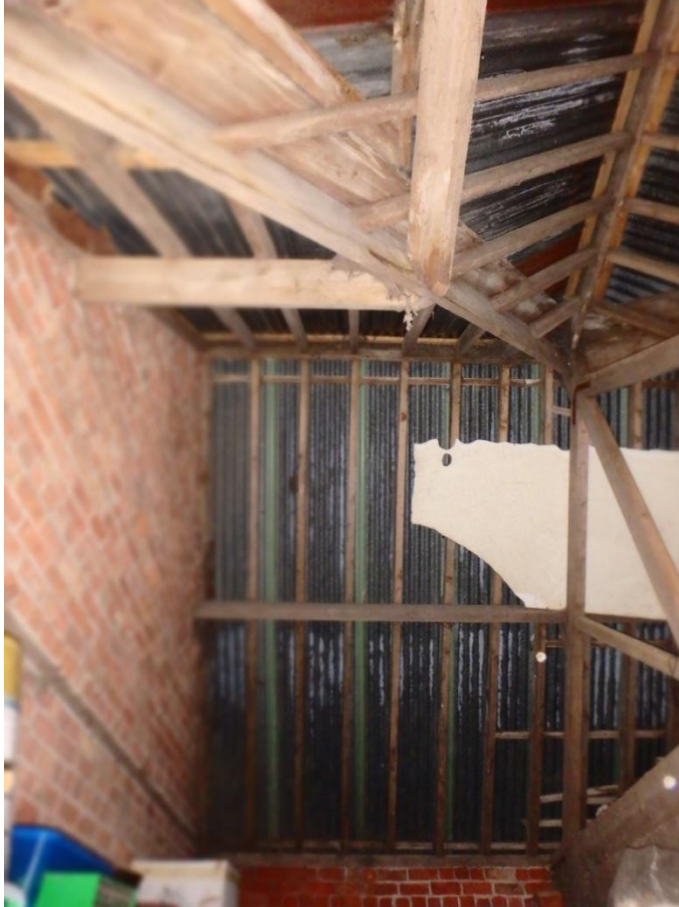
Plate 116: View of the roof supporting structure of Cell 6, from the south

Plate 116 features part of the roof supporting structure of **Cell 6**, which also corresponds to the eastern end of the roof supporting structure of the North Range. Here are the substantial angled roof end timbers and associated common and principal rafters and principal and secondary horizontal purlins. The rafters extend upwards to horizontal roof apex timbers.

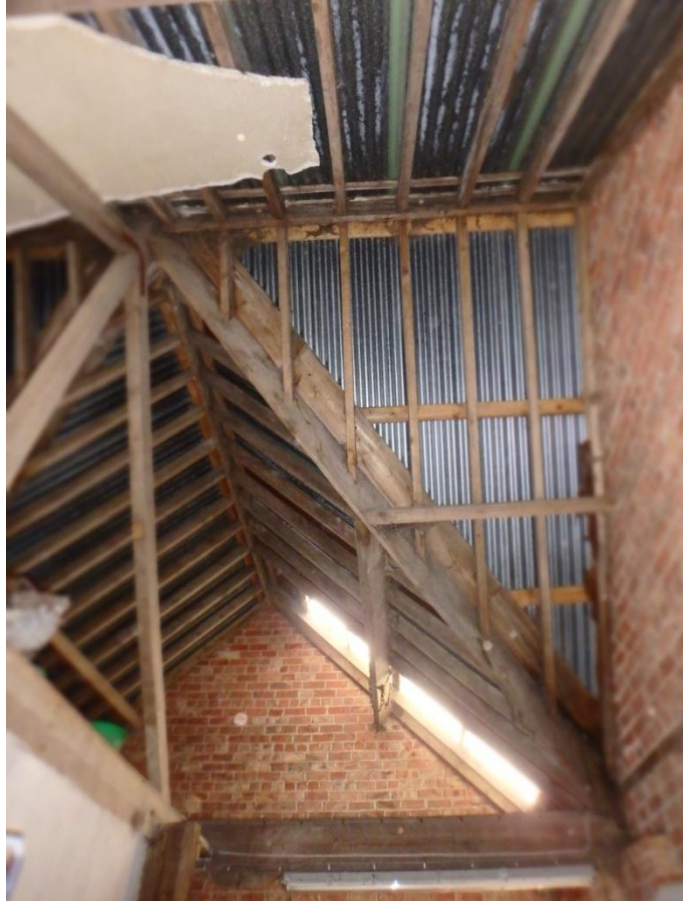
Plate 117: View of the roof supporting structure of Cell 6, from the north

Plate 117 provides a further view of the roof supporting structure of **Cell 6** and of the eastern end of the North Range. It also features the nature of the roof supporting structure of the northern end of the East Range, which is also composed of substantial angled roof end timbers. A series of common rafters, horizontal roof apex timbers and principal and secondary horizontal purlins are also featured.

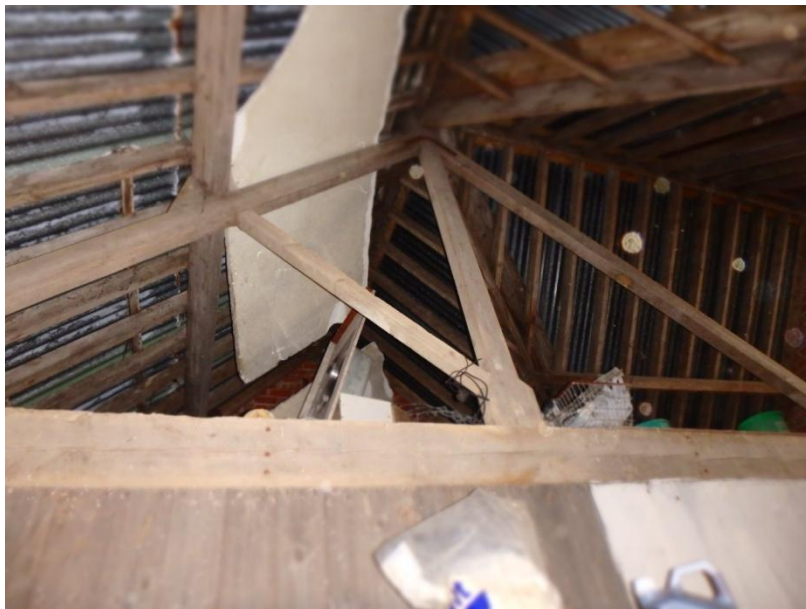
Plate 118: View of the roof supporting structure of Cell 6, from the west

In the foreground of Plate **118** is a substantial king post roof truss with the eastern end of the roof supporting structure of the North Range along with the northern end of the roof supporting

structure of the East Range also featured in the background making up the combined roof supporting structures of **Cell 6**.

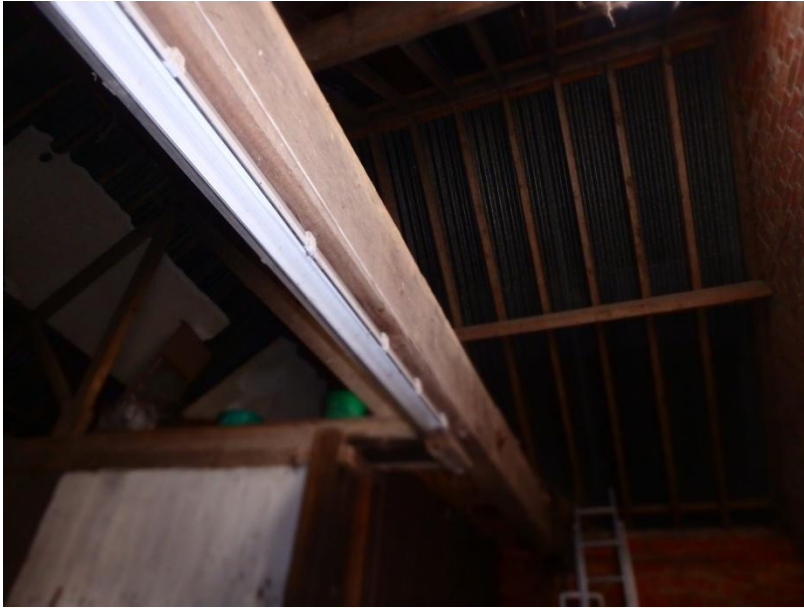
Plate 119: View of the roof supporting structure of Cell 6, from the west

Plate 119 features a substantial horizontal tie beam which extends across the length of **Cell 6** from north-south at ground floor ceiling level. **Plate 120** demonstrates that the aforementioned king post roof truss is attached to this tie beam to provide additional support and strength to the roof structures of **Cell 6** as a whole.
