**NEVILLE HALL
FREELANCE ARCHAEOLOGIST & CONSULTANT**

HISTORIC BUILDING RECORDING AT
WOODHOUSE FARM, HURN ROAD,
HOLBEACH, LINCOLNSHIRE

March 2018

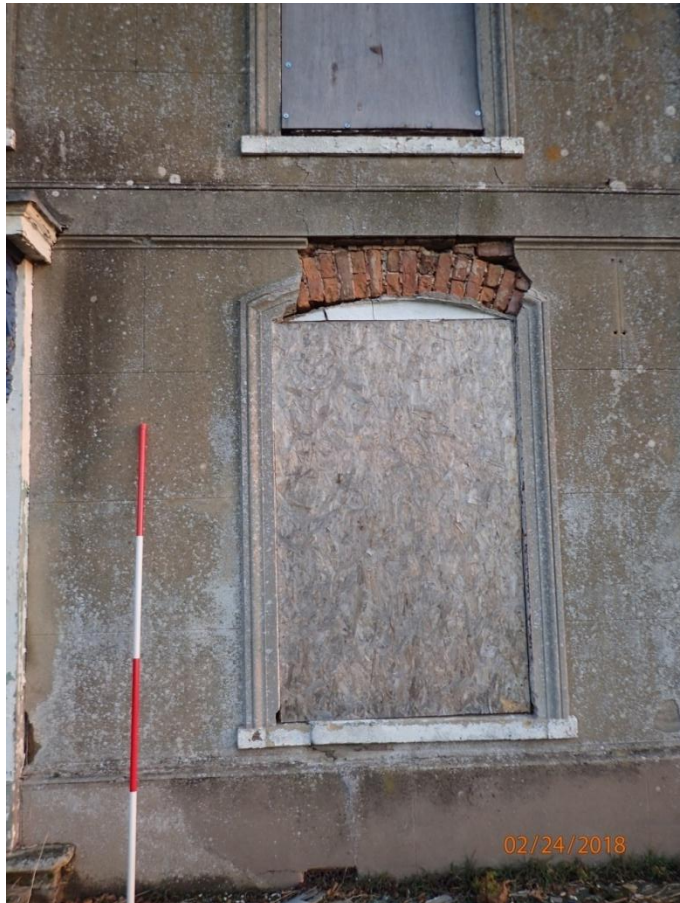
Plate 7: Detail: View of a ground floor window, from the south

Plate 7 features a detailed view of one of the south facing ground floor window openings, including the exposed underlying rounded window head in brick.

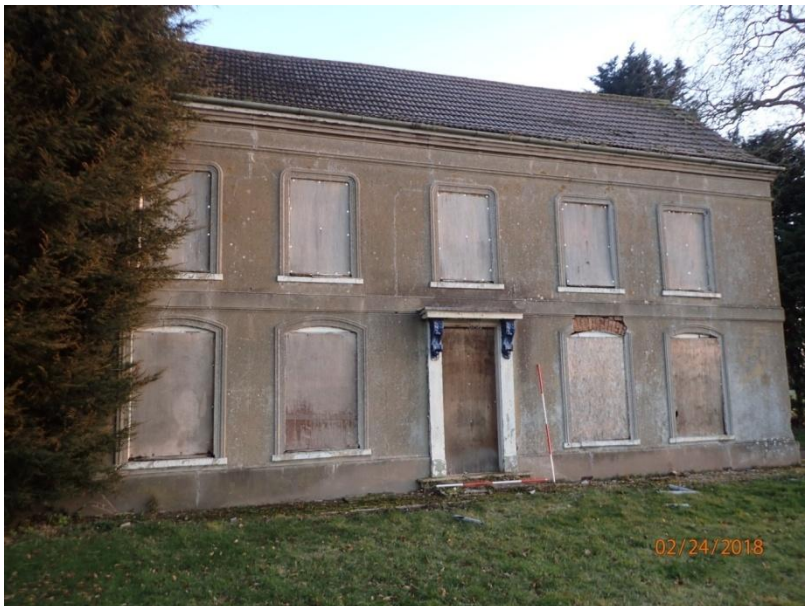
Plate 8: View of the South Elevation of the Farmhouse, from the south

Plates 5 and 8 provide views of the South Elevation of the Farmhouse. Almost the entirety of this South Elevation is covered over with modern cement rendering, which obscures the detail of the underlying construction. That this South Elevation may be of brick construction is hinted at by the rounded window head on one of the south facing ground floor window openings, composed of alternate courses of brick headers and of brick stretchers laid on end.

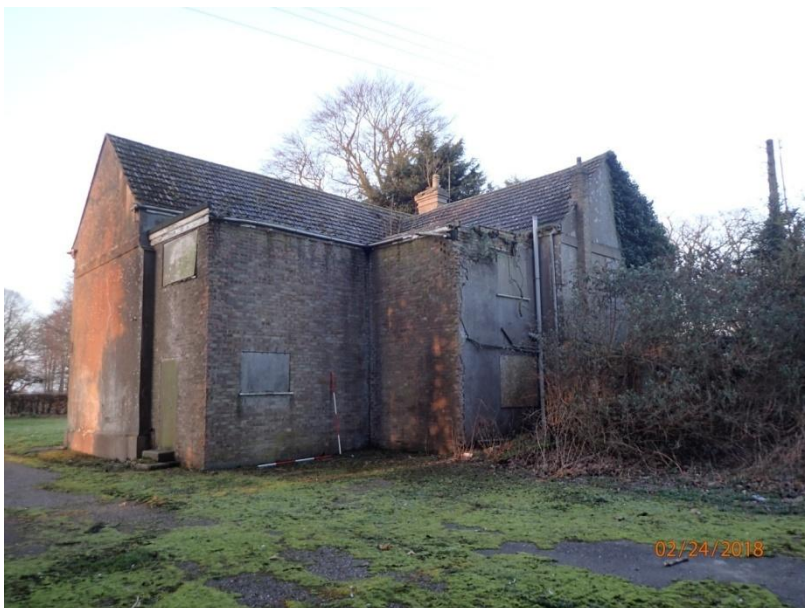
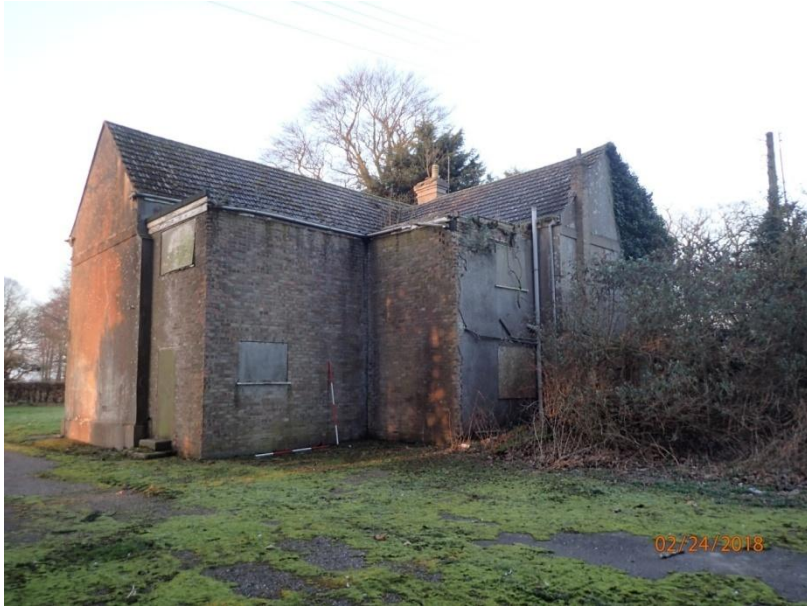
Plate 12: General View of the rear of the Farmhouse, from the north

Plate 13: General View of the rear of the Farmhouse, from the north

Plates 12 and 13 provide general views of the rear of the Farmhouse and of the attached modern rear extension from various northern perspectives. This shows that the Farmhouse also has a rear wing. This modern rear extension also covers over nearly all of the original North Elevation of the Farmhouse along with much of the adjoining East Elevation of the Rear Wing.

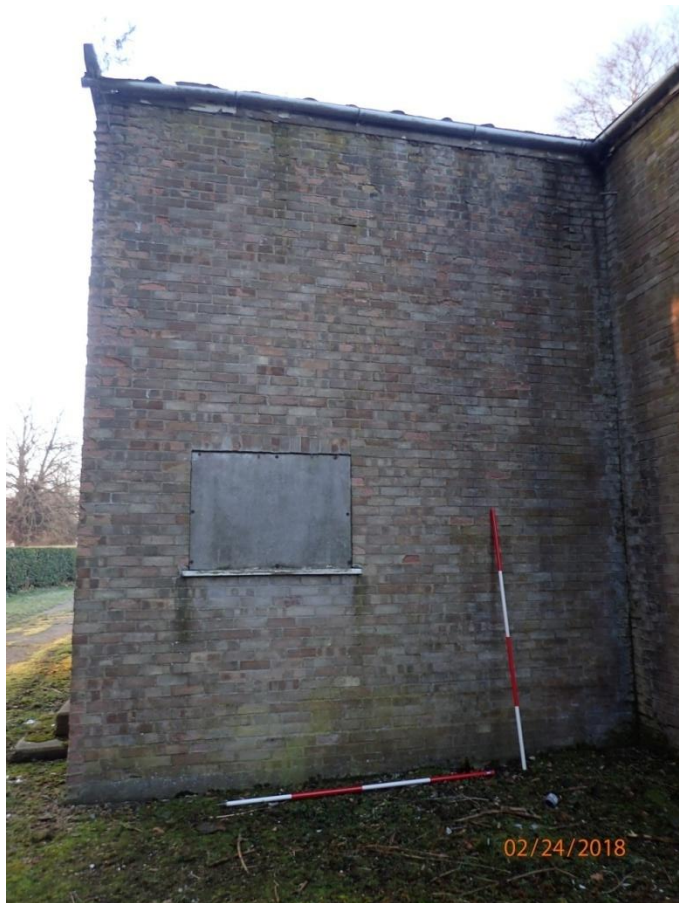
Plate 14: View of the First North Elevation of the Modern Rear Extension to the Farmhouse, from the north

Plate 14 features a detailed view of the first North Elevation of the modern rear extension. The brickwork wall fabric of this first North Elevation is composed of courses of brick stretchers in Stretcher Bond. At ground floor level is a north facing window opening, which has been boarded over. Only the timber sill at the base of the opening is visible. Above the opening is the flat head composed of one course of brick headers laid on edge. At just below roof levels are the timber fascia boards to which are attached the horizontal modern Upvc guttering.

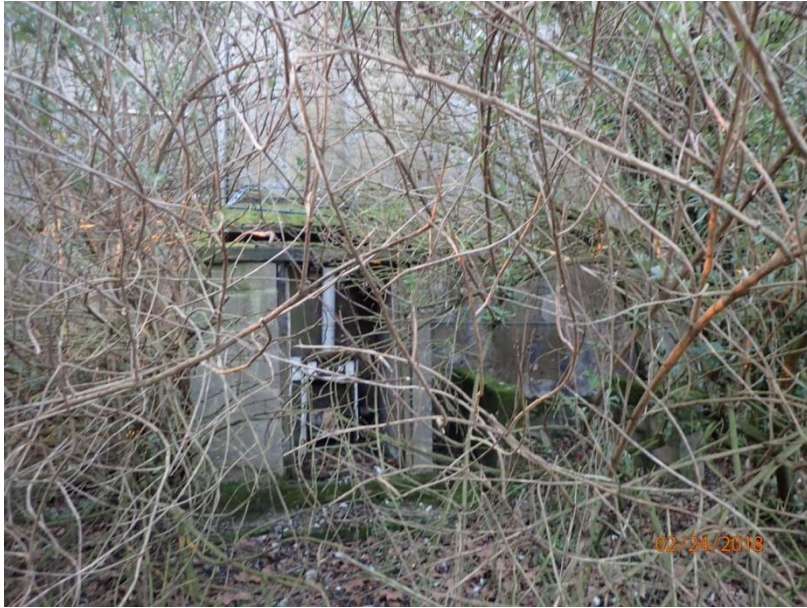
Plate 20: View of the lower levels of the North Elevation of the Farmhouse including the single storey rear outbuilding, from the north

Plate 20 features the lower levels of the North Elevation of the Rear Wing of the Farmhouse. This provides a further detailed view of the single storey rear outbuilding that is bonded to this North Elevation and its modern breeze block work. This has apparently been a former external boiler house. The lower levels of this North Elevation of the Rear Wing may also be seen. These lower levels are also entirely covered over with cement rendering obscuring the detail of the underlying build fabric.

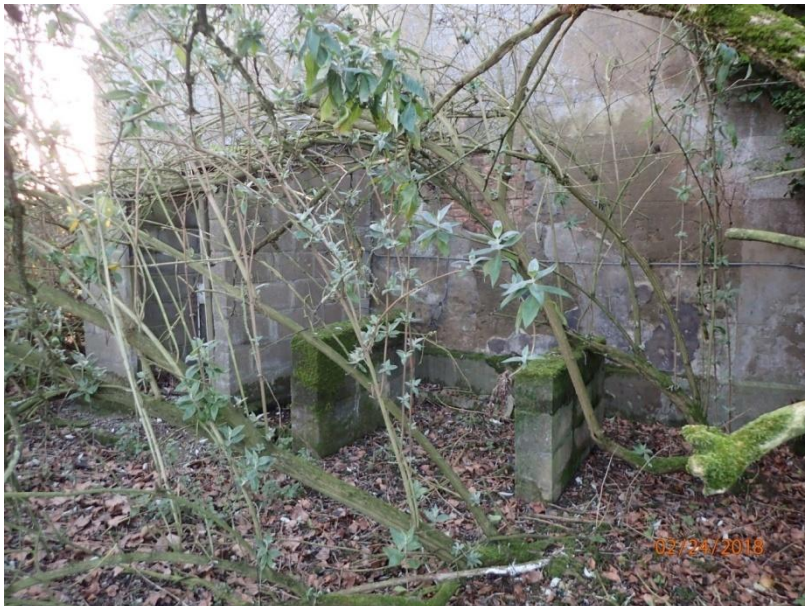
Plate 23: View of the lower levels of the North Elevation of the Farmhouse, from the north

Plate 23 furnishes a detailed view of the lower levels of this North Elevation of the Rear Wing of the Farmhouse. This features the covering of cement rendering at these lower levels as well as a further detailed view of the single storey rear boiler house that its bonded to this North Elevation. This shows in detail its construction of modern breezeblock work.

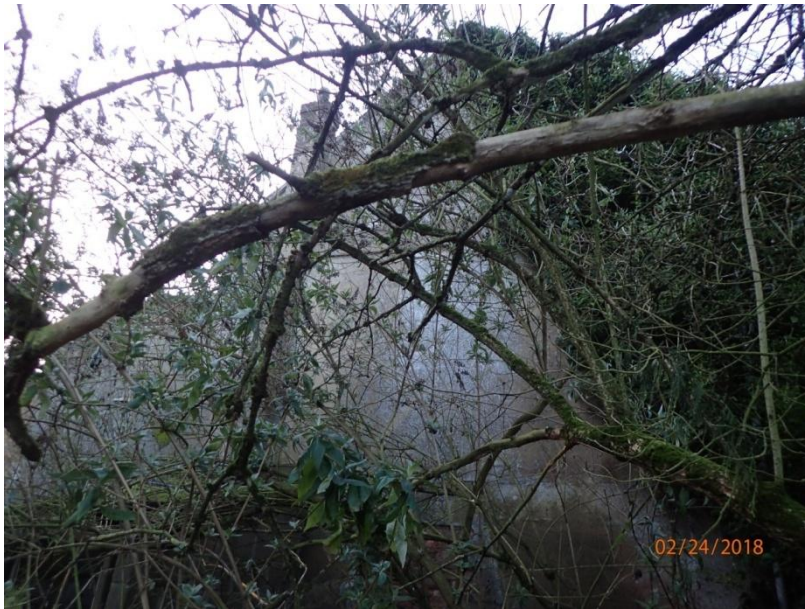
Plate 24: View of the upper levels of the North Elevation of the Farmhouse, from the north

Plate 24 provides a further detailed view of the upper levels of the North Elevation of the Rear Wing of the Farmhouse and shows its external covering of cement rendering.

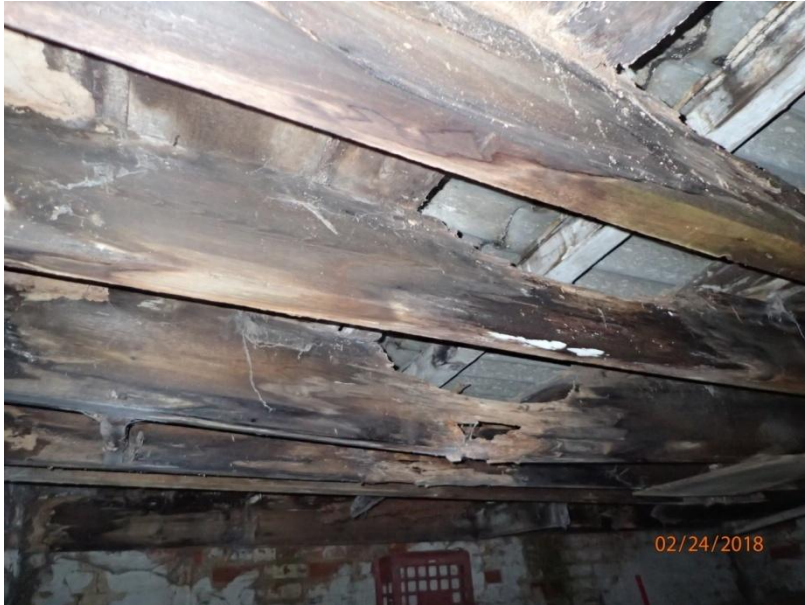
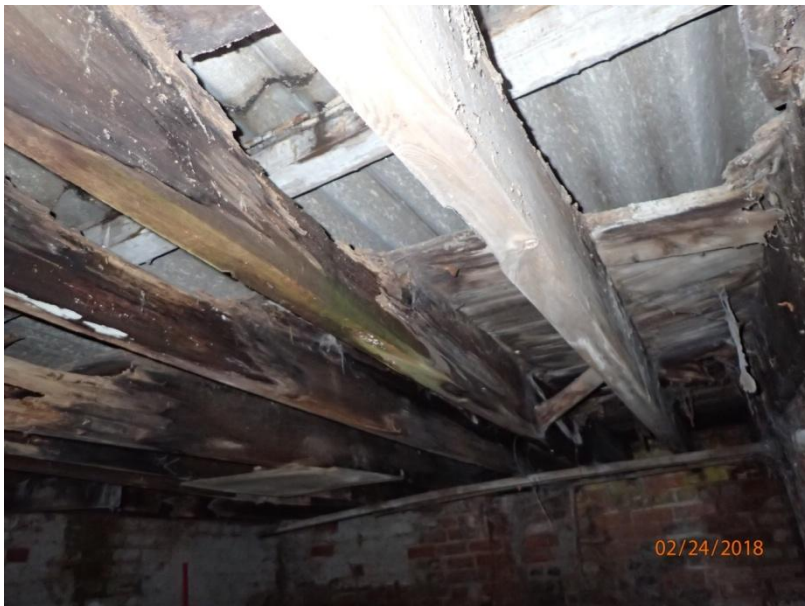
Plates 42 and 43 provide further detailed views of the ceiling of **Cell 1** from different viewpoints. These show the series of horizontal timber floor joists, the ends of which are inserted into the upper levels of the north and south walls. Also shown above the joists are a series of horizontal timber floor boards. This suggests that this building may have originally been of two storeys in height, with the upper first floor having been demolished, at least for this eastern part of **Outbuilding 1**. Sheets of modern corrugated iron had been imported to provide further roof covering outside the areas of timber floor planking.

Plate 42: View of the ceiling of Cell 1, from the east

Plate 43: View of the ceiling of Cell 1, from the south

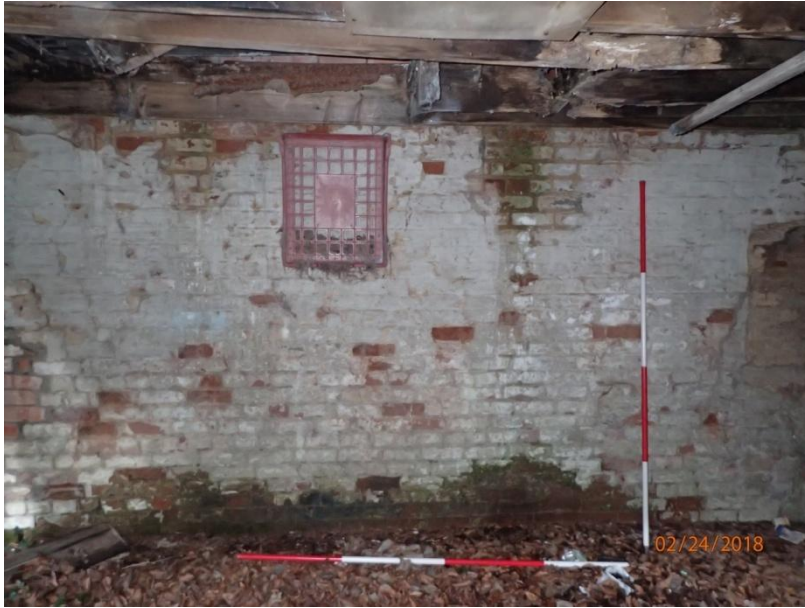
Plate 44 furnishes a view of the west wall of **Cell 1**. The brickwork wall fabric of this west wall has been obscured to a large extent by being covered over with layers of whitewash. But it is still possible to discern the detail. Most of the wall fabric here appears to be composed of courses of

brick stretchers with occasional courses of brick headers and occasional courses of mixed brick headers and stretchers.

Plate 44: View of the west wall of Cell 1, from the east

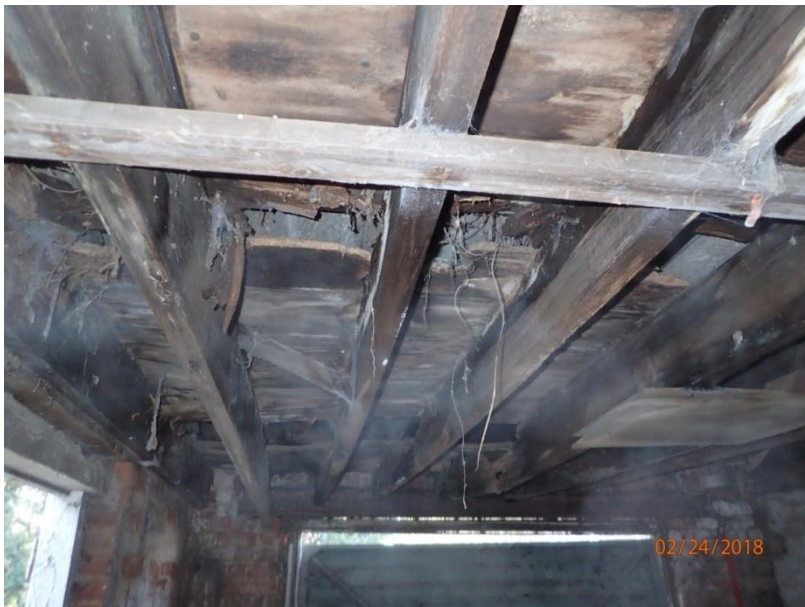
Plate 45: View of the ceiling of Cell 1, from the north

Plates 45 and 46 provide further detailed views of the ceiling of **Cell 1** from different viewpoints. These show the series of horizontal timber floor joists, the ends of which are inserted into the upper levels of the north and south walls. Also shown above the joists are a series of horizontal timber floor boards. This suggests that this building may have originally been of two storeys in height, with the upper first floor having been demolished, at least for this eastern part of **Outbuilding 1**. Sheets of modern corrugated iron had been imported to provide further roof covering outside the areas of timber floor planking.

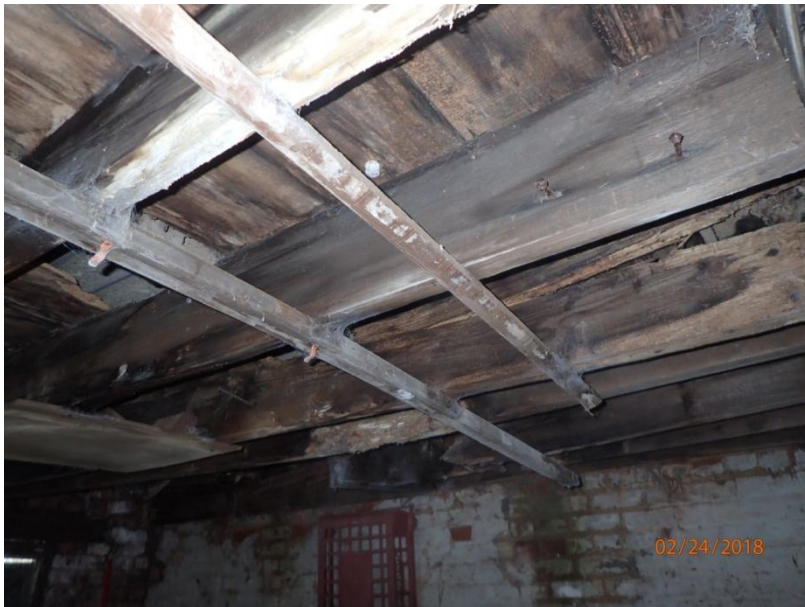
Plate 46: View of the ceiling of Cell 1, from the north-east

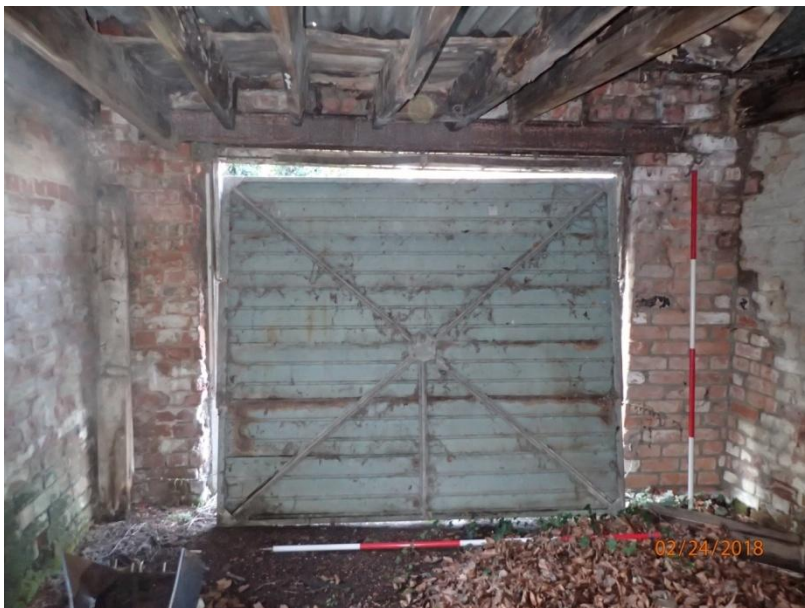
Plate 47: View of the south wall of Cell 1, from the north

Plate 47 furnishes an image of the south wall of **Cell 1**, most of which is occupied by the inner face of the modern cantilevered metal garage door. Above the opening is a horizontal lintel comprising an RSJ. The brickwork wall fabric of this south wall is mostly composed of courses of brick stretchers with occasional courses of mixed brick headers and brick stretchers.

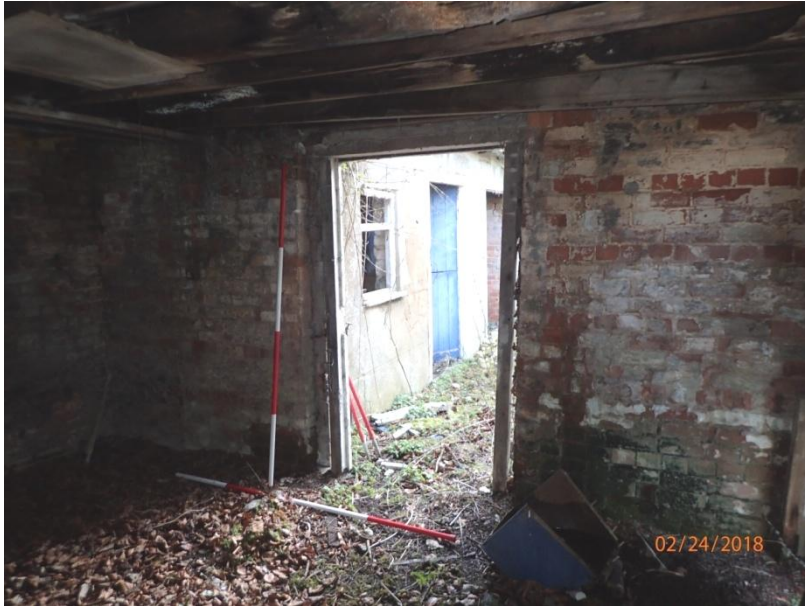
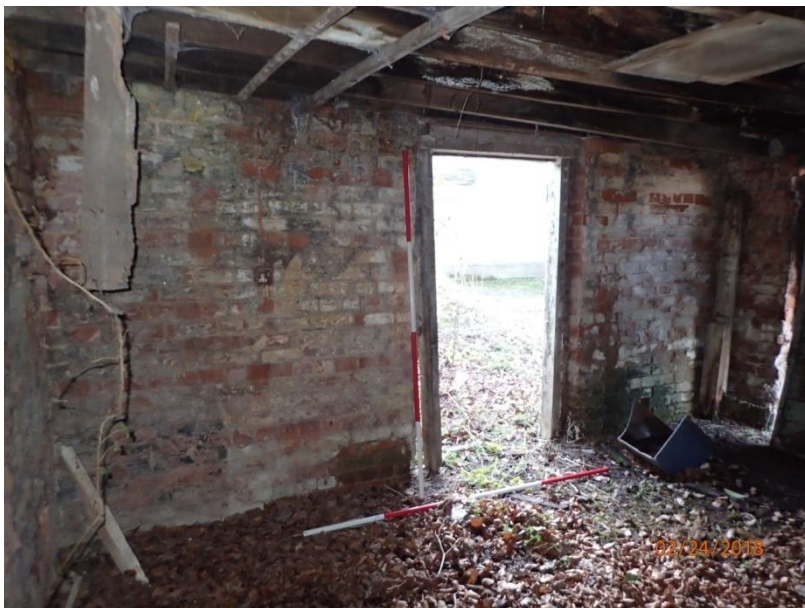
Plates 48 and 49 provide views of the east wall of **Cell 1** from different positions. The brickwork wall fabric of this east wall is mostly composed of courses of brick stretchers with occasional courses of brick headers and of courses of mixed brick headers and stretchers. Also shown is the inner face of the east facing door opening that was recorded externally on the opposing East Elevation. The door is absent. The door opening contains a simple timber frame of head and surrounds. Above the opening is an horizontal timber lintel that is incorporated into this brickwork wall fabric.

Plate 48: View of the east wall of Cell 1, from the west

Plate 49: View of the east wall of Cell 1, from the west

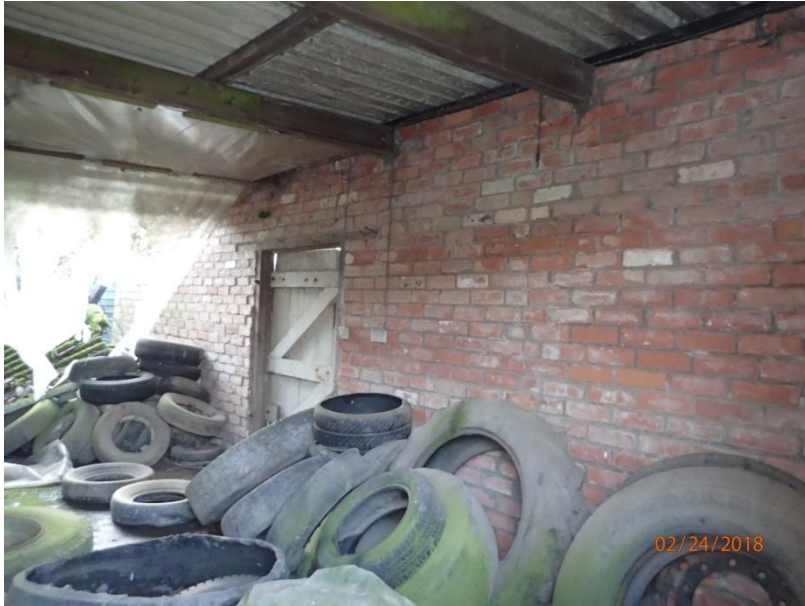
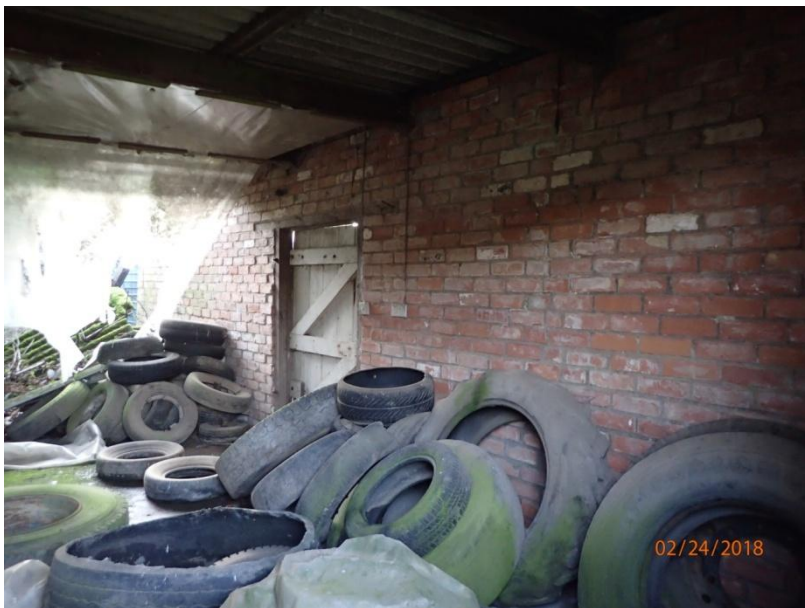
Plate 50: View of the south wall of Cell 2, from the west

Plate 51: View of the south wall of Cell 2, from the west

Plates 50 and 51 furnish views of the south wall of **Cell 2**. The brickwork wall fabric of this south wall is composed of courses of brick stretchers in Stretcher Bond. The inner face of the south facing door opening that was recorded externally on the opposing South Elevation is also shown. The opening contains a simple timber frame of head and surrounds. The door is composed of a series of vertical timber planks that are attached to an internal framework of angled and horizontal timbers. Above the opening is a horizontal timber lintel that is incorporated into the brickwork wall fabric.

The southern ends of the horizontal timber floor joists above may be observed to be inserted into the upper levels of this south wall.

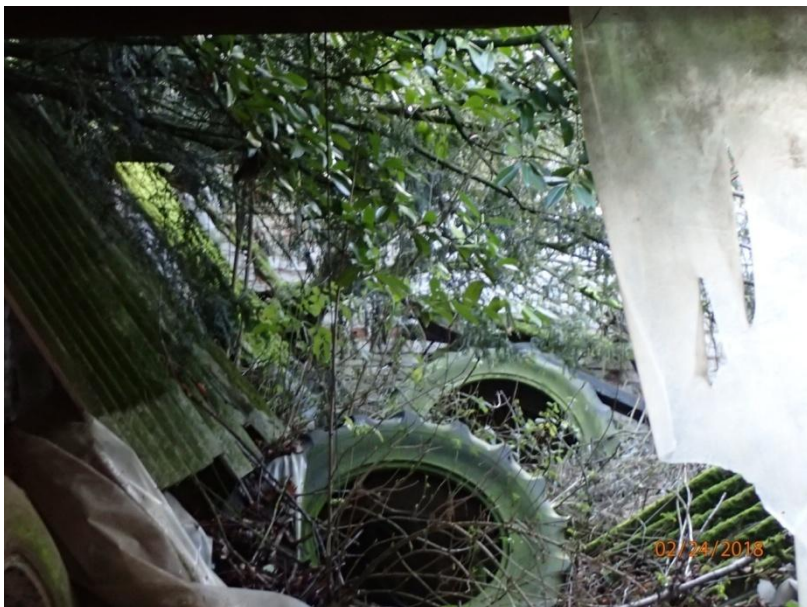
Plates 56-60 provides images of the eastern end of **Cell 2**, not much detail of which could be discerned, as this portion of the building was inaccessible. This portion of the building was roofless. Though modern sheets of displaced corrugated iron may be observed, which may have provided the roof covering here.

Plate 60: View of the interior of Cell 2, from the west

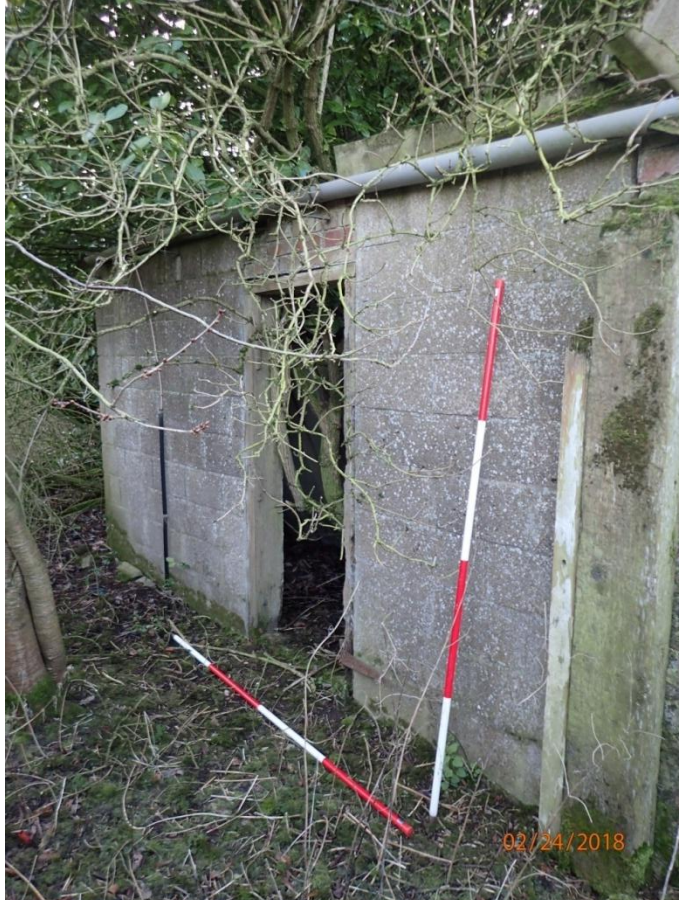
Plate 62: View of the North Elevation of Outbuilding 2, from the west

Plate 62 provides a detailed view of the North Elevation of **Outbuilding 2**. By contrast, the wall fabric of this North Elevation is composed of modern breezeblock work. There is horizontal modern UPVC guttering at just below roof levels. A north-facing door opening may also be seen. The door is absent from this opening, which contains a simple timber frame of head and surrounds. There are also indications that this door opening originally extended as far as the roof levels by brick infilling composed of modern mixed brick headers and stretchers.

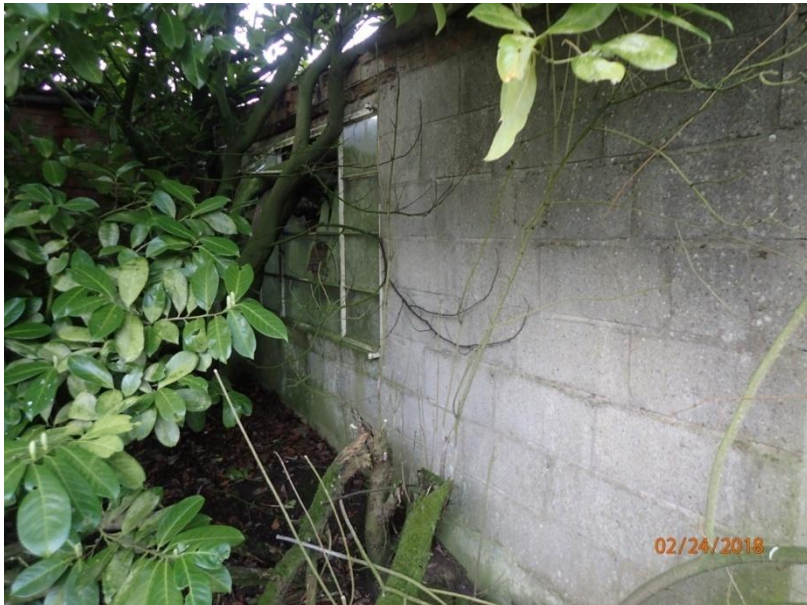
Plates 63 and 64 feature detailed images of the East Elevation of **Outbuilding 2**. The wall fabric of this East Elevation is also of modern breezeblock work. This Elevation also contains an east-facing widow opening. This is a modern twelve light glazed casement window with a metal frame. An horizontal timber lintel is located above the window opening and is incorporated into brickwork wall fabric, which is at the uppermost levels of this East Elevation just below the roof line. This brickwork is composed of two courses of mixed brick headers and brick stretchers.

Plate 64: View of the East Elevation of Outbuilding 2, from the north

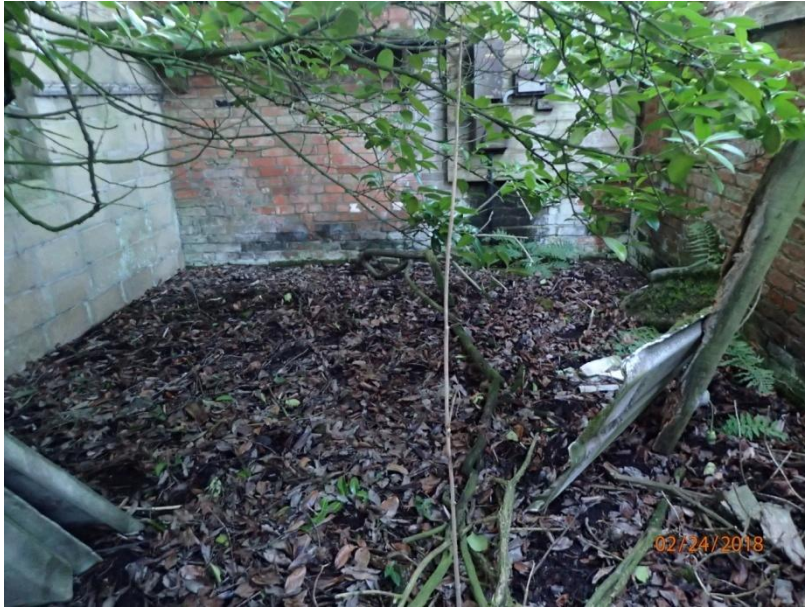
Plate 65: General view of the interior of Cell 3, from the north

Plate 65 presents a general view of the interior of **Cell 3** and shows that it is roofless. The nature of the floor is not discernible.

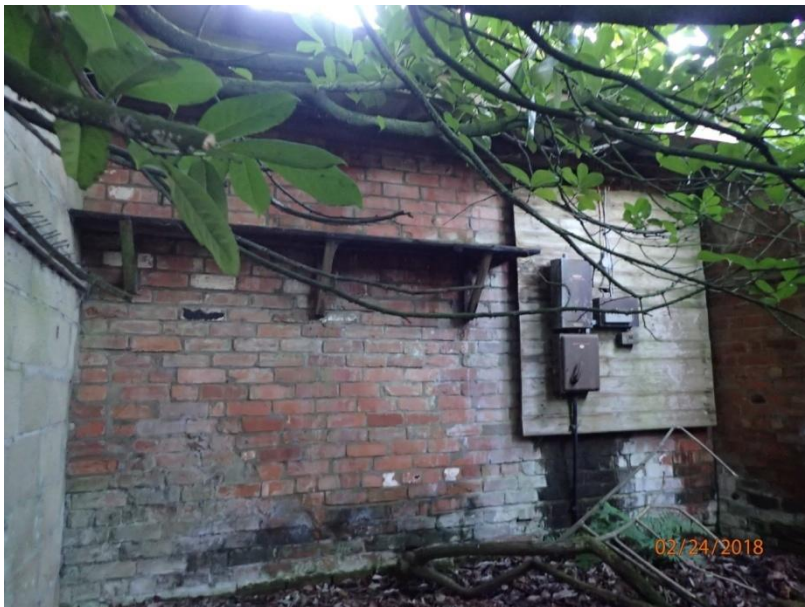
Plate 66: View of the north wall of Cell 3, from the north

Plate 66 features the north wall of **Cell 3**. The brickwork wall fabric of this north wall, which is also the internal dividing wall with **Outbuilding 1** to the south, is composed of courses of brick stretchers in Stretcher Bond with a single course of brick headers at the lower levels of this wall. Prior to the construction of **Outbuilding 2**, this north wall would have been the western part of the North Elevation of **Outbuilding 1**.

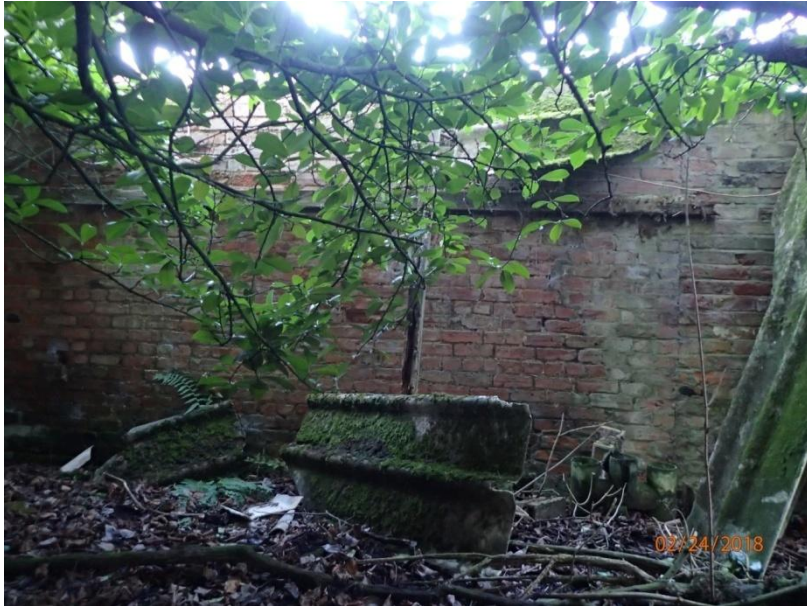
Plate 67: View of the west wall of Cell 3, from the east

Plate 67 provides a view of the west wall of **Cell 3**. The brickwork wall fabric appears to be a mixture. The southern portion is composed of three courses of brick stretchers that alternate with one course of brick headers in English Garden Wall Bond. The brickwork wall fabric of the northern portion of this West Elevation is mostly of courses of brick stretchers with occasional courses of mixed brick headers and stretchers. There is also some evidence of limited modern repair in brick such as at the uppermost levels.

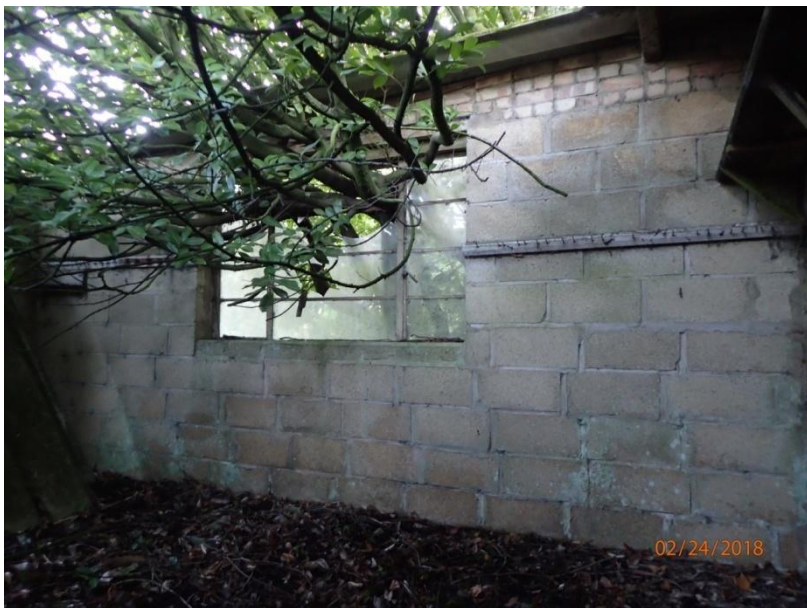
Plate 68: View of the east wall of Cell 3, from the west

Plate 68 features the east wall of **Cell 3**, which is of modern breezeblock work. The inner face of the east facing window opening that was recorded externally on the opposing East Elevation is also shown. This is a 12-light glazed casement window with a metal window frame. There is an horizontal timber lintel above the opening which is incorporated into the wall fabric. Also shown at

the uppermost level and at just below roof levels are four courses of brick stretchers in Stretcher Bond.

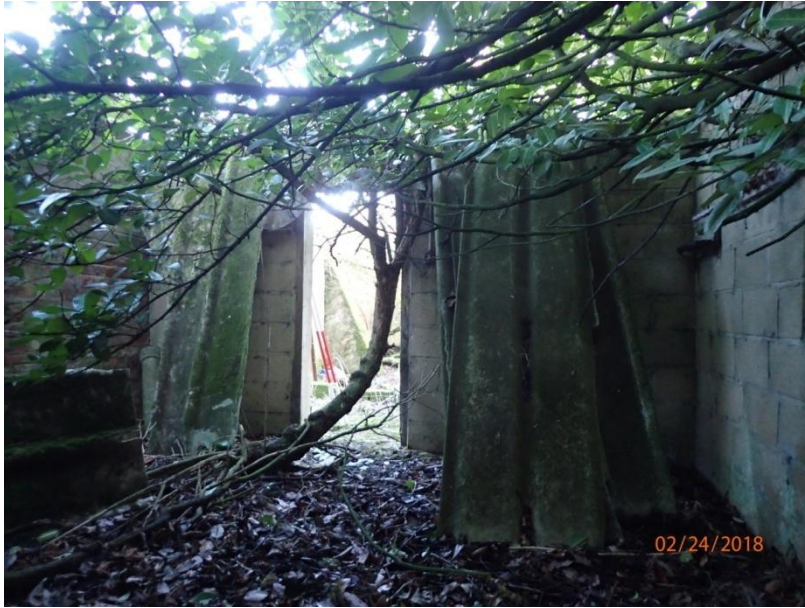
Plate 69: View of the north wall of Cell 2, from the south

Plate 69 features the north wall of **Cell 3**. Much of this is obscured from view. The wall fabric of this north wall is composed of modern breezeblock work. The inner face of the north facing door opening that was previously recorded on the opposing North Elevation is also shown. This has a simple timber frame of head and surrounds. The door is absent.

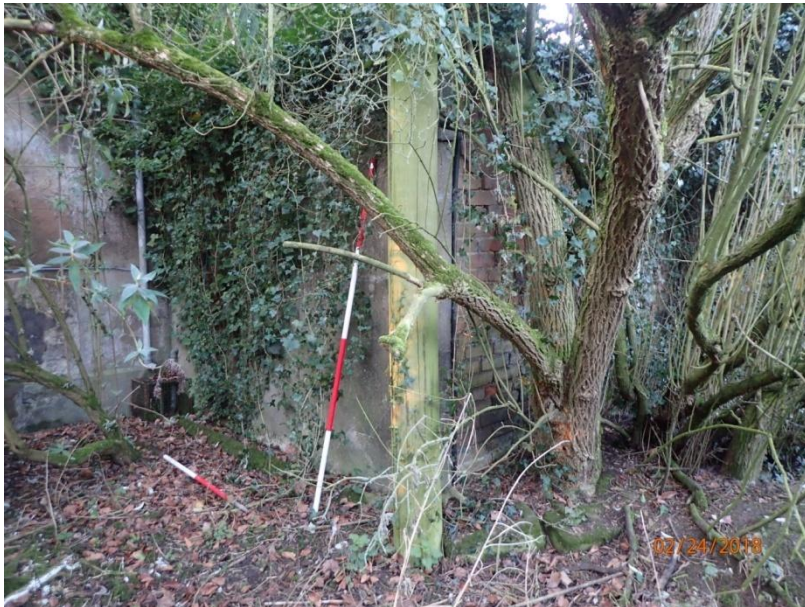
Plate 70: View of the East Elevation and part of the North Elevation of Outbuilding 3, from the north

Plate 70 provides a view of the east wall of **Outbuilding 3**, which is covered over with cement rendering. This obscures the underlying detail of the wall fabric here. It also features the eastern part of the adjoining North Elevation. Where visible, and where not obscured by dense tree and vegetation growth, the brickwork wall fabric of this North Elevation appears to be mostly composed of courses of brick stretchers.

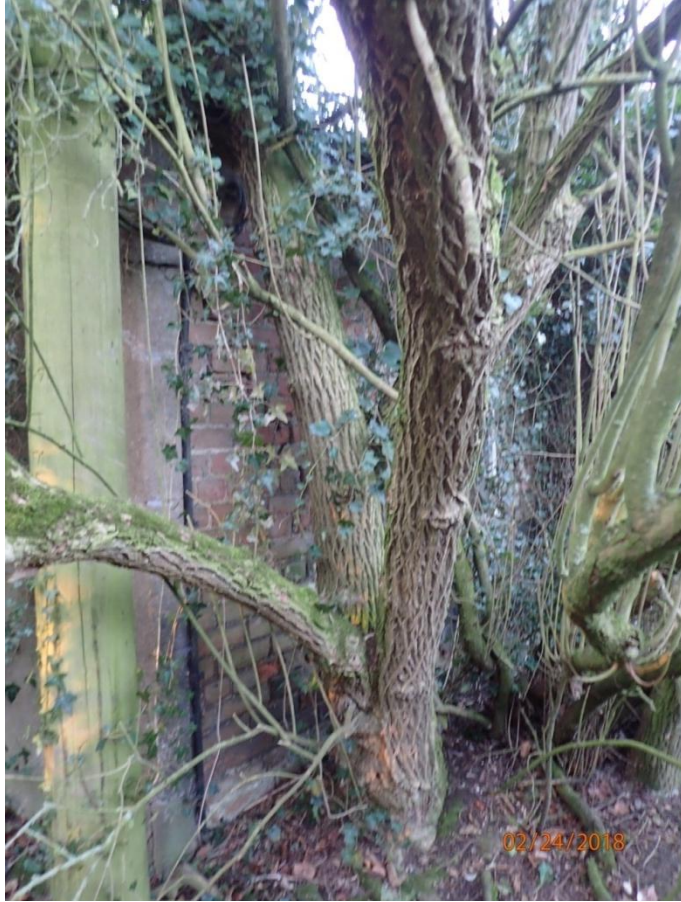
Plate 72: View of part of the North Elevation of Outbuilding 3, from the north

Plate 72 provides a detailed view of the eastern portion of the North Elevation of **Outbuilding 3**. Where not obscured by dense vegetation and tree cover, the brickwork wall fabric of this North Elevation appears to be mostly composed of courses of brick stretchers.

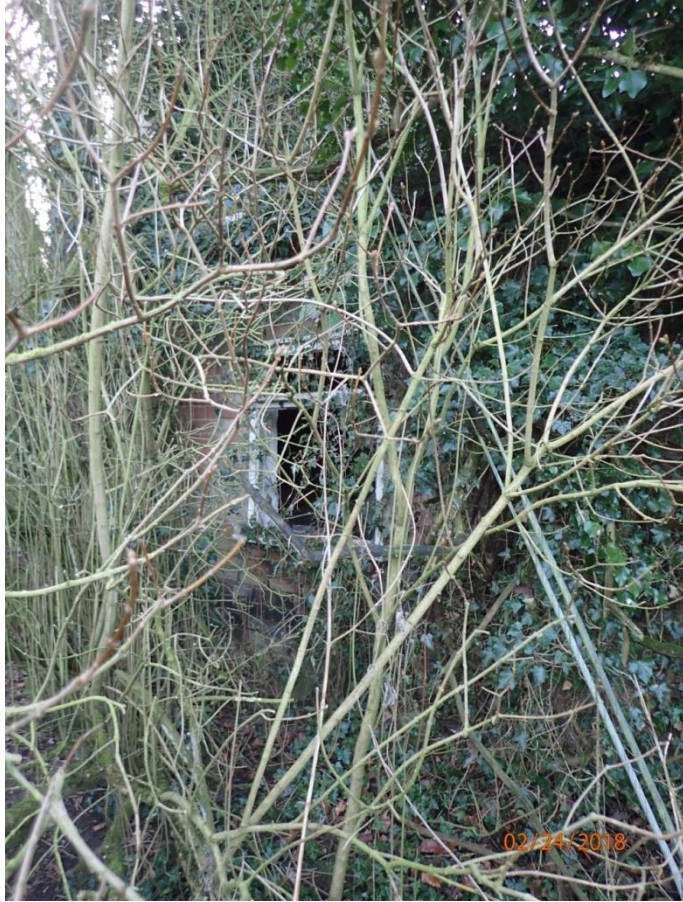
Plate 73 features a further view of the eastern portion of the North Elevation of **Outbuilding 3**. Where not obscured by dense vegetation and tree cover, there appears to be a north facing and unglazed window opening. This is a two light modern timber casement window with a simple timber frame of head, surrounds, horizontal transom and sill.

Plate 73: View of part of the North Elevation of Outbuilding 3, from the north

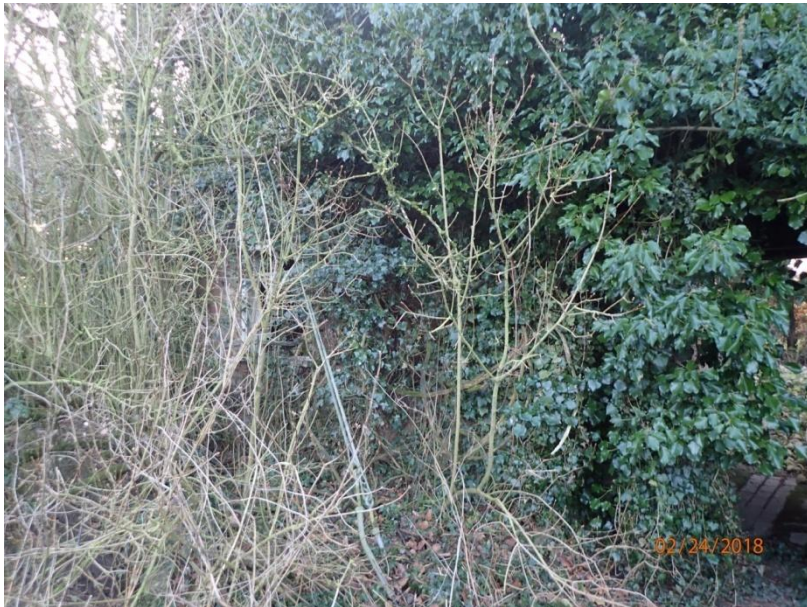
Plate 74 gives a good illustration of the very dense nature of the tree and further vegetation cover to the rear of **Outbuilding 3**.

Plate 74: View of part of the North Elevation of Outbuilding 3, from the north

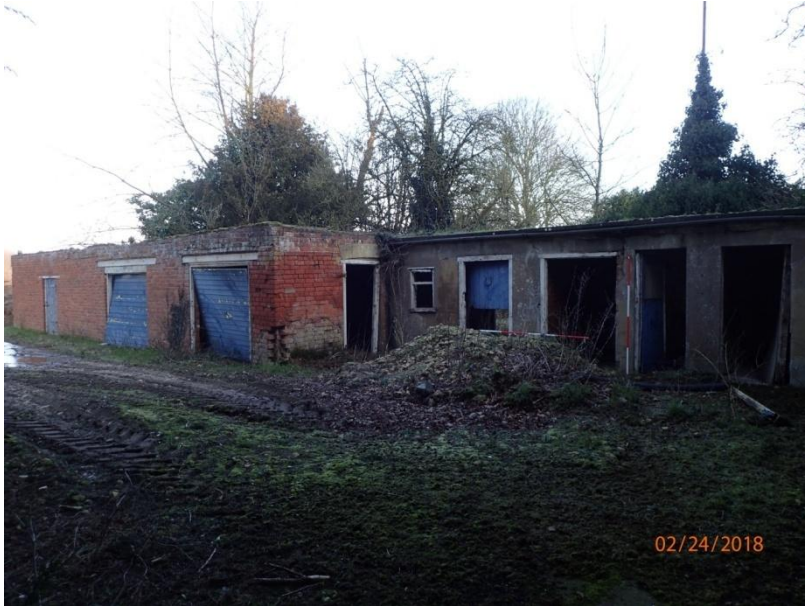
Plate 75: General view of Outbuilding 3 (to the right (east)) and Outbuilding 1 (to the left (west)), from the south

Plate 75 provides a general view of **Outbuilding 3** to the right (east) and of the adjoining **Outbuilding 1** to the left (west).

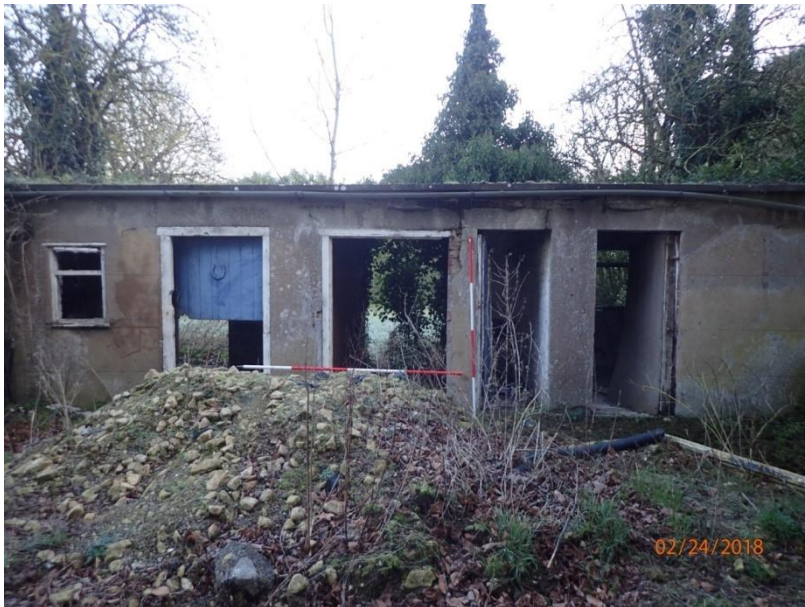
Plate 76: View of the South Elevation of Outbuilding 3, from the south

Plate 76 features a detailed view of the South Elevation of **Outbuilding 3**. The wall fabric of this South Elevation, which is probably of brick has been covered over with cement rendering, which obscures the detail of the underlying wall fabric. There is modern horizontal Upvc guttering at roof level and what appears to be the remains of a flat roof with a covering of modern roofing felt.

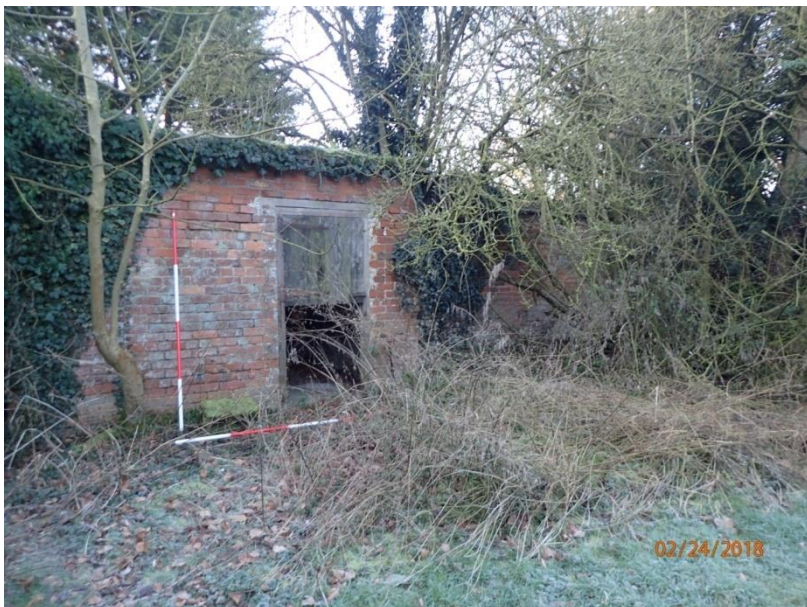
Plate 77: View of part of the North Elevation of Outbuilding 3, from the north

Plates 77 and 78 provide views of the western portion of the North Elevation of **Outbuilding 3**. The brickwork wall fabric of this portion of the North Elevation is composed of three courses of brick stretchers that alternate with one course of brick headers in English Garden Wall Bond. Also featured is a north facing window opening. The opening contains a simple timber frame of head and surrounds. There is an horizontal timber lintel above the opening which is incorporated into the brickwork wall fabric. The opening originally contained two timber half doors, of which only the upper half door survives. This is composed of a series of vertical tongued and grooved timber planks with two cast metal strap hinges to the left (east). The half door suggests that this portion of **Outbuilding 3** once functioned as a stables.

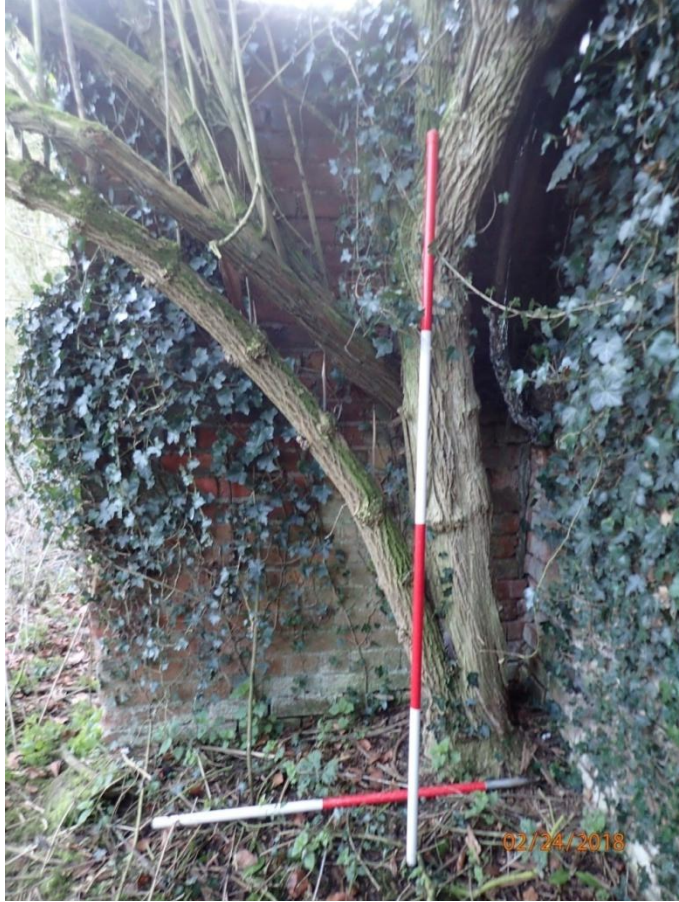
Plate 79: View of the West Elevation of Outbuilding 3, from the west

Plate 79 provides a view of the West Elevation of **Outbuilding 3**. Where not obscured by the dense vegetation and tree cover here, the brickwork wall fabric of this West Elevation appears to be composed of three courses of brick stretchers which alternate with one course of brick headers in English Garden Wall Bond.

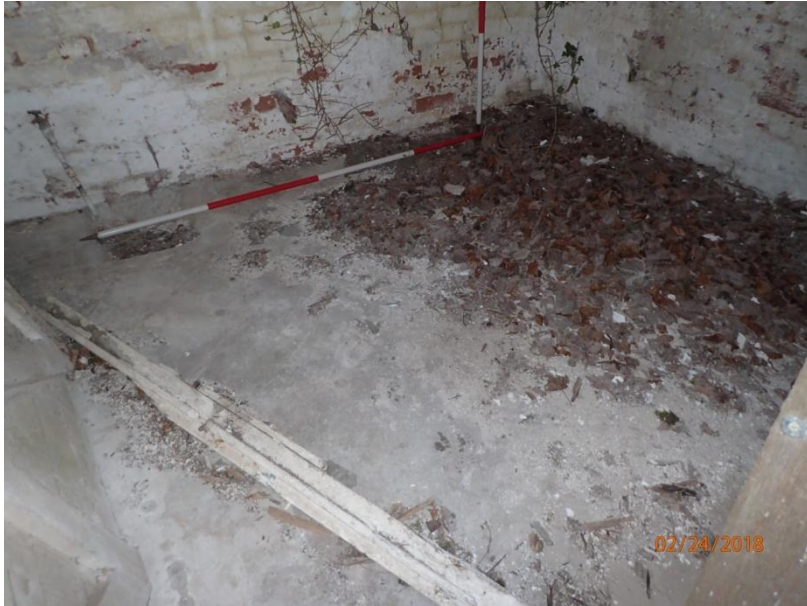
Plate 80 provides a view of the floor of **Cell 4**, which is of modern concrete.

Plate 80: View of the floor of Cell 4, from the south-west

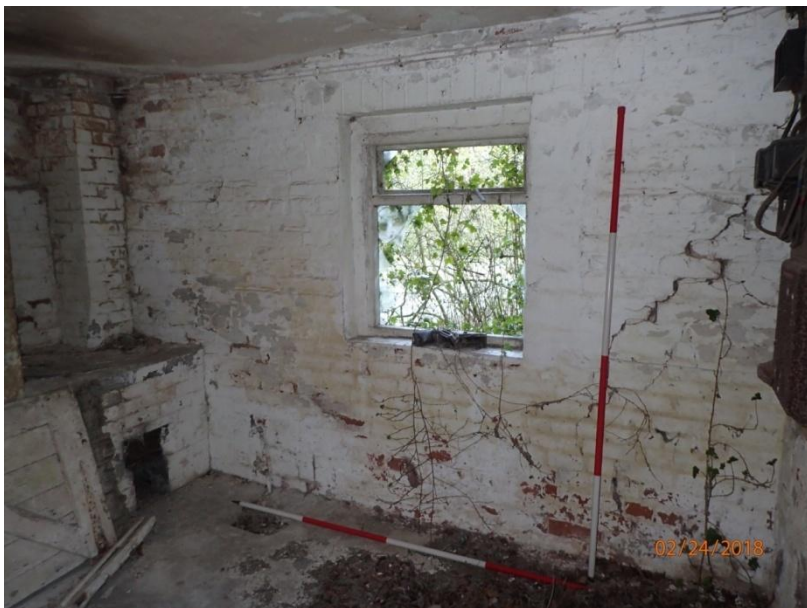
Plate 81 features the north wall of **Cell 4**. The brickwork wall fabric of this north wall has been covered over by layers of whitewash which has obscured to some extent, the detail of the underlying brickwork wall fabric. Where discernible, this fabric appears to be mostly composed of courses of brick stretchers. Also featured is the inner face of the north facing window opening, that was recorded externally on the opposing North Elevation. This is a two light unglazed modern timber casement window with a timber window frame of head, surrounds, horizontal transom and sill. The window opening is also slightly recessed. Above the opening is an horizontal timber lintel that is incorporated into the brickwork wall fabric.

Plate 81: View of the north wall of Cell 4, from the south
