**NEVILLE HALL
FREELANCE ARCHAEOLOGIST & CONSULTANT**

HISTORIC BUILDING RECORDING AT
WOODHOUSE FARM, HURN ROAD,
HOLBEACH, LINCOLNSHIRE

March 2018

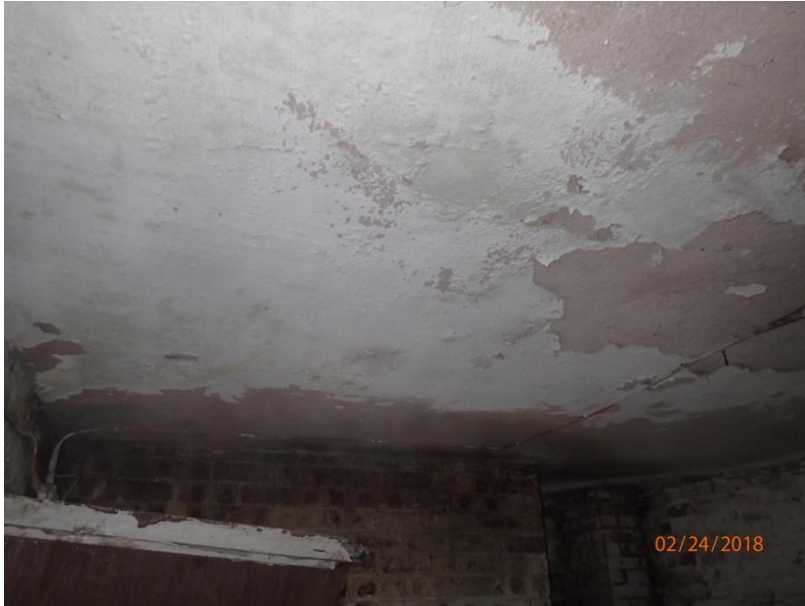
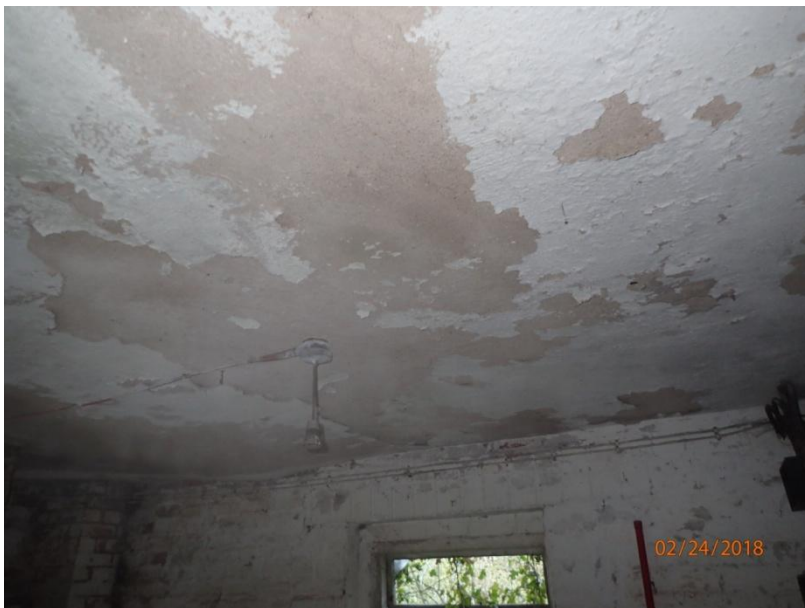
Plate 82: View of the ceiling of Cell 4, from the east

Plate 83: View of the ceiling of Cell 4, from the south

Plates 82 and 83 provide views of the ceiling of **Cell 4** from different perspectives. This is of modern origin and is covered over with plaster rendering.

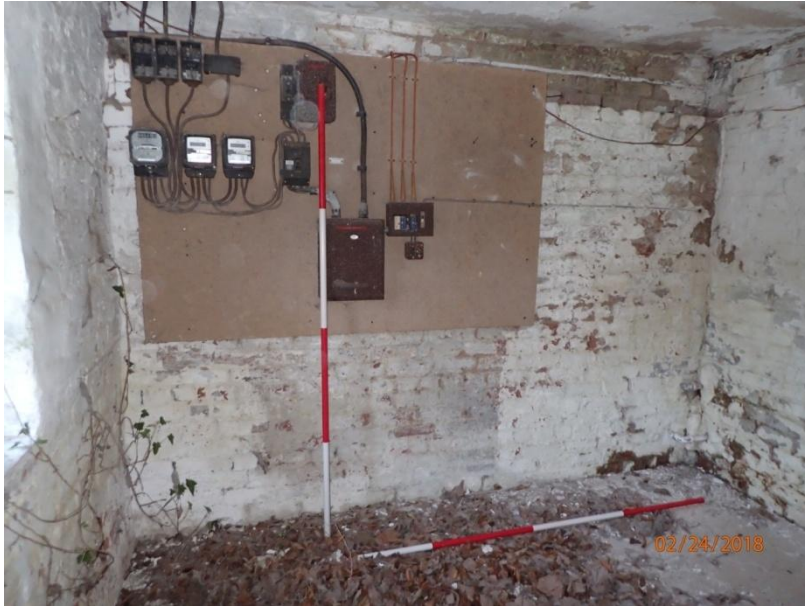
Plate 84 provides a view of the east wall of **Cell 4**. The brickwork wall fabric of this east wall has been covered over by layers of whitewash, which has obscured to some extent, the detail of the underlying brickwork wall fabric. Where discernible, this fabric appears to be mostly composed of courses of brick stretchers with occasional courses of brick headers.

Plate 84: View of the east wall of Cell 4, from the west

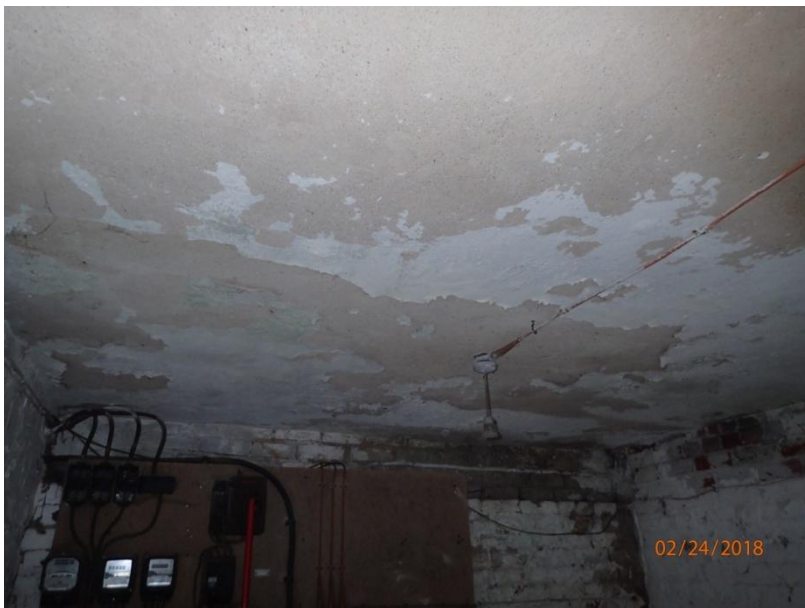
Plate 85: View of the ceiling of Cell 4, from the west

Plate 85 provides a further view of the ceiling of **Cell 4**, which is of modern plasterwork and rendering from a western perspective.

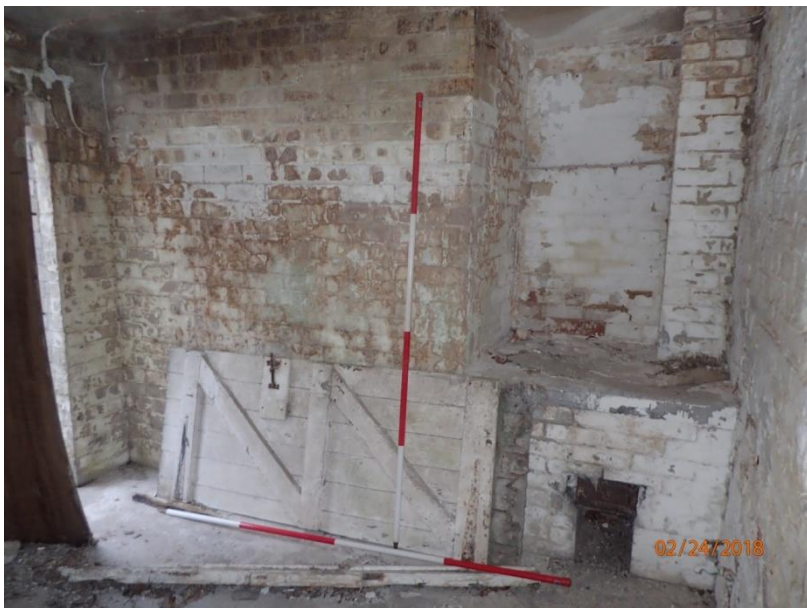
Plate 87: View of the west wall of Cell 4, from the east

Plate 87 provides a detailed view of the west wall of **Cell 4**. The brickwork wall fabric of this west wall has been covered over by layers of whitewash, which has obscured to a certain extent, the detail of the underlying brickwork wall fabric. Where discernible, this fabric appears to be mostly composed of courses of brick stretchers. To the right (north), is an alcove also in brick stretchers. Within this is a fireplace with a vertical brick chimney stack above this, both of which are also composed of courses of brick stretchers.

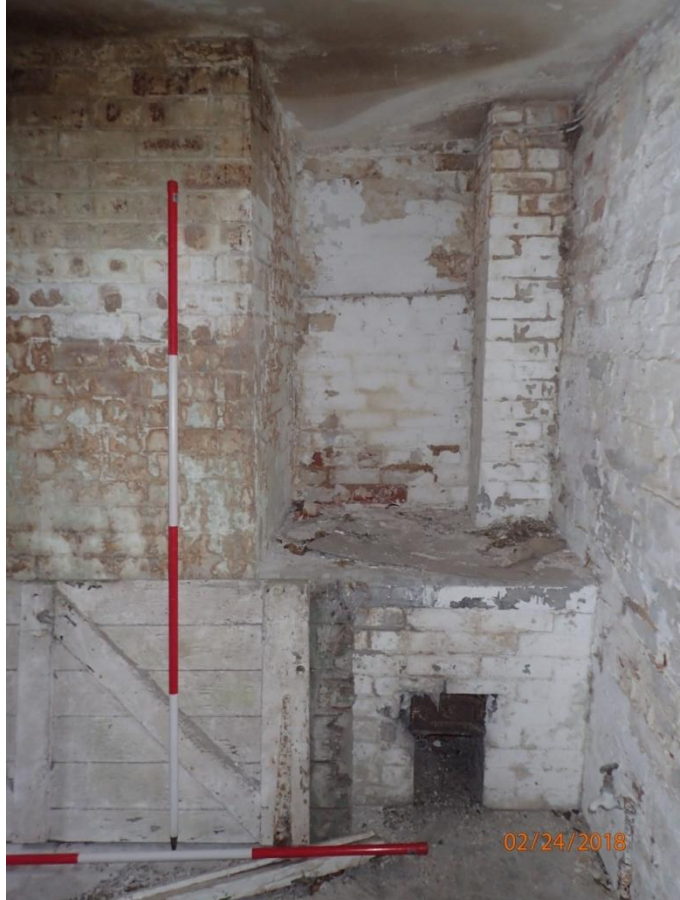
Plate 88 features a detailed view of the alcove with the brick fireplace and vertical brick chimney stack above this.

Plate 88: Detail: View of the chimney breast and fireplace in the west wall of Cell 4, from the east

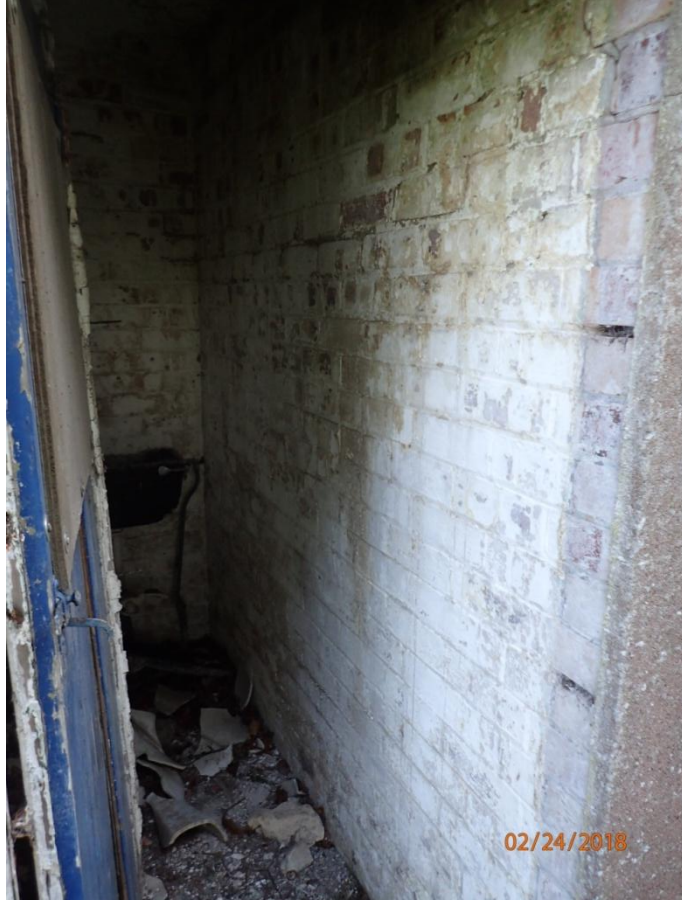
Plate 89: View of the east wall of Cell 5, from the south

Plate 89 features the interior of **Cell 5** including that of the east wall. This has been covered over with layers of whitewash , which has obscured to some extent, the underlying detail of the wall fabric here. Where discernible, this is composed of courses of brick stretchers.

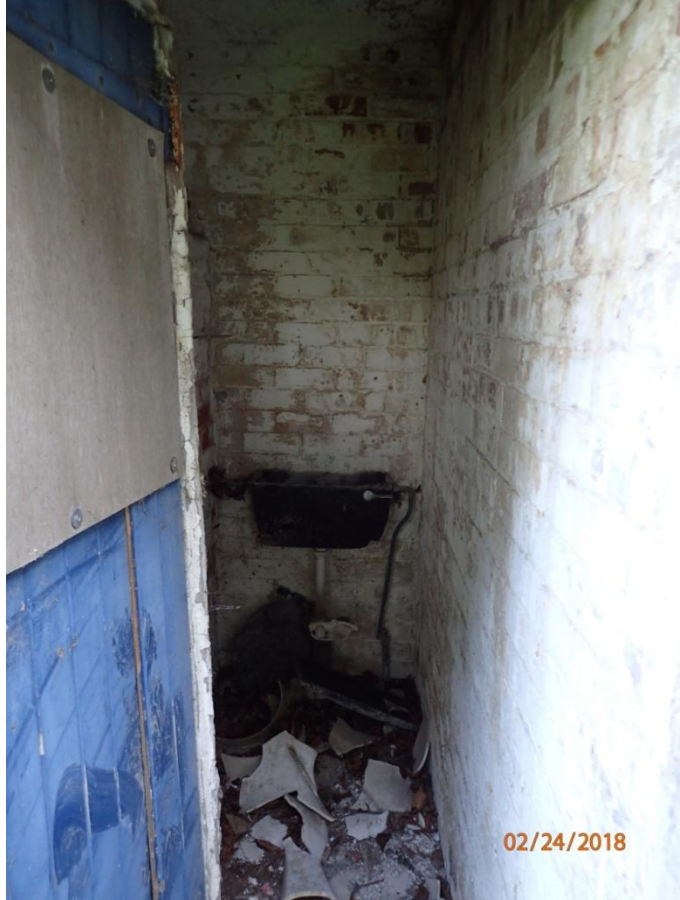
Plate 90: View of the interior of Cell 5, from the south

Plate 90 provides a further view of the interior of **Cell 5** from a southern perspective. This features the east wall and the back, north wall. This north wall has been covered over with layers of whitewash, which has obscured to some extent, the underlying detail of the wall fabric here. Where discernible, this is composed of courses of brick stretchers and of mixed brick headers and stretchers.

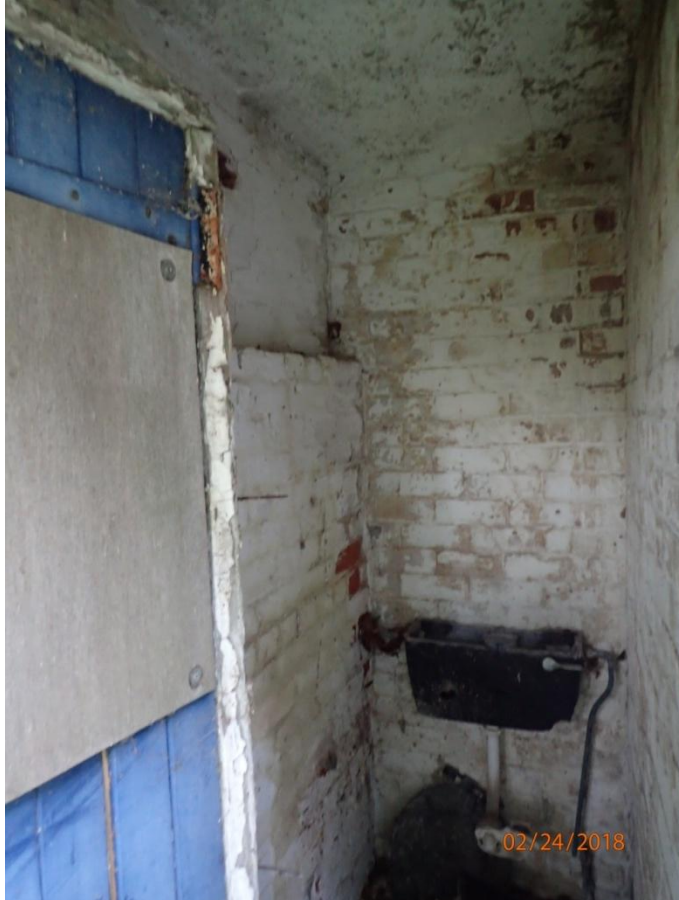
Plate 91: View of the interior of Cell 5, from the south

Plate 91 provides a further detailed view of the interior of **Cell 5**, including that of the north and west walls. The west wall is recessed at its upper levels, which has been covered over with layers of whitewash. This has also covered the underlying brickwork wall fabric here. The lower levels of this west wall have also been covered over with whitewash. Despite this, it is still possible to discern the nature of the brickwork wall fabric here, which appears to be mostly composed of courses of brick stretchers with the occasional course of brick headers.

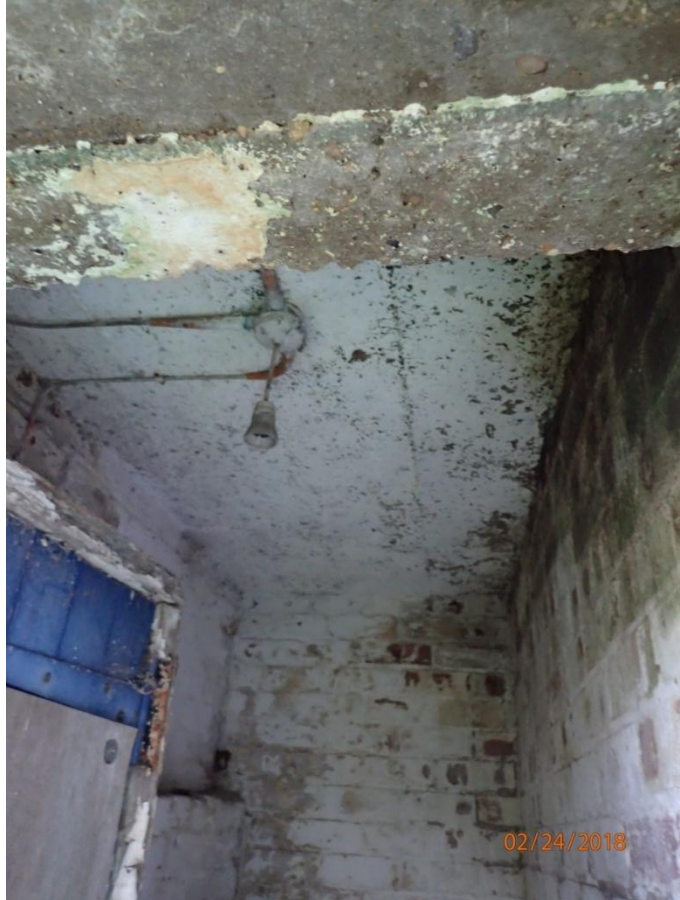
Plate 92: View of the interior of Cell 5, from the south

Plate 92 provides a further view of the interior of **Cell 5**, featuring its upper levels including that of the ceiling, which is of modern concrete.

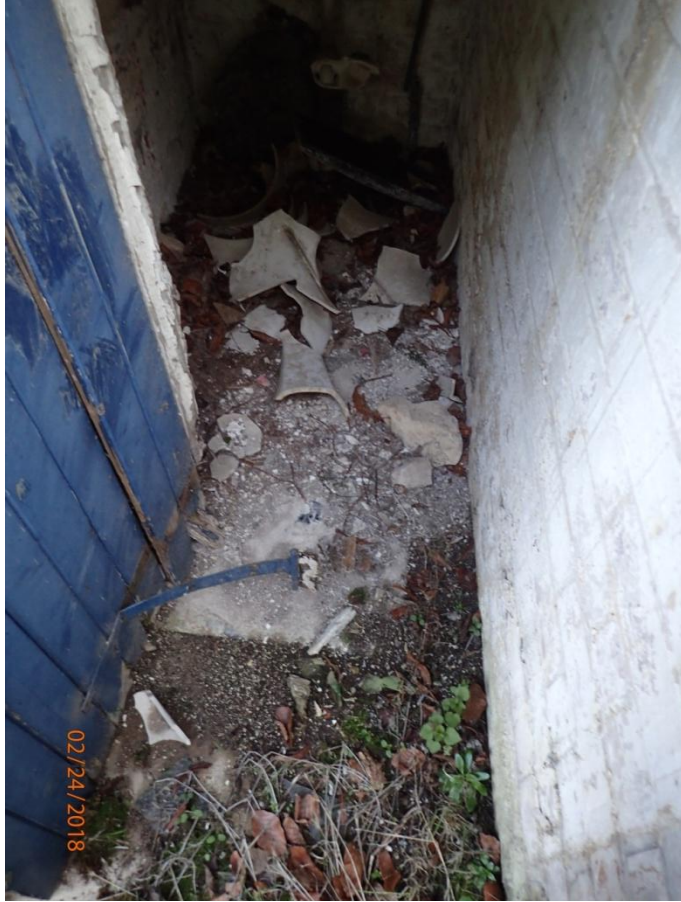
Plate 93: View of the floor of Cell 5, from the south

Plate 93 features the floor of **Cell 5**, which is also of modern concrete.

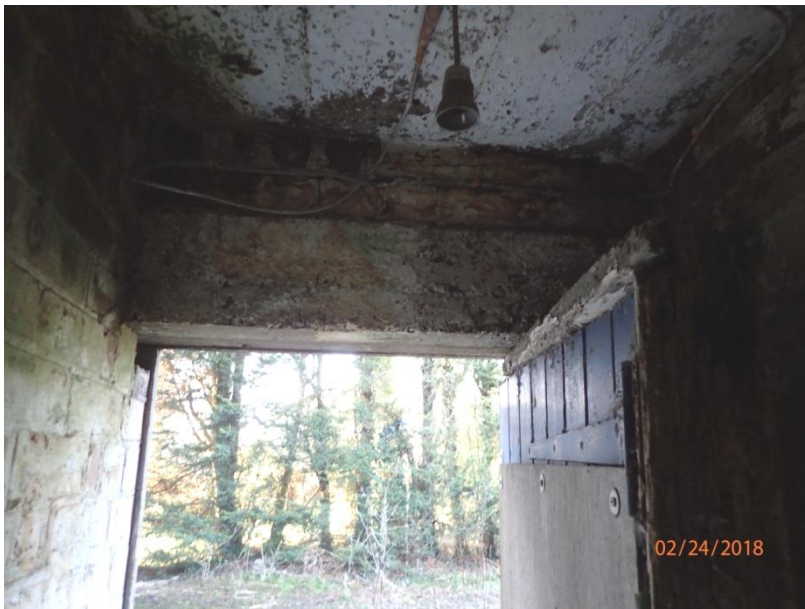
Plate 94: View of the upper levels of the south facing entrance of Cell 5, from the north

Plate 94 provides a view of the interior of **Cell 5** from a different northern viewpoint. This features the upper levels of the south facing door opening that was recorded externally on the opposing South Elevation. This shows the inner face of the timber door frame of head and surrounds and above this a concrete lintel incorporated into the wall fabric of the south wall.

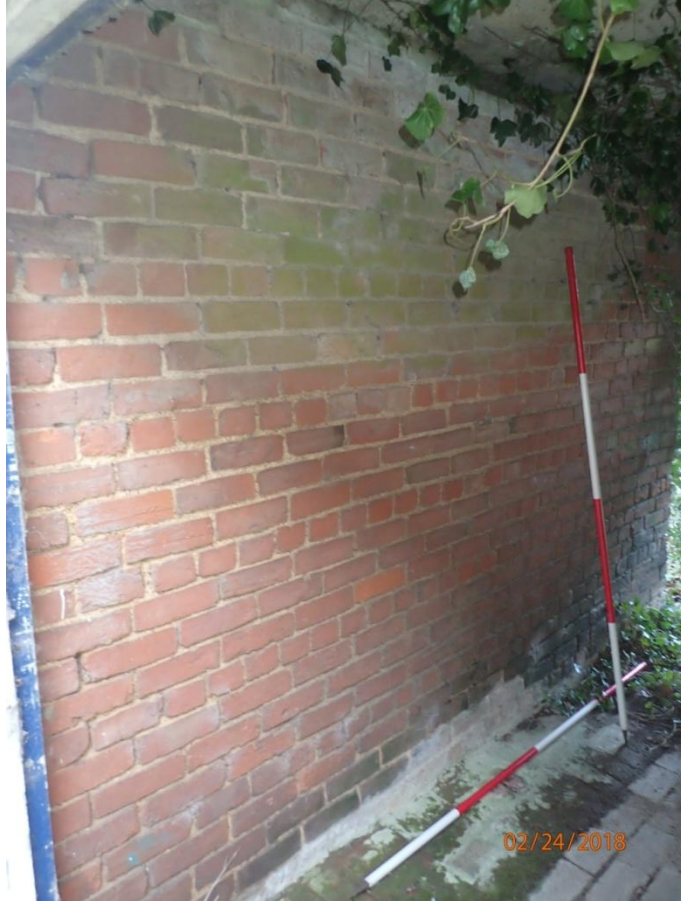
Plate 95: View of the west wall of the internal passageway or Cell 6, from the south

Plate 95 provides a view of the west wall of the internal passageway within **Outbuilding 3** or **Cell 6**. The brickwork wall fabric here is mostly composed of three courses of brick stretchers that alternate with one course of brick headers in English Garden Wall Bond. Within the upper levels there is a change to this wall fabric, which here is mostly composed of courses of brick stretchers with one course of mixed brick headers and stretchers.

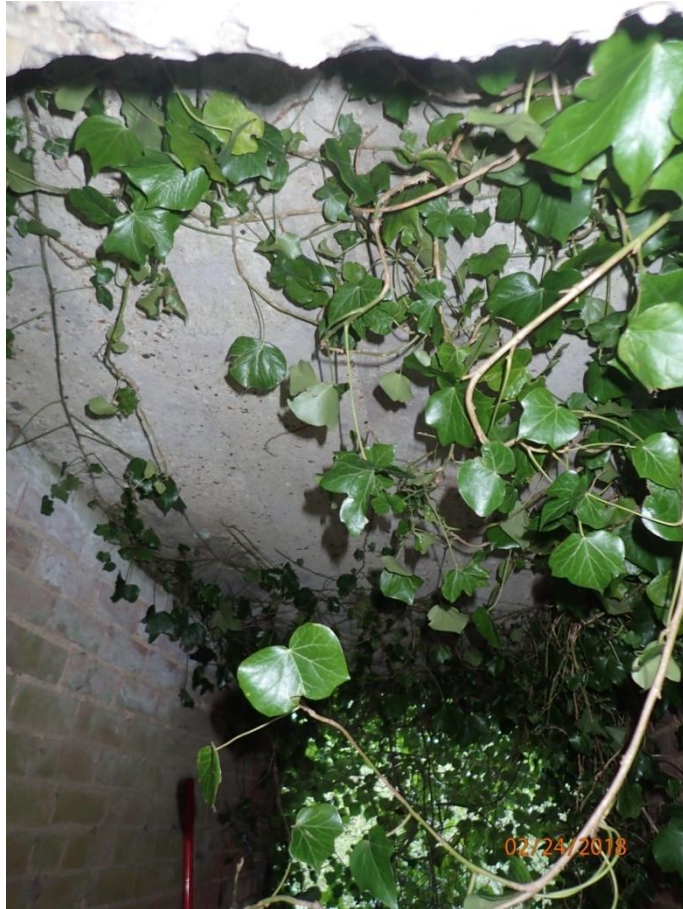
Plate 96: View of the concrete ceiling of the internal passageway or Cell 6, from the south

Plate 96 furnishes a view of the modern concrete ceiling of the internal passageway or **Cell 6**.

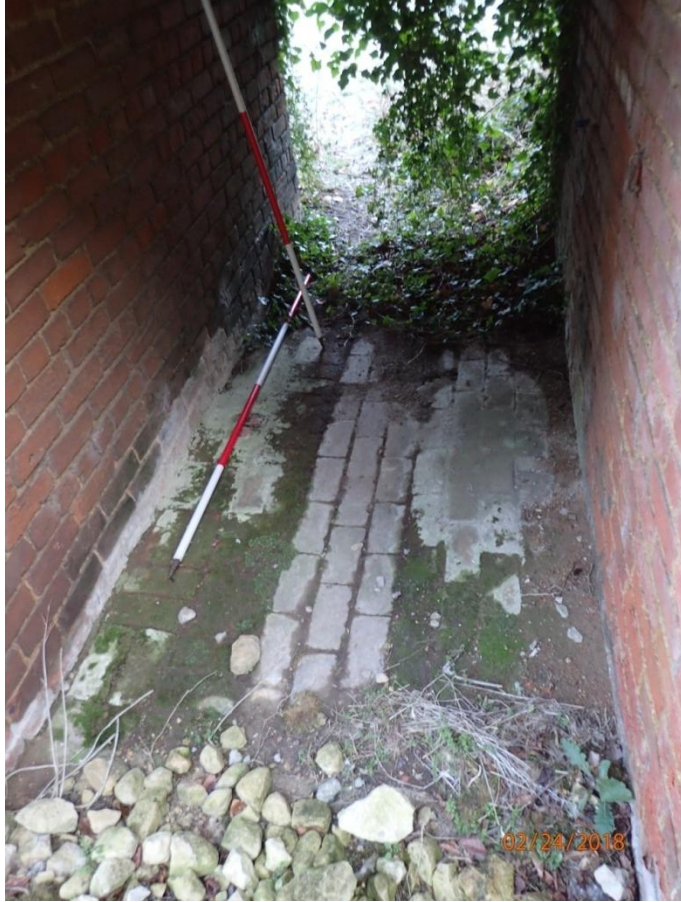
Plate 97: View of the floor of the internal passageway or Cell 6, from the south

Plate 97 provides an image of the floor of the internal passageway. This floor is composed of courses of brick stretchers laid on bed.

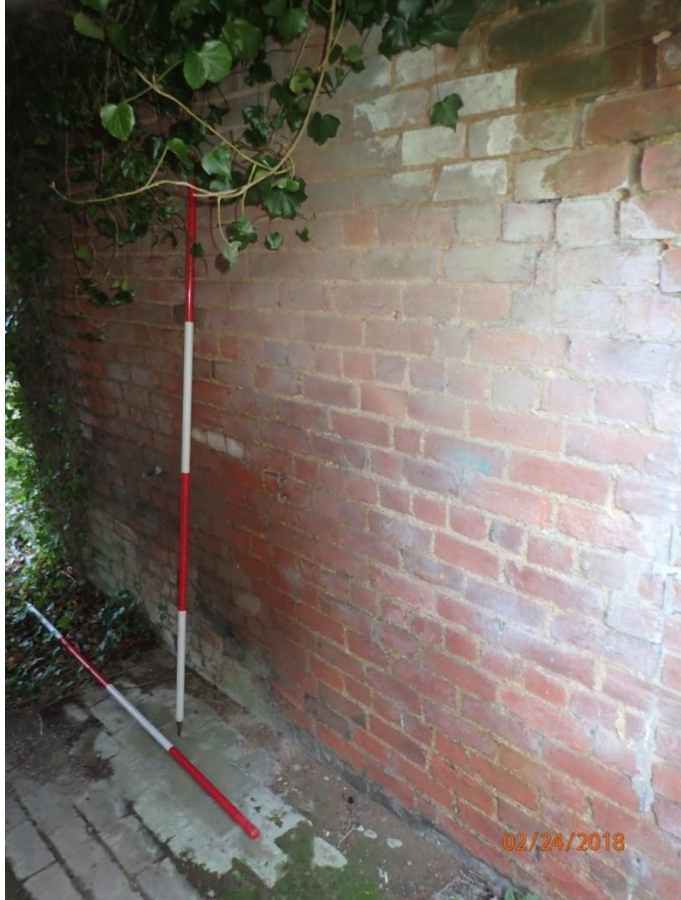
Plate 98: View of the east wall of the internal passageway or Cell 6, from the south

Plate 98 provides a detailed view of the east wall of this internal passageway or **Cell 6**. The brickwork wall fabric of this east wall is composed of three courses of brick stretchers that alternate with one course of brick headers or with one course of mixed brick headers and stretchers in English Garden Wall Bond.

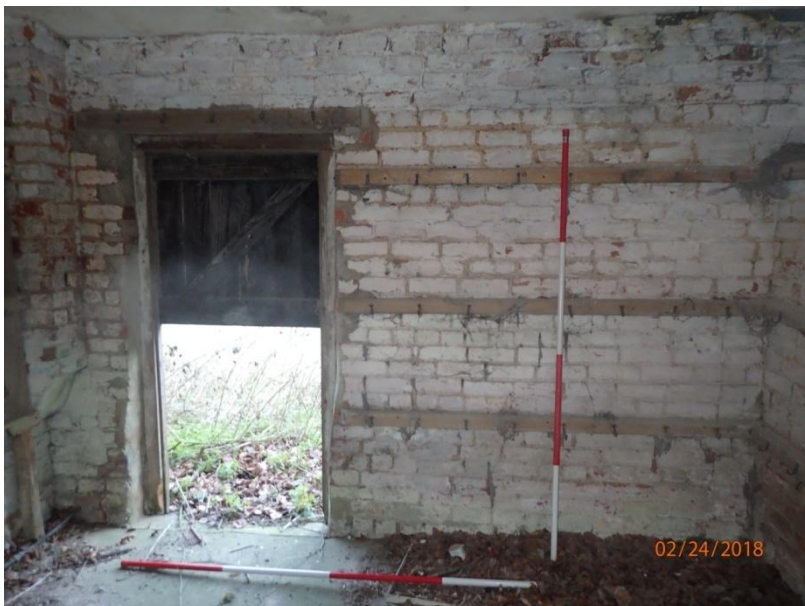
Plate 99: View of the north wall of Cell 7, from the south

Plate 99 provides a detailed view of the north wall of **Cell 7**. Despite being covered over with layers of whitewash, the brickwork wall fabric of this north wall is composed of three courses of brick stretchers which alternate with one course of brick headers in English Garden Wall Bond. To the left (west), is the inner face of a north facing door opening that was recorded externally on the opposing North Elevation. The opening contains a simple timber frame of head and surrounds and a concrete threshold at the base of this opening. The opening has one upper timber half door, the lower half door being absent. This indicates that **Cell 7** once functioned as a stable. The surviving half door is composed of a series of tongued and grooved vertical timber planks that are attached to an internal framework of angled and horizontal timbers. An horizontal timber lintel is above the opening and is incorporated in the brickwork wall fabric. The opening is recessed.

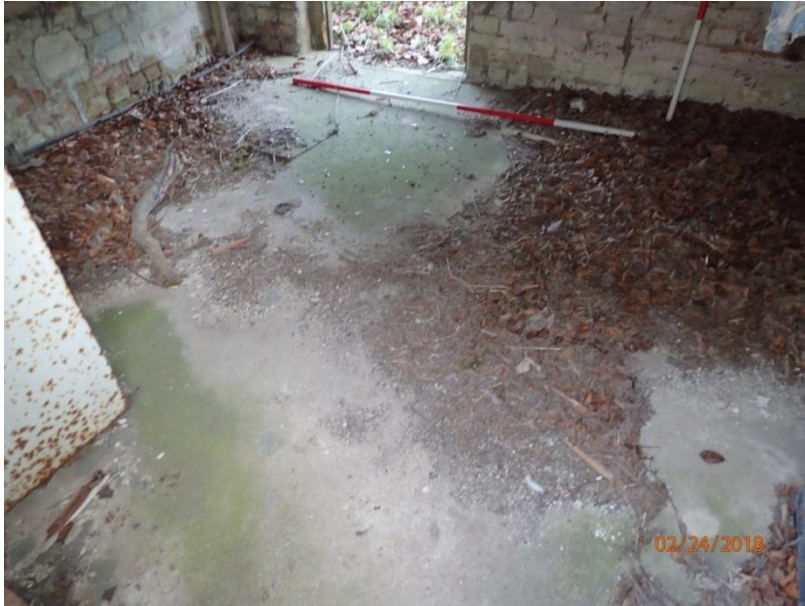
Plate 100: View of the floor of Cell 7, from the south

Plate 100 features the floor of **Cell 7**, which is of modern concrete.

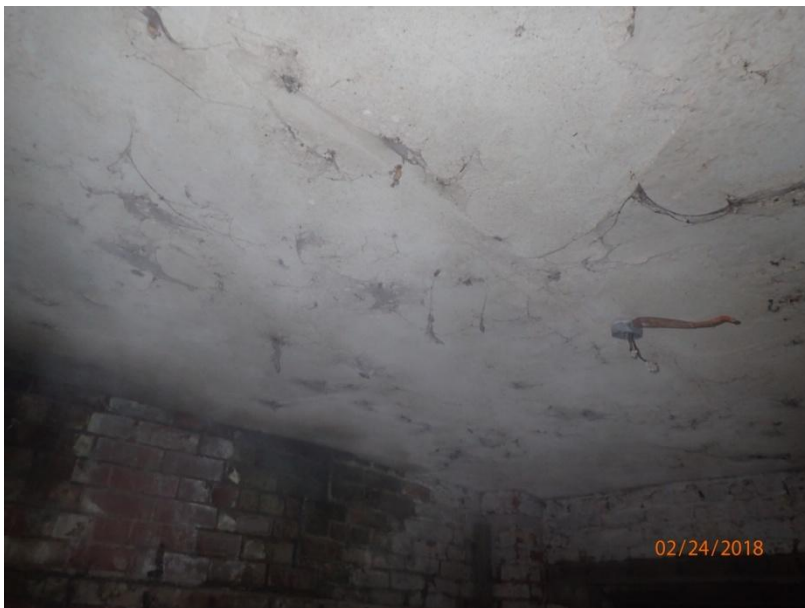
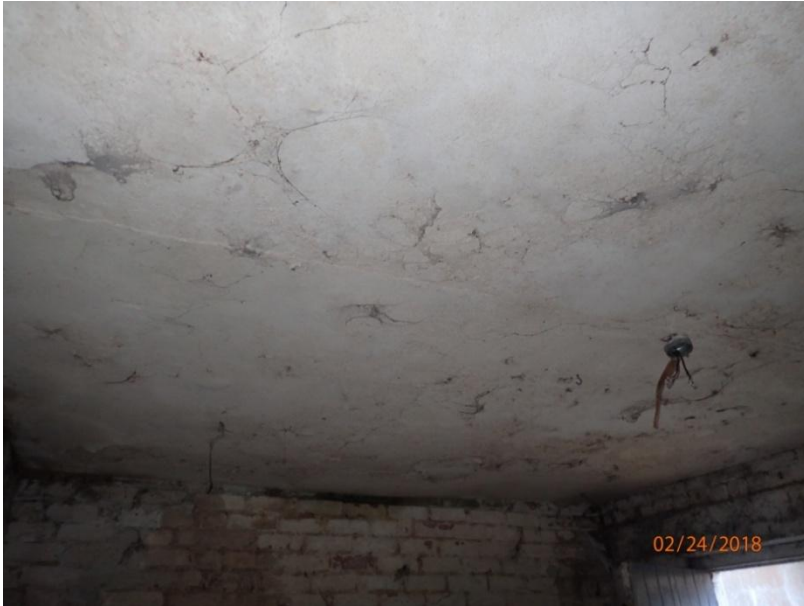
Plates 101 and 102 provide views of the ceiling of **Cell 7** from different perspectives, which is of modern plasterwork.

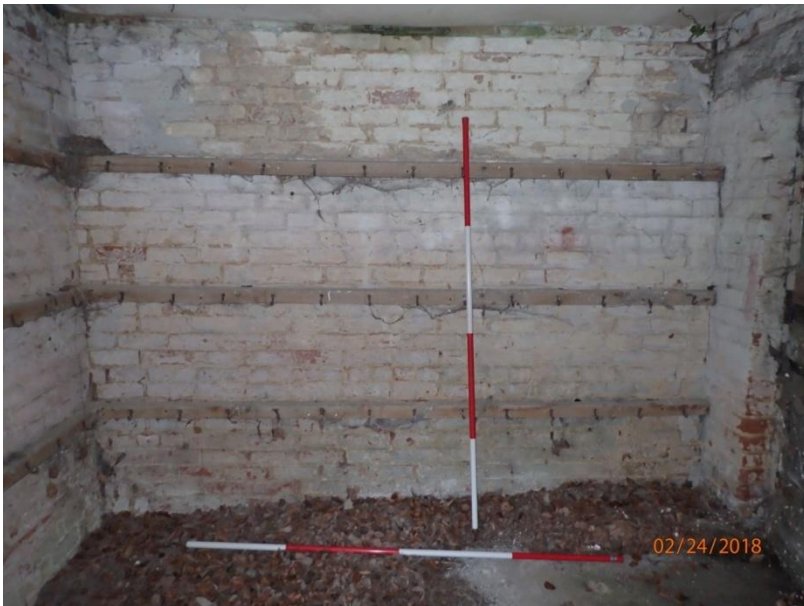
Plate 103: View of the east wall of Cell 7, from the west

Plate 103 provides a detailed view of the east wall of **Cell 7**. Despite being covered over with layers of whitewash, the brickwork of this east wall is mostly composed of courses of brick stretchers, with occasional courses of brick headers.

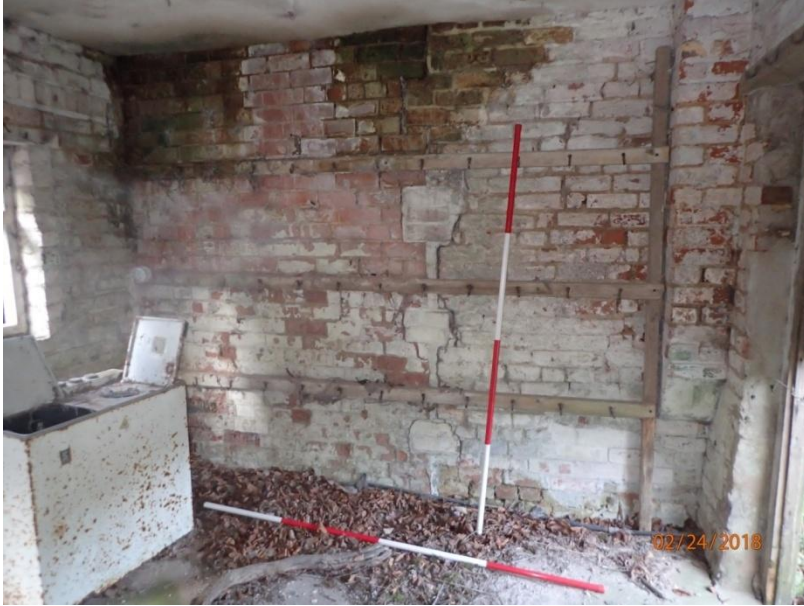
Plate 104: View of the west wall of Cell 7, from the east

Plate 104 features the west wall of **Cell 7**. The brickwork wall fabric of this west wall, despite being covered over with layers of whitewash, is mostly composed of courses of brick stretchers along with occasional courses of brick headers and of courses of mixed brick headers and stretchers.

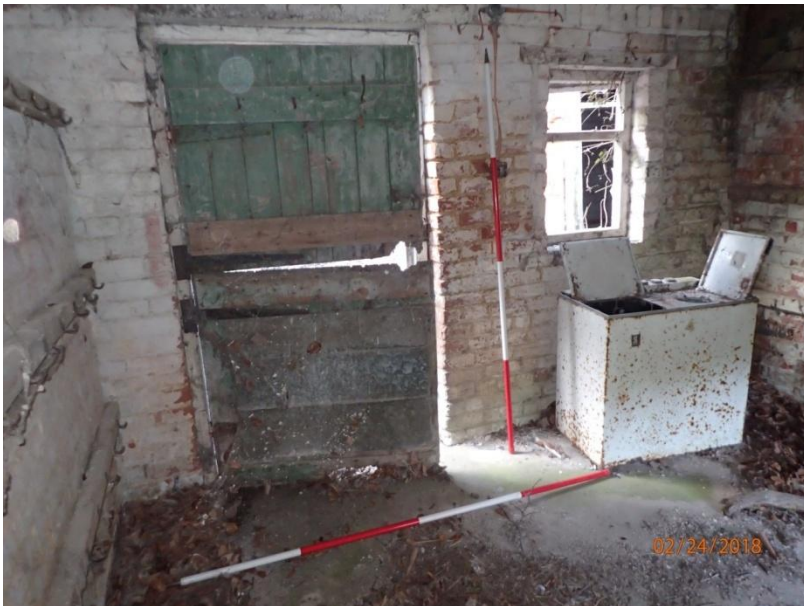
Plate 105: View of the south wall of Cell 7, from the north

Plate 105 provides a view of the south wall of **Cell 7**. The brickwork wall fabric of this south wall, despite being covered over with layers of whitewash, is mostly composed of courses of brick stretchers along with occasional courses of brick headers and of courses of mixed brick headers and stretchers.
