**Thornton Beam Engine House,  
Thornton,  
Fife,  
Standing Building Record,  
Data Structure Report**

**March 2016**

Client: Mr Mark Bruce  
Project: Thornton Beam Engine House  
Document Title: Standing Building Recording  
Job No: 224

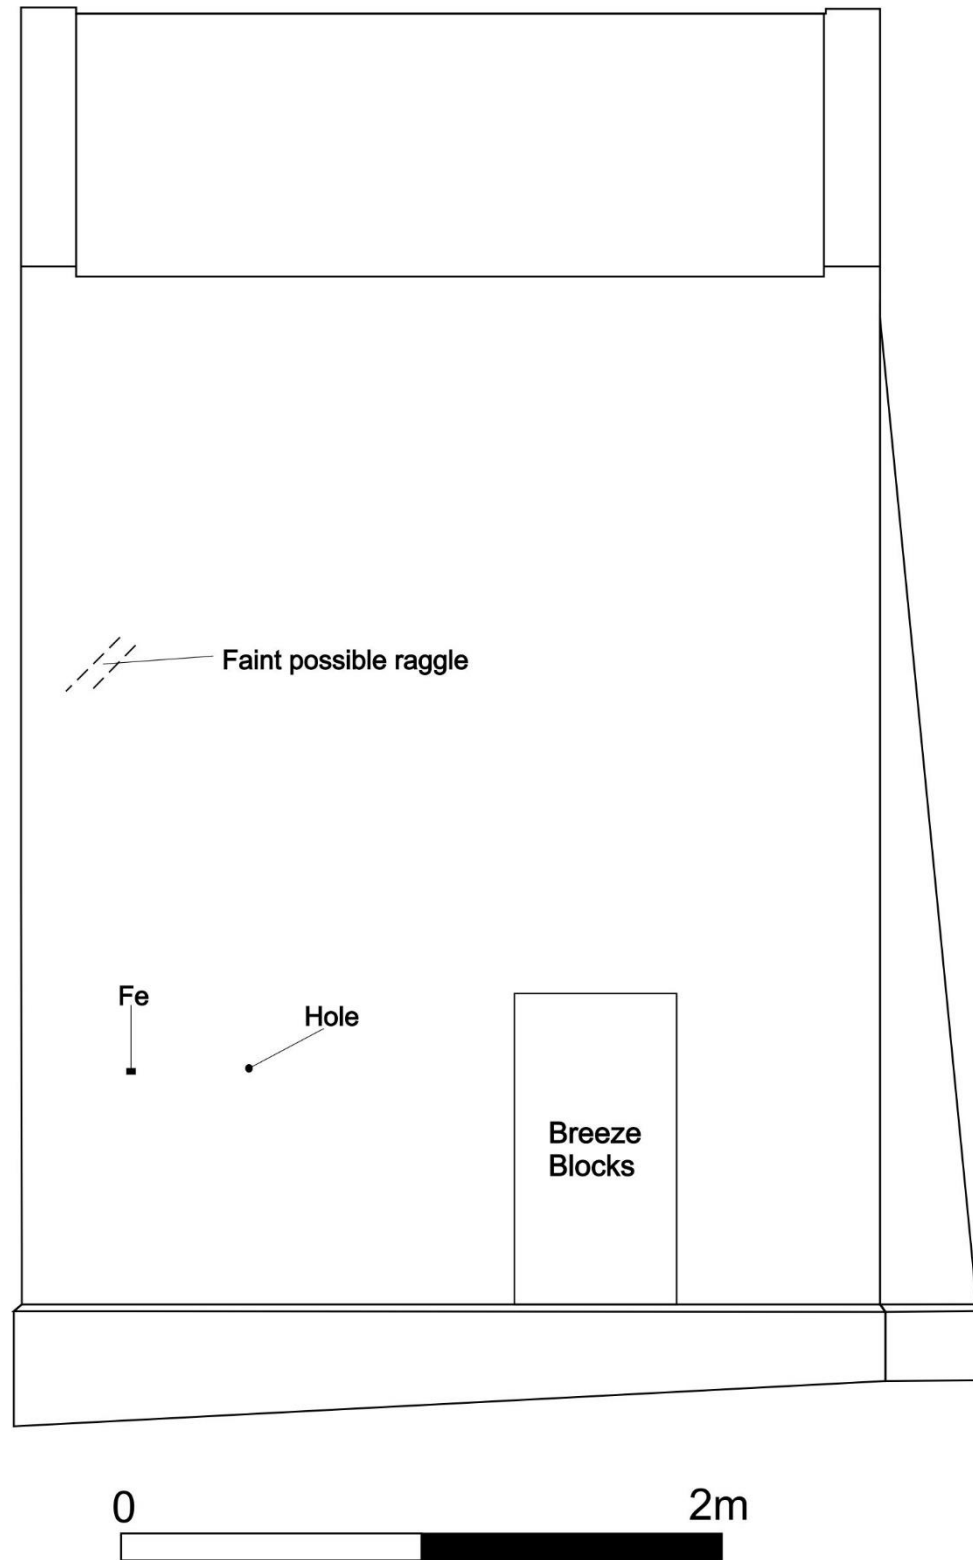
Figure 3: North facing elevation of Thornton Beam Engine House. Base elevation checked and edited from original courtesy of Alan Hardie Architect

5.2.1 The north elevation of Thornton Beam Engine House is the most unremarkable and unaltered elevation of the building (Plate 5). It has an entrance built as a primary feature in the western half of the wall, although this is now blocked with modern nine inch concrete blocks. The jambs and lintel of this opening are well dressed sandstone blocks, although not as high quality as those in the western elevation. The coursing of the stonework is reasonably consistent, specifically at the lower level, although this loses its consistency above door level, particularly on the western side.

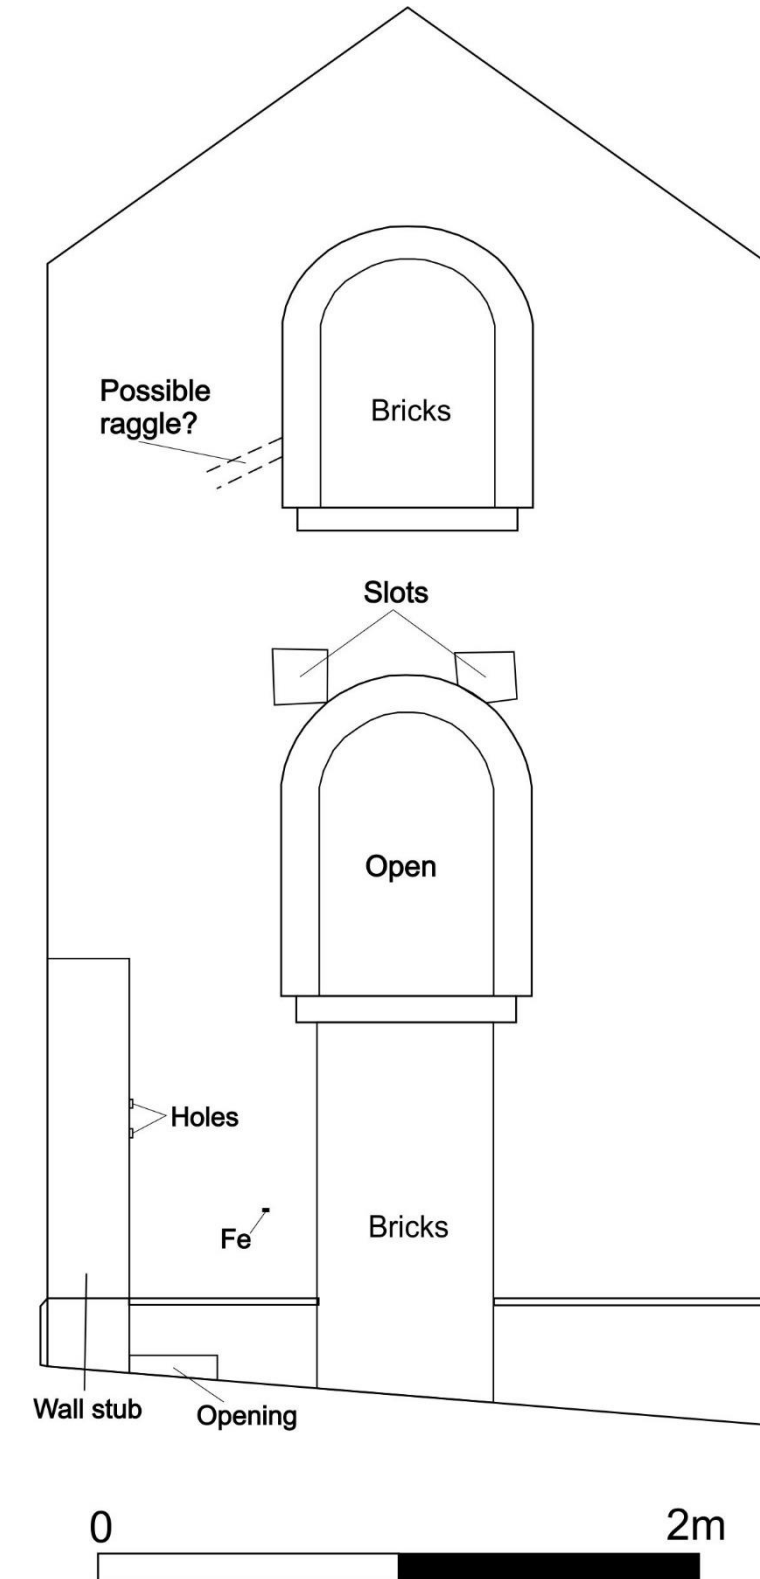
Figure 4: East facing elevation of Thornton Beam Engine House. Base elevation checked and edited from original courtesy of Alan Hardie Architect

5.3.1 The East elevation contains a number of openings (Plate 6). An entrance at ground level is now blocked by modern breeze blocks, while of the two arched openings above, located at first and second floor levels, the uppermost is blocked by what appear to be 19<sup>th</sup> century bricks. The function of these openings is not clear. The opening on first floor level has the height and location at floor level to have acted as a doorway. The upper, now blocked opening appears too small for this and may have been a window or associated with the use of machinery.
