Channel Tunnel Rail Link  
**Kvaerner Construction Ltd.**  
for Union Railways (South) Ltd.

**BROCKTON FARM, CHARING HEATH, KENT**  
ARCHAEOLOGICAL RECORD IN ADVANCE OF AND DURING DISMANTLING

NGR: TQ 9220 4890

**Oxford Archaeological Unit**  
April 2001

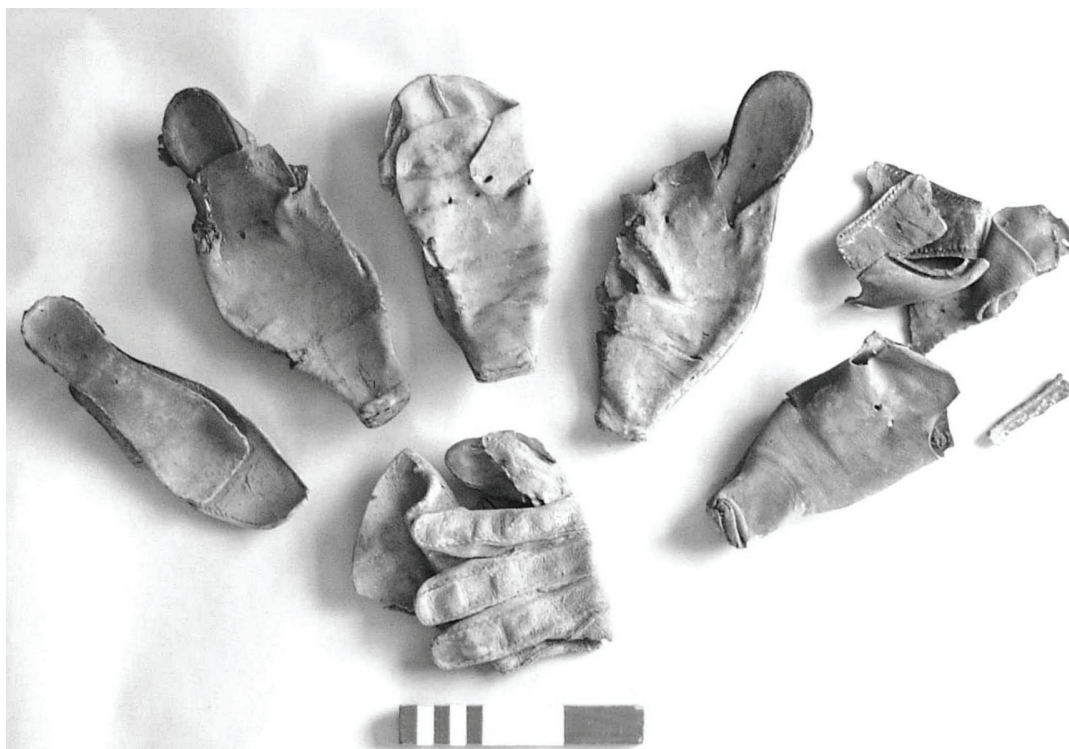
The selection of objects recovered from the wall void at Brockton would appear to represent a fairly standard assemblage for such 'spiritual midden' deposits. Spot dating of the shoes and other clothing items indicate an early –mid 18<sup>th</sup>-century date for the major part of this deposit. The poor condition of many of the items precludes more precise dating.

**Above:** Selection of early 18<sup>th</sup>-century shoes and leather glove from 'spiritual midden' deposit (15cm scale).

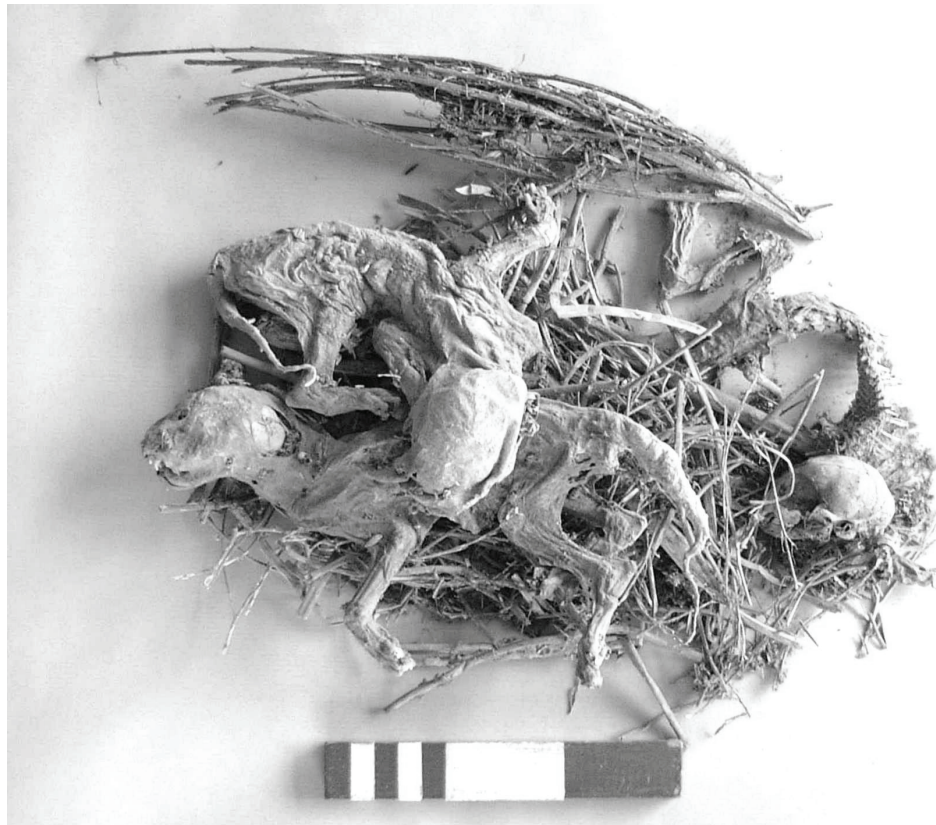
**Above:** three 'mummified' cats from spiritual midden deposit (15cm scale).
