Channel Tunnel Rail Link
Balfour Beatty Major Projects
for Union Railways (South) Ltd.

TALBOT HOUSE, SELLINDGE, KENT
ARCHAEOLOGICAL RECORD IN ADVANCE OF AND DURING DISMANTLING

Environmental Statement Route Window: 36

October 2002

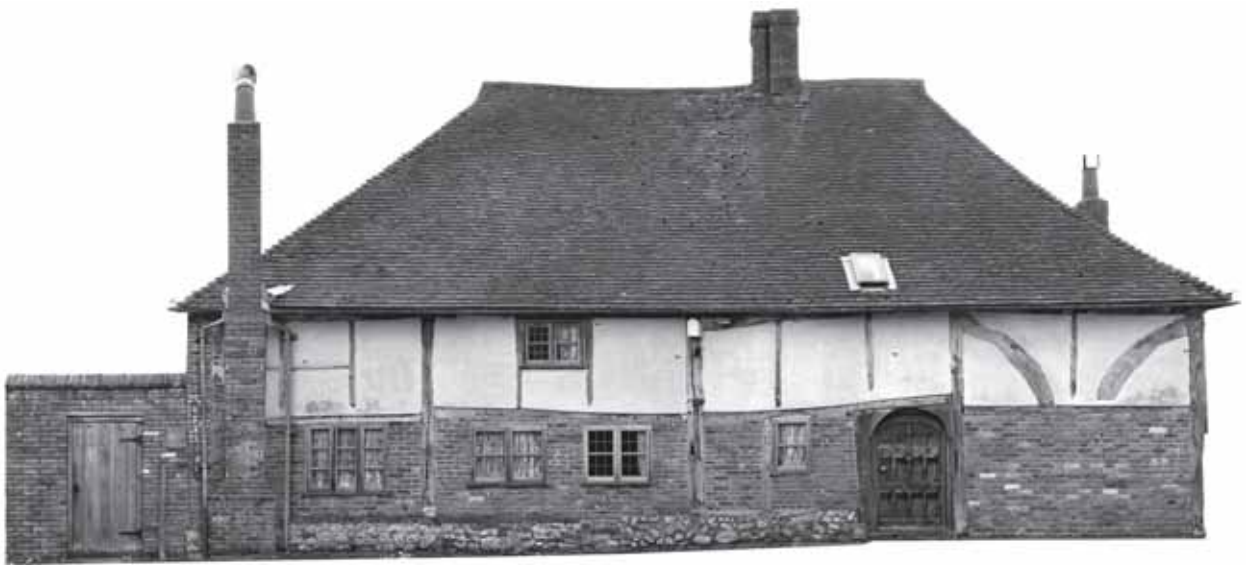
(a) North elevation

5.2.1 North Elevation (see Figure 5a)

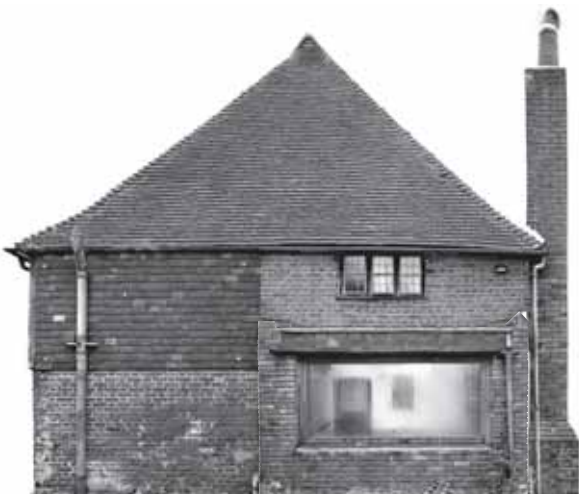
(b) East elevation

5.2.3 East Elevation (see Figure 5b)

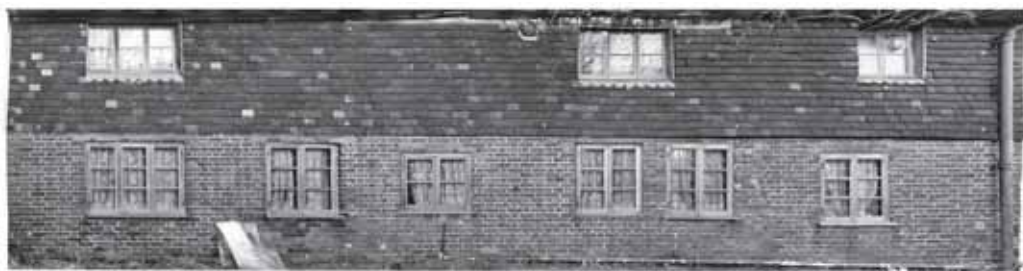
(d) South elevation

5.2.2 South Elevation (see Figure 5d)

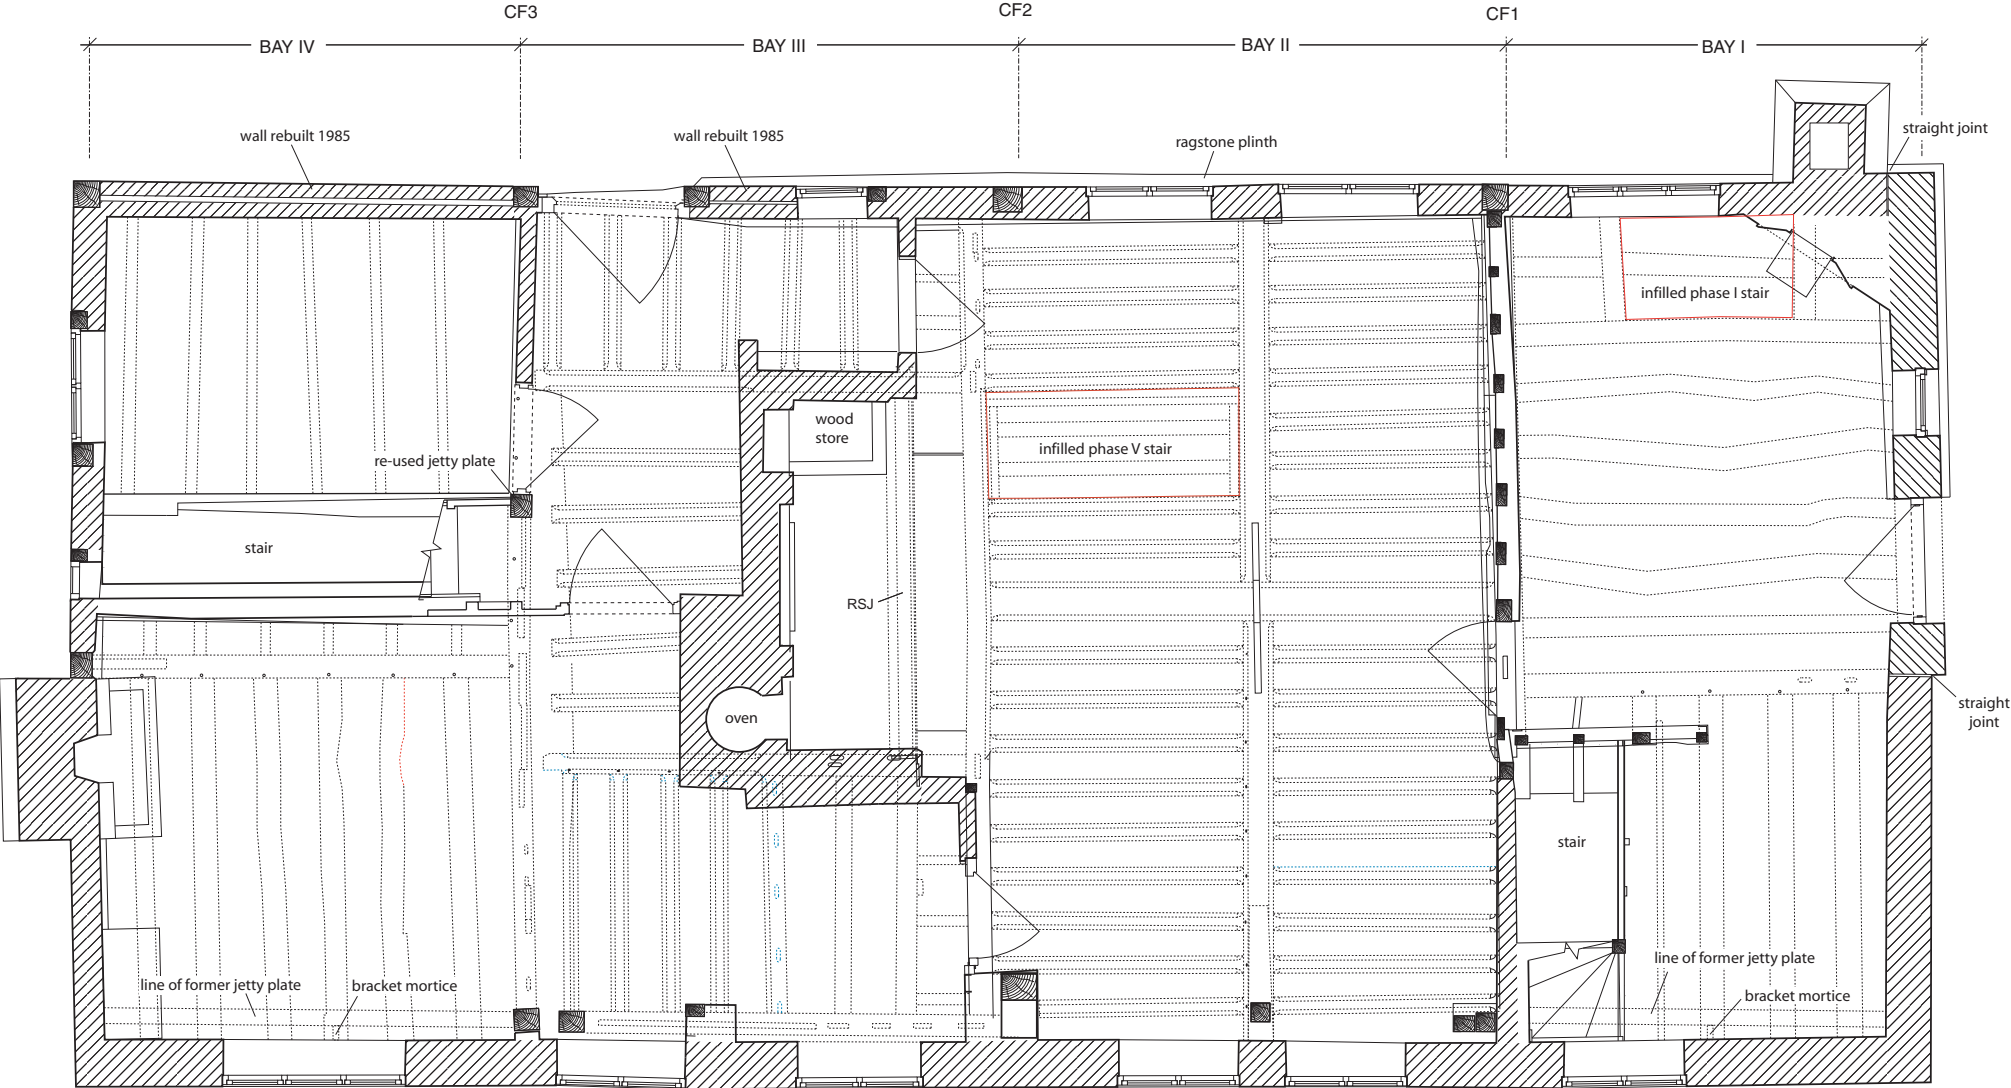
Figure 7 : Ground Floor Plan (as recorded)

6.1.6.1 Evidence for primary fenestration was recorded in a number of locations. At first floor level, *in-situ* evidence was recorded in the soffit of the principal longitudinal bressummer of the south elevation within bays I and IV. This clearly indicates that each of the upper rooms of the storeyed end bays were furnished with two-light window openings (*c.*1.30 wide) located centrally within their southern walls, with internal sliding shutters running in a longitudinal groove. A redundant mortice in the western jamb of the bay I opening indicates that the windows were originally 0.70m tall). Evidence for the fenestration of the lower rooms of bays I and IV was recorded *ex-situ* from a timber retrieved during dismantling (see Figure 28; WP-38 - post flanking western stair) which reasonably represents a re-used jetty plate from either bay I or bay IV. The soffit of the plate displays mortices for window jambs (0.15m wide at 1.40m centres) and a further central post dividing the window into two lights, each with three 'diamond' profile mullion mortices. As with the first floor windows, a 0.20m deep longitudinal groove along the inner edge of the soffit evidences the original existence of a sliding shutter. The central post would originally have been tenoned into the soffit of the central, jettied floor joist, mortices for which were identified in both bays I and IV (see Figure 7).

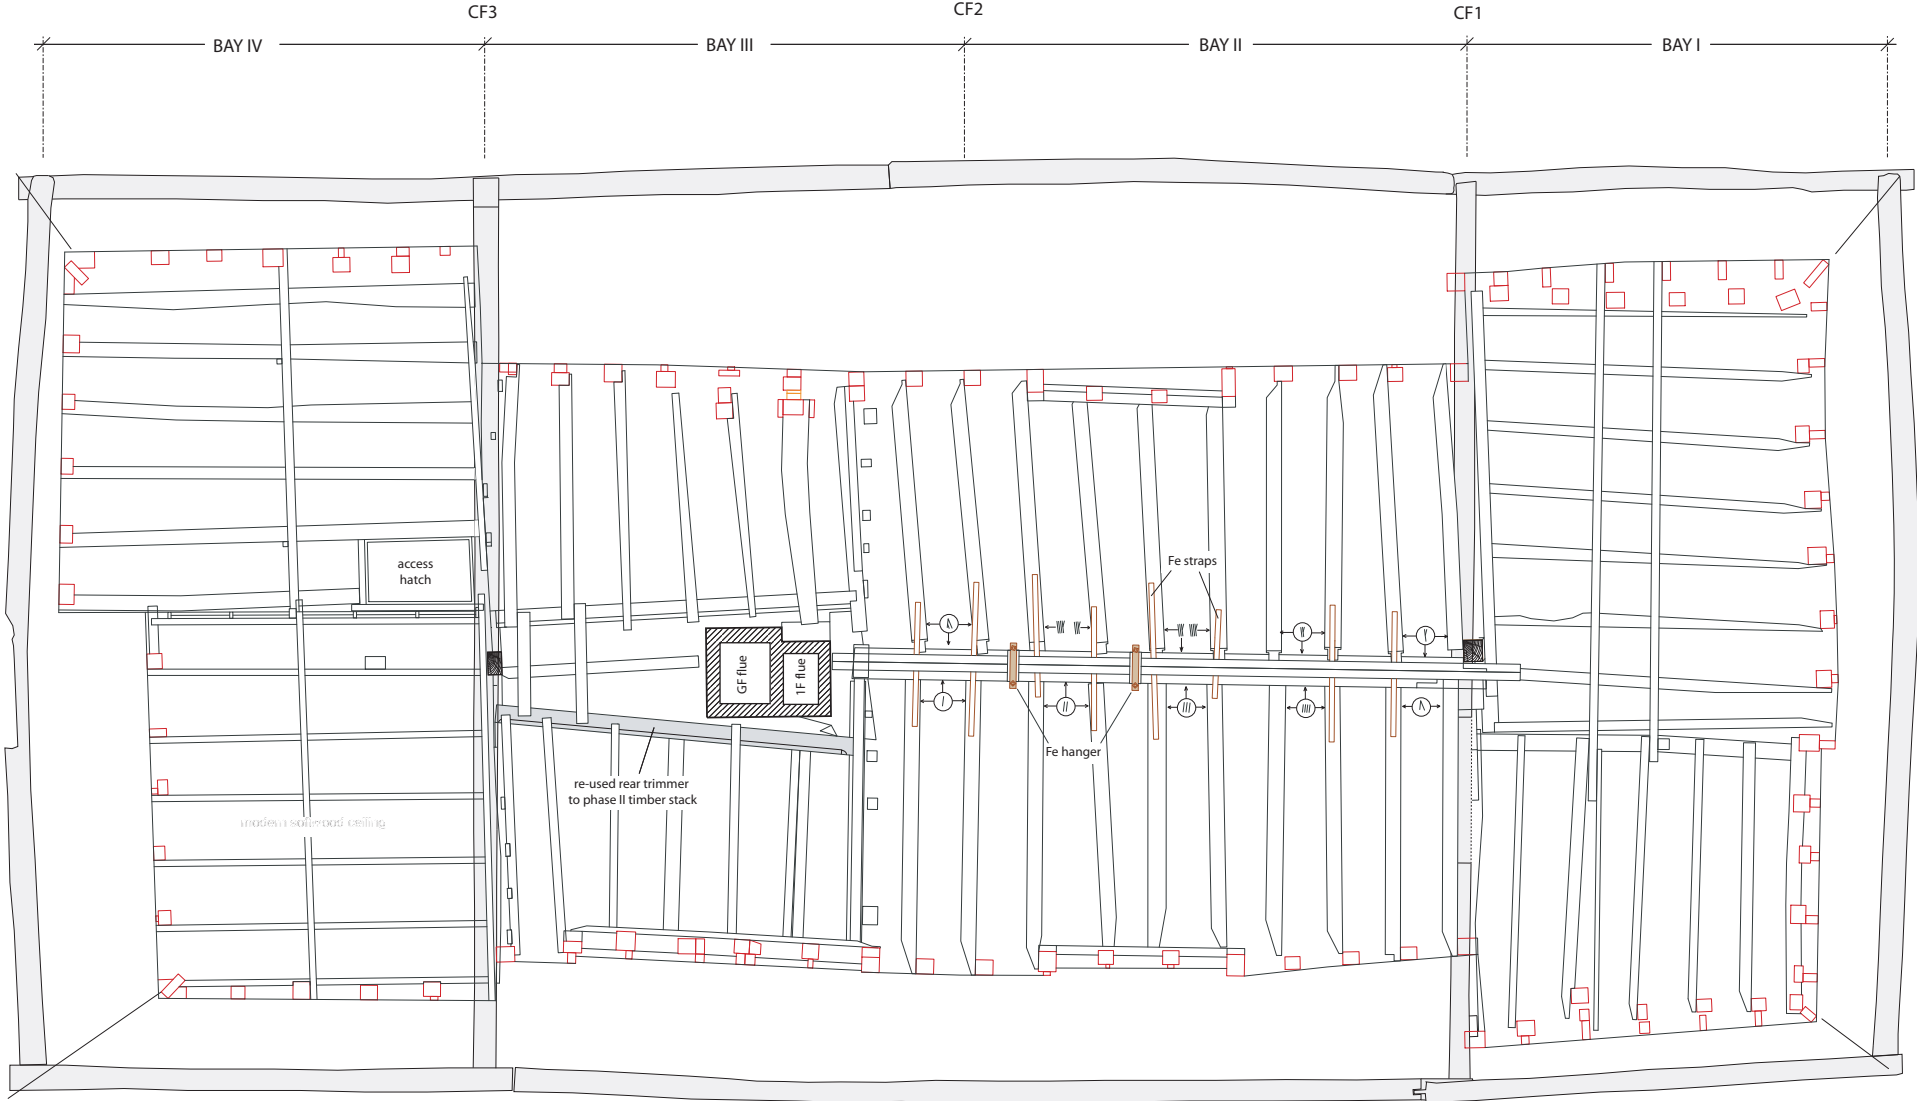
Figure 10 : Ceiling Level Plan (as recorded)

6.3.3 Insertion of ceilings to upper chambers (see Figure 10).

6.3.3.1 It was also during this phase of work that the three first floor chambers, formerly open to the roof, were ceiled for the first time so as to effect a reduction in internal draughts. In the hall chamber (east of the stack) the ceiling comprises a series of 10 pairs of transverse joists supported by a single a central, axial girder. To the east, the central girder is notched into the Phase I cross frame (see Figure 13), while to the west it is supported by the newly inserted framing above the level of the first floor fireplace lintel. The joists of the inserted ceiling display a consistent sequence of carpenter's marks with adjacent pairs being numbered I-V from west to east, those to the north of the axial girder being distinguished by an additional 'tick' (see Figure 10). Within bay III, the ceiling was supported by a pair of girders located to the north and south of the brick stack respectively. Ceiling joists within the end bays are aligned along the axis of the building.

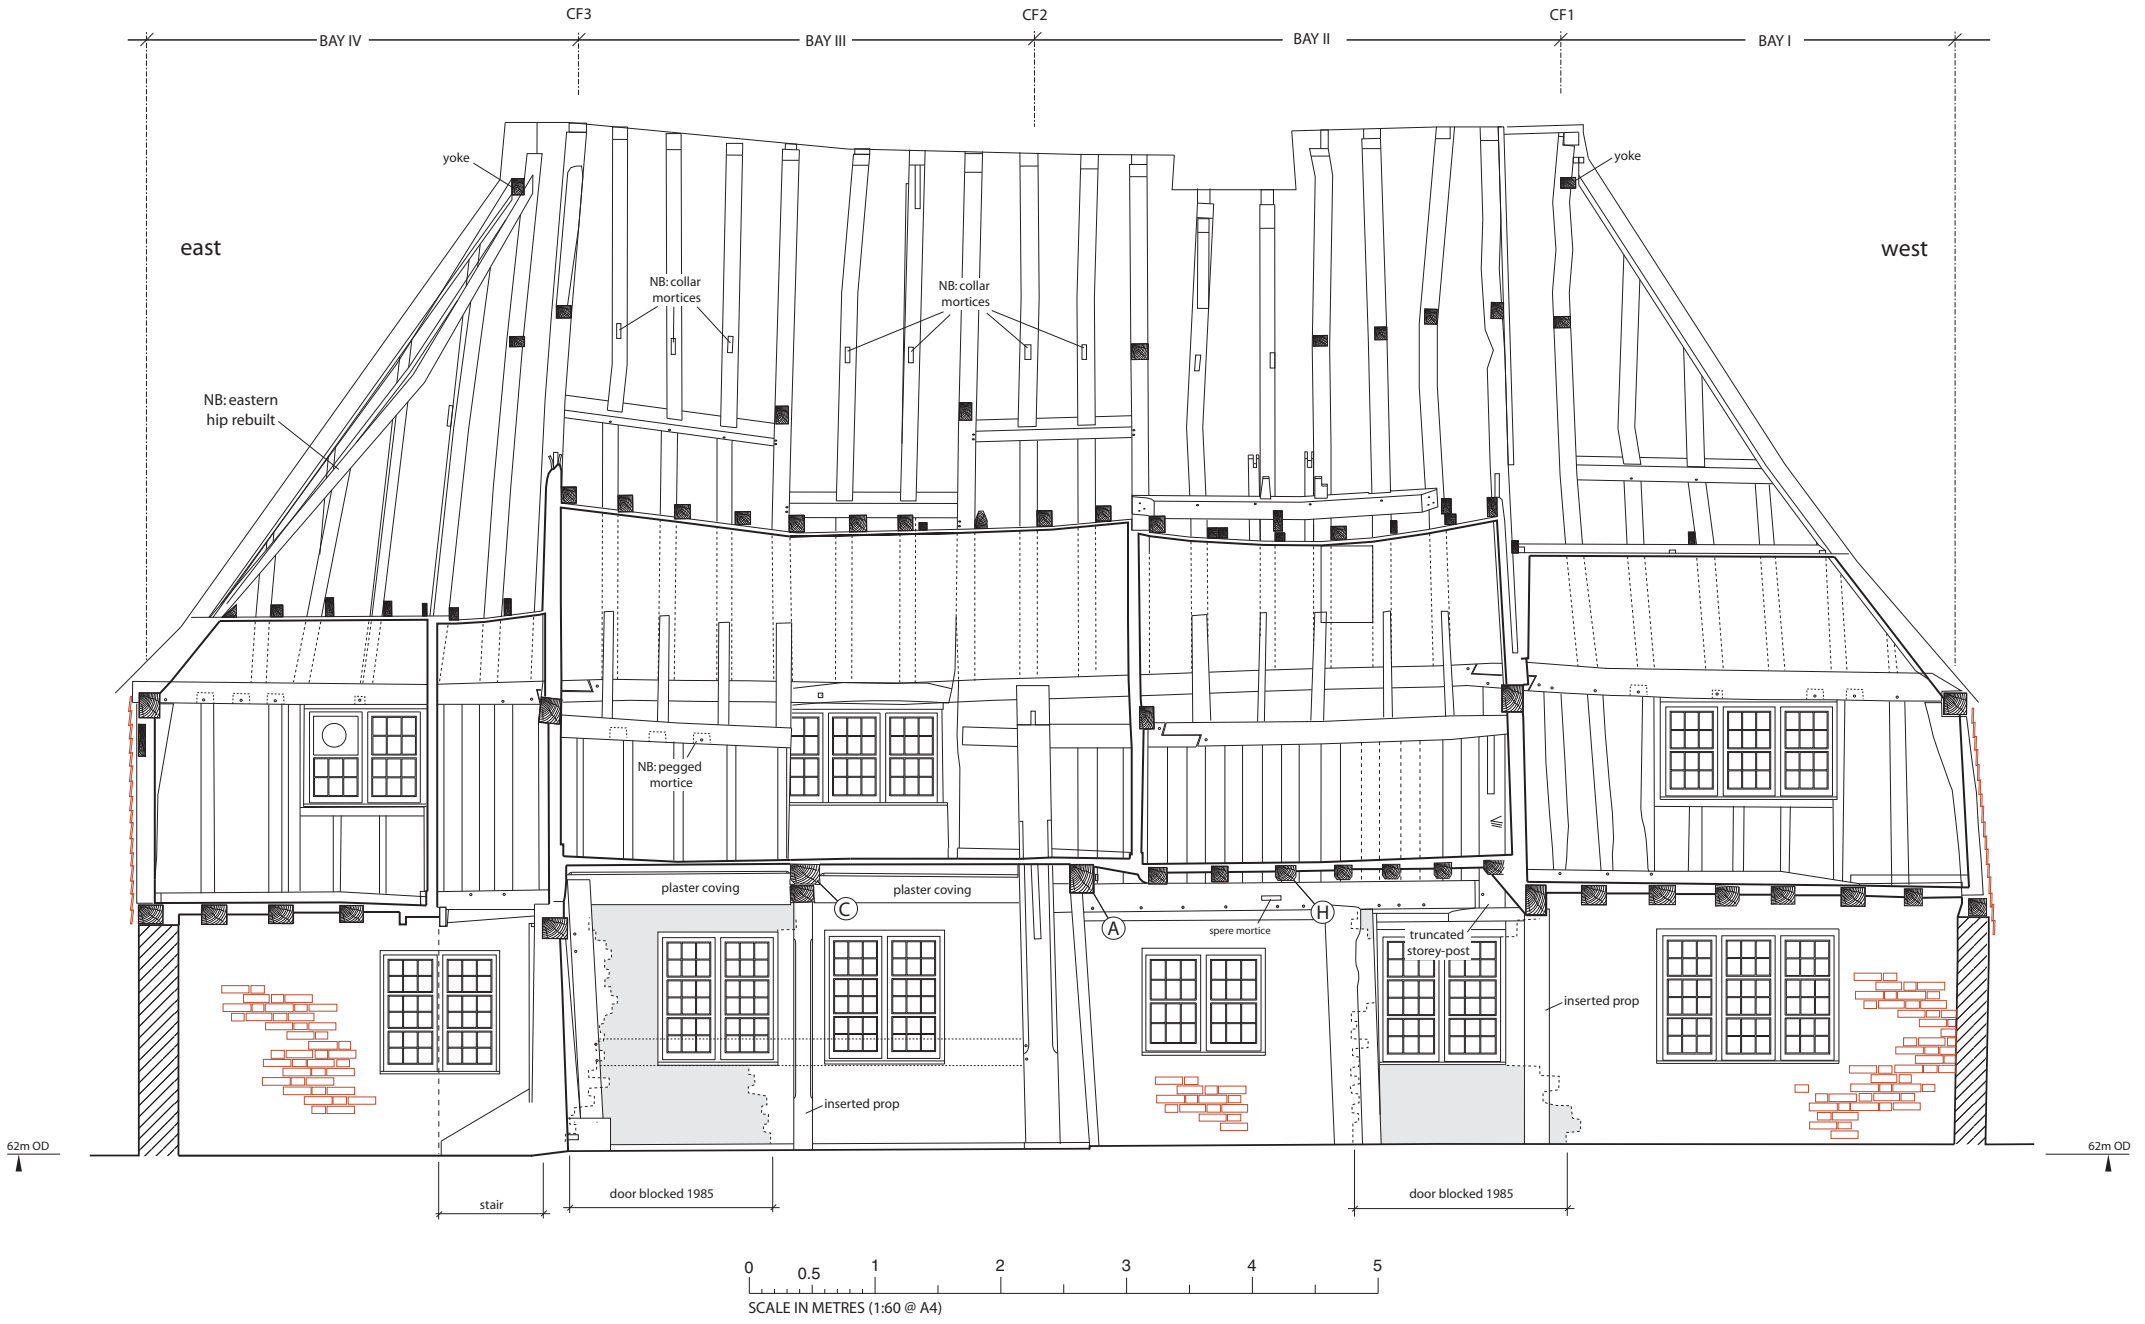
Figure 12 : Interior longitudinal elevation looking south (as recorded)

⁵ The bay II mid-rail, though missing, is evidenced by surviving double pegged mortices in the southern posts of CF1 and CF2 (see Figure 12).

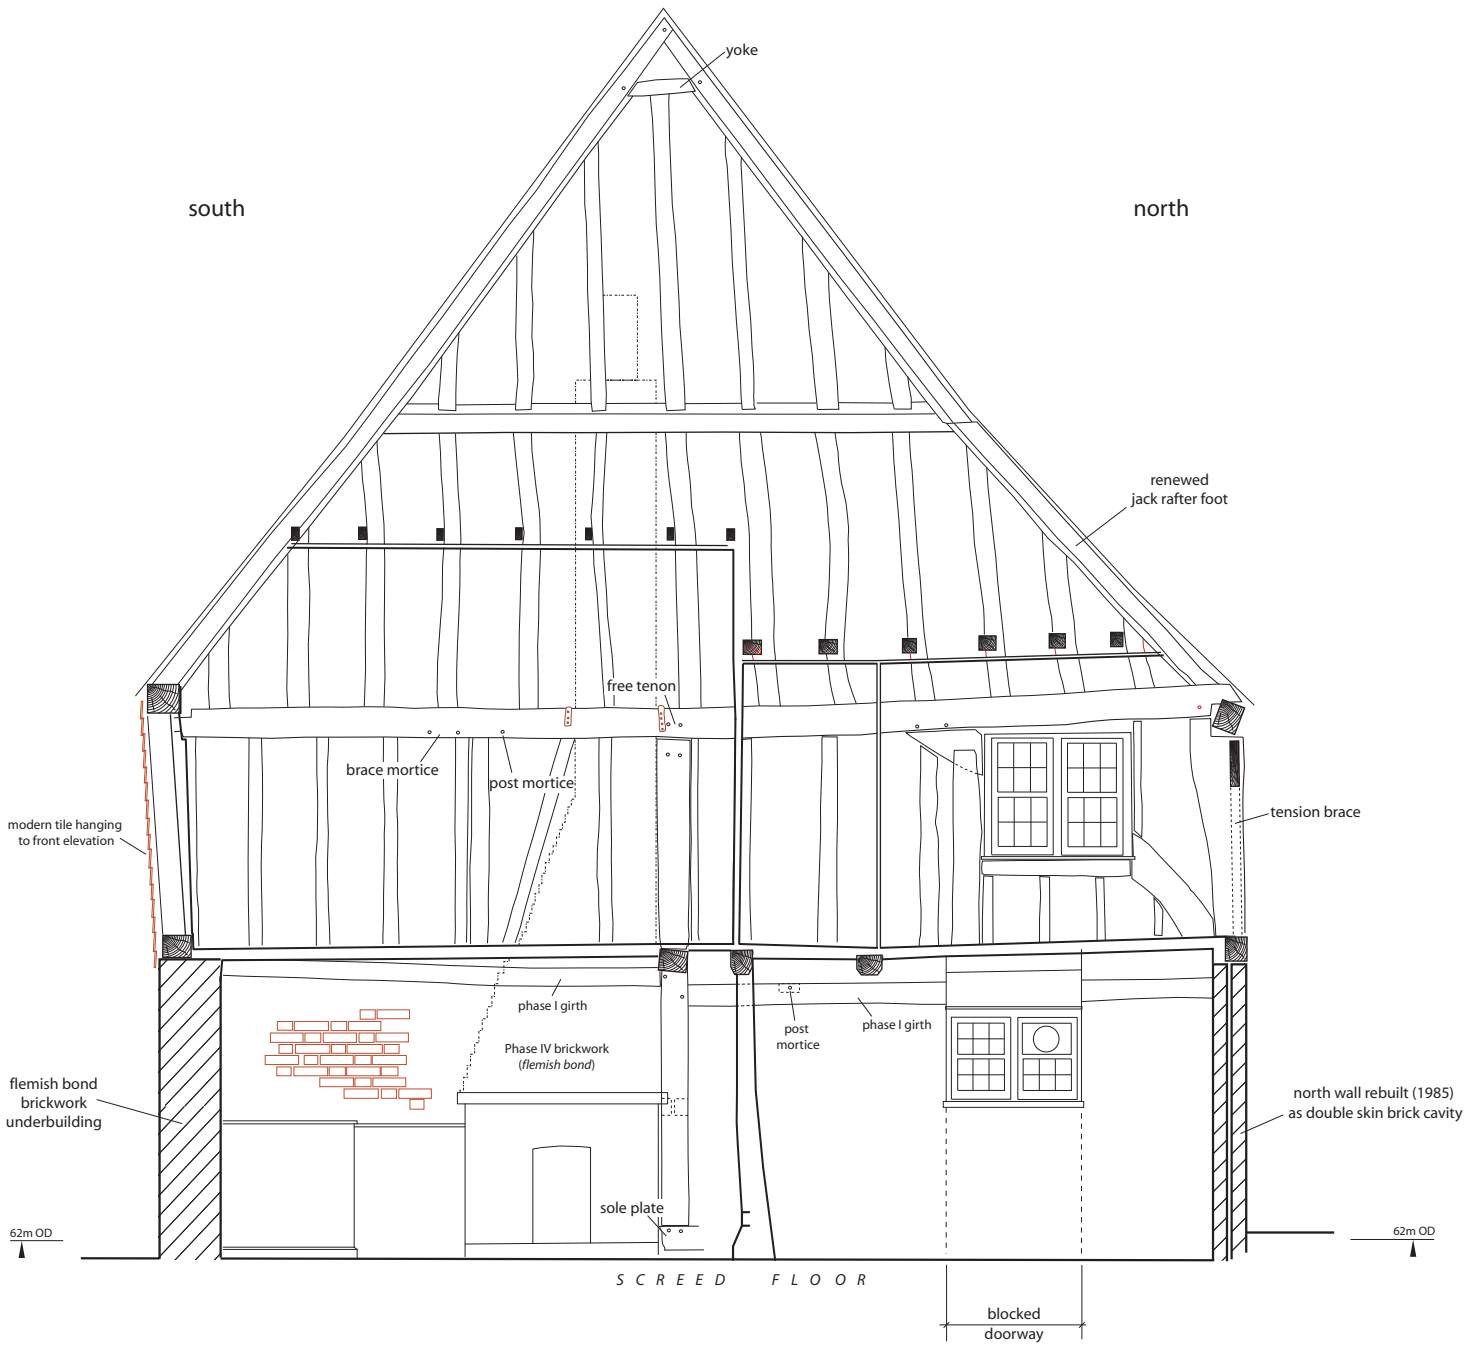
Figure 15 : Service (west) end internal elevation as recorded

6.1.3.4 The western (service) elevation retains its central full height post, girths, a small section of sole plate and its north-western corner post (see Figure 15). At first floor level, to the rear of the house a single ogee arch brace survives triangulating the corner post and the wall plate. A partially surviving brace mortice in the soffit of the wall plate suggests that this arrangement was mirrored to the front of the house. The frame between these braces would appear to have been subdivided by two vertical studs set to either side of the central, full-height wall post. It is probable that a further window, lighting the parlour chamber, was located between these studs, though no direct evidence for such an arrangement was recorded. Two opposing, unpegged mortices in the lower section of the wall post may represent the location of a sill for windows at ground floor level.

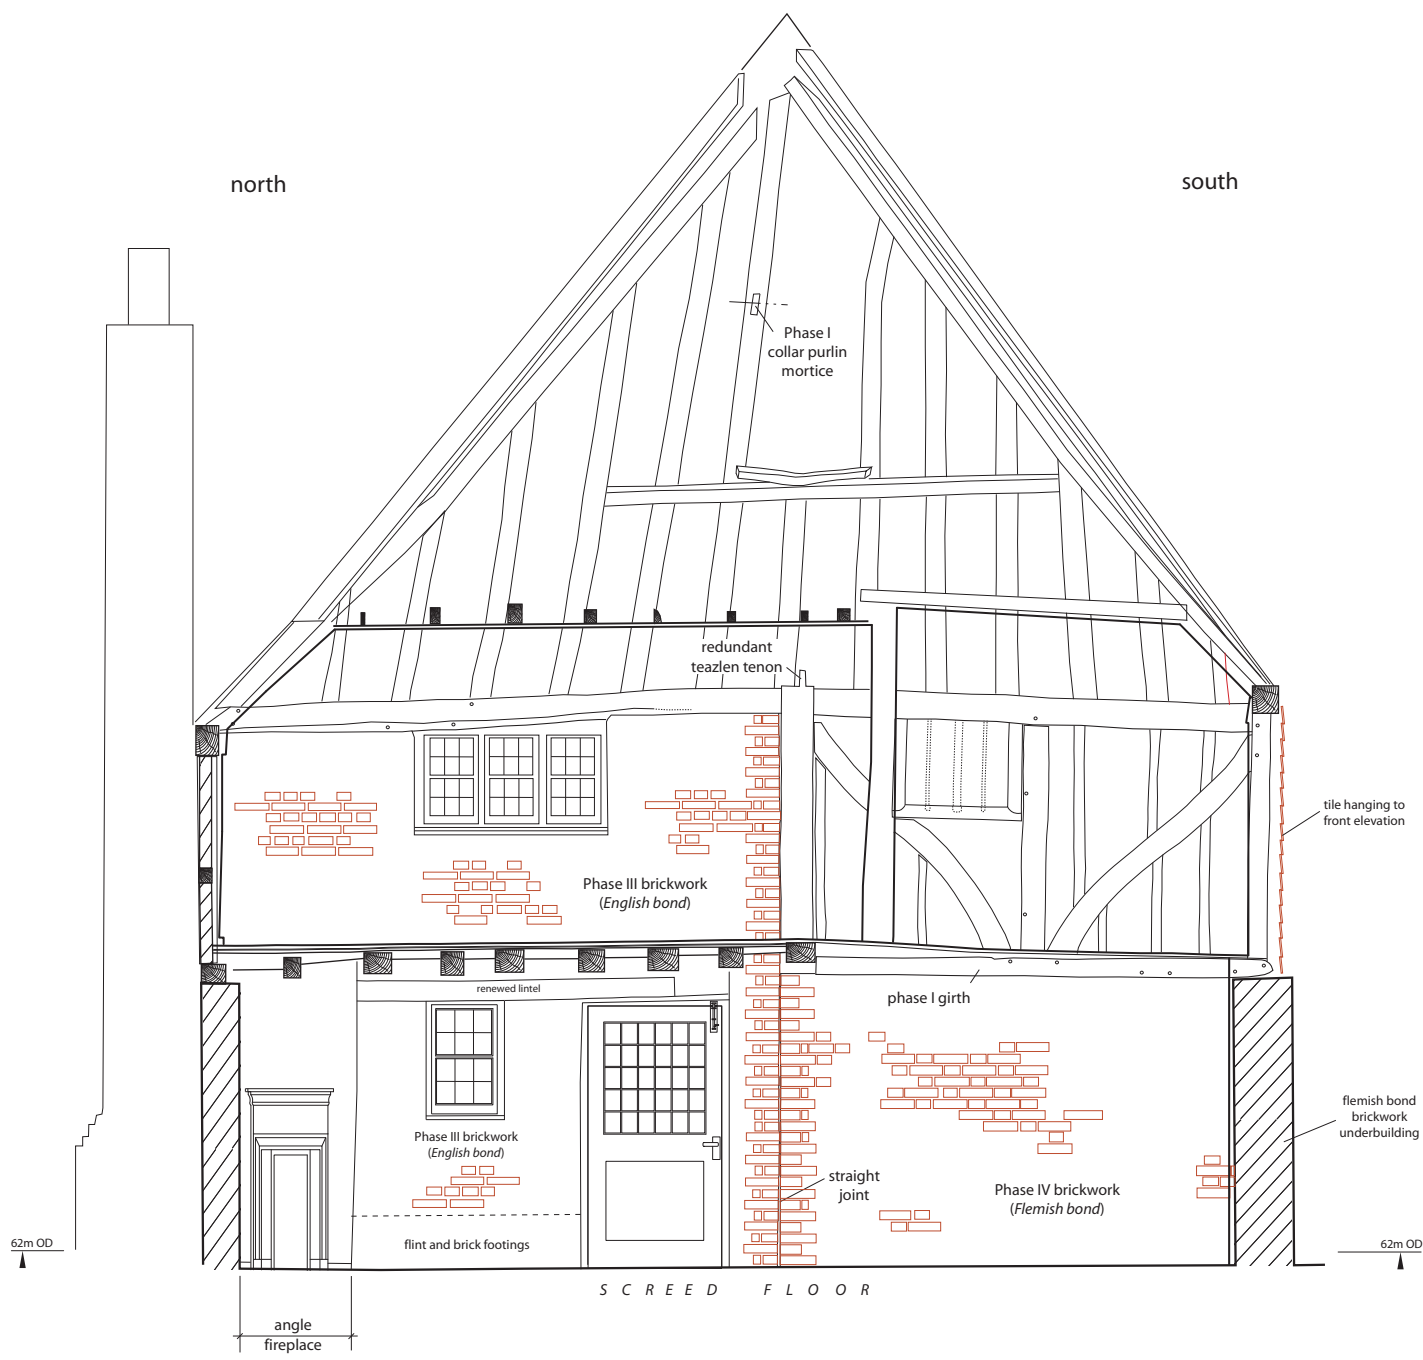
Figure 16 : Service (west) end internal elevation as recorded

- 6.1.3.2 The original arrangement of the eastern (parlour) elevation is difficult to reconstruct in any detail, having been extensively rebuilt. However, paired ogee tension braces do survive at first floor level towards the south (front) of the building, arranged to each side of vertical stud (see Figure 16). An interesting feature of the eastern elevation is the

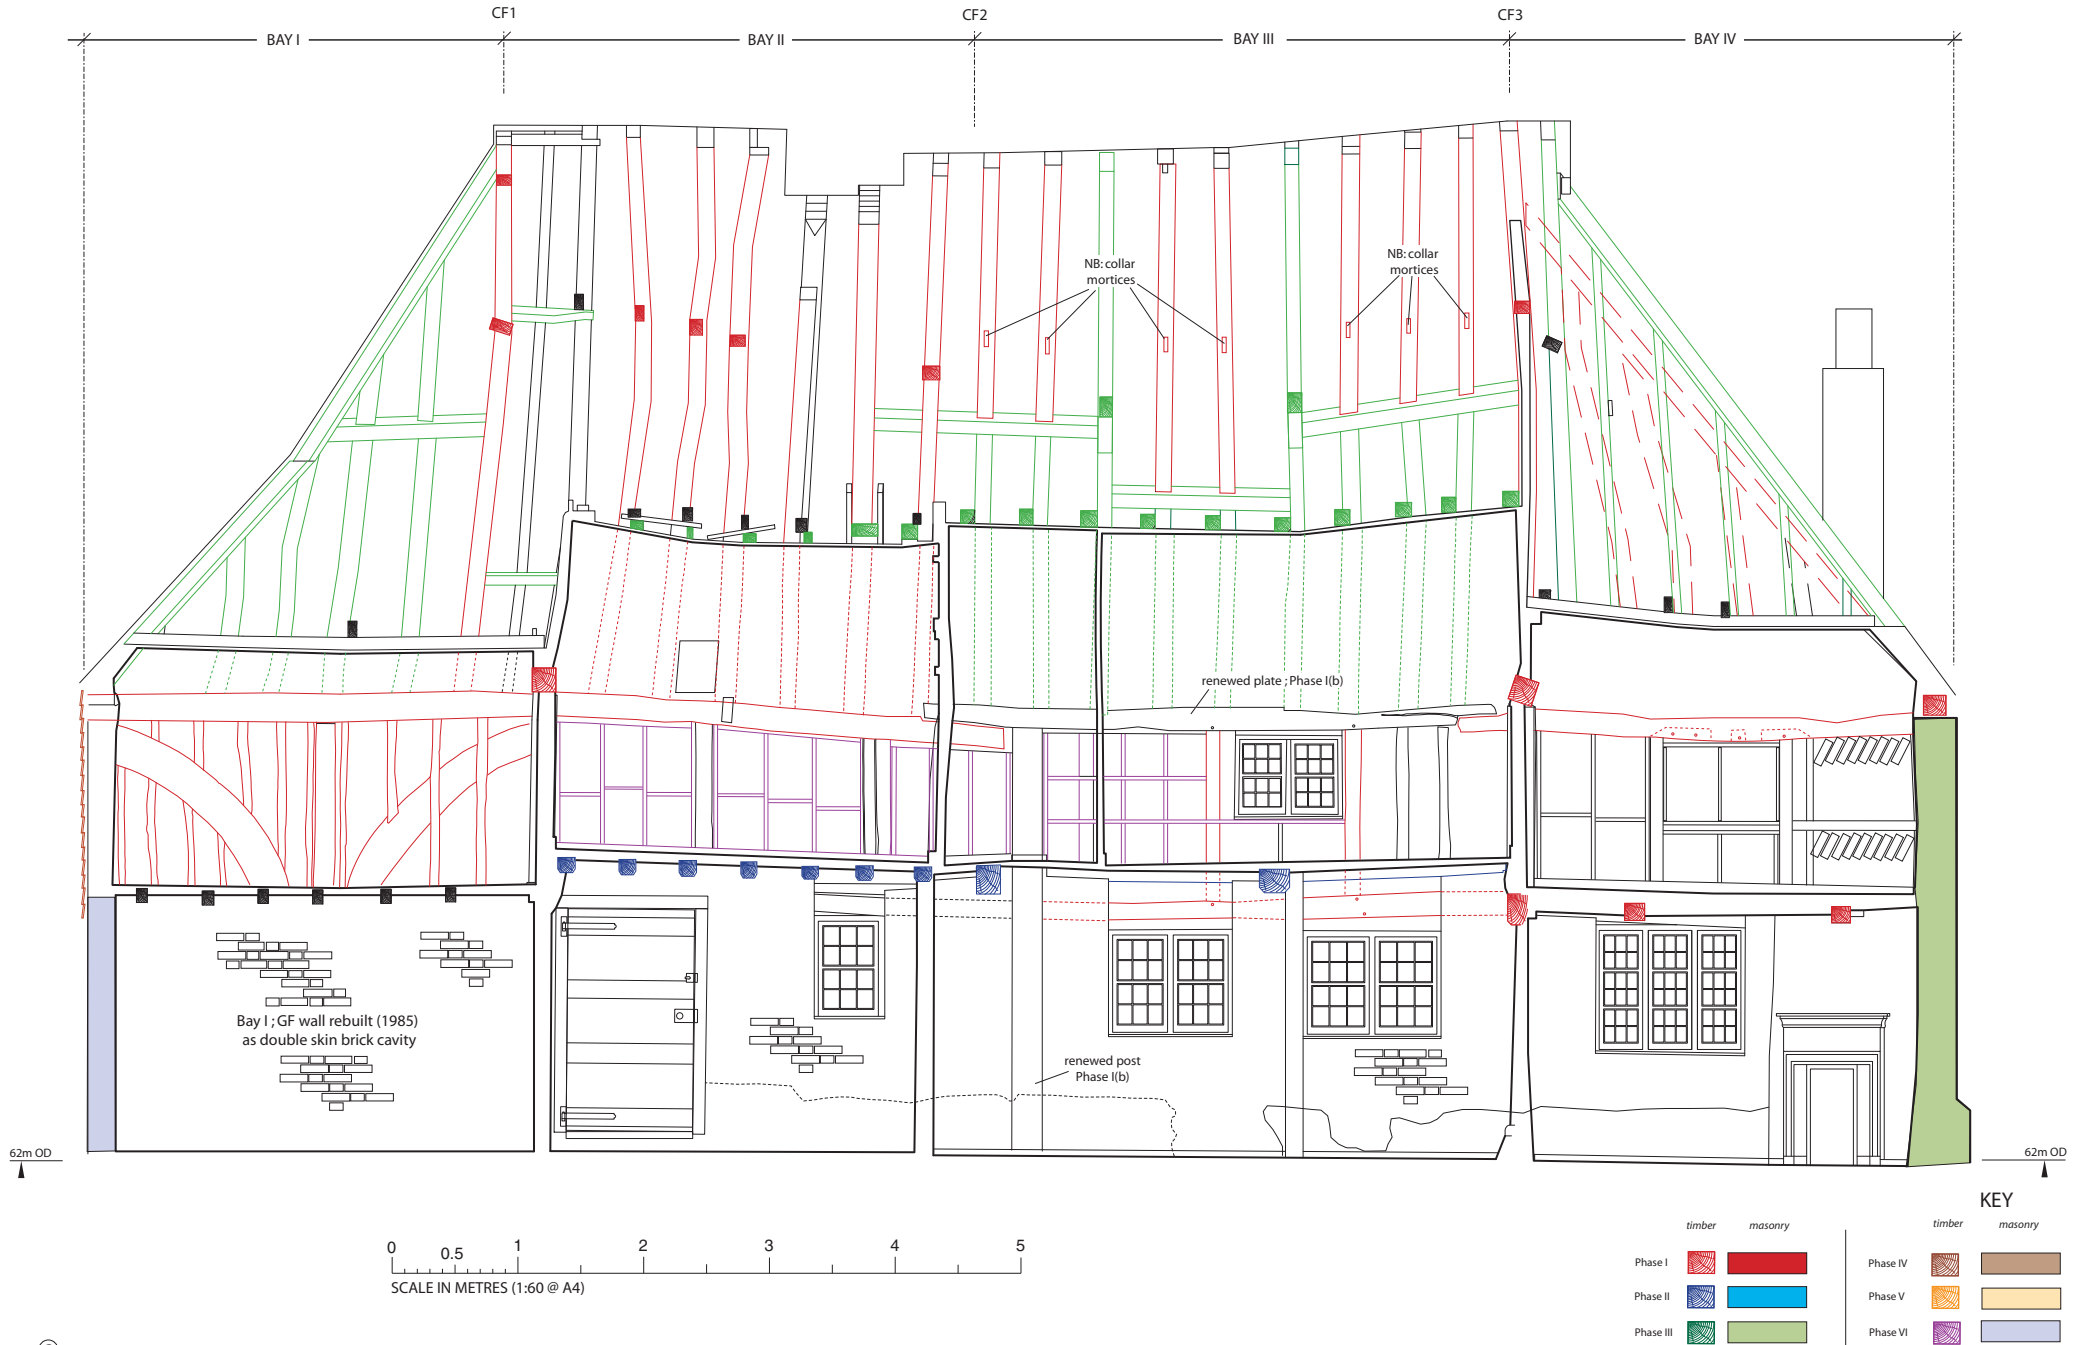
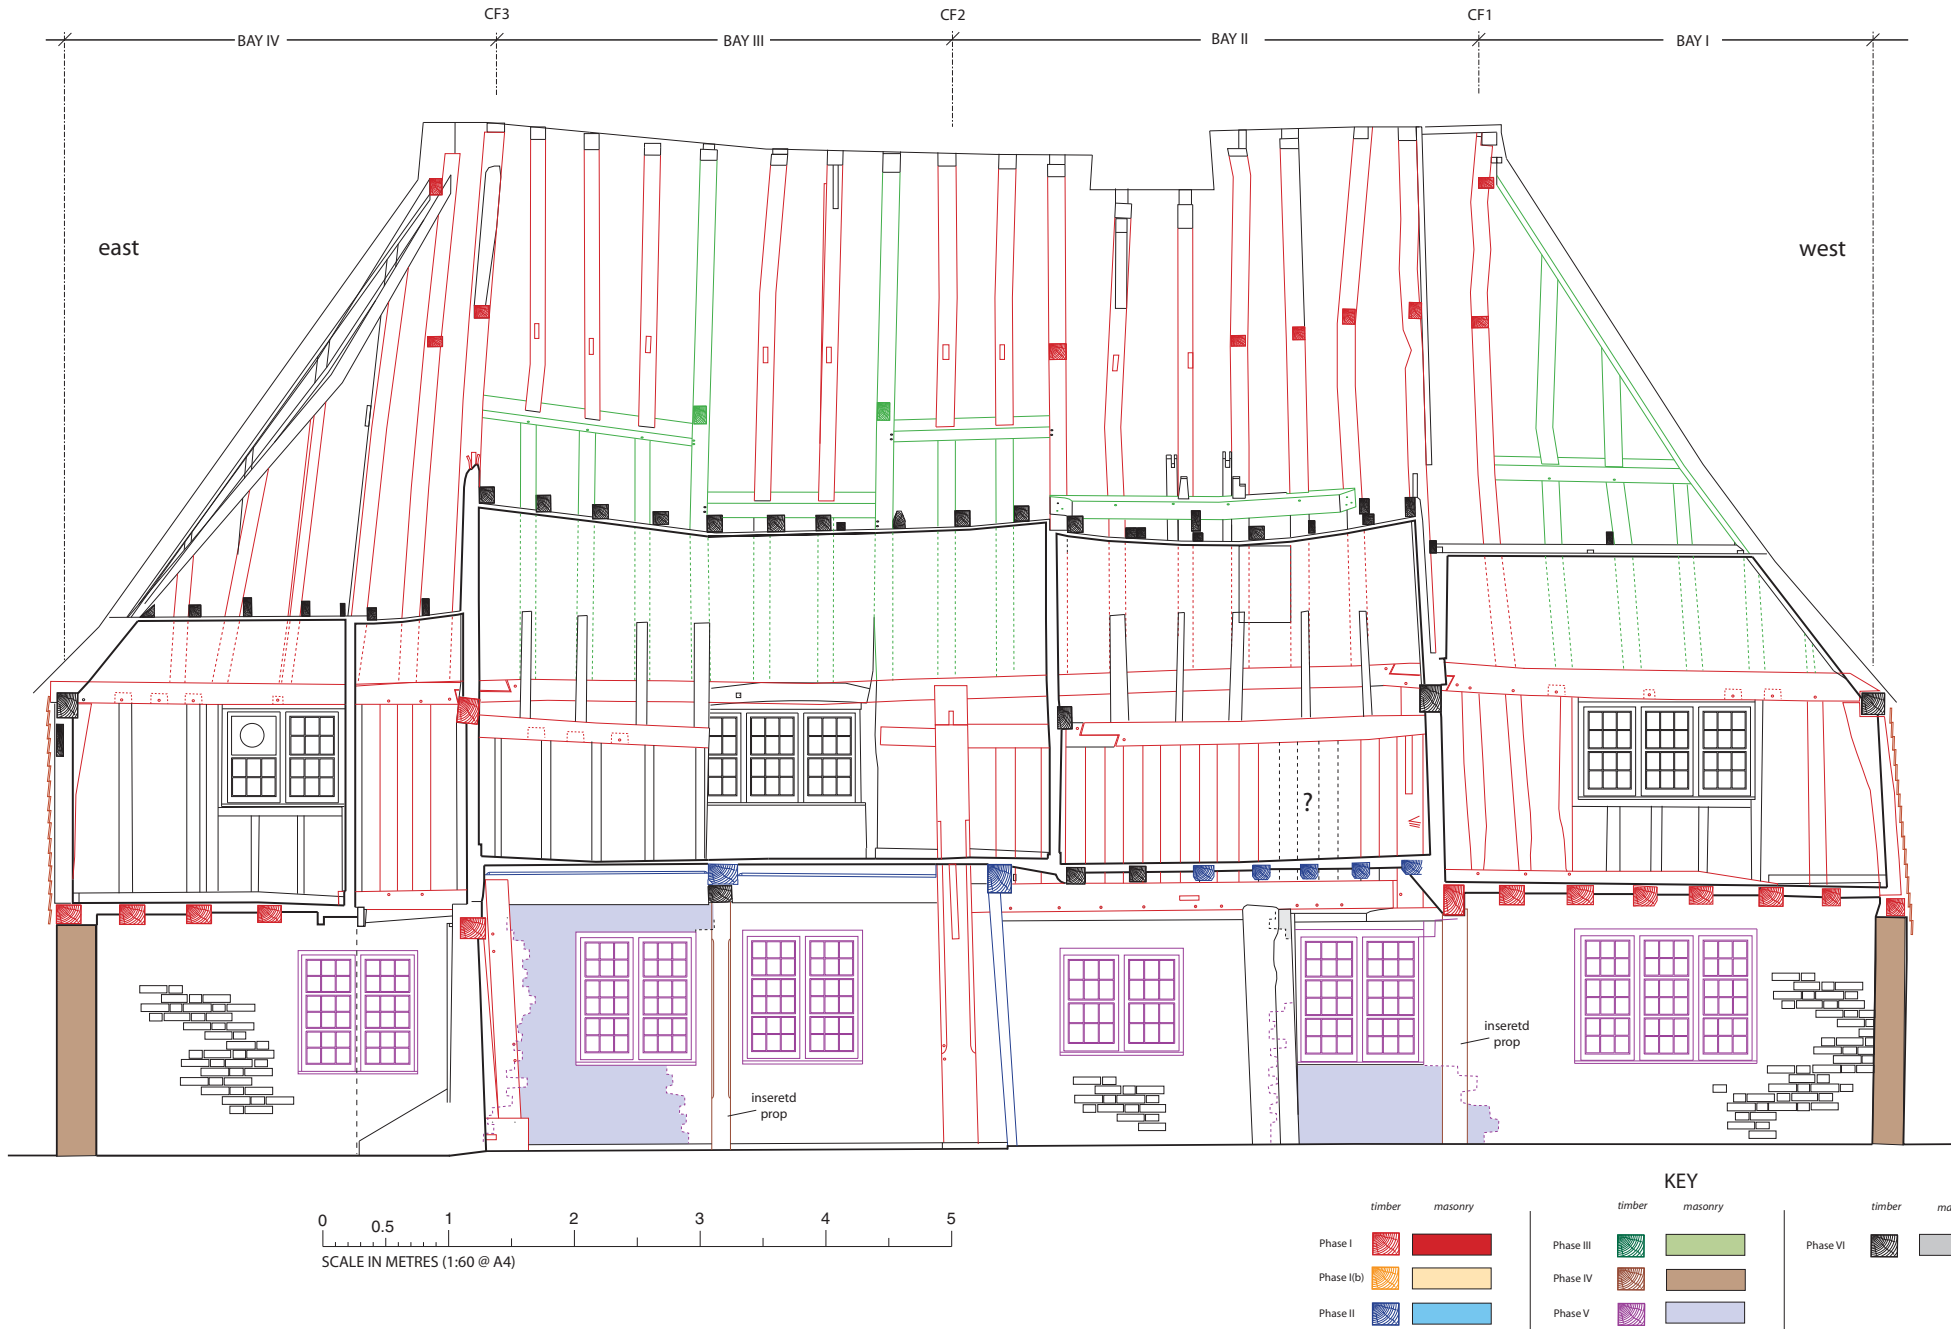
6.3.2.1 Contemporary with the introduction of the double-flue brick stack, a major programme of repair to the roof was undertaken. The western hip was rebuilt and that section of the crown-post roof west of the new stack (Bay II-W and Bay III) was replaced by a three bay roof of staggered butt-purlin form, though reusing a large number of original rafters (see Figures 19 and 20). To the east of the stack, a section of the original roof with collar

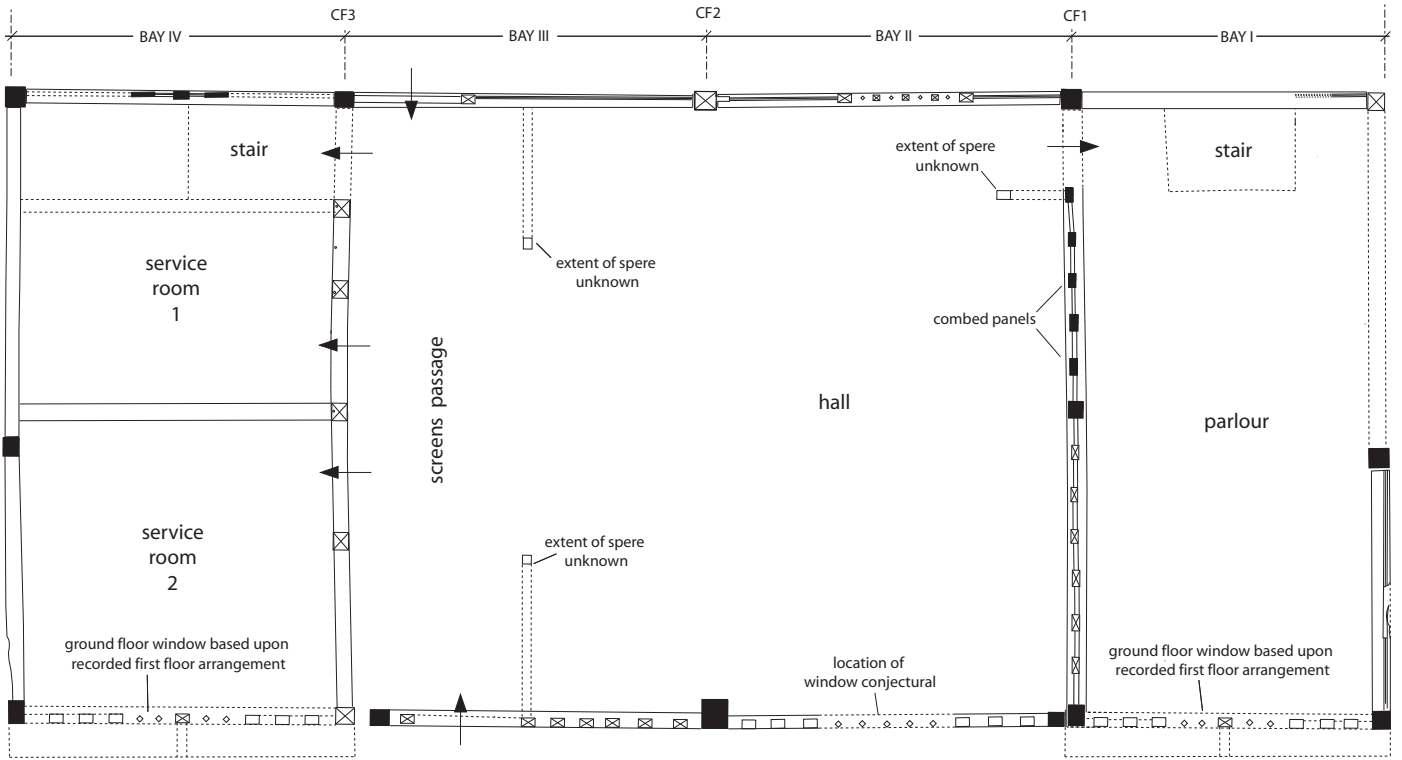
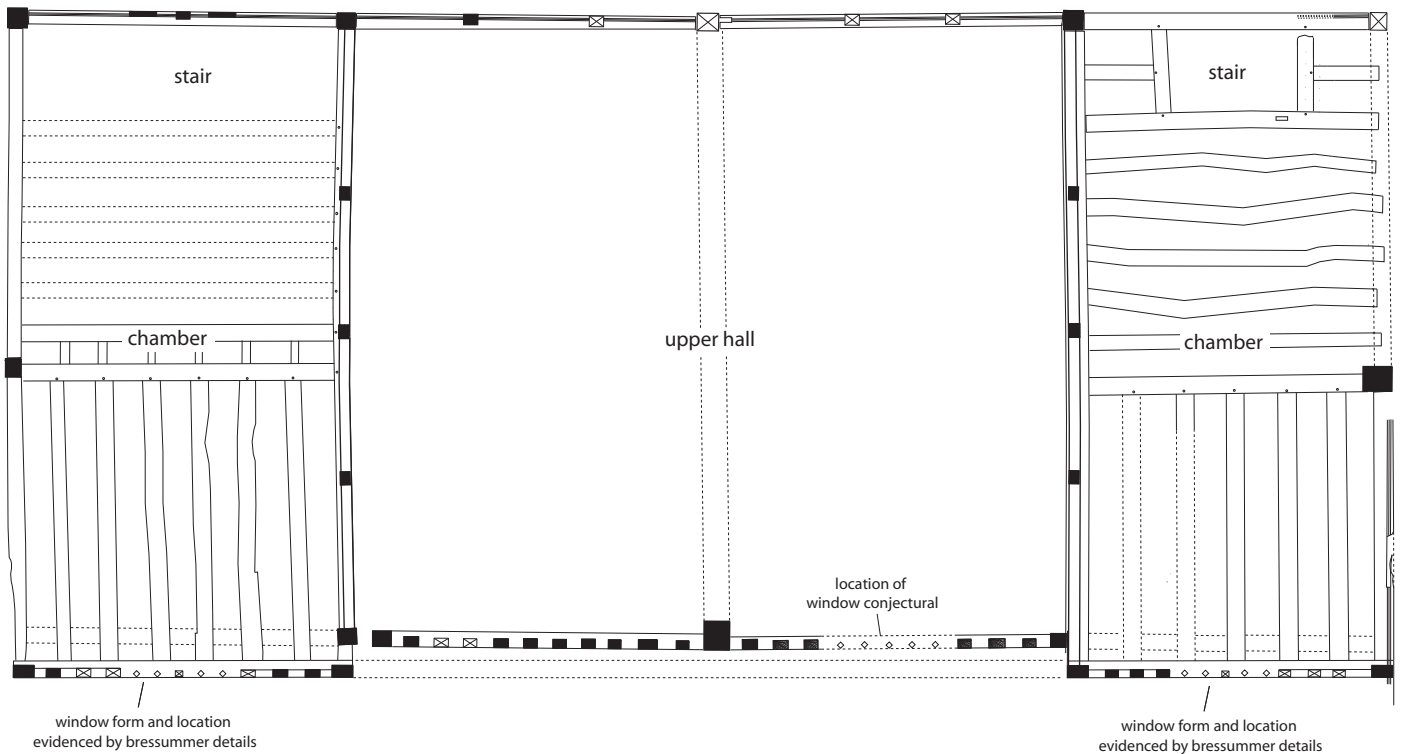
Figure 21 : PHASE I ; Reconstructed Ground and First Floor Plans

6.1.1 Plan form and internal layout (see Figure 21)

6.1.4.1 Internally, the bay system of the house was defined by a series of three cross frames, here numbered CF1 - CF3 from east to west (see Figure 21). CF1 and CF3 were both originally closed, forming the upper and lower ends of the hall respectively; both survive to a great extent within the extant structure (see Figure 24). Above the level of the cross beams, the walls are each divided into four panels by a series of three vertical studs, the panels being crossed by a series of deep braces which were originally exposed to both sides of the wall. The form of this bracing is, ostensibly, similar in both cross frames with arch braces rising to the centre and to the outer walls of the house producing a symmetrical pattern. Details of the bracing, however, are not uniform and, unusually, several of the braces rise from the cross beam to the tie as opposed to the normal arrangement of triangulating a horizontal and vertical member of the frame. At high level in each elevation, the tie beams support crown posts, slightly biased towards the front of the building, which are braced by paired, ogee tension braces.

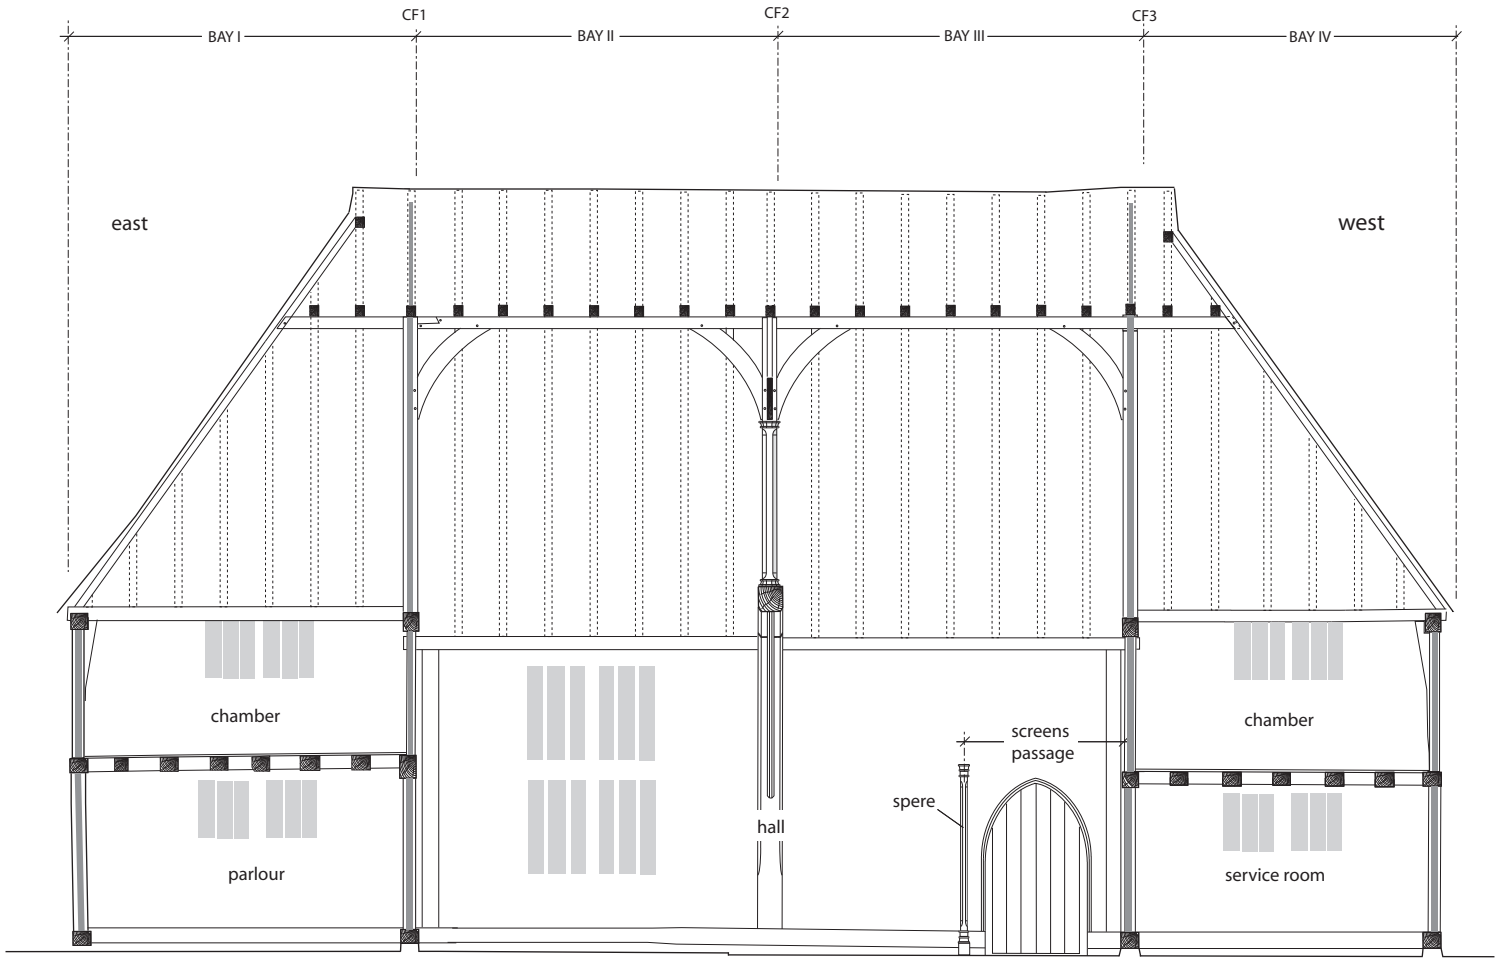
³ The reconstruction in Figure 23 is entirely conjectural and is included solely to illustrate the overall proportions and theoretical arrangement of the hall.

N.B. The hall cross section is included solely to illustrate the overall proportions and theoretical arrangement of the hall. No evidence has been recorded for the original form of the central tie, crown-post or arch bracing details. Likewise, the original form of the speres remain unknown. Those illustrated are purely conjectural.
