Channel Tunnel Rail Link
Balfour Beatty Major Projects
for Union Railways (South) Ltd.

TALBOT HOUSE, SELLINDGE, KENT
ARCHAEOLOGICAL RECORD IN ADVANCE OF AND DURING DISMANTLING

Environmental Statement Route Window: 36

October 2002

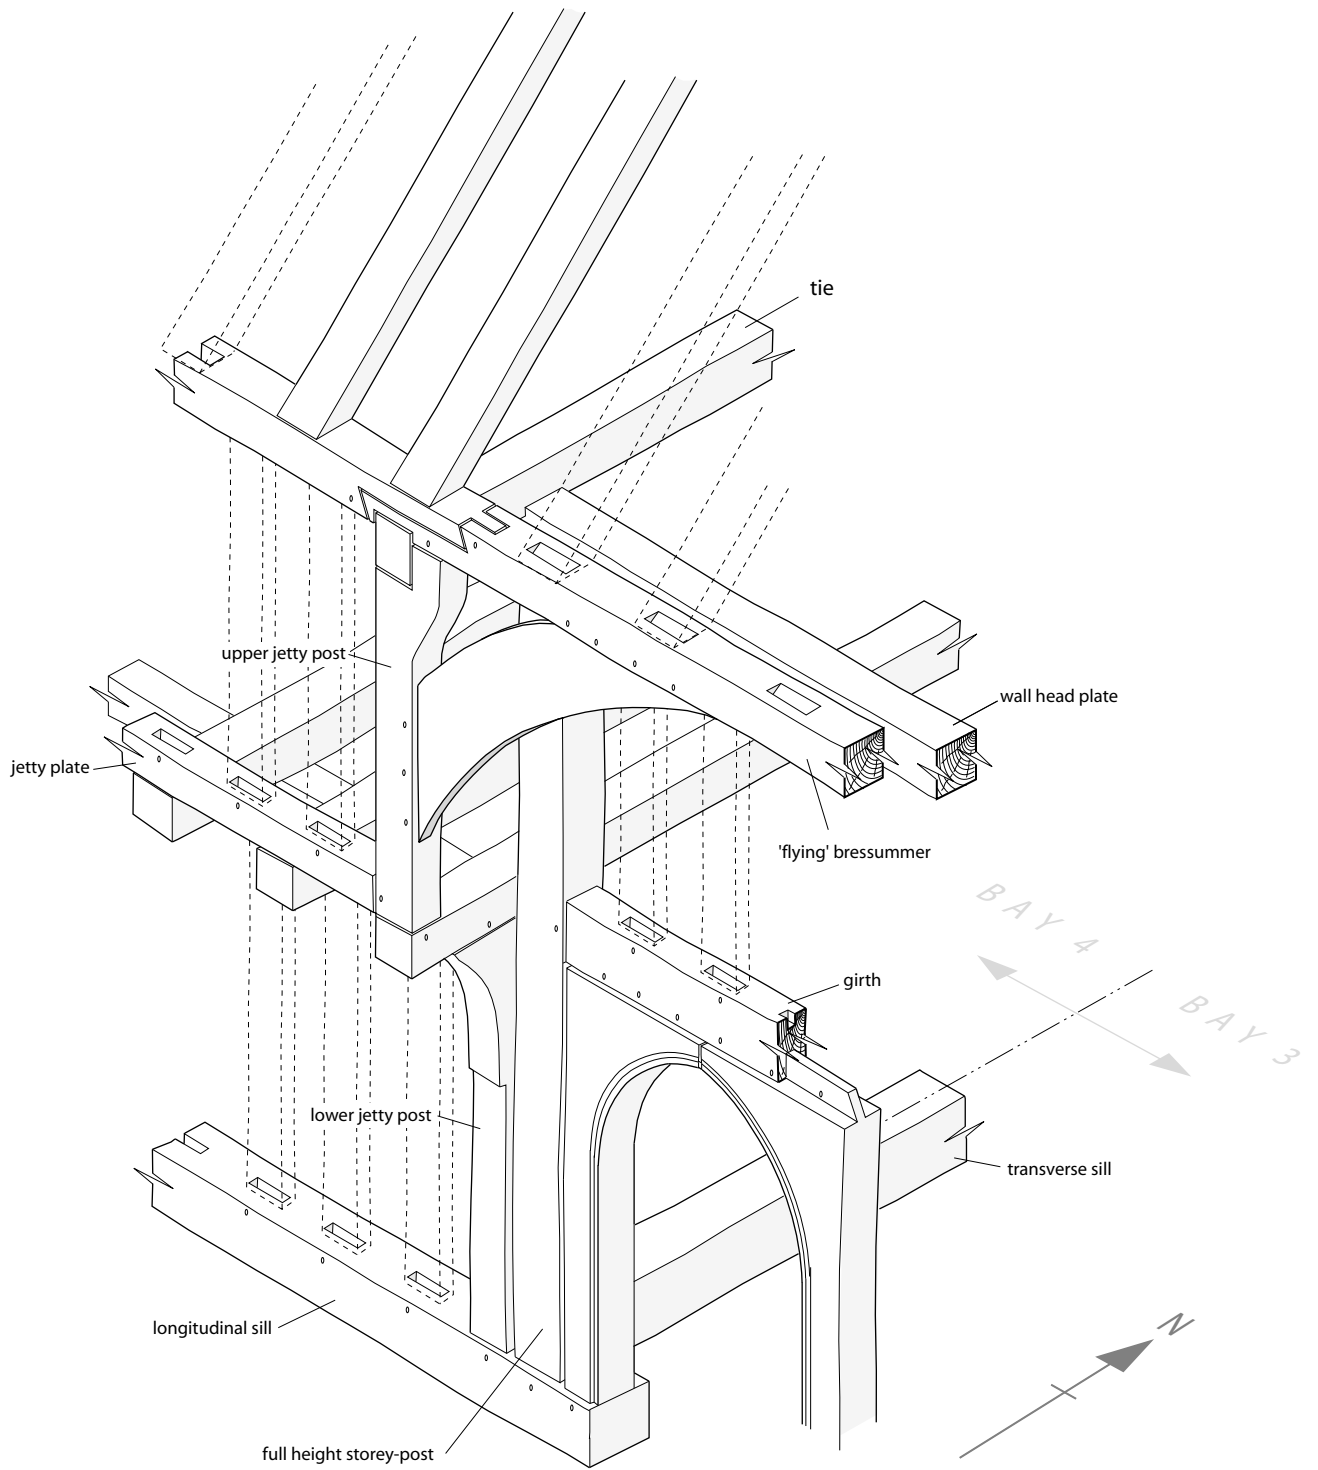
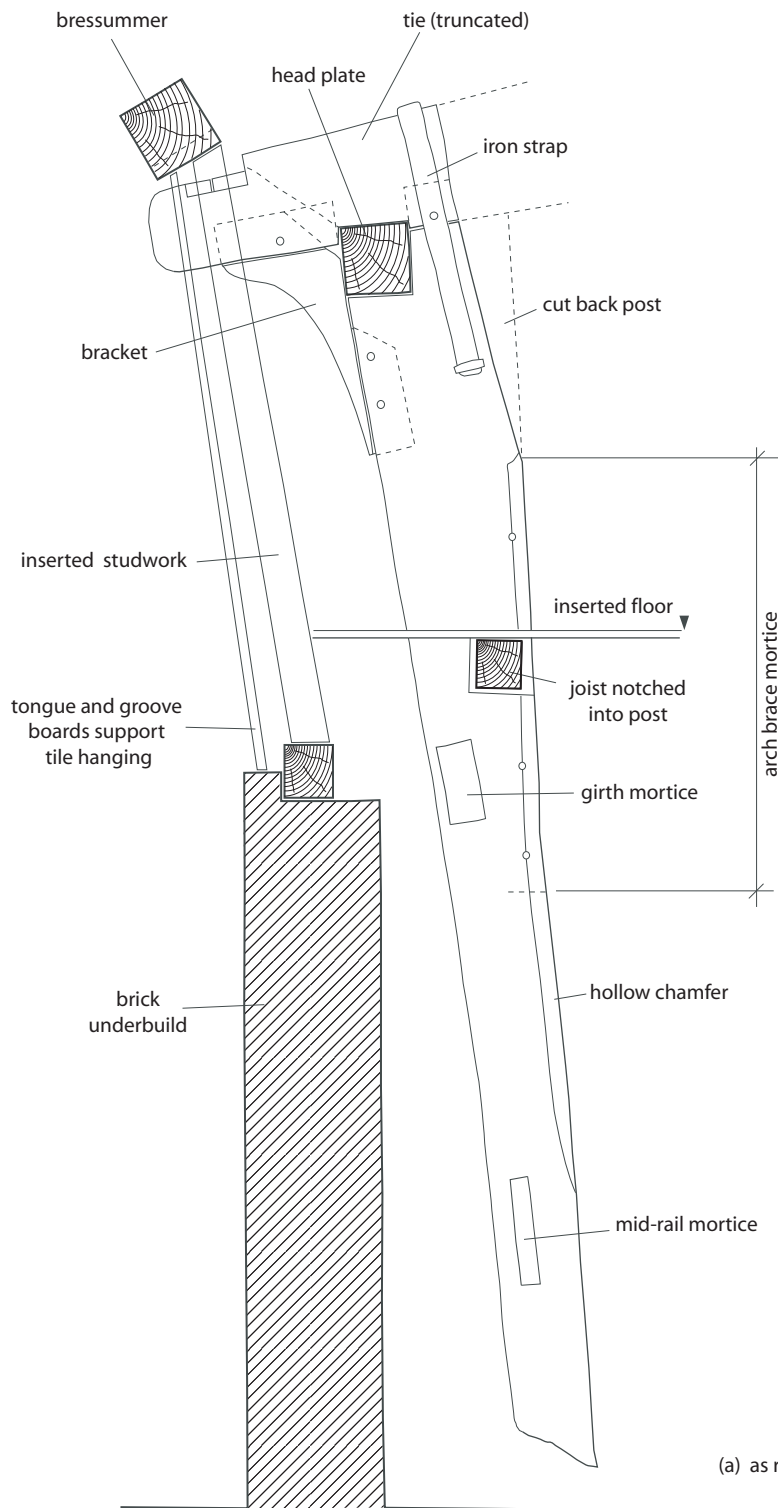
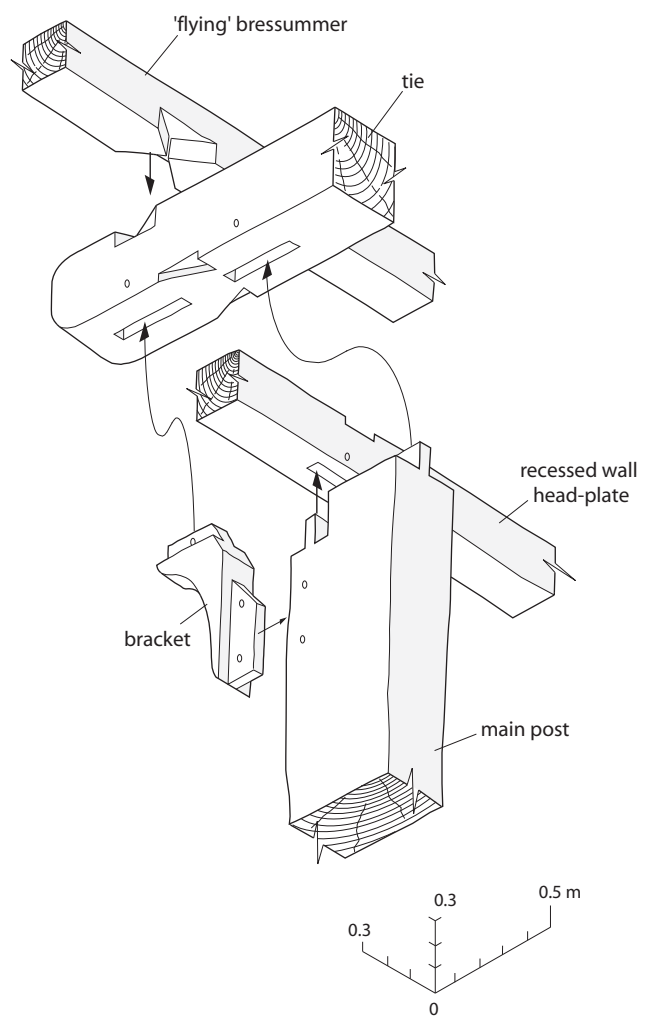
Figure 26 : PHASE I details : hall / jetty construction (reconstructed)

- 8.2.2 The structure as recorded during dismantling retained a relatively high proportion of its original fabric, despite having undergone several phases of adaptation and modification. This high survival allows for a fairly confident reconstruction of the original appearance of the house to be made, though certain elements, such as the central open truss, remain subject to speculation. The house displays a standard range of structural features and decorative details, though it also includes a number of less common structural details (eg. the detail at the junction of the hall and the storeyed end bays - Figure 26).

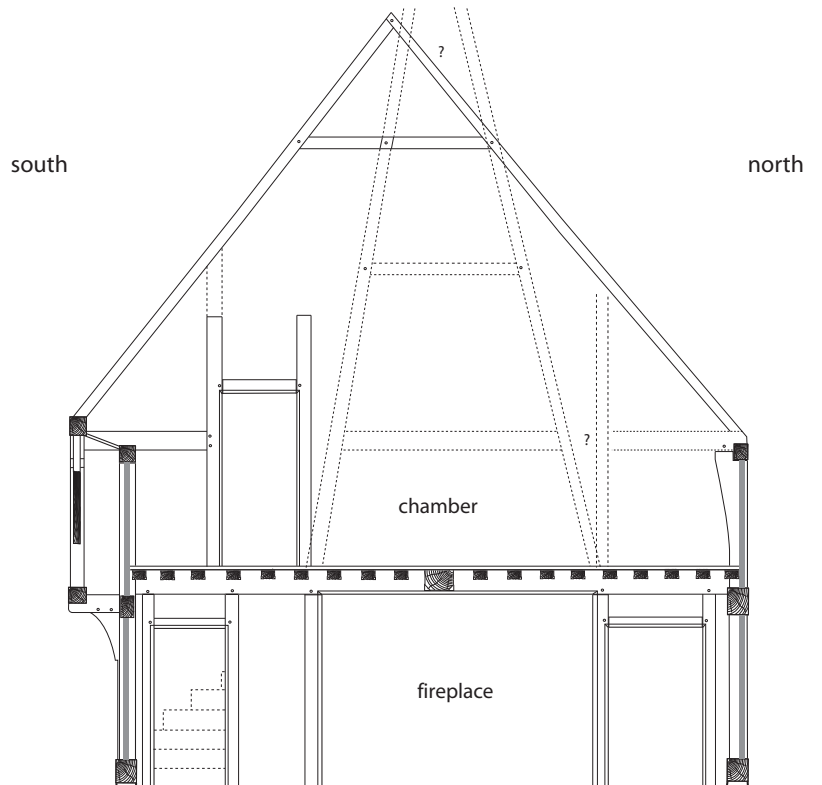
Figure 33 : PHASE II : reconstructed longitudinal and hall cross-section

6.2.3.2 While the arrangement of the timber stack at ground floor level can be reconstructed in some detail and with a reasonable degree of certainty from surviving evidence, the form of the stack above the level of the inserted floor is a little more problematical. However, fragmentary details recorded in the upper surfaces of the flanking beams, the rear trimmer and at high level within the roof allow for a conjectural reconstruction to be made. Dovetail mortices on the inner face of stack trimmers (E and F, Figure 35) indicate that the eastern face of the flue at first floor level was set back by some 0.40m from the leading edge of the ground floor mantel beam (A). A series of 'v'-profile stave seatings to the west of the mortices in both the northern and southern trimmers would appear to indicate that the flue at first floor level was fully enclosed (as opposed to a 'smoke bay' arrangement) and that the flue was again flanked by daub panels. An angled lap mortice in the collar immediately above the front face of the flue at first floor level may indicate that the southern face of the flue tapered towards the roof line (see Figure 33b). It is unclear whether the northern face of the flue was similarly tapered.

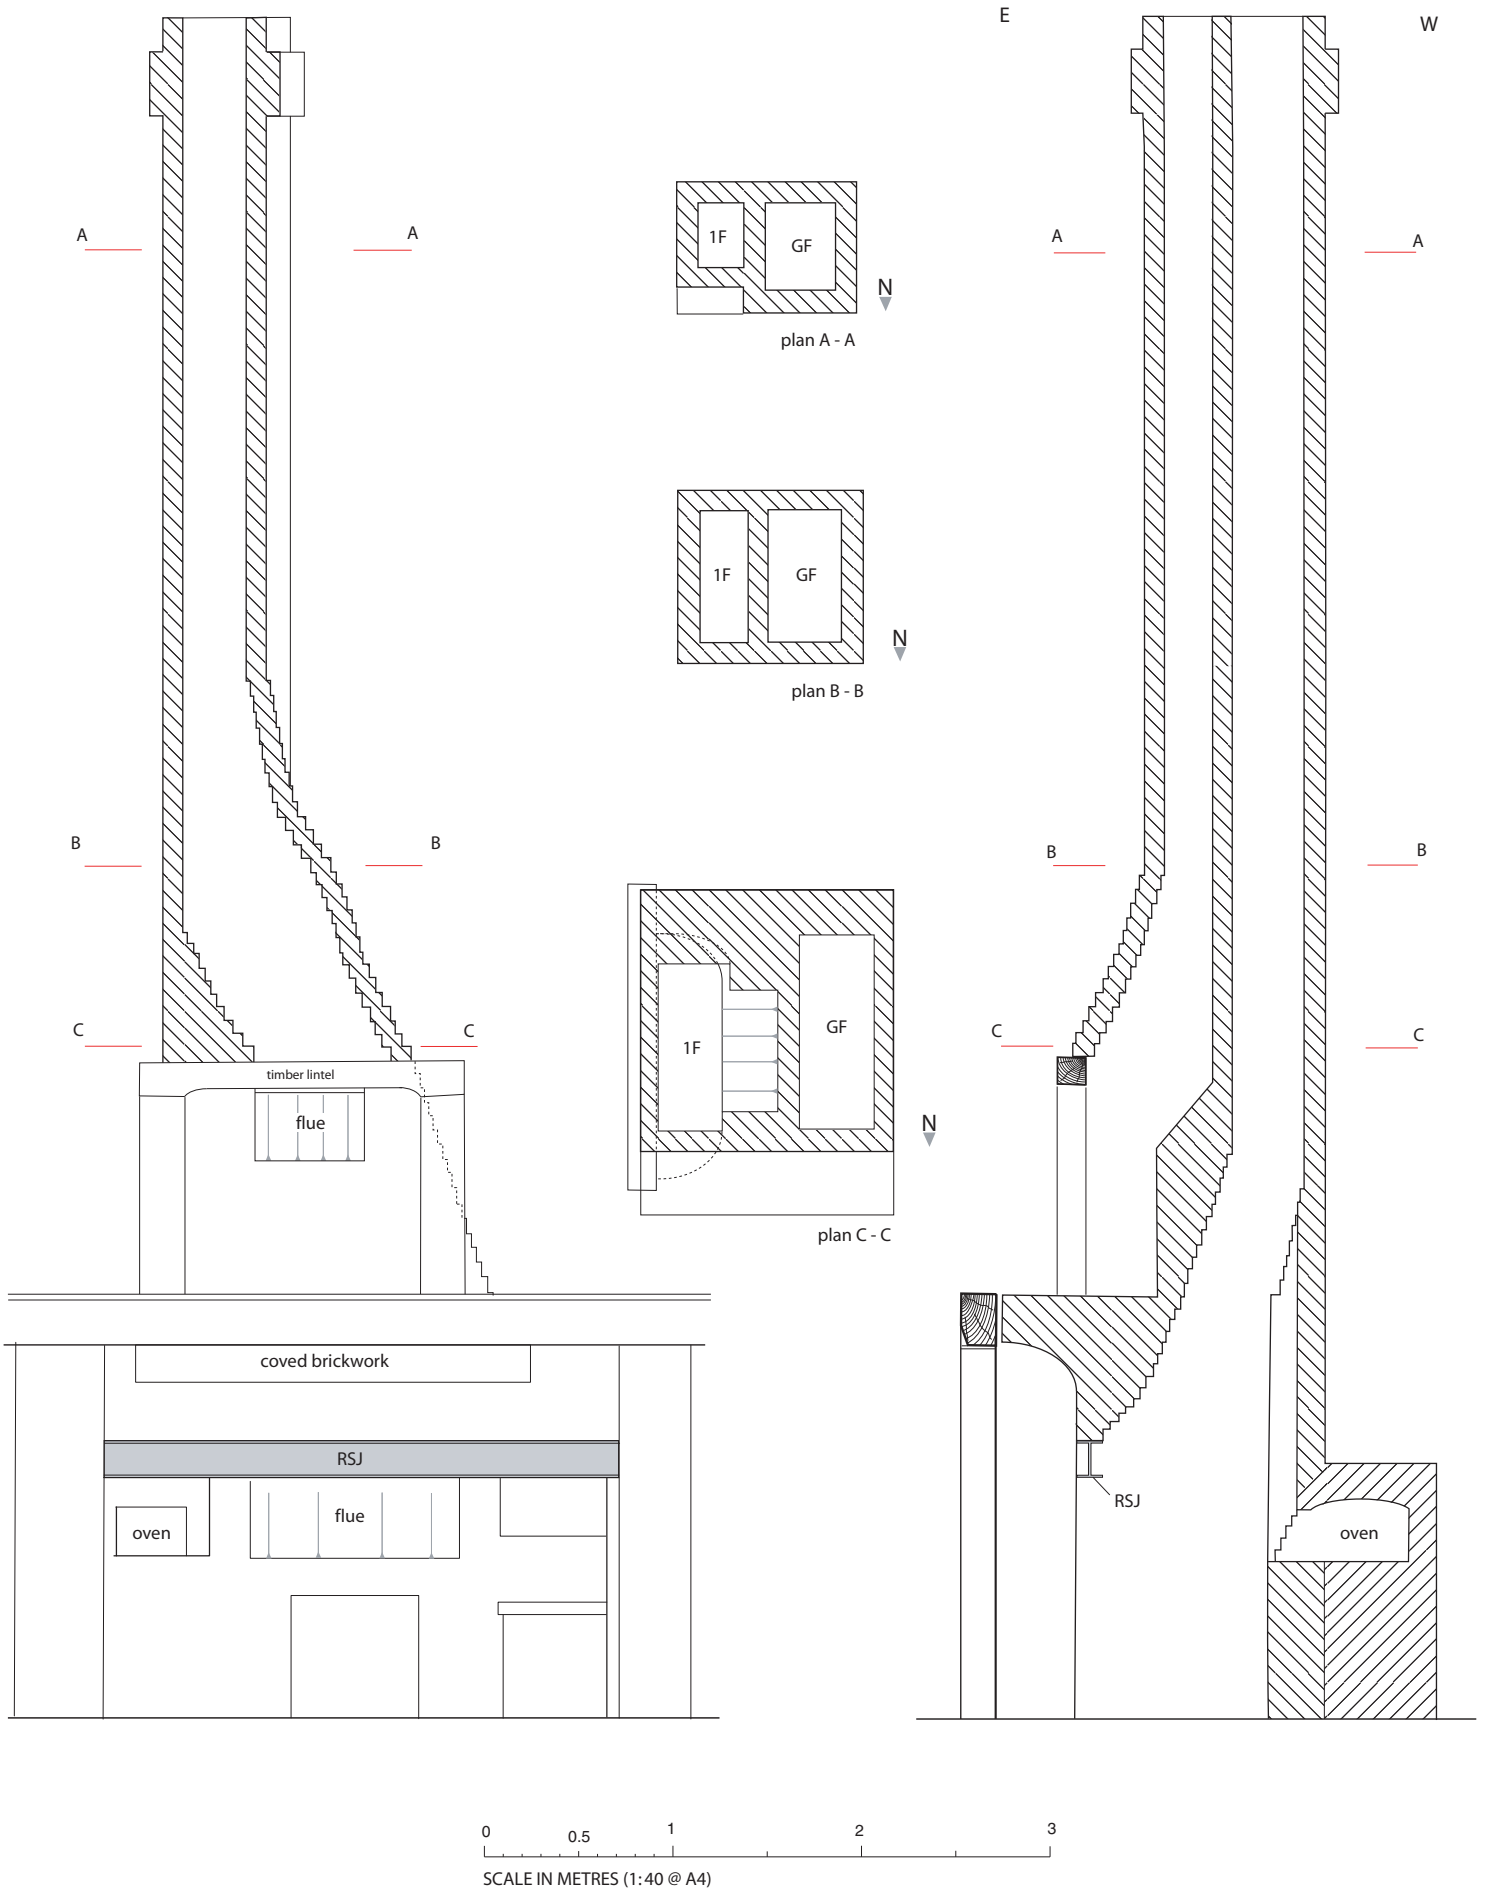
Figure 39: PHASE III : Details of brick stack

6.3.1 The Brick Stack (see Figure 39)

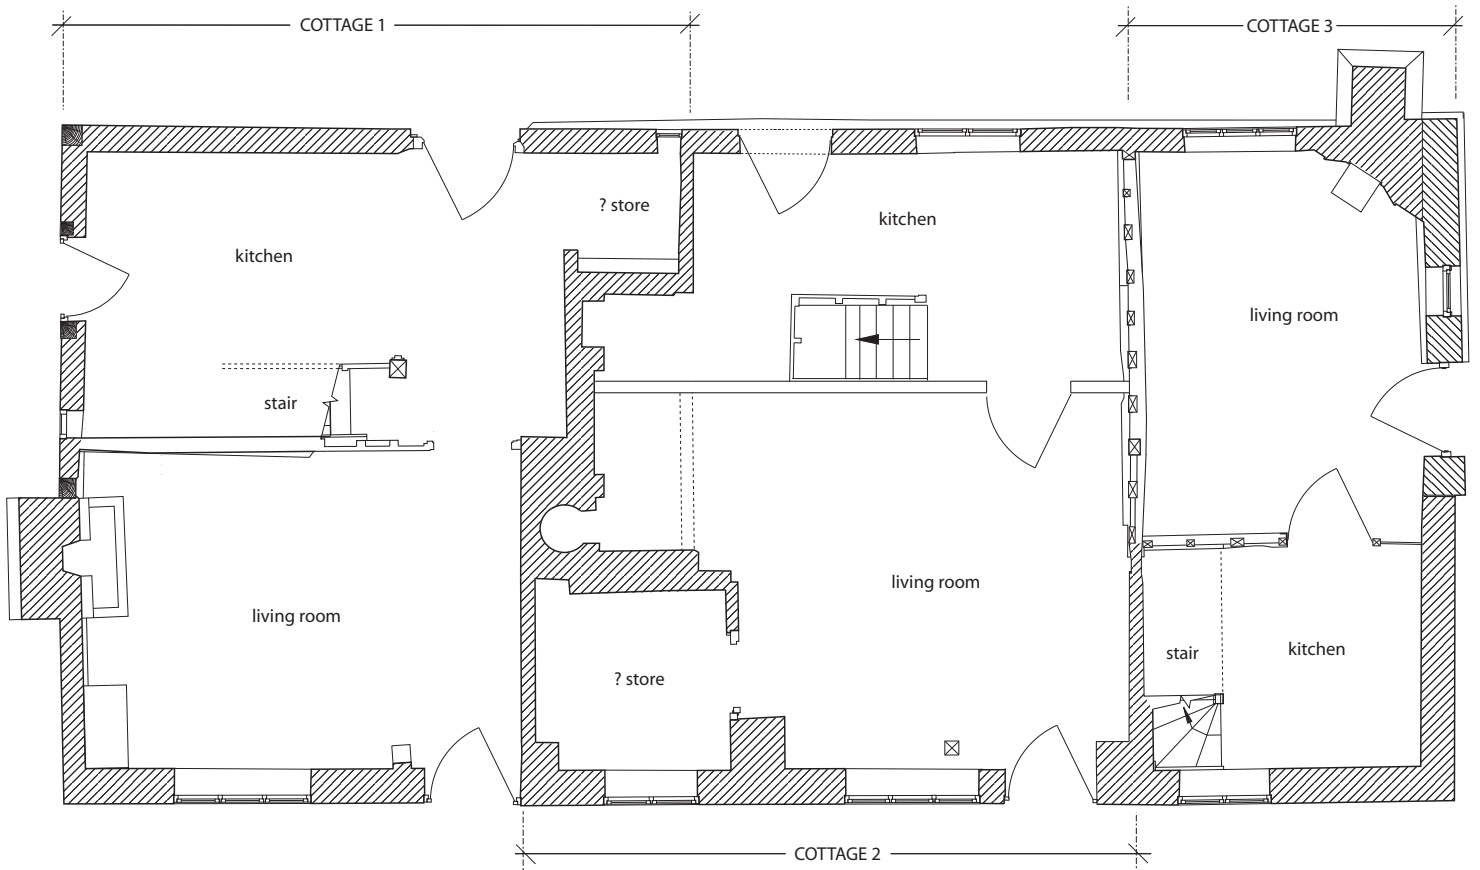
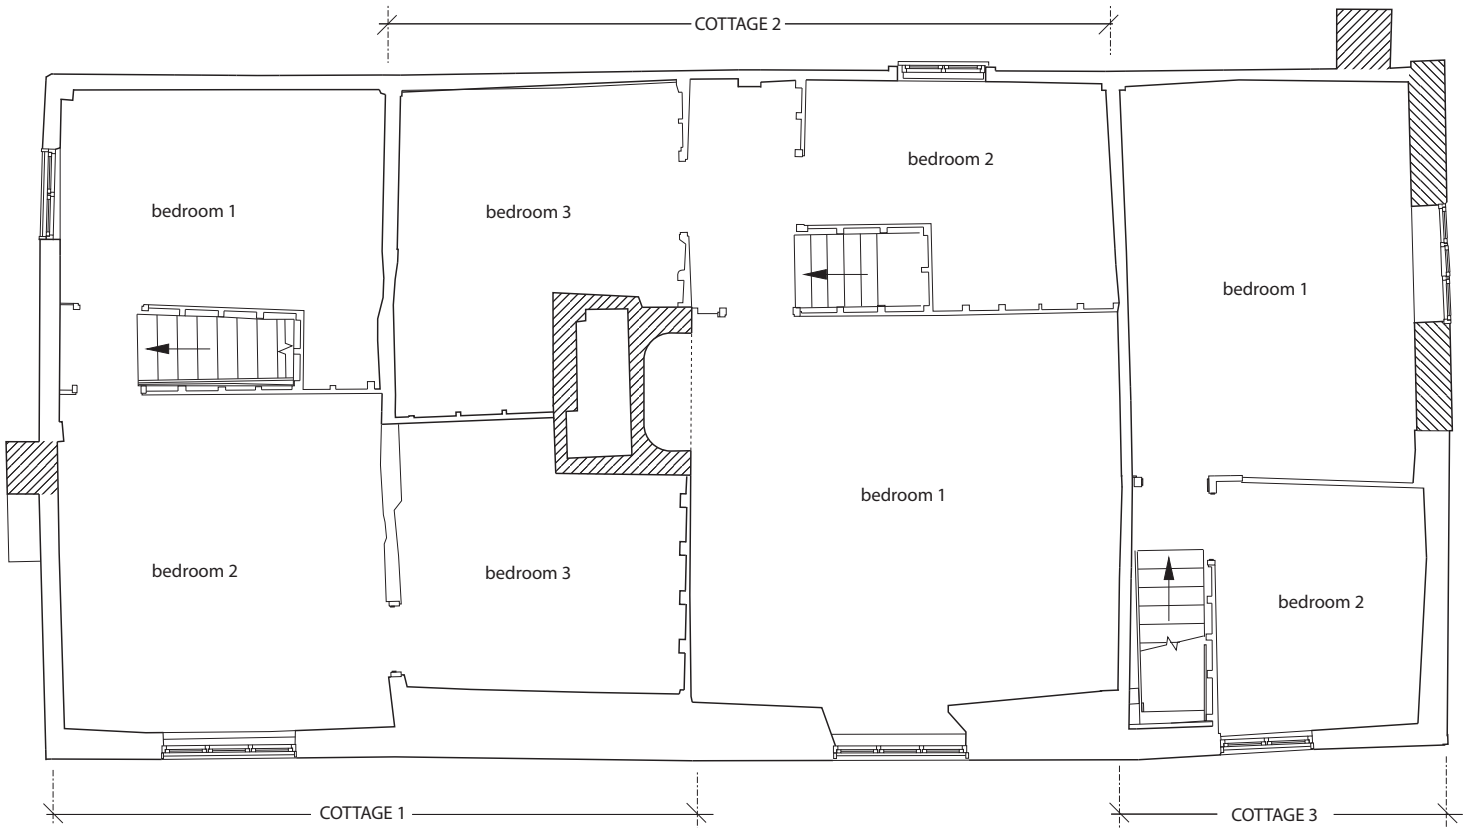
Figure 40: PHASE V : Railway Cottages: internal arrangements prior to conversion in 1985

5.3.2.1 The arrangements of the upper floor are somewhat idiosyncratic as a result of the process of its evolution, particularly the insertion of a series of simple stud partitions during the 19th-century when the property was divided into three independent cottages (see Figure 40). The floor levels within bays I and IV, reflecting the level of the primary upper chambers, are set some 0.38m below that within bays II and III which comprises the surviving 16th-century floor, inserted within the original open hall of the medieval house. Originally bays I, IV and II/III were independent of each other and were served by separate stairs, an arrangement that was also adopted during the 19th century sub-division. The principal divisions at this level were, and continue to be formed by the surviving primary cross frames CF1 and CF3. Further partitions are arranged around the inserted brick stack, comprising framing related to its timber precursor, and by the studwork walls

- 5.3.2.3 Bay II, originally forming the 16th-century hall chamber is, in its present state, divided into two separate rooms F10 and F11, with a connecting hallway (F10a), formerly also enclosing a 19th-century stair (now covered over) serving the central of the three cottages (see Figure 40). Room F11 (4.0m N/S x 4.6m E/W) is accessed from the Bay I landing to the east via a doorway cut through the primary cross frame, truncating the Phase I tie and associated arch bracing. The western limit of the room is defined by the Phase III brick fireplace and, to the south, by relict 16th-century framing contemporary with the inserted floor. A doorway to the south of the fireplace gives access to room F8 to the west. The north wall is formed by 19th-century stud partition on line of northern limit of brick fireplace. The southern wall is timber framed, retaining elements of the Phase I hall wall including a section primary bressummer, truncated for the insertion of a three light casement window. To the south west corner of the room, the upper section of the principal post of the central cross frame (CF2) survives with a small section of truncated tie beam (see Figure 27).
