Hedrick Rigg Level 2 Assessment

Hedrick Rigg Level 2 Building Assessment

The work is in response to an Application for Planning Permission Planning permission (DM/21/01835/FPA): Conversion of Farm Buildings to create three residential units. A building survey Level 2 is required as a condition of the planning permission.

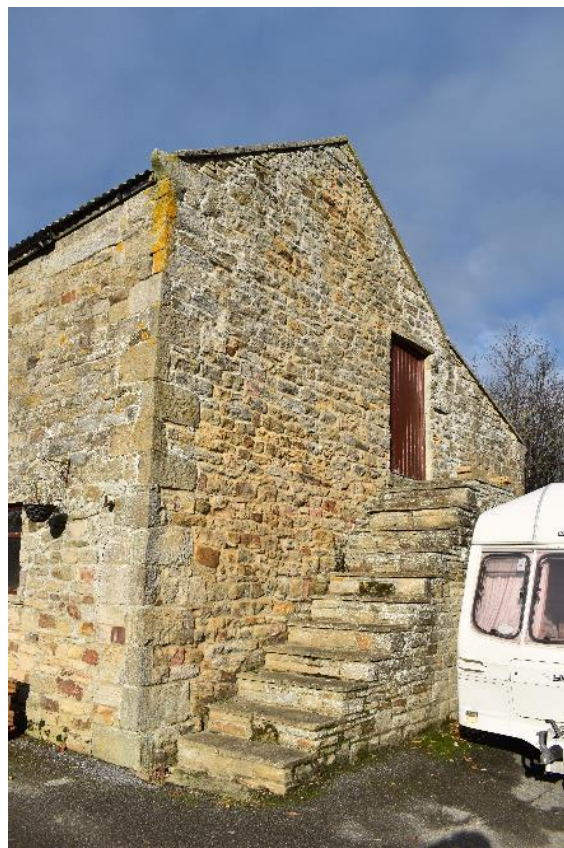
Plate 4: External stair to Granary

- 4.1.2 Granary – Two storey square building of random coursed stone with stone quoins, corbel eaves stones stone kneelers to the gables with a corrugated roof supported by timber trusses, purlins and rafters (Plates 3, 4, 32, 33, 34 and 35). The first floor is accessed by external steps and an internal ladder. Timber floor in reasonable condition and it is used for storage. Timber windows in poor condition and a first-floor window to the south side has been blocked up.

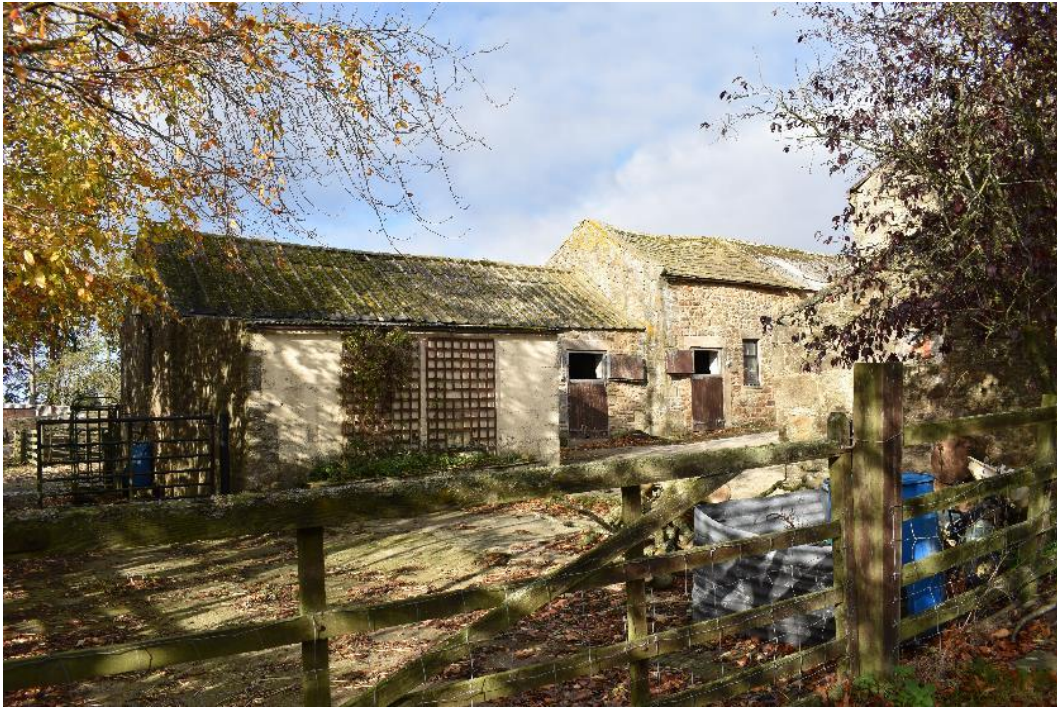
Plate 9: Milking and Dairy Shed

- 4.1.8 Dairy – Small lean-to roofed building joining the Milking shed. The timber entrance double door is to the north side along with a small window. The south wall is random coursed stone, but the remaining walls have been rebuilt in blockwork and painted. The roof is a shallow mono-pitch with two timber purlins supporting corrugated sheeting (Plates 9, 12 and 68).

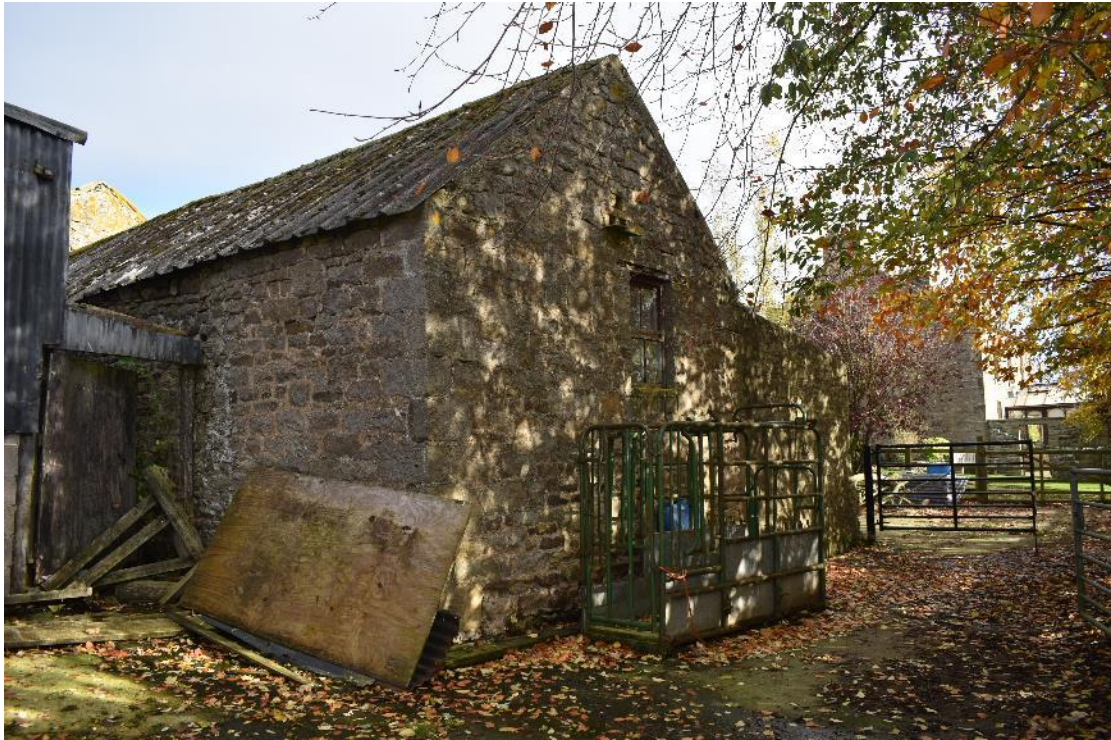
Plate 13: Milking shed

- 4.1.7 Milking Shed – This section of building is set lower than the previously discussed buildings forming the west side of the courtyard. It is the same random coursed stone with a king post truss with timber purlins and rafters supporting a corrugated sheet roof. There is a later additional timber double tie repair. The walls are white limewashed. There is a timber window to the south gable and three owl holes with protruding perch stones (Plates 12, 13, 20, and 65 to 67).

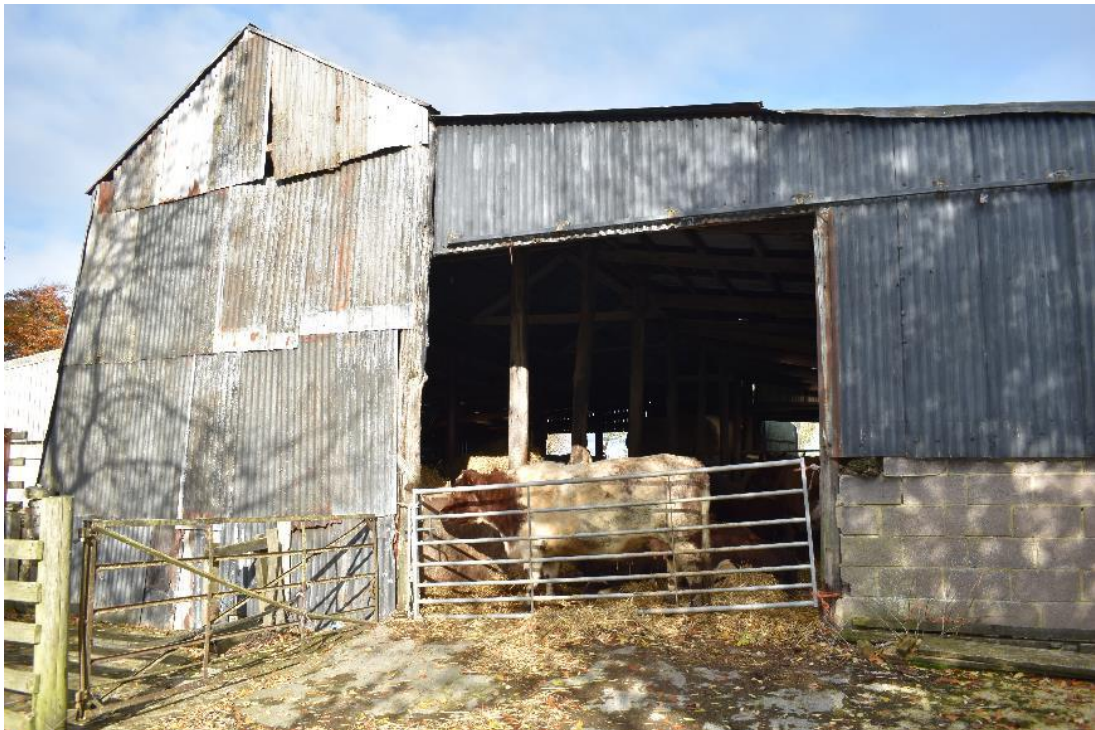
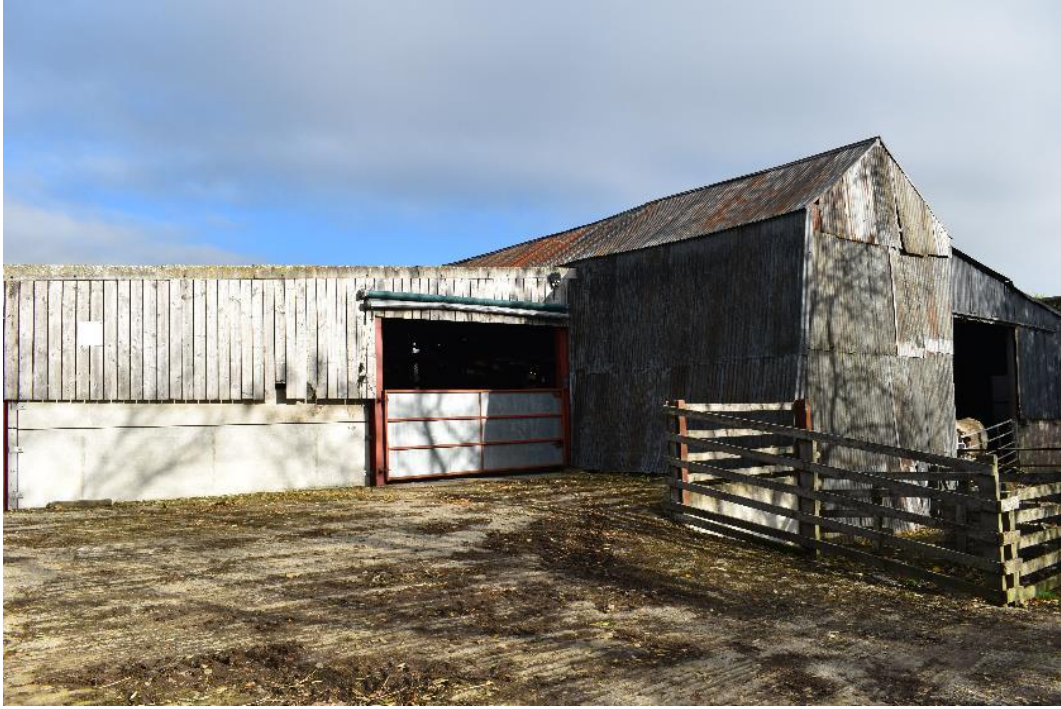
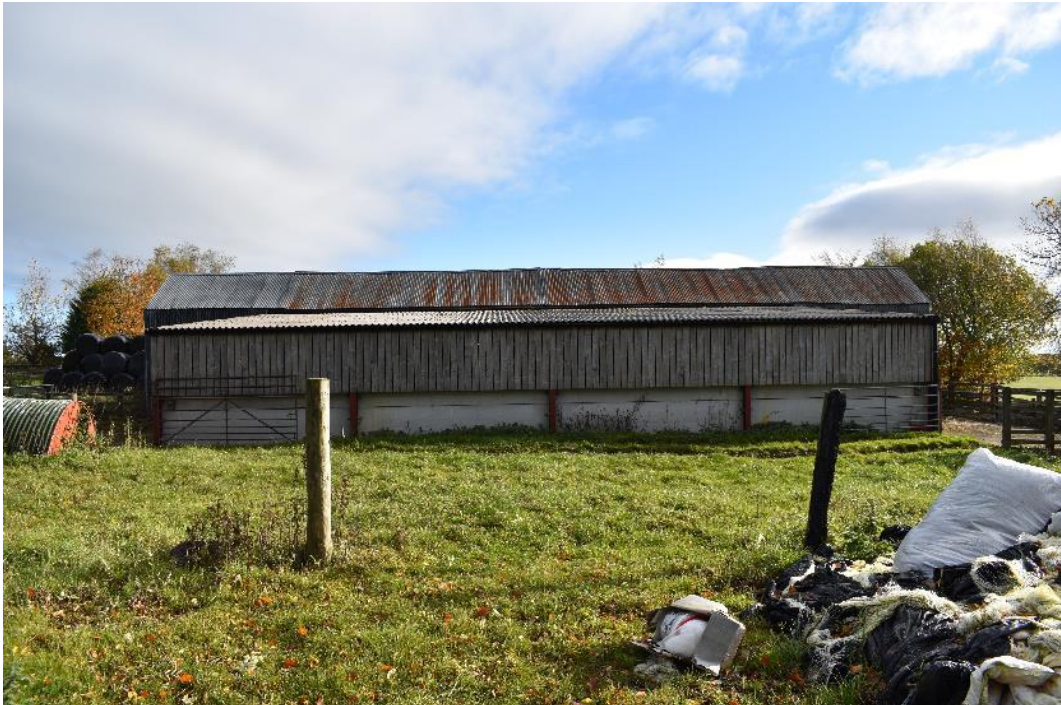
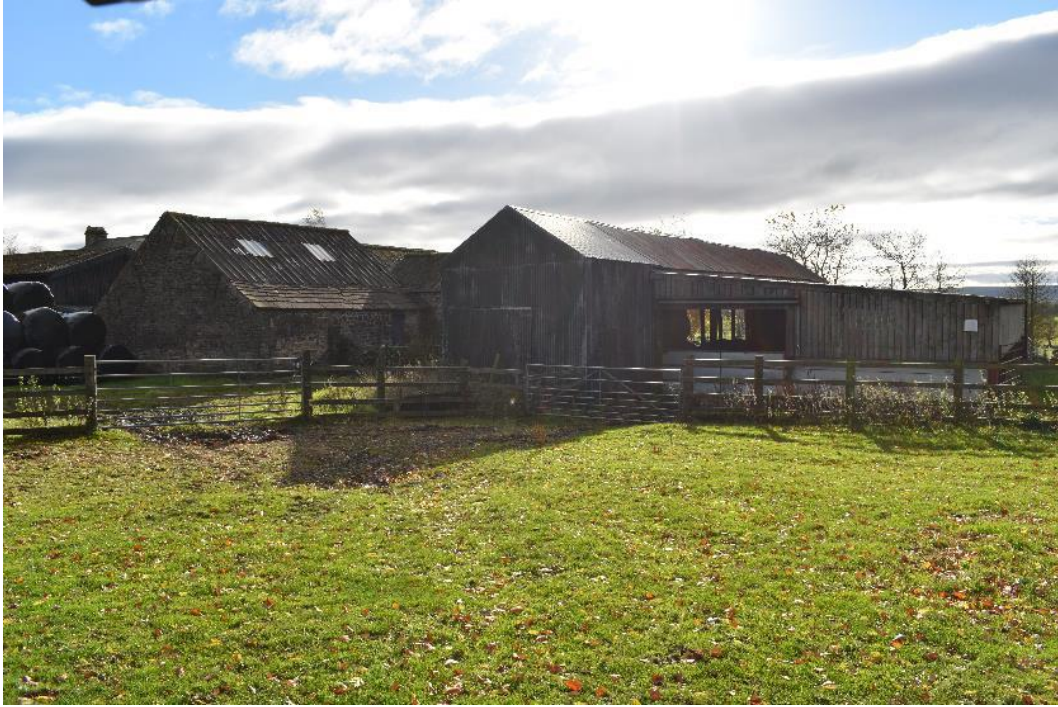
- 4.1.9 Pole Sheds (Cow sheds) – This building comprises of three bays of a mono-pitched timber post and beam structure to the east side, a simple timber truss pitched centre 'aisle' and a mono-pitched steel post and timber beamed roof to the west side. The floor plan is split into several cattle stalls or pens and is used for machinery storage. This is all a much later addition with the east section having low blockwork walls and corrugated cladding and roof and the west section steel framed, low concrete panelled walls and corrugated cladding and roof (Plates 14 - 17 and 57-62).

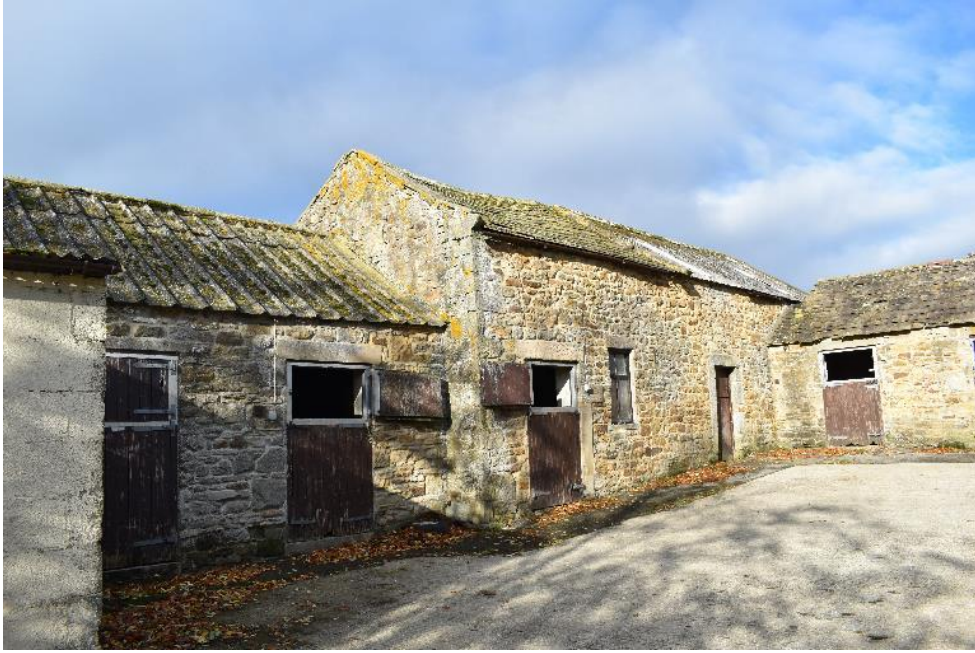
Plate 21: Courtyard looking North West to Straw Barn and Loose Box

- 4.1.6 Loose Box – This section of building forms the end of the higher of the courtyard buildings to the west and is the same random coursed stone walls. The roof trusses have square and diagonal ties that have been reinforced with timber plates, timber purlins and rafters but with the original stone slates set between stone kneelers to the dividing and end gable walls. A gable window to the south wall has been blocked up with stone. This wall has stone quoins and eaves corbel stone (Plates 21, 22, 26, 63 and 64).

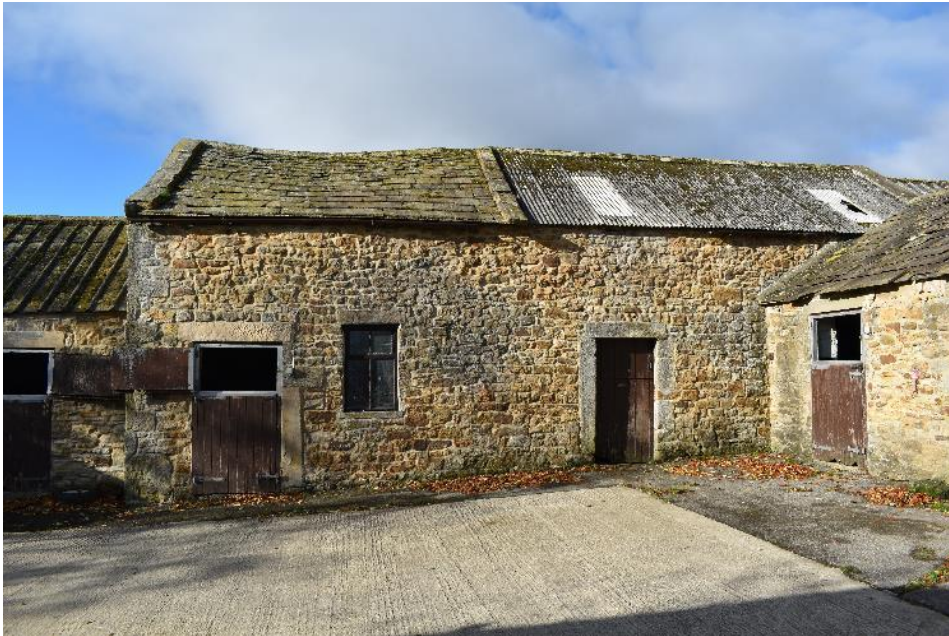
Plate 26: Courtyard looking West to Loose Box and Straw Barn

- 4.1.5 Straw Barn and Store 2 – Random coursed bare stone walls inside and out with a triangular timber roof truss and purlin structure directly supporting corrugated roofing sheets. Some cracking is evident to the gable end walls. Timber stable doors and shuttered windows, high level to the store (Plates 26, 43-48).

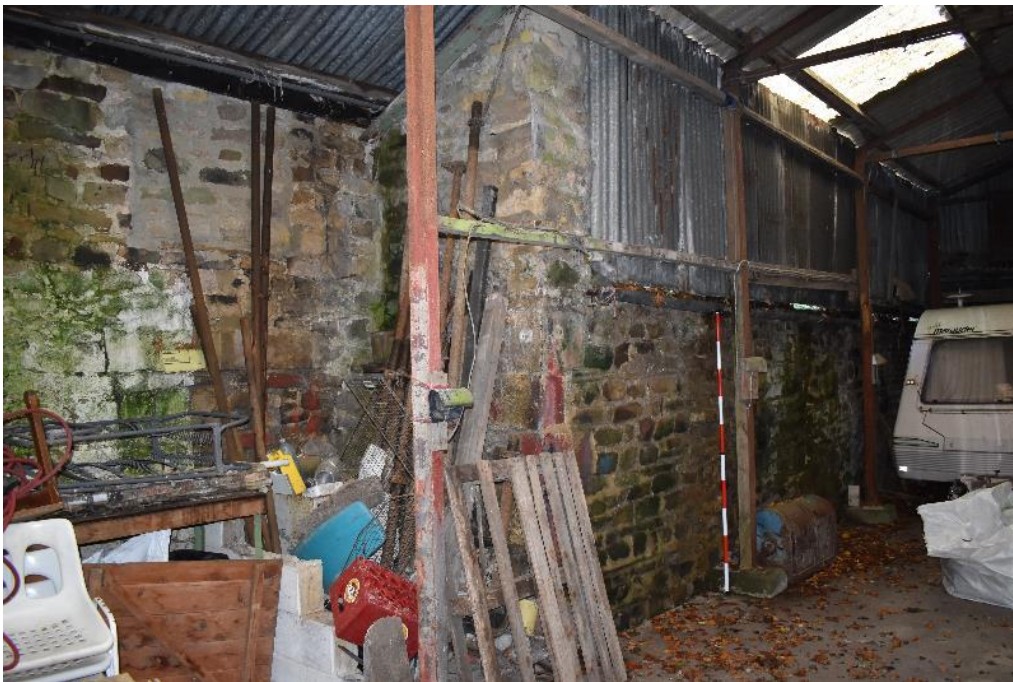
Plate 52: Garage/Stable Wall

- 4.1.4 Garage, Workshop and Wood Store – Set behind the stables to the north, the garage is an extension to the original wood store ad workshop which are of the same materials as the other outbuildings. The garage is a lightweight steel post and truss frame clad with corrugated sheeting and block wall to the front (east). It abuts the stables to the south side. The workshop and wood store have the same timber truss, purlin and rafter construction as the buildings running to the west side of the courtyard but have a corrugated sheet roof covering. Condition is generally poor with bare stone walls, wood decay and damaged roof sheets (Plates 51 to 56).
