Archaeological Report

Weirs and Channels East of the Lake,
Ragley Hall,
Alcester,
B49 5NJ.

Planning ref. 17/02593/FUL and 17/02594/LBC

Prepared by: Stephen Wass MA MCIfA, Polyolbion Archaeology

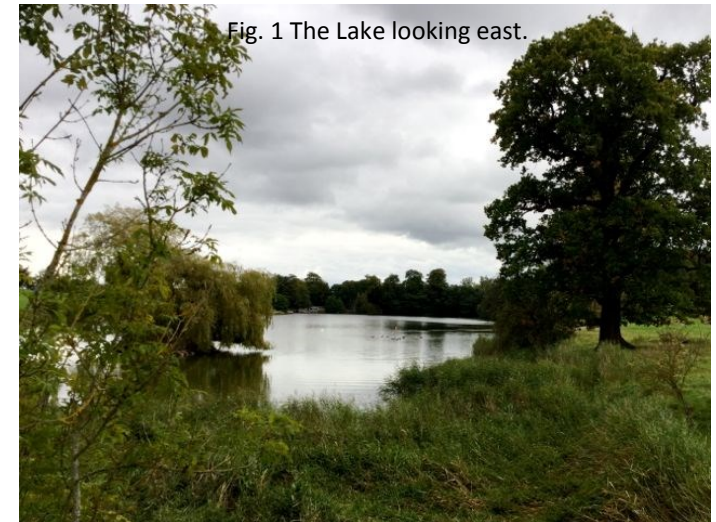
Fig. 1 The Lake looking east.

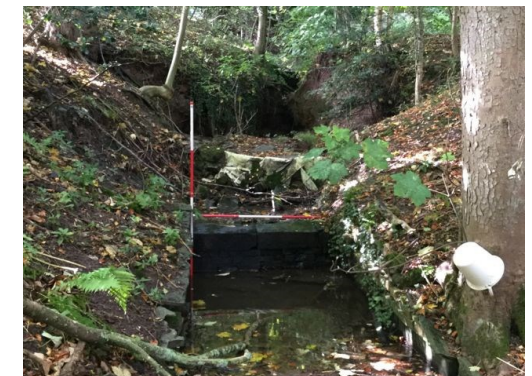
Fig. 7 The base of the channel looking north.

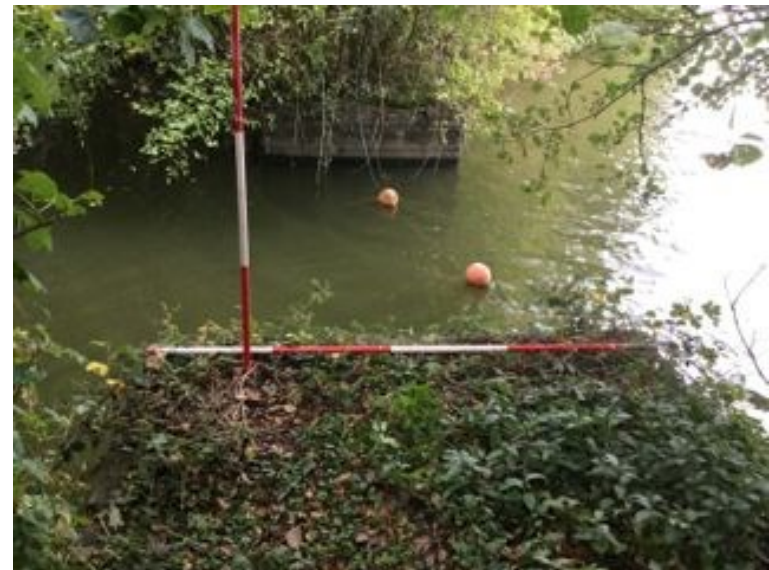
Fig. 9 Stone piers flanking entry to 'harbour' looking west.

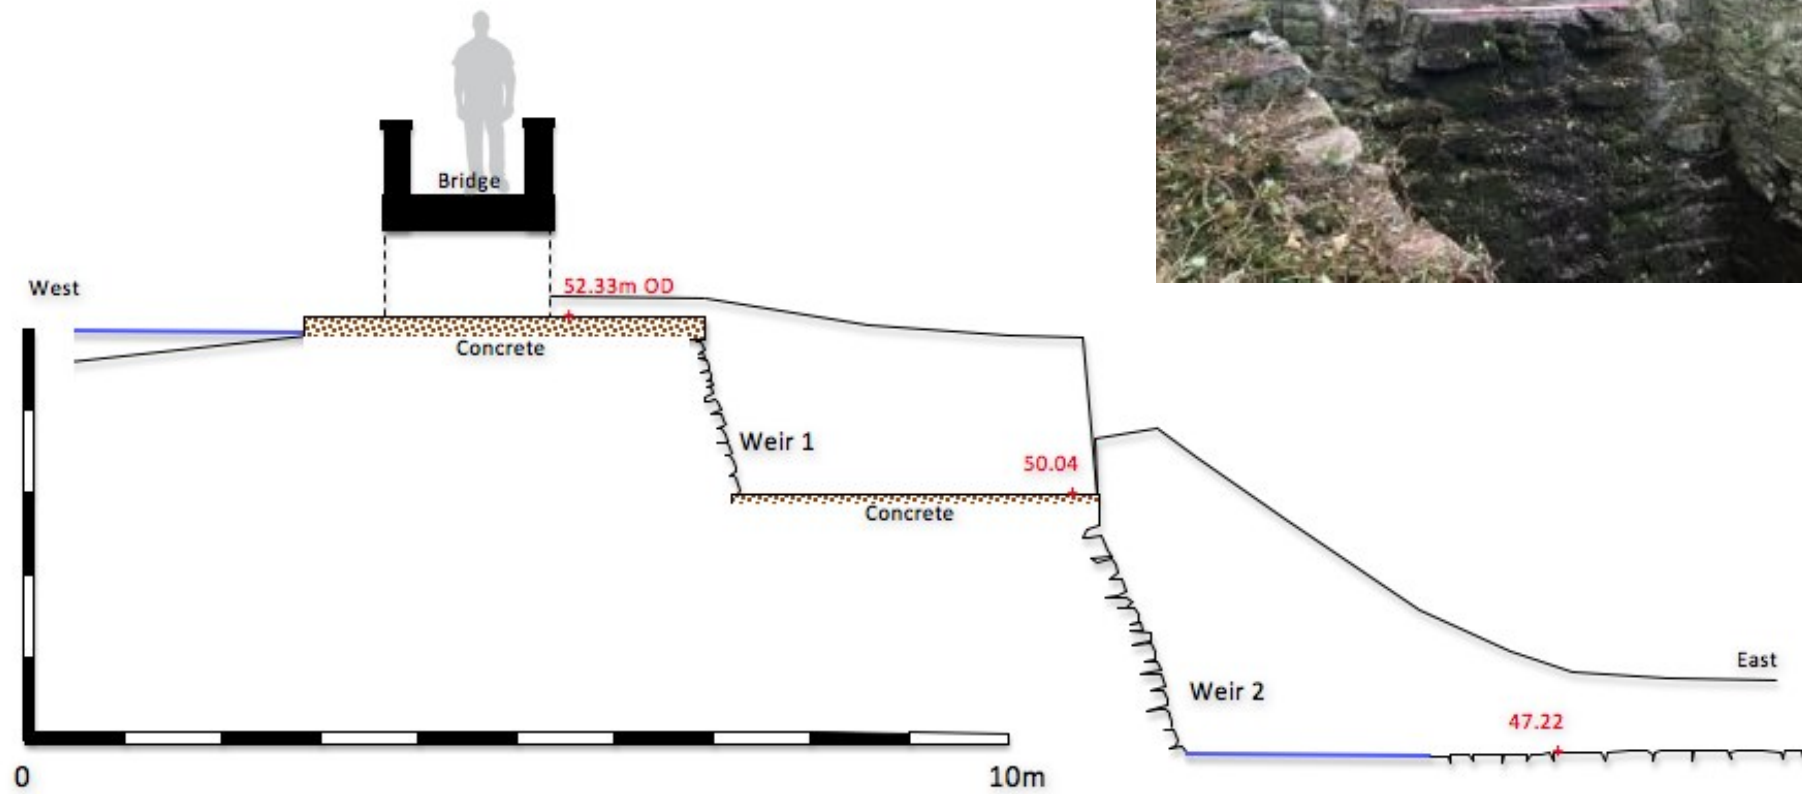
4.2.1 The second and largest weir, around 3m east of weir 1 lies skewed across the line of the channel turning the flow towards the north by about 20 degrees (Fig. 12). This change in direction is necessary to direct the flow of water along the south side of the existing valley. As well as the lip being angled the batter on the face of the weir itself is skewed so the slope at the northern end is steeper than to the south. The face is 3.2m wide and 2.6m high at its lowest central point and built of large blocks of coursed rubble. There is no evidence of any major repair. Some stones on the upper course do project forwards and this have been an attempt to push the nappe further out from the face of the weir (Fig, 14).

Fig. 14 The bridge with weirs 1 and 2 looking west.

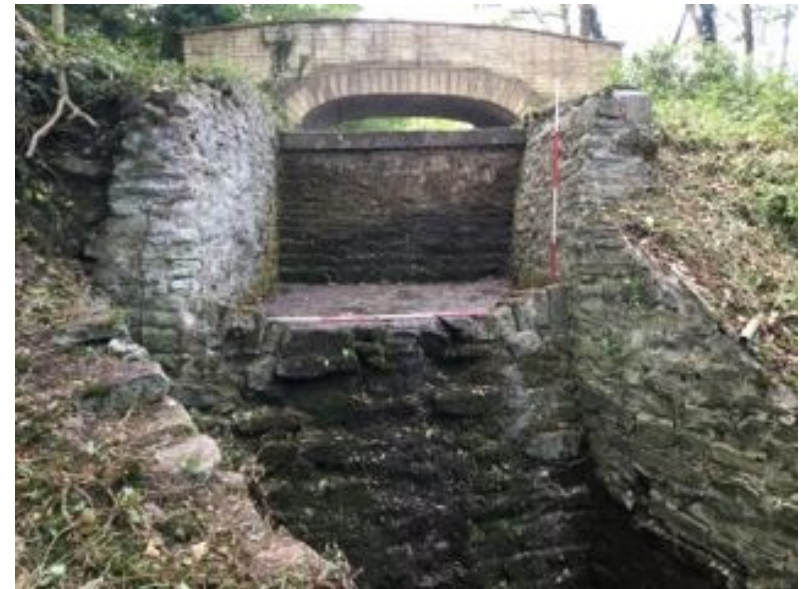
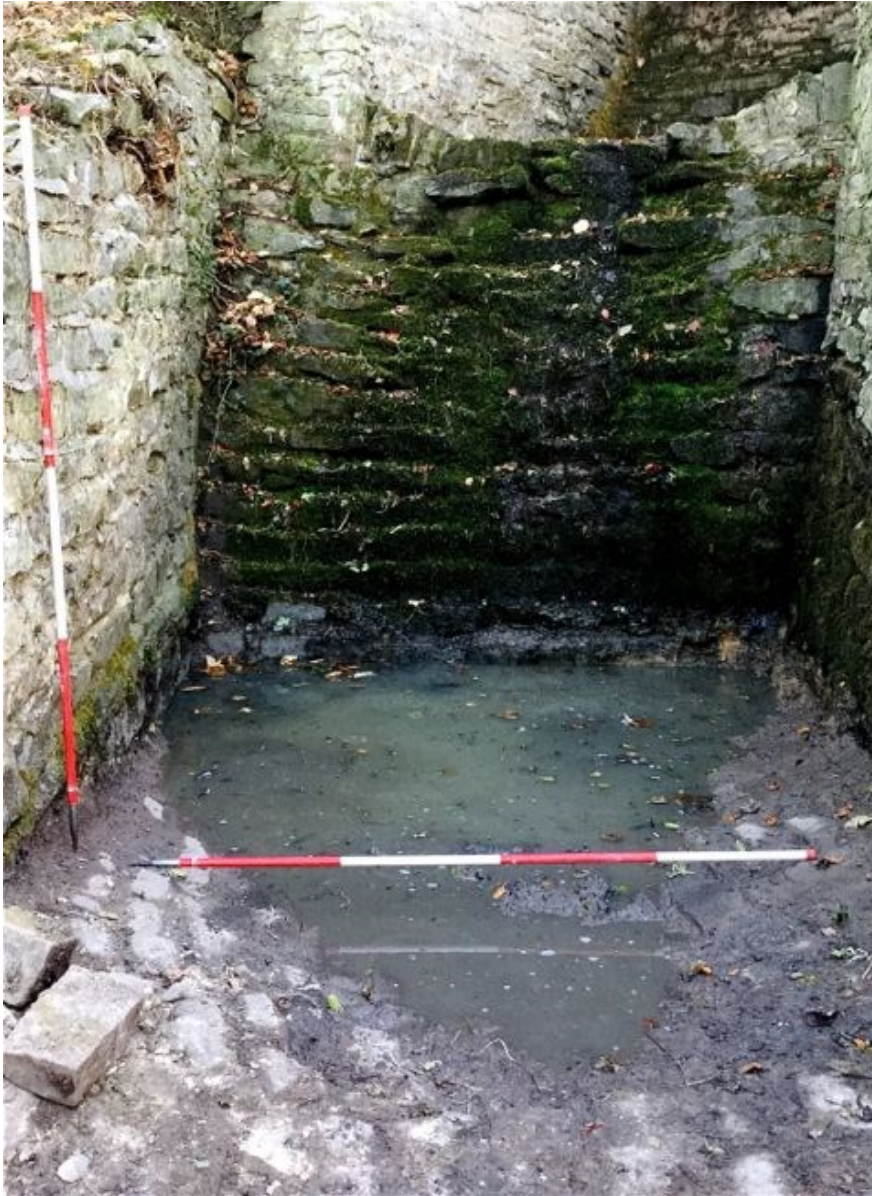
Fig. 15 Weir 2 and stilling basin looking west.

4.3.1 At the foot of weir 2 lies a sunken area of channel with a base of large stone setts which extends out for roughly 6m (Fig. 15). This has a dished profile and was probably designed as a stilling basin to absorb some of the turbulence at the foot of the largest cascade. Beyond that the larger stone setts (Fig. 18) continue for an additional 5m before giving way to lighter stone setts at a point where presumably turbulence is no longer an issue (Fig. 19). The tall flanking

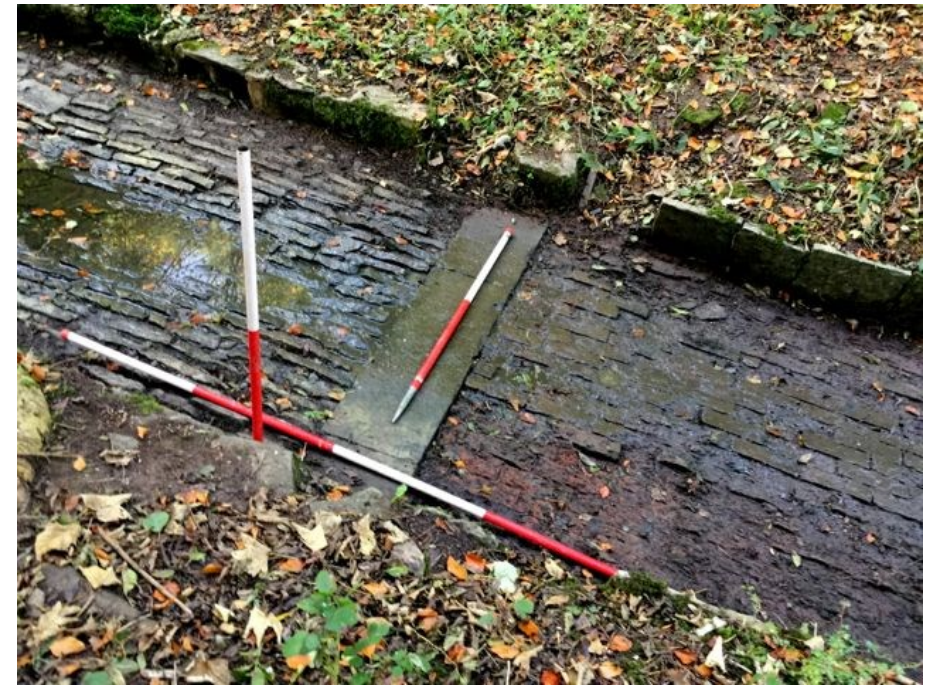
Fig. 16 Junction between the stone and brick base for the channel looking north.

walls to the channel reduce in height as the dam drops away until they consist of a couple then a single course lining the channel as it continues eastwards. At around 24m east of weir 2 the pitched stone surface and is replaced for the next 3m by longitudinally laid brick (Fig. 21). The junction between the two is marked by three well dressed stone blocks set in line (Fig. 16). The brick based channel also has a different form of lining using thin stone slabs set on edge.

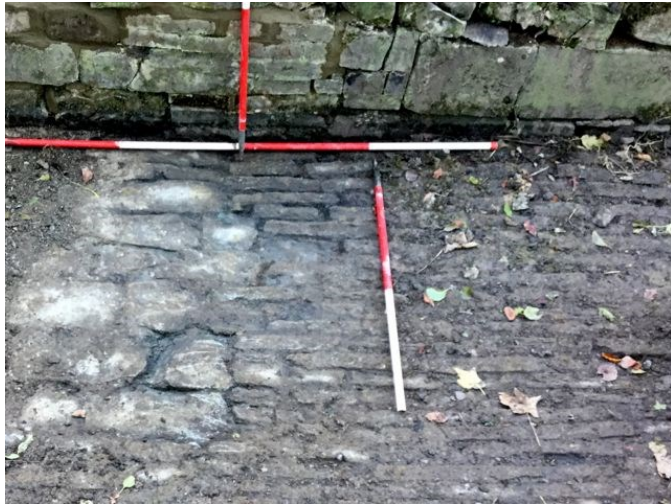
Fig. 18 Junction of stone setts, east end of stilling basin looking north.

Fig. 19 Junction of large stone setts with small stone setts, looking north.

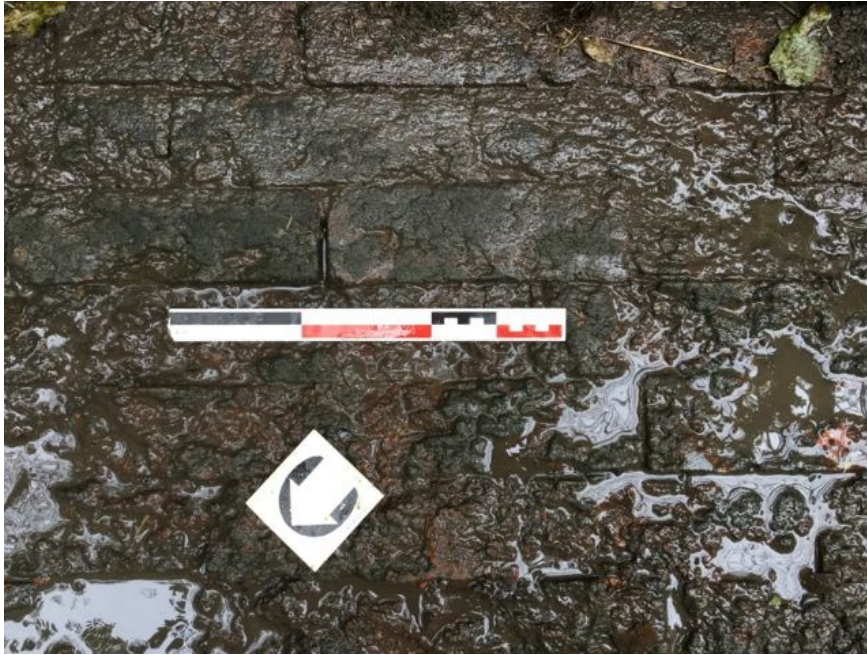
Fig. 21 Detail of brick lining to channel.

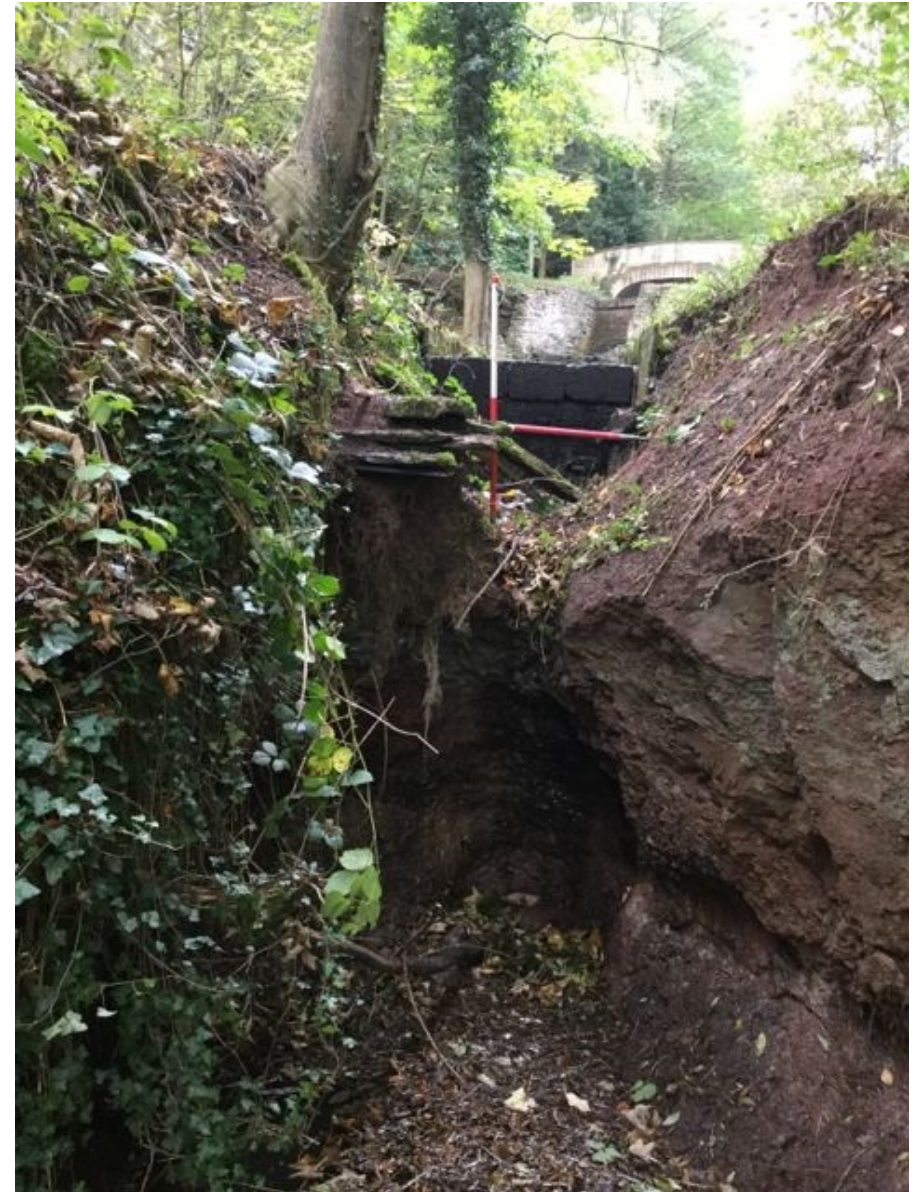
Around 5m downstream, on the south side of the channel are a pair of large stone slabs whilst above them the bank is revetted in brick (Fig. 23). Immediately beyond these remains the water plunged down almost 2.5m into deeply cut ravine (Fig. 24) which broadens out into a scoured pool measuring some 10m in length and 7m in width. The margins of this expose the red marly clay derived from the underlying mudstones.

Fig. 24 The ravine to the east of weir 3 looking south west.

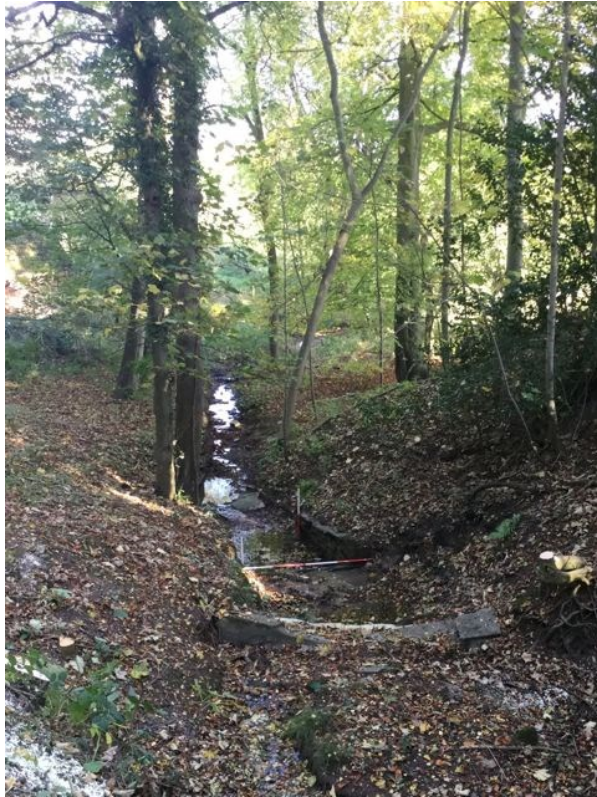
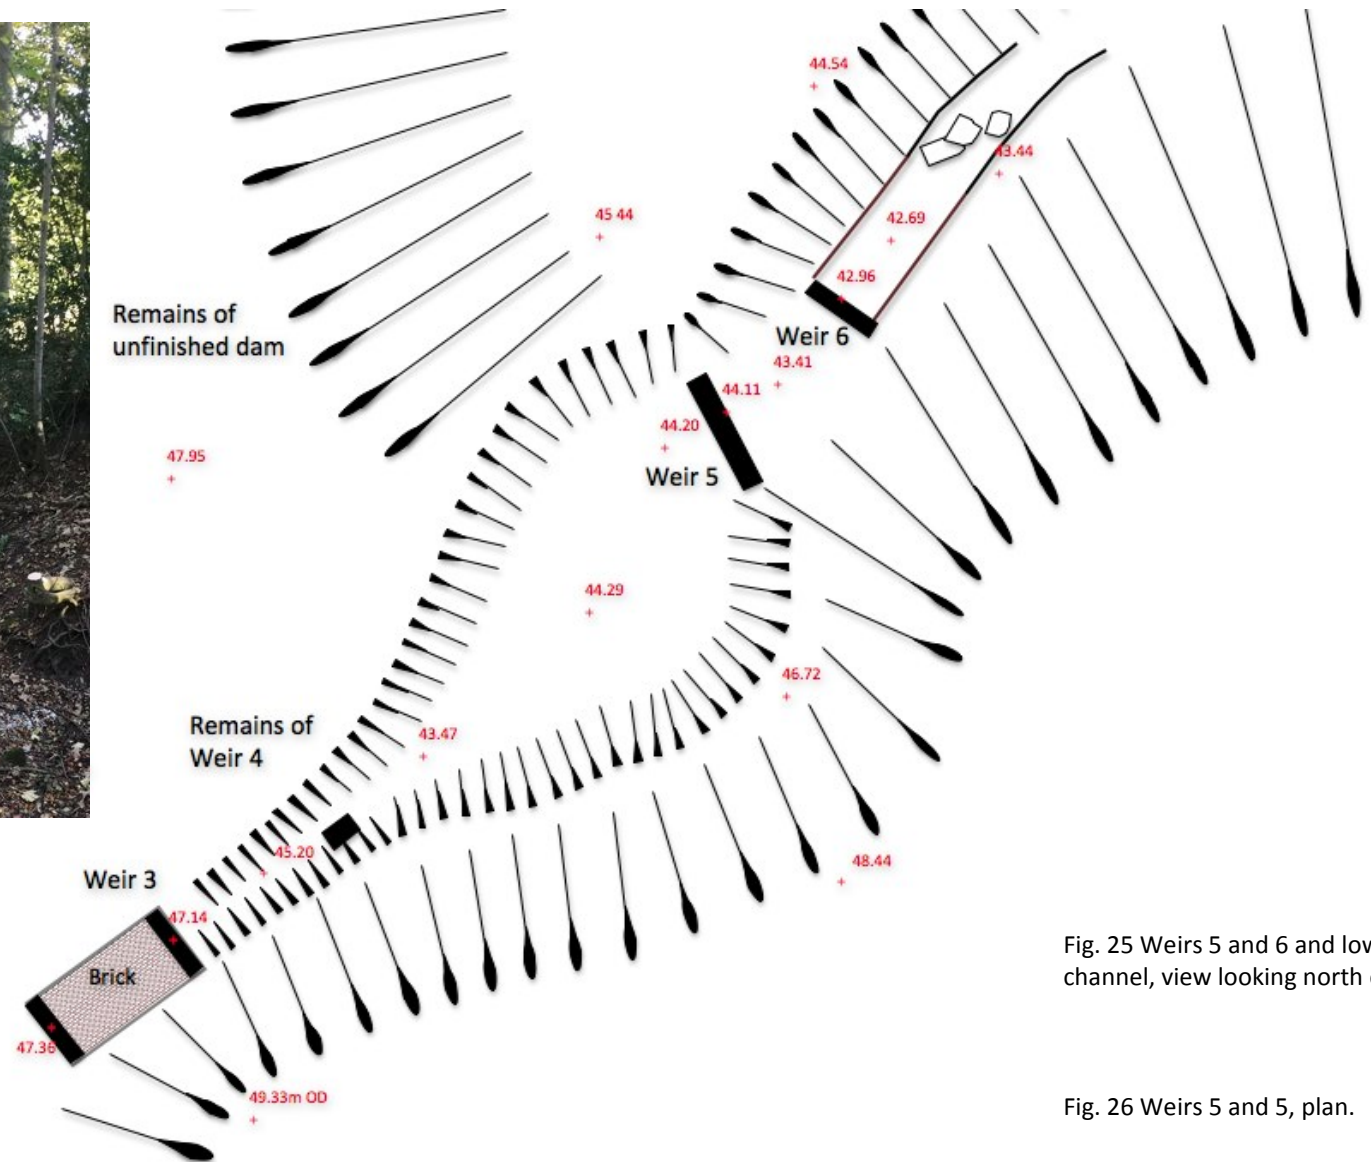
Fig. 25 Weirs 5 and 6 and lower channel, view looking north east.

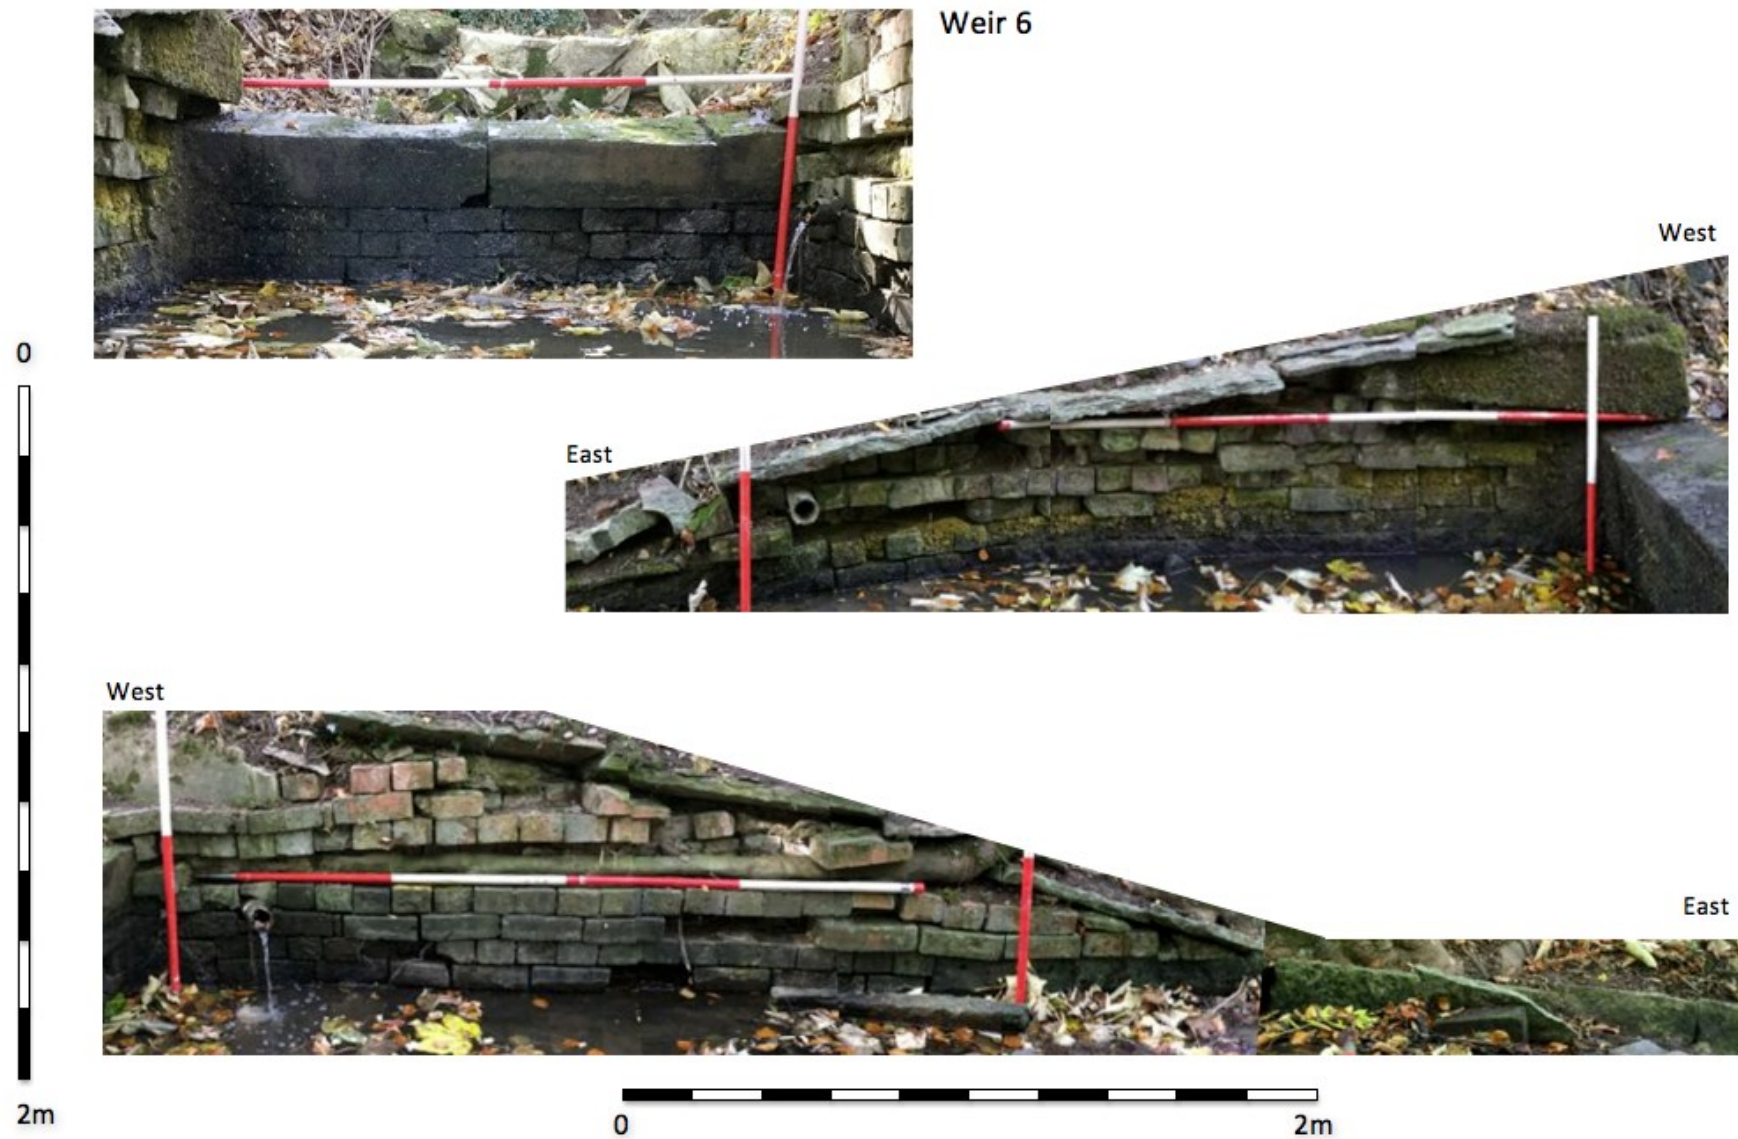
Fig. 31 Weir 6 face and flanking walls to downstream channel, composite photos.

4.5.2 Weir 6, 4.5m beyond weir 5 was in a better state of repair and consisted of a single course of well shaped stone blocks above 5 or 6 courses of brickwork. This was carried round to edge the downstream channel for around 5m with flanking walls with stone coping slabs (Fig. 29). The channel at this point was water filled and heavily silted in places. The brick walling gave way to edging with vertical stone

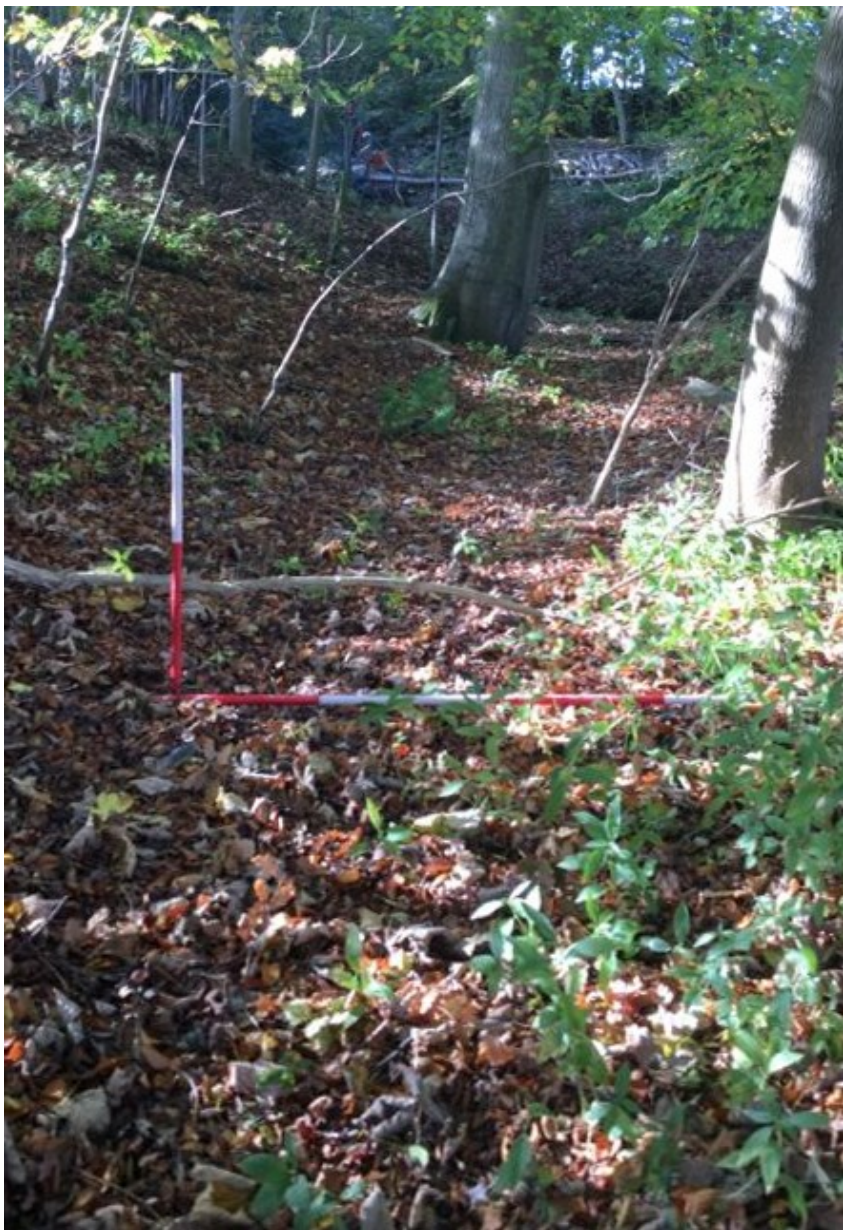
Fig. 33 Earthwork looking west on line of original channel?

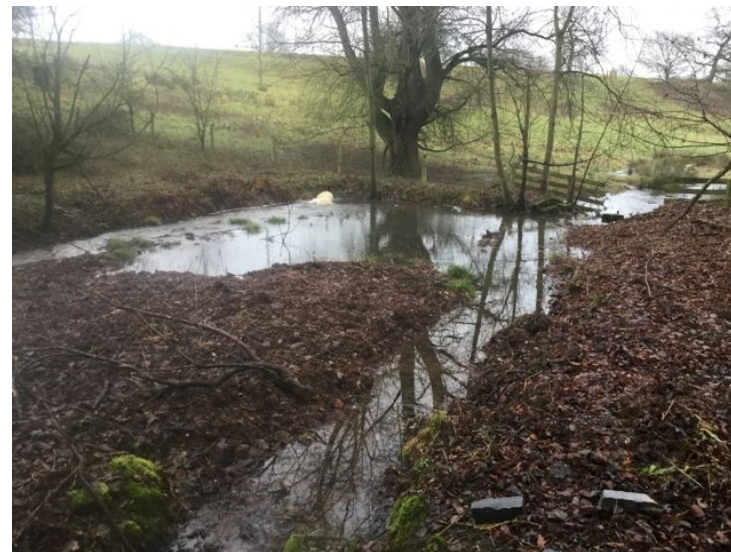
4.7.1 The roughly circular pool (Fig. 34) is around 15m in diameter and may be a very recent addition to the landscape. It does not appear in the early OS maps and as indicated above the early channel may have continued to flow along the foot of the scarp a little further south. The exit from the pool is marked by an irregular construction

Fig 34 Pool south of pump house looking north east.

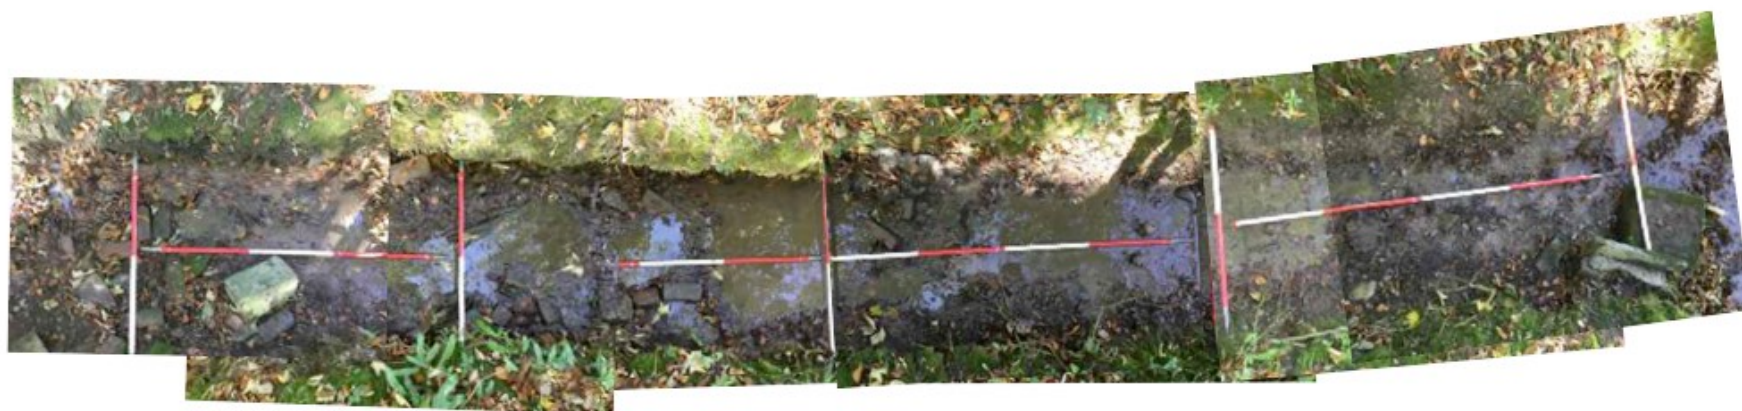
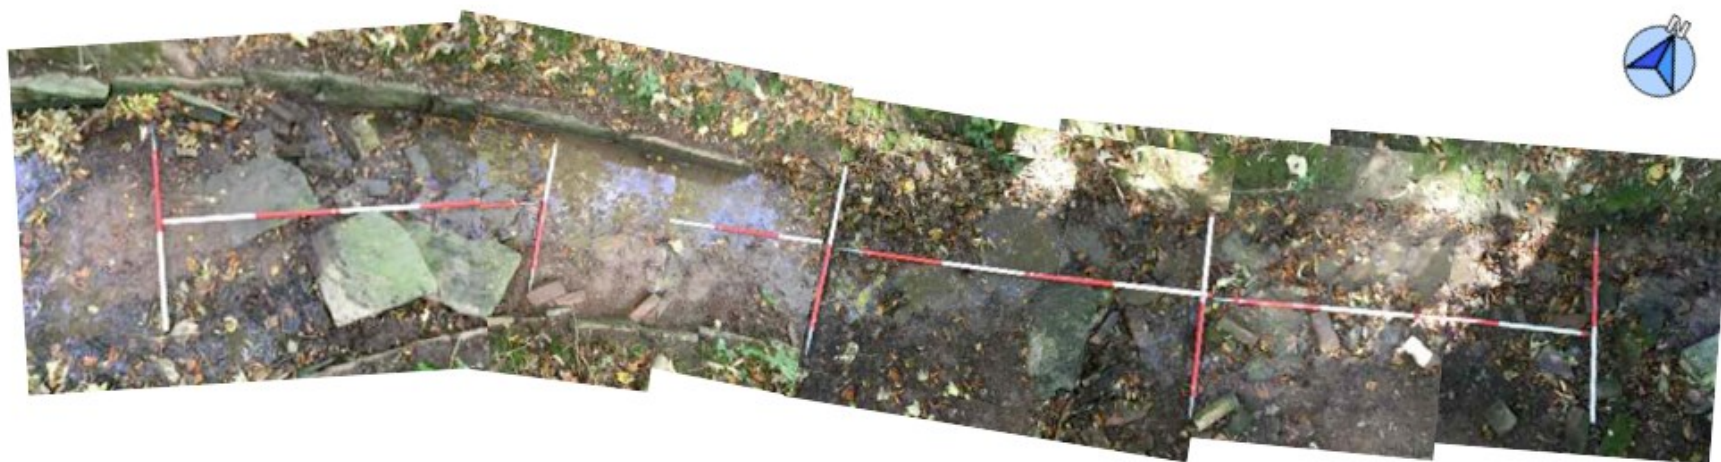
Fig. 36 Lower portion of channel, composite photo.

4.6.1 The remainder of the channel continued down the valley in a north easterly direction for just under 15m (Fig. 36). There was no evidence of stone or brick lining for any part of this although plenty of brick and stone fragments had accumulated within banks of silt. Small test pits were dug into the bank at three locations to confirm the lack of any structural elements. Indeed early OS mapping indicates that the original line of the out flowing channel appears to bend slightly to the south beyond weir 6 on a line today marked by a shallow dry ditch (Fig. 35). The present day channel finishes at a small, heavily silted up, pool south of a derelict brick pump house. At this point are the remains of what may have been another small weir consisting of a couple of stone blocks in situ and one larger one displaced into the pool to the north (Fig 32).

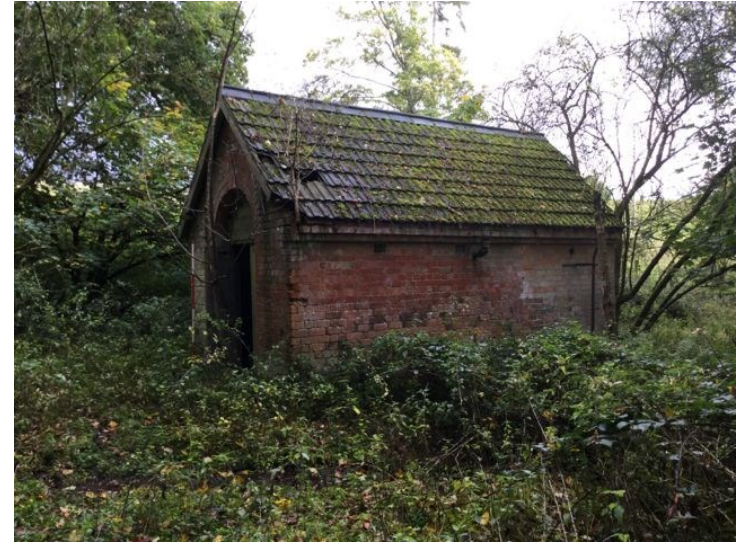
4.8.3 The Pump house and oil engine (Warwickshire HER ref. MWA1446). This structure lies close to the northern side of the valley approximately 70m east of the dam. It is a single cell brick building currently under a concrete tile roof, presumably a replacement for an earlier slate one, with opposed entrances in the gable ends (Fig 38). Inside are the considerable remains of an oil engine (Fig. 39). No attempt was made to identify the maker but it probably dates from the late nineteenth or early twentieth century. The building does not appear of the tithe map from the 1850s but is present on the OS 6 inch to the mile map from the 1880s.

Fig. 38 Pump house looking north.

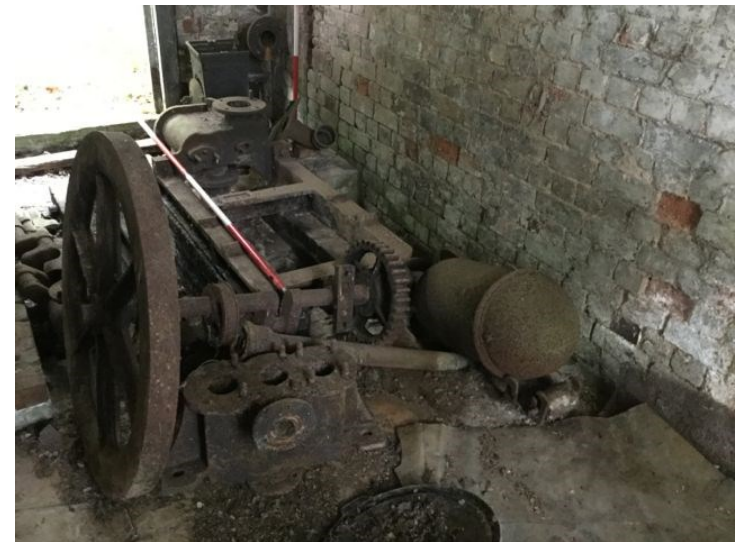
Fig. 39 Oil engine within pump house looking north.

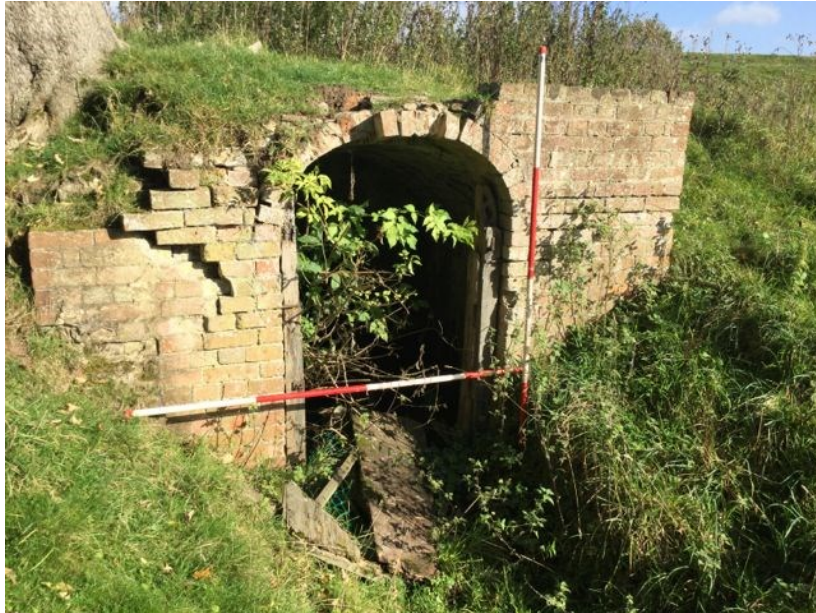
4.8.4 The spring house. Built into the valley side some 30m to the north east of the pump house is a small brick chamber entered from the south by an arched doorway (Fig. 40). The structure is in very poor condition and was not entered but from its situation it seems likely that this was put up to accommodate some sort of mechanism for tapping water from a spring at this point.

Fig. 40 Spring house looking north.

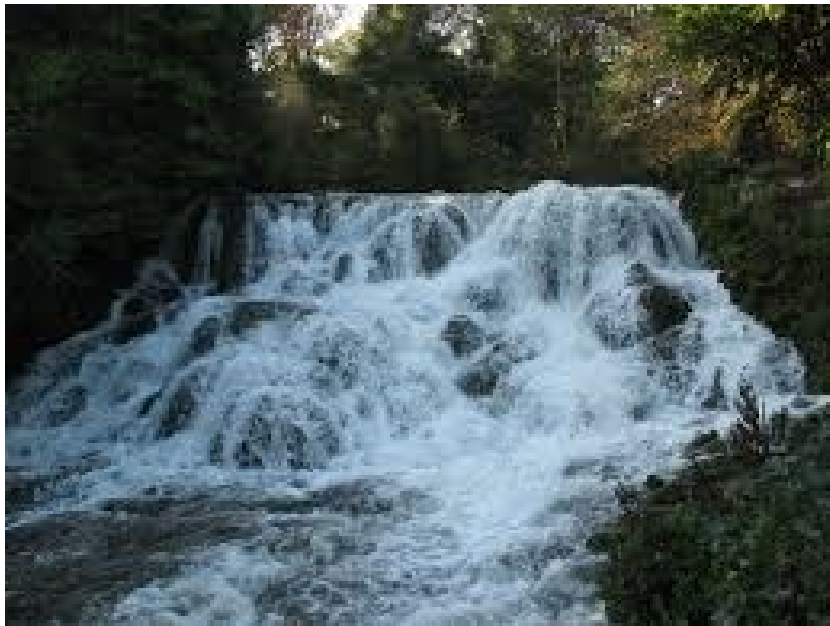
Fig. 41 The weir at Blenheim looking north.

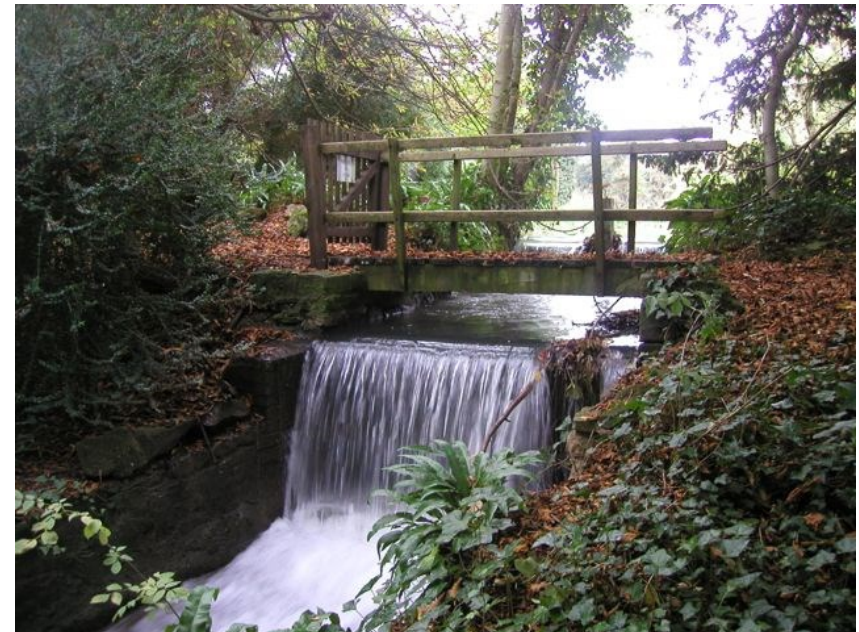
he did construct, notably at Blenheim (Fig. 41) , features which managed to drop the level of waters in a dramatic but naturalistic way. The closest parallel the author has seen is at Kiddington in Oxfordshire, another site where Brown's influence is suspected.^{xv} Here we have a similar arrangement with water drained from the lake over a small steep weir set between flanking walls below a footbridge (Fig. 42). The construction at Ragley seems to more about an engineering solution than an artistic one. It is perhaps significant how small an impact on the landscape the cascades make.

Fig. 41 The weir at Kiddington looking north west.
